## PHOTO LOG

| Facility Name: | Amite BioEnergy (Drax) |
| EPA Media: | Stormwater - Industrial |

| Date Stamp: | 3/5/2024 |

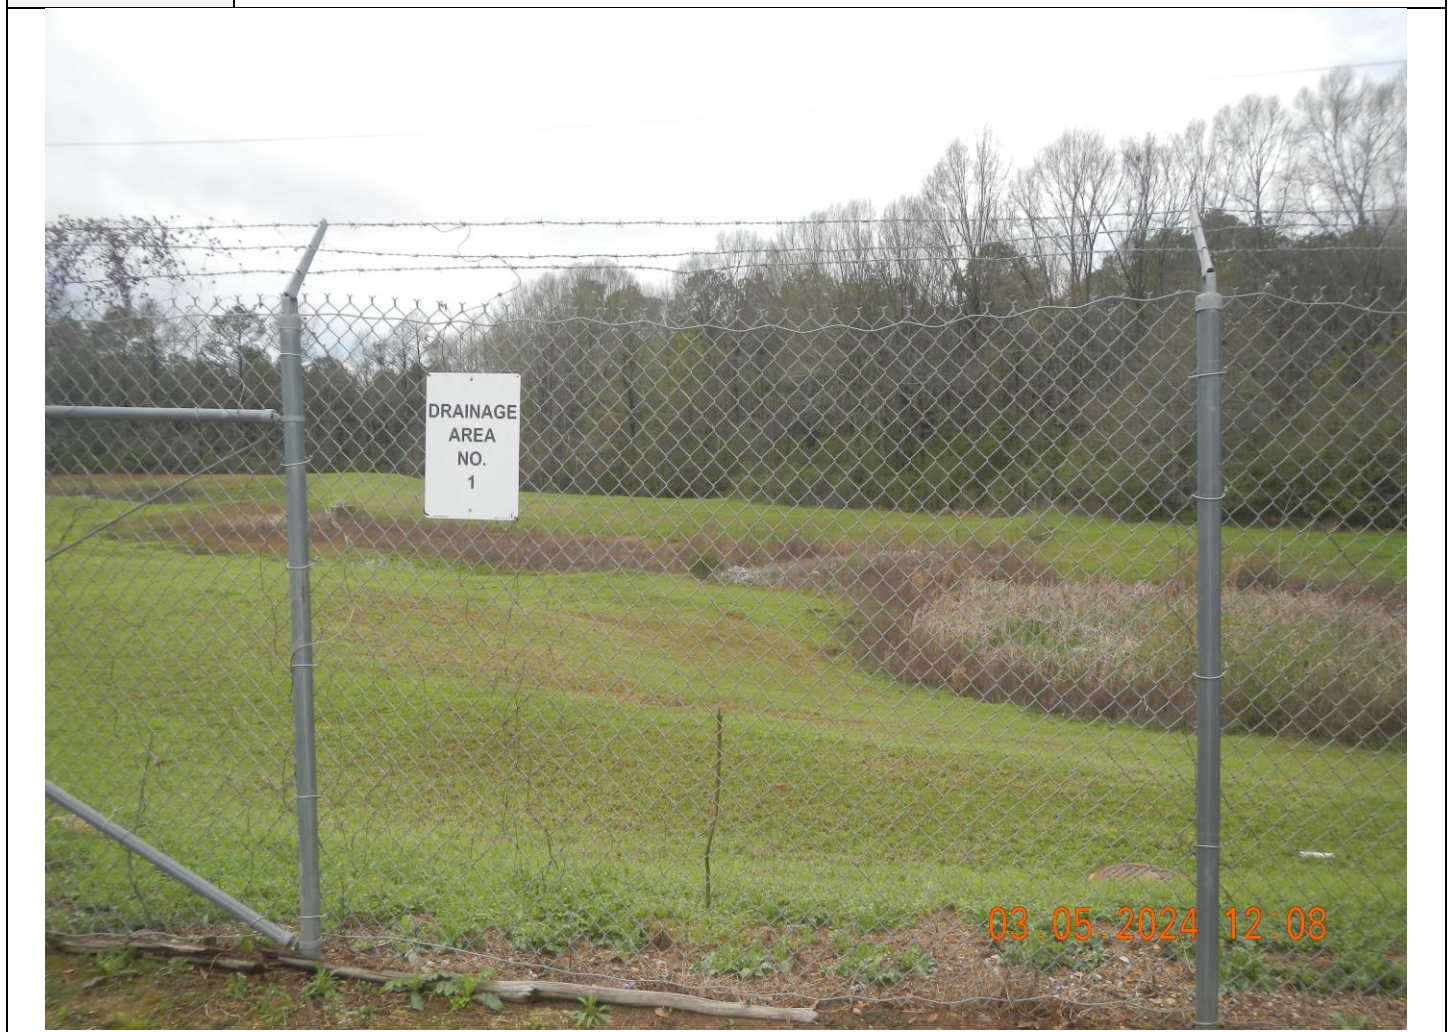
| <b>Photo ID:</b> | DSCN2908.JPG |

| <b>Description:</b> | Labels in the field correspond with the outfall numbers assigned in the SWPPP. |

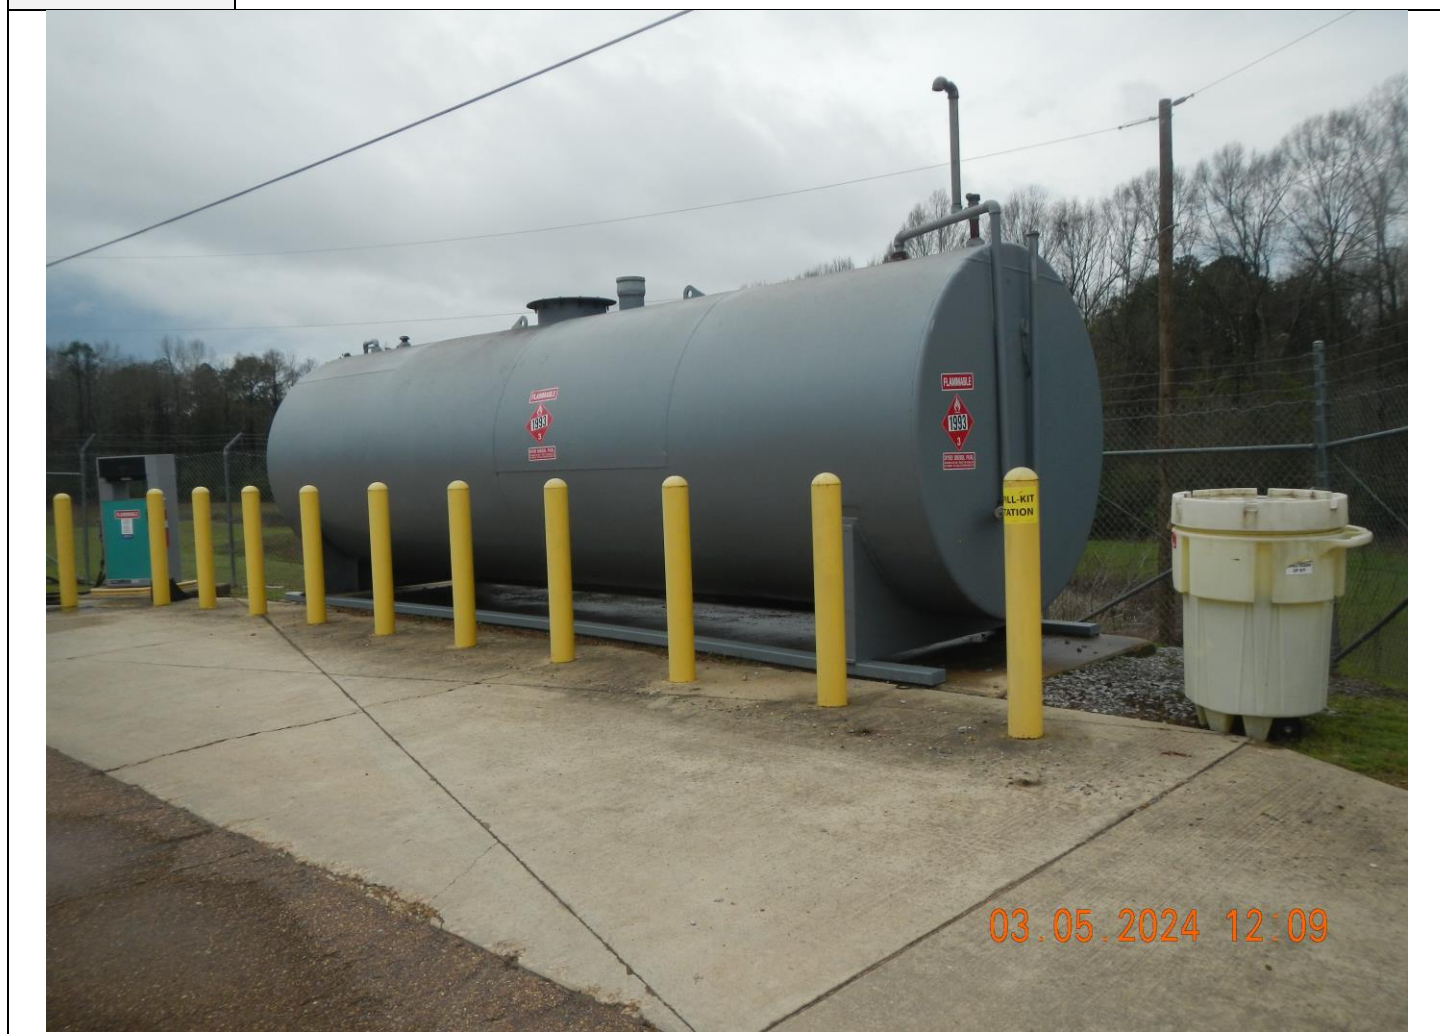
| <b>Photo ID:</b> | DSCN2909.JPG |

| <b>Description:</b> | View of the facility's diesel fuel tank and a nearby spill kit. |

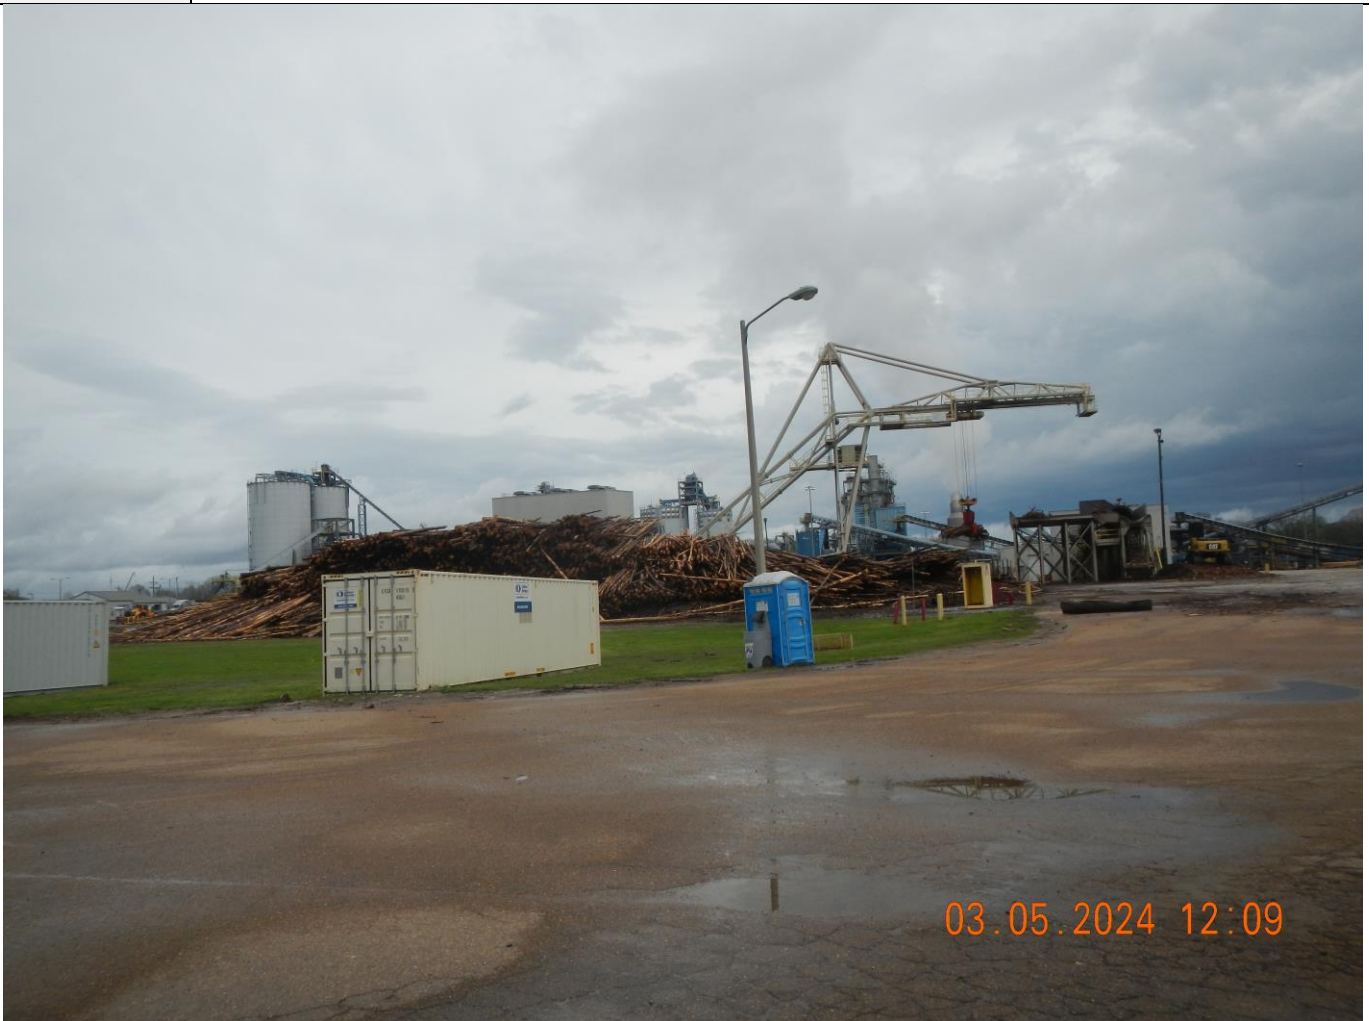
| <b>Photo ID:</b> | DSCN2910.JPG |

| <b>Description:</b> | Additional view of site and log storage area |

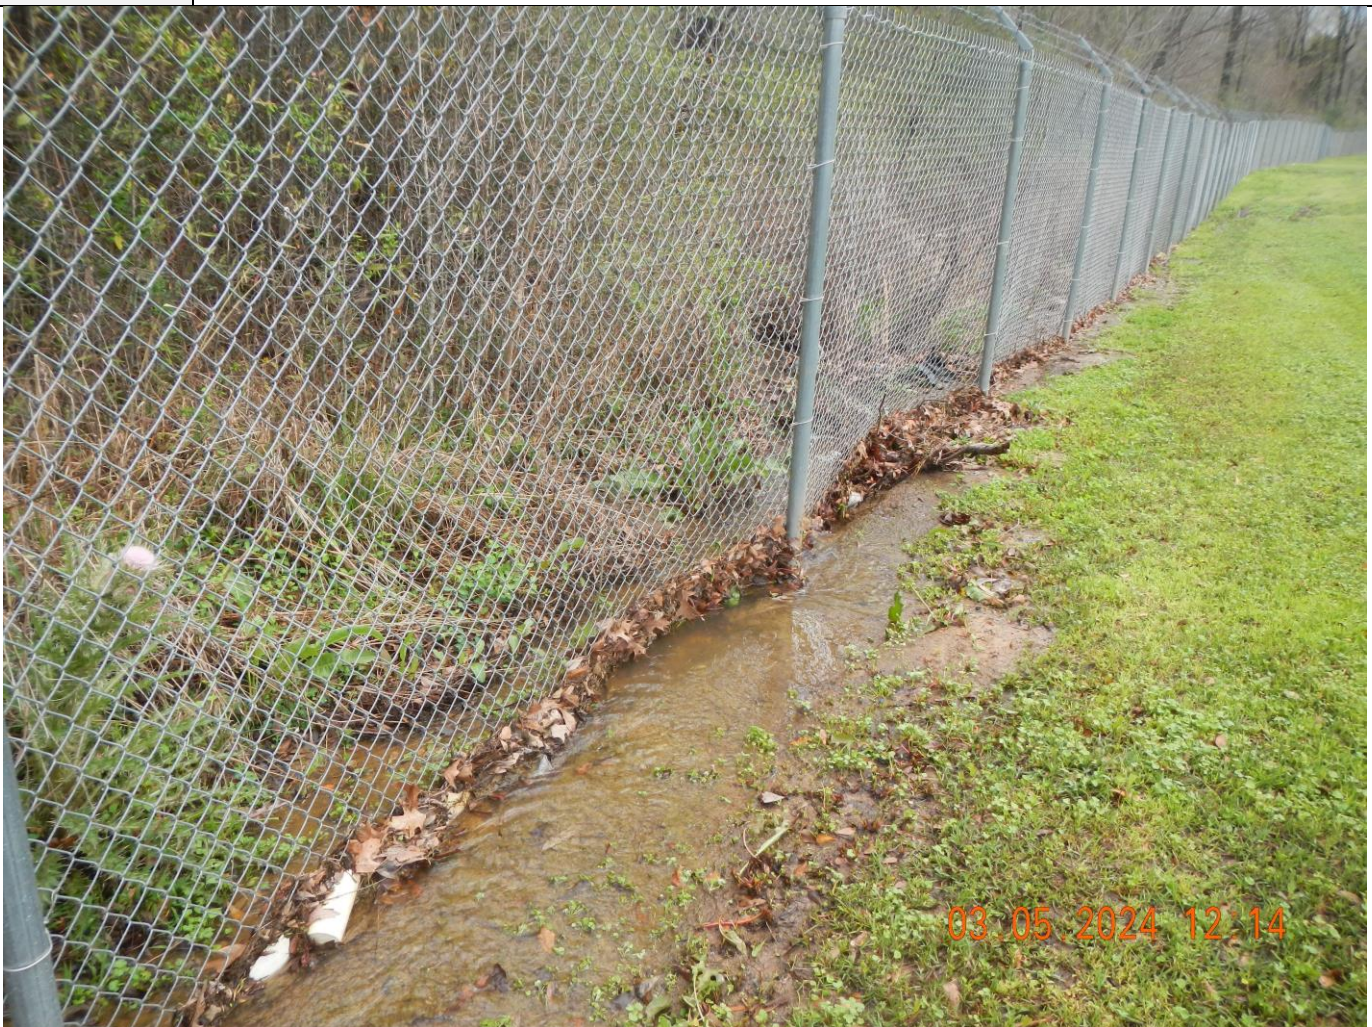
| <b>Photo ID:</b> | DSCN2911.JPG |

| <b>Description:</b> | Location where outfall 003 leaves the property. |

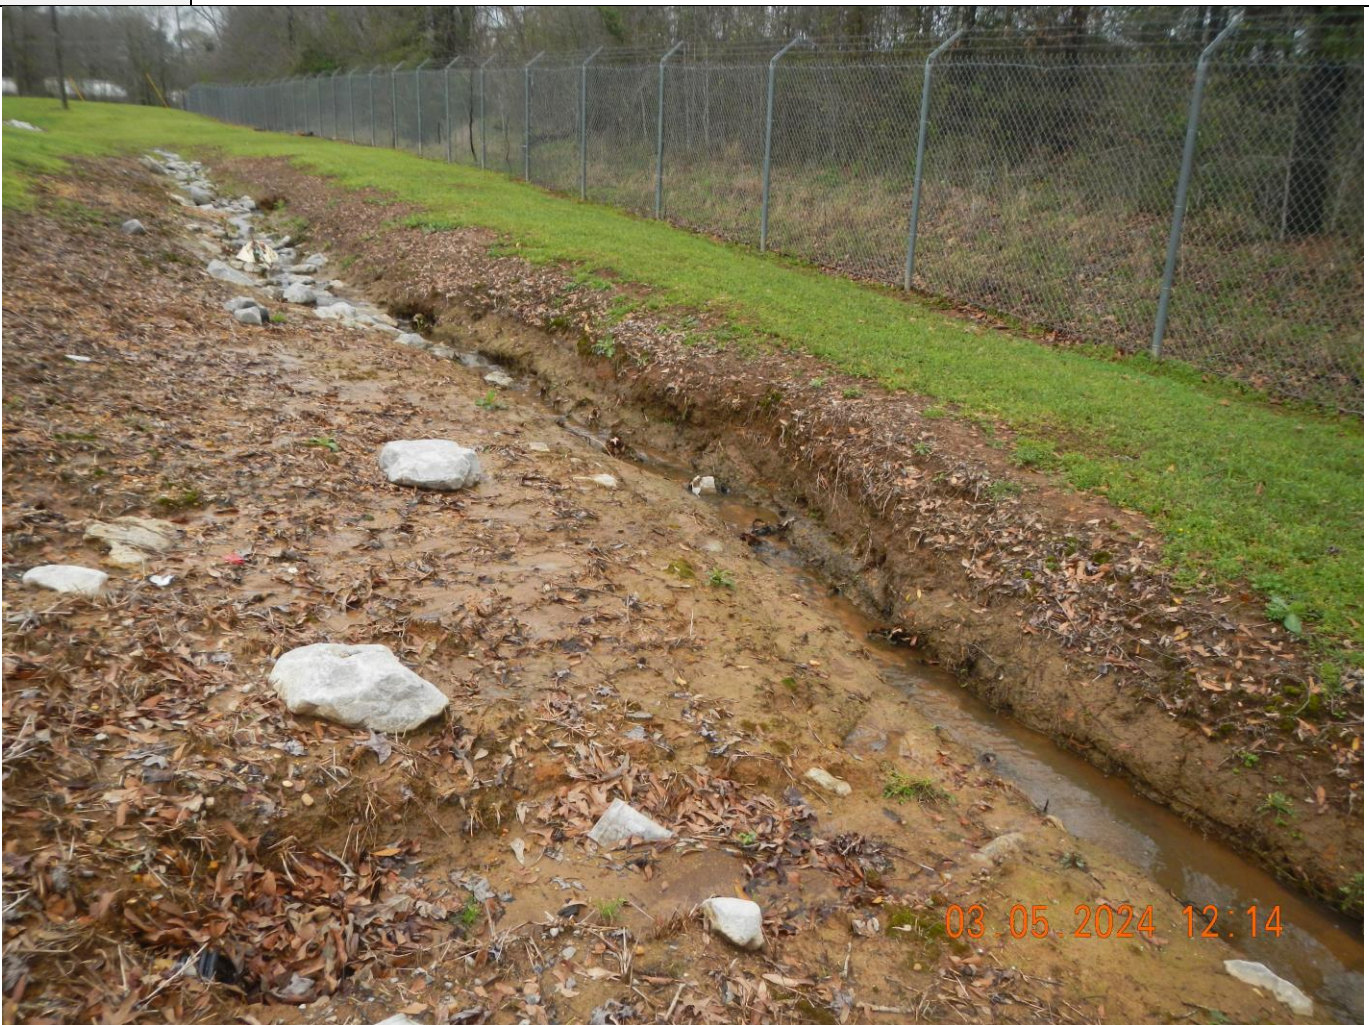
| <b>Photo ID:</b> | DSCN2912.JPG |

| <b>Description:</b> | Looking upgradient at the channel for Outfall 003. The sides of the conveyance were beginning to erode and had some bare areas. |

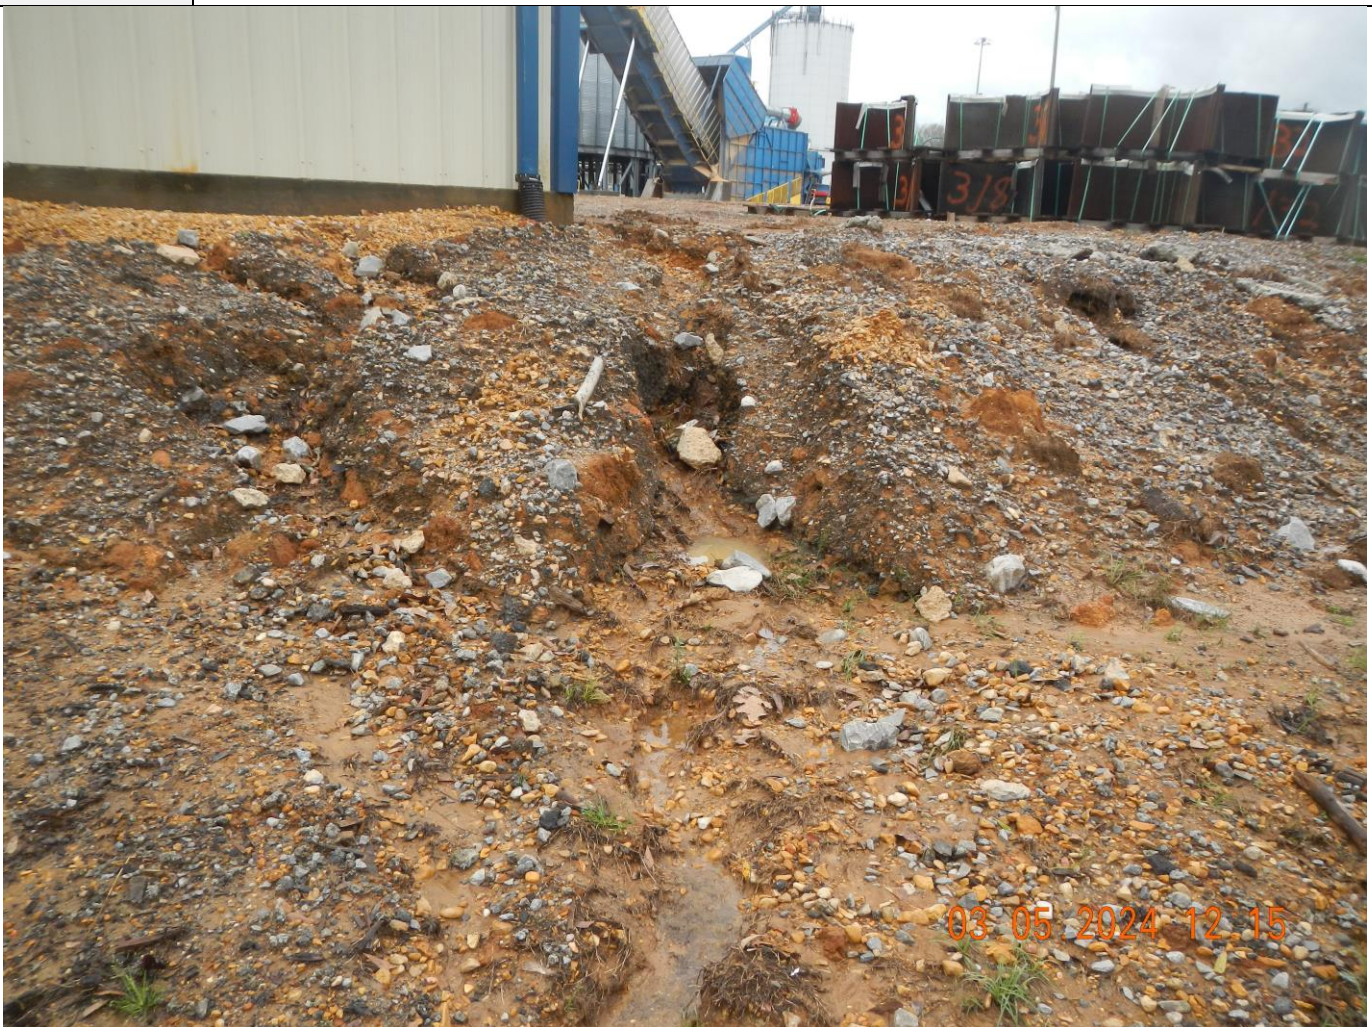
| <b>Photo ID:</b> | DSCN2913.JPG |

| <b>Description:</b> | The slopes behind the maintenance shed and above the conveyance for Outfall 003 (see photo DSCN2912) showed signs of erosion and rill formation. |

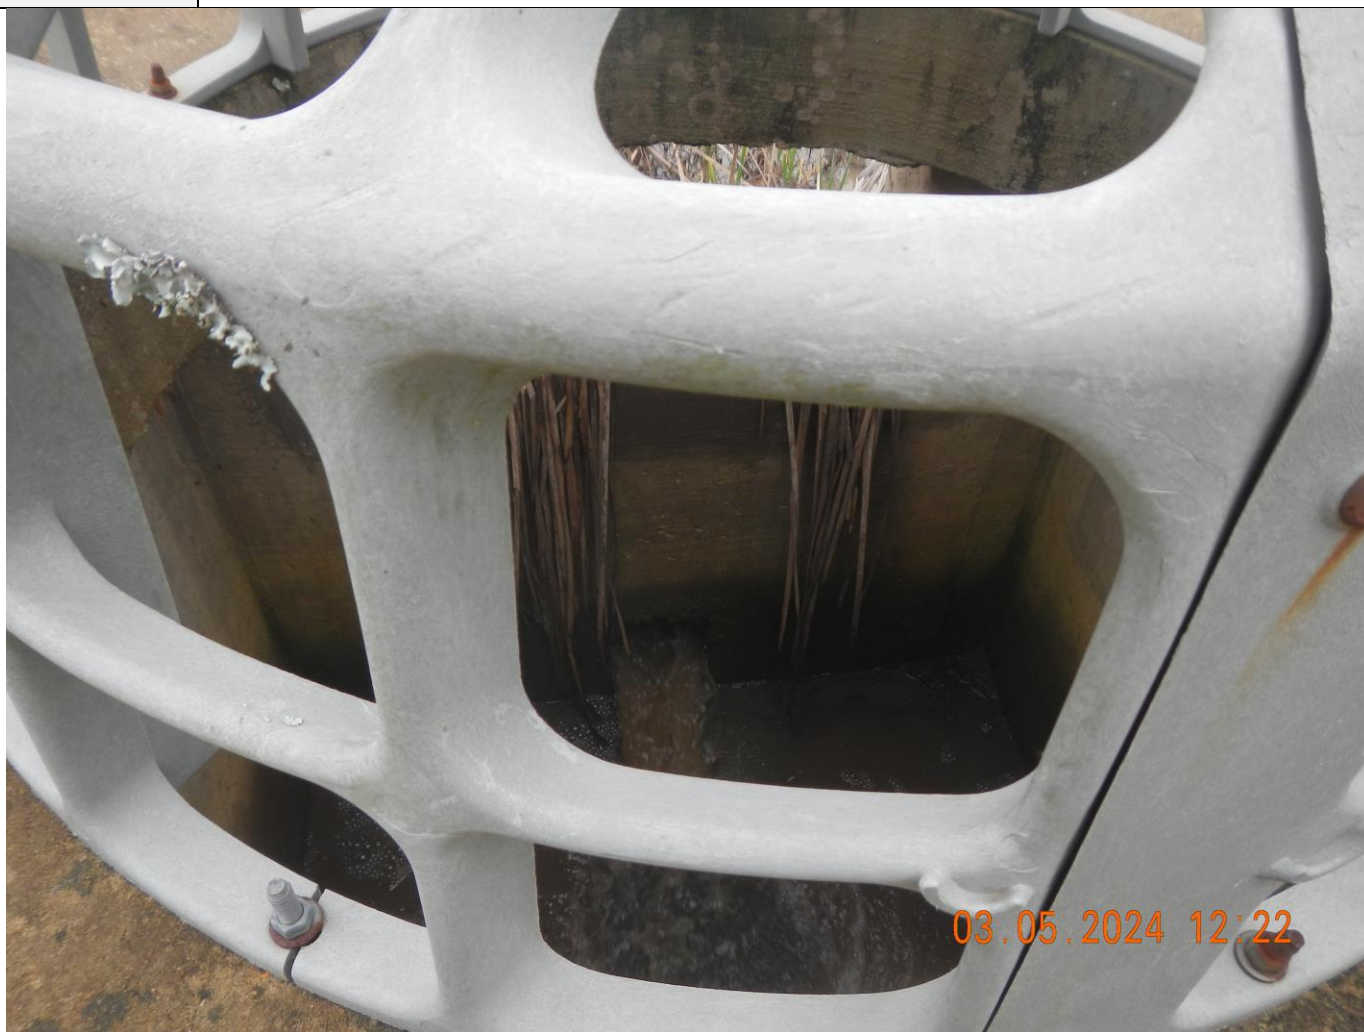
| <b>Photo ID:</b> | DSCN2915.JPG |

| <b>Description:</b> | See also photo DSCN2916. View of water discharging from the skimmer into the riser structure at pond 001. Outfall 001 is shown in photo DSCN2919. |

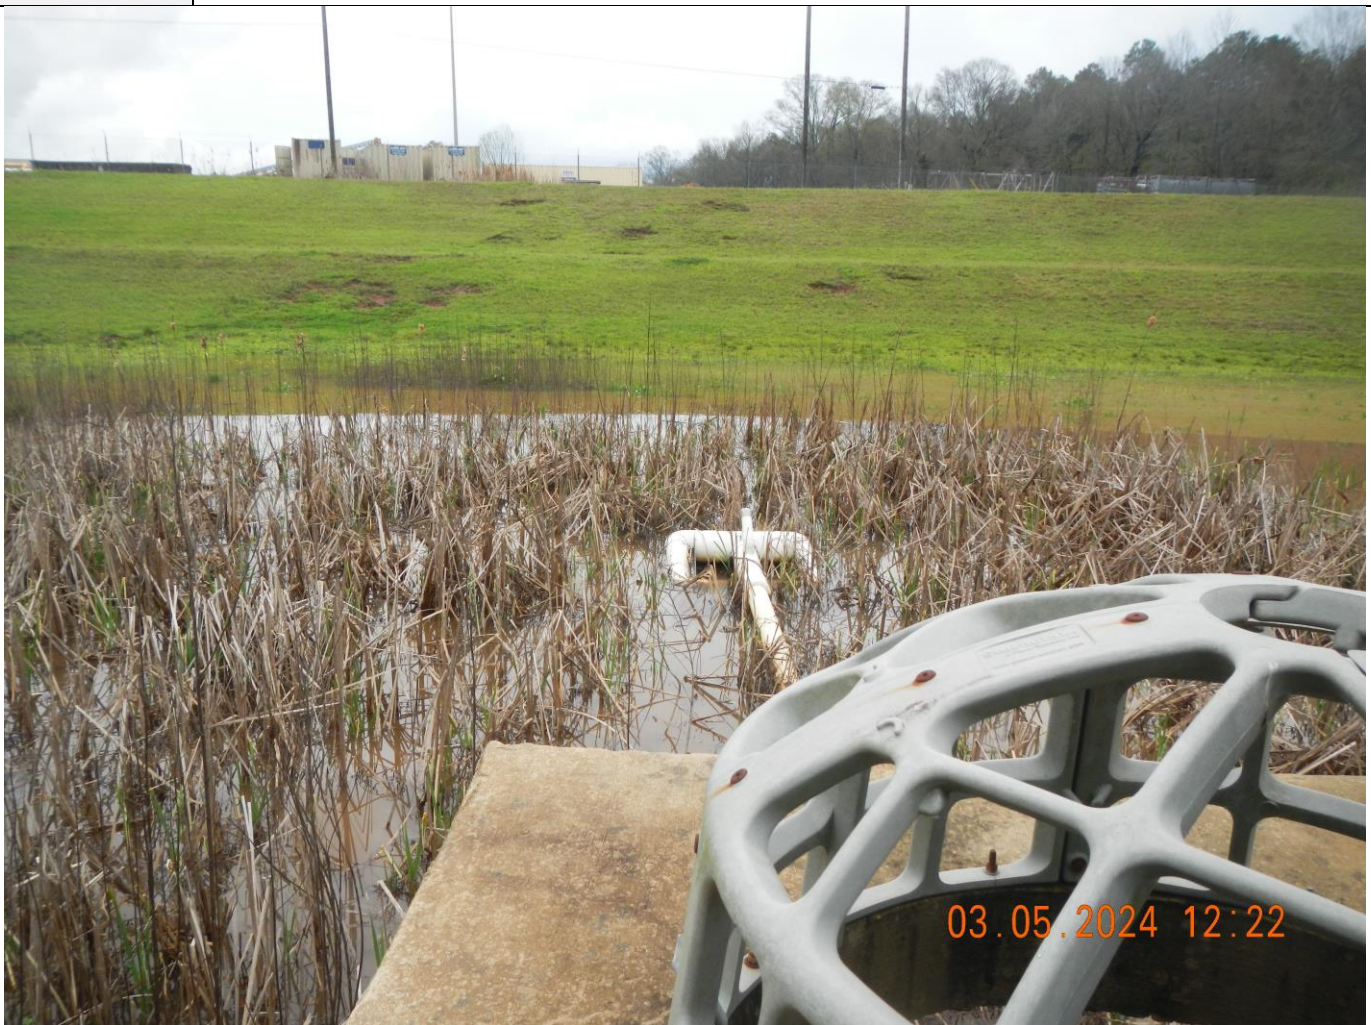
| <b>Photo ID:</b> | DSCN2916.JPG |

| <b>Description:</b> | See also photo DSCN2915. The riser structure at pond 001 was equipped with a floating surface skimmer. |

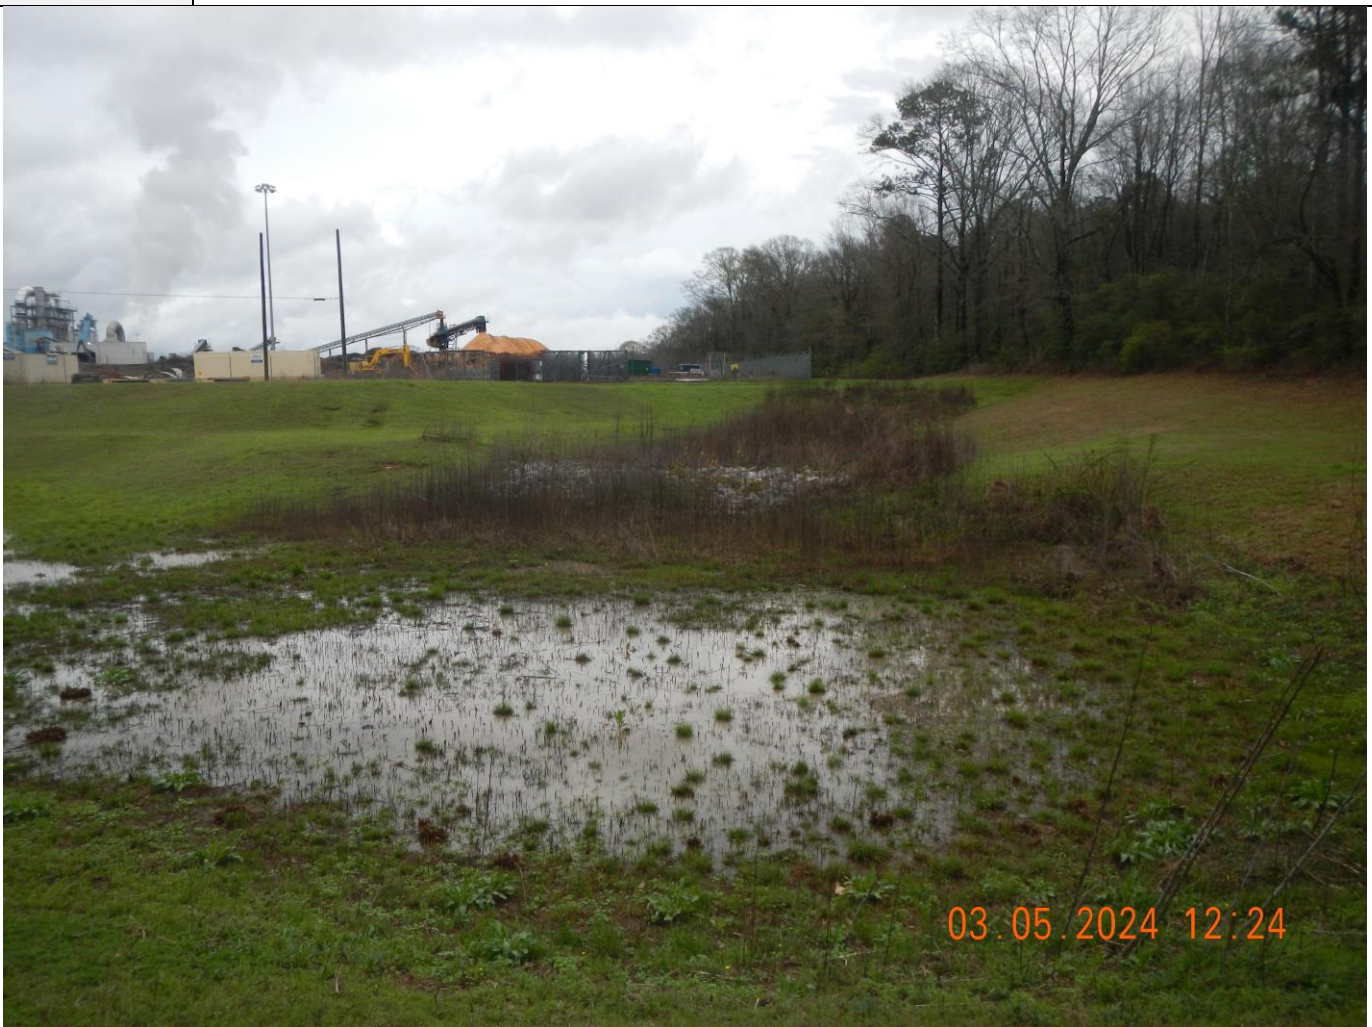
| <b>Photo ID:</b> | DSCN2917.JPG |

| <b>Description:</b> | Additional view of pond 001. |

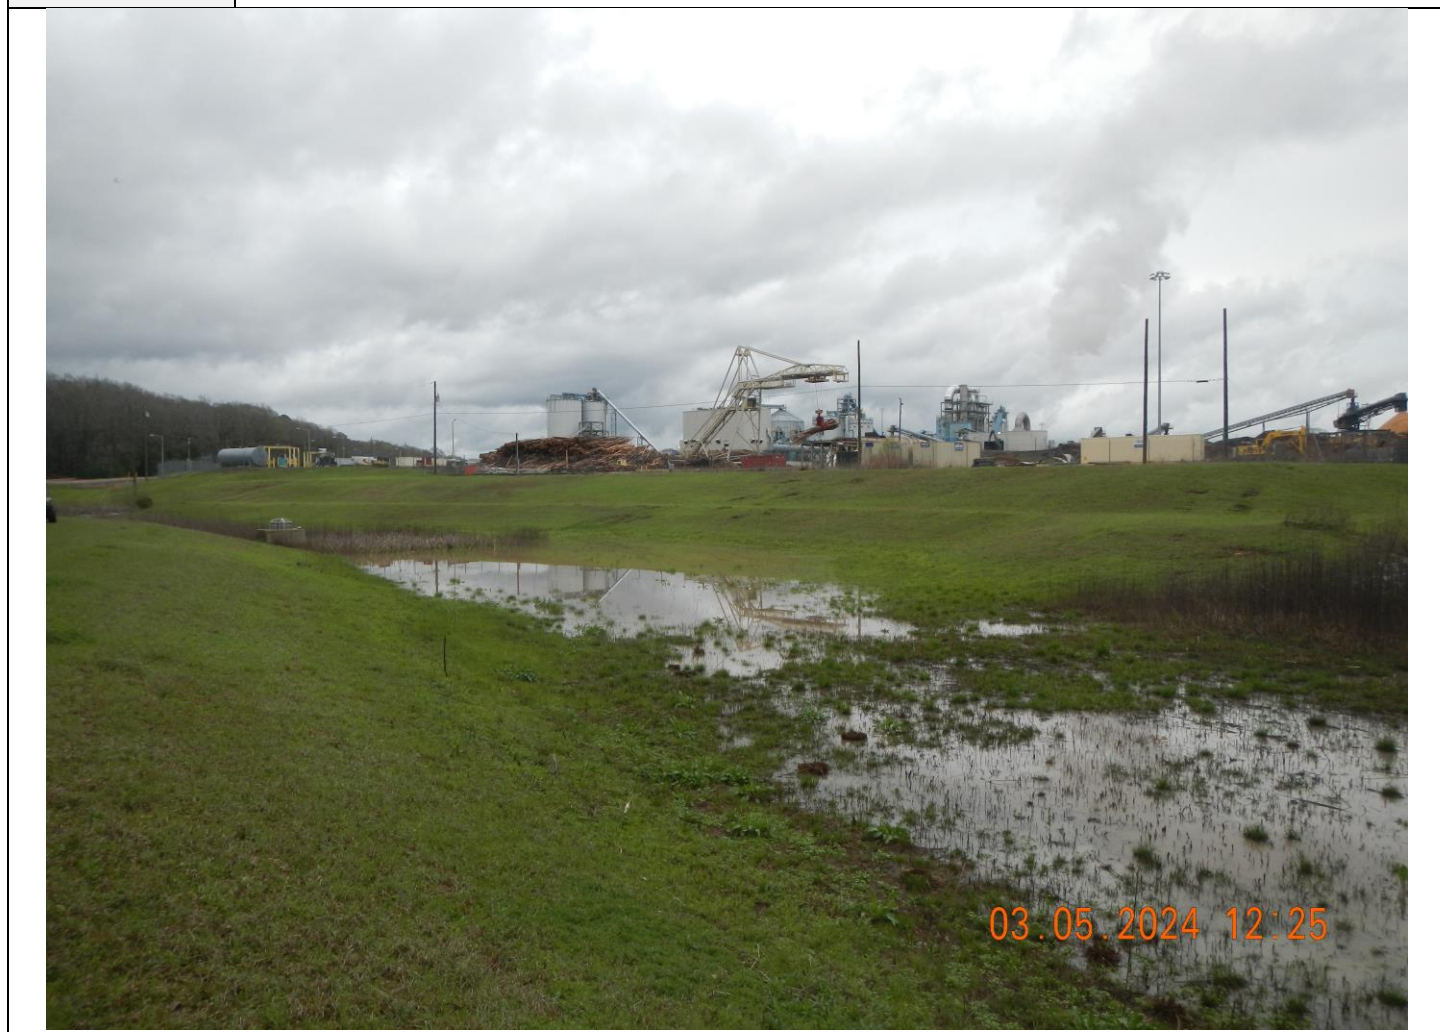
| <b>Photo ID:</b> | DSCN2918.JPG |

| <b>Description:</b> | Additional view of pond 001. The riser structure is visible in the center-left of the photo. |

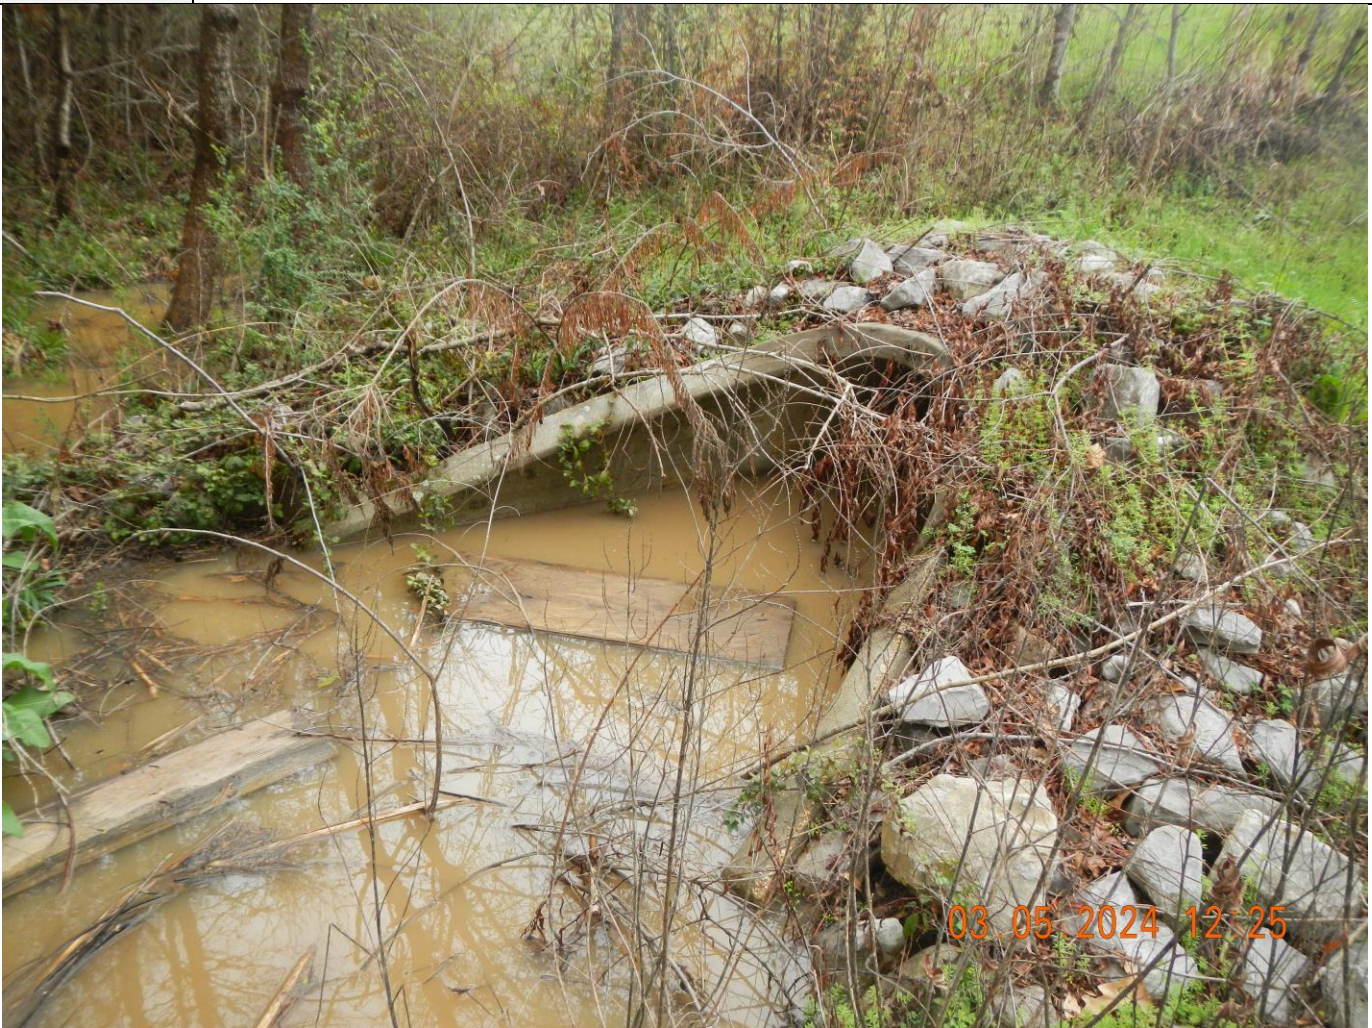
| <b>Photo ID:</b> | DSCN2919.JPG |

| <b>Description:</b> | View of outfall 001. |

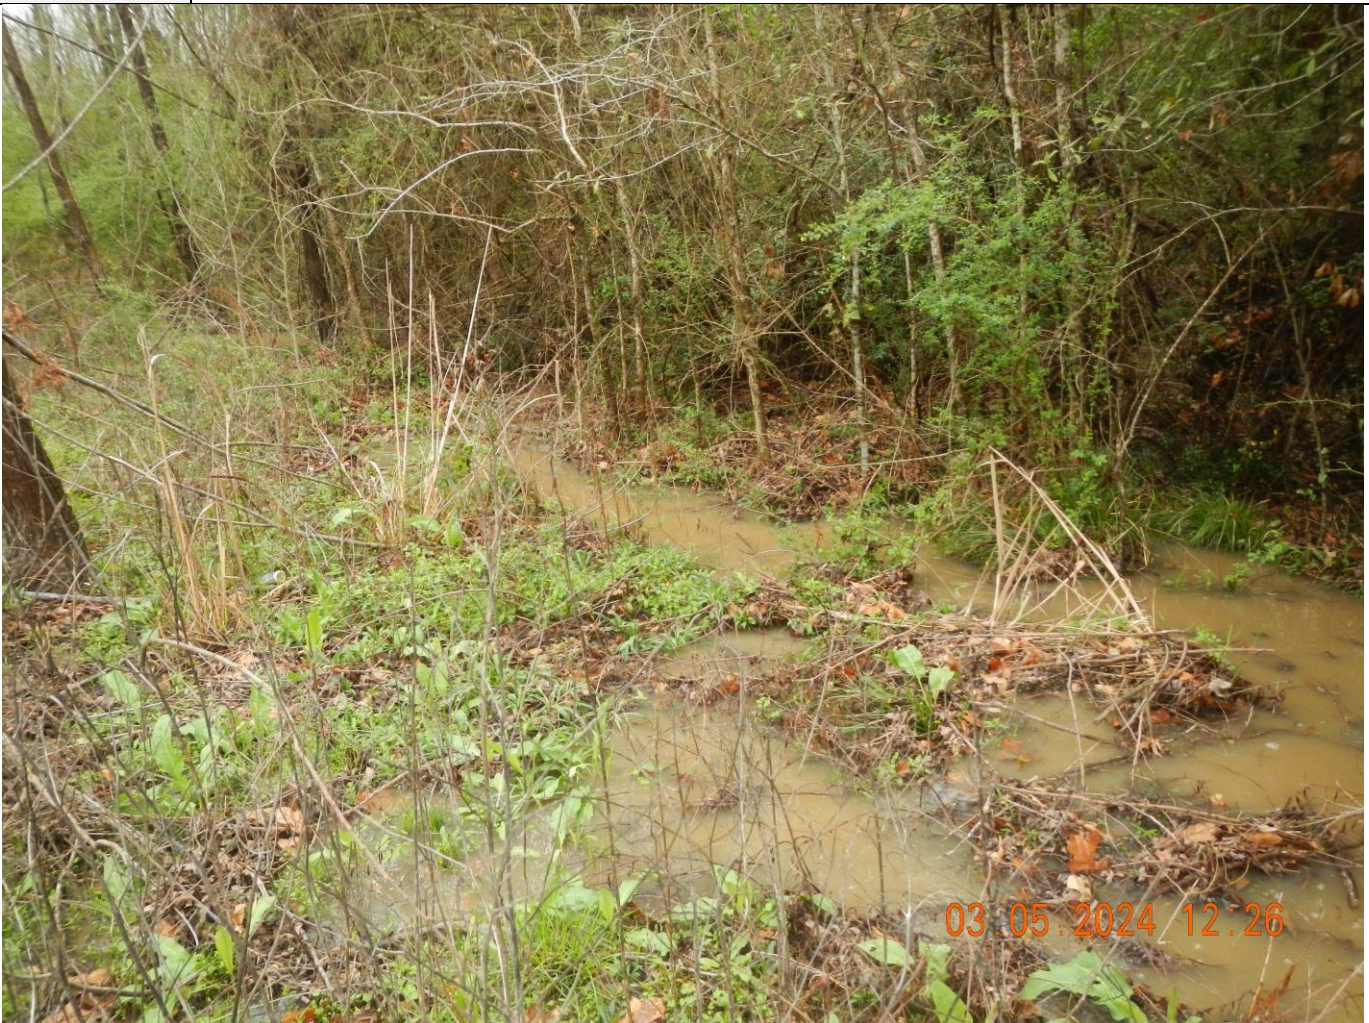
| <b>Photo ID:</b> | DSCN2920.JPG |

| <b>Description:</b> | Looking downgradient from outfall 001. |
