INSPECTION REPORT

| Type of Inspection | CEI - Compliance Evaluation Inspection | | |
| Facility or Site Name | West Portsmouth WWTP | | |

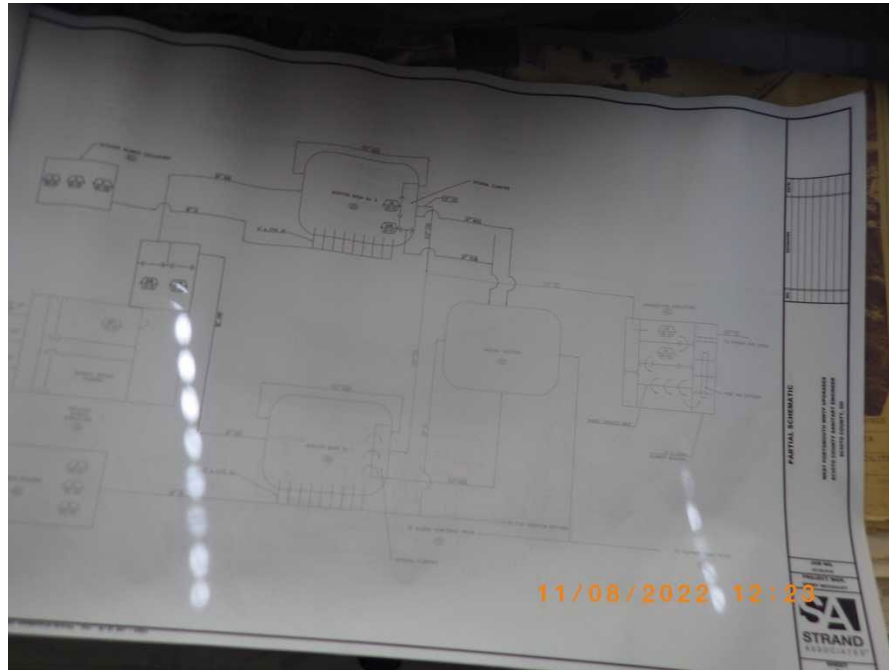
| WWTP Schematic | RIMG2895.JPG | |

| Photo of the West Portsmouth WWTP schematic that includes both the old and the new WWTP. | | |

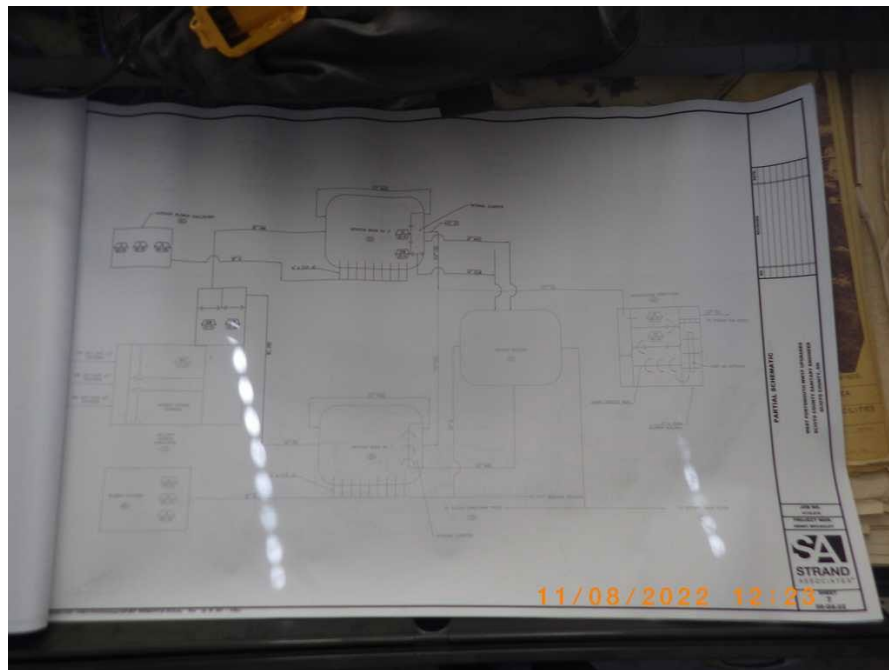
| WWTP Schematic | RIMG2896.JPG | |

| Schematic of the new and old treatment plant. | | |

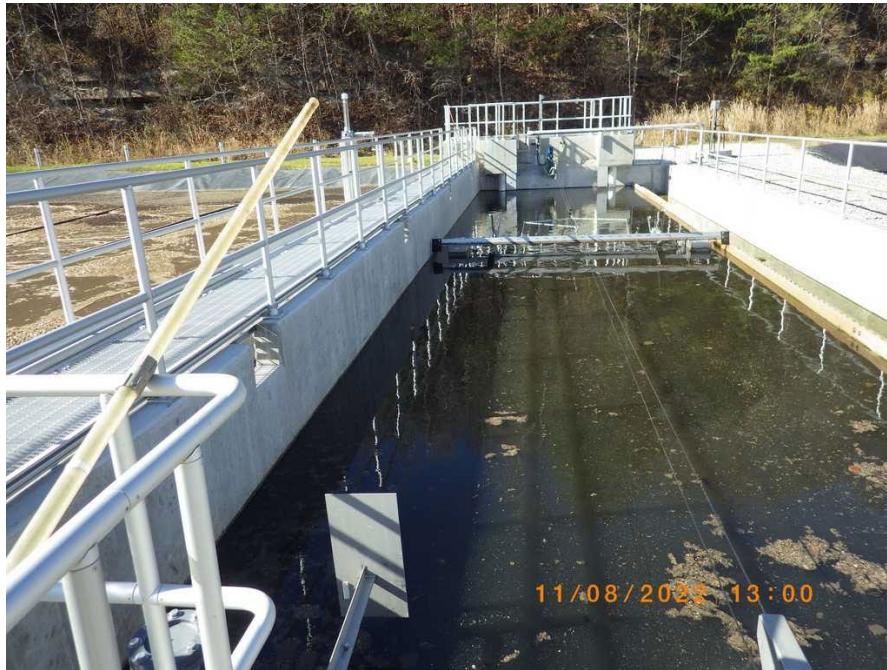
| New clarifier | RIMG2906.JPG | |

| View of the new clarifier. Camera looking west. | | |

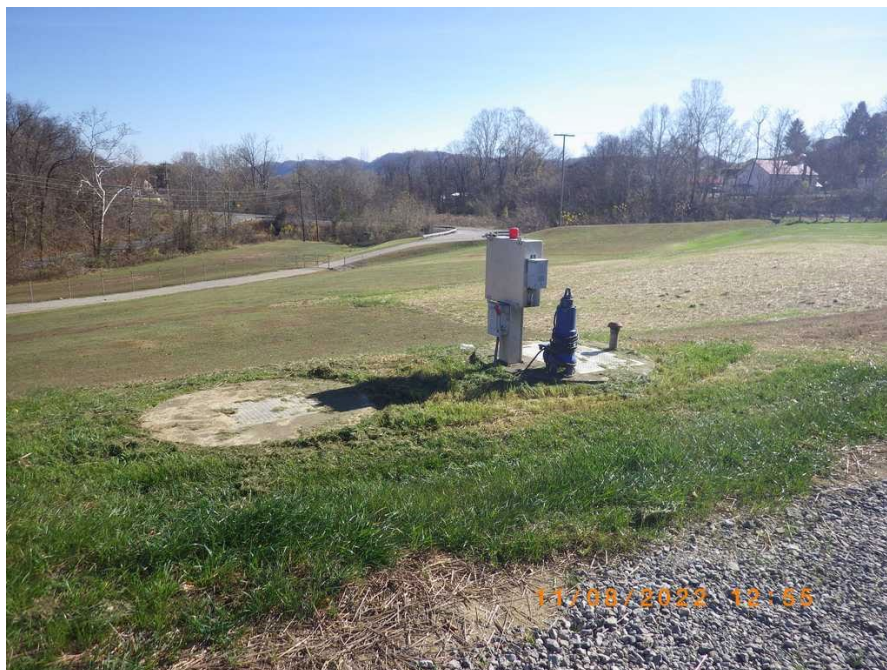
| Pump station | RIMG2902.JPG | |

| Pump station and checkout pit. Camera looking southeast. | | |

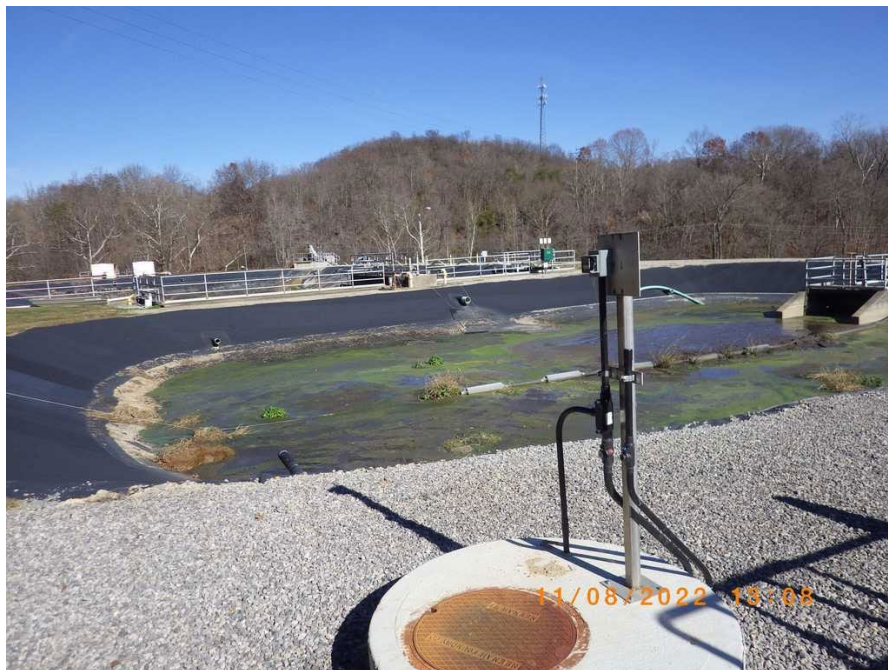
| Aerobic digester | RIMG2912.JPG | |

| Aerobic digester and the valve pit that controls the flow from the clarifier. Camera looking northwest. | | |

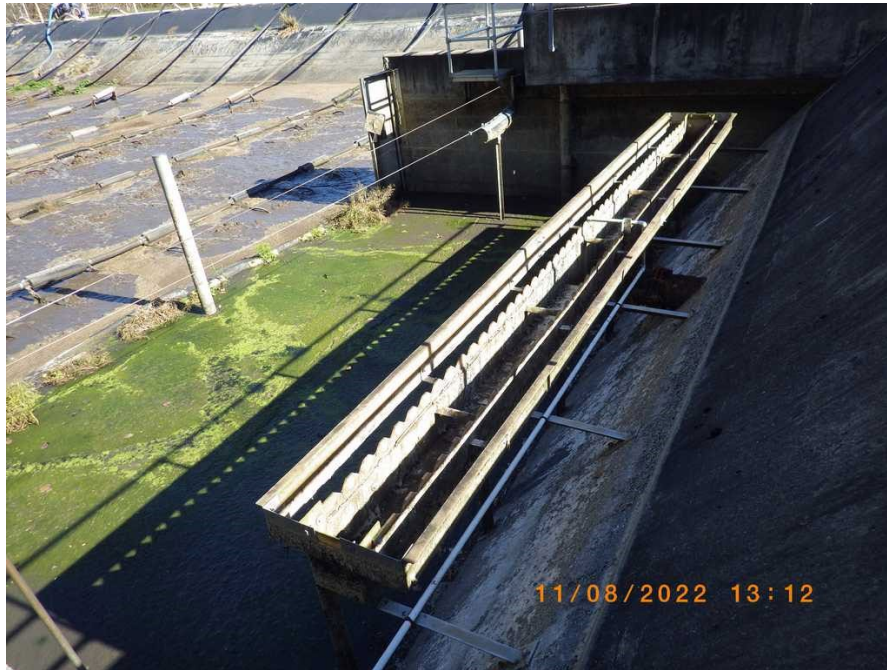
| Old clarifier | RIMG2913.JPG | |

The USEPA inspectors observed Aeration Basin #1 that was currently being used as an aerobic digester during the time of the inspection. The digester's return flow was routed back into the process. The USEPA inspectors observed two built-in clarifiers in Aeration Basin #1 that were not operational at the time of inspection.

| The old clarifier next to the old aeration tank. The return flow pipe can be seen in the background. Camera looking west. | | |

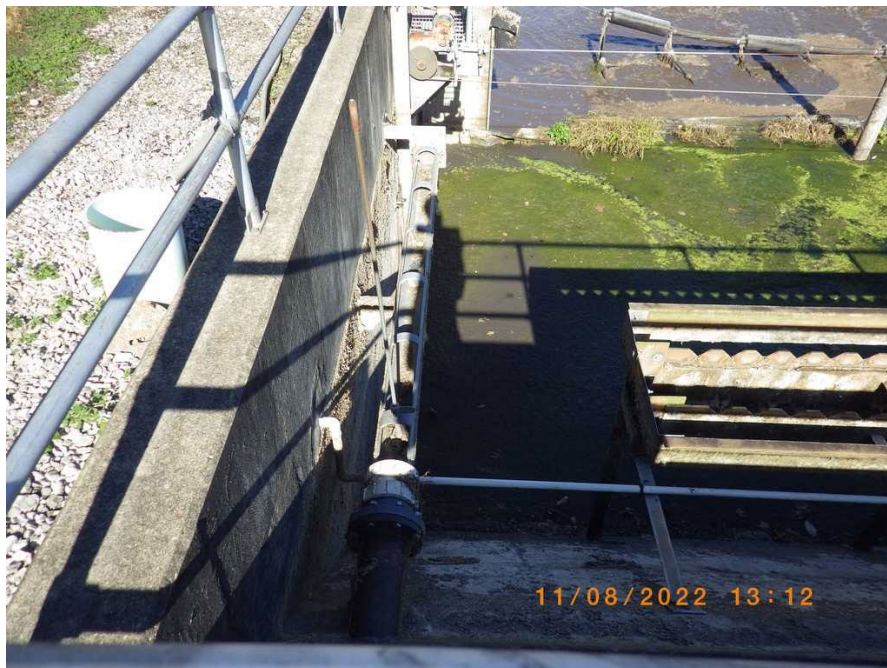
| Skimmer | RIMG2914.JPG | |

| Skimmer in the old clarifier. Camera looking north. | | |

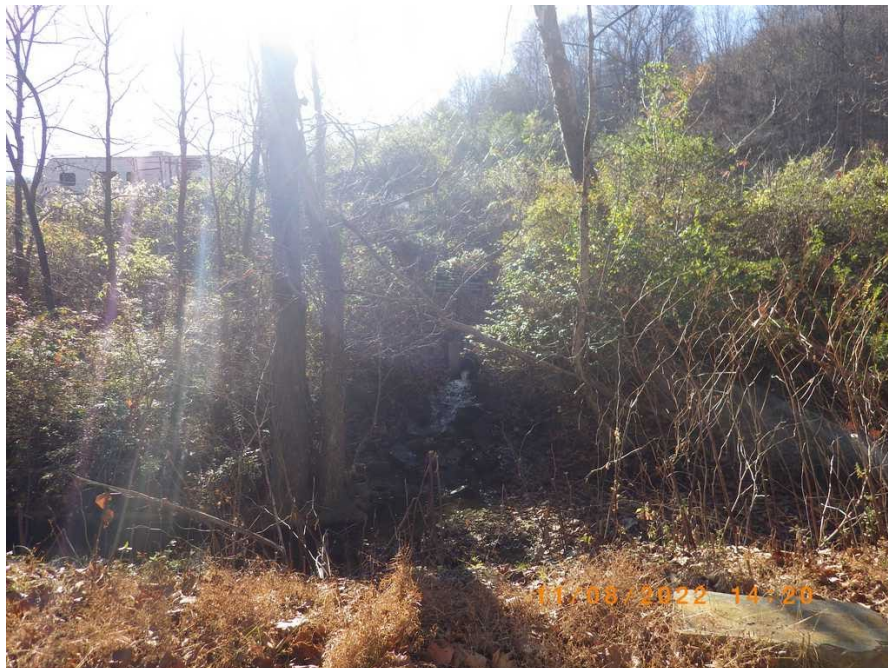
| Outfall 001 | RIMG2925.JPG | |

| Outfall 001. Camera looking west. | | |

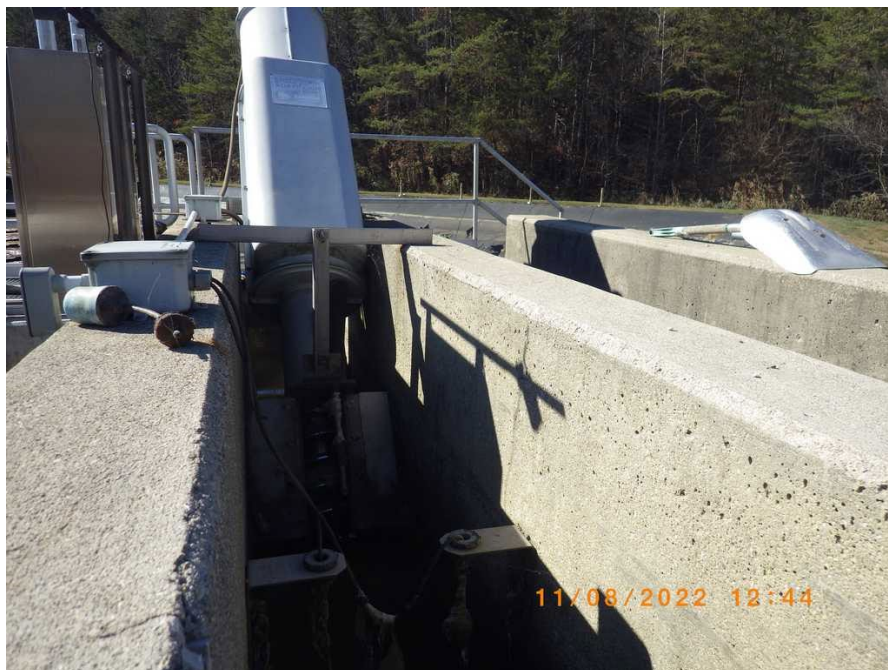
| Spiral screen | RIMG2899.JPG | |

| Close-up view of the spiral screen at the headworks. Camera looking west. | | |

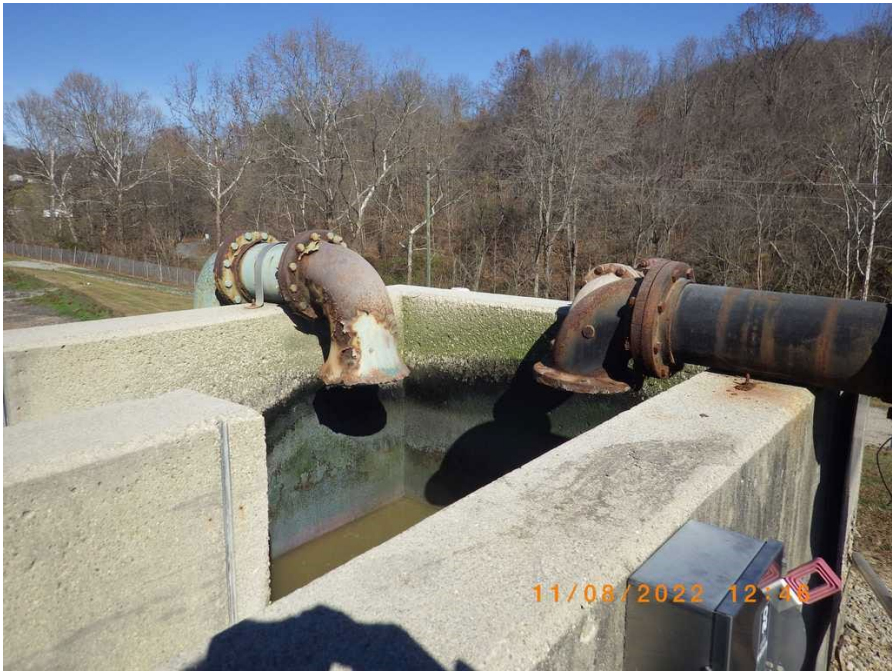
| Influent pipes | RIMG2900.JPG | |

| All three influent pipes were observed to be corroded. | |

| Three rusted influent pipes. Camera looking east. | | |

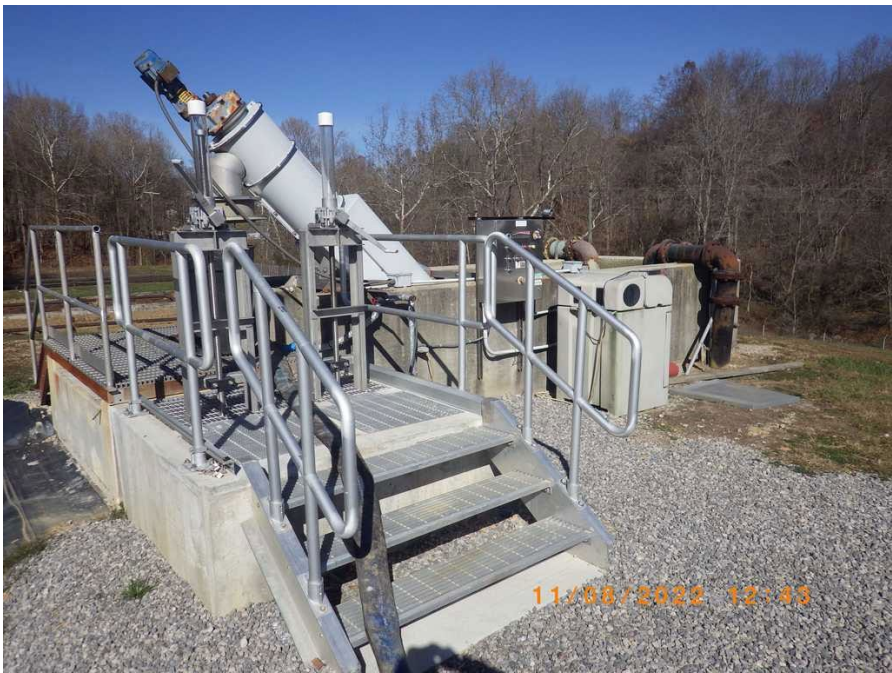
| Headworks | RIMG2898.JPG | |

| Overview of the headworks. Camera looking northeast. | | |

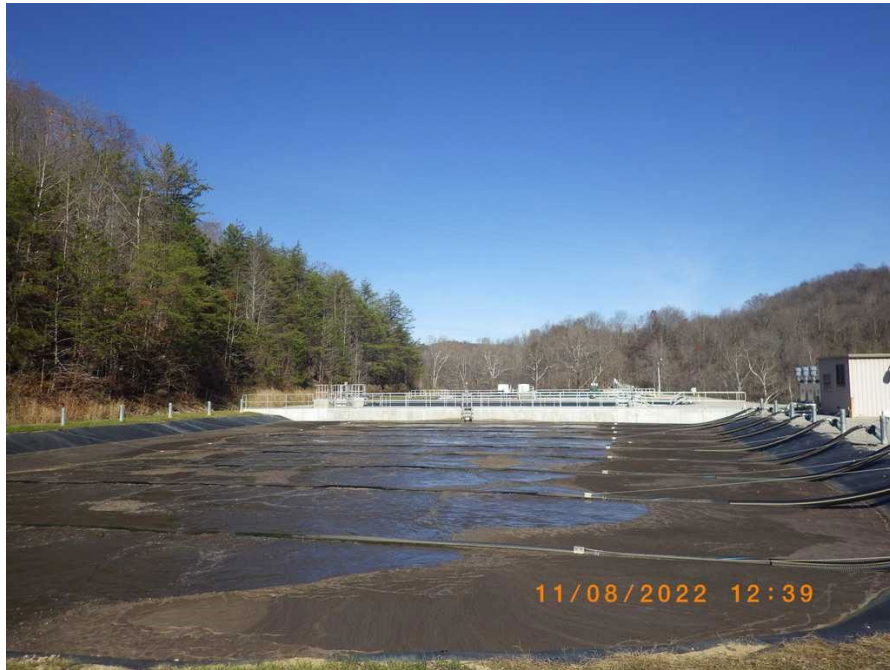
| New aeration tank | RIMG2897.JPG | |

| Overview of the new aeration tank. Camera looking north. | | |

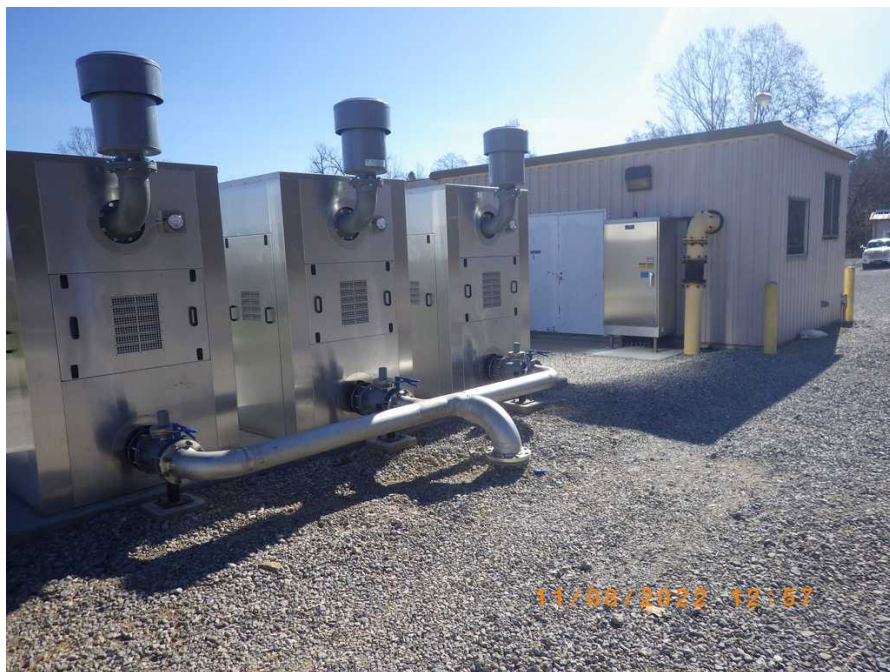
| New Blowers | RIMG2903.JPG | |

| New blowers and the blower building in the background. Camera looking south. | | |

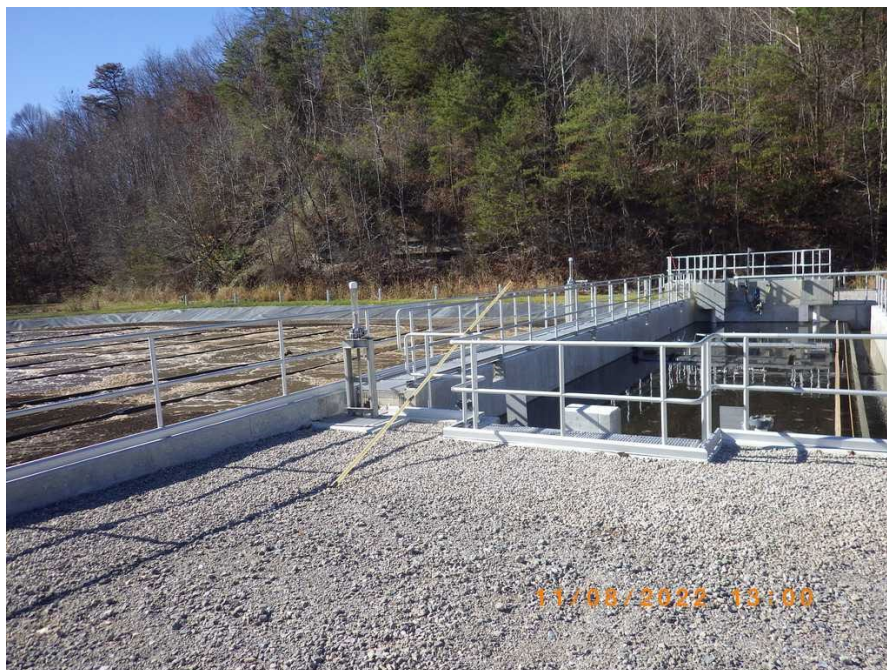
| New Clarifier | RIMG2907.JPG | |

| New clarifier next to the new aeration tank. Camera looking west. | | |

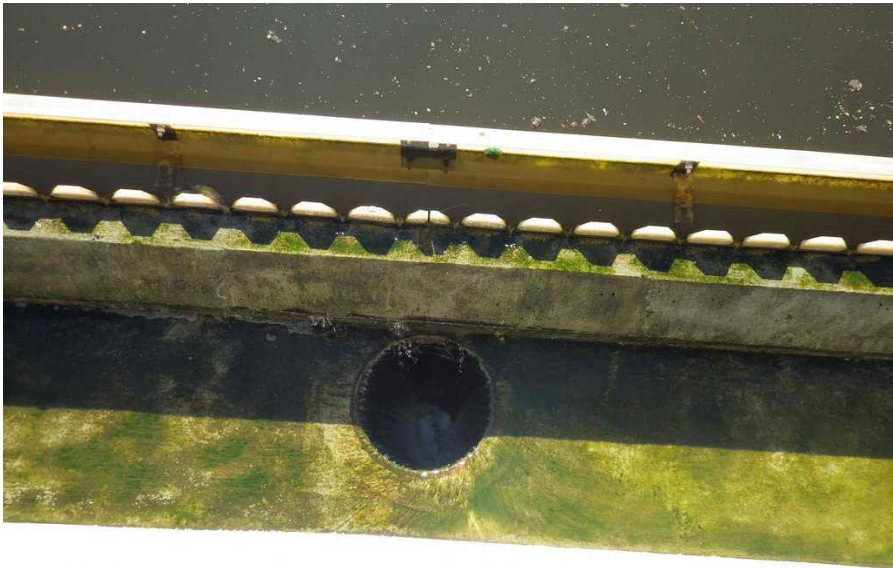
| Clarifier effluent | RIMG2908.JPG | |

| Effluent from the new clarifier. | | |

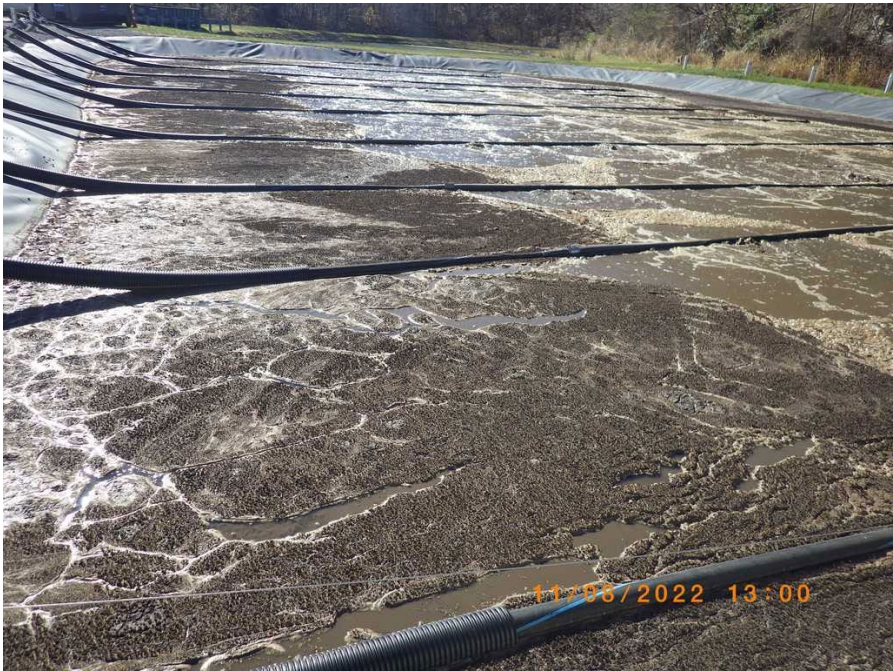
| New aeration tank | RIMG2905.JPG | |

| View of the new aeration tank. Camera looking west. | | |

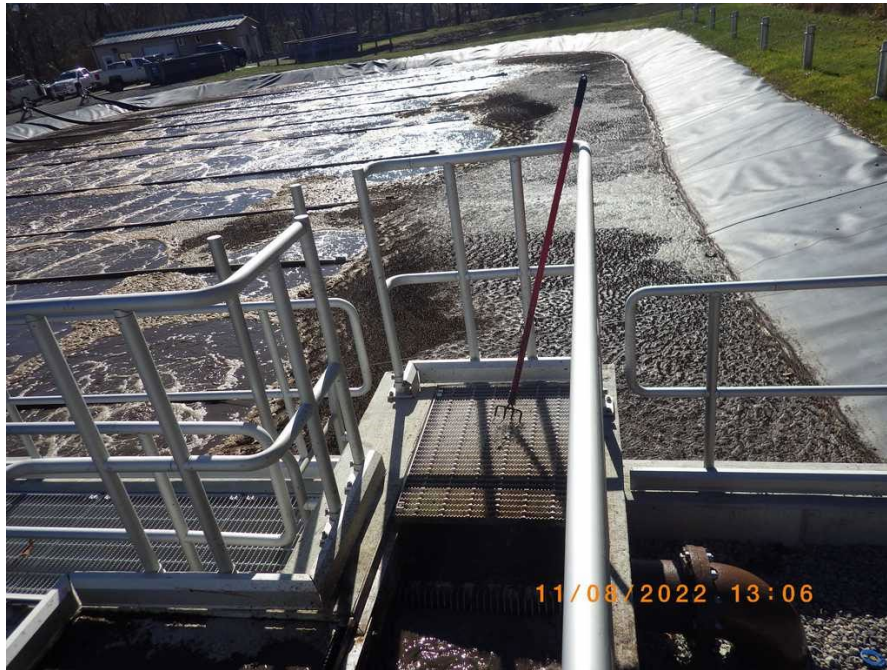
| Return flow | RIMG2911.JPG | |

| Return flow from the clarifier to the aeration basin at the east end of the clarifier. Camera looking south. | | |

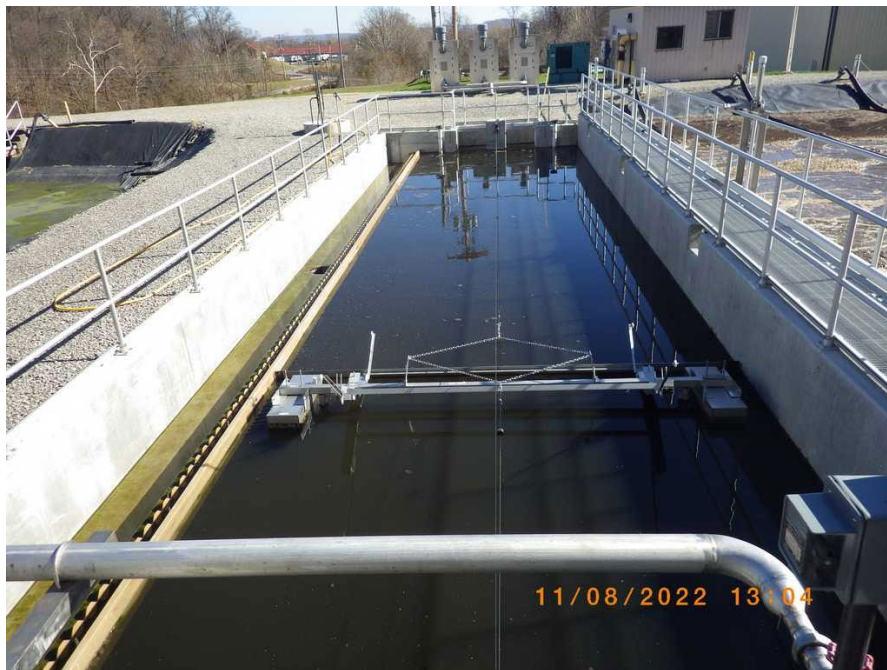
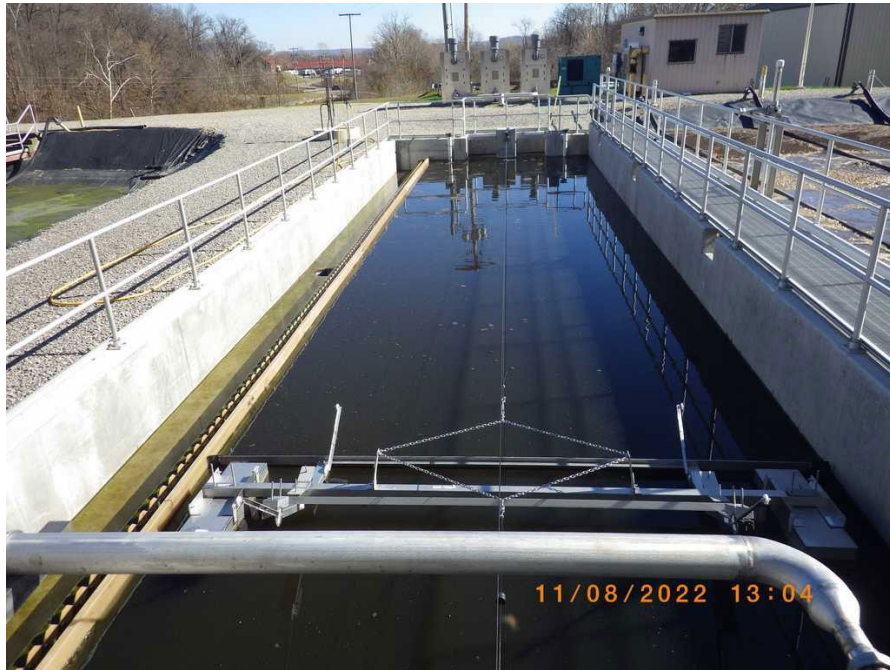
| New clarifier | RIMG2910.JPG | |

| New clarifier and the skimmer in it moving west. Camera looking west. | | |

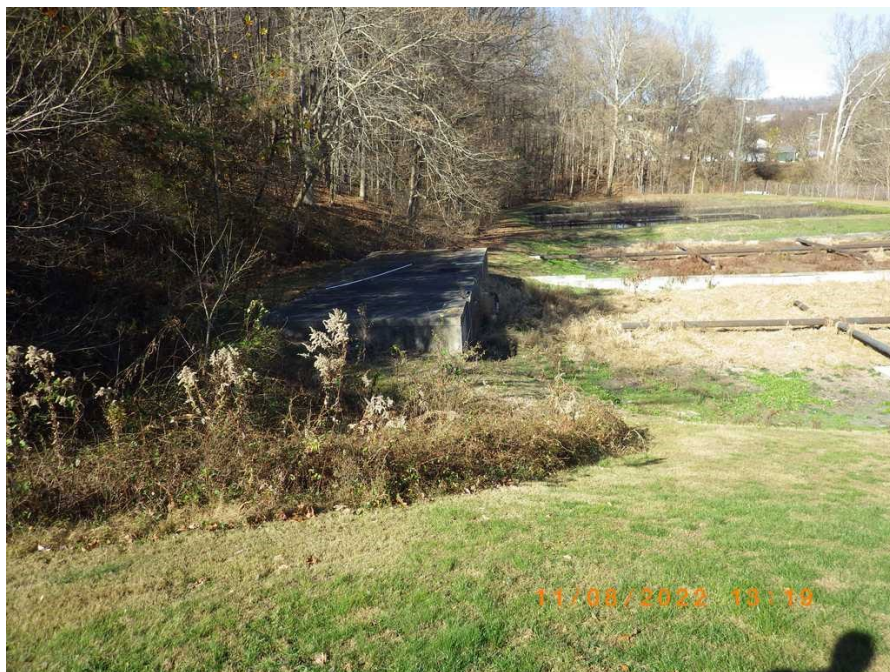
| Dosage tanks | RIMG2917.JPG | |

| Dosage tank splits the flow from the aeration tank to the sand filters. Camera looking north. | | |

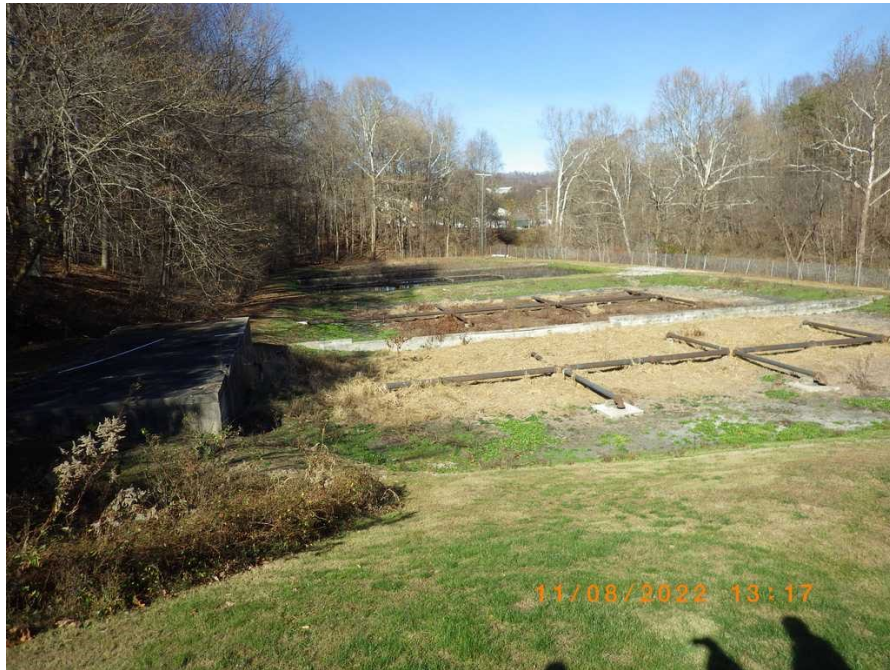
| Sand filters | RIMG2916.JPG | |

| Four sand filters. The first two in the photo had sludge in them and the third one was the only one being used. Camera looking north. | | |

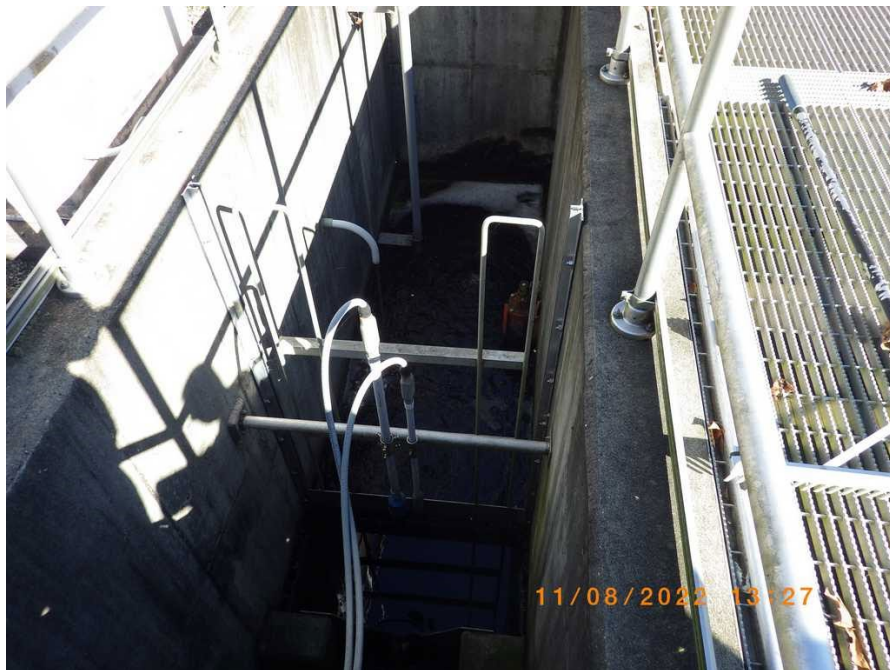
| Post-aeration tank | RIMG2920.JPG | |

| Post aeration tank and the flow meter at final tank. Camera looking east. | | |

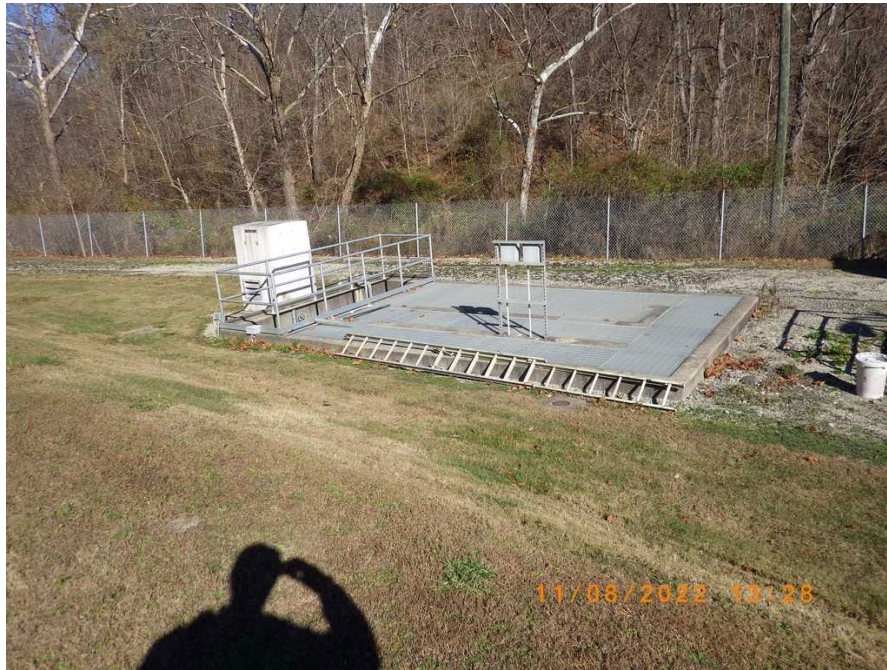
| Final tank | RIMG2921.JPG | |

| Overview of the final tank. Camera looking northeast. | | |

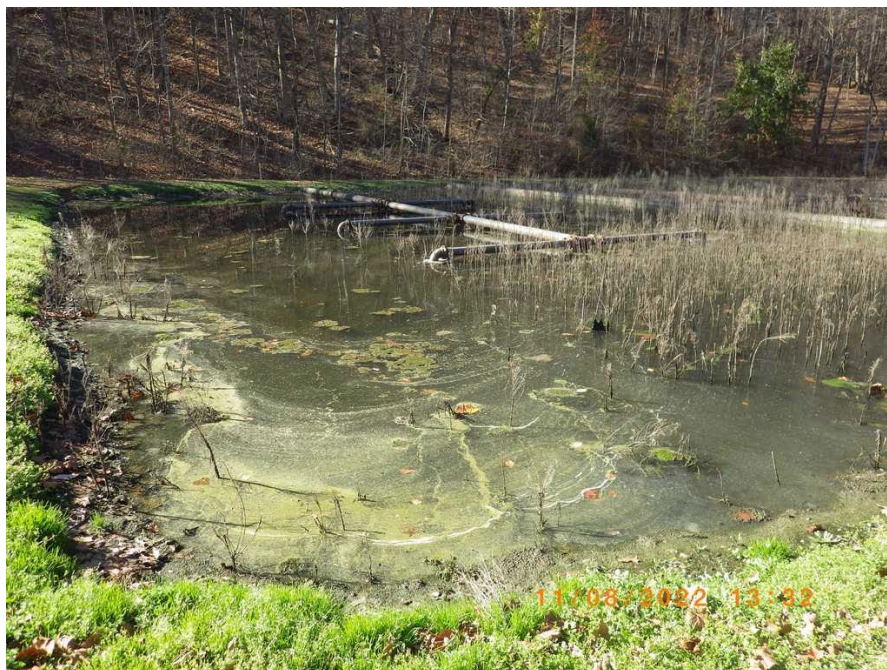
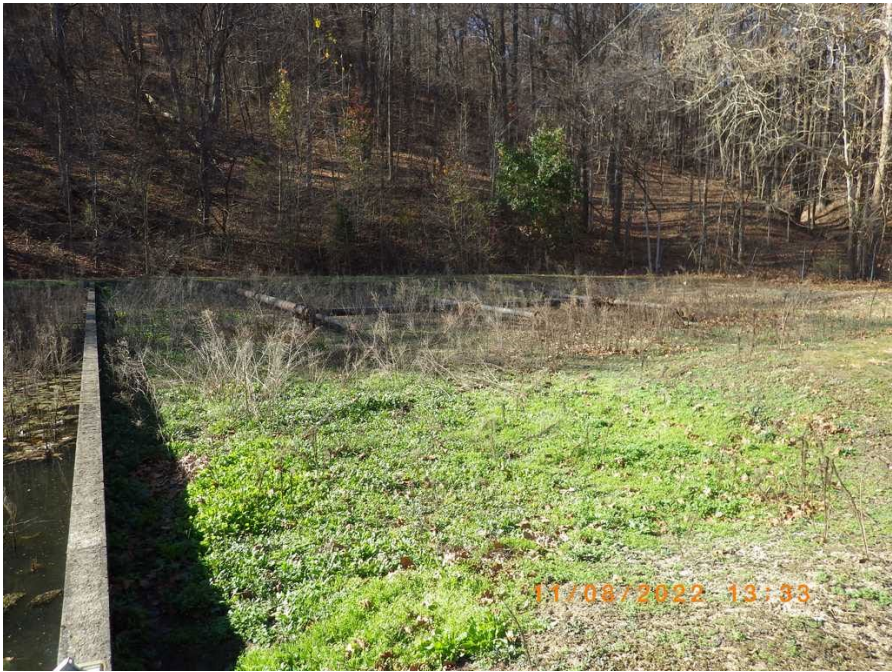
| Sand filters | RIMG2922.JPG | |

| Sand filters 3 and 4. Camera looking west. | | |
