**Region 6 - Enforcement & Compliance Assurance Division**  
**INSPECTION REPORT**

| Regulatory Program(s) | NPDES CAFO | |
| Company Name: | Van Der Jagt Dairy | |

## **Section I – INTRODUCTION**

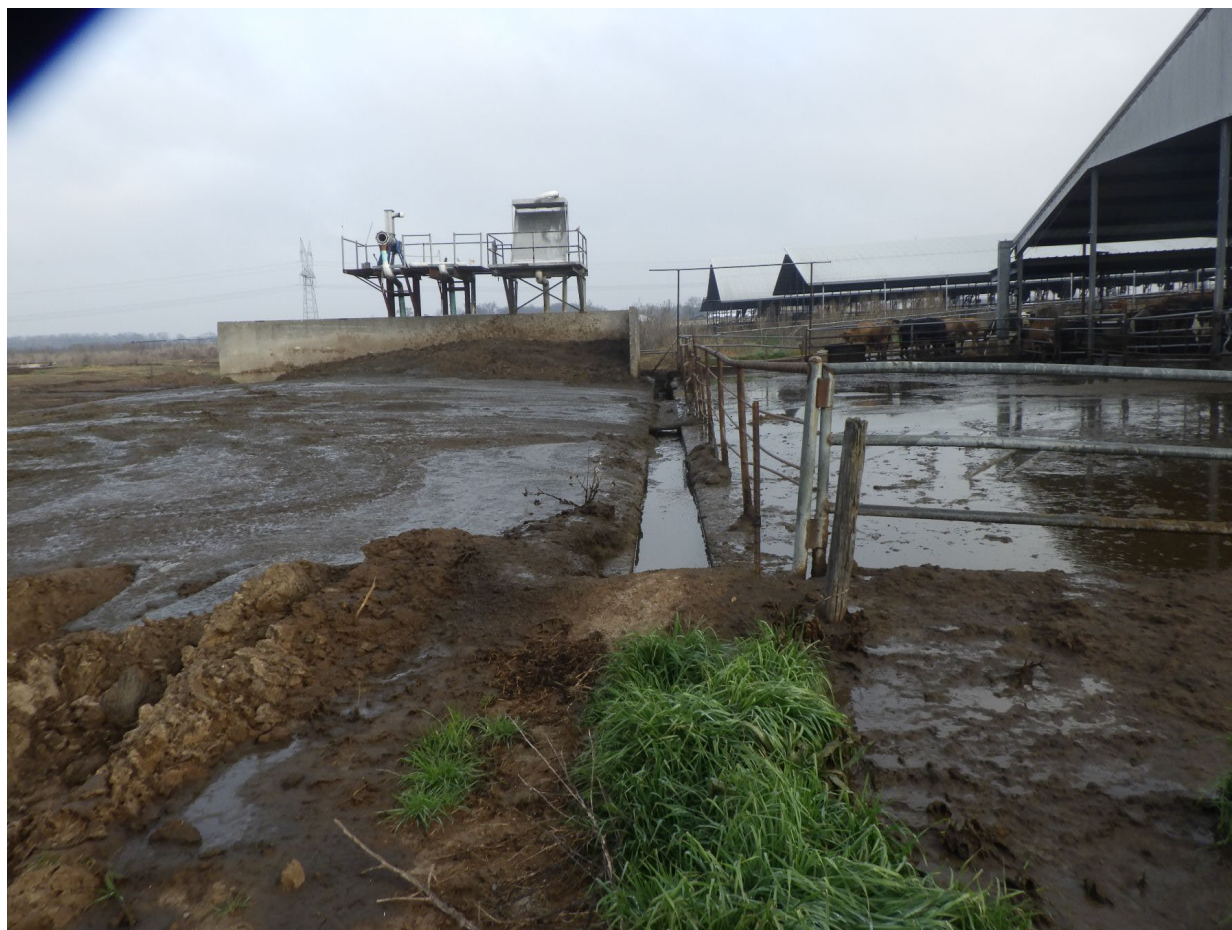
Photo No. 1

There are three settling basins, one solid separating screen, and two wastewater lagoons located in the production area. The solid separating screen is directly west of the freestalls (Appendix 1, Photo 1). Two concrete lined settling basins follow the screen (Appendix 1, Photo 9). The third settling basin is earthen lined and is west of the freestalls directly before RCS 1 (Appendix 1, Photo 8). RCS (Retention Control Structure) 1 and RCS 2 are located west of the freestalls (Appendix 1, Photos 2 & 6). The facility has 6 LMUs (Land Management Unit): 1 - 56 acres, 2 - 53 acres, 3 - 32 acres, 4 - 56 acres, 5 - 22 acres, 6 - 34 acres. The facility plants coastal Bermudagrass and SG for hay and silage. Wastewater and manure can be applied to all LMUs using center pivots and draghose.

All the RCSs for the facility are designed to receive the production area wastewater runoff done by Jerry Kendall on 06-15-17. RCS 1 required capacity is 17.5 acre/ft with actual capacity of 18.0 acre/ft, RCS 2 required capacity is 33.5 acre/ft with actual capacity of 33.5 acre/ft. All the RCSs have a permeability rating greater than  $1 \times 10^{-7}$ . There were no signs of erosion in the embankments and cattle are unable to access the lagoons. All pole markers showed adequate freeboard and are below the 25-yr/24-hr rain event mark. The facility uses gravity flow to route all runoff to RCS (Appendix 1, Photos 1, 3, 4, & 7).

| Description: | View to the north. West end of the south freestalls. Channel to RCS#1 with mortality composting in background. | | |

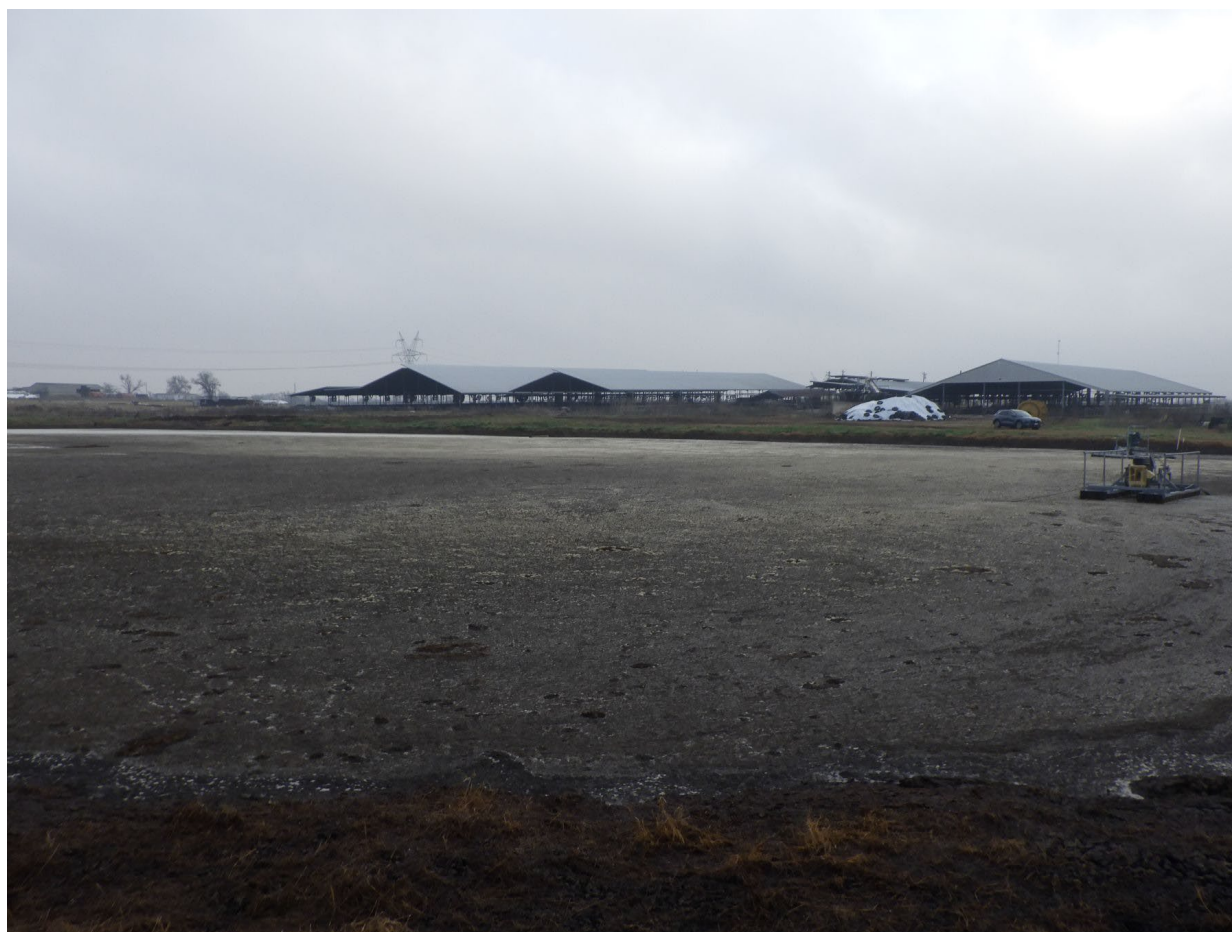
Photo No. 2

Mortalities are composted on site directly west of the freestalls underneath the solid separating screen within the drainage of RCS 1. (Appendix 1, Photos 2 & 3).

| Description: | View to the east. RCS#1 with freestalls and settling basin in background. | | |

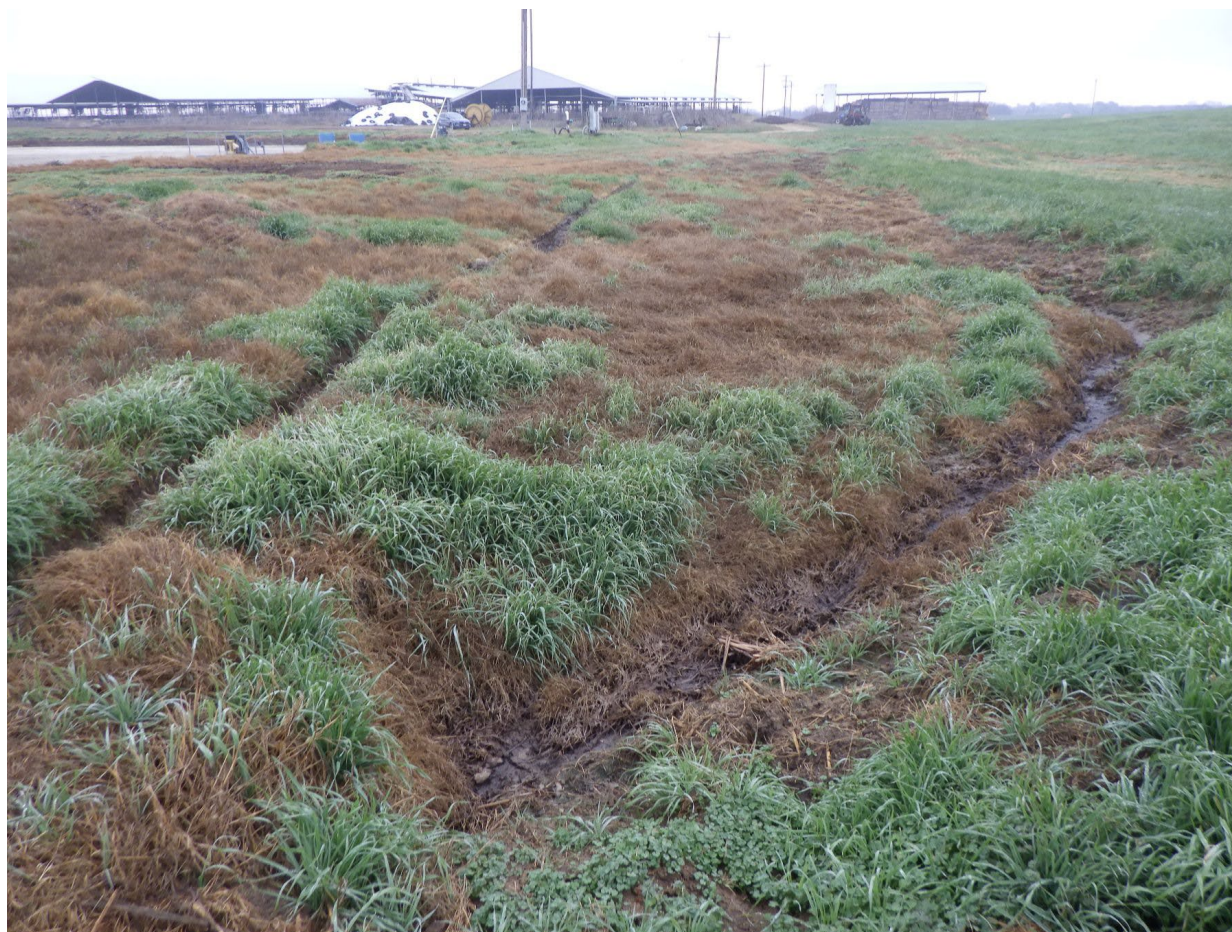
Photo No. 3

| Description: | View to the east. Drainage channel from composting pile to RCS#2. | | |

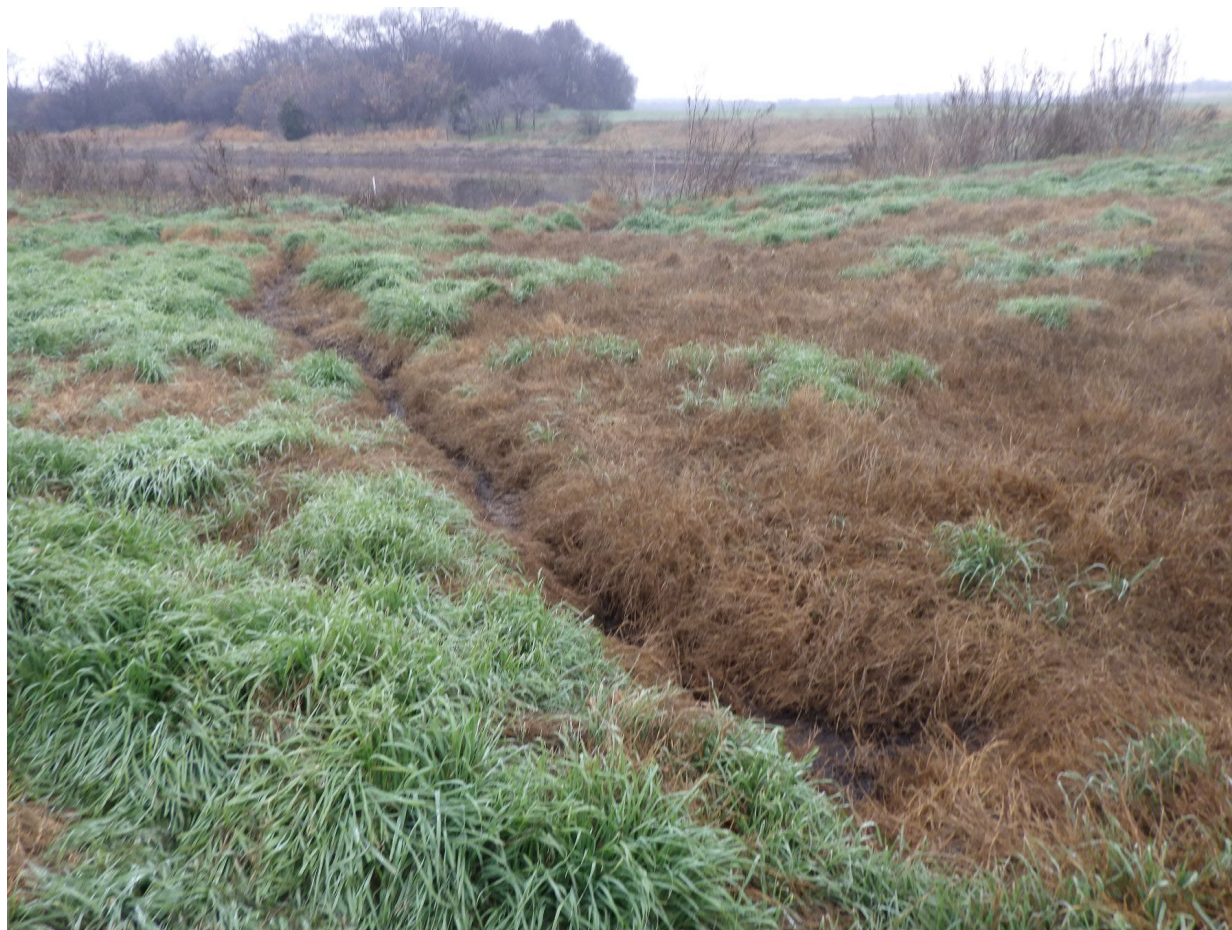
Photo No. 4

| Description: | View to the west. Outfall from composting drainage channel into RCS#2. | | |

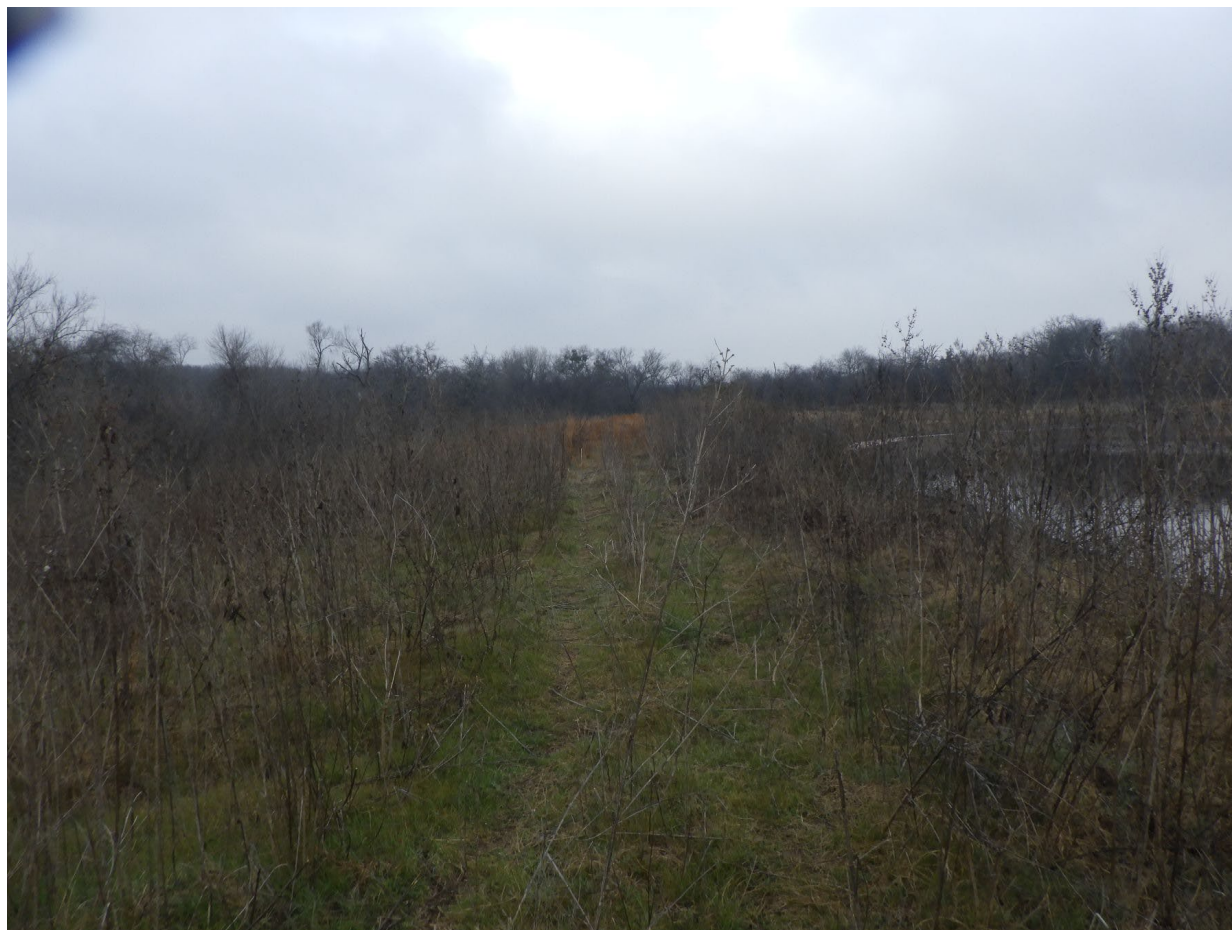
Photo No. 5

The TCEQ CAFO permit (TXG921343) was issued to Van Der Jagt Dairy on 08-12-2024, and it expires on 07-19-2029. The facility permits 1500 milking cows. At the time of the inspection, there were approximately 1430 milking cows. Cows are milked twice daily and housed in covered freestalls between milkings. Freestalls are flushed with recycled wastewater twice daily. The facility borders Chaffin Creek on the western side (Appendix 1, Photo 5). Chaffin Creek is part of the Lake Fork Reservoir watershed.

| Description: | View to the north. Berm between RCS#2 and Chaffin Creek. | | |

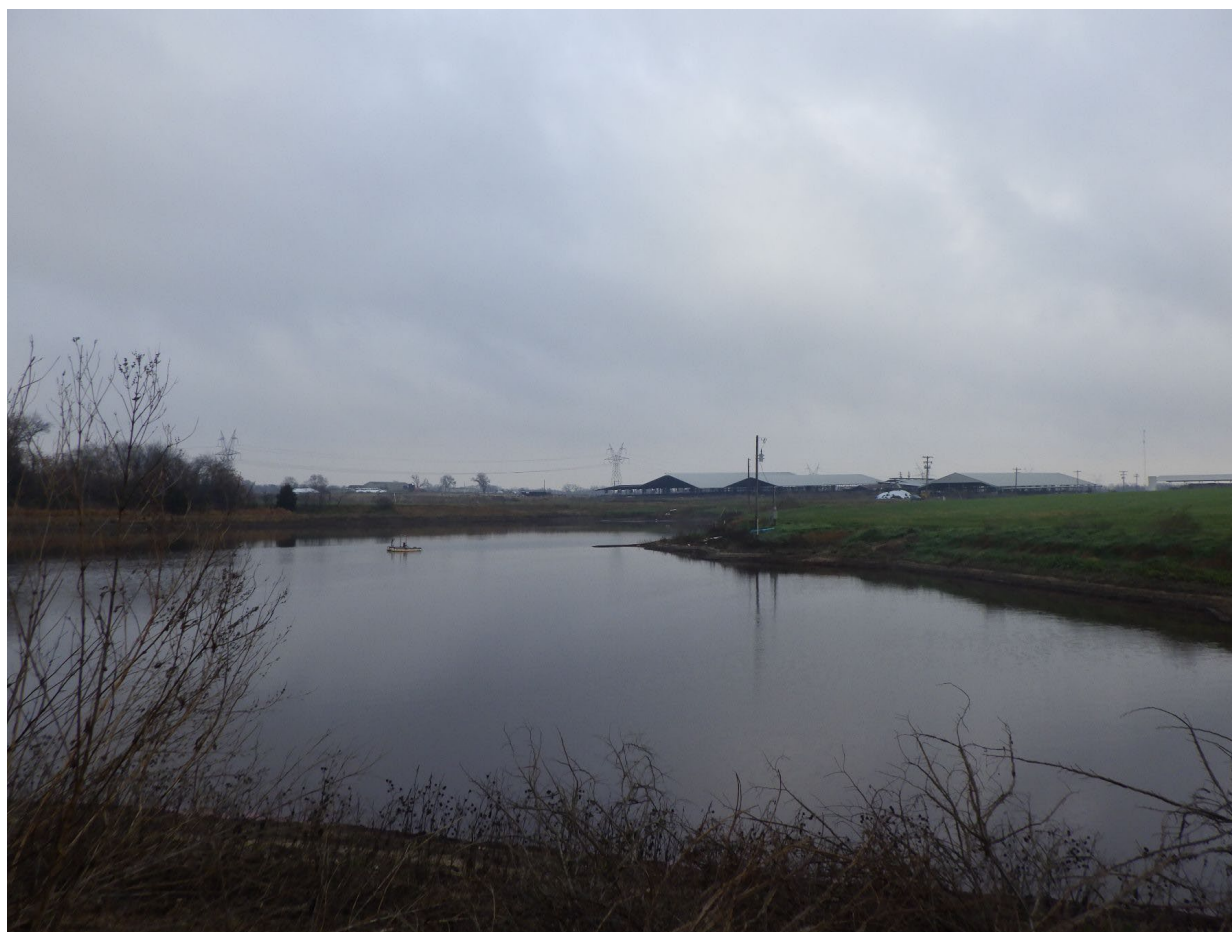
Photo No. 6

| Description: | View to the east. RCS#2 with RCS#1 and freestalls in background. | | |

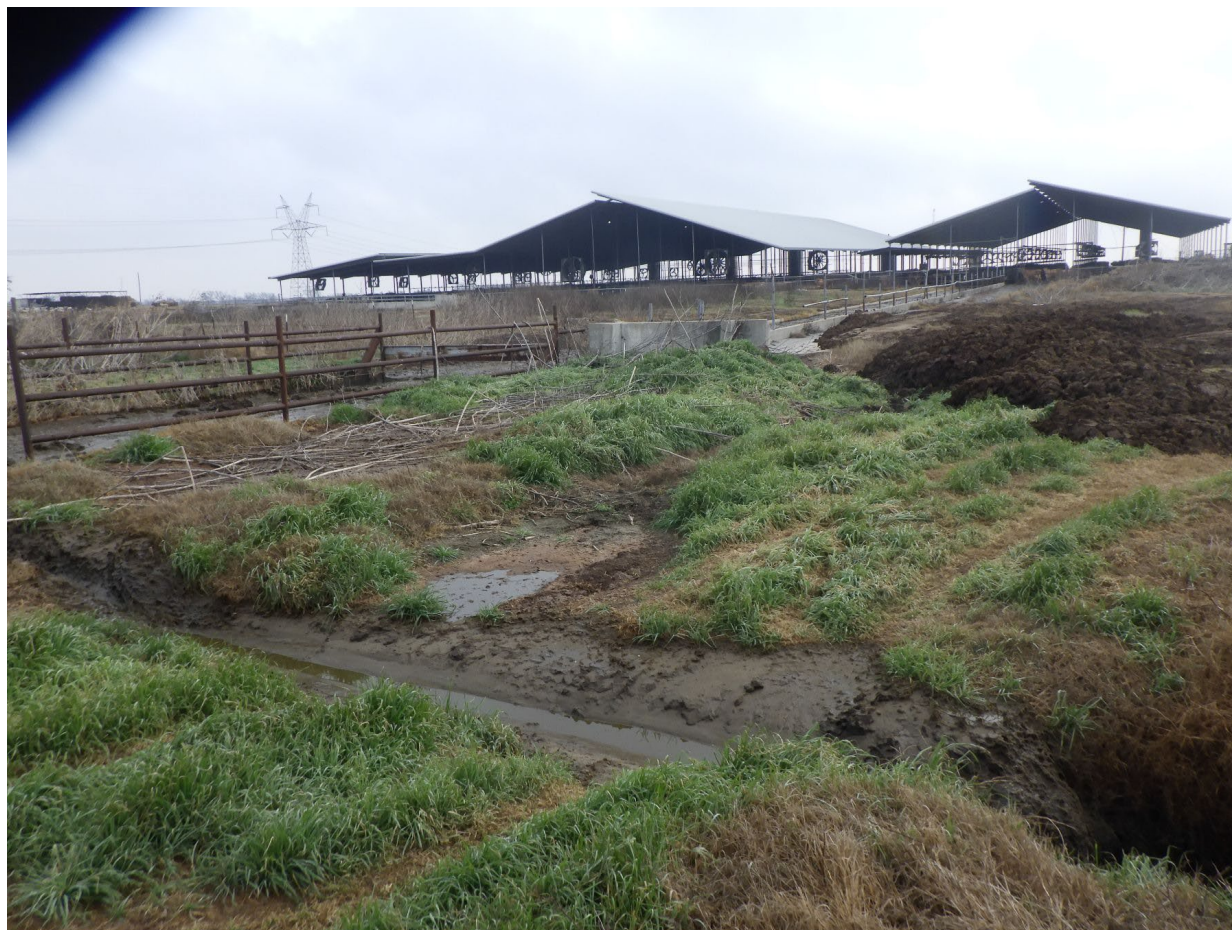
Photo No. 7

| Description: | View to the northeast. Runoff channel from north freestalls to RCS#1. | | |

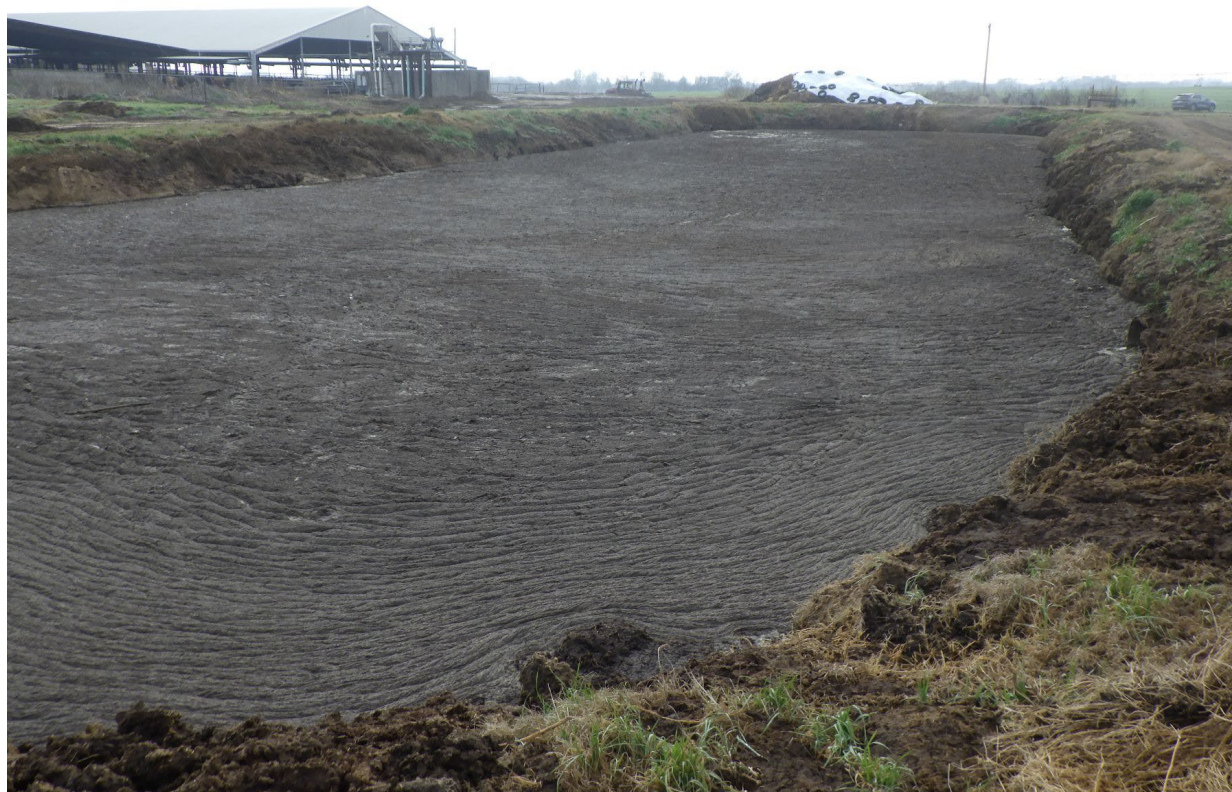
Photo No. 8

| Description: | View to the south. Settling basin west of the freestalls before RCS#1. | | |

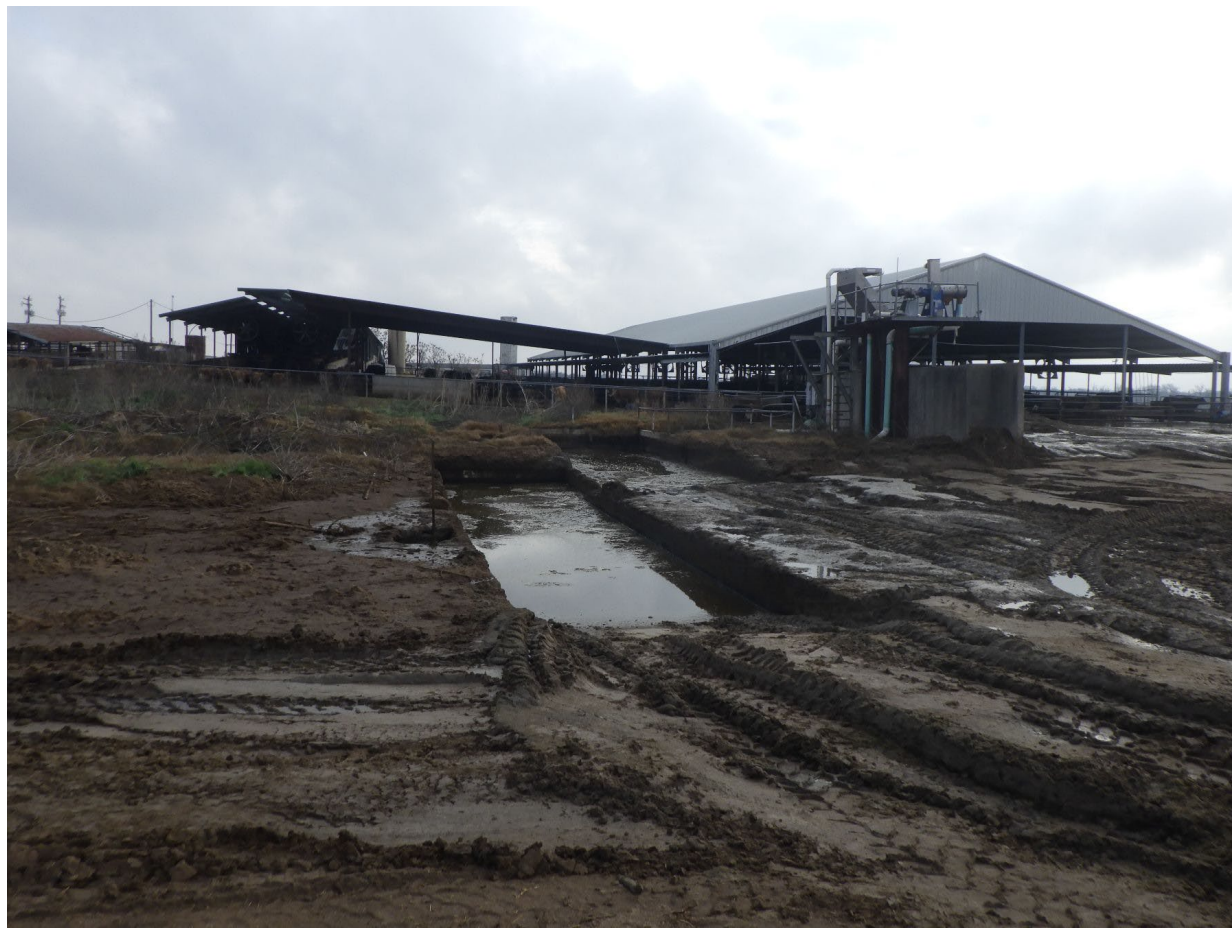
Photo No. 9

| Description: | View to the east. Concrete settling basins before the earthen settling basin. West of the freestalls. | | |
