**INSPECTION REPORT**

| <b>Type of inspection:</b> | CEI - Compliance Evaluation Inspection | |
| <b>Permittee Name:</b> | Harsco Environmental | |
| <b>Permit Number:</b> | OH0084030 | |

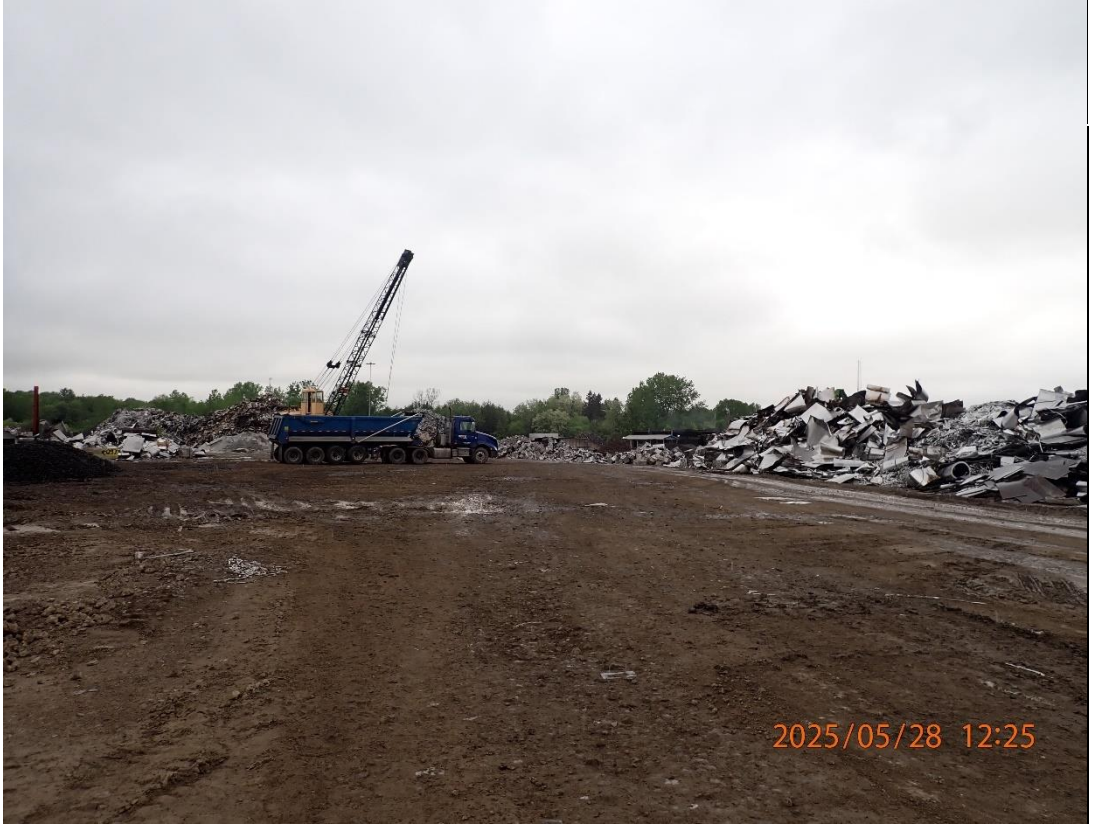
| <b>Photo No.: 1</b> | <b>Time:</b><br>1:25 PM | | |

| <b>Photo Description:</b><br>Site overview from Facility entrance. | | | |

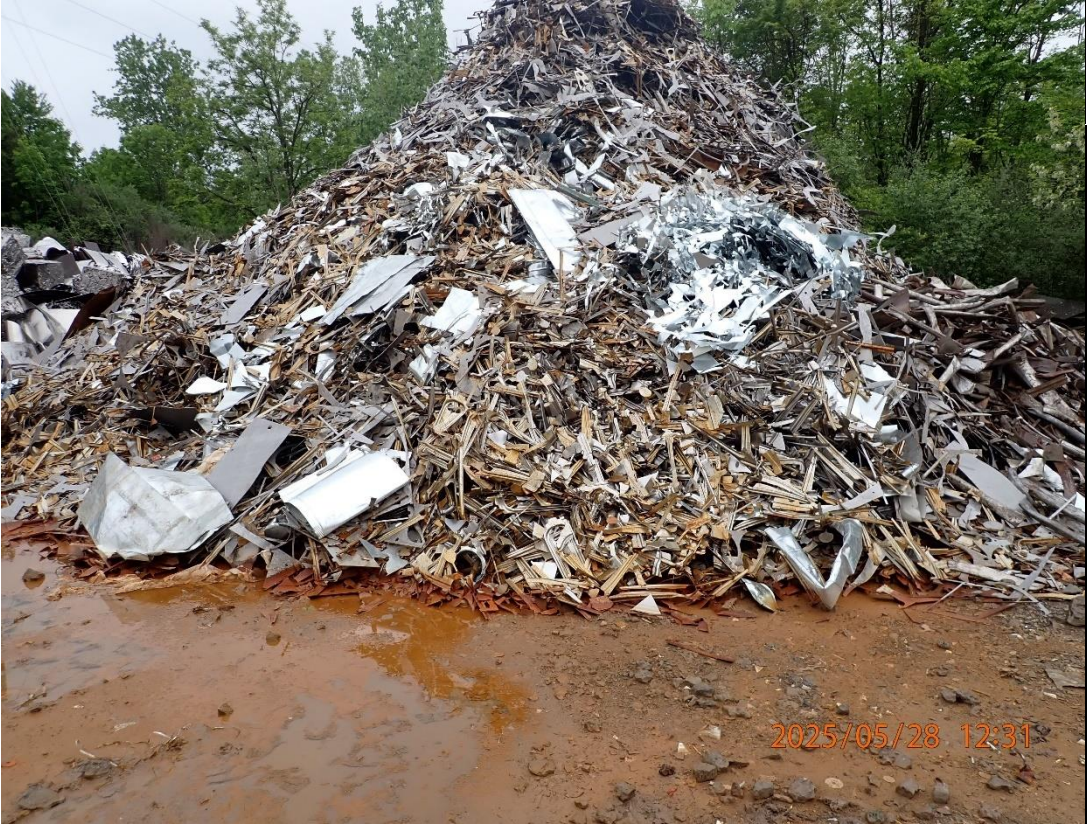
| <b>Photo No.:</b> 2 | <b>Time:</b><br>1:31 PM | | |

| <b>Photo Description:</b><br>Scrap metal pile with some visible rust on some scrap. | | | |

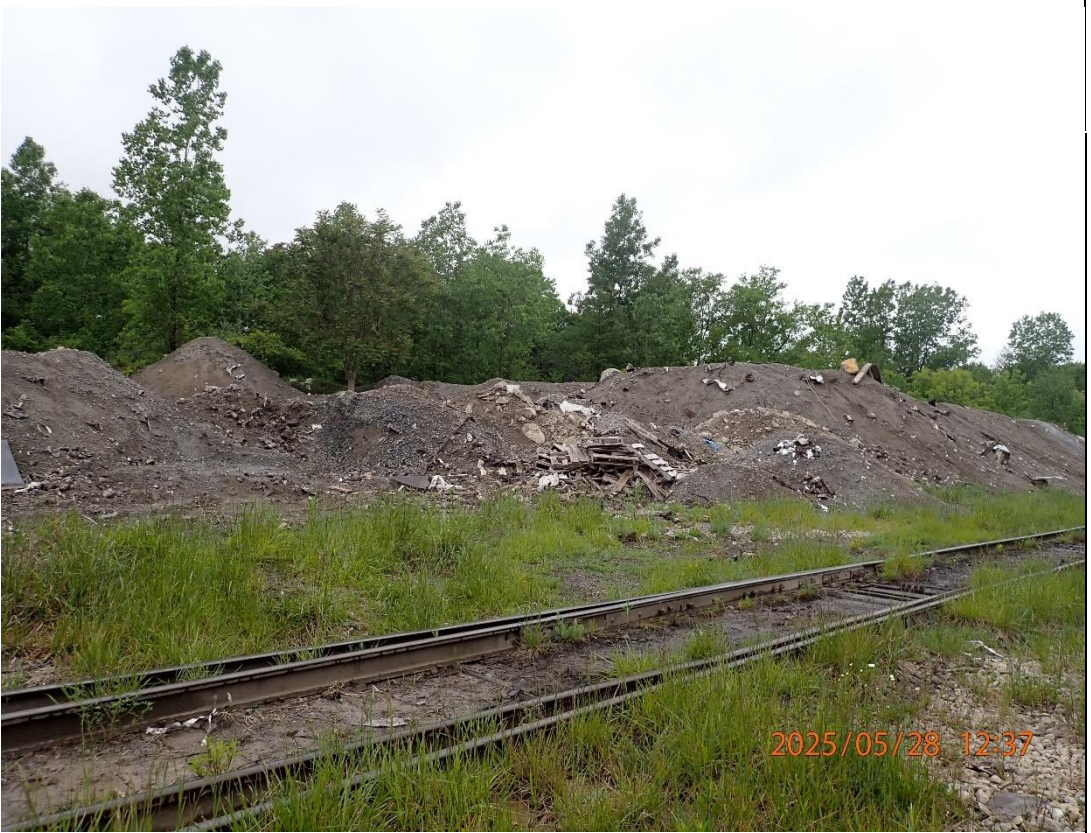
| <b>Photo No.: 3</b> | <b>Time:</b><br>1:37 PM | | |

| <b>Photo Description:</b><br>Slag piles from CCMW used to prevent runoff. | | | |

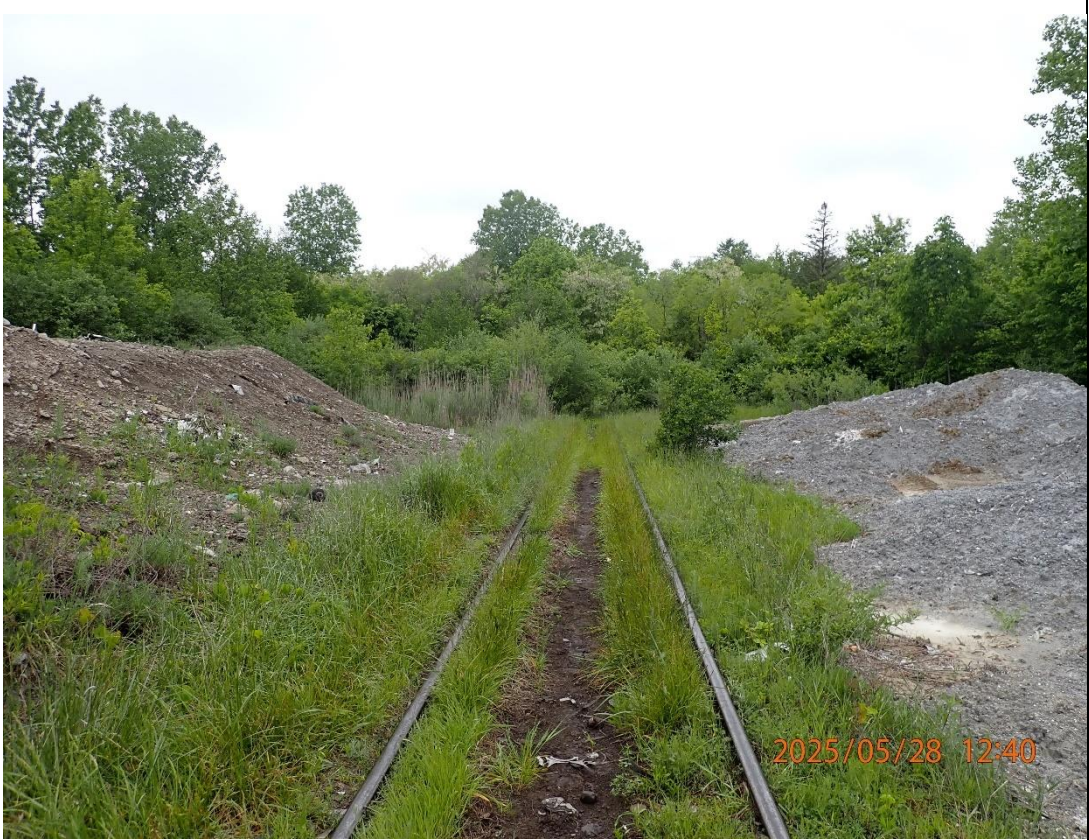
| <b>Photo No.: 4</b> | <b>Time:</b><br>1:40 PM | | |

| <b>Photo Description:</b><br>End of property on the West end. No scrap piles located in this area. | | | |

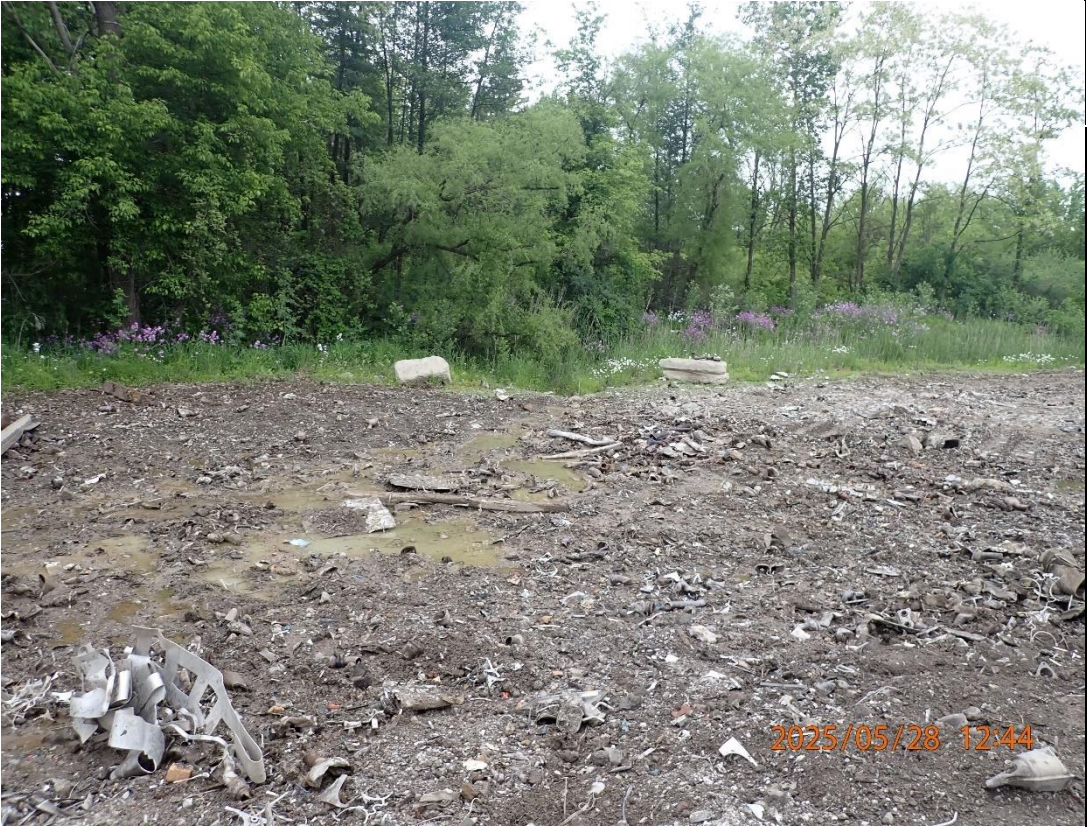
| <b>Photo No.: 5</b> | <b>Time:</b><br>1:44 PM | | |

| <b>Unique Identifying No.</b> | <b>Observation</b> | <b>Area of Concern?</b> |
|---|---|---|
| <b>MS-OB-001</b> | During the site tour, inspectors observed a stormwater collection ditch that surrounded the Facility's North and East sides to bring water to the onsite stormwater holding pond. (Photos 5, 6, 8, and 11) | No |

| <b>Photo Description:</b><br>Collection pond pathway in back. | | | |

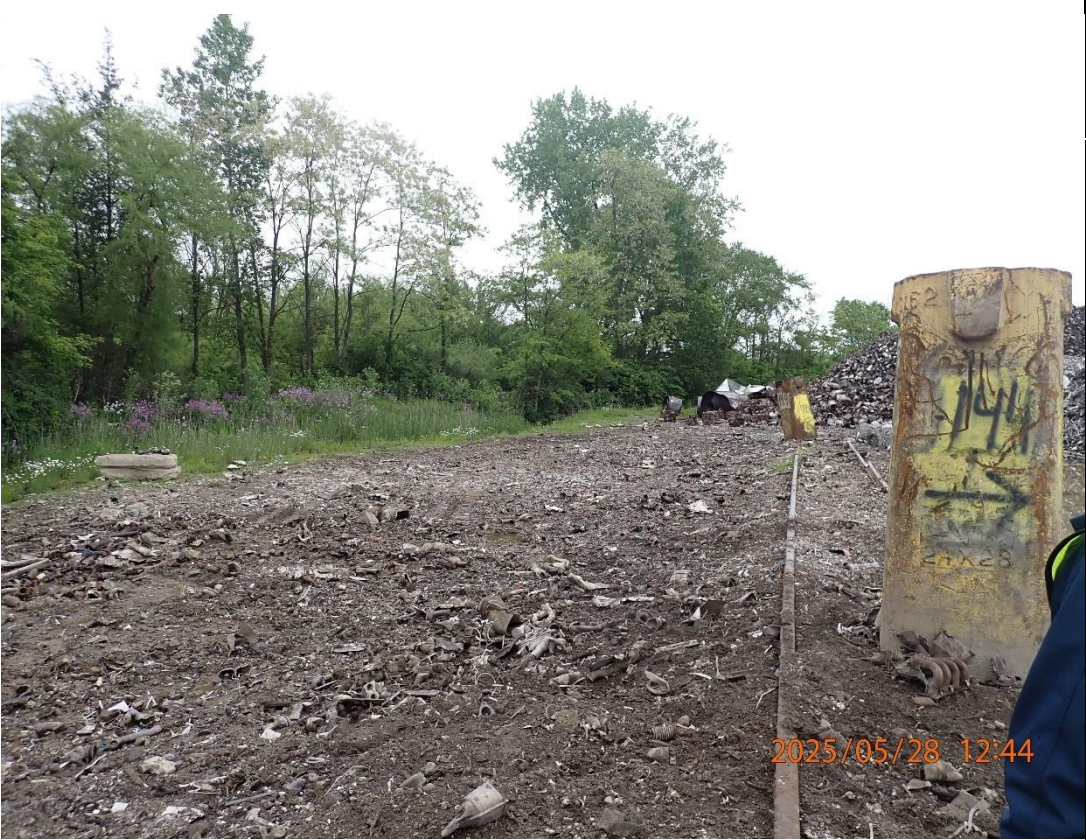
| <b>Photo No.: 6</b> | <b>Time:</b><br>1:44 PM | | |

| <b>Photo Description:</b><br>Collection pond pathway/ditch bordering Facility. | | | |

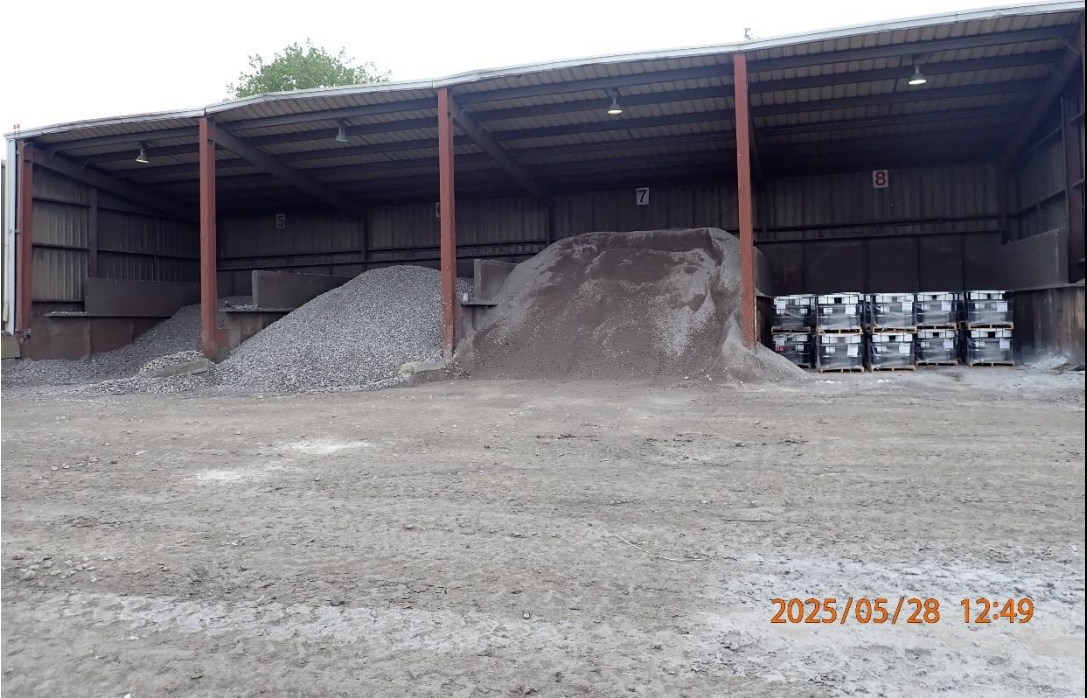
| <b>Photo No.:</b> 7 | <b>Time:</b><br>1:49 PM | | |

| <b>Unique Identifying No.</b> | <b>Observation</b> | <b>Area of Concern?</b> |
|---|---|---|
| <b>MS-OB-002</b> | During the site tour, Inspectors observed alloys stored onsite for CCMW that were kept in a specific area under coverage, protected from rain. (Photo 7) | No |

| <b>Photo Description:</b><br>Alloy silos. | | | |

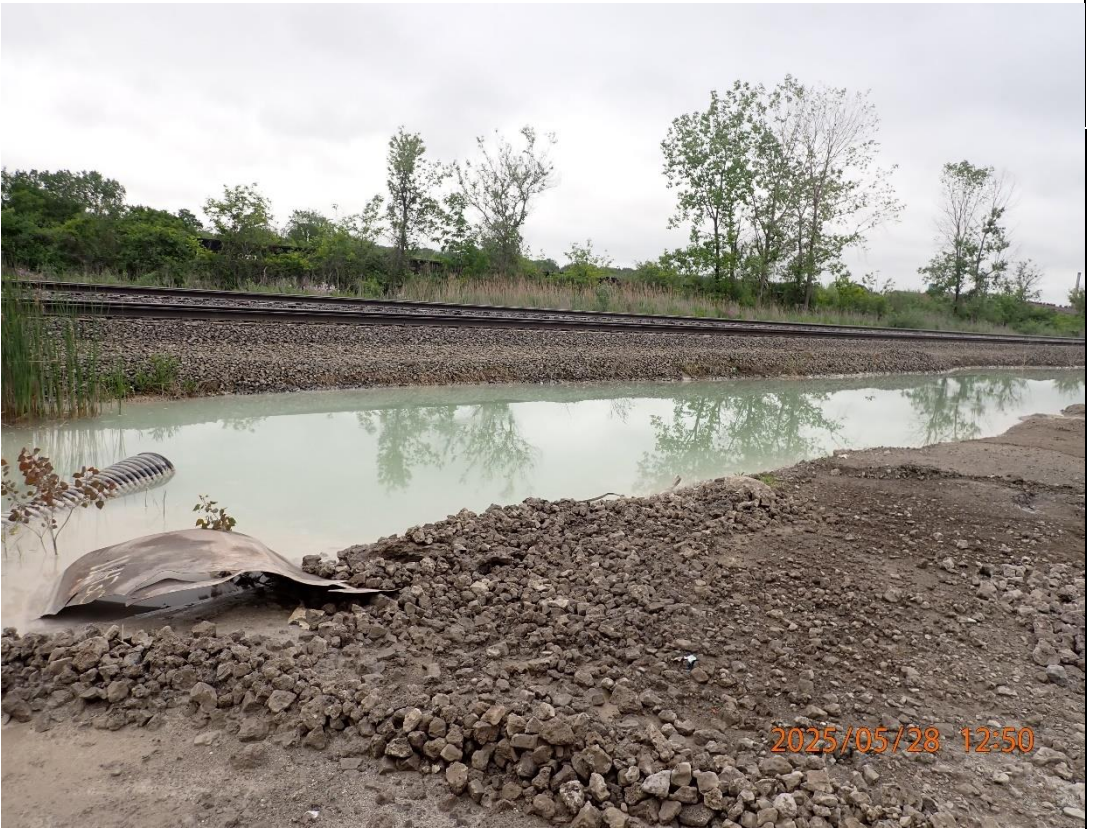
| <b>Photo No.: 8</b> | <b>Time:</b><br>1:50 PM | | |

| <b>Photo Description:</b><br>Ditch connected to holding pond. | | | |

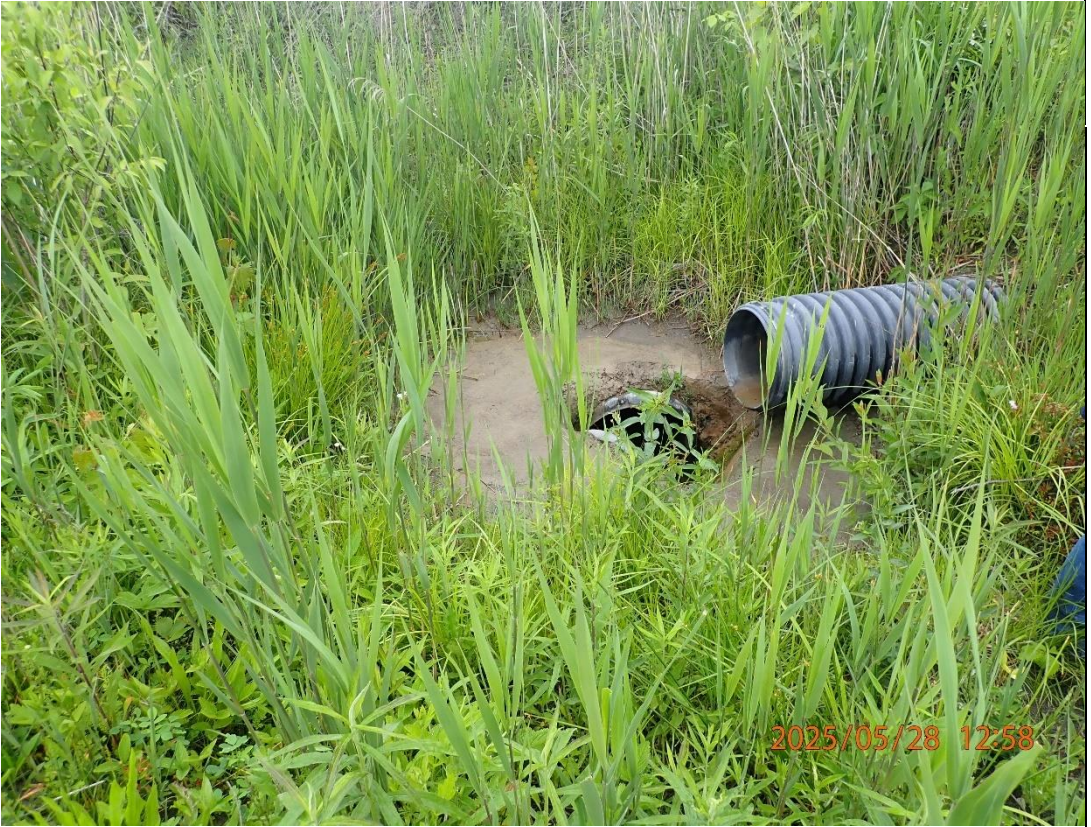
| <b>Photo No.:</b> 9 | <b>Time:</b><br>1:58 PM | | |

| <b>Photo Description:</b><br>Inflow from holding ditch connected to storm water pond. | | | |

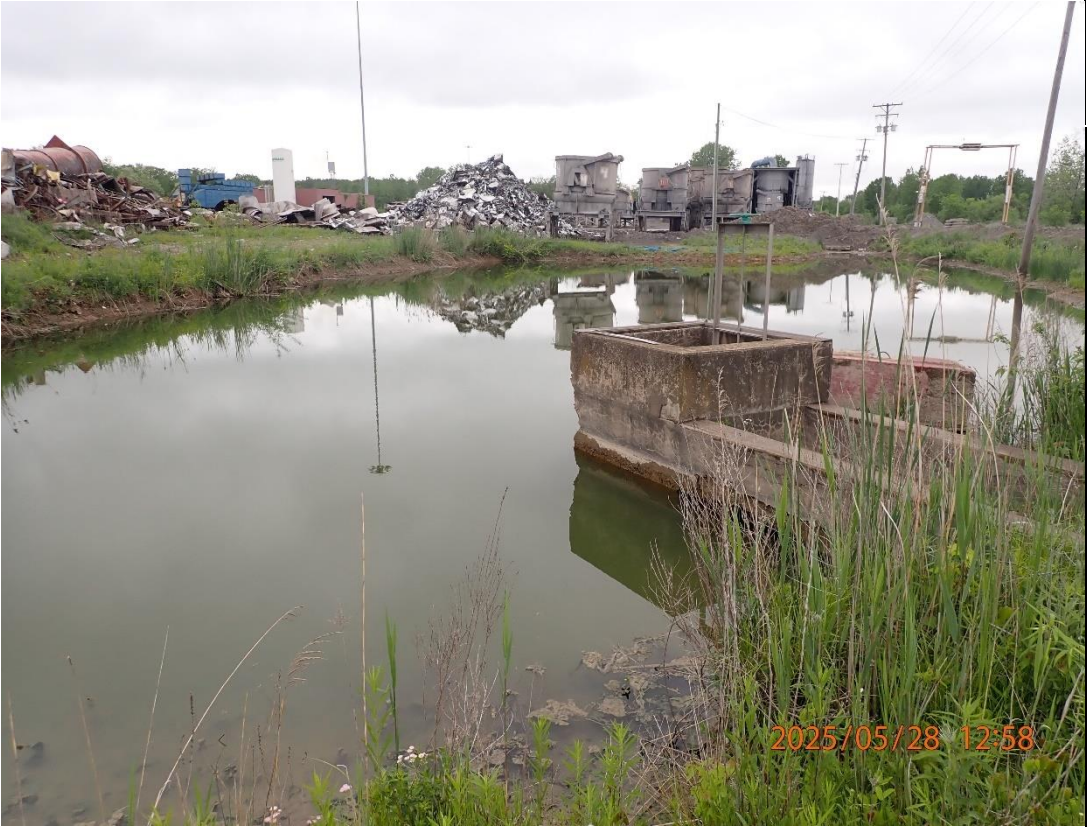
| <b>Photo No.: 10</b> | <b>Time:</b><br>1:58 PM | | |

| <b>Photo Description:</b><br>Storm water holding pond. | | | |

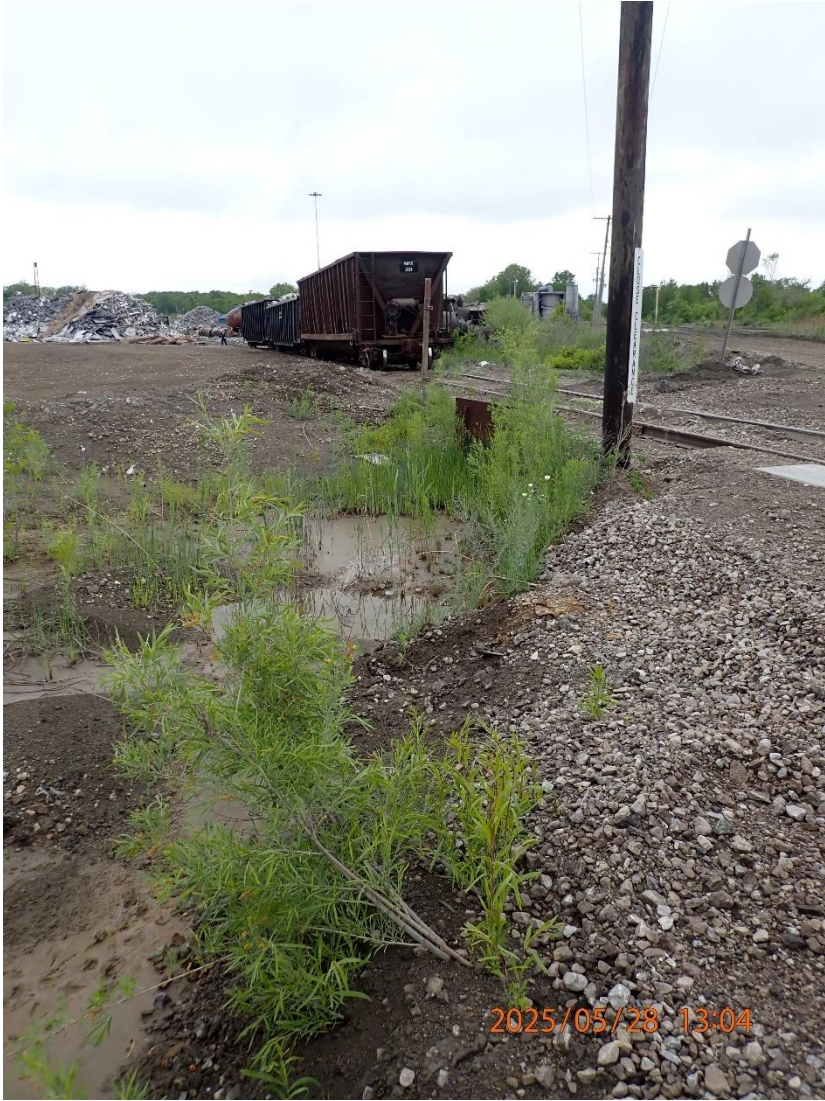
| <b>Photo Description:</b><br>Collection ditch from the road surrounding the Facility and connected to the storm water holding pond. | | | |
