**Region 6 - Enforcement & Compliance Assurance Division**  
**INSPECTION REPORT**

| Inspection Date(s): | 01-20-2026 | |
| Company Name: | <b>Sulphur Springs Livestock Auctions</b> | |
| Identification/Permit Number: | TX0144801 | |

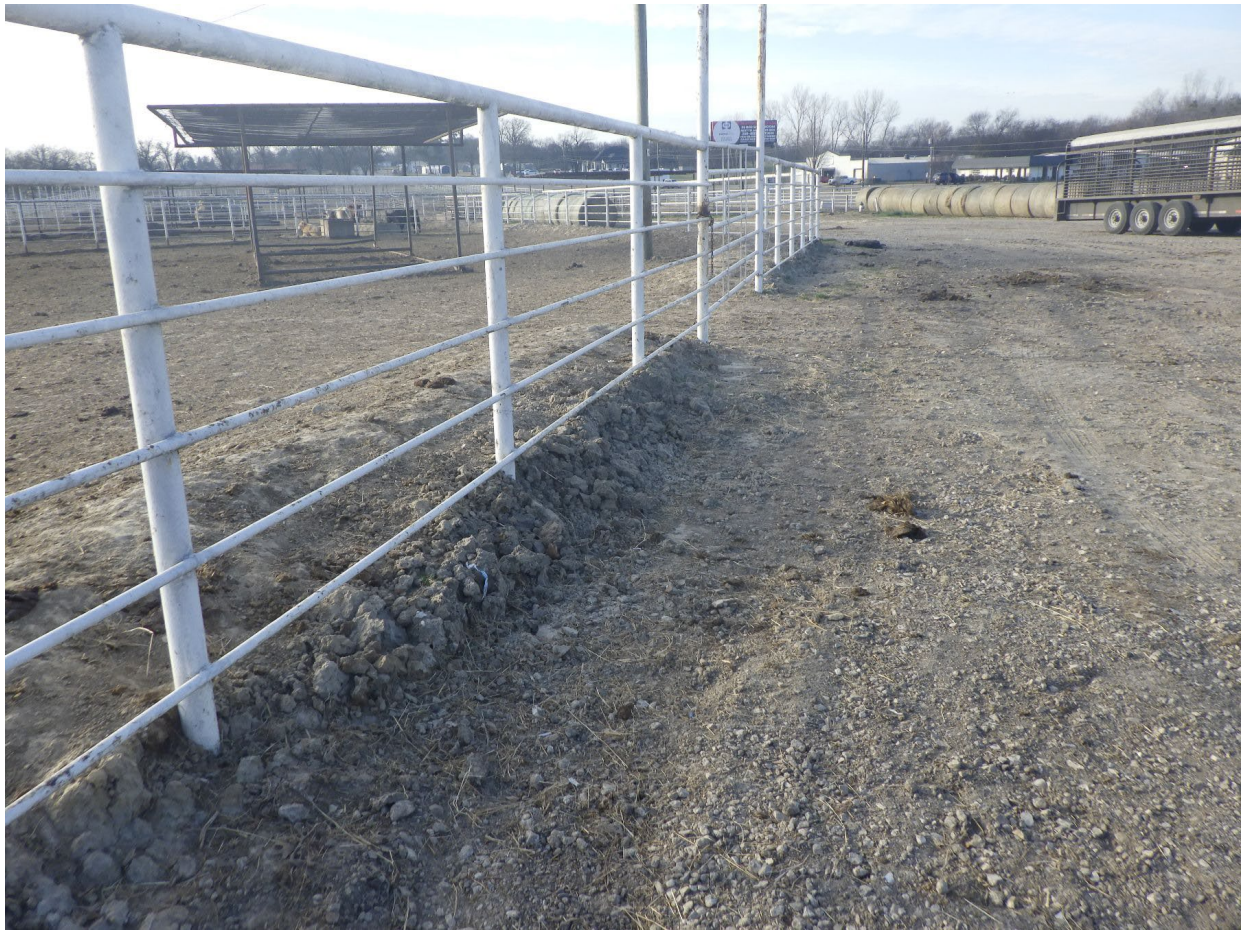
Photo No. 1

| Description: | View to the southwest. Berm along the west perimeter pens. | | |

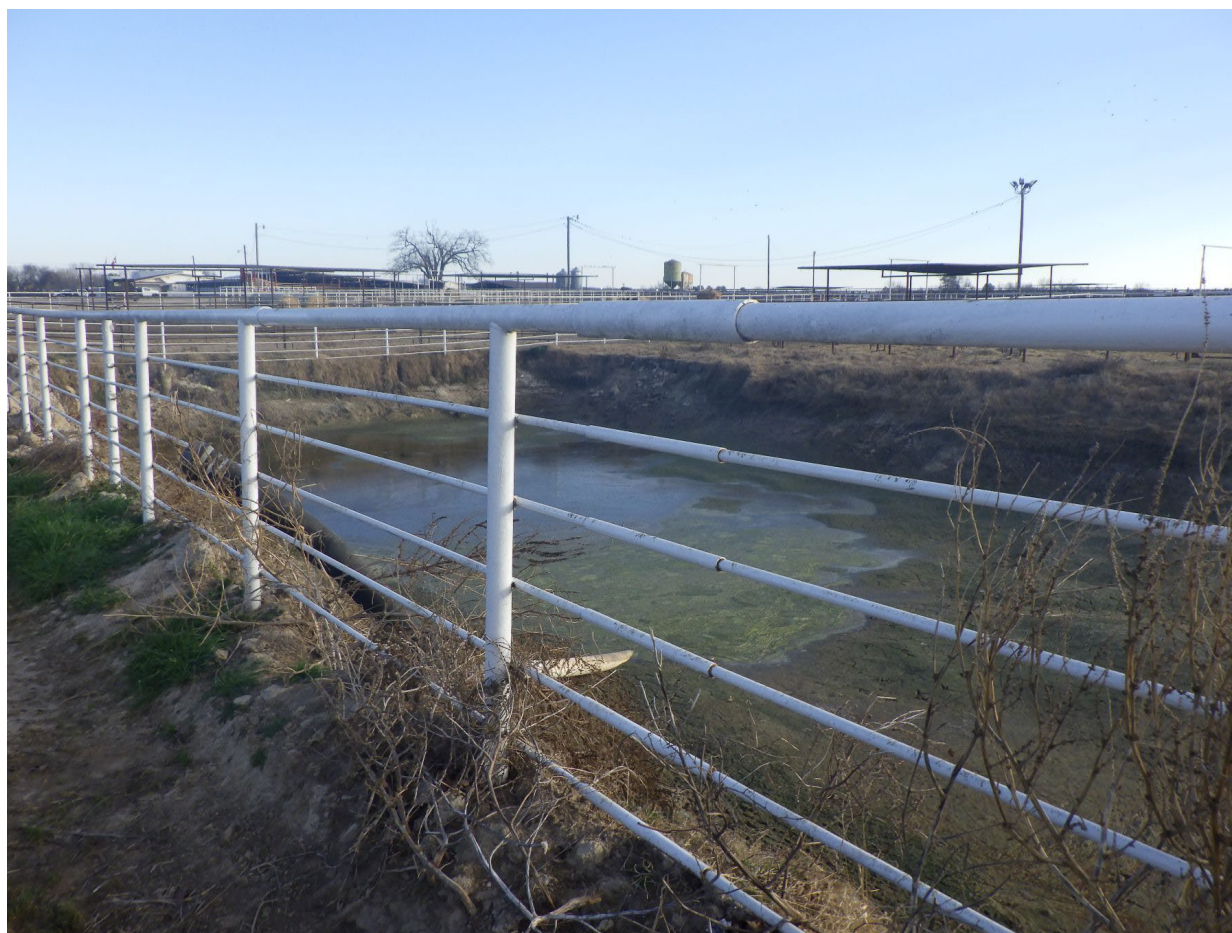
Photo No. 2

There are three RCSs (Retention Control Structures) located in the production area: CCRP (concrete retention pond), RCS 1, and RCS 2 (Appendix 1, Photos 2,5, & 12). CCRP and RCS 1 act in series where CCRP can pump directly to RCS 1. CCRP is on the west side of the pens and RCS 1 is on the east side of the pens. RCS 2 is on the north end of the facility. The facility has an agreement with their neighbor to land apply on a field designated as LMU 1.

| Description: | View to the north. CCRP#1 with pump to RCS#1. | | |

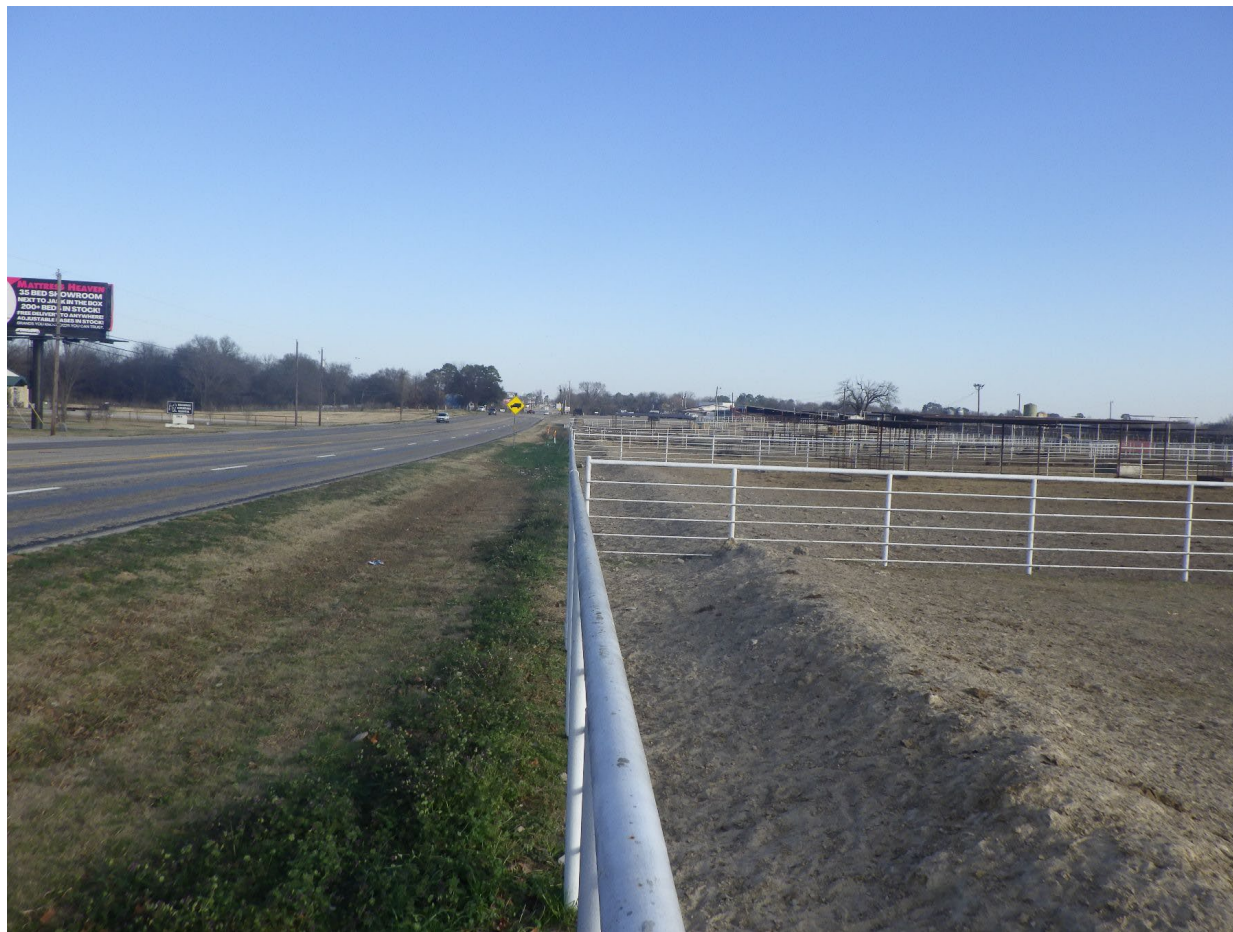
Photo No. 3

| Description: | View to the north. West perimeter of the pens with berm alongside S Broadway St. | | |

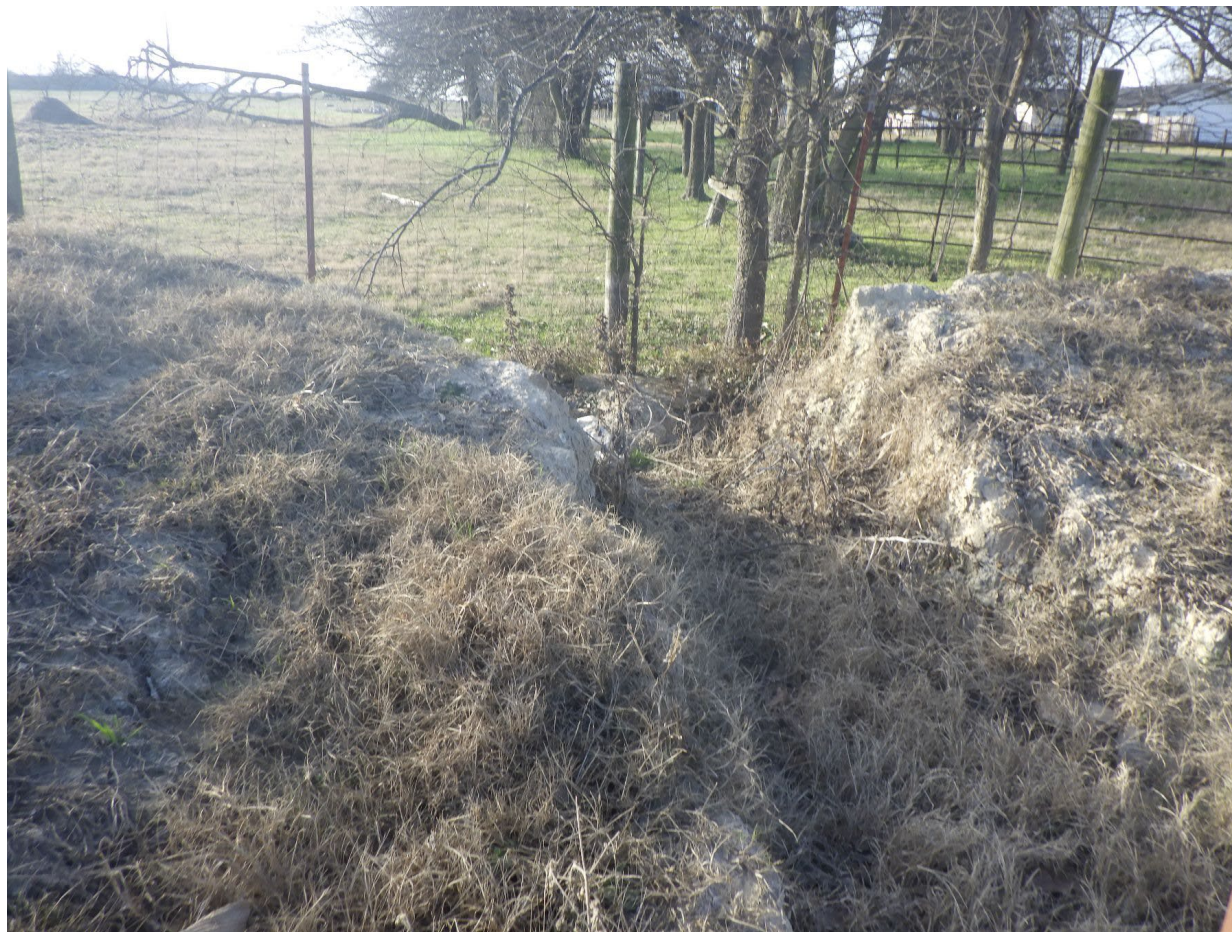
Photo No. 4

information was certified on 06-24-2025 by M. Berry P.E. Pole markers were installed directly after the inspection by the consultant and photo evidence was provided to EPA for follow-up (Appendix 2, Photos 1-7). A visual check of the lagoons showed adequate freeboard and are below the 25-yr/24-hr rain event mark. There were no signs of erosion and cattle did not have access to the lagoons. The facility is using berms, pumps, and land grading to route all runoff to RCS (Appendix 1, Photos 1, 3, 7, 11, 13, & 14). There was a break in the berm on the south perimeter of the facility (Appendix 1, Photo 4) (See Areas of Concern).

| Description: | View to the south. Break in the berm along the southern perimeter of the facility. | | |

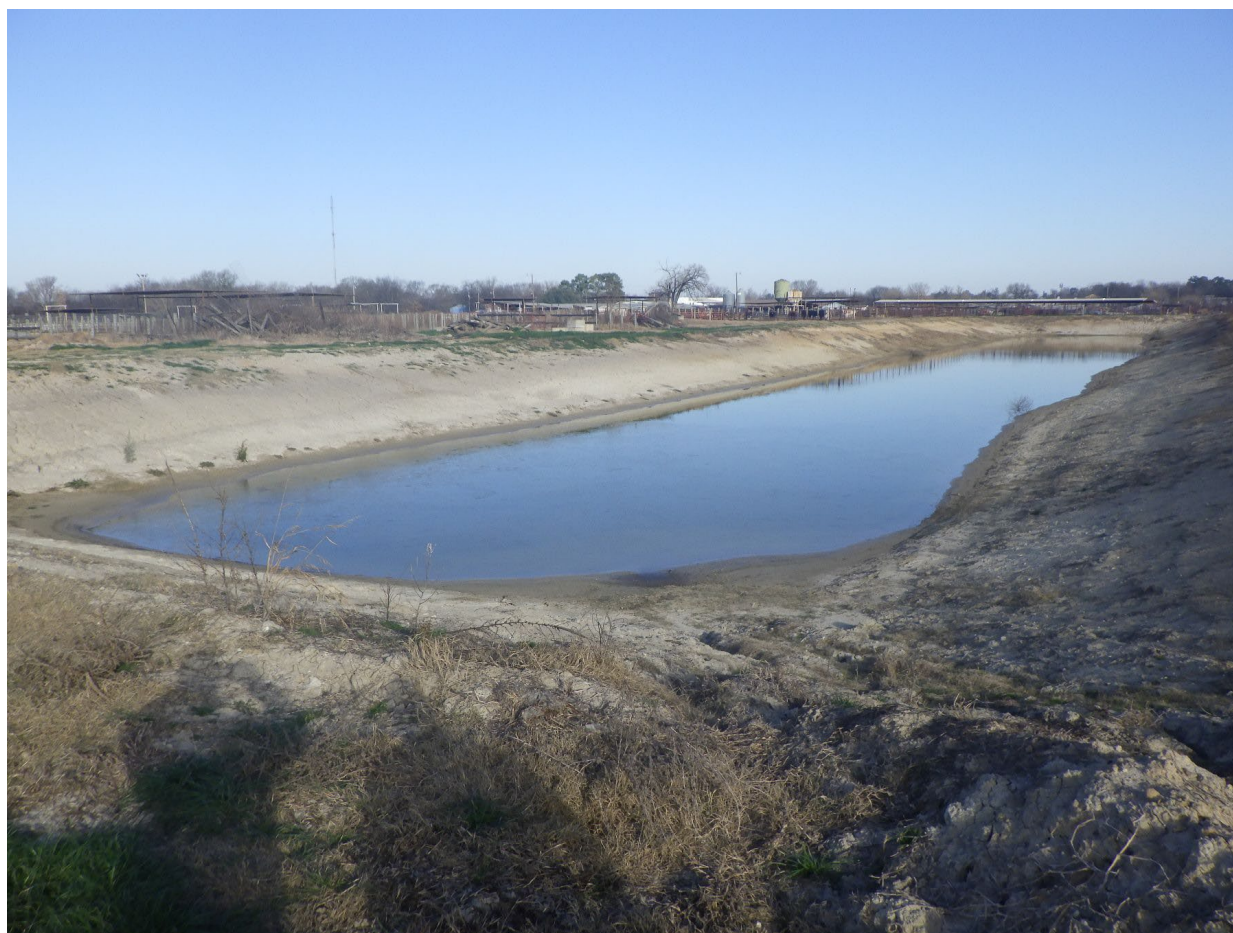
Photo No. 5

| Description: | View to the northwest. RCS#1 located on the east side of the facility with pens in background. | | |

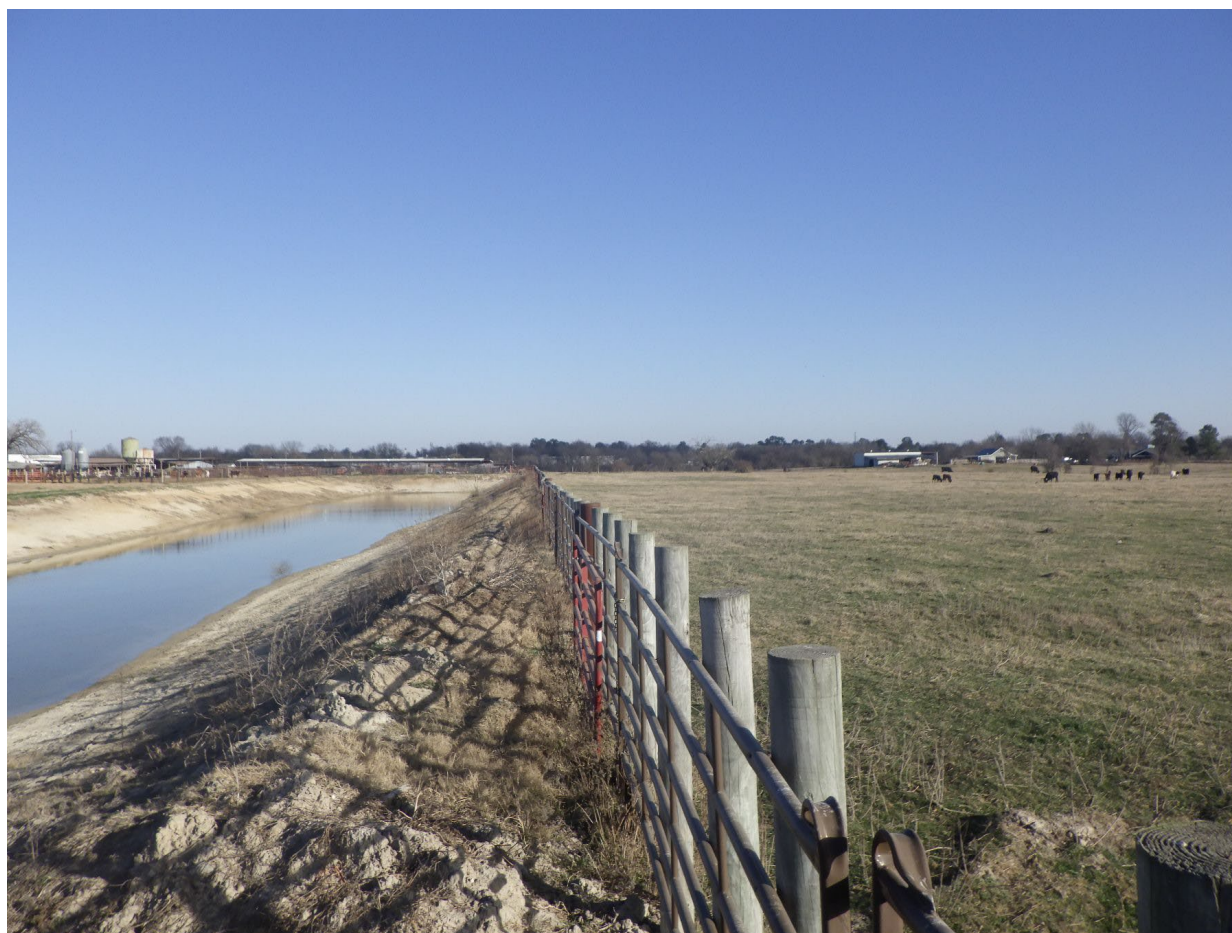
Photo No. 6

| Description: | View to the north. Eastern edge of the facility on the berm between RCS#1 and neighboring field used for land application. | | |

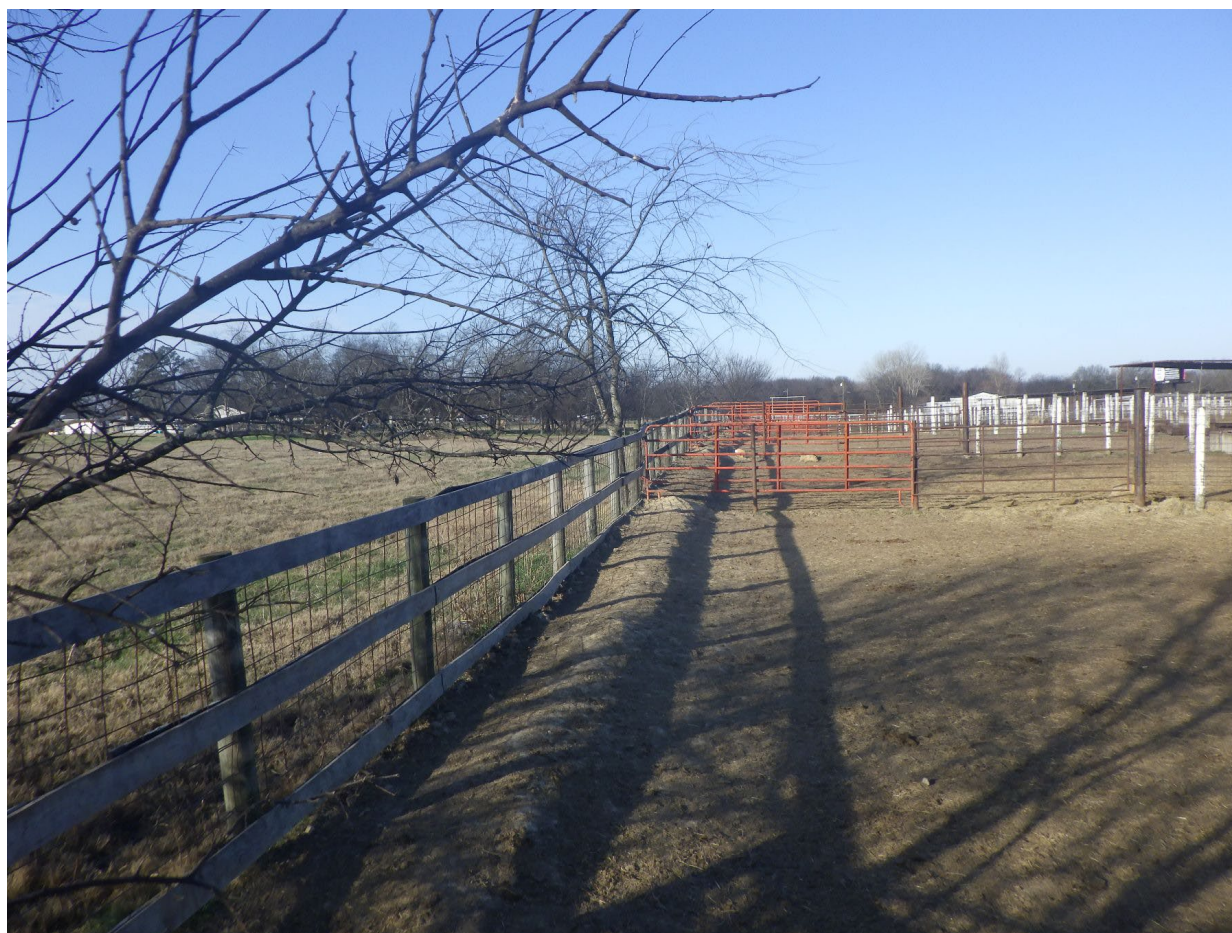
Photo No. 7

| Description: | View to the west. South perimeter of the facility. | | |

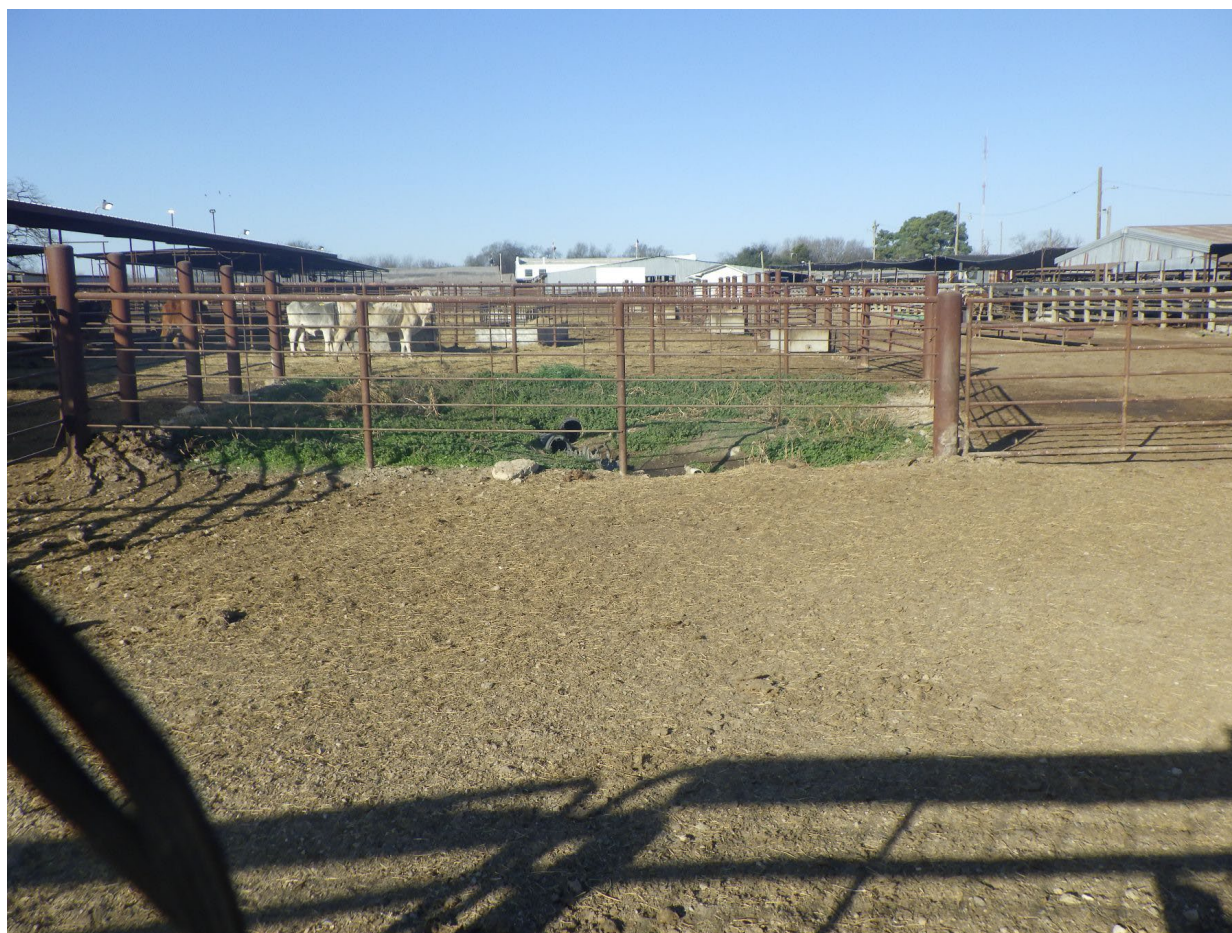
Photo No. 8

The facility has an agreement with their neighbor to the east for land applying wastewater generated at the facility. This field is denoted as LMU 1 in their NMP. LMU 1 is 15 acres. There was no sign of ponding from land application. However, there was a drainage channel from the facility's lateral water line that was draining into the field at the time of the inspection (Appendix 1, Photos 8-10) (See Areas of Concern).

1. There is a break in the lateral water line that will allow for runoff from the pens to exit offsite. "Wastewater must be contained in RCSs properly, designed, constructed, operated, and maintained according to the provisions of this general permit" Part III.A 5.(a)(4) of the Texas Commission of Environmental Quality General Permit to Discharge Wastes.
2. There is a break in the berm on the south perimeter of the facility. "Stormwater runoff must be diverted from contact with feedlots and holding pens, and manure or process wastewater storage systems" Part III.A.6.(c)(2) of the Texas Commission of Environmental Quality General Permit to Discharge Wastes.

| Description: | View to the west. Break in lateral water line exposing line to runoff from the facility. Pipe outfall leads to field on east perimeter of facility directly behind photo. | | |

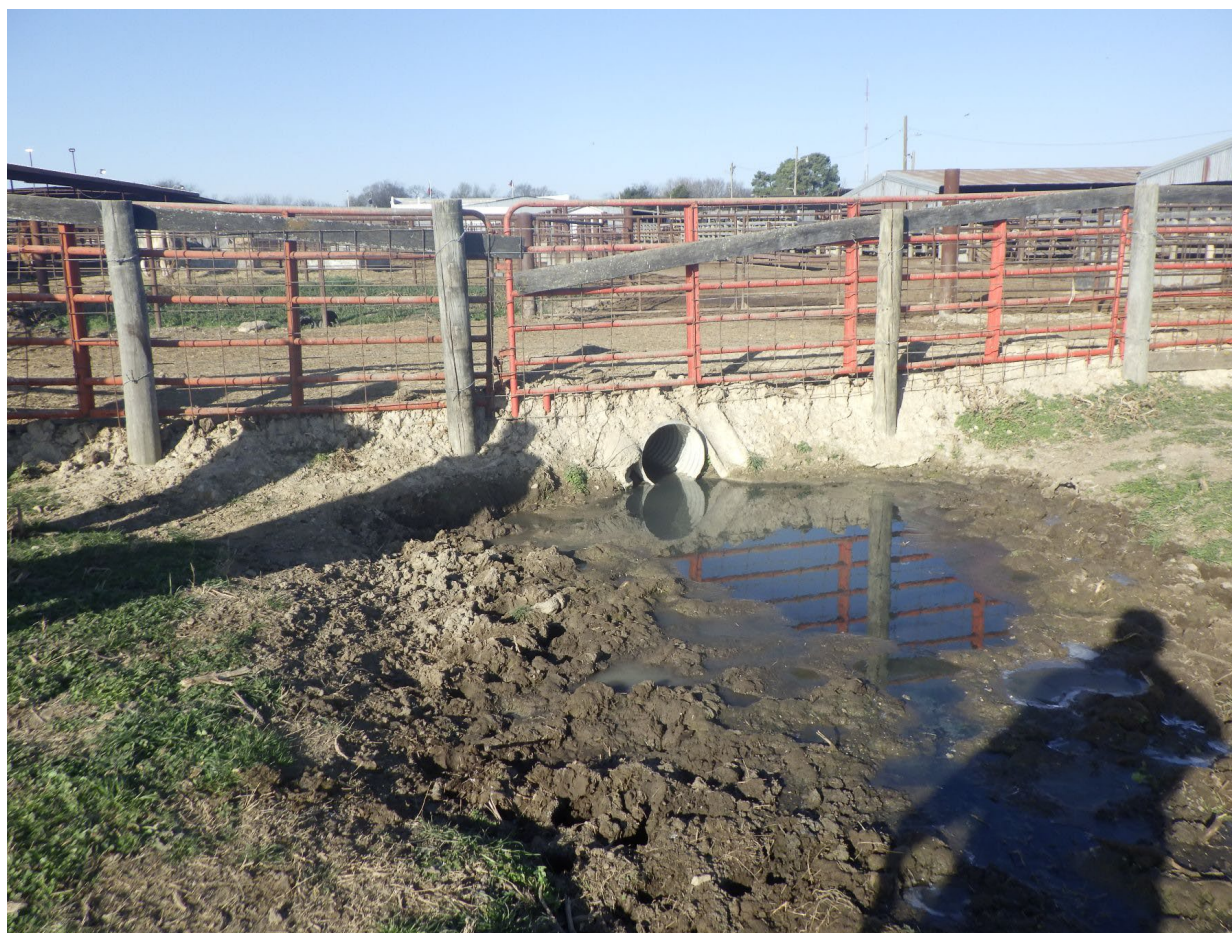
Photo No. 9

| Description: | View to the west. Culvert outfall from the lateral water line that leads into field to the east. | | |

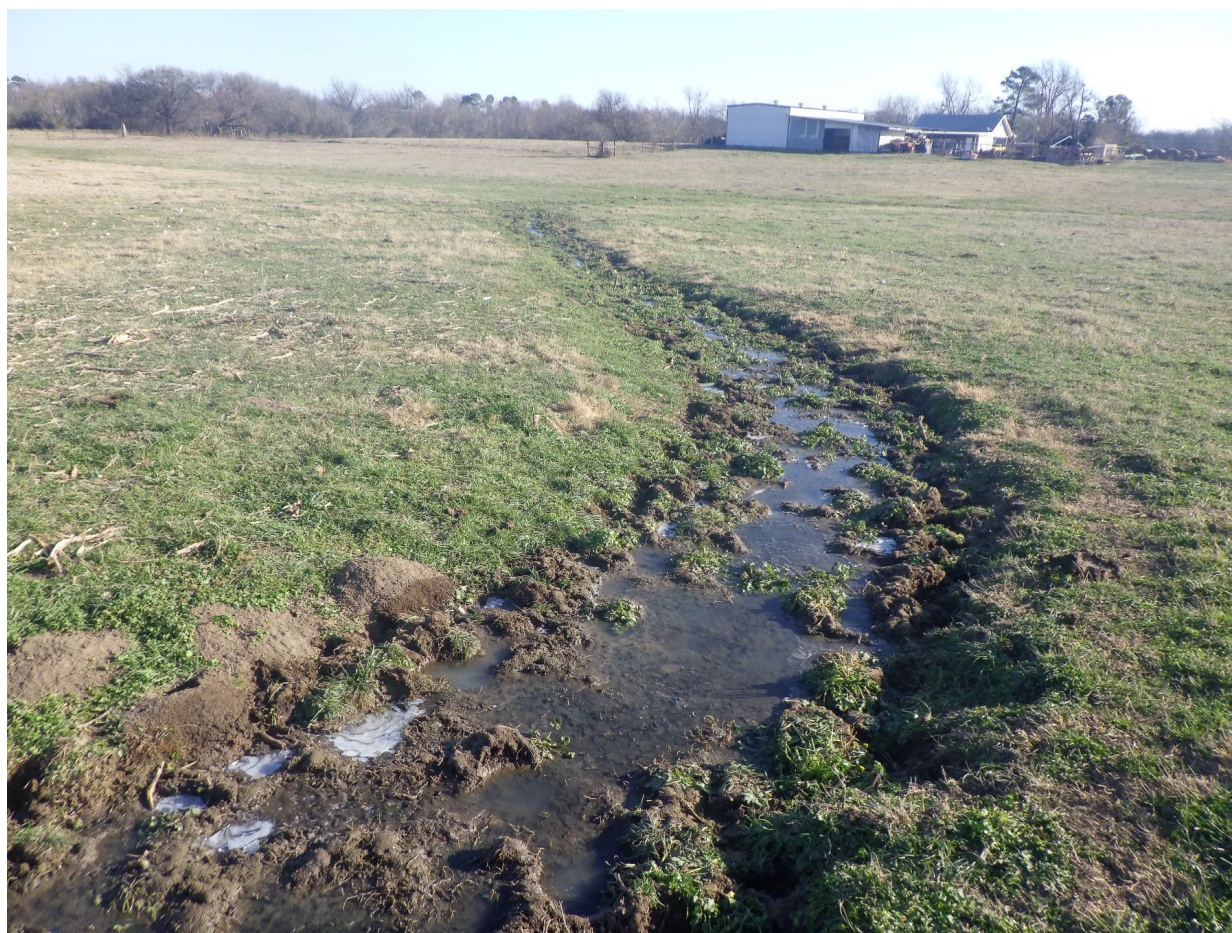
Photo No. 10

| Description: | Drainage path of lateral water line into the neighboring field to the east. | | |

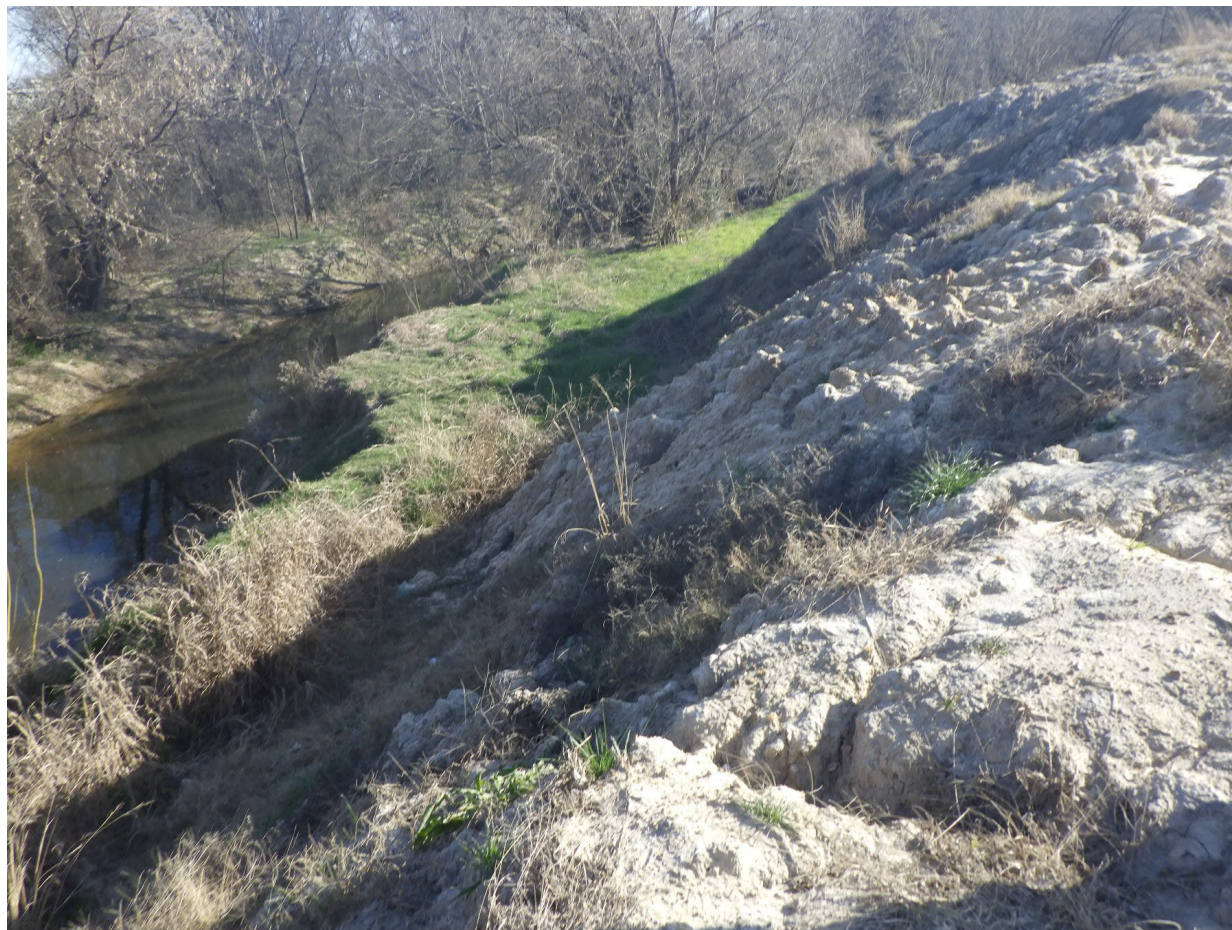
Photo No. 11

| Description: | View to the east. On top of berm between RCS#2 and Rock Creek. | | |

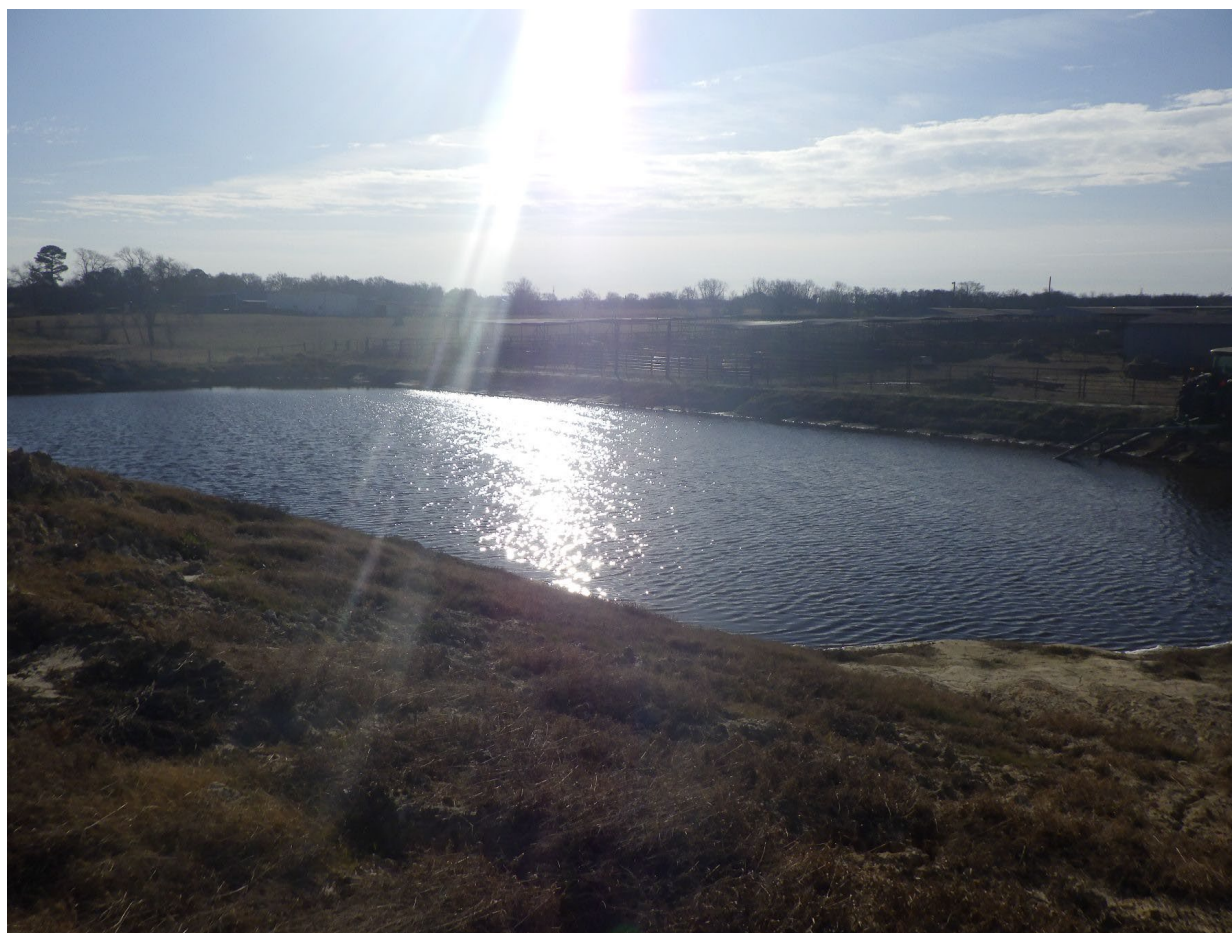
Photo No. 12

| Description: | View to the southeast. RCS#2 with pens in background. | | |

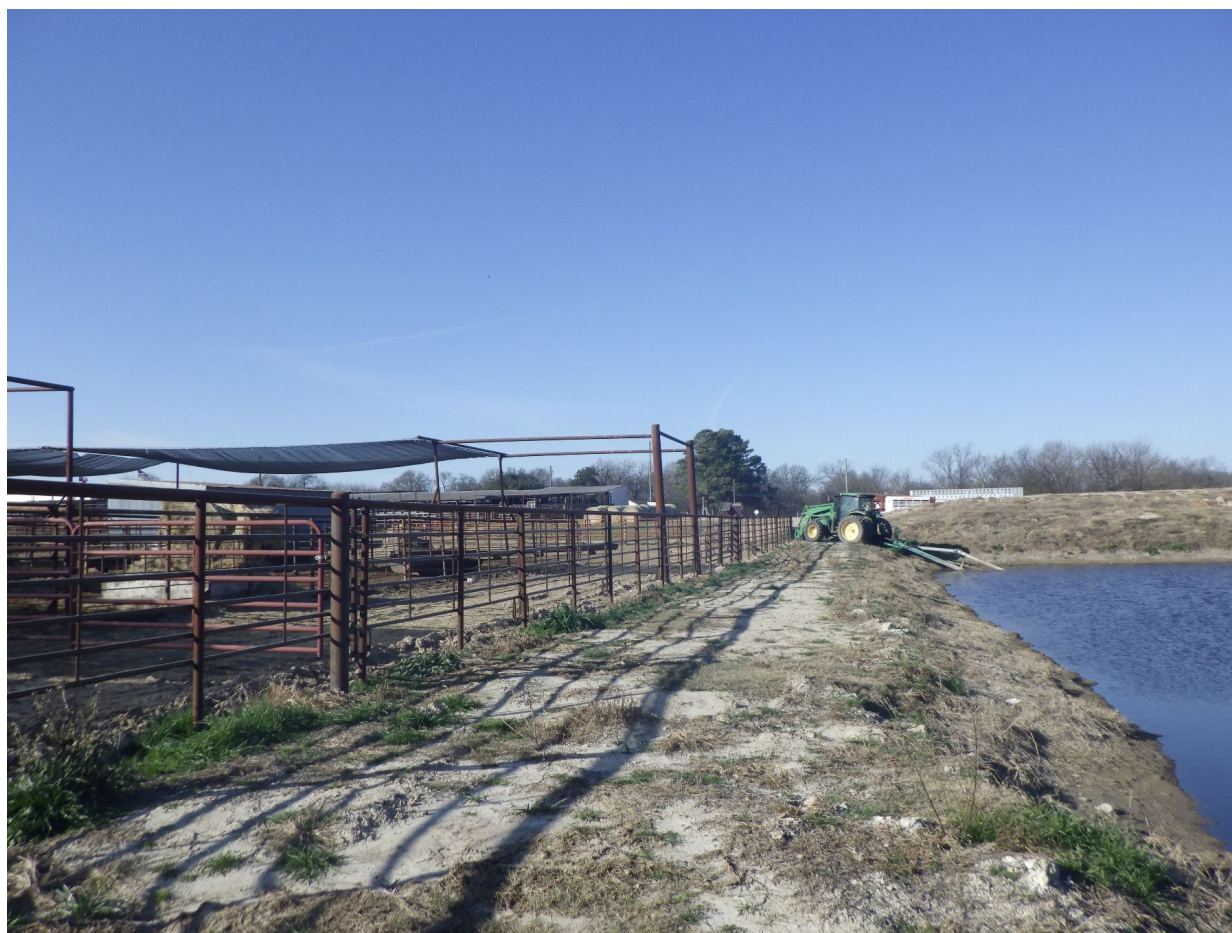
Photo No. 13

Hay commodities are stored above drainage of RCS 2 (Appendix 1, Photo 13).

| Description: | View to the west. Hay storage in drainage of RCS#2. | | |

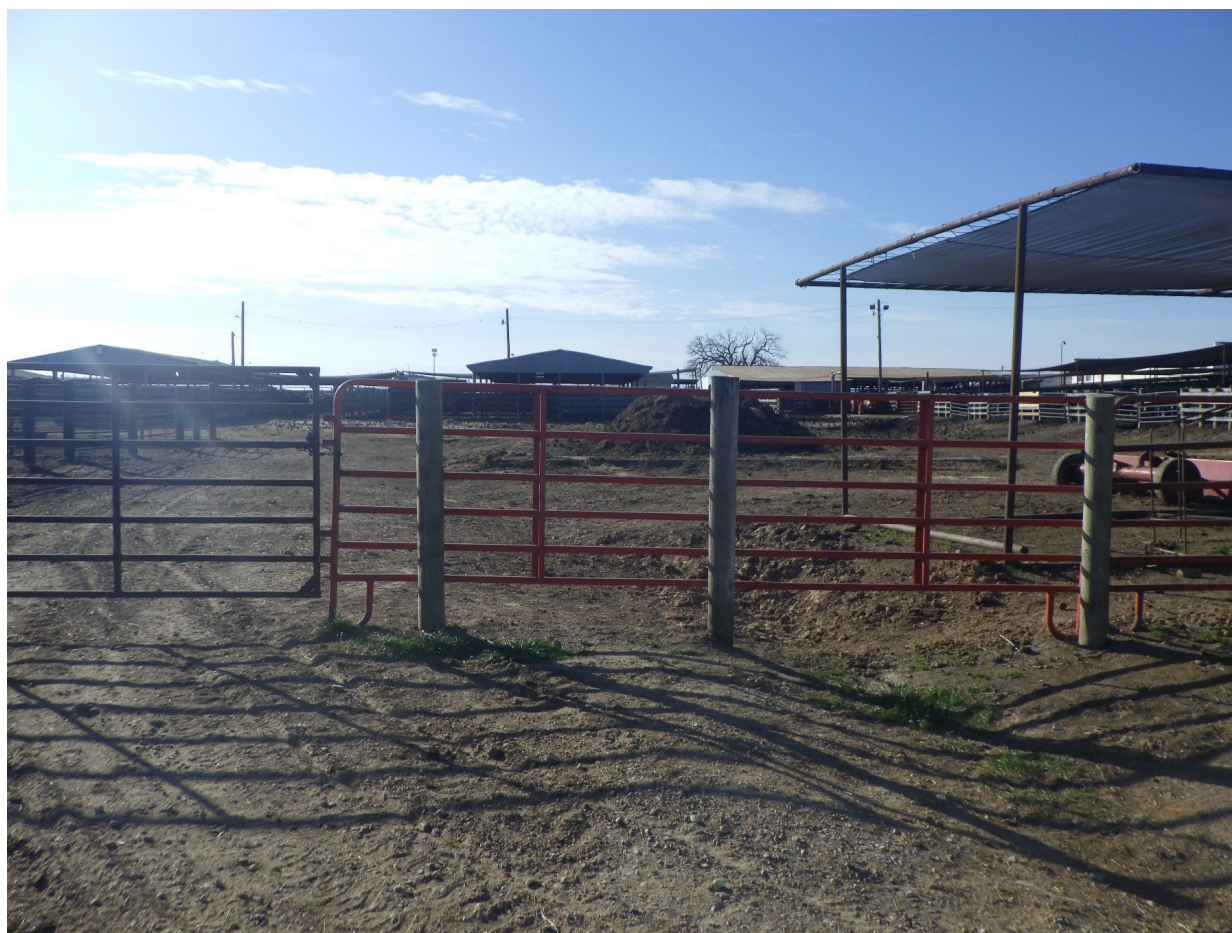
Photo No. 14

| Description: | View to the south. Manure stockpile within drainage of RCS#2. | | |

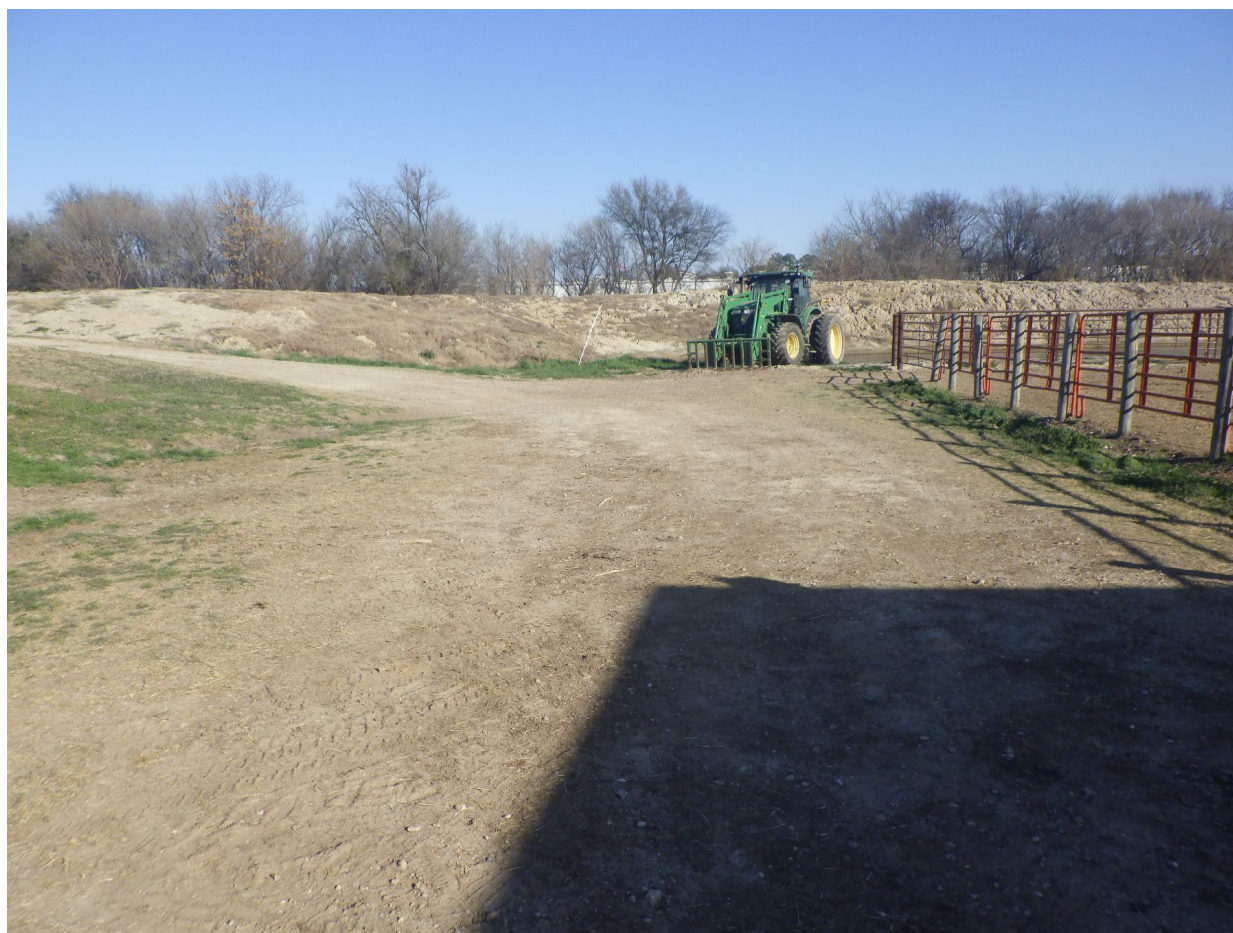
Photo No. 15

| Description: | View to the north. Drainage path leading from manure stockpile to RCS#2. | | |
