**Region 6 Compliance Assurance and Enforcement Division  
INSPECTION REPORT**

| Inspection Date(s): | March 11-13, 2019 | | |
| Company Name: | <b>Total Environmental Solutions, Inc. (TESI)</b> | | |
| Identification/Permit Number: | LA0074853 | | |

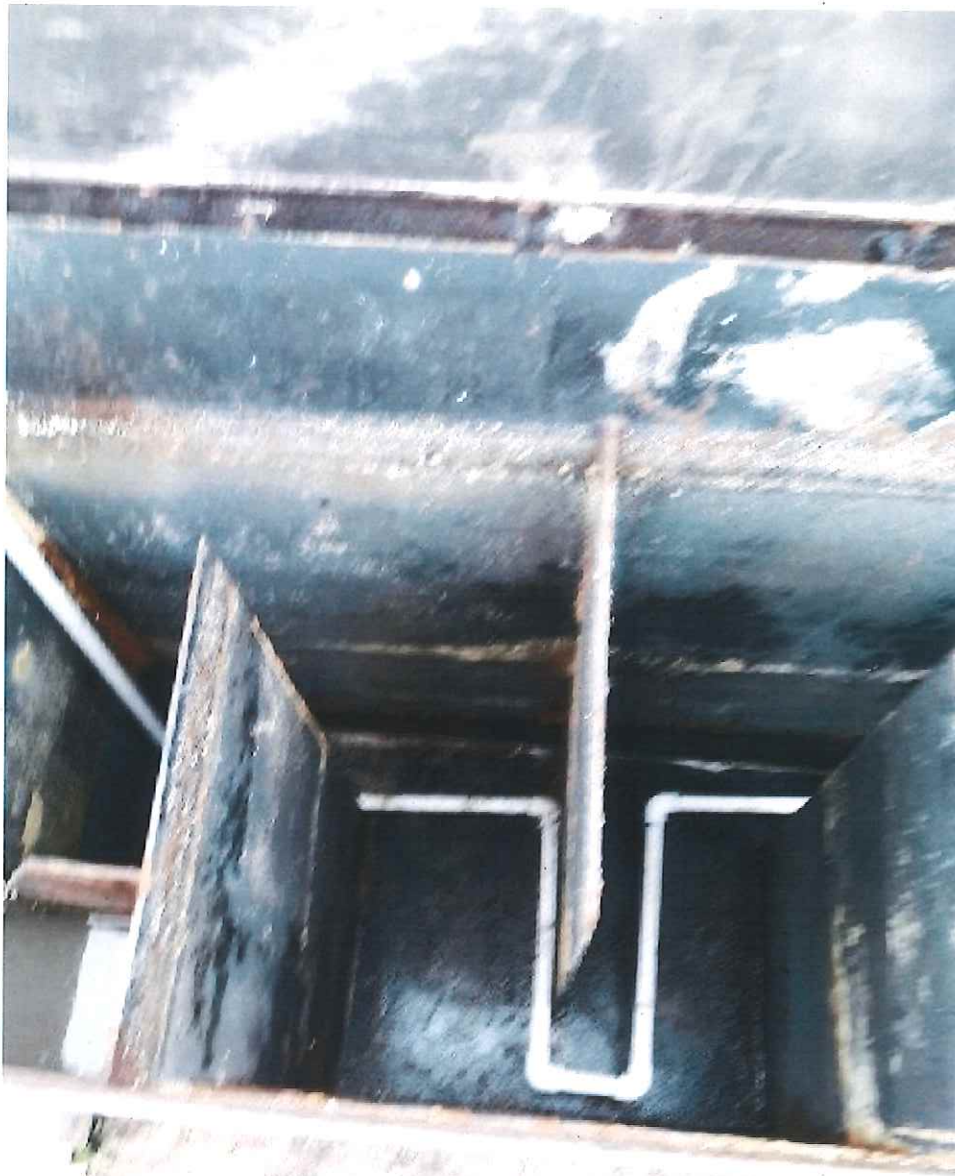
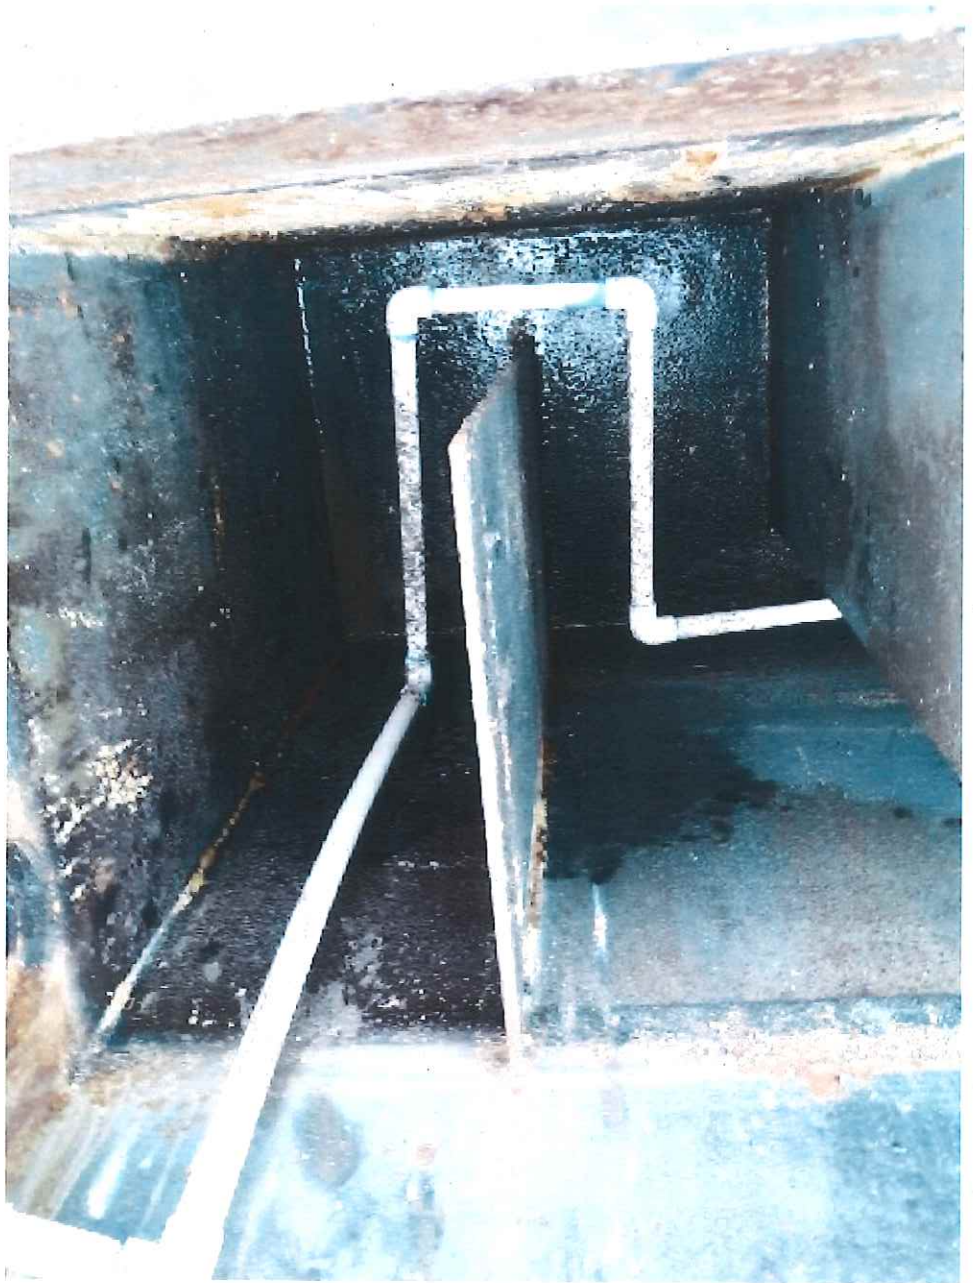
| DATE | PROBLEM | WHAT WAS DONE | COMPLETED |
|---|---|---|---|
| Tuesday,<br>March 12,<br>2019 | The chlorine contact chamber was observed as having a thin film of solids, presumably sludge, accumulated on the bottom. Likely entered the chamber as the pumping of clarifier supernatant neared completion. No solids were observed in discharge nor on discharge side of V-notch weir. | The plant equipment was temporarily powered down as normal operating water levels had not returned (e.g., water level in clarifier remained a couple feet below the effluent weir). During this time, the chlorine contact chamber was cleaned by pumping the contents back to the head of the plant. All solids were removed from chlorine contact chamber. Returned plant equipment to normal operating conditions. | Yes<br>(Morning of<br>3/12/19) |

3-12-19 Kindco CCC Pump Back into Plant

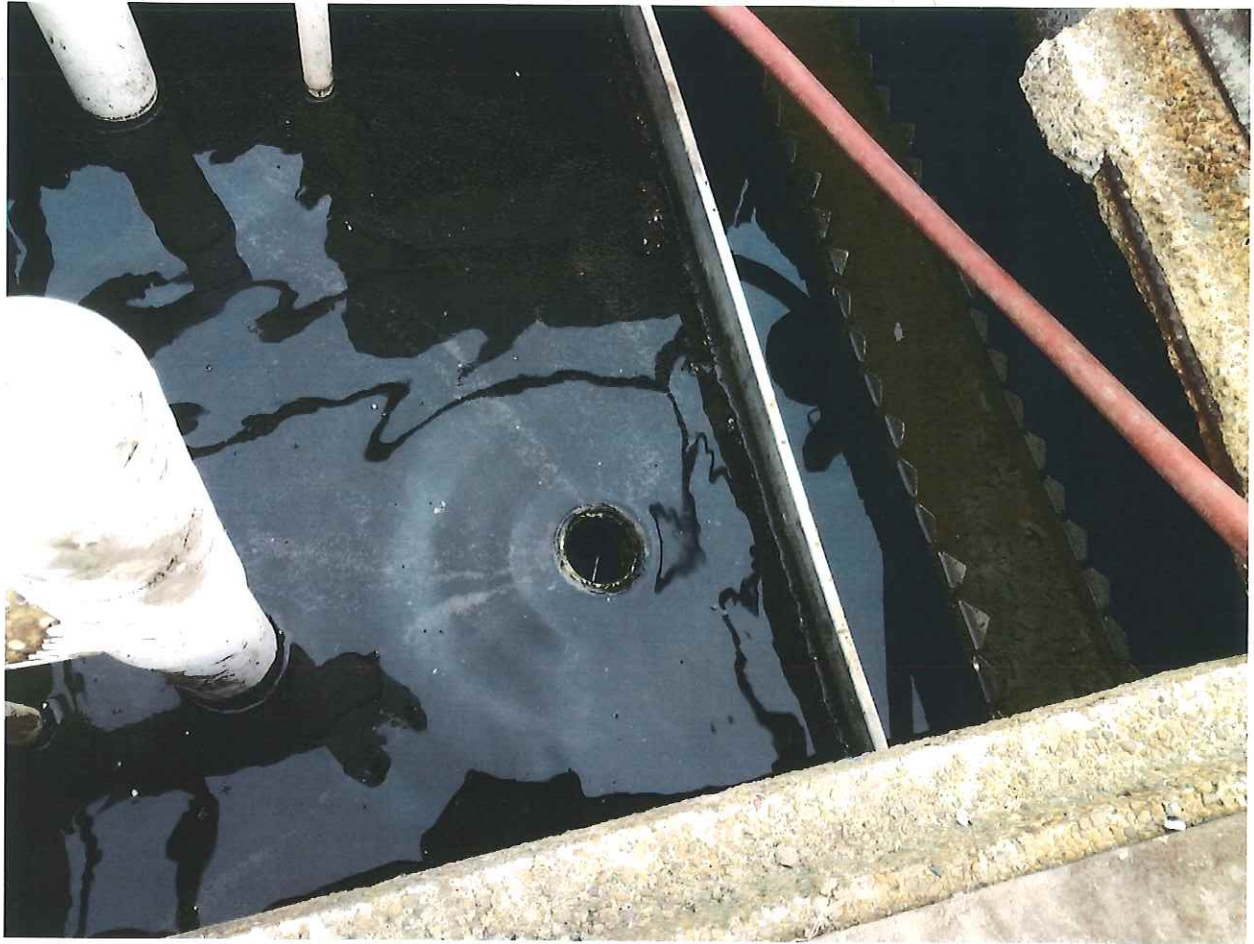
| DATE | PROBLEM | WHAT WAS DONE | COMPLETED |
|---|---|---|---|
| Wednesday,<br>March 13,<br>2019 | No problems suspected. Needed to verify plant was operating properly. | Technician conducted an operations site visit and verified that the plant was not leaking. The plant and all equipment were operating as intended, including discharging of a clear effluent. | Yes<br>(Morning of<br>3/13/19) |

3-13-19 Kindco Follow UP

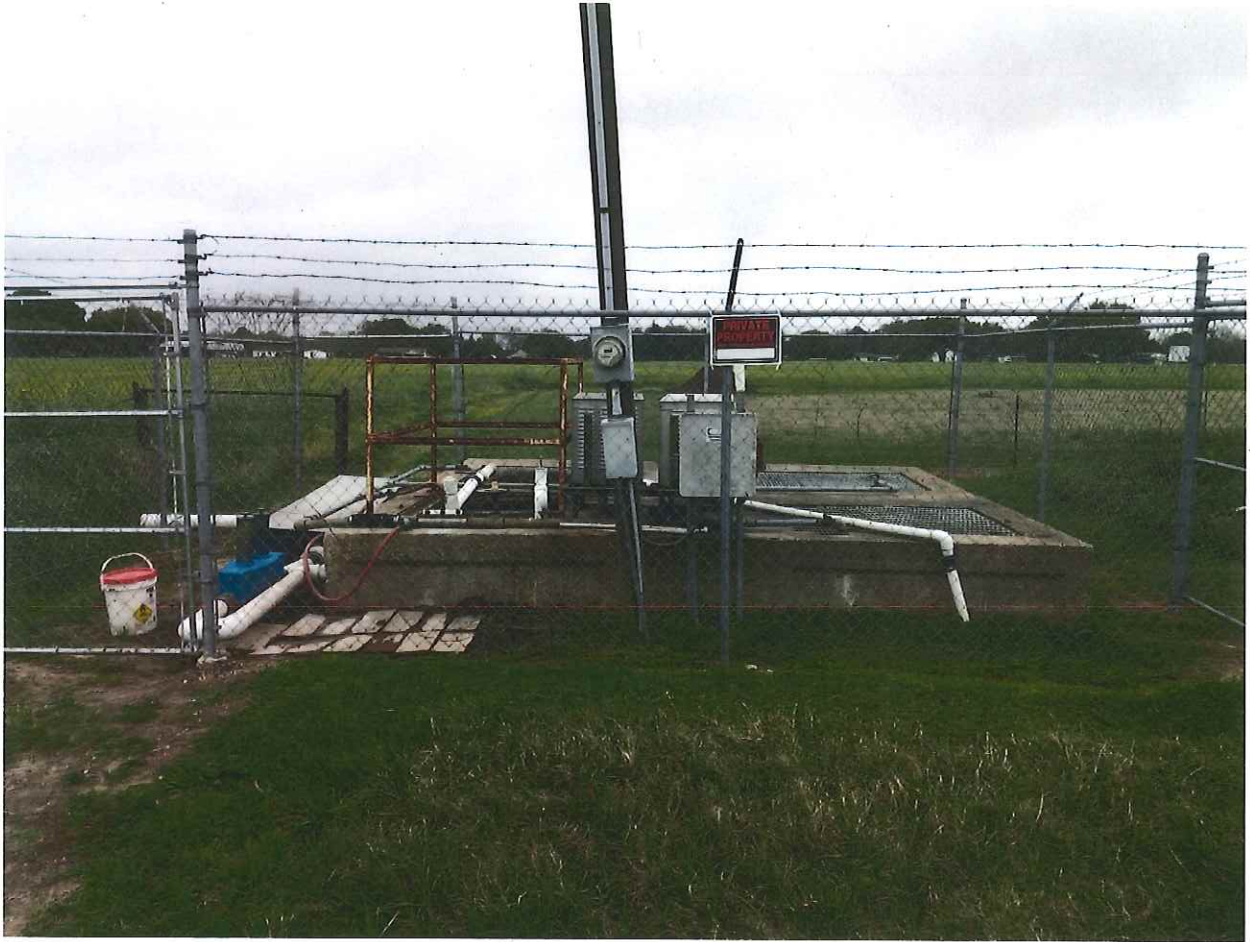
3-13-19 Kindco Follow UP

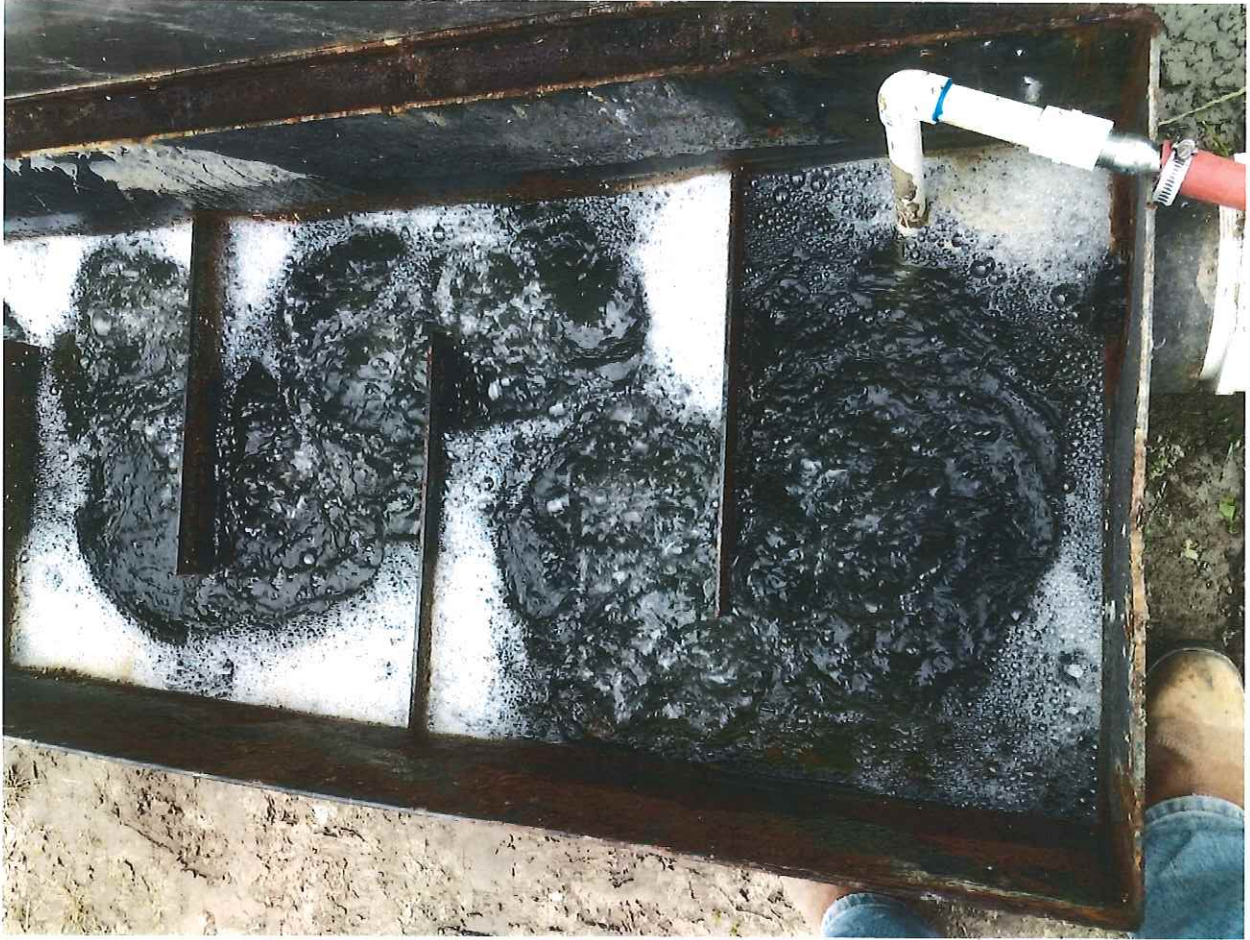
3-13-19 Kindco Follow UP

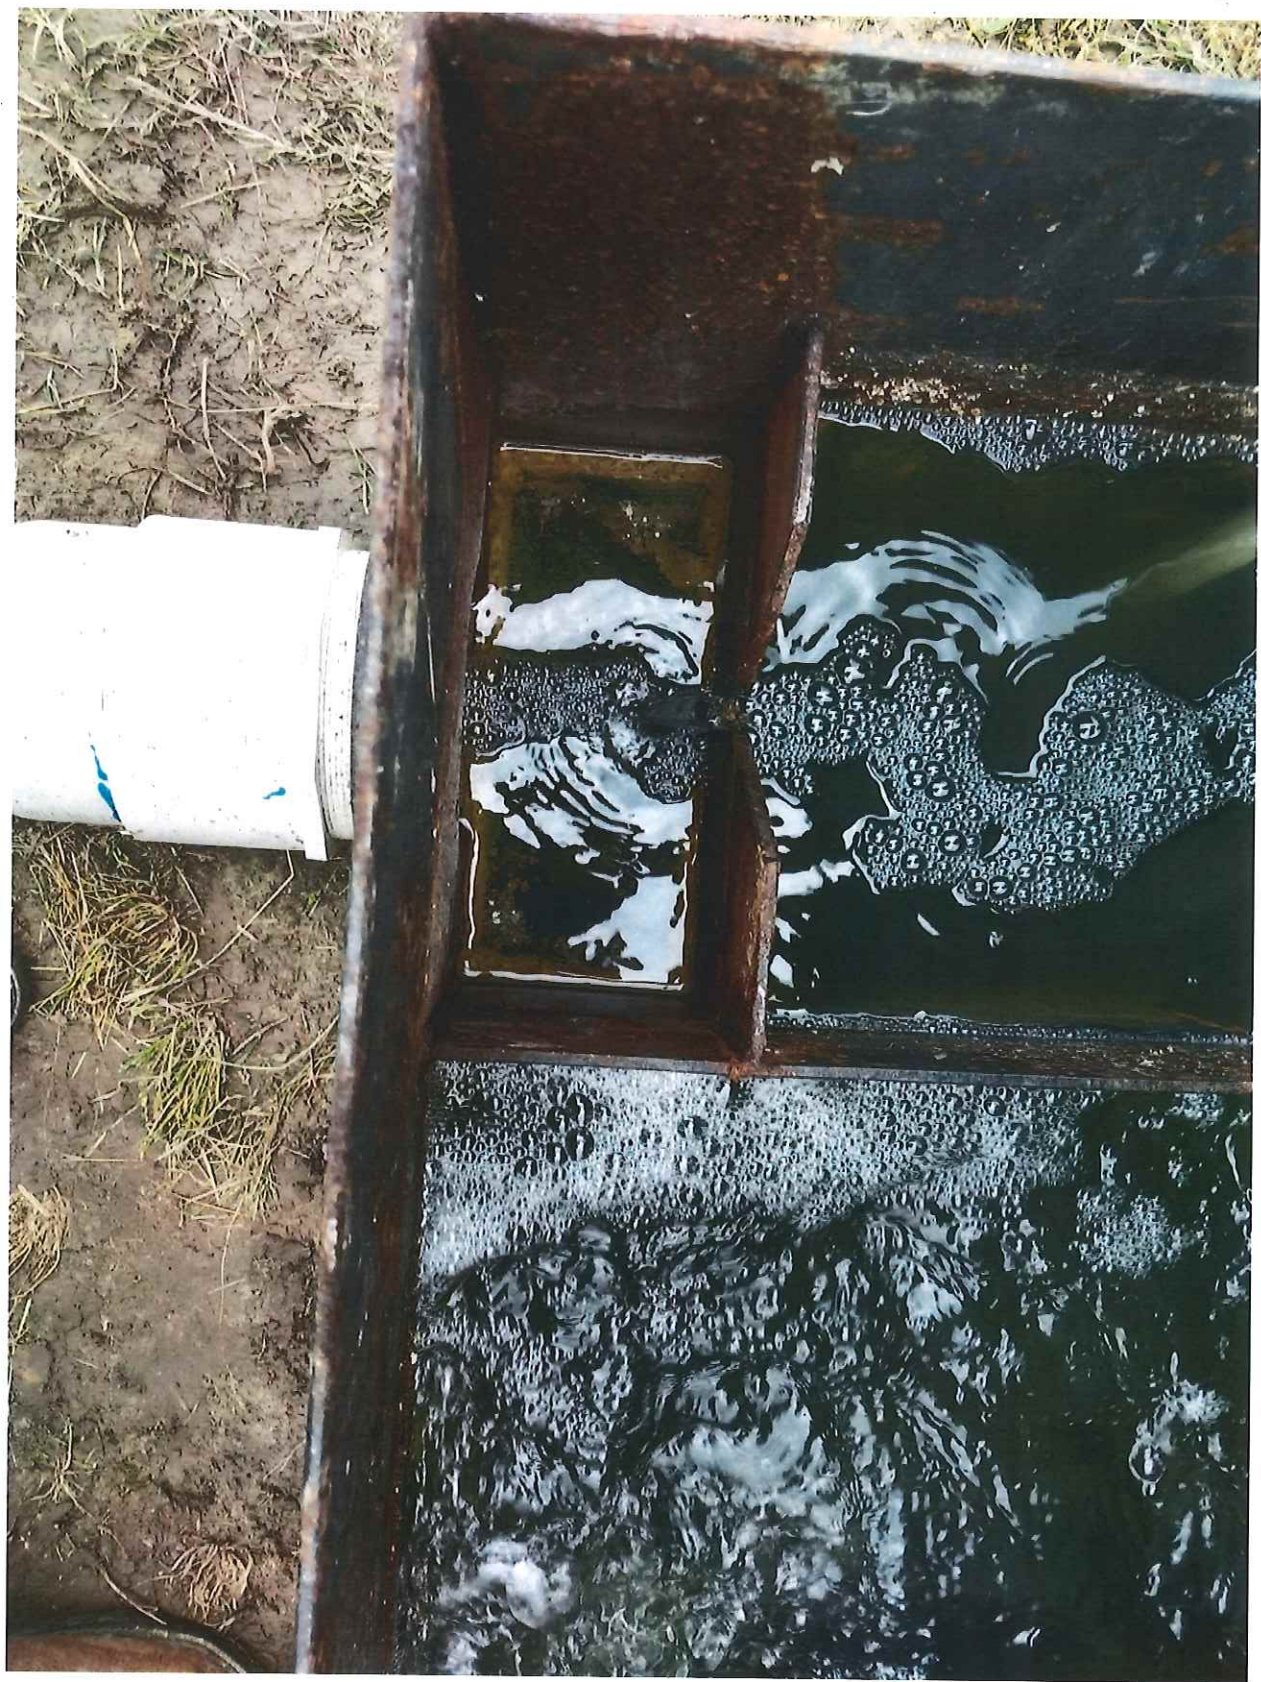
3-13-19 Kindco Follow UP

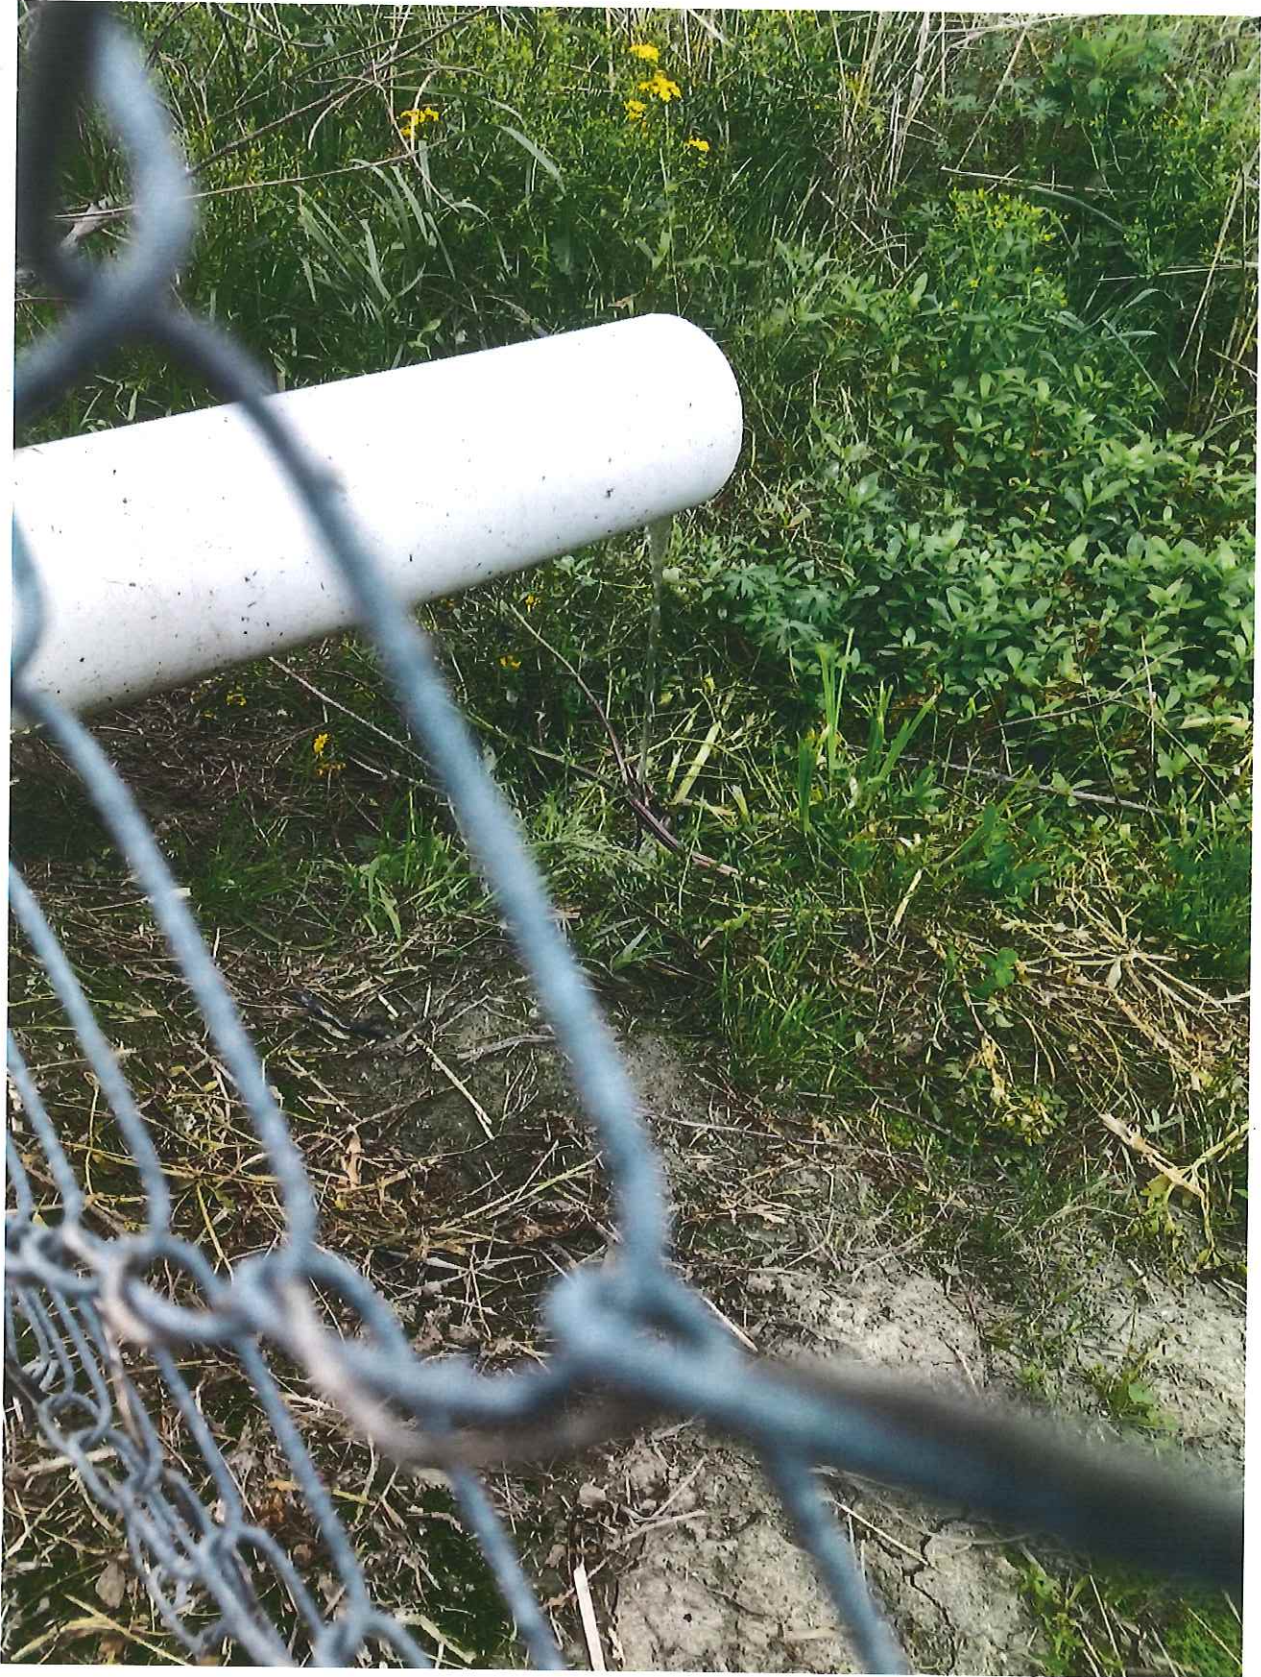
3-13-19 Kindco Follow UP
