**WASTEWATER TREATMENT SYSTEM  
COMPLIANCE EVALUATION INSPECTION REPORT**

**Purpose:** NPDES Compliance Evaluation Inspection

**Facility:** Big Sand Lake/West Hertel Wastewater Treatment Plant  
St. Croix Chippewa Indians of Wisconsin Reservation  
P.O. Box 67  
Hertel, Wisconsin 54893  
(NW ¼ of Section 2, T38N, R15W)

**Date of Inspection:** October 27, 2020

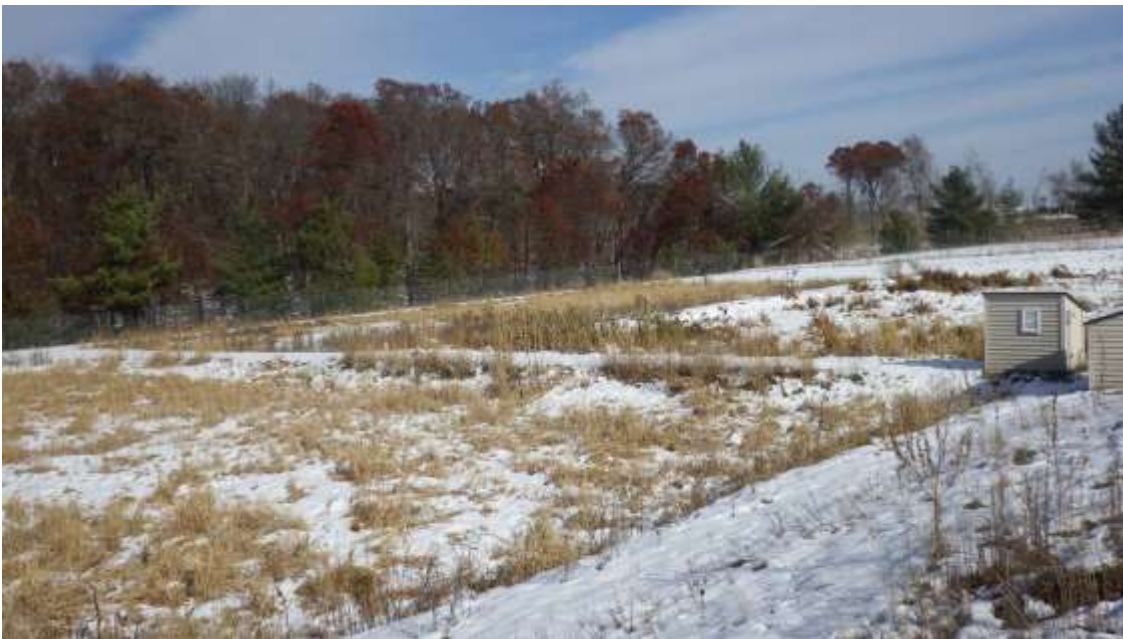
5: STWH0005

- Two treatment wetlands have been offline for two years due to invasive grass and vines, and worms were observed in the effluent flume. Pursuant to Permit Part I.C.3 and Part II.B.1, the Tribe shall at all times properly operate and maintain all facilities and systems of treatment and control;

Description: Treatment wetlands 1-3 (in order left to right). Note cattails growing in offline treatment wetlands 1 and 2.

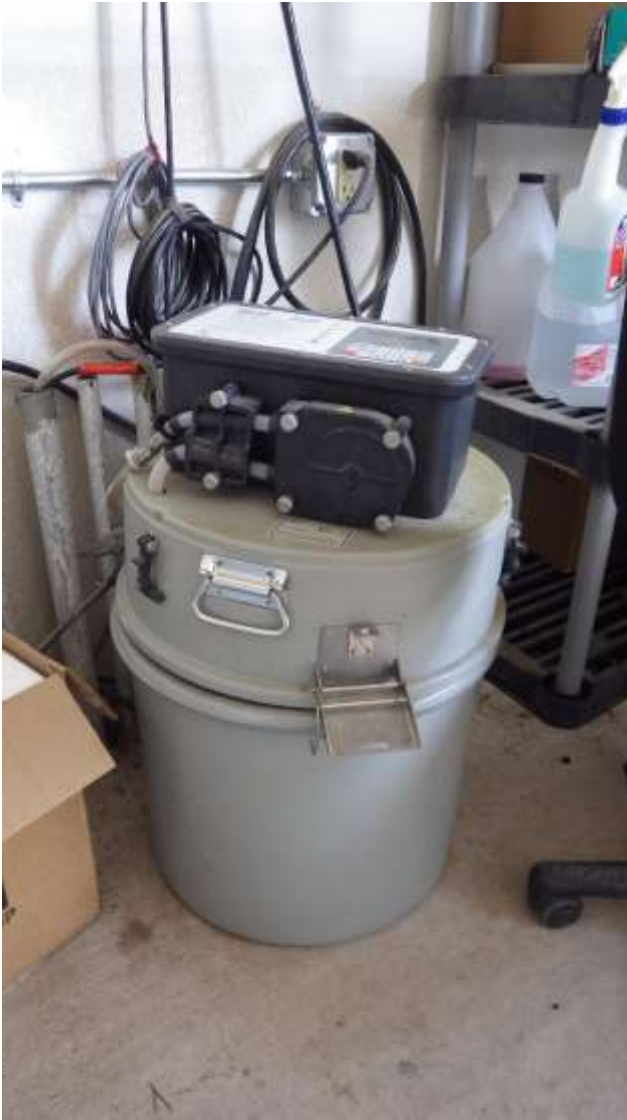
9: STWH0009

- Influent samples are collected as grab samples. Composite samples are required for BOD<sub>5</sub>, copper, and total phosphorus. [Permit Part I.B];
- Effluent samples collected via 24-composite sampler must be preserved (e.g., refrigerated) in accordance with 40 CFR Part 136;

Description: Effluent ISCO composite sampler.

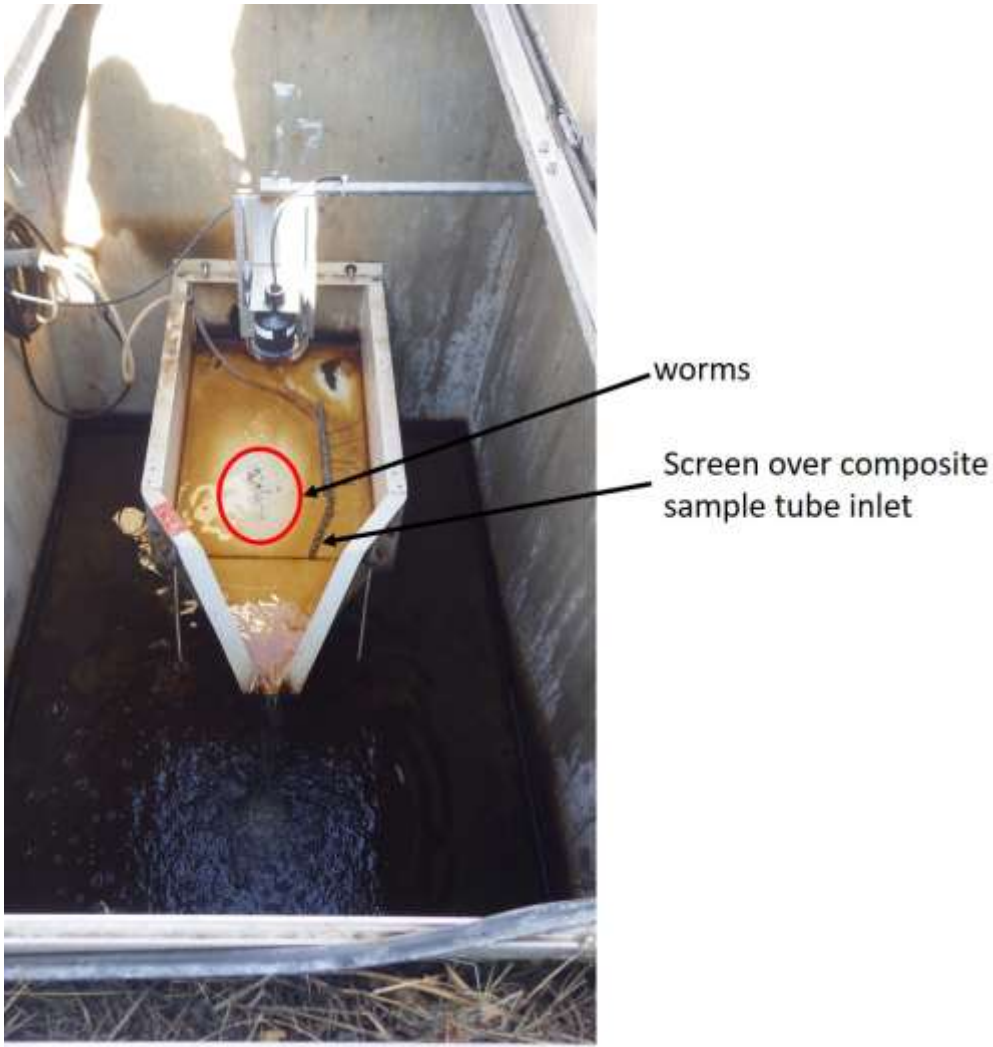
13: STWH0013

- Effluent composite sampler tube inlet was covered by a screen to keep worms from being drawn into the composite sampler. Pursuant to Permit Part I.A.b, representative samples shall be collected in the effluent line after the single-pass filter effluents combine;

Description: Effluent parshall flume. Note worms along the bottom of the flume, and screen covering composite sampler tube inlet.

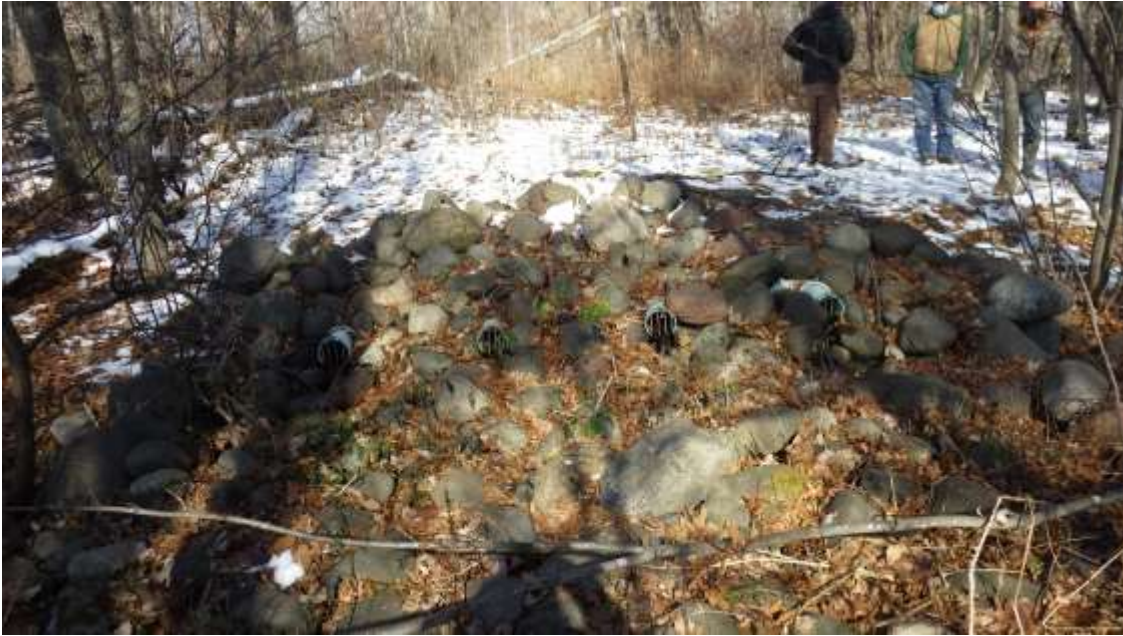
14: STWH0014

Description: Diffused outlets to final effluent Outfall 001.
