**Region 6 Compliance Assurance and Enforcement Division  
INSPECTION REPORT**

| Inspection Date(s): | 03/14/2025 | | |
| Company Name: | International Paper Co | | |
| Facility Name: | Mansfield Mill | | |

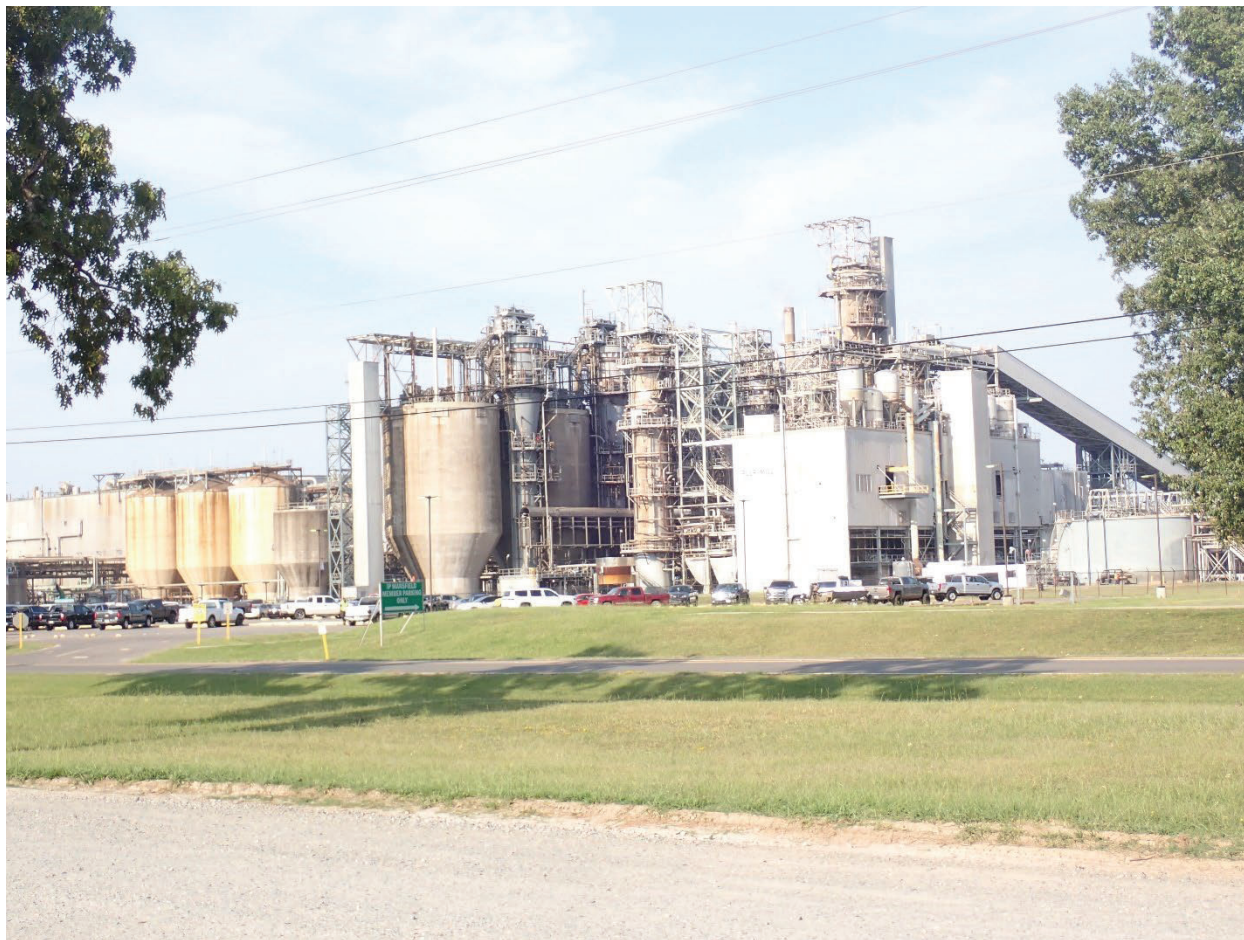
Photo No. 1

Photograph File Name: P8220160.JPG  
Date of Photograph: 08/22/2024  
Latitude and Longitud: 32.1567100 -93.5599159  
Orientation: N  
Map Datum: WGS-84  
Time of Photo: 04:34 PM  
Photographer: Jack Arias  
Description: This image shows the entrance and the facility.

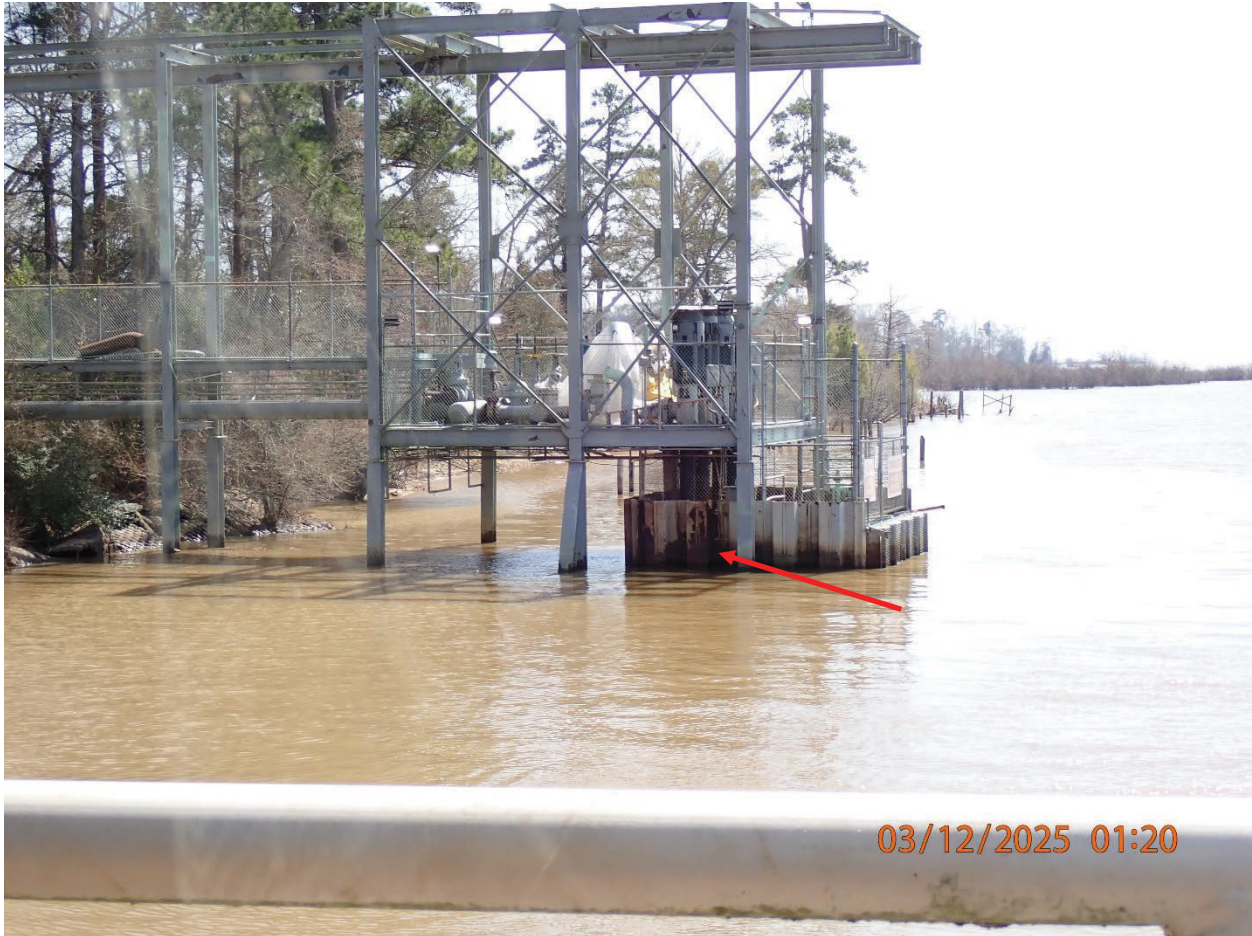
The Mansfield Mill operates a cooling water intake structure (CWIS) and a closed cycle cooling water system. The Mansfield Mill withdraws water from Toledo Bend Reservoir through a CWIS located approximately 7 miles south of the facility and uses at least 23 percent of the water they withdraw exclusively for cooling purposes. The design intake flow of the system is 18.8 MGD and the actual intake flow is 17.1 MGD. The system includes four pumps with trash racks. The bottoms of the trash racks are approximately 25 to 30 feet below the reservoir surface water level. Section 316(b) of the Clean Water Act requires that cooling water intake structures (CWIS) reflect the best technology available (BTA) for minimizing environmental impacts due to the impingement of fish and shellfish on intake structures and the entrainment of eggs and larvae through cooling water systems. At the time of the inspection, Ms. Allie Cozad informed the inspectors that CWIS repairs (found in inspection on 08/21-22/2024) were not achieved (current 2025 inspection) and will be performed in 2026 as part of the maintenance process at the facility. Facility will shut off operations temporarily to allow facility's crew to safely perform maintenance and upgrades to facility's infrastructure. We confirmed deficiencies on the integrity of the CWIS such as 1) debris inside the stainless-steel trash rack box; 2) corrosion and a large hole on the stainless-steel trash rack wall structures that contain and protect the intake pipes connected to the pumps; and 3) a lack of records regarding the screened caisson structure designed to prevent large organisms or debris from entering the system and reduce impingement of small organisms or further restrict smaller debris (See Photo No. 2 in Appendix 1).

1. There are visible deficiencies of the cooling water intake structure (CWIS) at Toledo Bend Reservoir. **Part II Subpart P** (Page 24 of 24) of the of the NPDES permit “The cooling water system must be operated and maintained as represented in the application 316b application”, **Part 125.94 Subpart d** of the Clean Water Act “require periodic reporting on your progress towards installation and operation of site-specific entrainment controls. These reports may include updates on planning, design, and construction or other appropriate topics as required by the Director” and **Section B.3.** (page 78 of 93) of the of the NPDES permit “The permittee shall at all the times properly operate and maintained all facilities and systems of treatment and control

Description: This image shows the Water Intake Structure that intake fresh water from Toledo Bend Reservoir for the cooling and industrial processes at the facility. The design intake flow of the system is 18.8 MGD and the actual intake flow is 17.1 MGD.

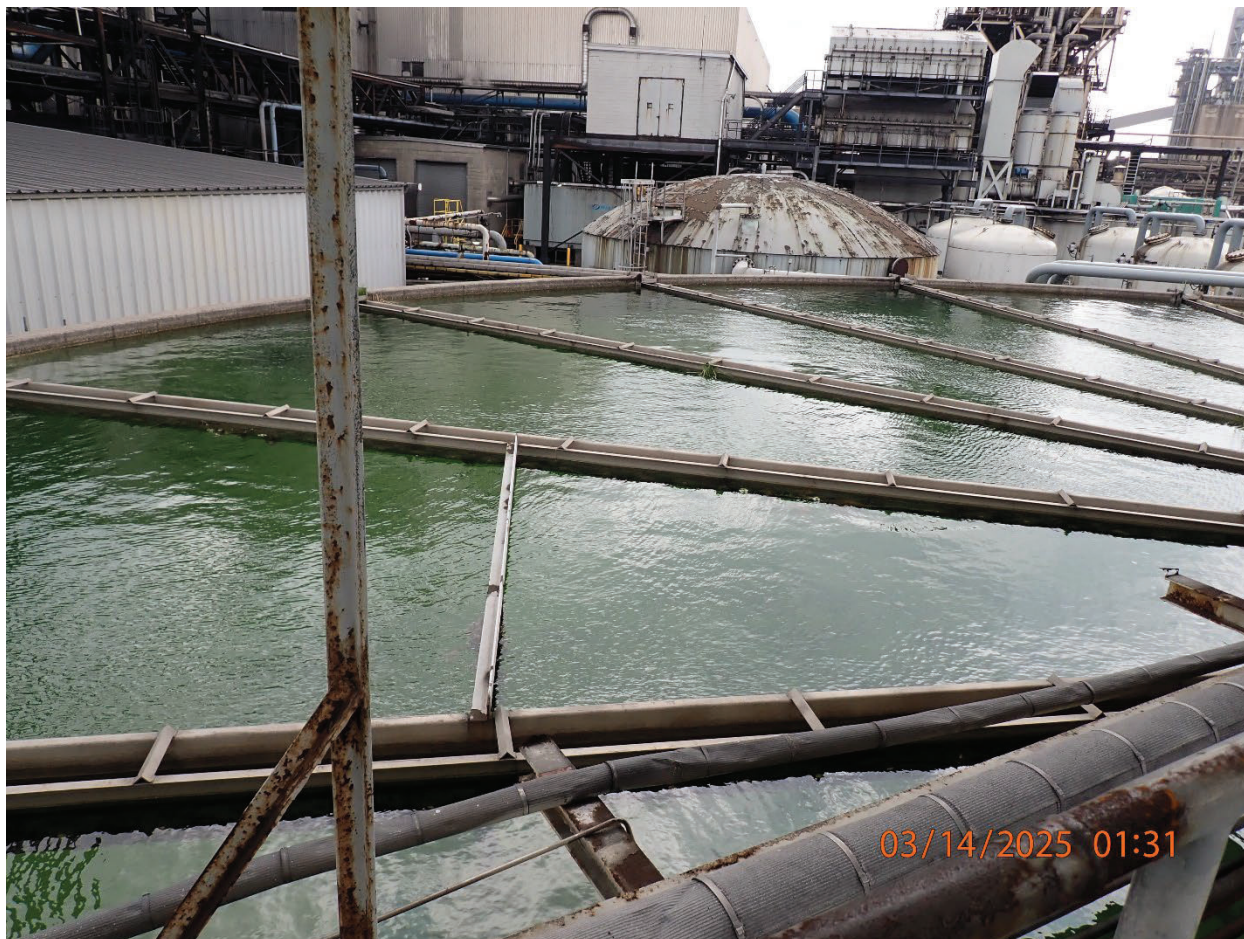
Photo No. 3

Make-up water for use at the Mansfield Mill is obtained from Toledo Bend Reservoir and from several groundwater production wells. Intake water from Toledo Bend Reservoir is treated in two clarifiers (south and north clarifiers) prior to being routed to the treated water reservoir for use in utilities and mill process units. Groundwater from several production wells is routed directly to the Treated Water Reservoir. At the time of the inspection, we observed that because of the prior 2023 inspection, the facility removed plants and algae layers inside the south and north clarifier systems (See Photo Nos. 3 – 5 in Appendix 1).

Photograph File Name: P3140281.JPG  
Date of Photograph: 03/14/2025  
Latitude and Longitud: 32.1592963 -93.5568618  
Orientation: SE  
Map Datum: WGS-84  
Time of Photo: 1:31 AM  
Photographer: Jack Arias  
Description: This image shows the south clarifier system.

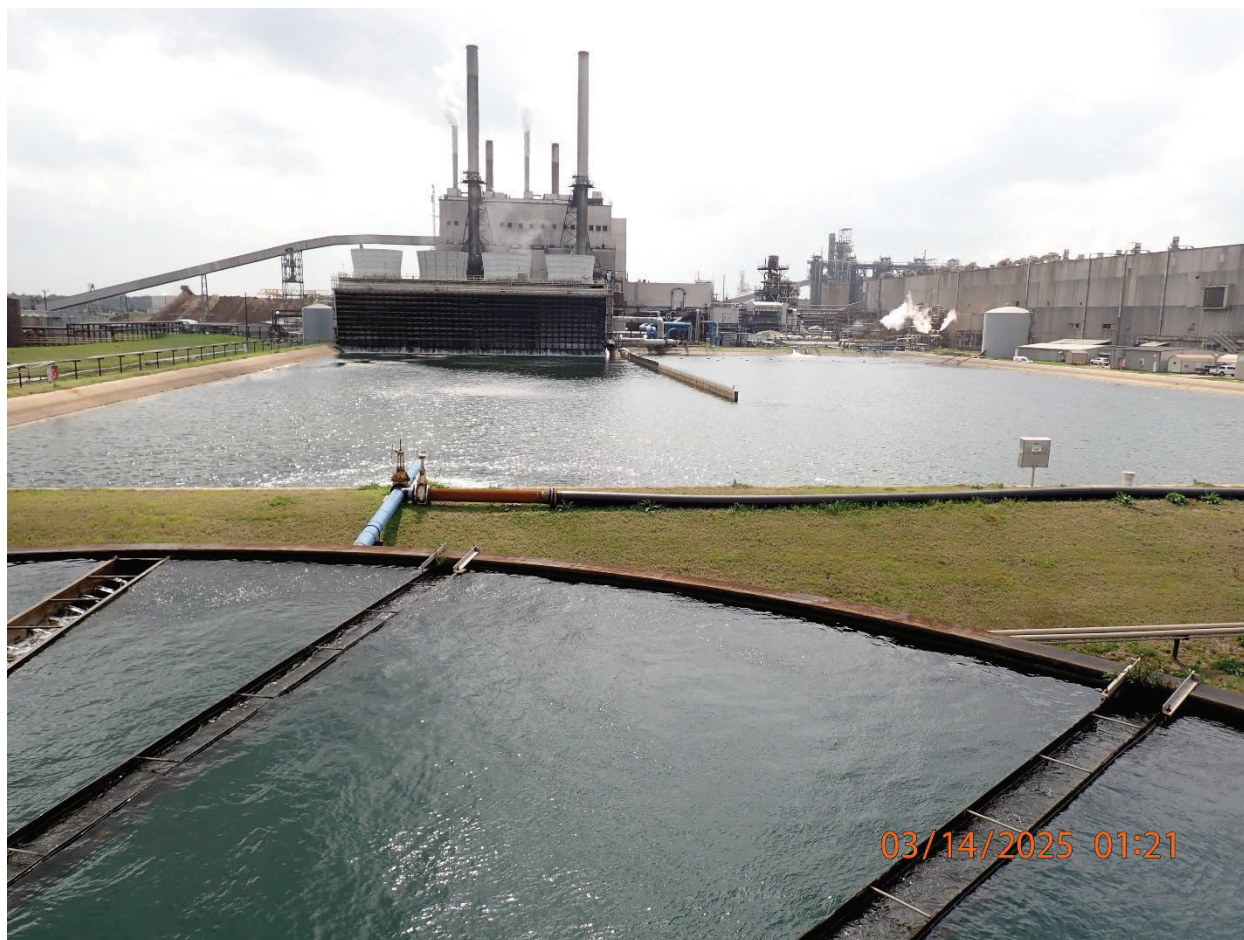
Photo No. 4

Photograph File Name: P83140275.JPG  
Date of Photograph: 03/14/2025  
Latitude and Longitud: 32.161268 -93.555912  
Orientation: NE  
Map Datum: WGS-84  
Time of Photo: 1:21 PM  
Photographer: Jack Arias  
Description: This image shows the north clarifier system.

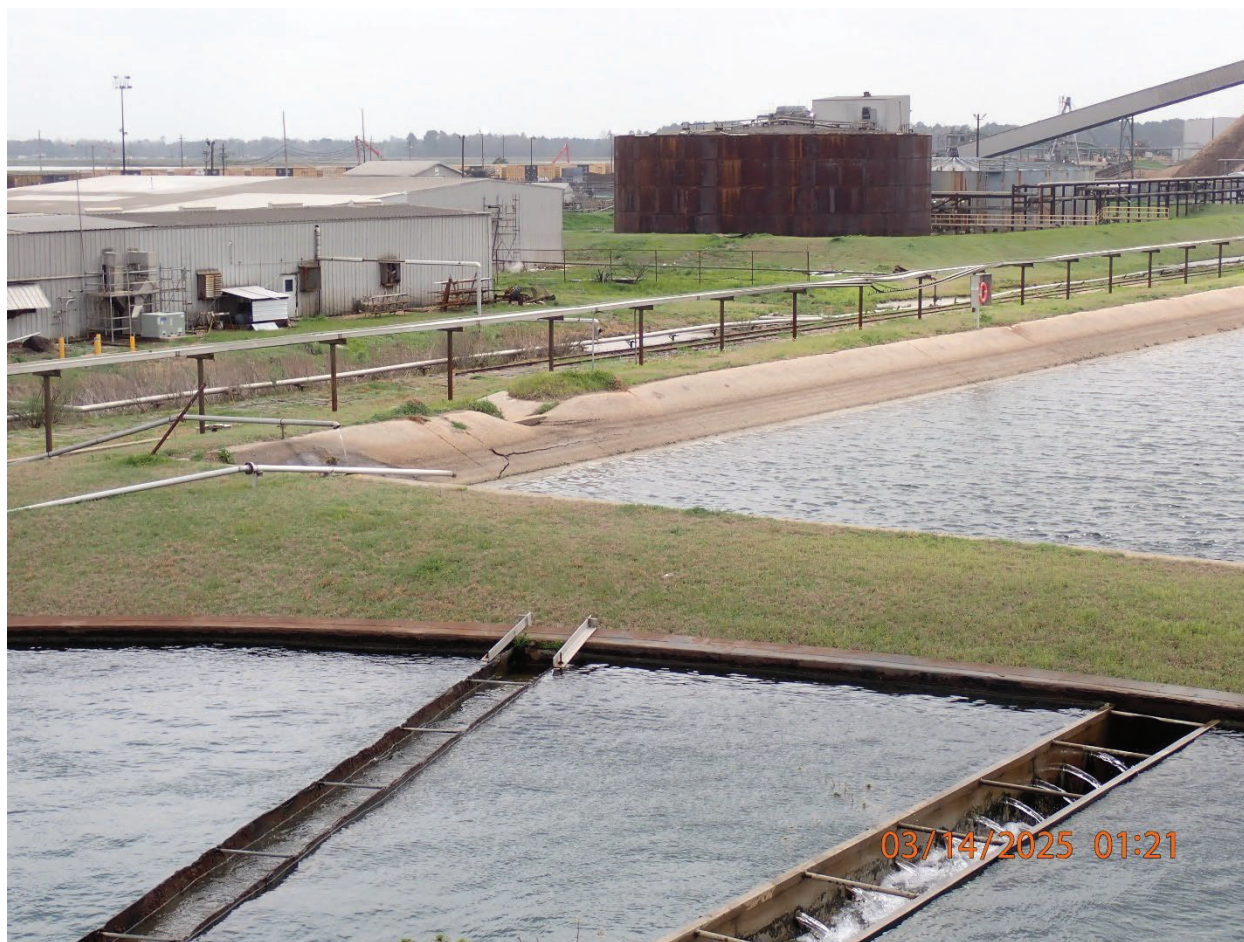
The Treated Water Reservoir receives water from Toledo Bend Reservoir. The water is treated through two clarifiers (south and north clarifiers) systems and discharge into the Treated Water Reservoir for use in utilities and mill process units. Its main purpose is to provide capacity water to maintain facility operations for specific periods of time. We observed that because of prior 2023 inspection, the facility fixed the water overflow from the reservoir into a ditch system next to the reservoir leading to Outfall 003 (See Photo No. 5 in Appendix 1).

Photograph File Name: P83140274.JPG  
Date of Photograph: 03/14/2025  
Latitude and Longitude: 32.161268 -93.555912  
Orientation: NE  
Map Datum: WGS-84  
Time of Photo: 1:21 PM  
Photographer: Jack Arias  
Description: This image shows the treated water reservoir.

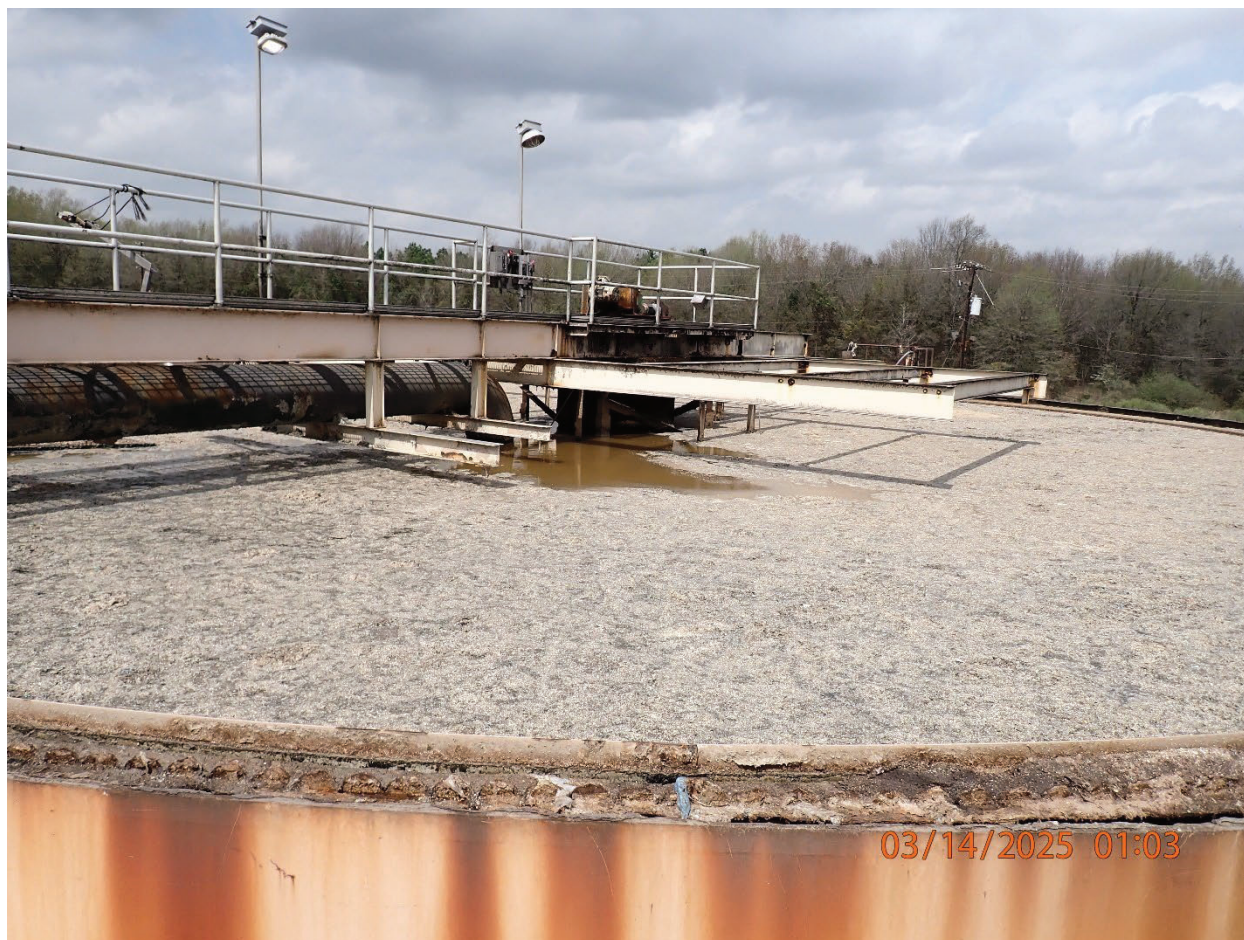
Photo No. 6

Photograph File Name: P3140254.JPG  
Date of Photograph: 3/14/2025  
Latitude and Longitud: 32.16083333 -93.55944444  
Orientation: NW  
Map Datum: WGS-84  
Time of Photo: 1:03 PM  
Photographer: Jack Arias  
Description: This image shows an active effluent lift clarifier system.

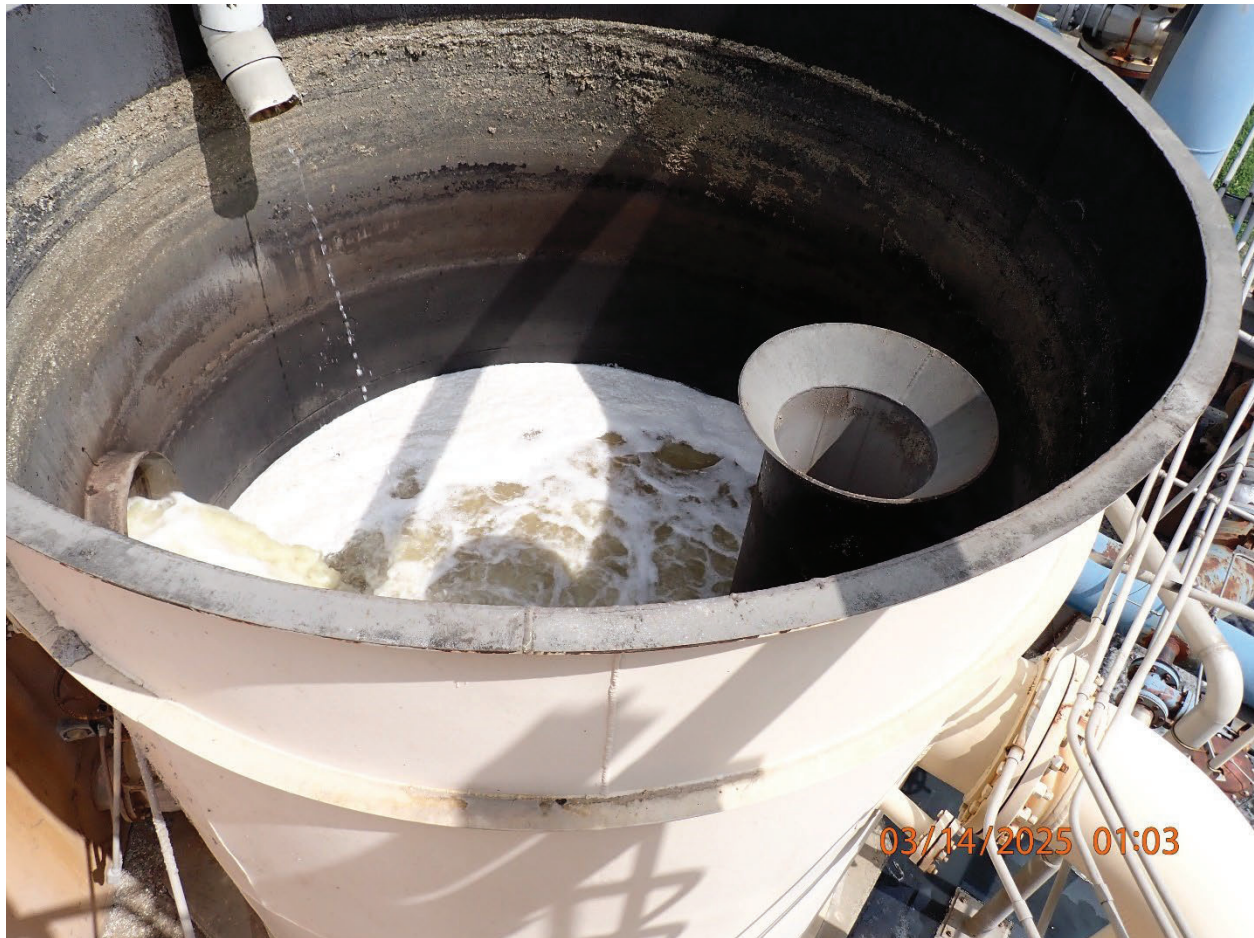
Photo No. 7

This image shows a tank that is part of the lift pit system. The tank received and collected wastewater from the lift pit system.

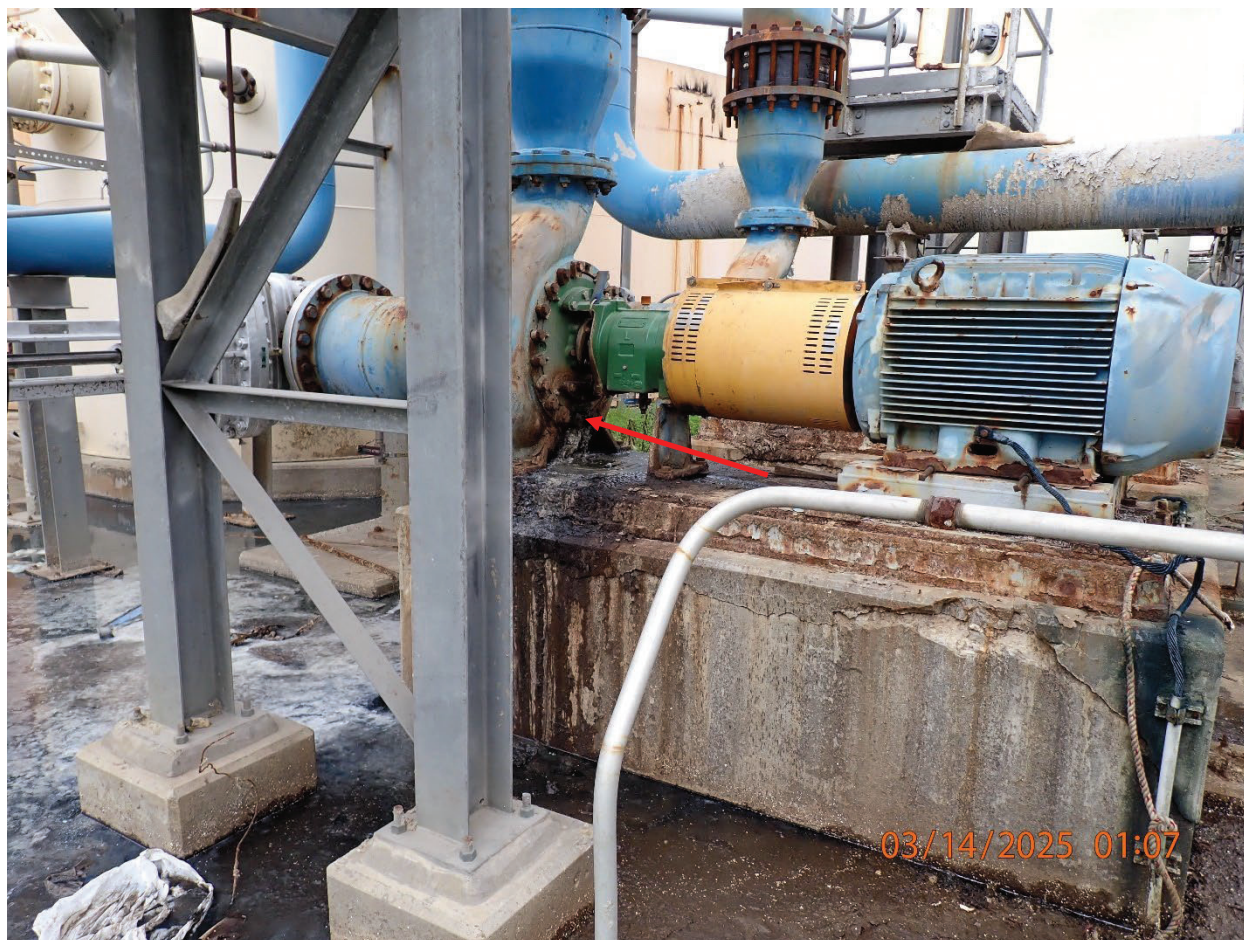
Photo No. 8

3. There is a wastewater leak from the pipe system next to effluent lift pit tank. Also, we observed sludge material on the floor and walls and wastewater runoff coming from the storing containers next to effluent lift pit tank. **Section B.3.** (page 78 of 93) of the of the NPDES permit “The permittee shall at all the times properly operate and maintained all facilities and systems of treatment and control which are installed or used by the Permittee to achieve compliance with the conditions of this permit”

Photograph File Name: P3140263.JPG  
Date of Photograph: 3/14/2025  
Latitude and Longitud: 32.161422, -93.559796  
Orientation: NW  
Map Datum: WGS-84  
Time of Photo: 1:07 PM  
Photographer: Jack Arias  
Description: This image shows a wastewater leak from pipes next to the lift pit system.

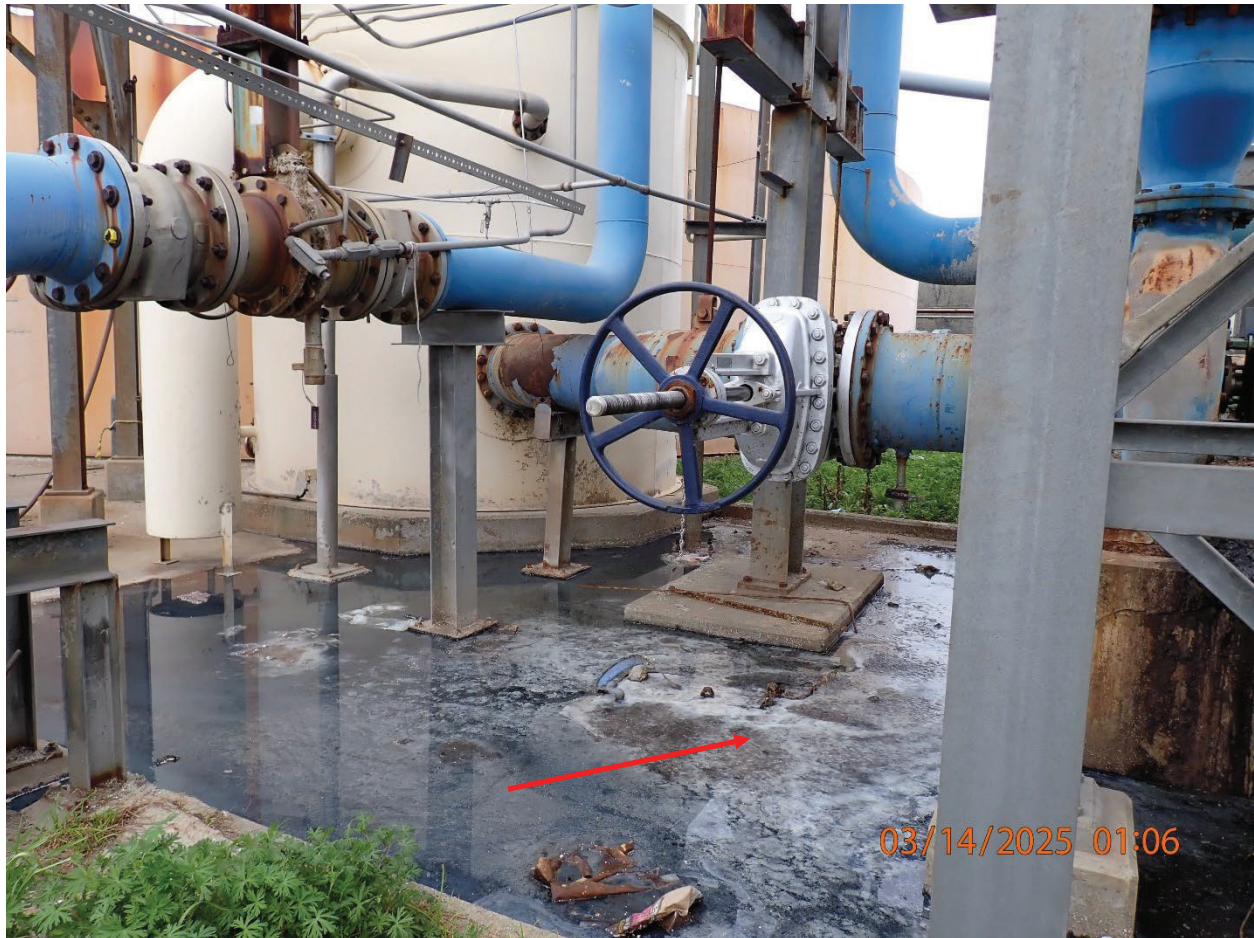
Photo No. 9

Photograph File Name: P3140262.JPG  
Date of Photograph: 3/14/2025  
Latitude and Longitude: 32.161422, -93.559796  
Orientation: NW  
Map Datum: WGS-84  
Time of Photo: 1:06 PM  
Photographer: Jack Arias  
Description: This image shows a wastewater pool next to the lift pit system because of pipe leaks.

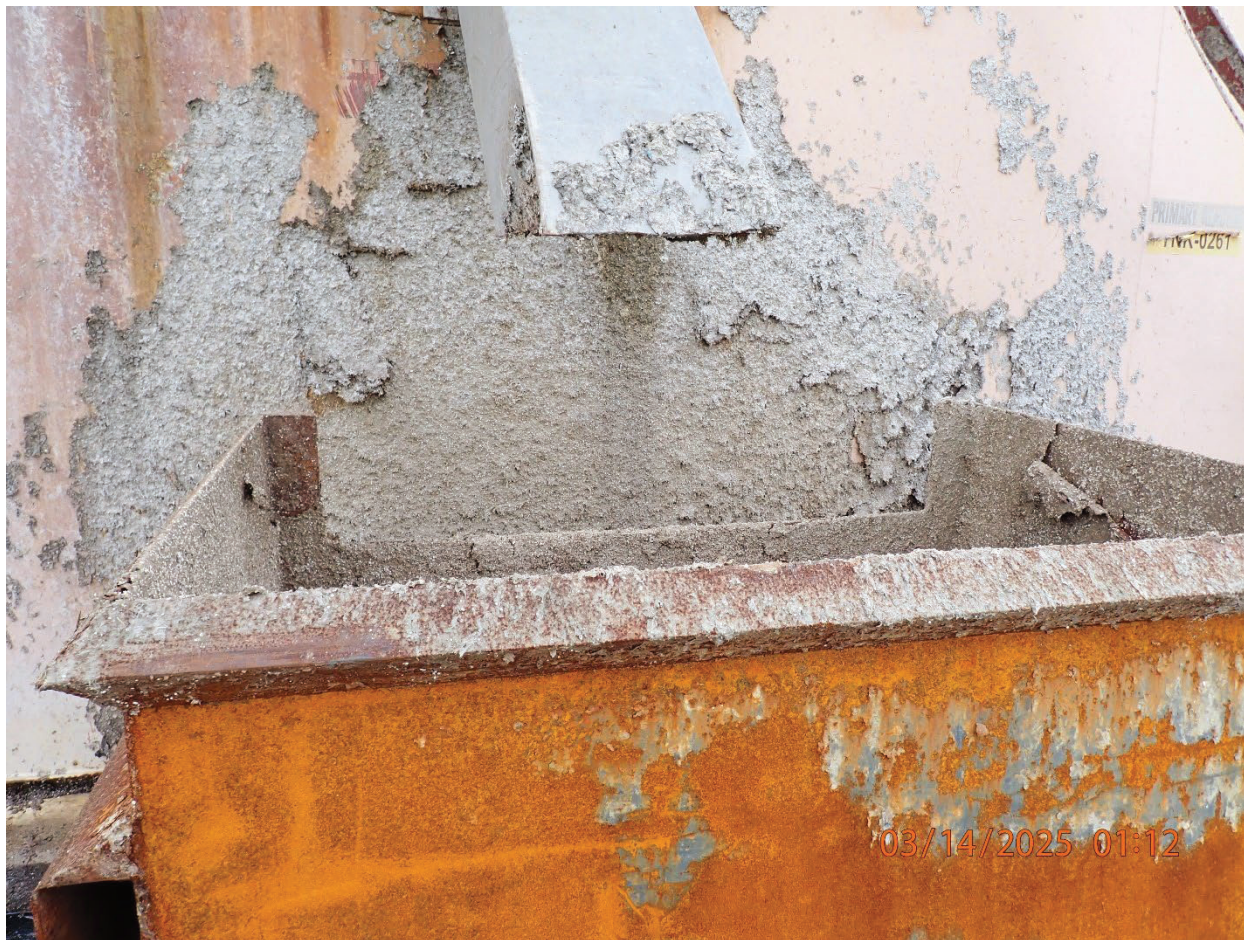
Photo No. 10

Photograph File Name: P3140270.JPG  
Date of Photograph: 3/14/2025  
Latitude and Longitud: 32.161411, -93.559906  
Orientation: NW  
Map Datum: WGS-84  
Time of Photo: 1:12 PM  
Photographer: Jack Arias  
Description: This image shows sludge material outside of storing container (floor and wall of clarifier) next to effluent lift pit tank.

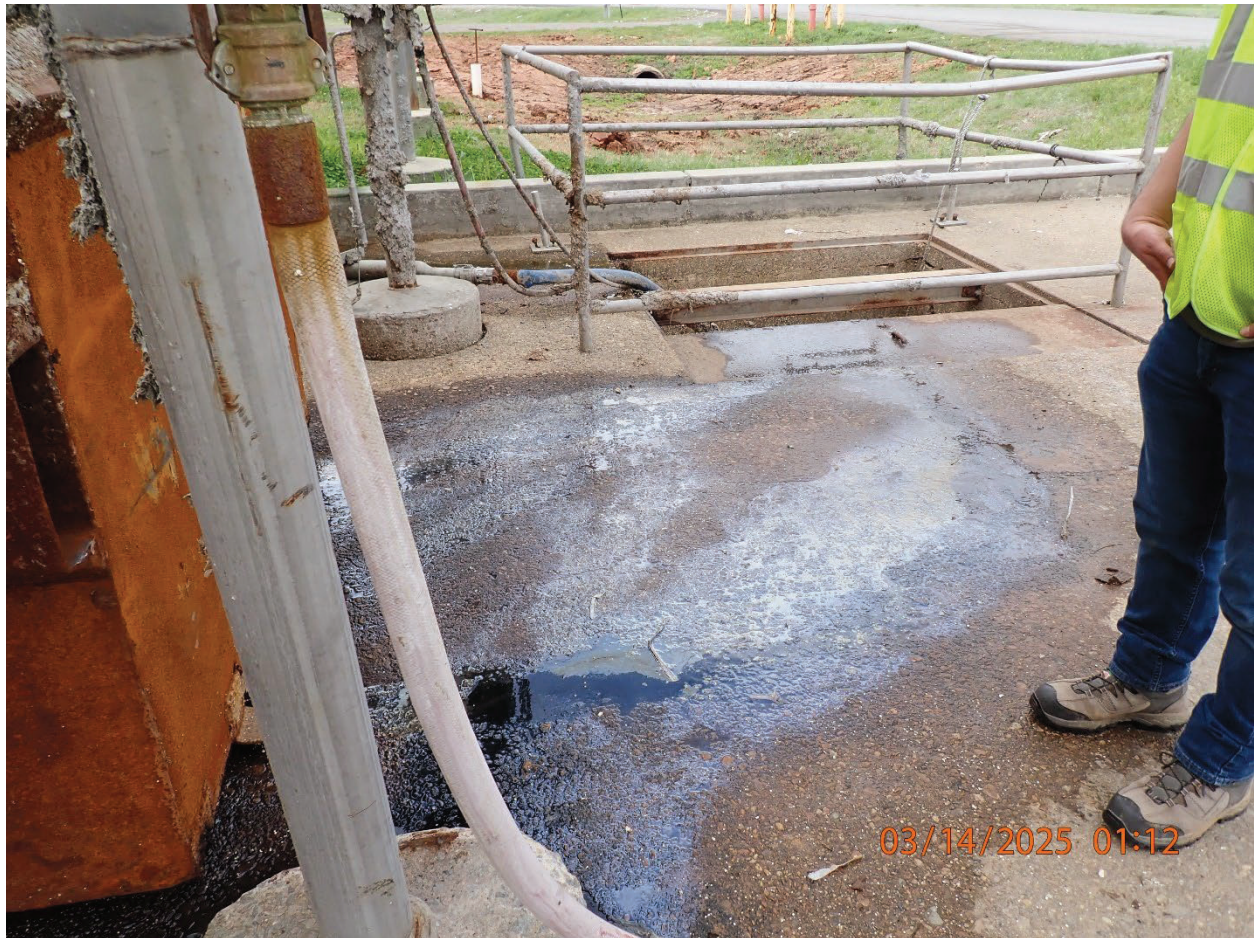
Photo No. 11

Photograph File Name: P3140272.JPG  
Date of Photograph: 3/14/2025  
Latitude and Longitude: 32.161411, -93.559906  
Orientation: NW  
Map Datum: WGS-84  
Time of Photo: 1:12 PM  
Photographer: Jack Arias  
Description: This image shows wastewater runoff coming from the storing containers next to effluent lift pit tank.

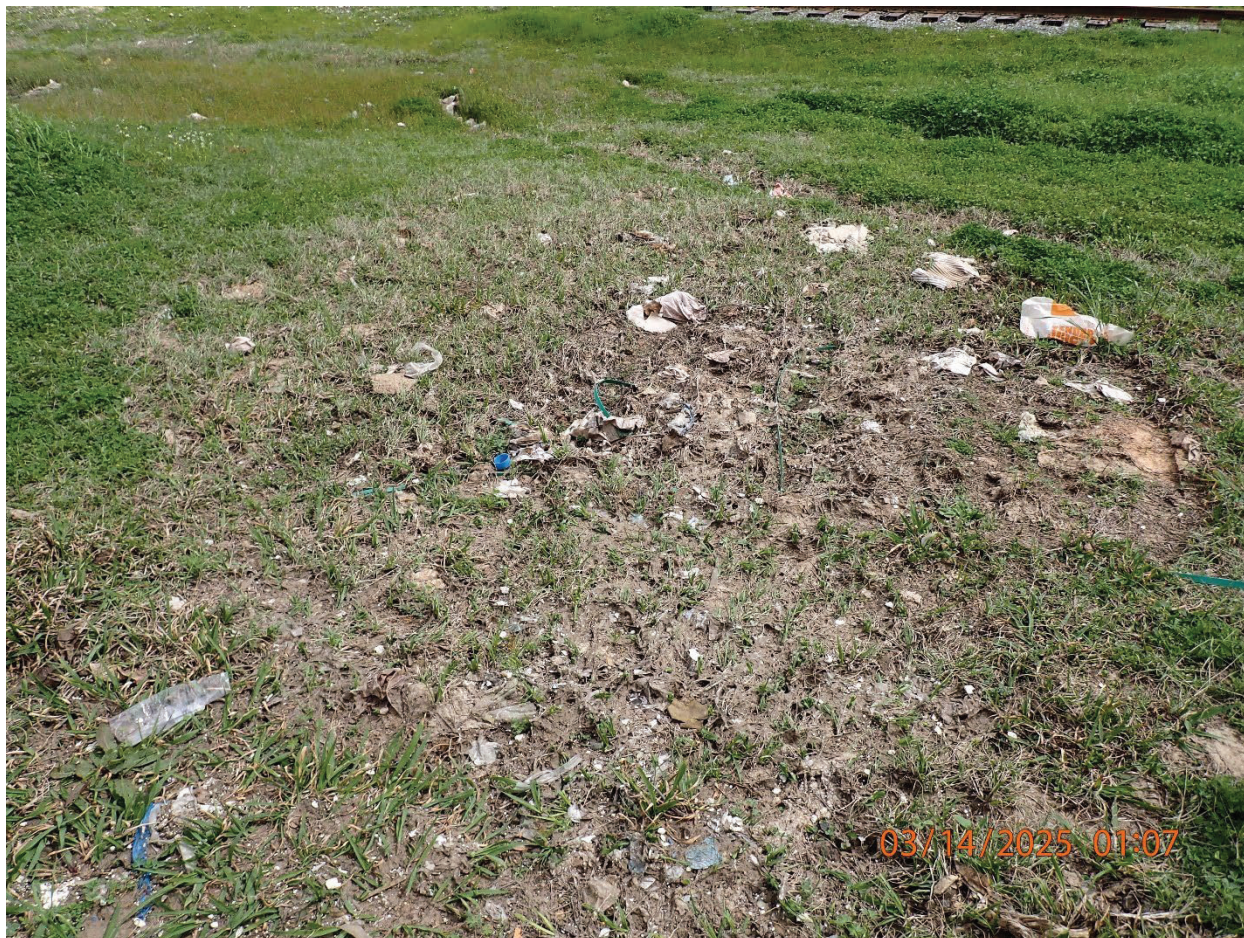
Photo No. 12

The storm water system is designed to collect and manage rainwater runoff from the facility and surrounding areas. At the time of the inspection, we observed solid waste and sludge material getting into the storm water system near the effluent lift pit tank (See Photo Nos. 12-14 in Appendix 1).

4. There is solid waste and sludge material getting into the storm water system near the effluent lift pit tank. **Section B.3.** (page 78 of 93) of the of the NPDES permit “The permittee shall at all the times properly operate and maintained all facilities and systems of treatment and control which are installed or used by the Permittee to achieve compliance with the conditions of this permit”

Photograph File Name: P3140265.JPG  
Date of Photograph: 3/14/2025  
Latitude and Longitude: 32.161431, -93.559716  
Orientation: NW  
Map Datum: WGS-84  
Time of Photo: 1:07 PM  
Photographer: Jack Arias  
Description: This image shows solid waste and sludge material getting into the storm water system near the effluent lift pit tank.

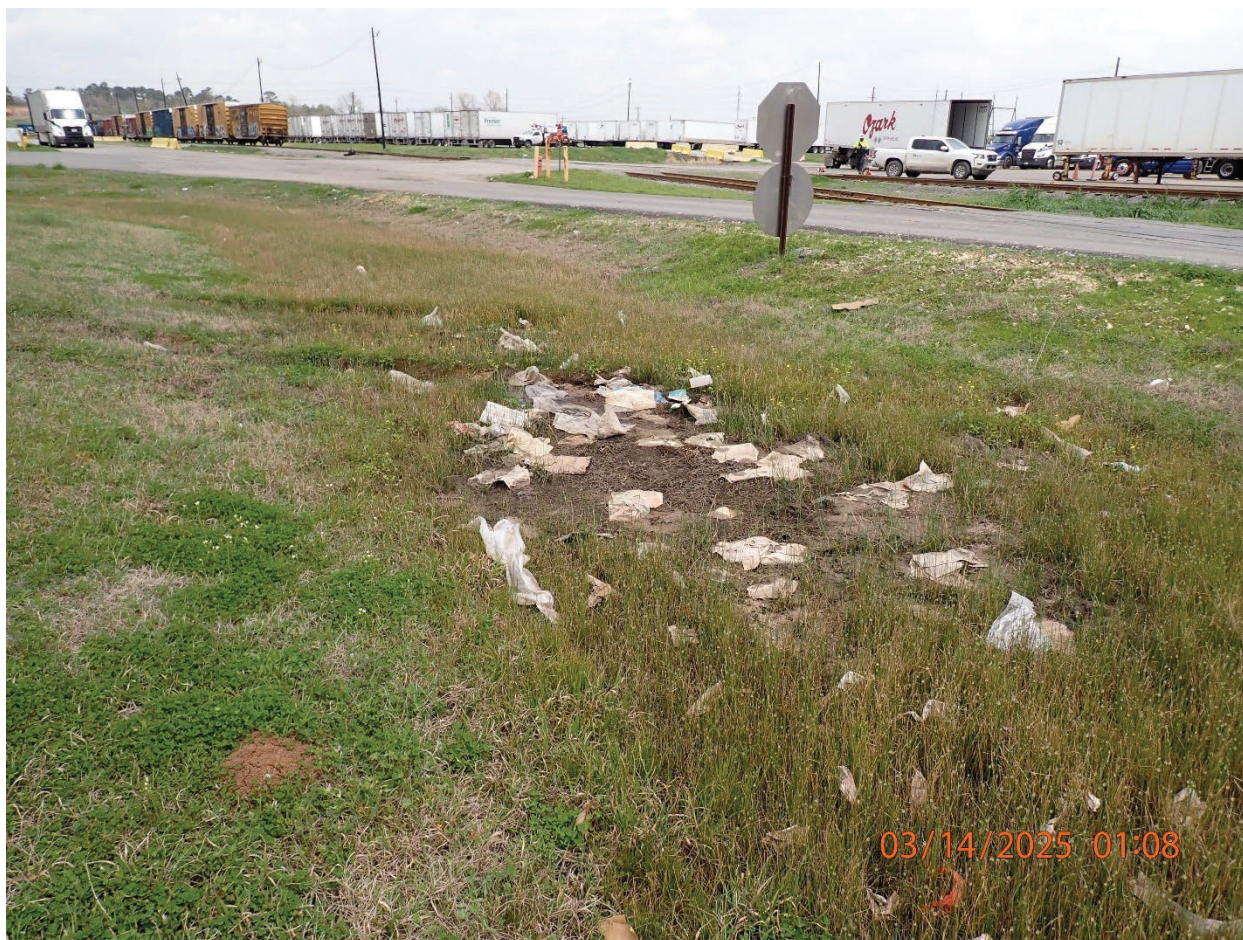
Photo No. 13

Photograph File Name: P3140267.JPG  
Date of Photograph: 3/14/2025  
Latitude and Longitud: 32.161453, -93.559652  
Orientation: NW  
Map Datum: WGS-84  
Time of Photo: 1:08 PM  
Photographer: Jack Arias  
Description: This image shows solid waste and sludge material getting into the storm water system near the effluent lift pit tank.

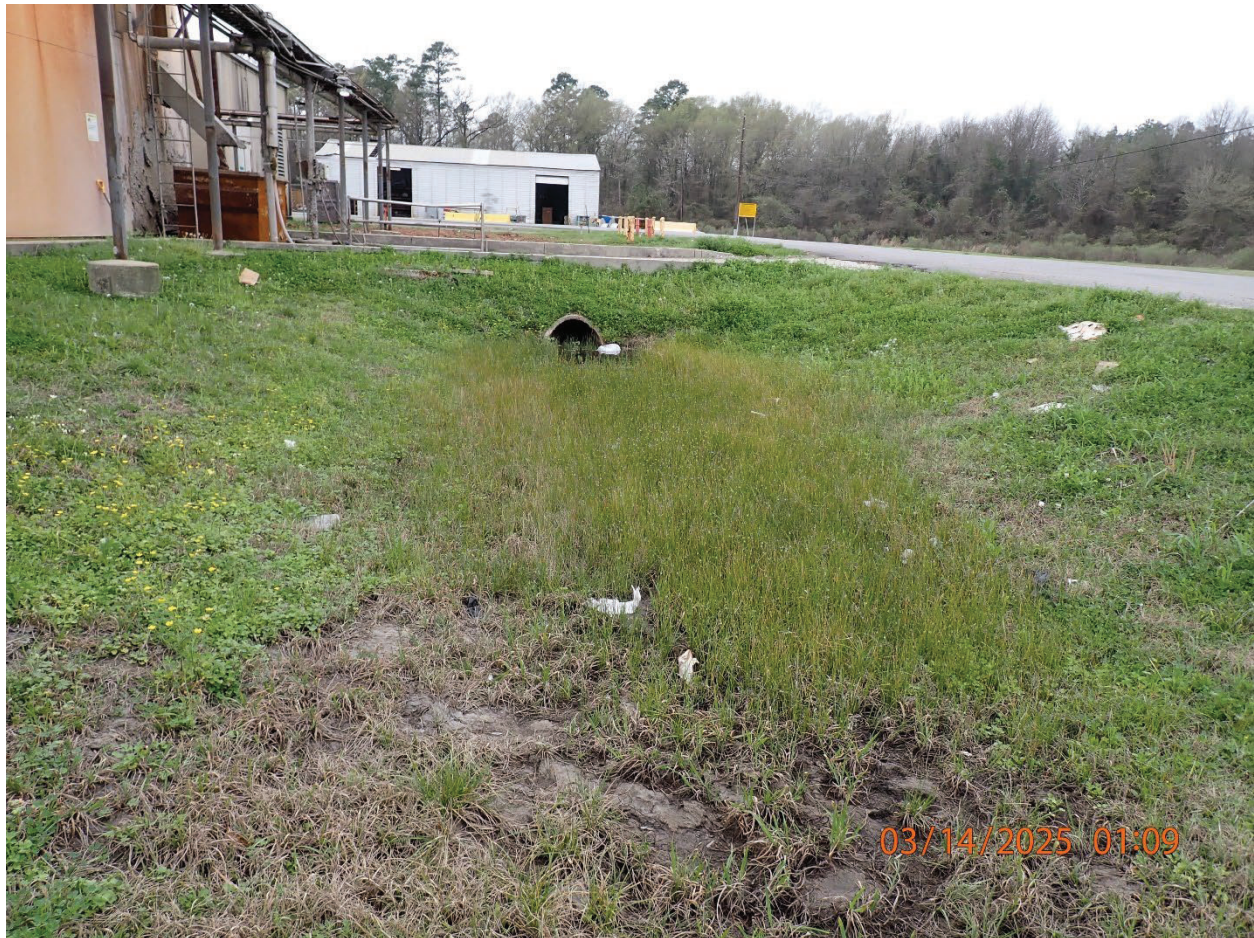
Photo No. 14

Photograph File Name: P3140268.JPG  
Date of Photograph: 3/14/2025  
Latitude and Longitude: 32.161421, -93.559809  
Orientation: NW  
Map Datum: WGS-84  
Time of Photo: 1:09 PM  
Photographer: Jack Arias  
Description: This image shows solid waste and sludge material getting into the storm water system near the effluent lift pit tank.

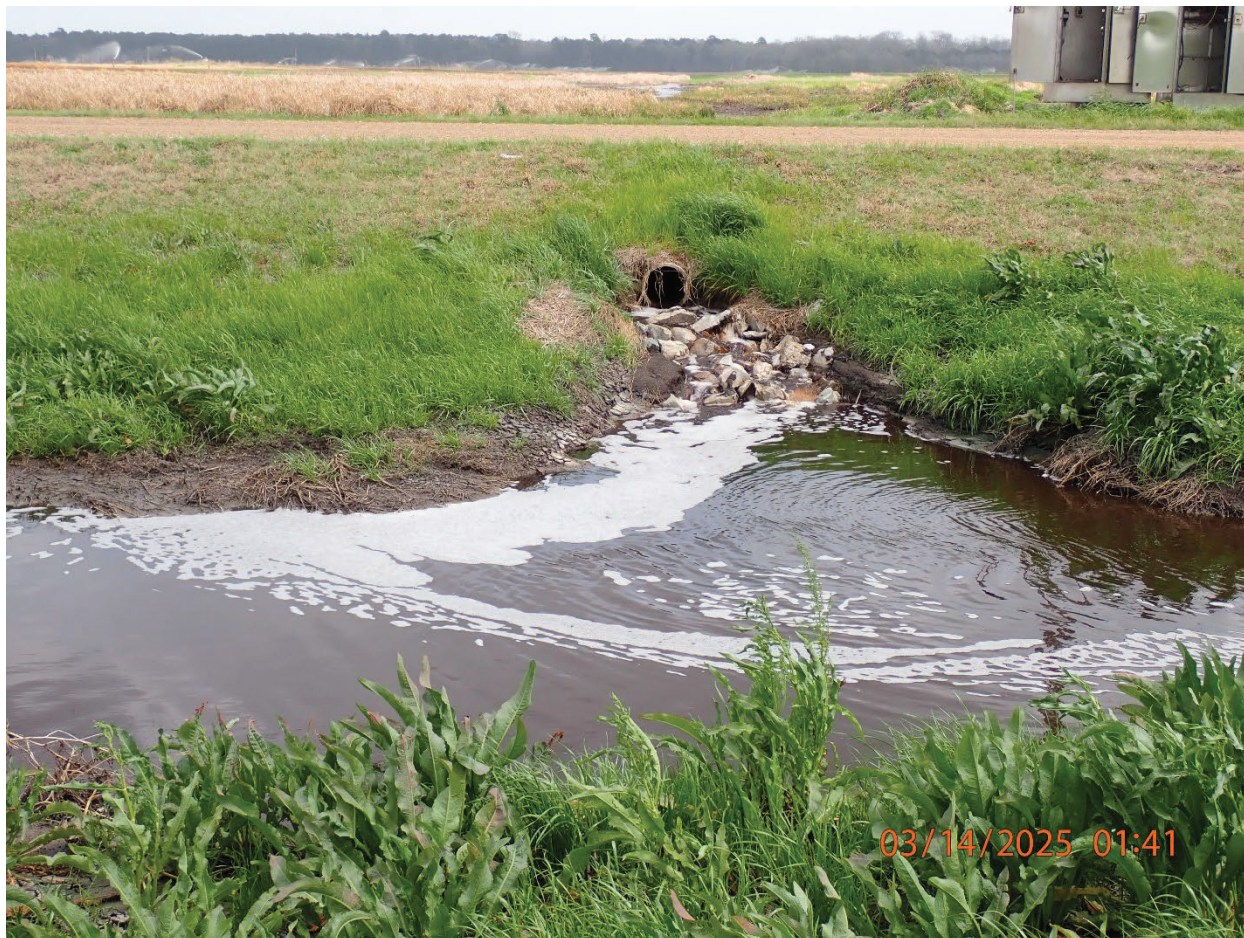
Photo No. 15

This image shows visible foam material coming from the overland flow treatment system. This is connected to the retention pond before being pumped to the Red River via Outfall 001.

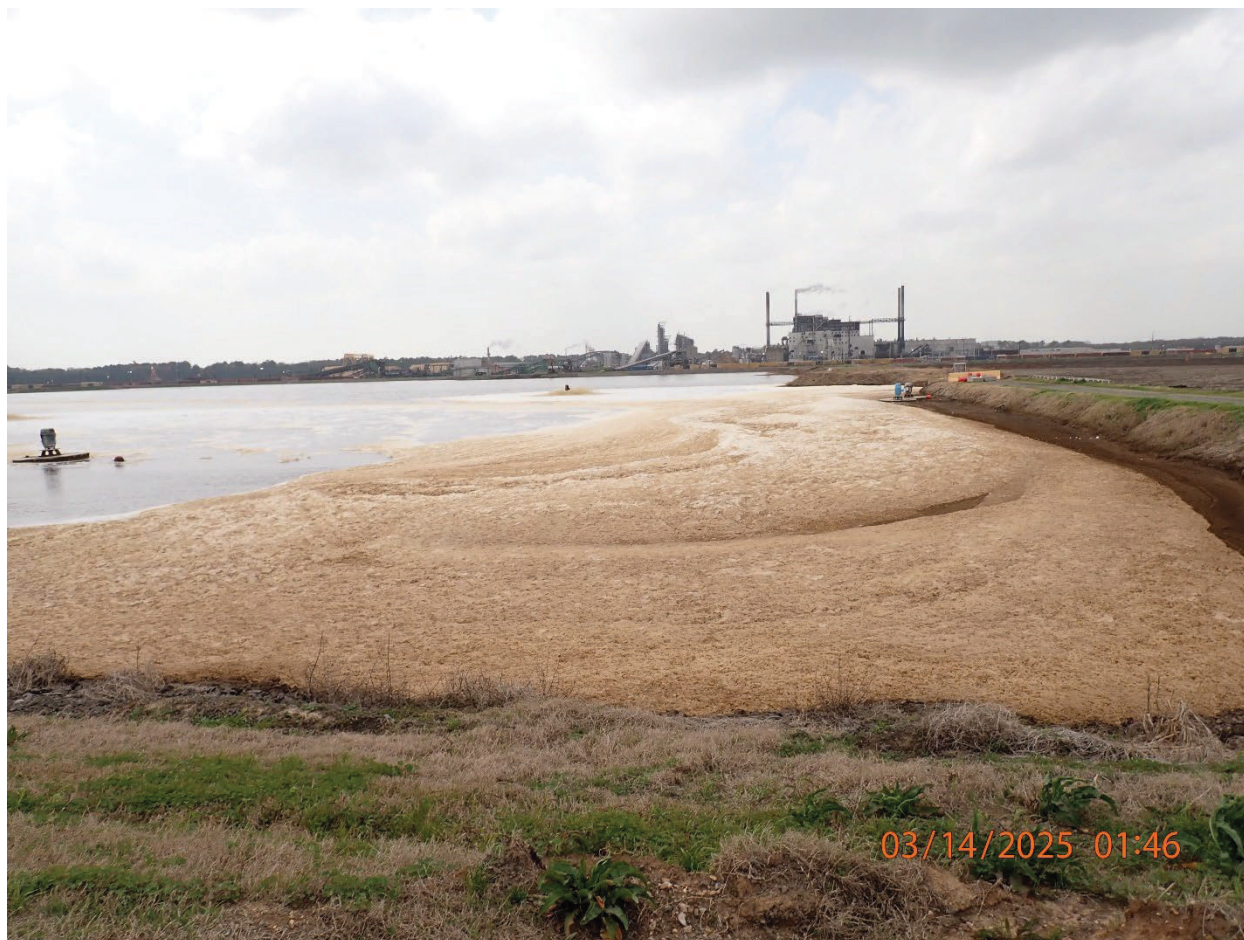
Photo No. 16

This image shows visible foam material built-up at the emergency surge basin that is connected to the retention pond before being pumped to the Red River via Outfall 001.

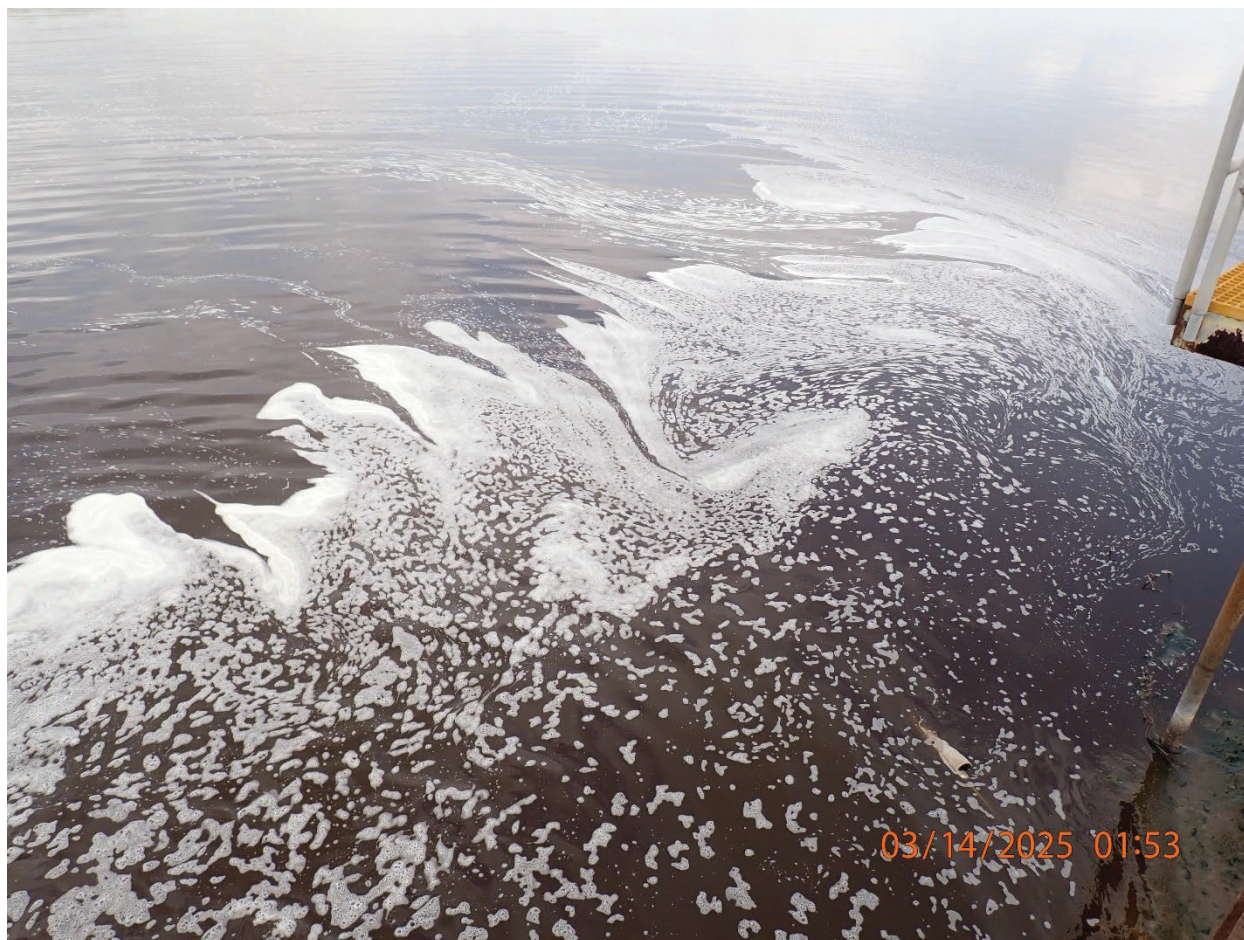
Photo No. 17

Description: This image shows visible foam formations at the retention pond before being pumped to the Red River via Outfall 001.
