**Region 6 Compliance Assurance and Enforcement Division  
INSPECTION REPORT**

| Inspection Date(s): | 03/14/2025 | | |
| Company Name: | International Paper Co | | |
| Facility Name: | Mansfield Mill | | |

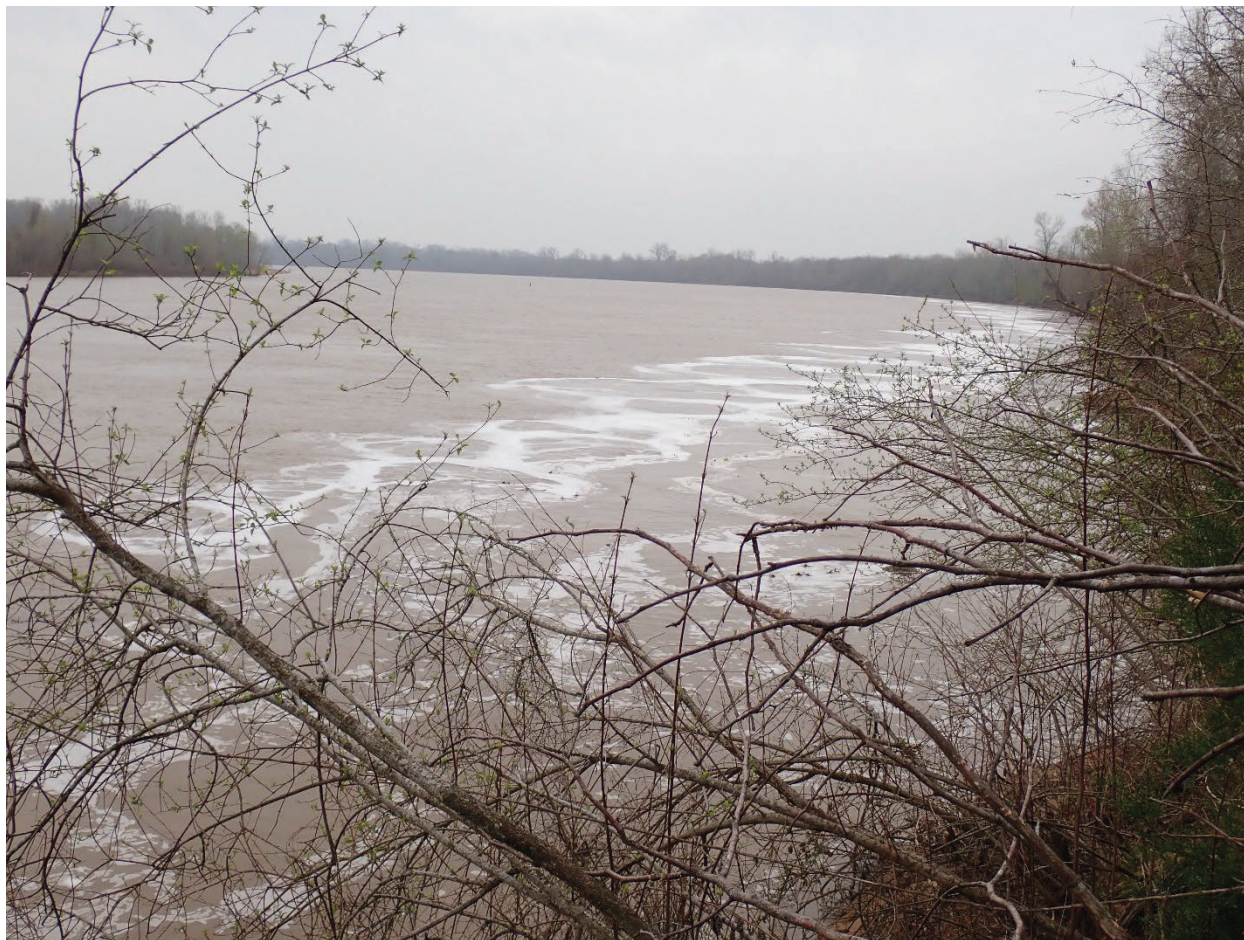
Photo No. 18

2. There is visible foam material coming out from outfall 001 at Red River. The discharge flow at Red River is approximately 9,000 gallons per minute. **RLP 1. Outfall 001. N-3 LAC 33: IX.1113.B** (page 32 of 93) of the NPDES permit “There shall be no discharge of floating or settleable solids or visible foam in other than trace amounts, nor of free oily materials, nor of toxic materials in quantities such as to cause toxicity to aquatic organisms”

Photograph File Name: P3130211.JPG  
Date of Photograph: 03/14/2025  
Latitude and Longitud: 32.123855 -93.461912  
Orientation: E  
Map Datum: WGS-84  
Time of Photo: 12:00 PM  
Photographer: Jack Arias  
Description: This image shows visible foam material coming out from outfall 001 at Red River.

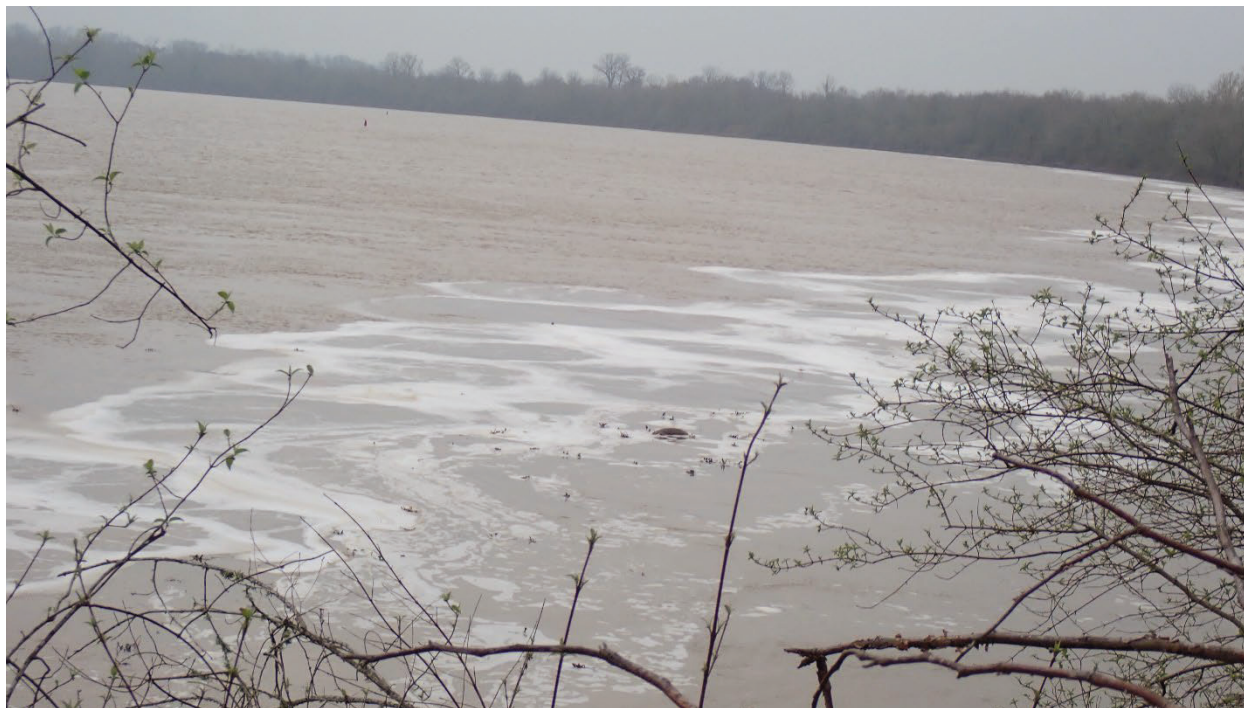
Photo No. 19

Photograph File Name: P3130218.JPG  
Date of Photograph: 03/14/2025  
Latitude and Longitude: 32.123855 -93.461912  
Orientation: E  
Map Datum: WGS-84  
Time of Photo: 12:00 PM  
Photographer: Jack Arias  
Description: This image shows visible foam material coming out from outfall 001 at Red River.
