**UNITED STATES ENVIRONMENTAL PROTECTION AGENCY**  
**REGION III**  
**Four Penn Center – 1600 John F Kennedy Blvd**  
**Philadelphia, Pennsylvania 19103-2852**

**Report Title:** Clean Air Act Inspection of Haysite Reinforced Plastics LLC  
**Inspection Date(s):** September 26, 2023  
**Regulatory Program(s):** Title V, SIP, NESHAP  
**Company Name:** Haysite Reinforced Plastics LLC  
**Facility Name:** Haysite Reinforced Plastics LLC  
**Facility Location:** 5599 New Perry Highway  
Erie, PA 16509  
**Latitude:** 42.08408 **Longitude:** -80.05502  
**County/Parish:** Erie County  
**AFS/ICIS-Air Number:** PA000511900  
**Permit Number:** 25-00783  
**NAICS Code:** 326130 **SIC:** 3083  
**Unique Project #:** 3E23CA037A

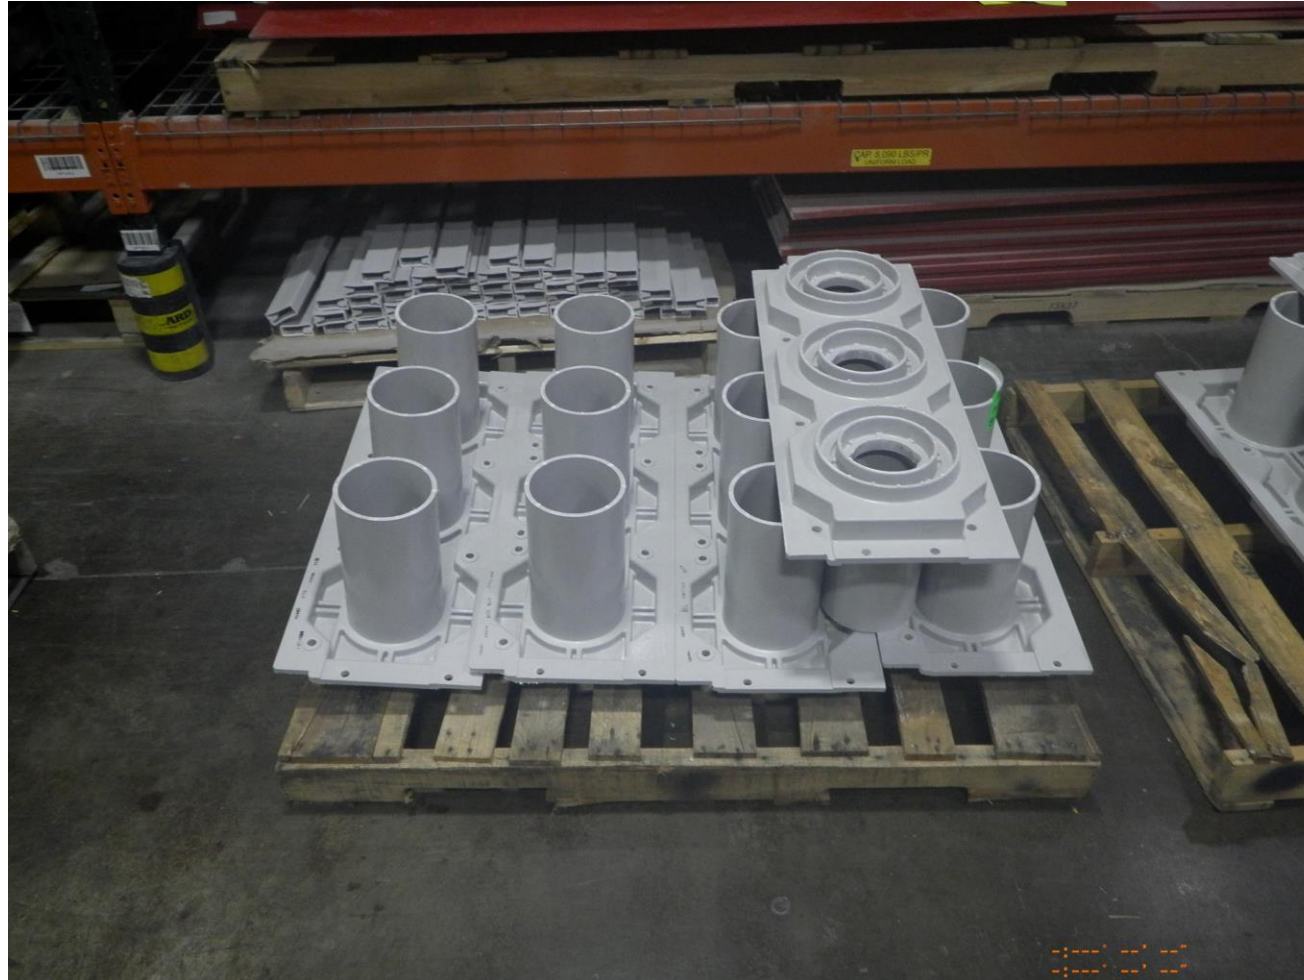
Photo Number: 2

Photo Description: Compression Molded Finished Product

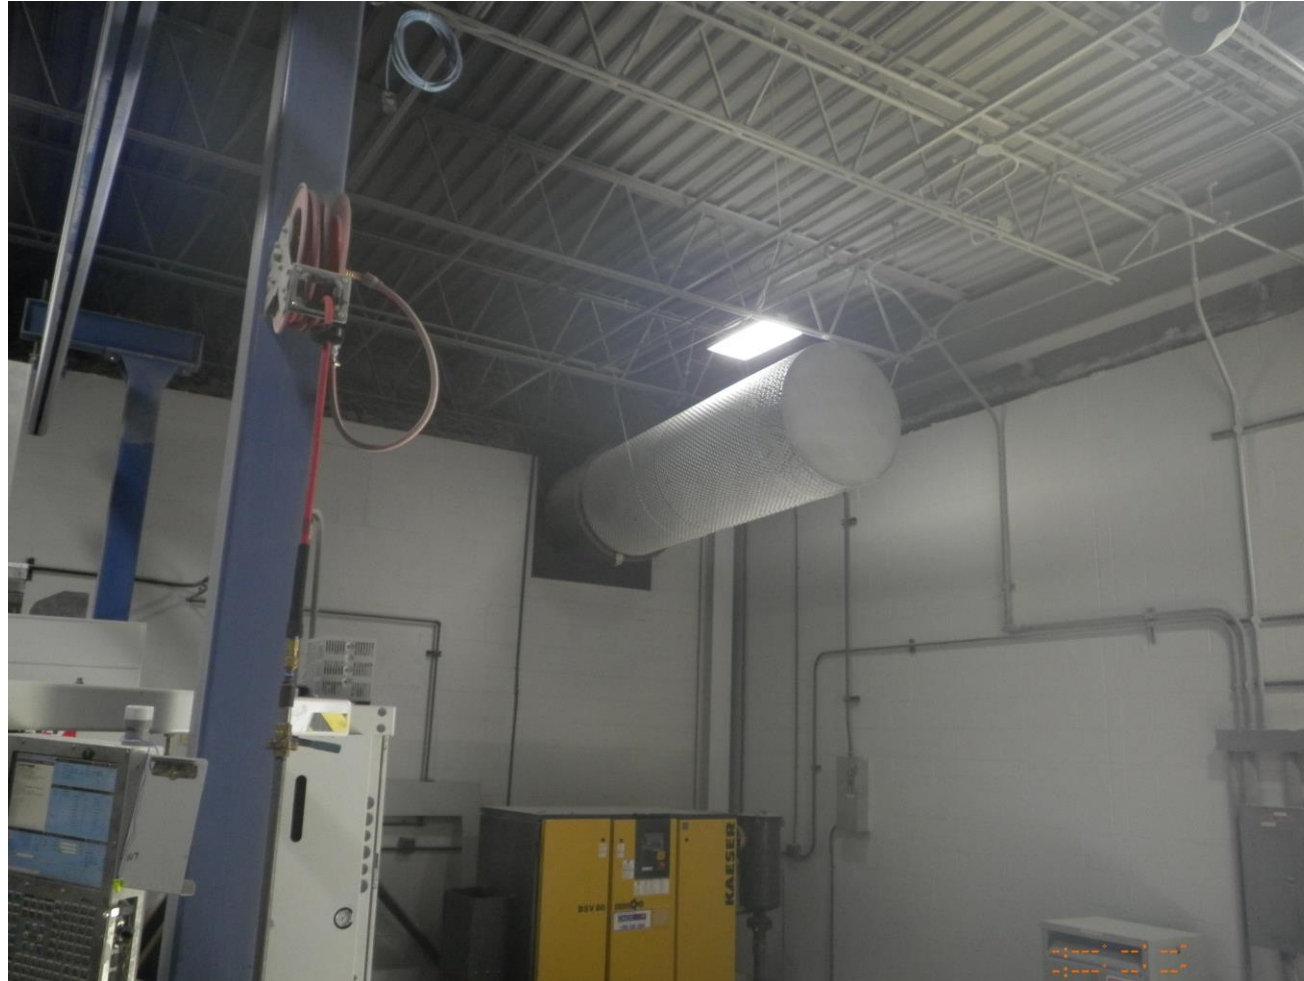
Photo Number: 3

The inspection team first observed a quality/patch room in which closed containers of approximately five-gallon capacity were observed. After which, the inspection team went to the shear/saw room which had a panel saw, sander, and two machining devices. These machines were ducted to a dust collector located on the exterior of the building. The exhaust of this dust collector vented back into the shear/saw room. The inspection team observed the Facility's natural gas emergency generator which was located in a smaller room in this area. At the time of the inspection, the generator was not operating and the hour meter for the emergency generator was 243.7 hours. The Facility's workers took their lunch break at this time, so the dust collector was turned off when we went outside. The dust collector is required by the permit to operate anytime the process in the shear/saw room is in operation. The inspection team returned to the shear/saw room and had the Facility turn on the dust collector so we could observe the pressure drop reading while in operation. The pressure drop observed during the inspection was 1.6" w.g. White dust was observed on the ceiling above the dust collector exhaust.

Photo Description: Shear Saw Sander Dust Collector Exhaust

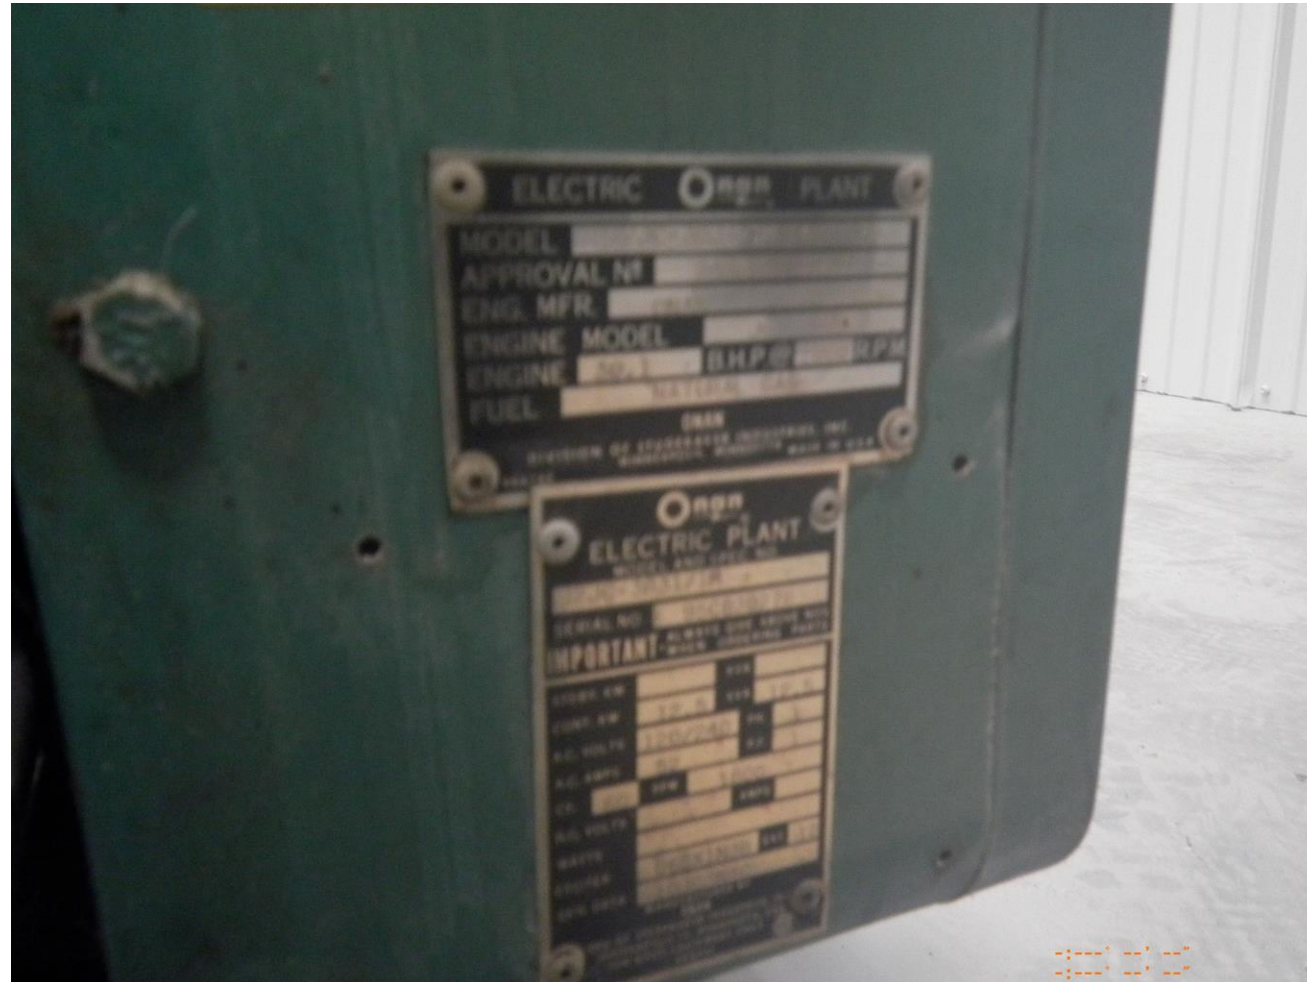
Photo Number: 4

Photo Description: Emergency Generator Nameplate

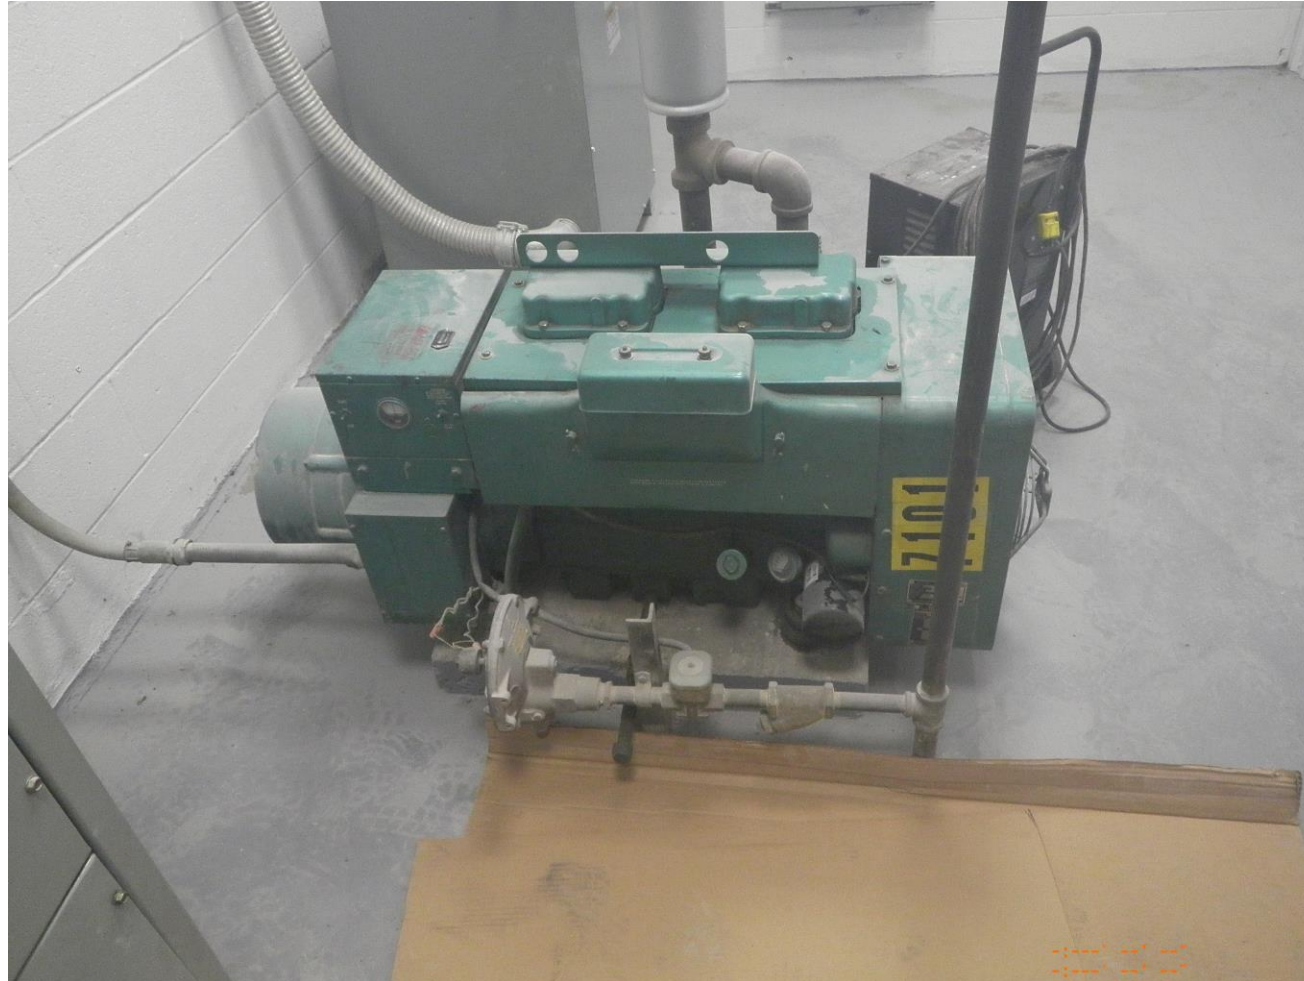
Photo Number: 5

Photo Description: Emergency Generator

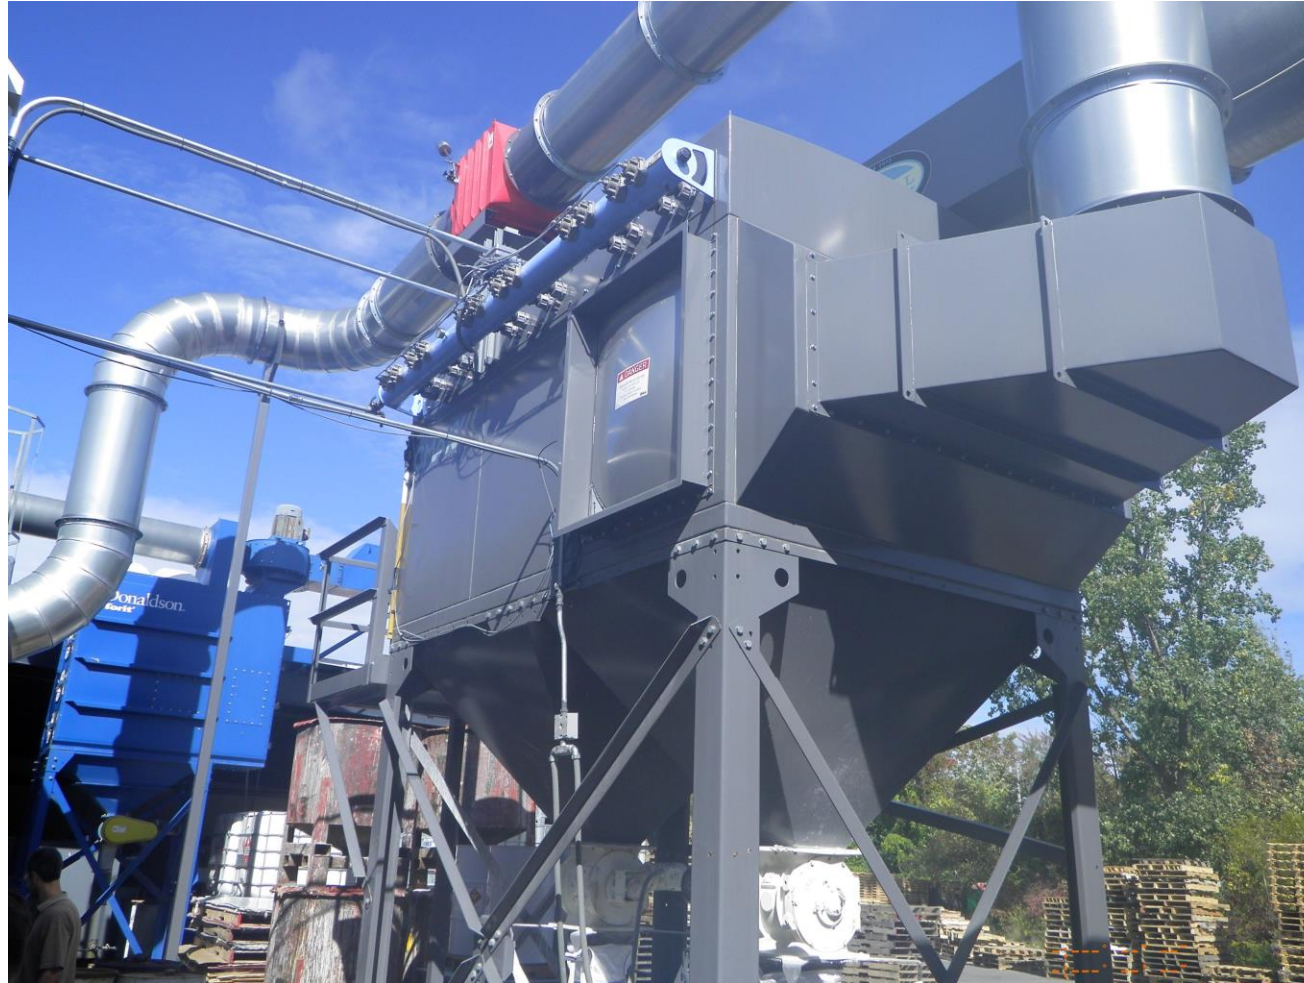
Photo Number: 6

Photo Description: Shear Saw Room Dust Collector (not operating during picture)

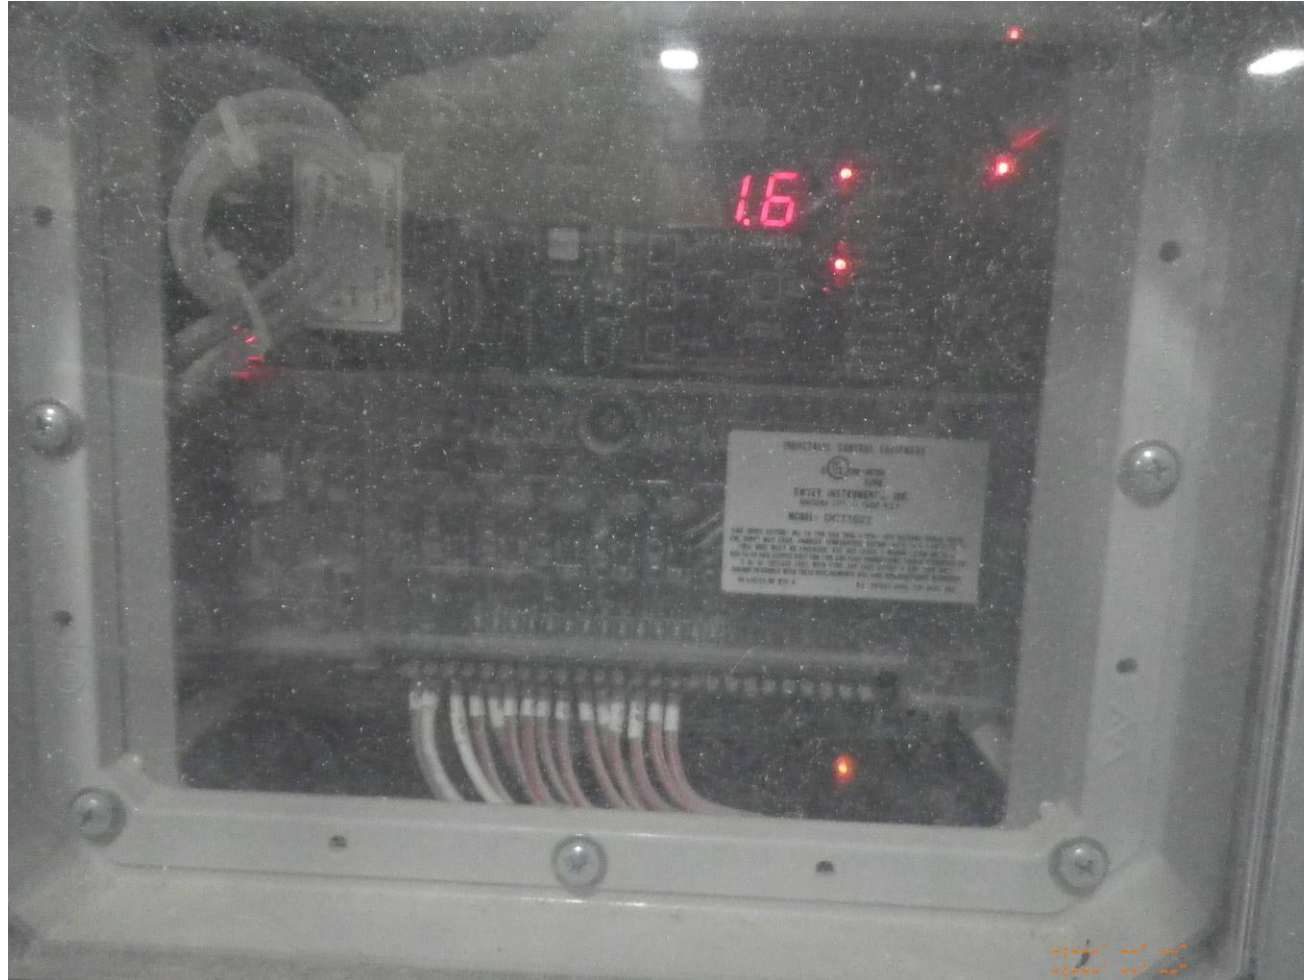
Photo Number: 7

Photo Description: Shear Saw Room Dust Collector Pressure Drop (in operation)

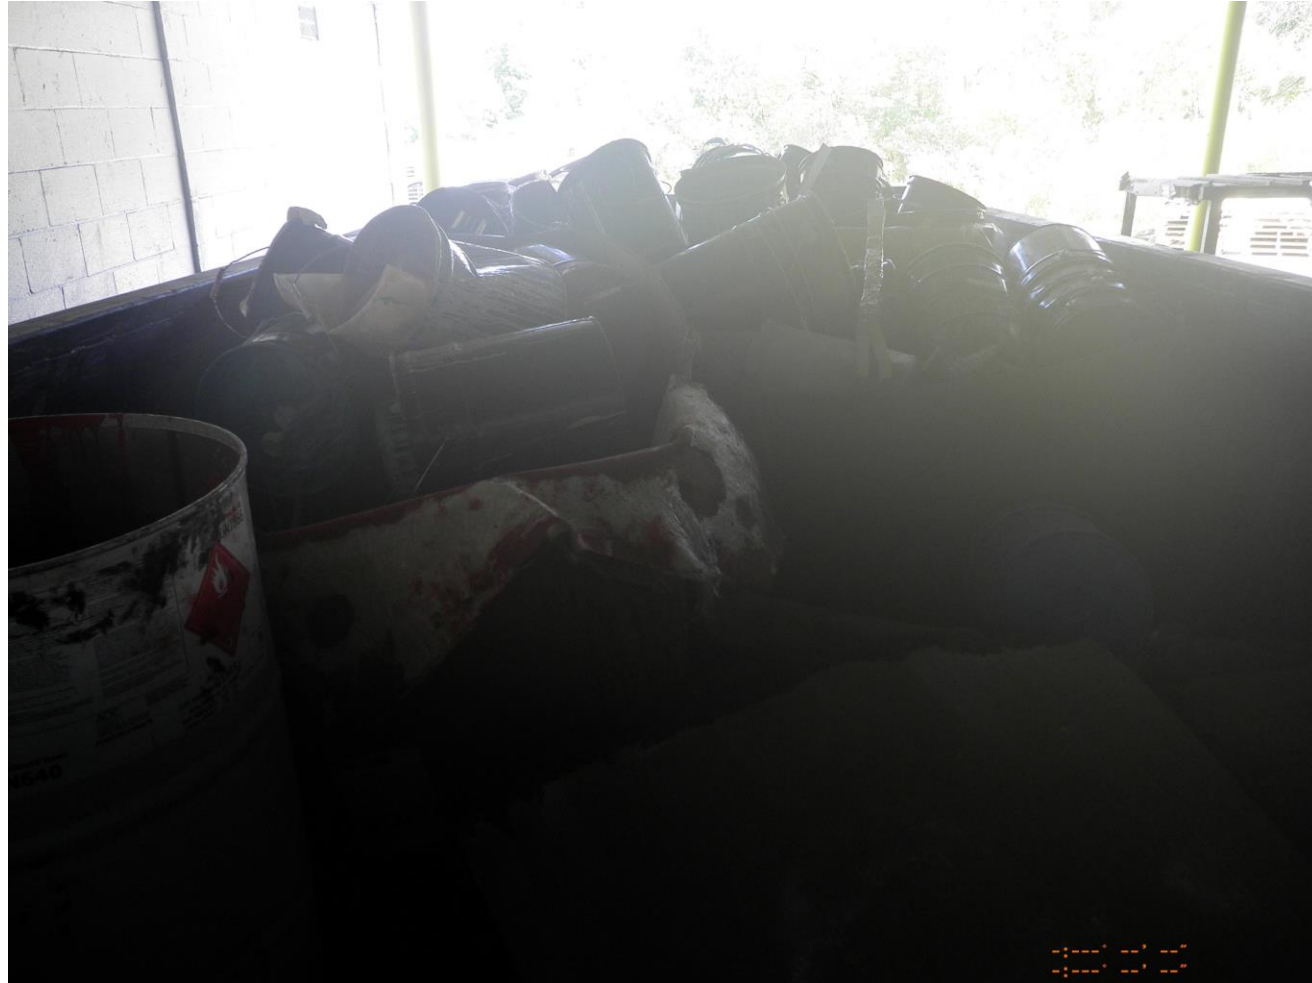
Photo Number: 8

The inspection team then proceeded to the exterior shipping area which is located under an overhang. There was an odor noted in this area near the barrels by the roll-up door. Drums were observed in this area which were being cured for disposal. Nearly all the fifty-five-gallon drums had clear plastic covers which the Facility called poly closures. Many of the drums had labels indicating they contained resin, and some were observed to have rags or other waste products which may have been resin laden. One of the drums of particular note was an open drum containing a sheet barrel resin with a styrene monomer as an ingredient. Adjacent to the drums was an curing oven that is used to cure leftover resin in the drums prior to disposal. EPA also observed a roll-off dumpster located in the area with cured resin buckets and drums. Haysite stated that the roll-off is sent off-site for disposal.

Photo Description: Roll-off Dumpster with Cured Resin Buckets

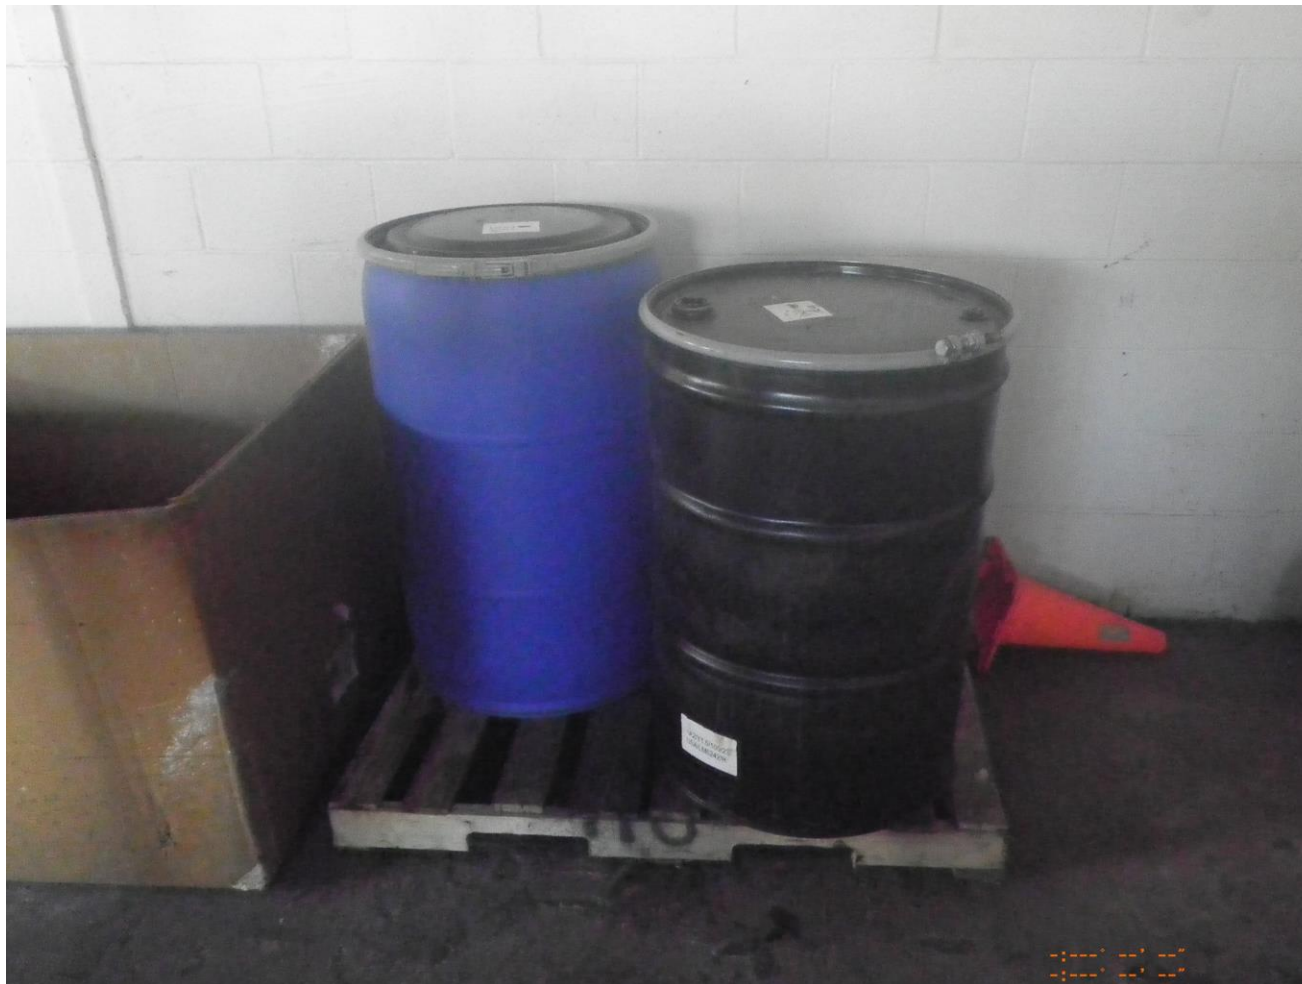
Photo Number: 9

Photo Description: Two Drums Labeled Acid for Disposal

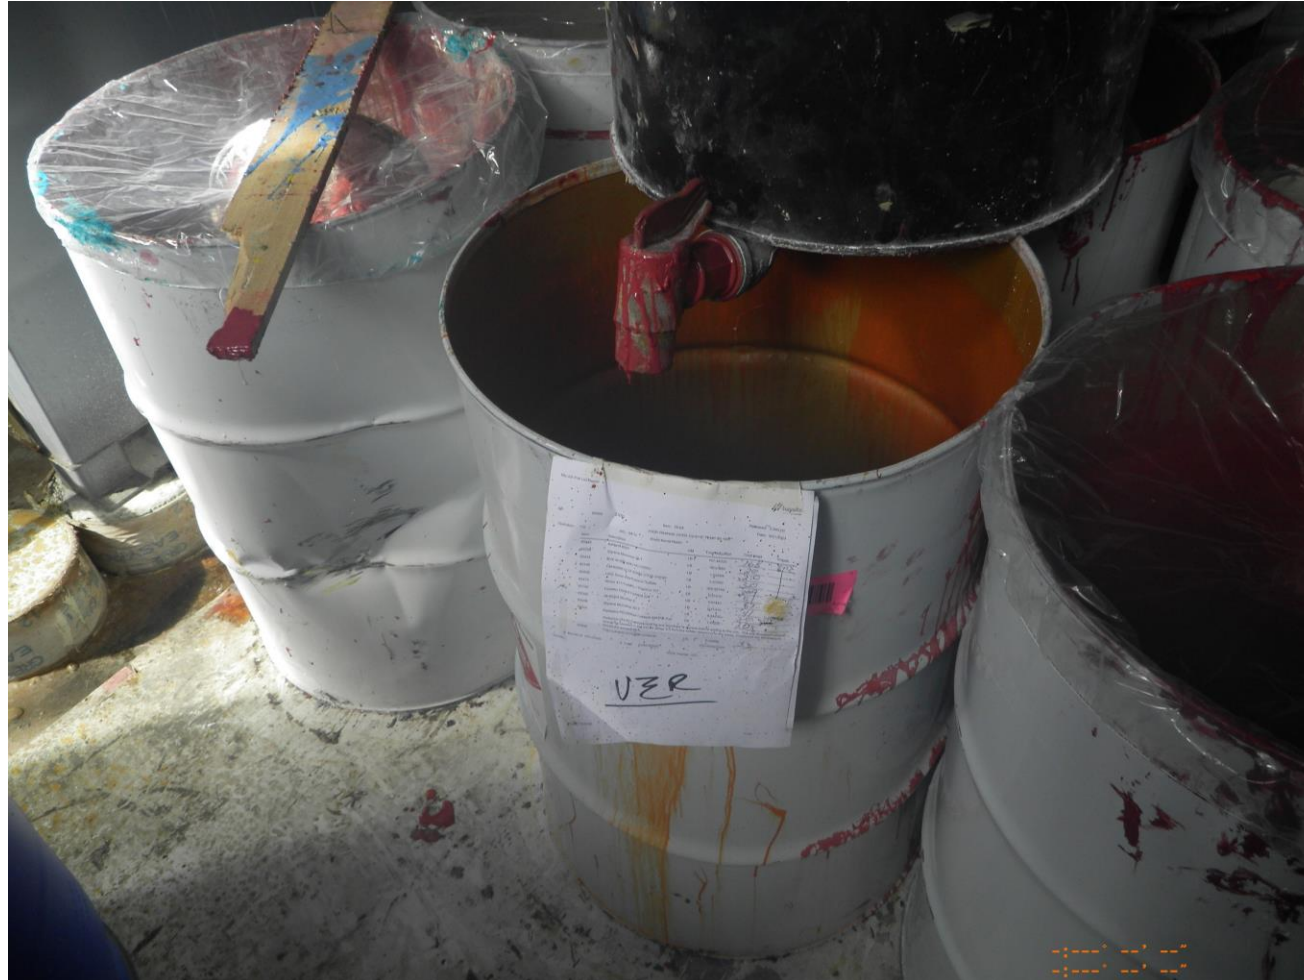
Photo Number: 10

- Haysite covers open drums containing VOC and HAP resins with plastic poly covers rather than a metal sealed lid. These covers are not typical to other covers observed on drums at sites. EPA will conduct a review of the poly film covers for the fifty-five-gallon drums to determine if they meet the closed cover requirements.

Photo Description: Open Resin Drum Outside

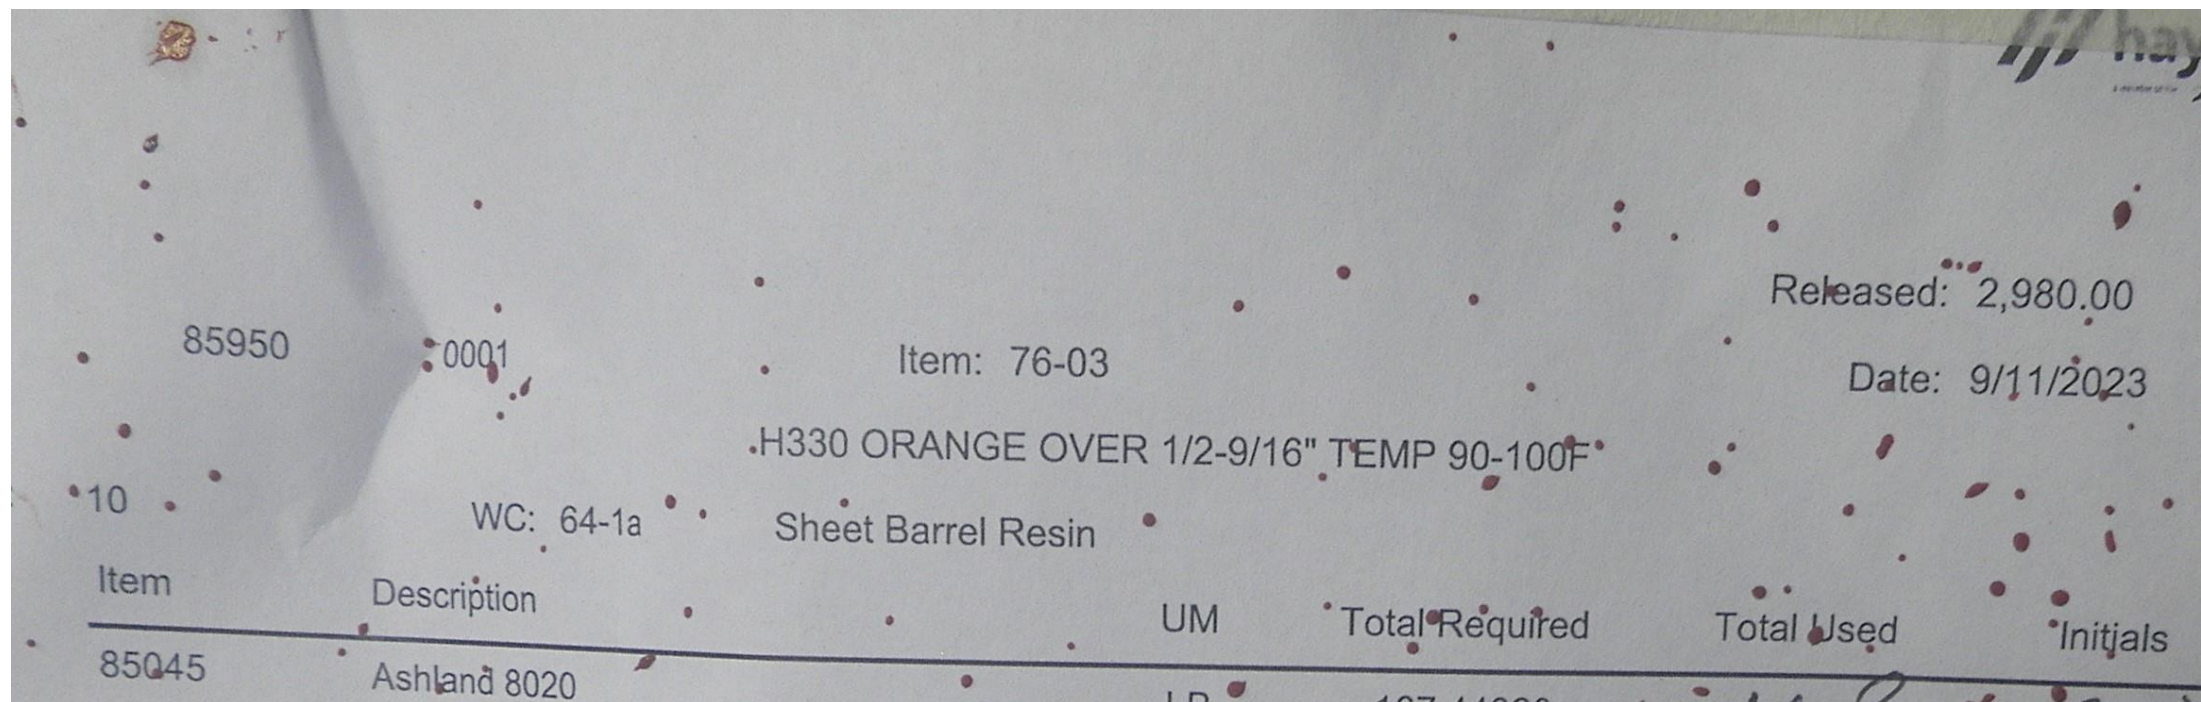
Photo Number: 11

Photo Description: Spec Sheet for Product on Side of Open Resin Drum

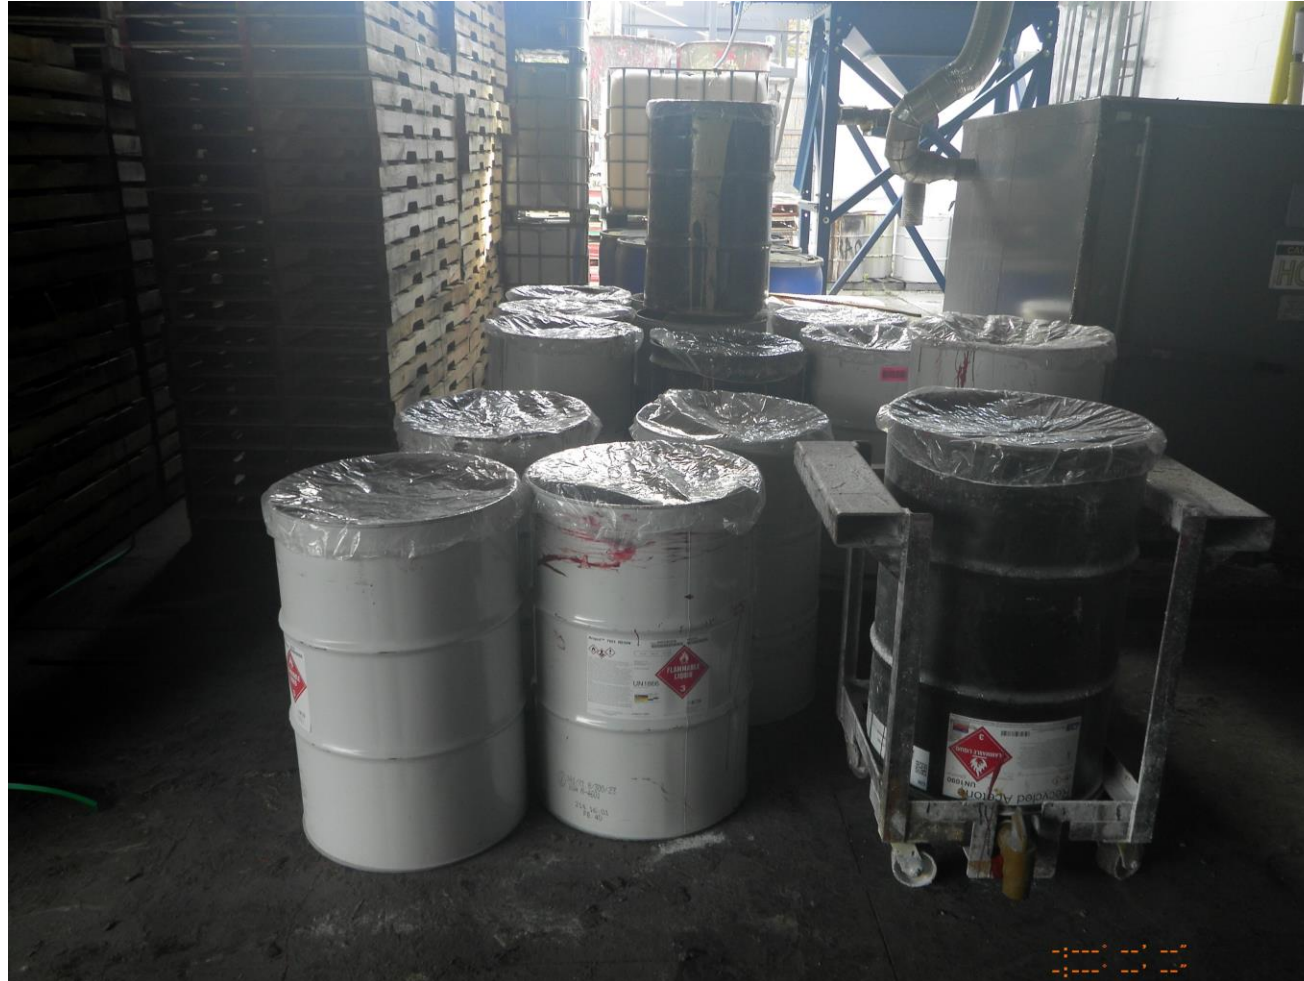
Photo Number: 12

Photo Description: Drums Waiting to be Cured in Oven

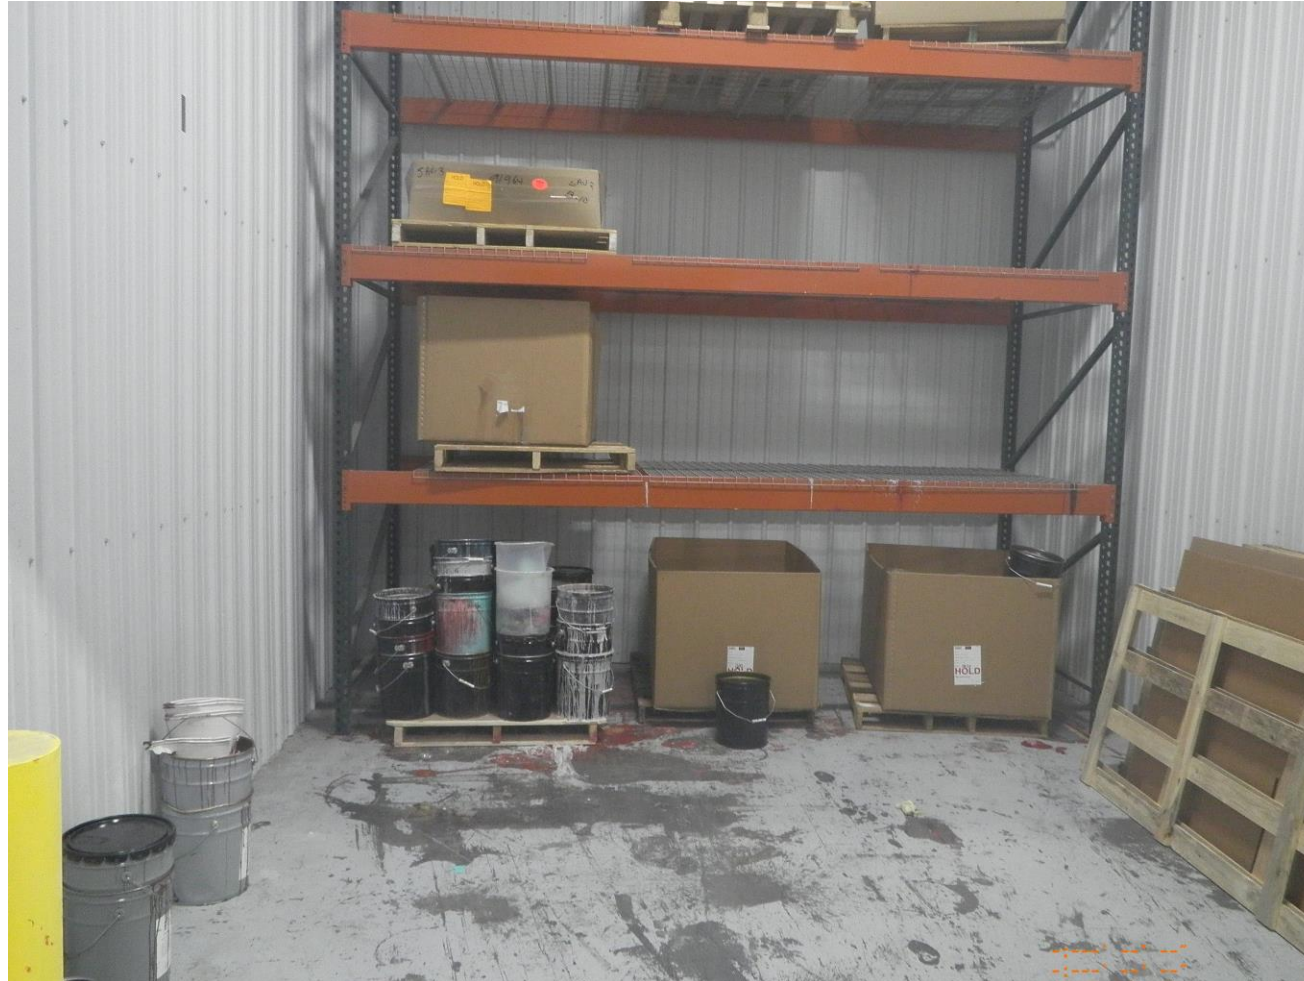
Photo Number: 13

The inspection team then observed the hot room, which is used to cure resins for a couple of days with the duration depending on the product. The hot room has a high ceiling, and no emission controls were observed. During the inspection, the hot room was filled below half capacity. EPA then observed the bulk storage tank room. Upon entry an odor was noted by EPA. The Facility stated the seven tanks are filled from the top when raw materials are received and are drained to have the inside cleaned every three to five years. Two of the tanks contain a styrene monomer and five tanks contain thermoset polyester resins; one of which was Ashland

Photo Description: Hot Room with Open Buckets

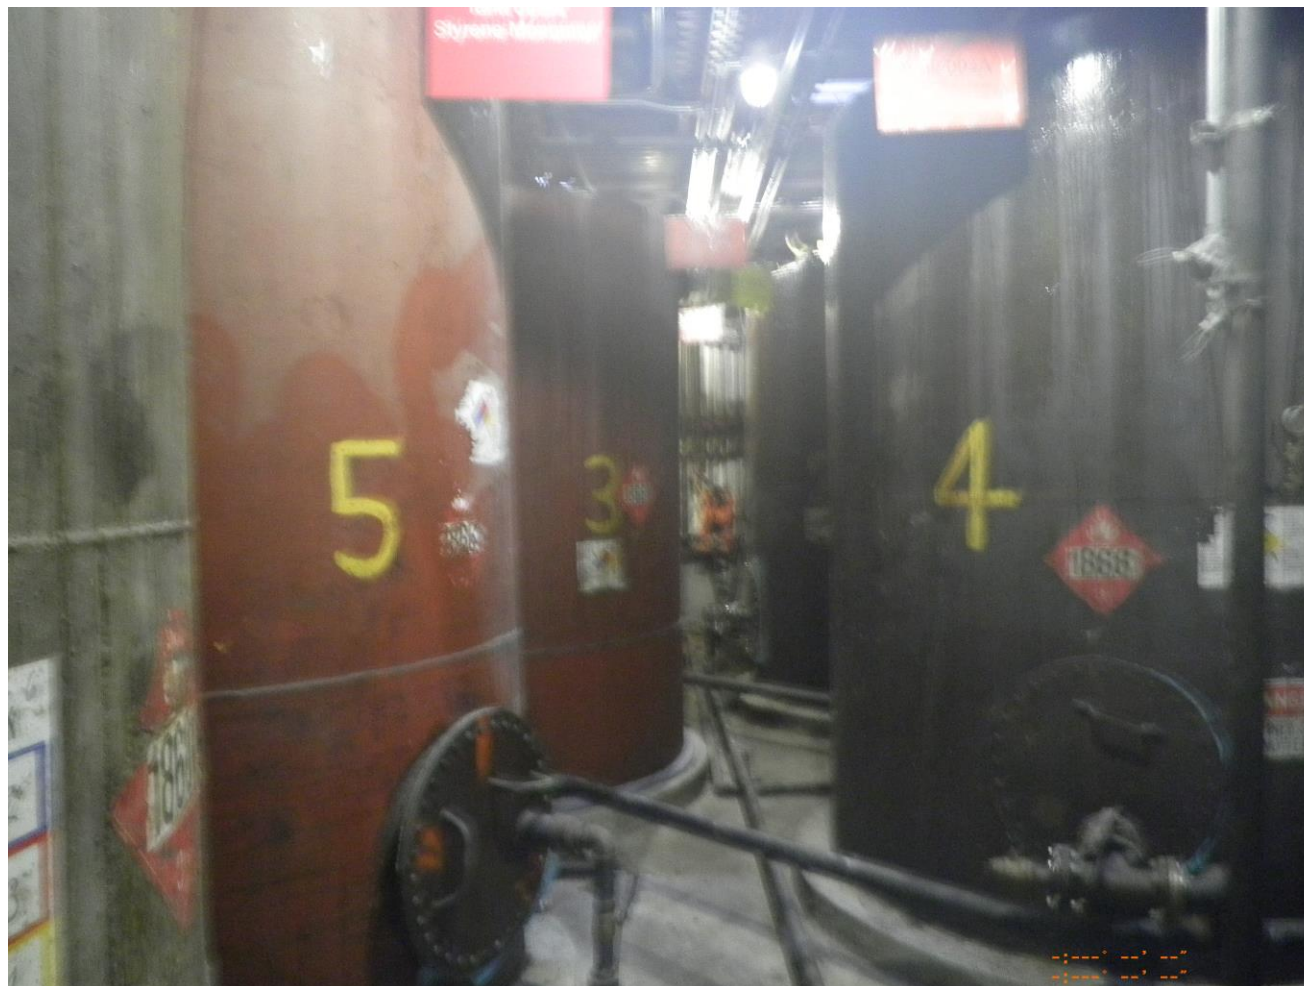
Photo Number: 15

7320-1. The Facility also stated that resin is the most common raw material. All of the seven tanks were observed to have streaks and staining on the top and sides, likely from past overfilling.

Photo Description: Bulk Storage Tanks

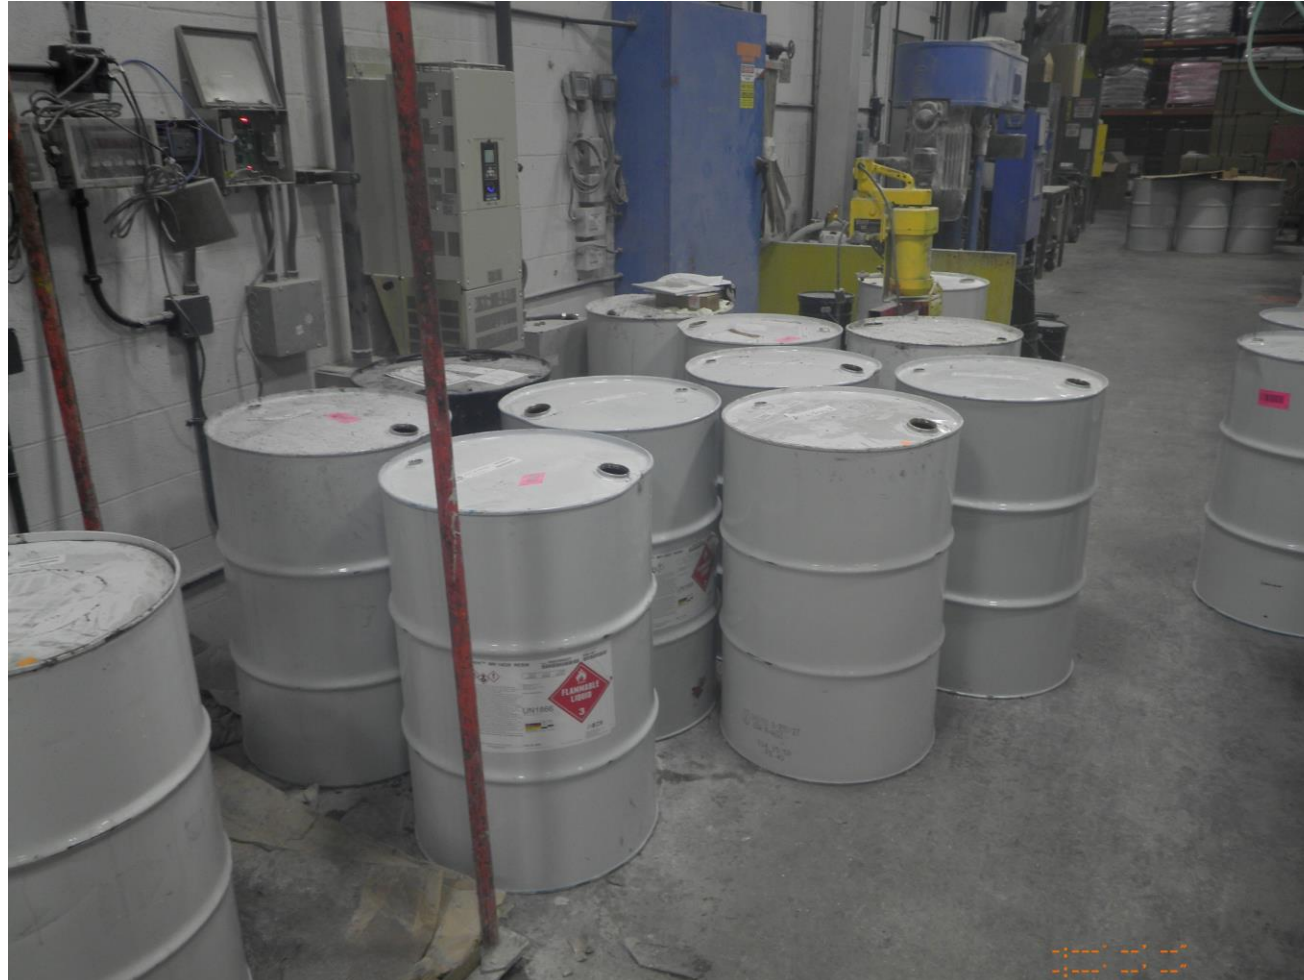
Photo Number: 16

Outside of the raw material batch mixing room EPA observed multiple drums with metal lids and opened pouring spouts while others were observed to have poly closures. The inspection team then proceeded outside and observed the mixing room dust collector and pultrusion dust collector. The mixing room dust collector had a tarp on top which the Facility stated was to keep out the elements. The Facility also stated the plan is to redo the whole mixing room to a state-of-the-art mixing room in the next three years. The Facility stated the pultrusion dust collector has eight cartridges. Later in the inspection, the inspection team recorded the mixer room dust collector had a pressure reading of 4.8" w.g. and the pultrusion puller dust collector had a reading of 1.0" w.g. There were no extra filters observed for the dust collectors.

Photo Description: Open Resin Drums Outside Mixing Room

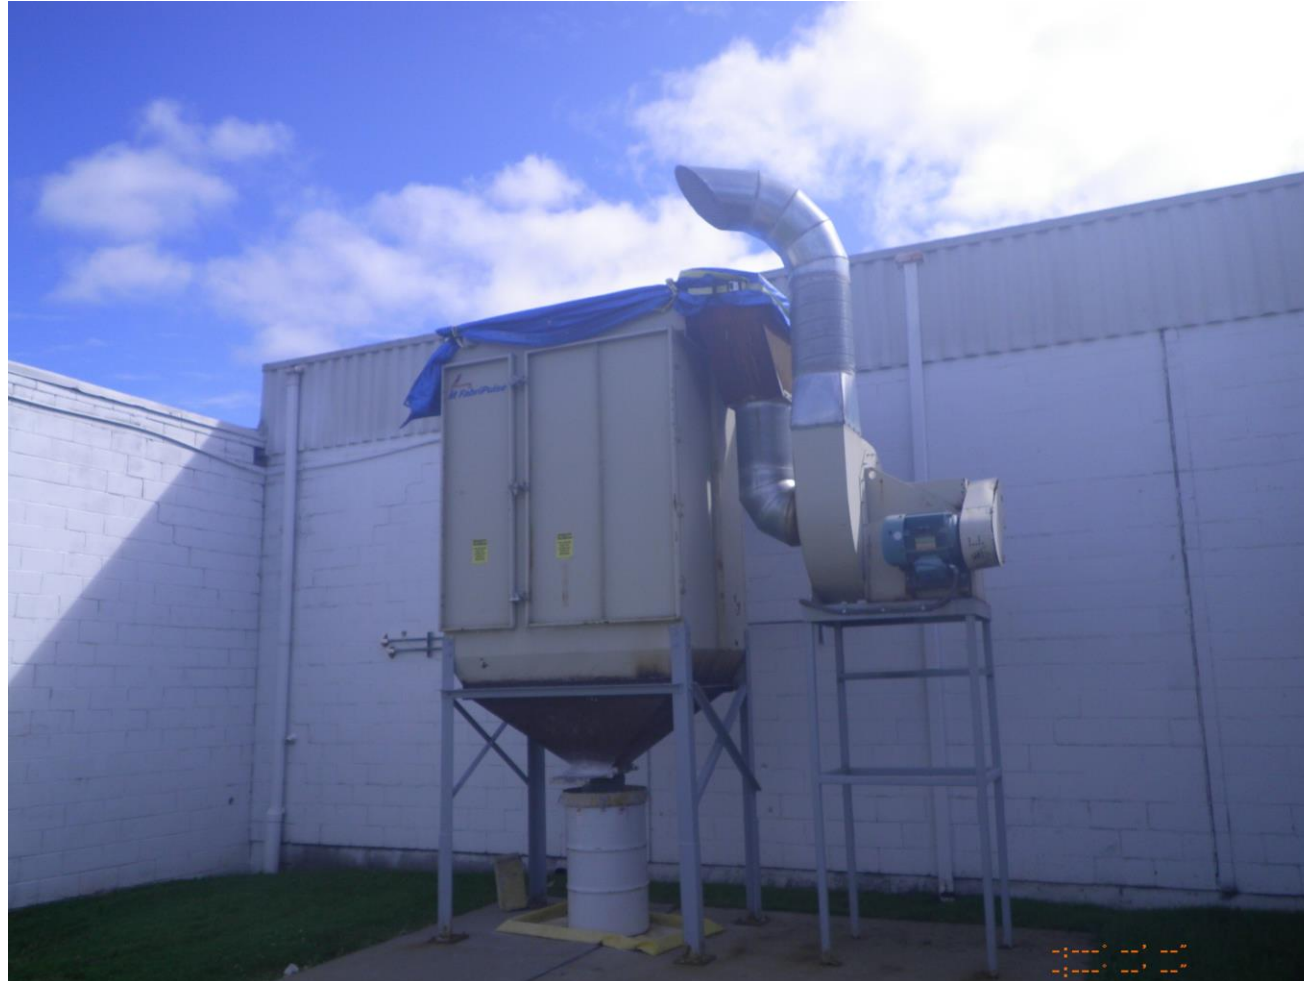
Photo Number: 17

Photo Description: Mixing Room Dust Collector

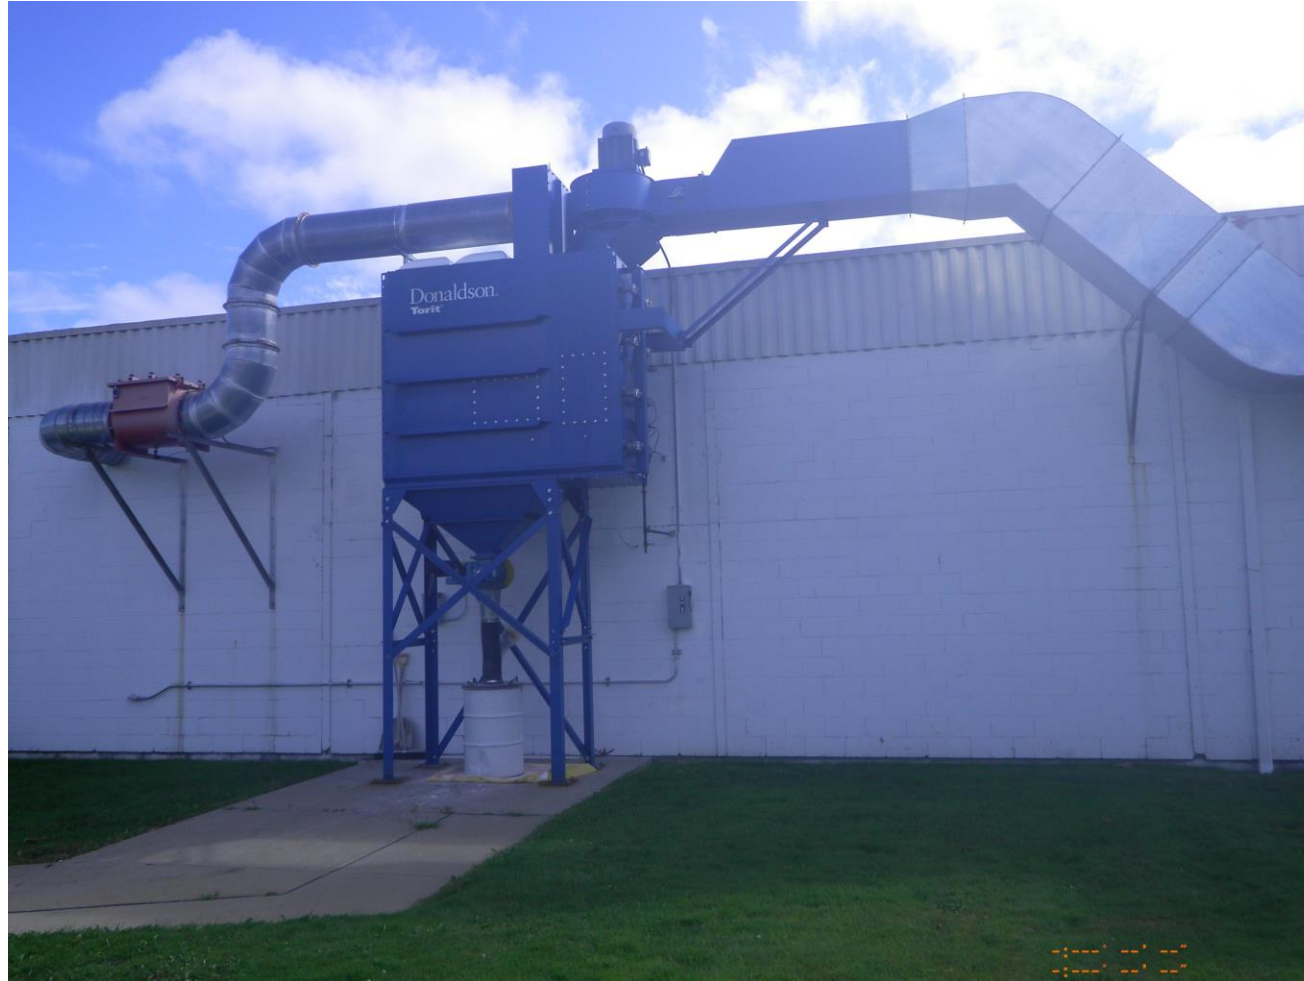
Photo Number: 18

Photo Description: Pultrusion Dust Collector
