**UNITED STATES ENVIRONMENTAL PROTECTION AGENCY**  
**REGION III**  
**Four Penn Center – 1600 John F Kennedy Blvd**  
**Philadelphia, Pennsylvania 19103-2852**

**Report Title:** Clean Air Act Inspection of Haysite Reinforced Plastics LLC  
**Inspection Date(s):** September 26, 2023  
**Regulatory Program(s):** Title V, SIP, NESHAP  
**Company Name:** Haysite Reinforced Plastics LLC  
**Facility Name:** Haysite Reinforced Plastics LLC  
**Facility Location:** 5599 New Perry Highway  
Erie, PA 16509  
**Latitude:** 42.08408 **Longitude:** -80.05502  
**County/Parish:** Erie County  
**AFS/ICIS-Air Number:** PA000511900  
**Permit Number:** 25-00783  
**NAICS Code:** 326130 **SIC:** 3083  
**Unique Project #:** 3E23CA037A

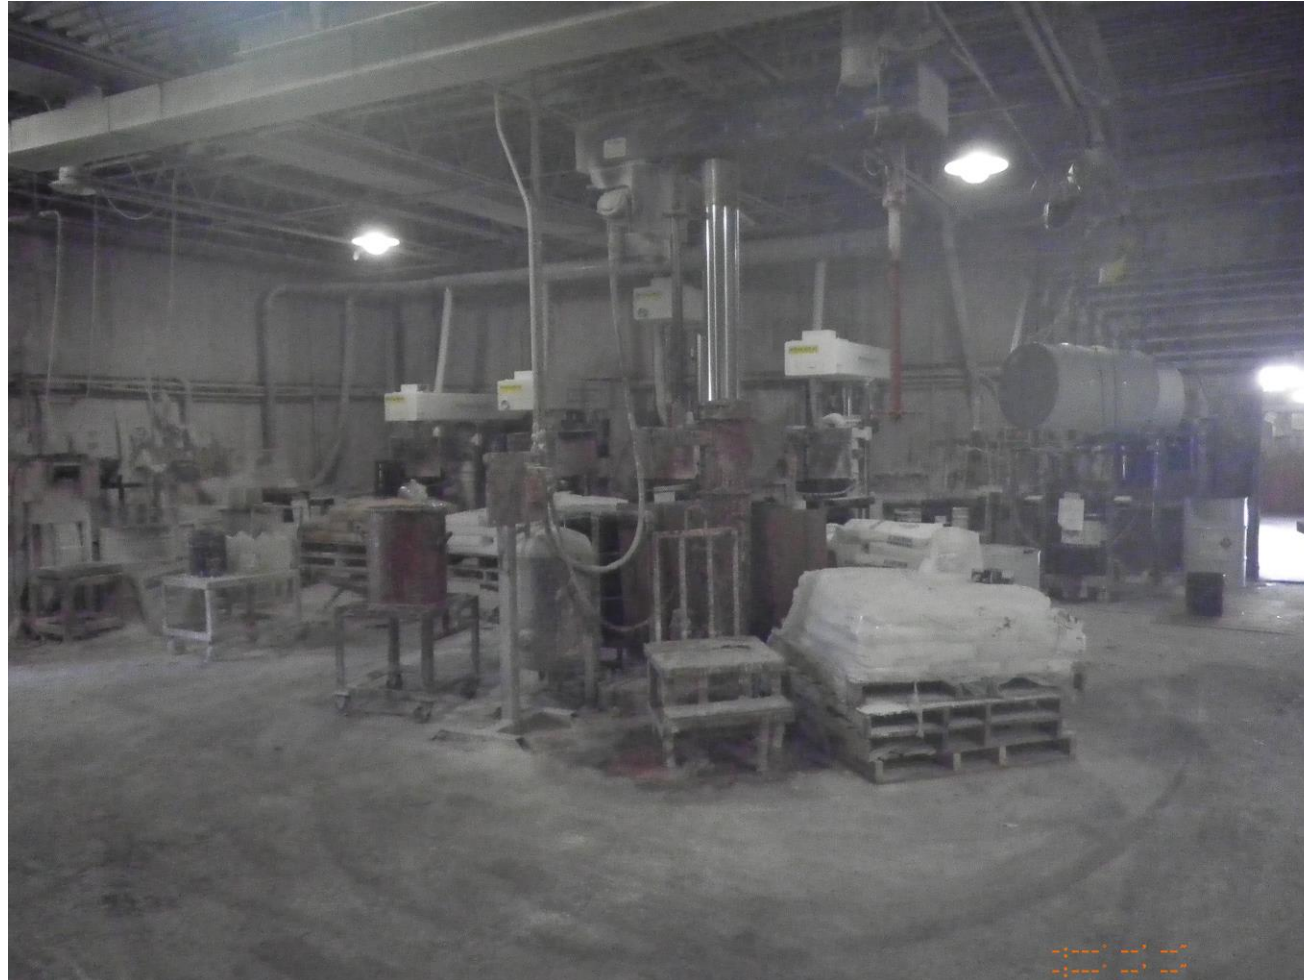
Photo Number: 19

The raw material mixing room had drums containing raw material resins suspended from the ceiling so they could more easily be moved around the room. There were a couple smaller, approximately five-gallon, buckets denoted as "color" observed open. There were two larger batch mixers located in the room. Neither batch mixer was in use at the time of the inspection. One of the large mixers was open to the atmosphere and was empty but the Facility could not quickly locate the lid (approximately 12" diameter). One of the three rotary mixers was in use during the inspection. The rotary mixers had an opening around the motor of approximately 8" diameter. Adjacent to the mix room, there was an acetone storage shed. The new acetone was located on one side of the shed and the used acetone was located on the other. This shed vented outside with no emission controls. There was staining of different colors on the ground and walls in this shed.

Photo Description: Mixing Room

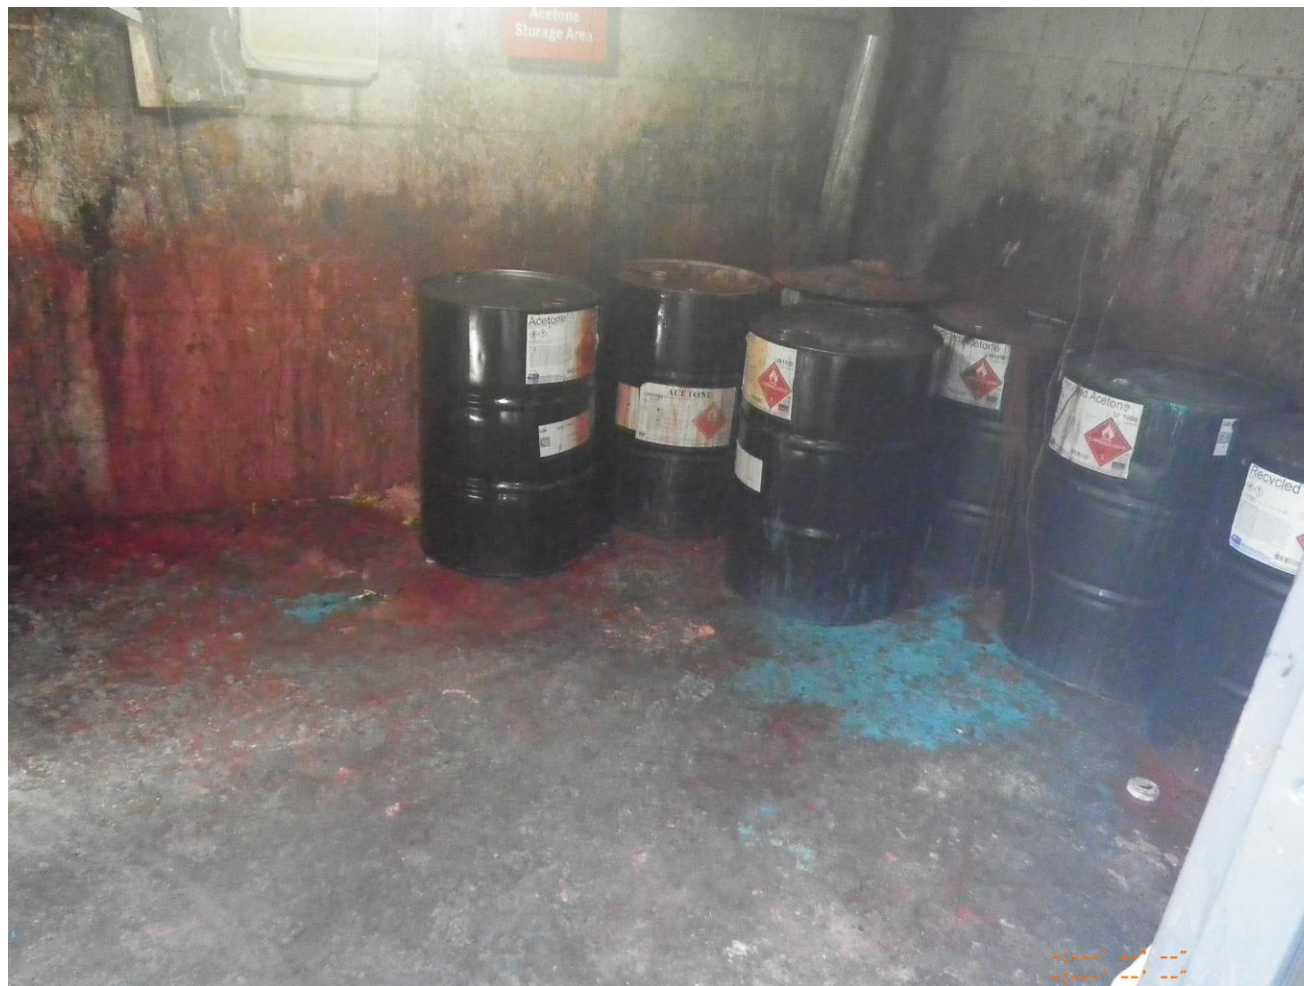
Photo Number: 20

Photo Description: Spent Side of Acetone Hut

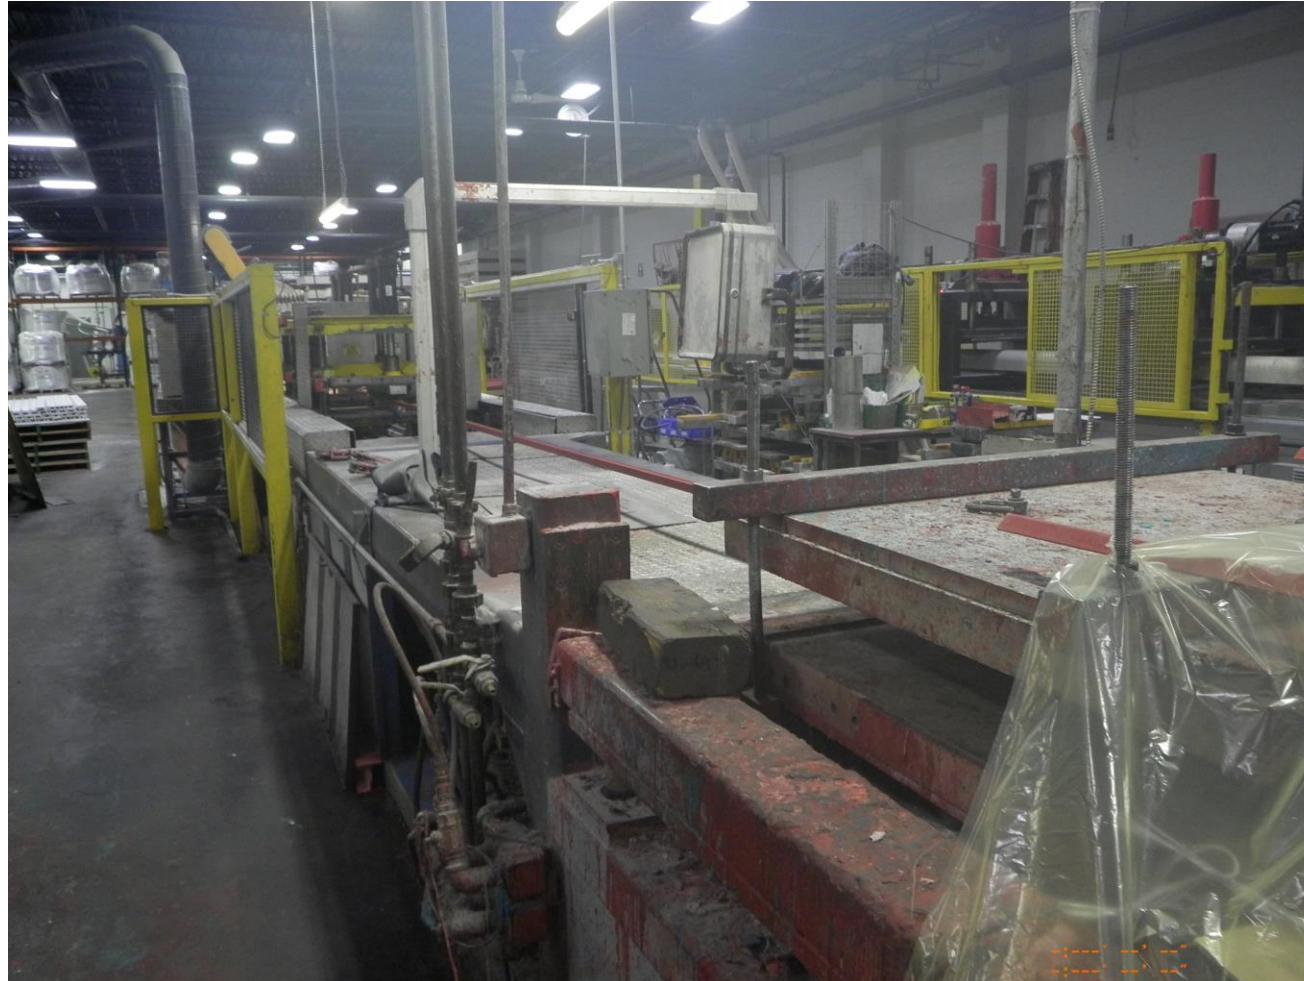
Photo Number: 21

The EPA inspection team proceeded to the pultrusion puller area. Raw material batches are introduced into the machine along with a glass mesh string and are pulled through the pullers. The Facility stated that pullers #3 and #4 are set to be replaced within a couple years and a request for determination (RFD) was submitted to PADEP to determine if a permit is necessary. The Facility stated puller #7 can pull more glass than puller #3 or puller #4 and its resin bath is a little larger. Pullers #5 and #6 were not operating at the time of the inspection.

Photo Description: Pultrusion Puller #3

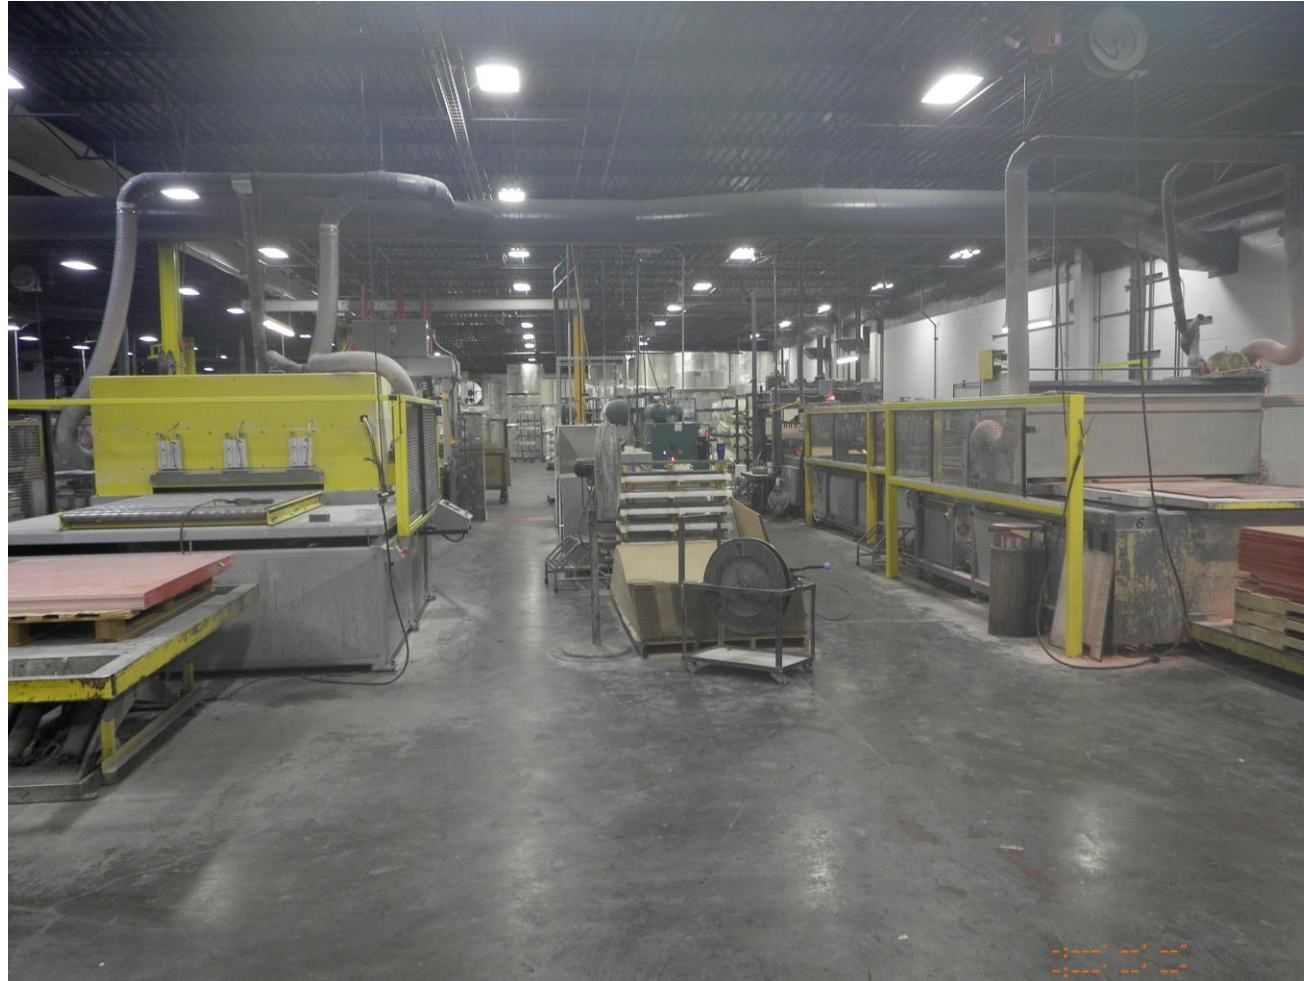
Photo Number: 22

Photo Description: Pultrusion Pullers #5 and #6

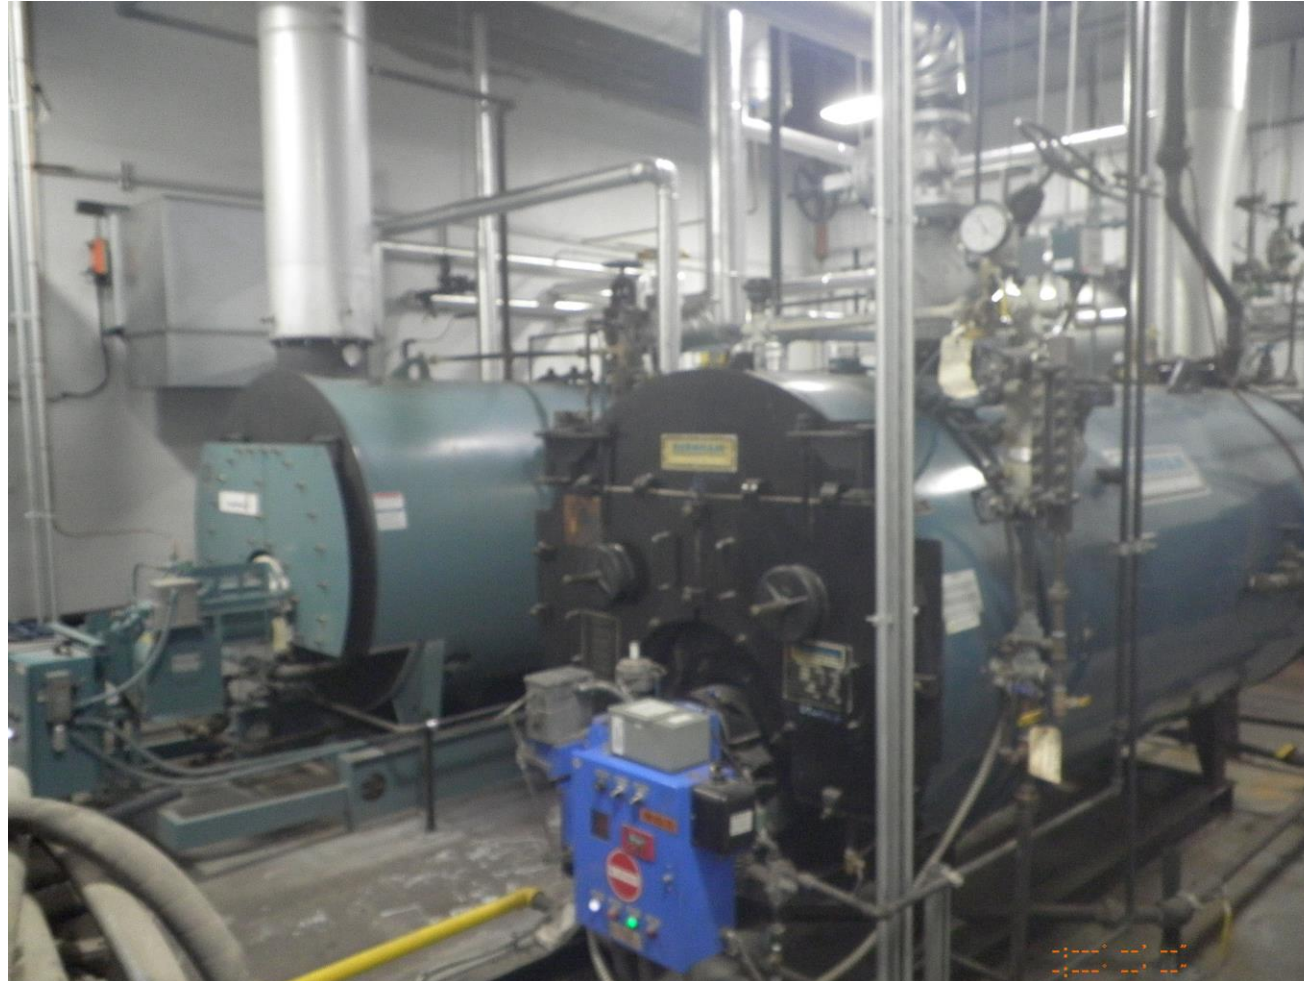
Photo Number: 23

EPA observed two boilers located within the boiler room. One was a Burnham boiler that was rated at 3,348,000 BTU/hour and was labeled for use with either natural gas or #2 fuel oil. The Facility stated they only use natural gas and do not use #2 fuel oil. The other boiler was a Cleaver Brooks from 2021 and was rated at 4,184,000 BTU/hour. Both boilers are used to provide process steam.

Photo Description: Burnham and Cleaver Brooks Boilers

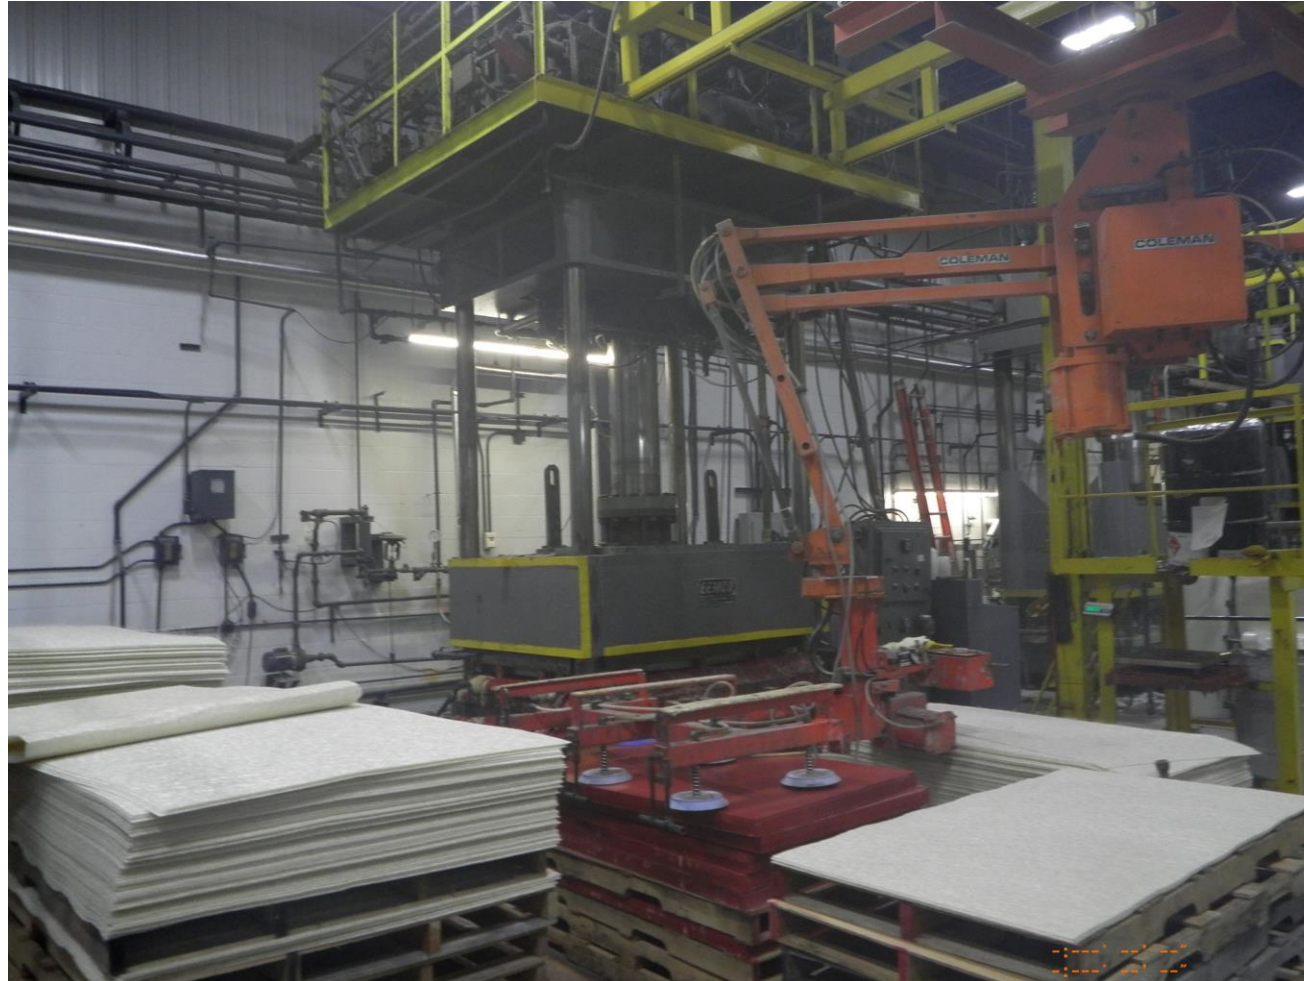
Photo Number: 24

Photo Description: French Oil Press
