PROGRESS REPORT  
TECHNICAL SERVICES DEPARTMENT  
AQ. 31694

JOB NO:- 27/7130/2333

REPORT:- No. 1

Title: ARCOLORS EFFLUENT - VISIT TO N.C.R. (BOREHAM WOOD)

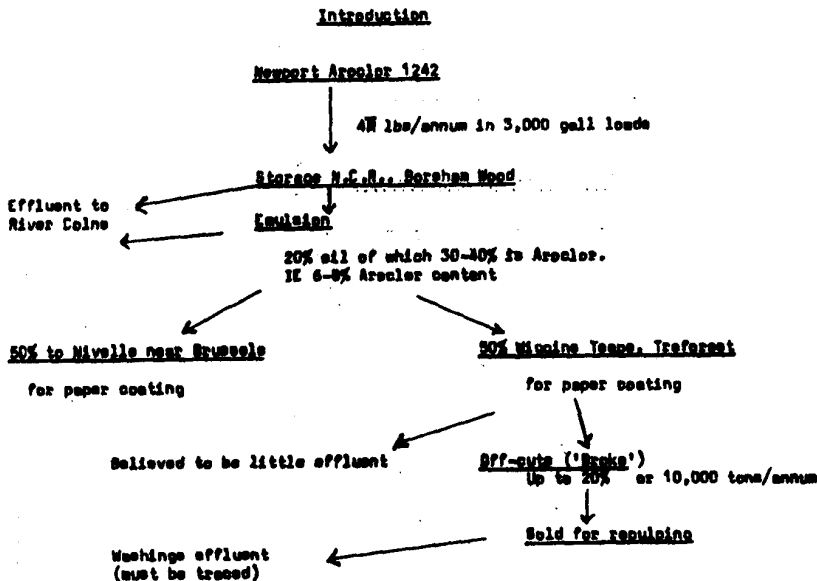
The above diagram illustrates what happens to the Arcolor at N.C.R. and in the paper coating process.

The tank levels were allowed to balance out by keeping the bottom outlet valves open. It is not known whether only one or all the valves to the individual storages were opened when discharging a road tank. On several occasions spillages had occurred as a result of discharging into one tank at a faster rate than the tank levels could balance out. An N.C.R. clerk was apparently supposed to look after the off-loading.

Level indicators were provided on the tanks, but these were inconveniently located in a shed obstructed by various kegs of raw materials. There appeared to be no official off-loading instructions.

A drum was provided to catch drips at the flexible hose, but installation of an interceptor pit to prevent spills on to ground entering the municipal surface water drainage system is recommended. This should also handle drainage from the adjacent emulsion tanker loading area.

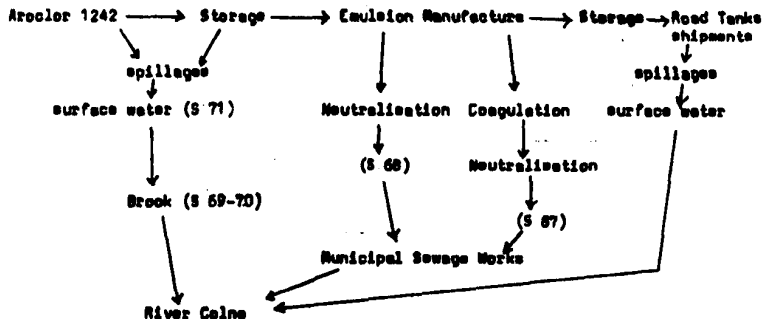
#### Borham Wood Effluents

The above diagram indicates where samples (S\_) were taken at Borham Wood. These are listed below:-

The low PCB content of the main effluent stream was surprising in view of its contaminated milky appearance. This analysis is to be confirmed. The blue appearance of the centrifuge effluent stream was presumably due to the dye incorporated in the W.C.R. emulsion, and would therefore be consistent with the high contamination level found.

The contamination levels in the surface water drain and the brook confirmed that considerable amounts of PCB had been discharged in this direction from spillages in the tanker off-load/storage area. At the time of sampling pollution of the water was at a comparatively low level, but the mud in the brook was heavily contaminated from earlier spillages.
