INQUIRY OF "NEAR MISS" ACCIDENT - HENRY PLANT

**Subject** Near miss accident,

Subject: Near Miss Accident from Improper Electrical Lock-out

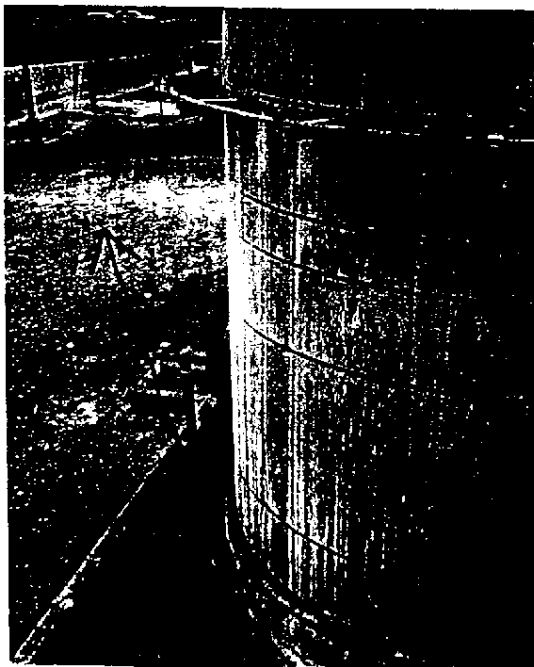
3. This is the chain that was wrapped around the pipe support. This is also the valve that was used to close the bottom drain. Arrow shows path and final location of pipe.
