## **RCRA Inspection Report**

Dunbarton Corporation Rediframe Division  
1101 Technology Drive  
Dothan, Alabama 36303  
Houston County

January 14, 2025, at 9:45 a.m. CST

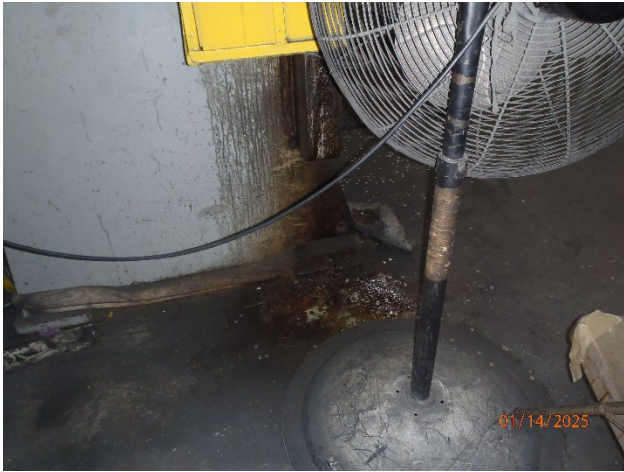
The inspectors observed gear oil leaks on the floor around two of the Press Brakes (Pictures 1-2). Absorbent pads used to collect the oil leaks were full and leaking and needed to be replaced.

Picture 1 – Press brake machine oil release

**Pursuant to ADEM Admin. Code r. 335-14-17-.03(4)(d) [40 C.F.R. § 279.22(d)], upon detection of a release of used oil to the environment, the facility must clean up and manage properly the released used oil and other materials.**

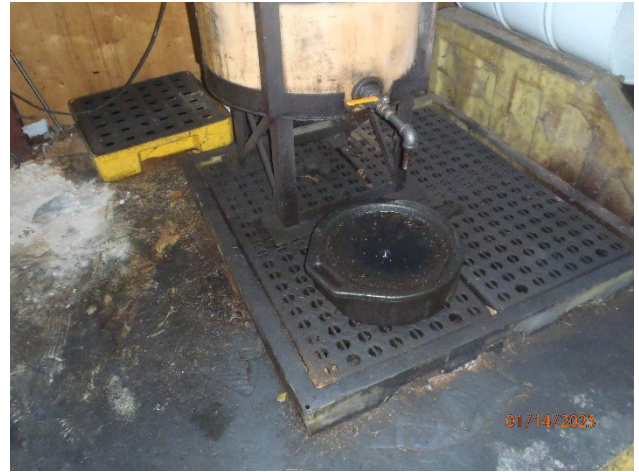
- An oil tank on secondary containment pallet had a black drip catch pan below the nozzle that was full and needed to be cleaned, and not labeled. The secondary containment pallet was also full of used oil and need to be cleaned out.
- The floor surrounding the used oil drum storage area was saturated with oil and covered in absorbent.
- Two 55-gallon oil containers on a dual dispensing and spill containment system. The containment system was filled with used oil and debris and needed to be cleaned out. The containers were closed and labeled.
- Three white 5-gallon containers of used oil. One of the containers was not closed.
- Two black 55-gallon containers of used oil. One of the containers had a funnel that was not closed, and the top of the second container was covered in used oil and needed to be cleaned off.

Picture 4 – Used Oil Drum Storage unmarked secondary containment

**Pursuant to ADEM Admin. Code r. 335-14-17-.03(4)(c)1. [40 C.F.R. § 279.22(c)(1)], containers and aboveground tanks used to store used oil at generator facilities must be labeled or marked clearly with the words "Used Oil."**

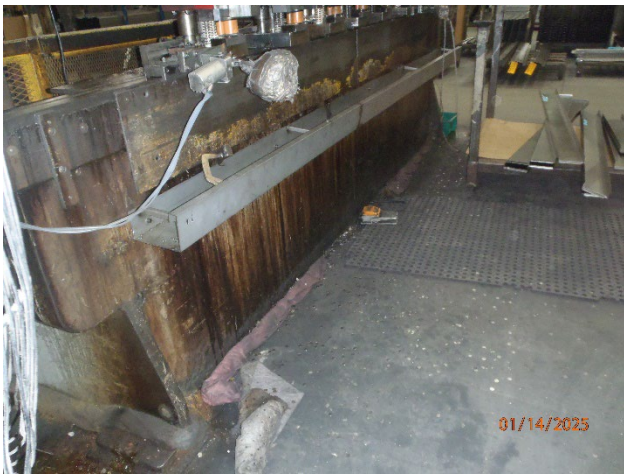
Picture 2 – Press brake machine oil release

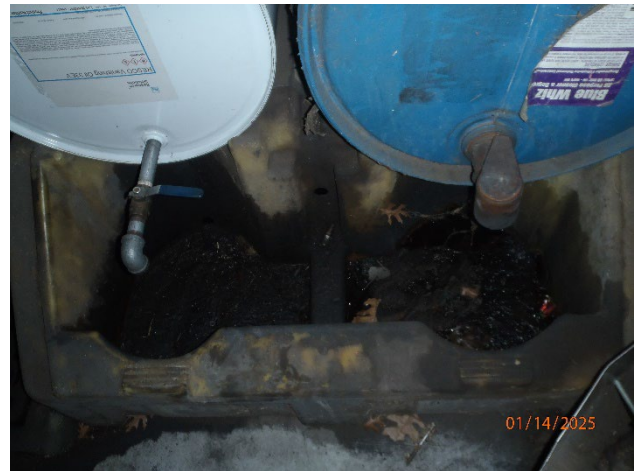
Picture 5 – Used Oil Drum Storage secondary containment

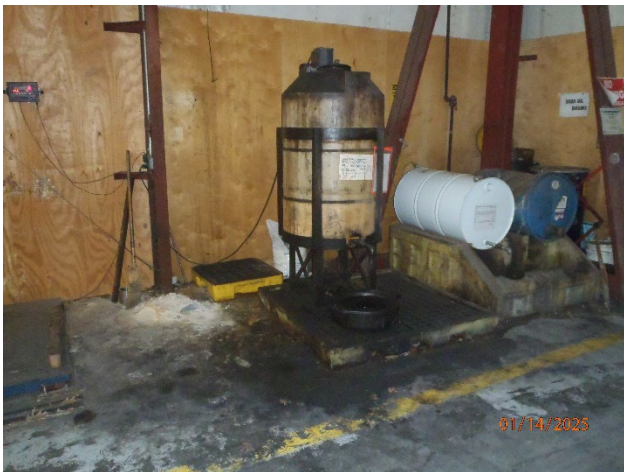
Picture 3 – Used Oil Drum Storage

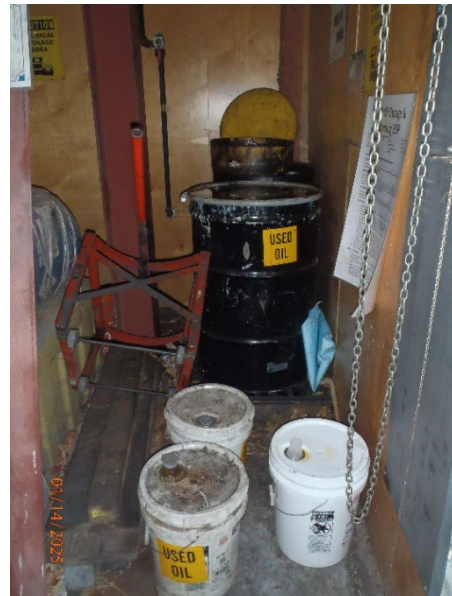
Picture 6 – Used Oil Drum Storage open container

**Pursuant to ADEM Admin. Code r. 335-14-17-.03(4)(a)1. Used oil generators shall not store used oil in units other than used oil tanks, containers, or units subject to regulation under Chapters 335-14-5 and 335-14-6. A container holding used oil must always be closed during storage, except when it is necessary to add or remove used oil.**

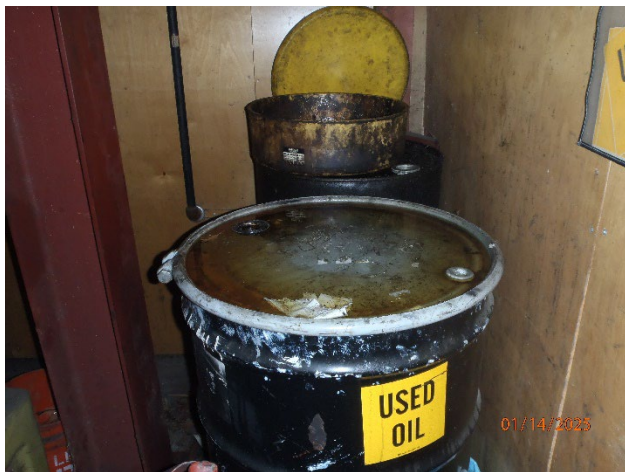
Picture 7 – Used Oil Drum Storage oil release and open lid

**Pursuant to ADEM Admin. Code r. 335-14-17-.03(4)(d) [40 C.F.R. § 279.22(d)], upon detection of a release of used oil to the environment, the facility must clean up and manage properly the released used oil and other materials.**

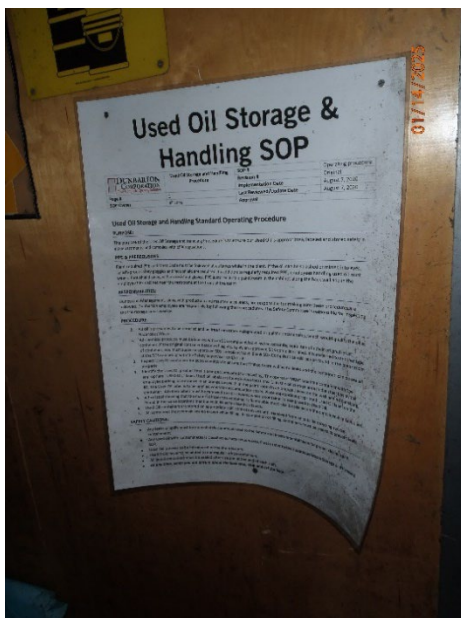
Picture 8 – Used Oil Drum Storage

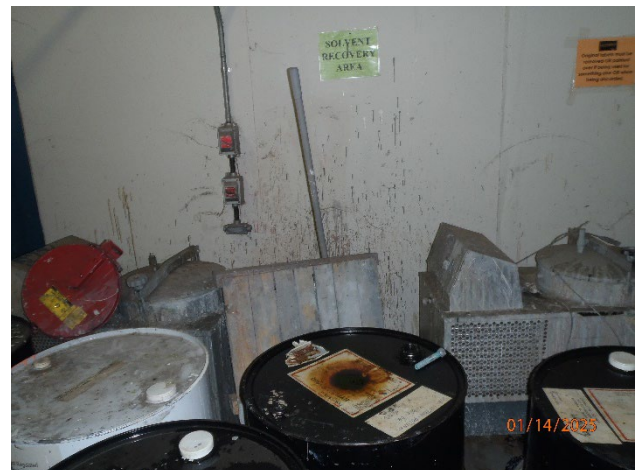
Next door, in the Paint Mixing Room, was the less than 90-day CAA. One black 55-gallon container of Waste Paint Related Material labeled D001, F003, F005, with the flammable liquid hazard indicator, and dated January 8, 2025 (Pictures 13-14). Next to the CAA was a solvent recovery area that had not been used for several years. The inspectors observed containers of lubricant oil, and two solvent recovery stills that needed repair (Pictures 12, 13, 14, 15). Mr. Young stated that the parts for stills were being ordered.

Picture 11 – Paint Area solvent recovery still pending repair

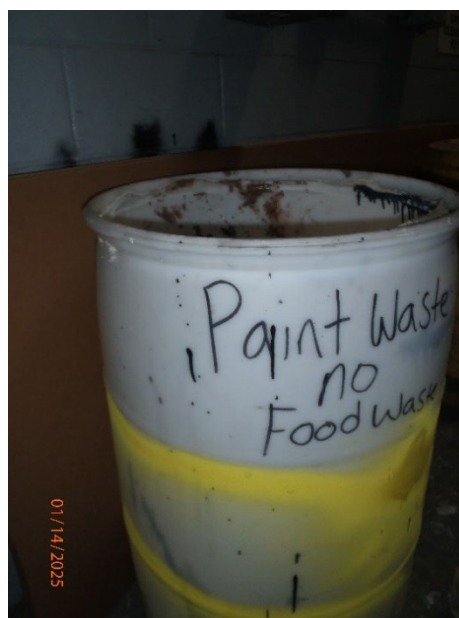
Outside the Paint Mixing Room was a white 55-gallon container of paint waste. The container was not closed and held paint debris and empty paint containers with dried paint residue (Pictures 16-17). The inspectors asked Mr. Young, Mr. James Williams, Paint Booth Technician, and Mr. Troy Hahn, Maintenance Manager and were told that the dried paint residue was from the air-dry paint that was non-hazardous. The inspectors also observed a solvent rinse pot used to clean paint guns (Picture 18). The solvent was still in use, and Mr. Hahn explained that the dirty solvent is added to the CAA container for disposal.

Picture 16 – Paint Area air dry paint waste container

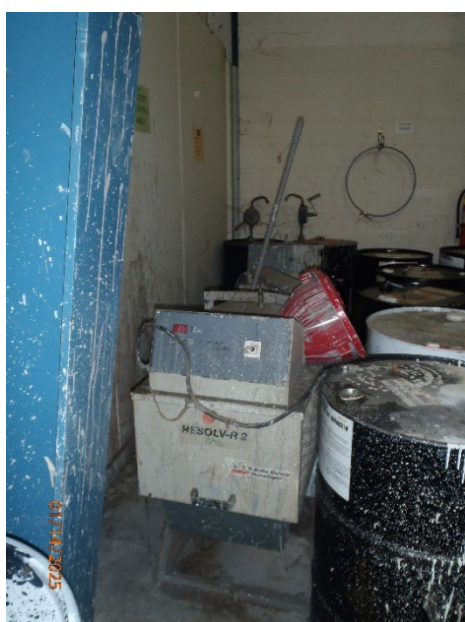
Picture 14 – Paint Area solvent recovery still pending repair

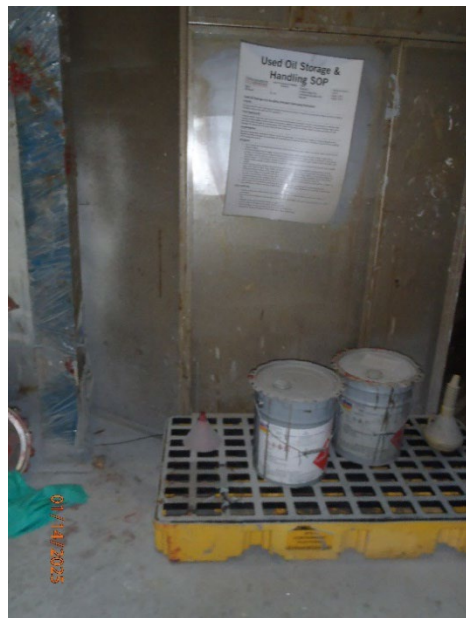
The inspectors walked the paint line and observed two 5-gallon used oil containers on a secondary containment pallet. One of the containers was empty and the other container was not closed or labeled (Picture 23).

Picture 22 – Paint Area used oil container not closed or labeled

**Pursuant to ADEM Admin. Code r. 335-14-17-.03(4)(a)1. Used oil generators shall not store used oil in units other than used oil tanks, containers, or units subject to regulation under Chapters 335-14-5 and 335-14-6. A container holding used oil must always be closed during storage, except when it is necessary to add or remove used oil.**

**Pursuant to ADEM Admin. Code r. 335-14-17-.03(4)(c)1. [40 C.F.R. § 279.22(c)(1)], containers and aboveground tanks used to store used oil at generator facilities must be labeled or marked clearly with the words "Used Oil."**

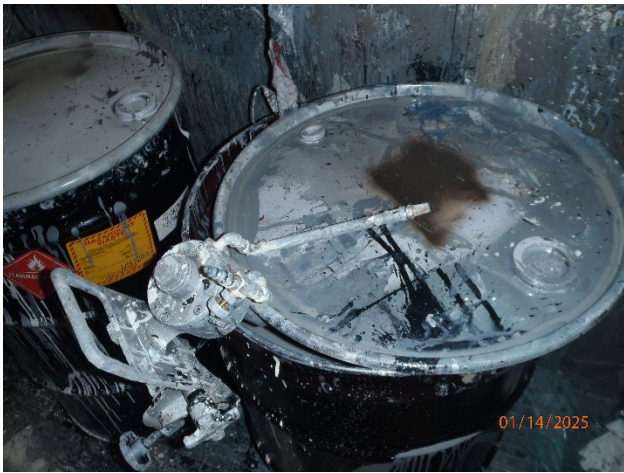
Dunbarton manages a satellite accumulation area (SAA) in the Ransburg #1 paint line area. The paint line generates hazardous waste paint related material. The inspectors observed two black 55-gallon containers in this SAA. Only one container had hazardous waste inside, and the container was located by the Ransburg #1 paint line. The container was equipped with a flat lid with a ring, which was not closed and had a paint gun inside (Pictures 24-27). The drum was marked and labeled D001, F003, F005 hazardous waste paint related material, and identified with a flammable hazard. Mr. Young explained that the container held solvent flush, from dumping 5-gallon containers into the 55-gallon container. The solvent flush was being used to clean the paint gun between paint changeovers. However, no one was actively working in the area, and the container was open at the time of the inspection.

Picture 24 – Paint Area SAA container open

**Pursuant to ADEM Admin. Code r. 335-14-3-.01(5)(a)4 [40 C.F.R. § 262.15(a)(4)], which is a condition of the SAA Permit Exemption, a generator is required to keep containers of hazardous waste closed at all times during accumulation, except when adding, removing, or consolidating waste; or when temporary venting of a container is necessary for the proper operation of equipment, or to prevent dangerous situations, such as build-up of extreme pressure.**

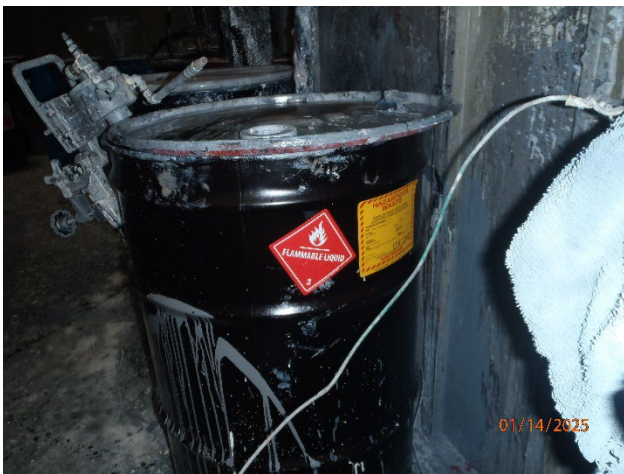
Picture 25 – Paint Area SAA container open
