**Region 6 Compliance Assurance and Enforcement Division  
INSPECTION REPORT**

| Inspection Date(s): | 09/10/2018 – 09/13/2018 | | |
| Company Name: | <b>International Paper Company</b> | | |
| Facility Name: | <b>Bogalusa Mill</b> | | |

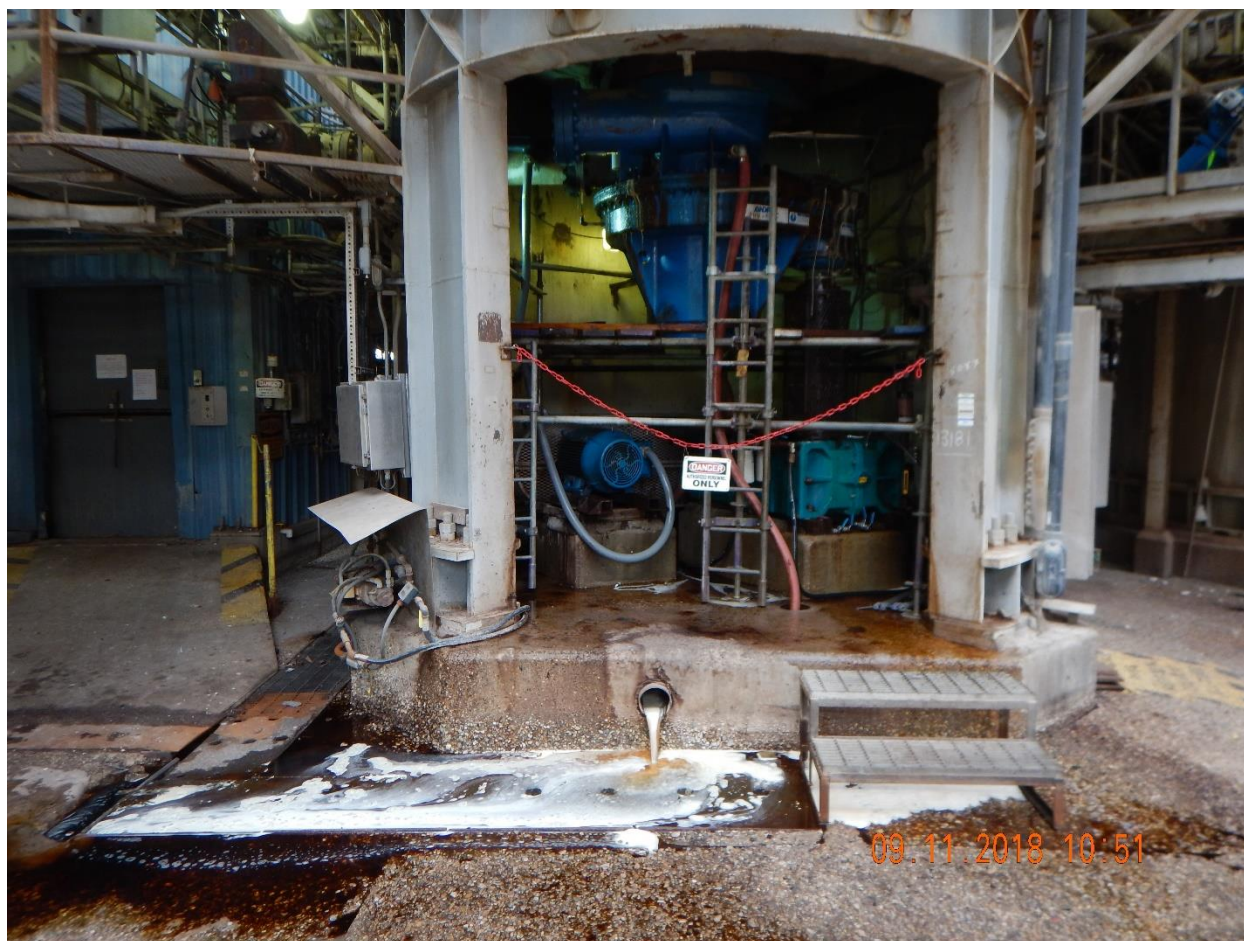
Photo No. 5

| Description: | Leak at bottom of K1 impregnation vessel |

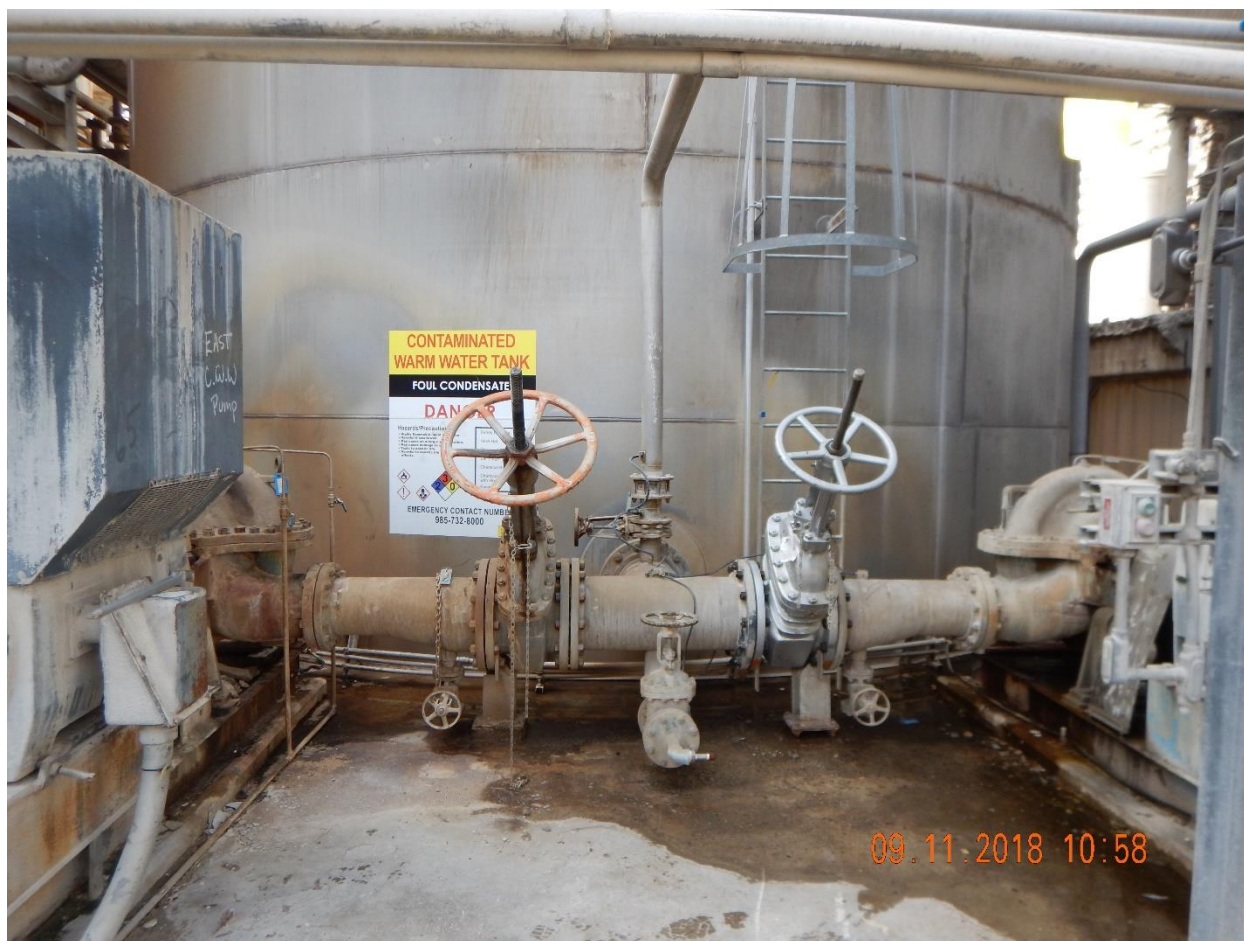
Photo No. 6

3) Contaminated Warm Water Tank and Controls: The IP Bogalusa Mill operates a contaminated warm water tank that operates as part of the condensate collection system; therefore, the requirements of 40 C.F.R. § 63.446(d)(2) may be applicable. Those requirements state that all openings on a condensate tank shall be maintained in a closed, sealed position. In addition, those requirements state that all openings must be free of detectable leaks as indicated by an instrument reading of less than 500 parts per million above background. The "gooseneck" vent not included in the site-specific LDAR plan, and no negative pressure tests have been performed.

| Description: | Tank identification for Contaminated Warm Water Tank – also labeled Foul Condensates |

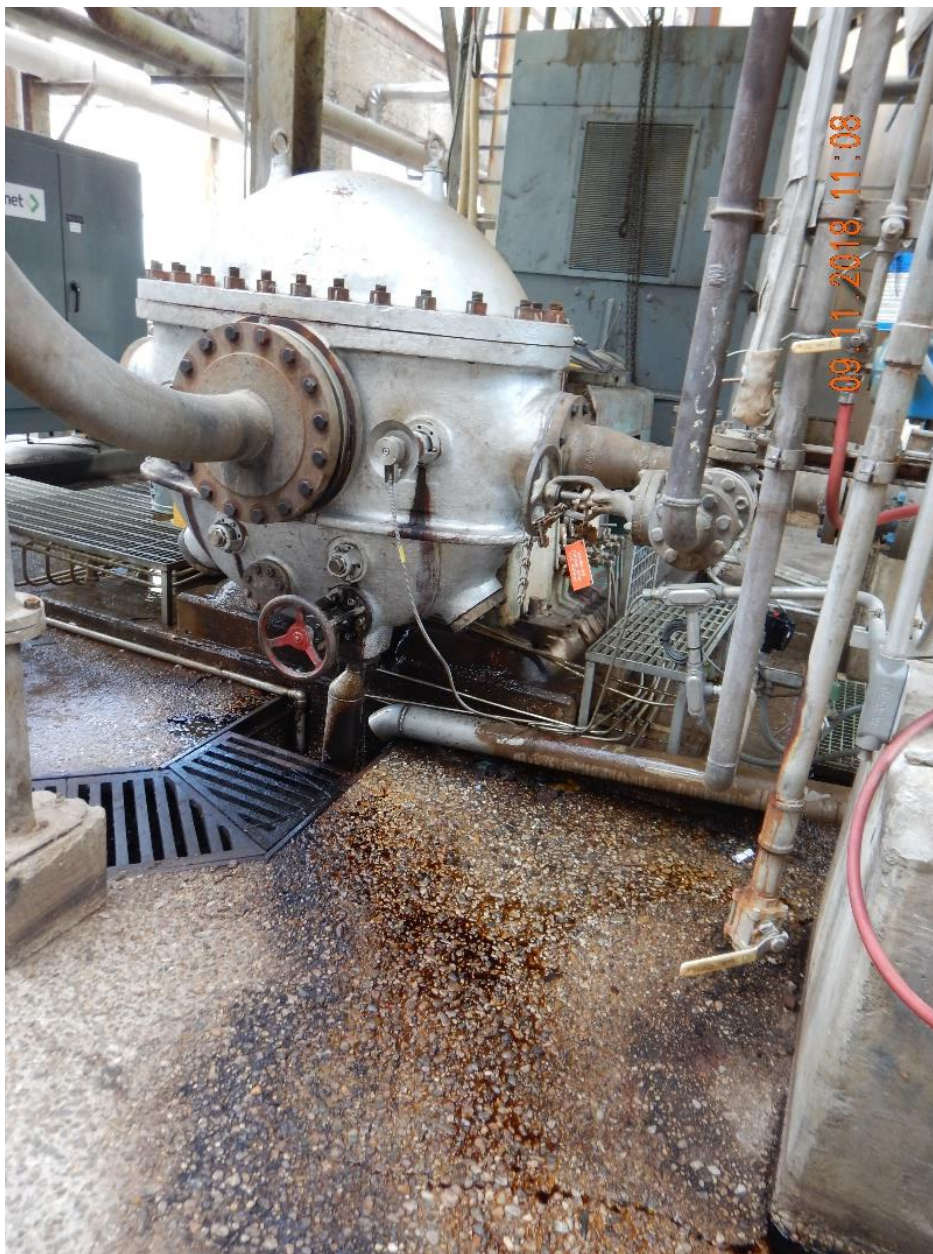
Photo No. 7

| Description: | Weak black liquor leak at head of blow line at K4 refiner |

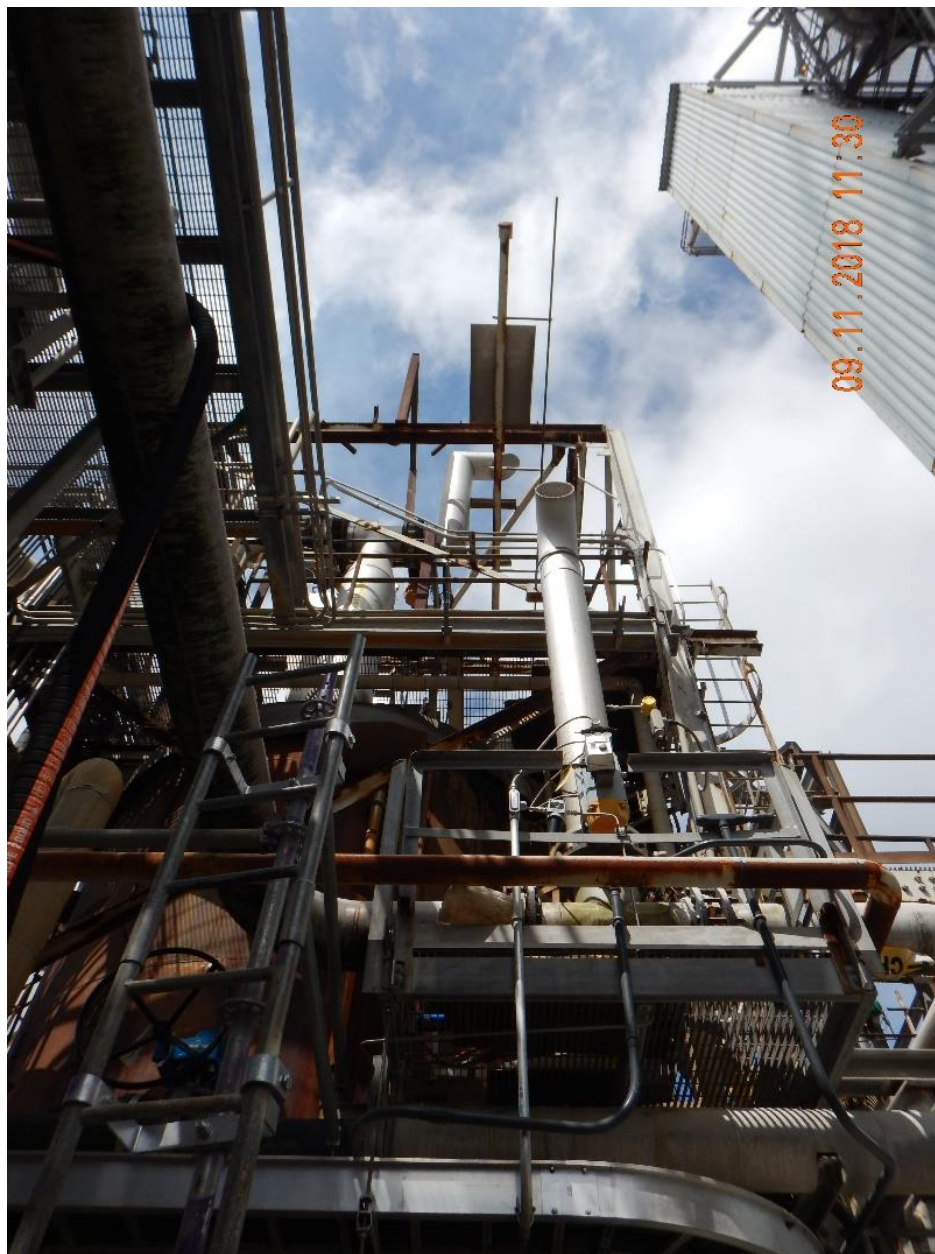
Photo No. 8

| Description: | Bypass of control device allowing LVHC gases to vent to atmosphere |

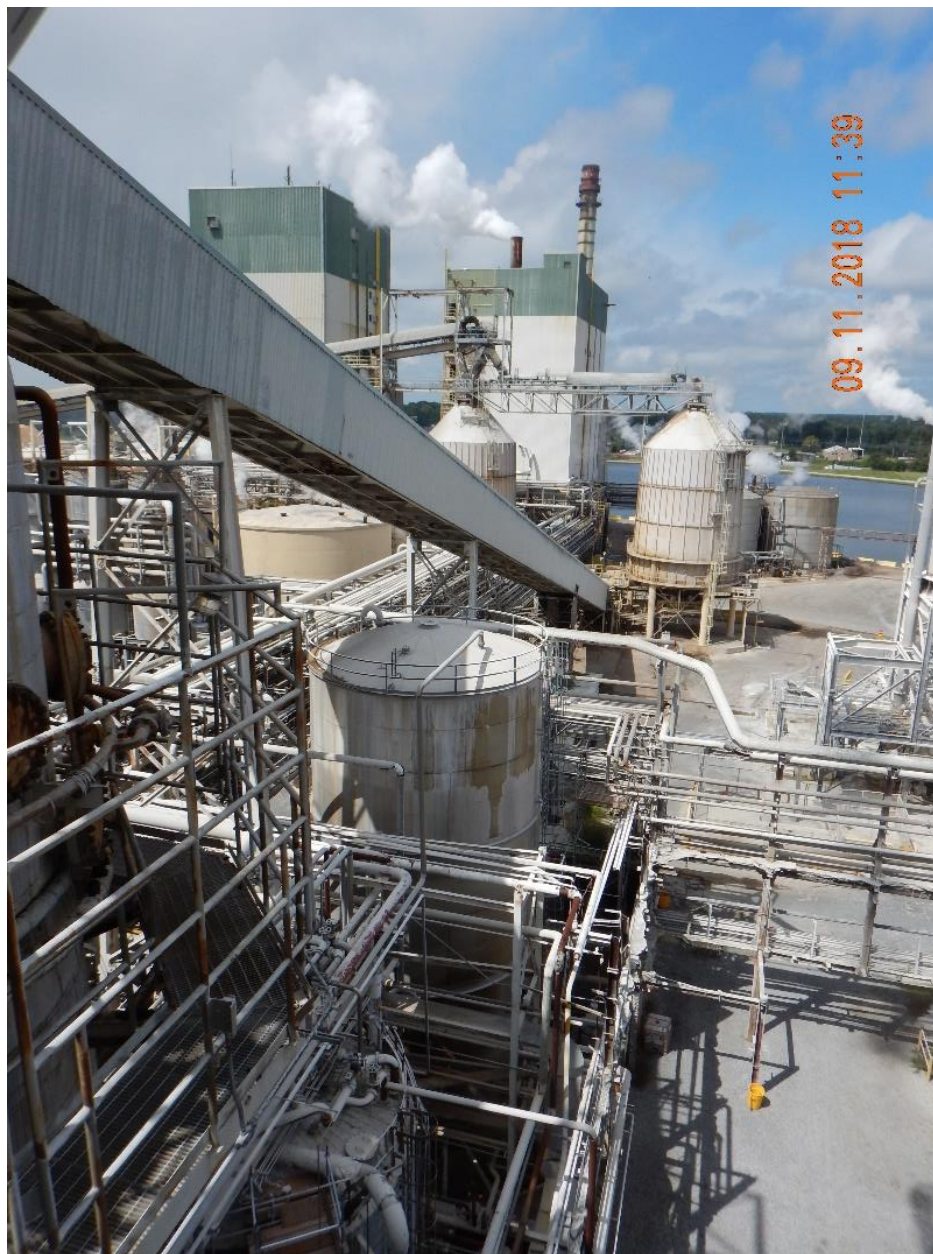
Photo No. 9

| Description: | Top of Contaminated Warm Water Tank at center showing "gooseneck" vent |

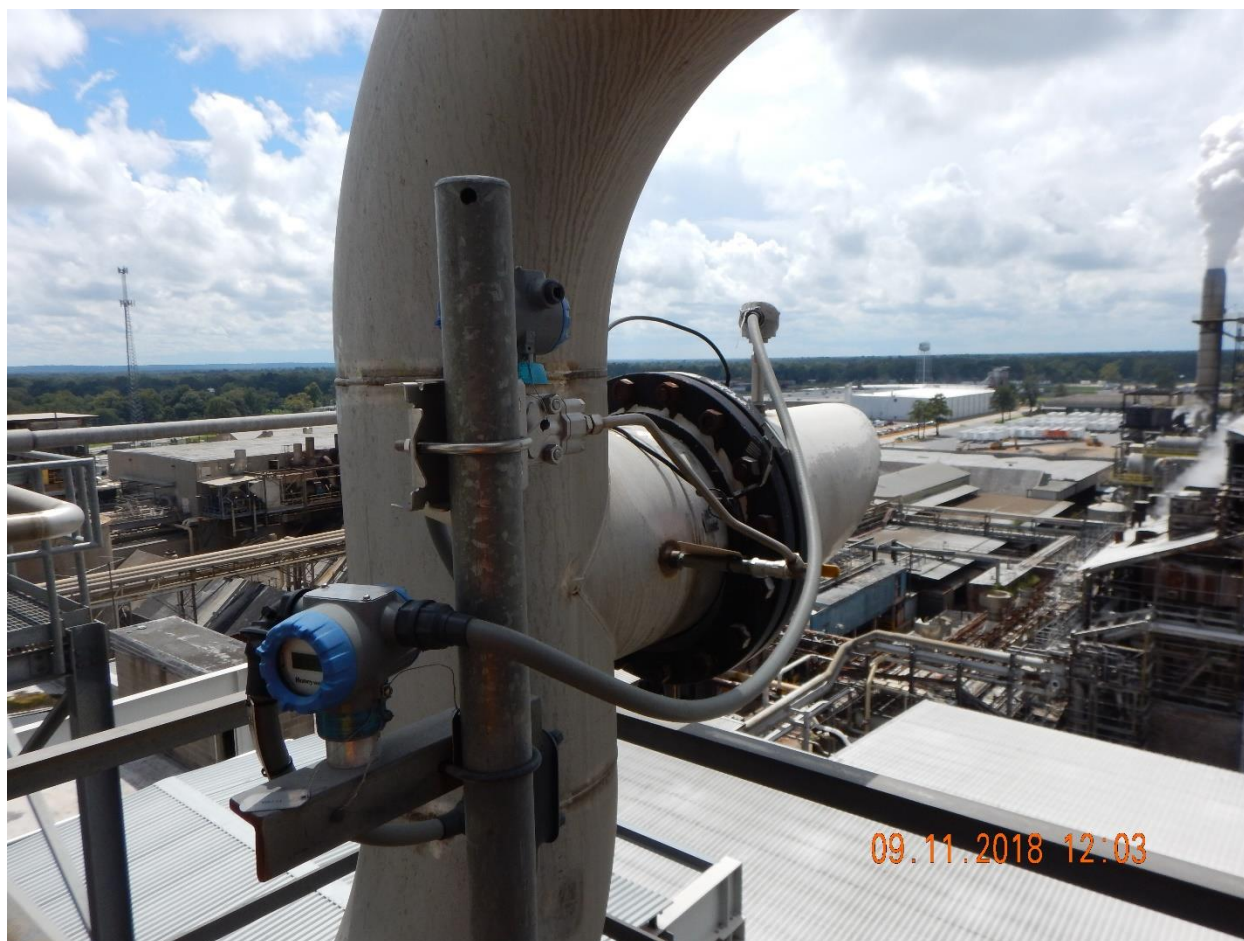
Photo No. 11

| Description: | Monitoring for temperature and pressure at rupture disk |

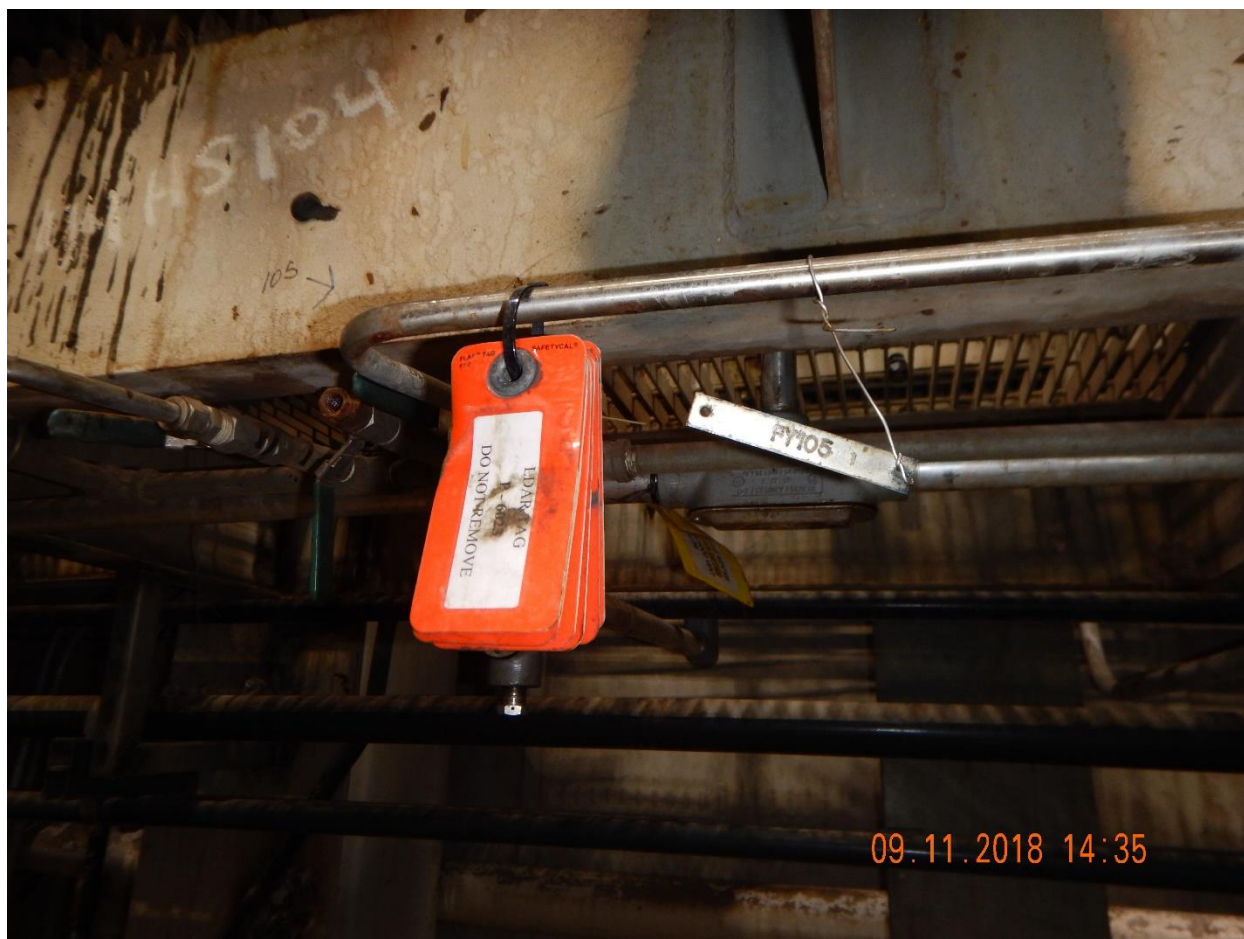
Photo No. 12

| Description: | Grouped LDAR tags in building near drum washers |

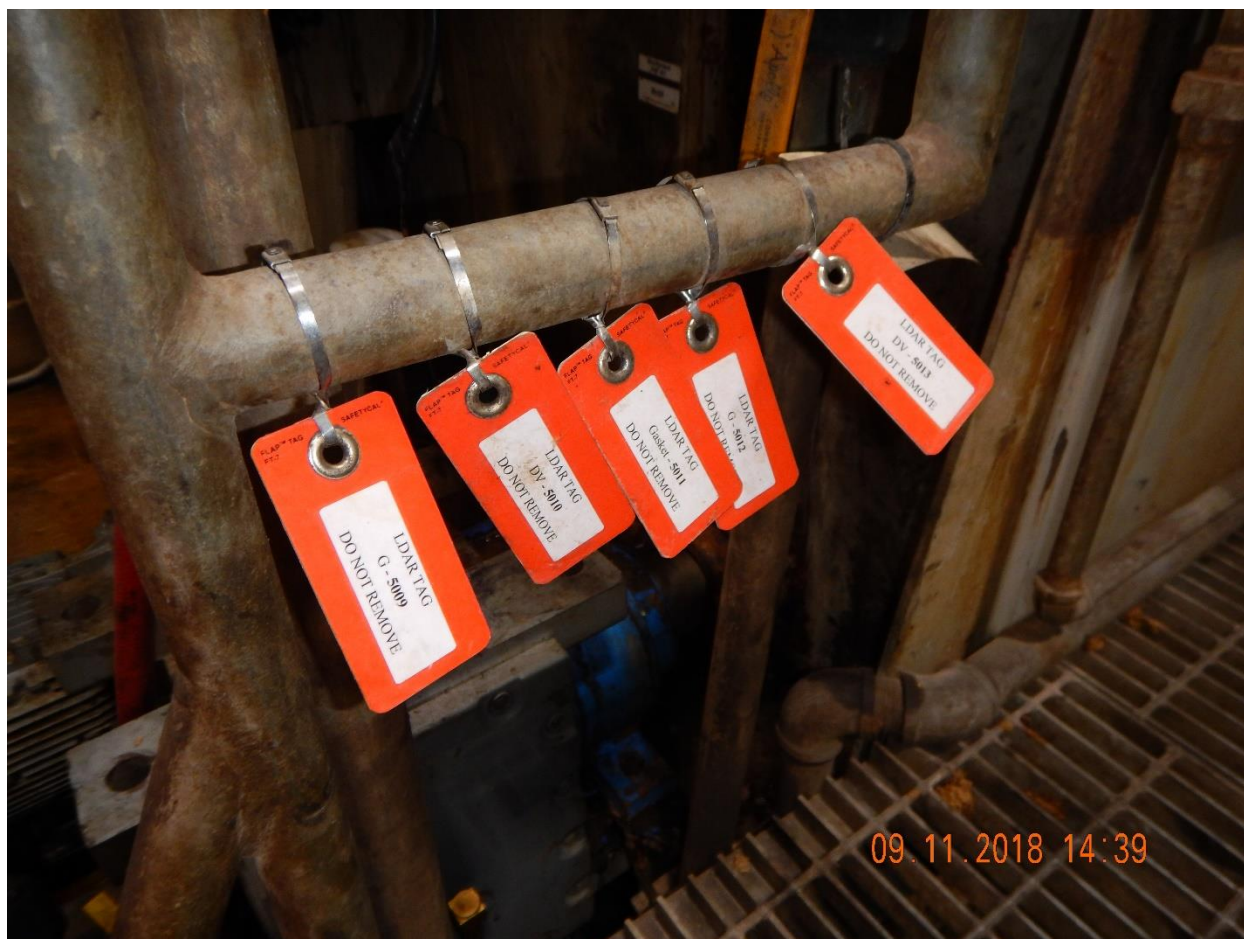
Photo No. 13

| Description: | Additional LDAR tags attached to railing in building near drum washers |

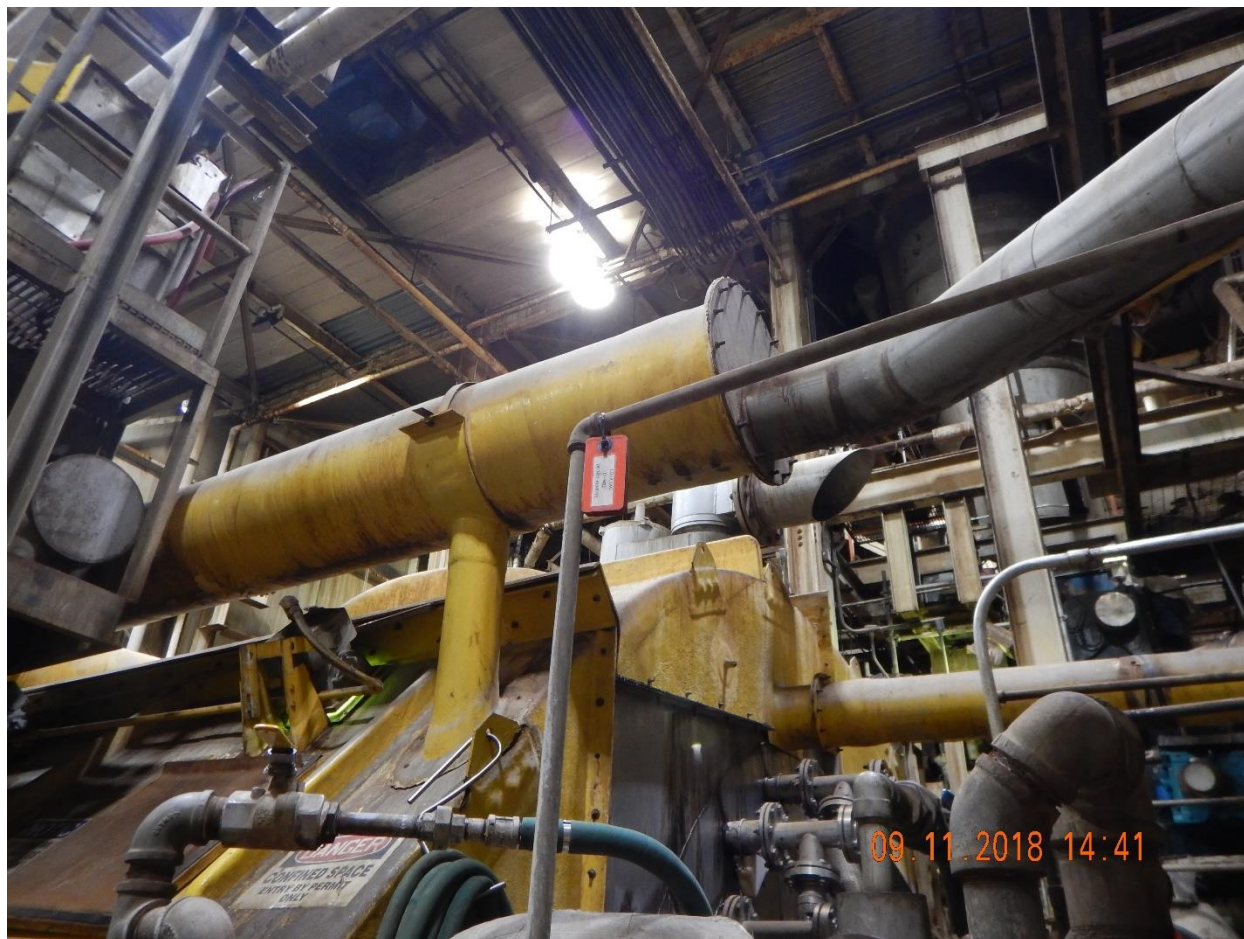
Photo No. 14

2) Leak Detection and Repair: The IP Bogalusa Mill has numerous inconsistencies between the site-specific LDAR monitoring plan and actual components that were discovered during the on-site inspection. Additionally, a missing car seal was also noted during the on-site inspection at LDAR Tag No. MV-11014E.

| Description: | Grouped LDAR tags attached to line in foreground; Previously monitored components in background of tags (no longer in LDAR plan) |

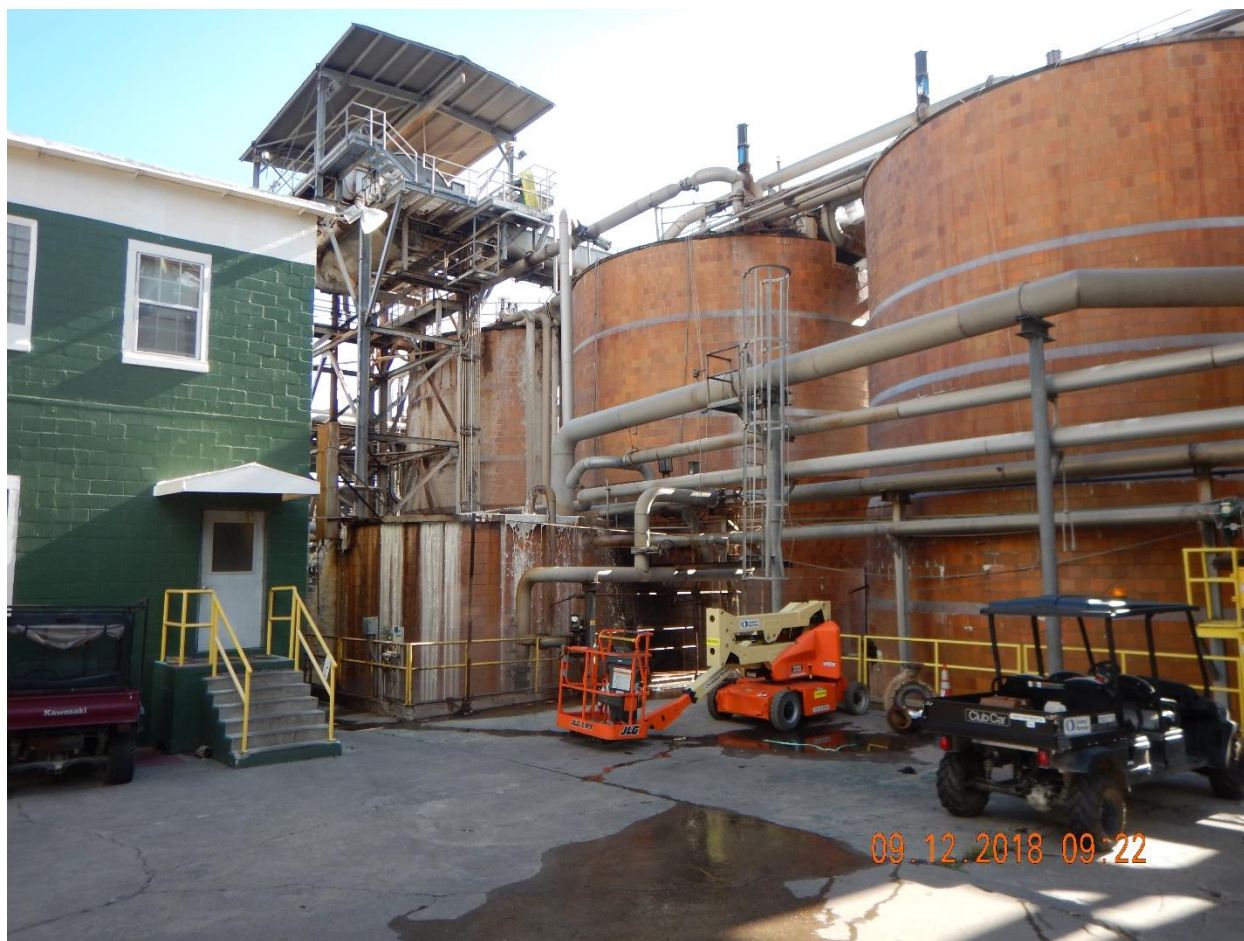
Photo No. 15

| Description: | White water tank overflowing |

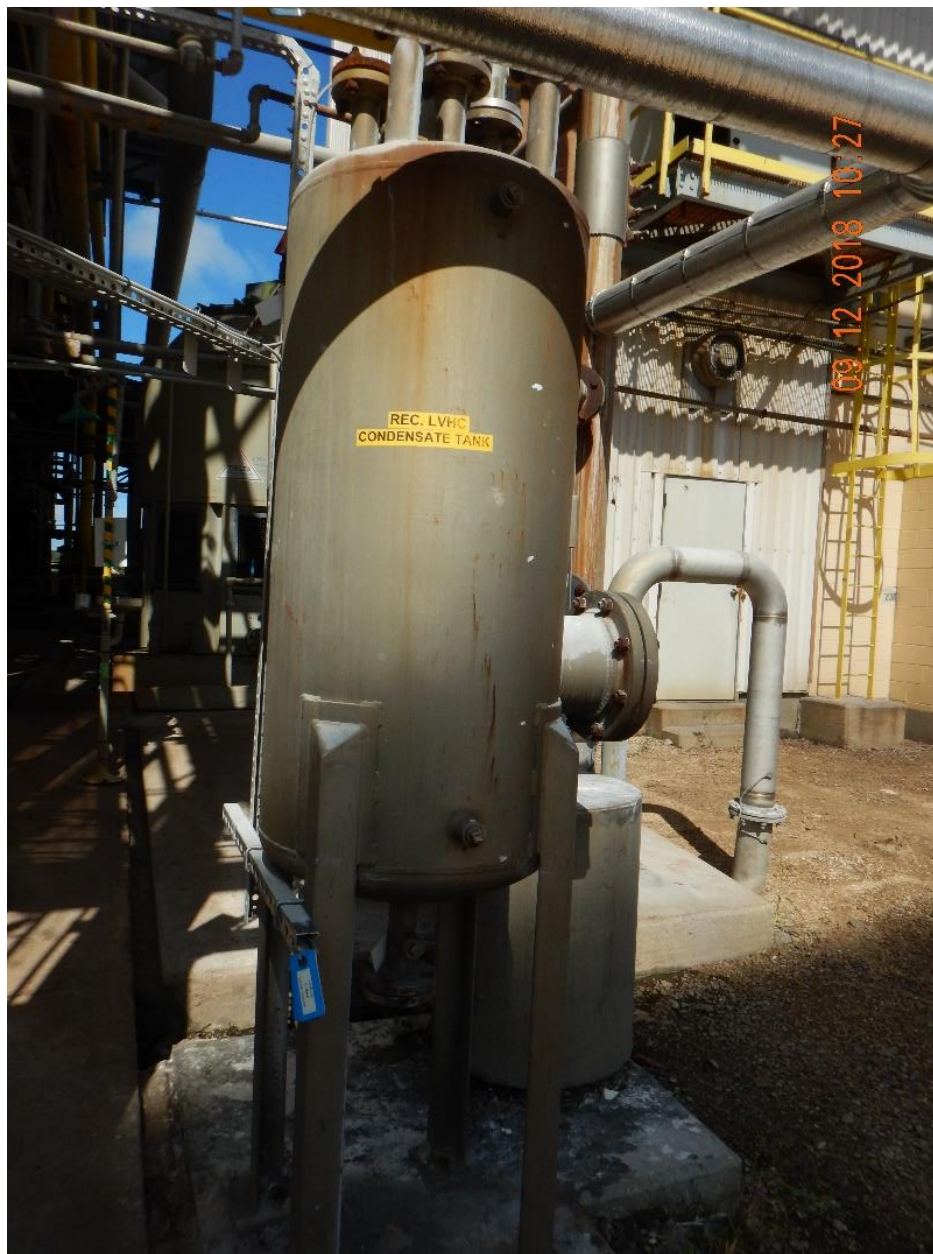
Photo No. 19

| Description: | LVHC condensate tank near recovery boilers with different color for LDAR tags |
