## Region 6 - Enforcement & Compliance Assurance Division

### INSPECTION REPORT

| <b>System Owner:</b> | City of Sherman | |
| <b>System Name:</b> | City of Sherman Public Water System (PWS) | |

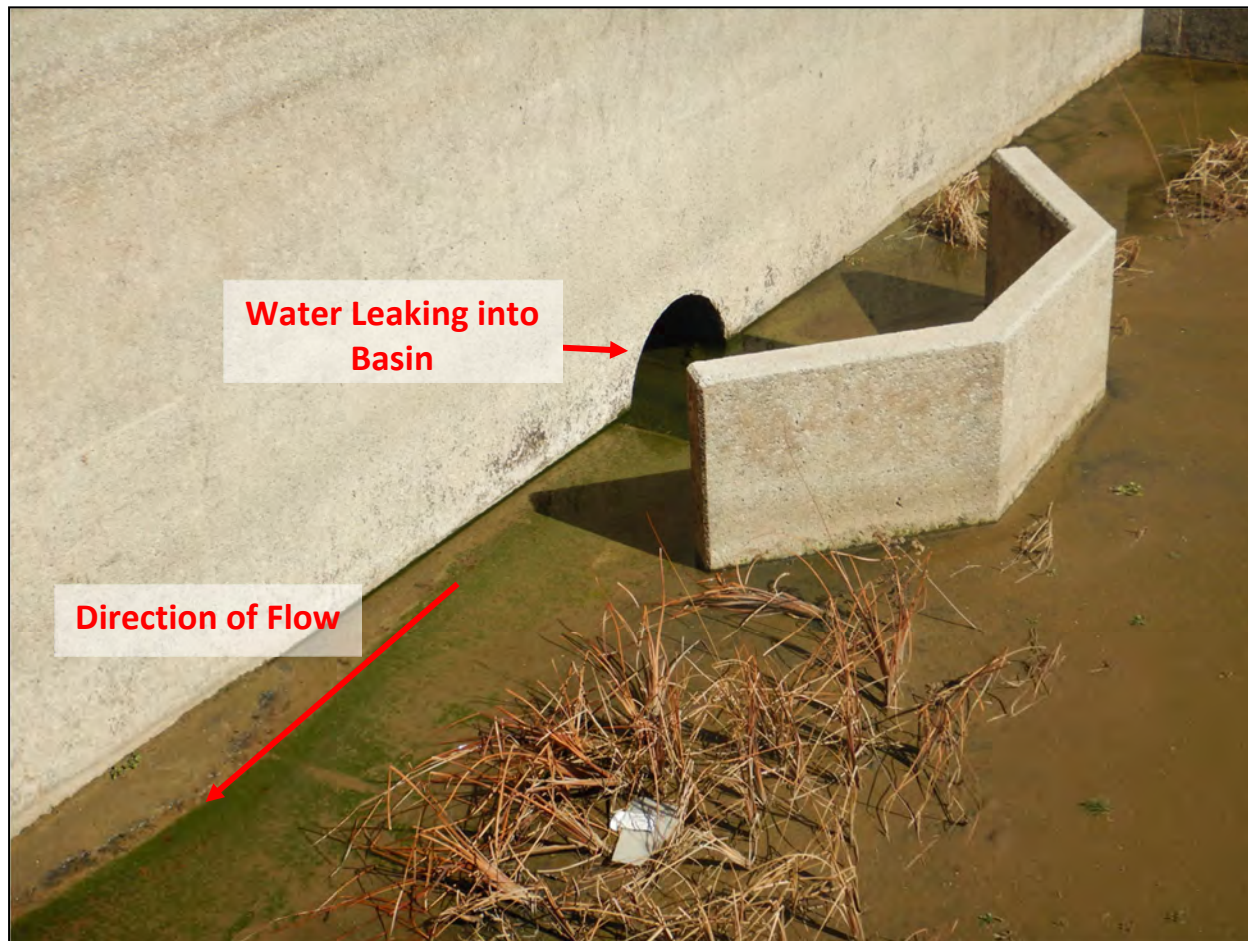
**Photograph 2. 2/13/2024 1:00 PM DSCN9217.JPG**

Following the raw water vault, the pre-sedimentation basin was observed. Water was observed to be leaking into the pre-sedimentation basin at an estimated rate of a few gallons per minute during the inspection, and System representatives suggested that the raw water valve might have been leaking or not completely closed (refer to [Appendix 1, Photograph 2](#)). The water was discharging through a partially open gate to the sanitary sewer (refer to [Appendix 1, Photograph 3](#)). It was unclear to the EPA Inspection Team how the sanitary sewer was connected to the basin or if there was a structure between the basin and the sanitary sewer. The potential for a cross-connection was not evaluated during the inspection. System representatives closed the raw water valve completely following the observation, and the leak stopped.

**Conventional Plant, Pre-Sedimentation Basin** View of water leaking into the influent end of the pre-sedimentation basin at the conventional plant at an estimated rate of a few gallons per minute. System representatives suggested that the raw water valve might have been leaking or not completely closed.

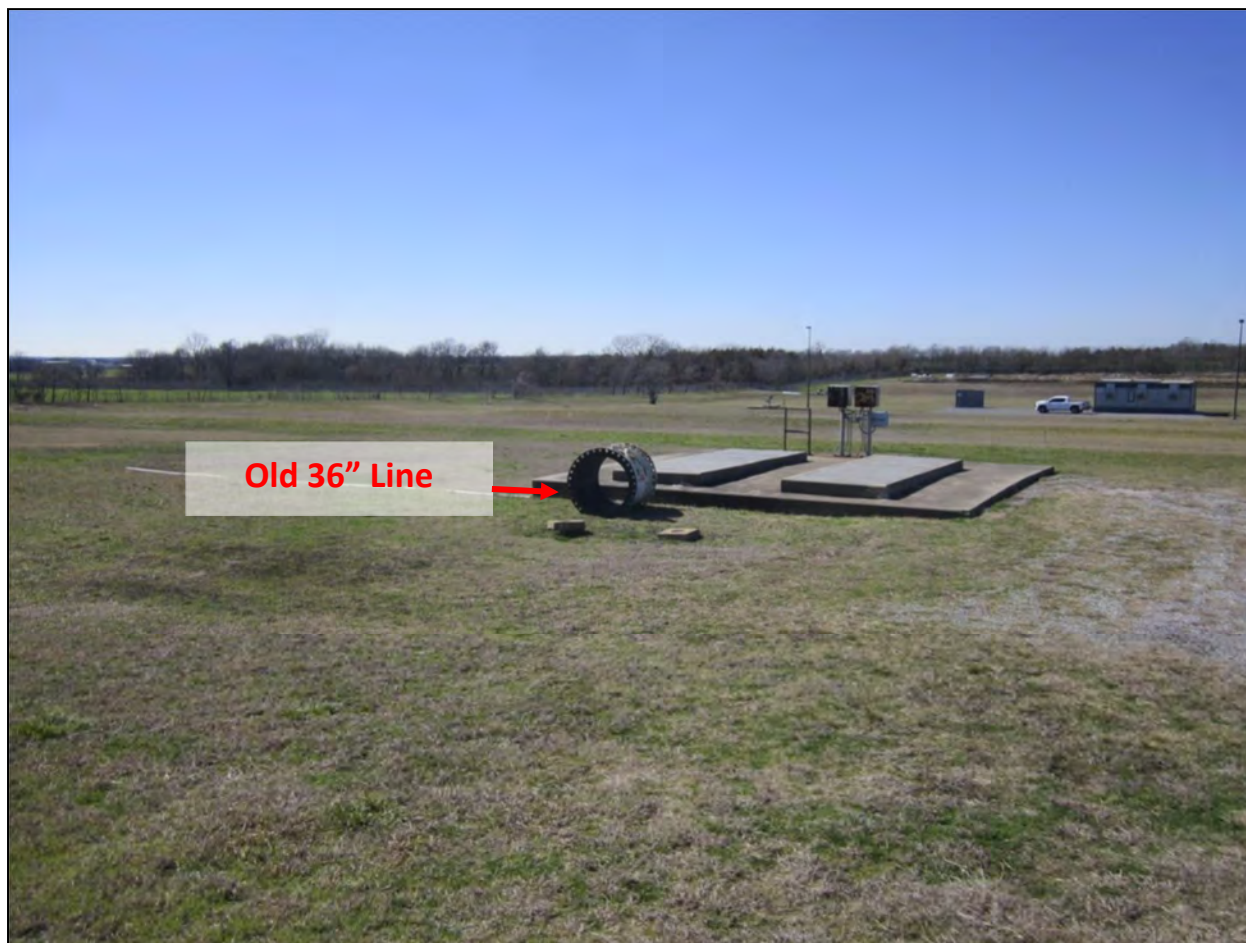
**Photograph 4. 2/13/2024 1:07 PM DSCN9222.JPG**

**Conventional Plant, In-Line Static Mixers** View of the vault containing the two, inline static mixer lines. There are two parallel lines, an 18-inch line and a 36-inch line. The System was in the process of replacing the 36-inch due to a structural failure caused by heavy corrosion. A removed section of the 36-inch line was next to the vault. System representatives stated that during normal operation, HCl is injected immediately upstream of the mixers.

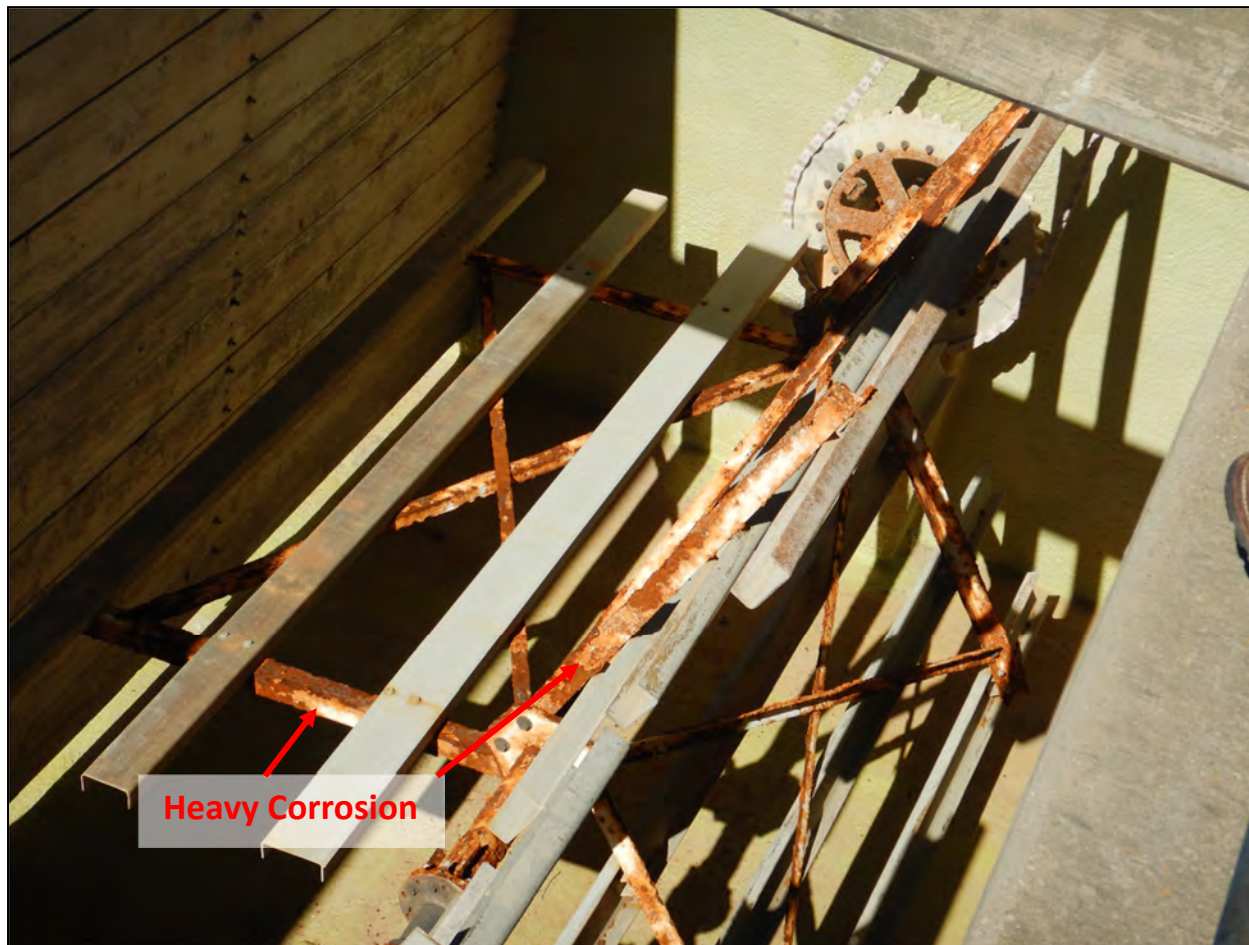
**Photograph 5. 2/13/2024 1:16 PM DSCN9229.JPG**

**Conventional Plant, Flocculation Basins** View inside one of the flocculation basins. The interior metal components were corroded. System representatives indicated that the components would be replaced before the conventional plant was put back online.

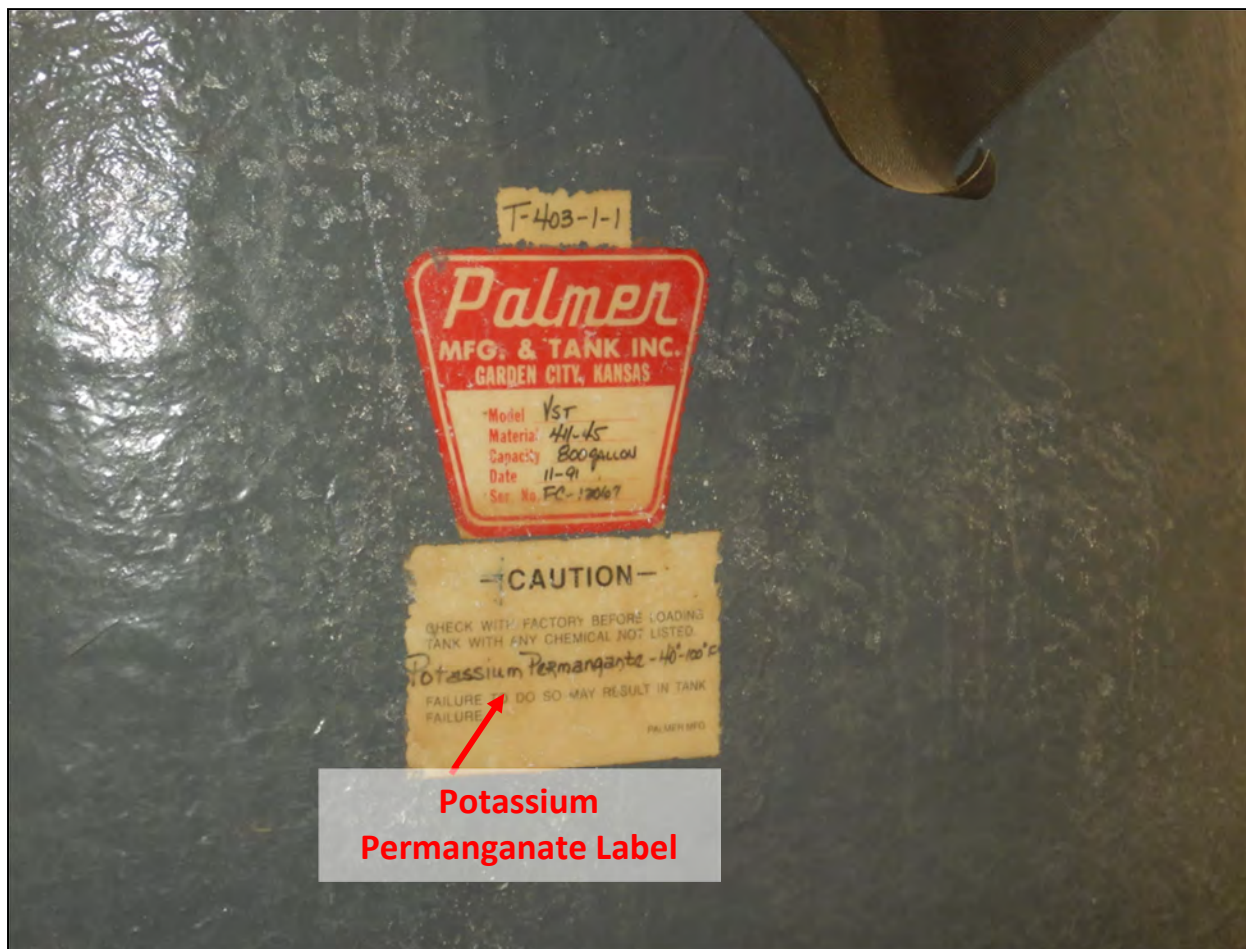
Photograph 11. 2/13/2024 2:29 PM DSCN9284.JPG

**Conventional Plant, Chemical Storage Room** View of one of the two labels on the two copper sulfate day tanks. The labels both said potassium permanganate even though potassium permanganate was no longer used in the treatment process.

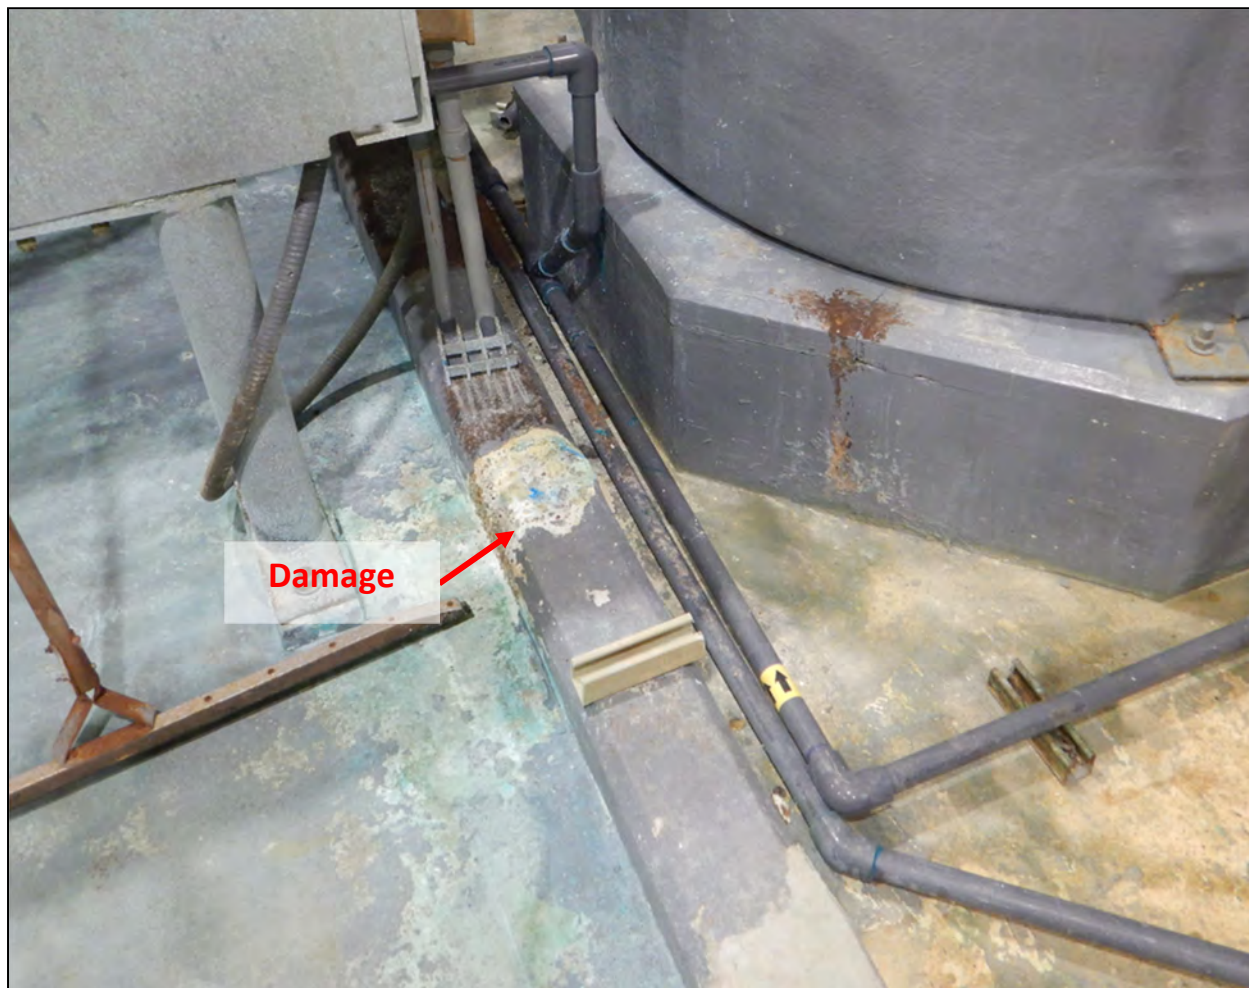
**Photograph 12. 2/13/2024 2:22 PM DSCN9280.JPG**

**Conventional Plant, Chemical Storage Room** View of the secondary containment wall surrounding the two copper sulfate day tanks. The wall was damaged in one location. When this observation was made to System representatives, the wall was repaired (refer to [Appendix 4, Follow-Up Material](#)).

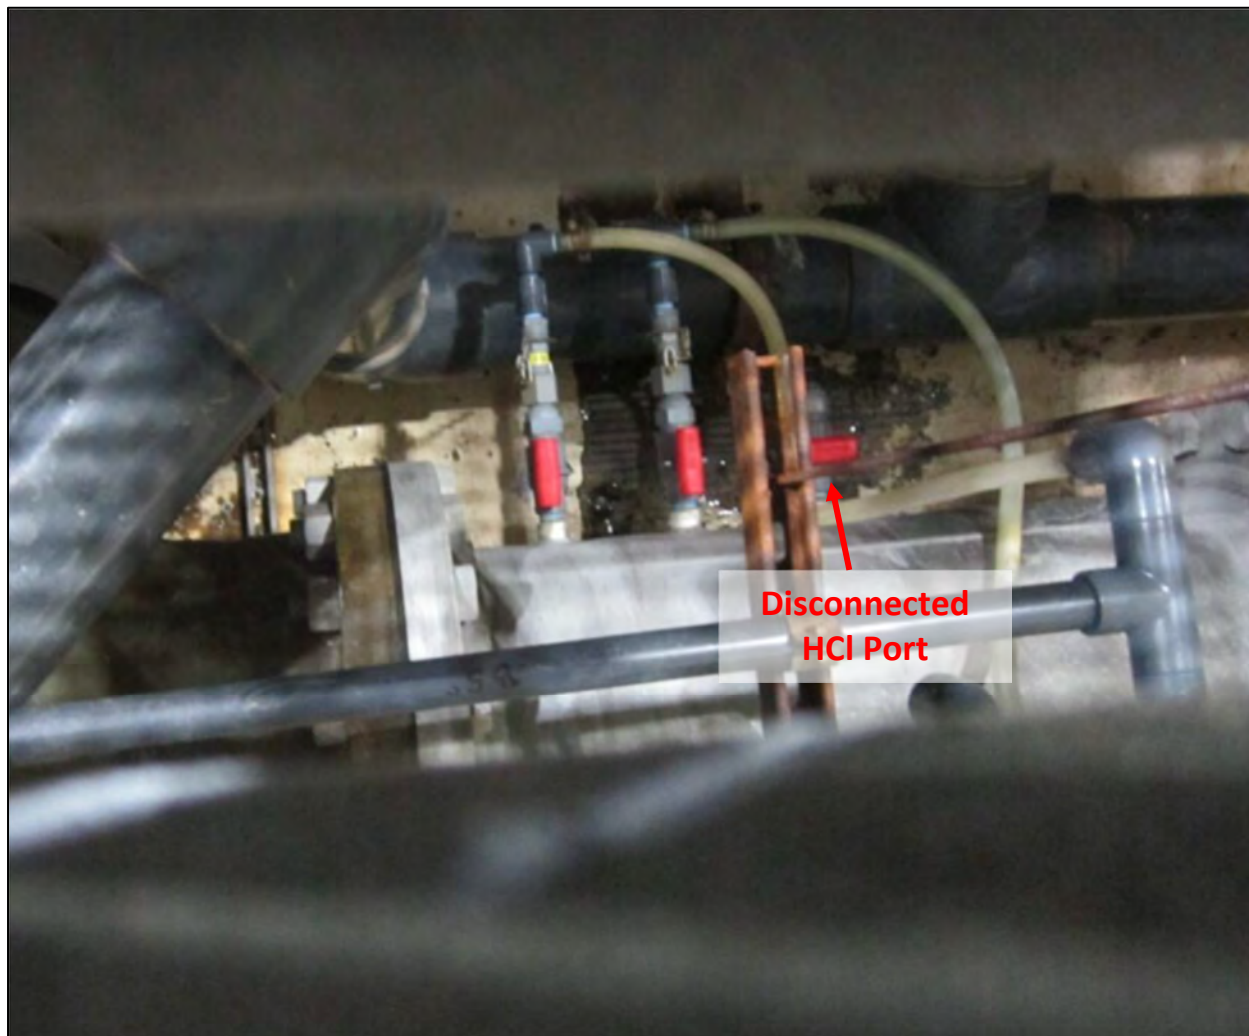
**Photograph 17. 2/13/2024 3:25 PM IMG\_0094.JPG**

**Membrane (UF/RO) Plant, RO Supply Line** View of the three unlabeled chemical injection ports into the RO supply line that feeds UF permeate to the RO units. The line to the HCl port had failed and was disconnected. The line was in the process of being replaced.

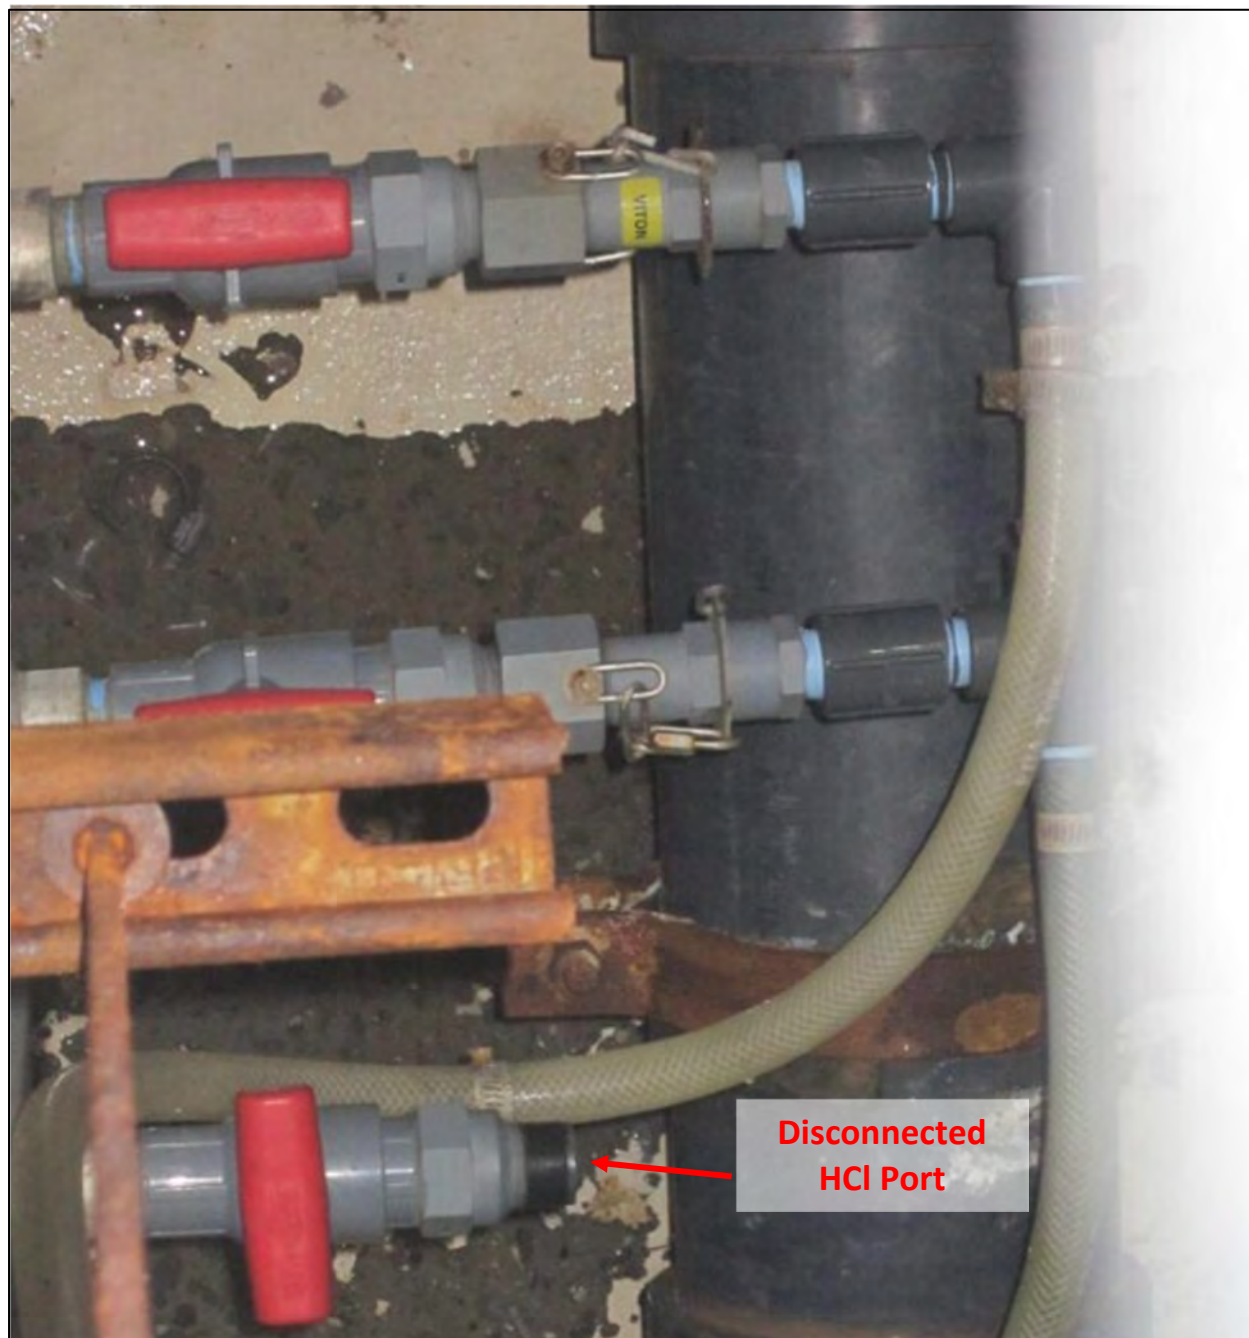
Photograph 18. 2/13/2024 3:25 PM IMG\_0095.JPG

**Membrane (UF/RO) Plant, RO Supply Line** Additional view of the three unlabeled chemical injection ports and the disconnected HCl line.

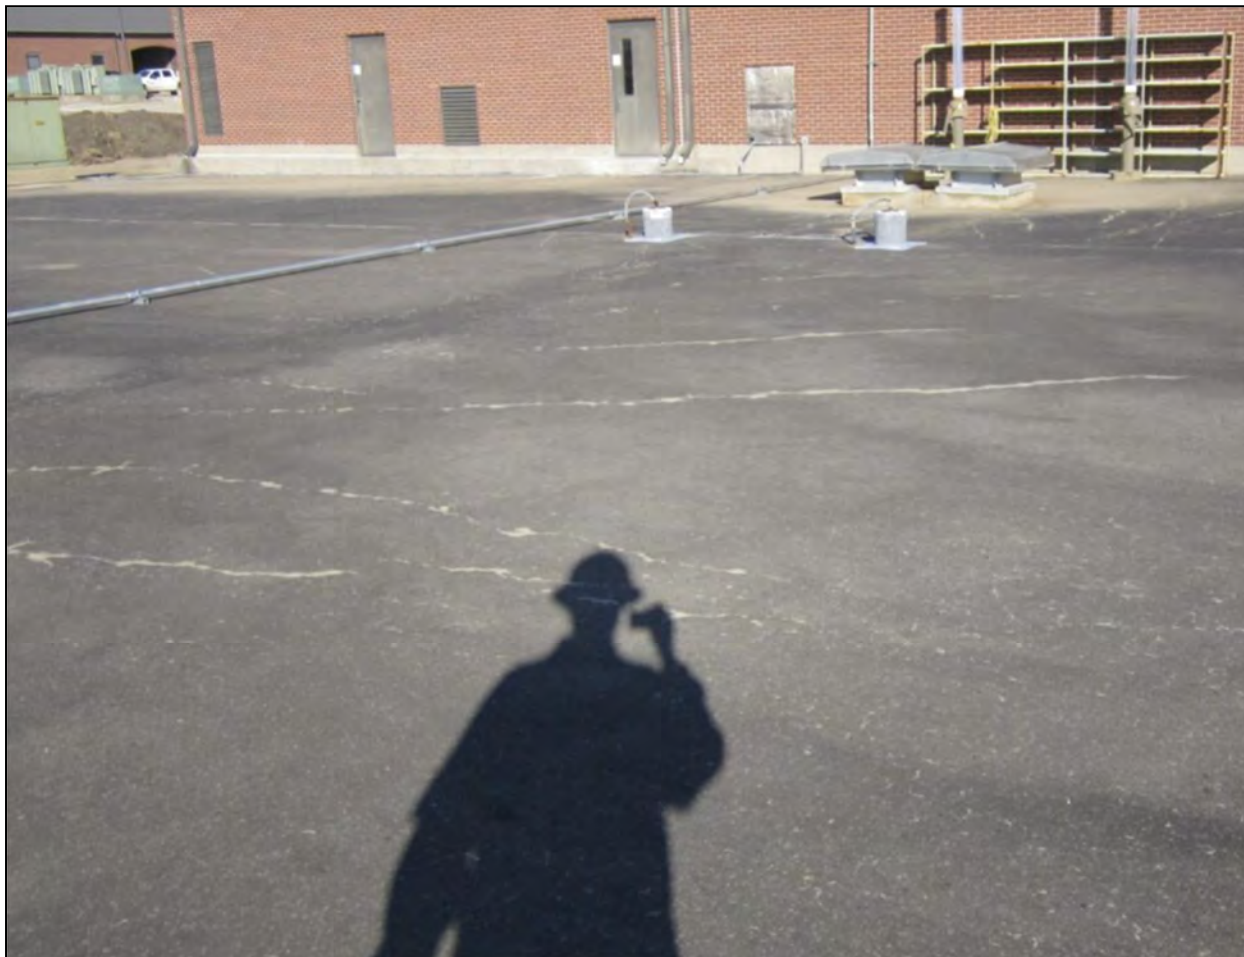
**Photograph 22. 2/13/2024 4:09 PM IMG\_0124.JPG**

**North and South Clearwells** View of cracks on the surface of the clearwells that appeared to have been repaired.

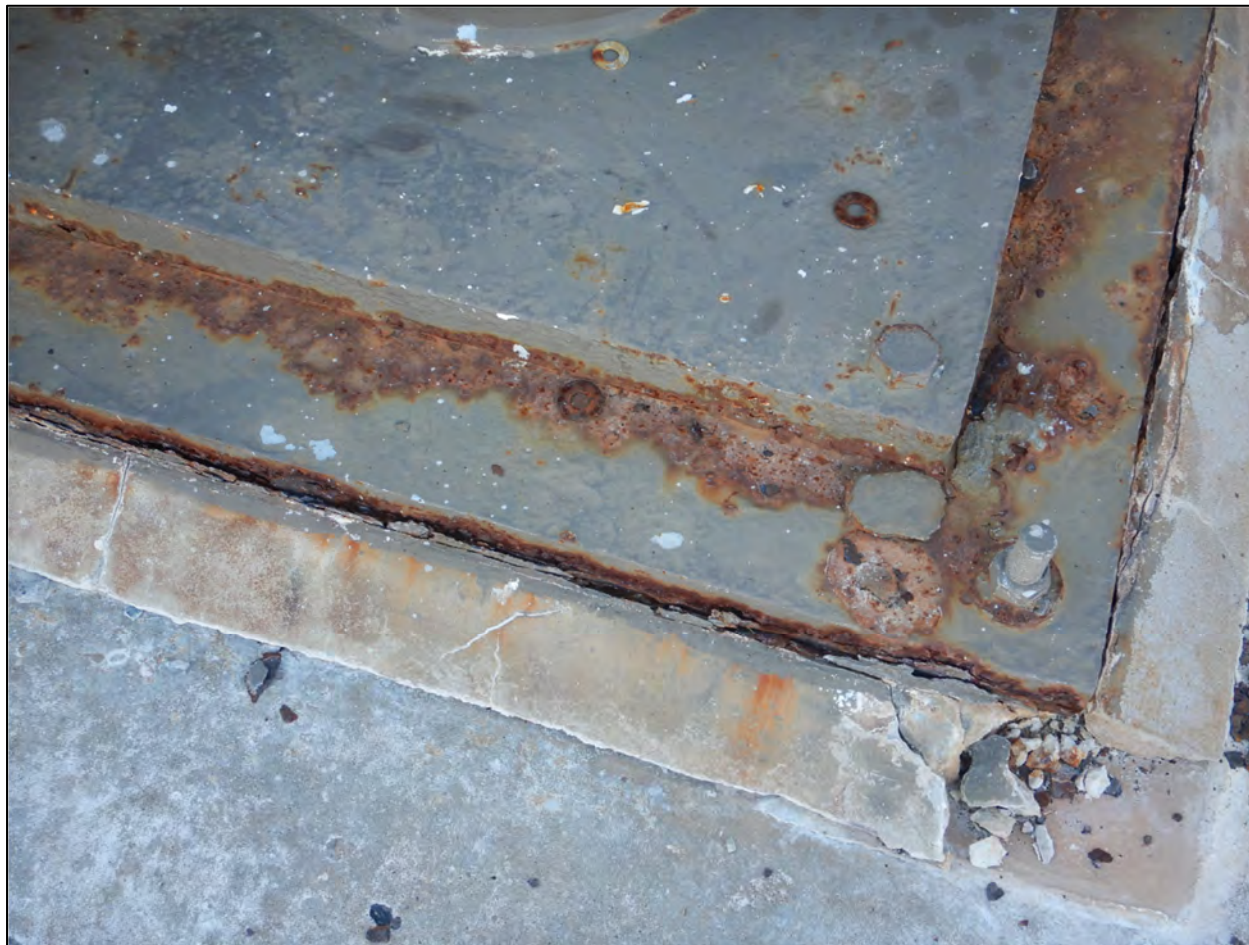
**Photograph 28. 2/13/2024 4:11 PM DSCN9359.JPG**

**High Service Pump Station** Close-up view of one of the metal bases of the high service pump motors. The bases were heavily corroded, and there were cracks between the metal base and the concrete seals; it was unclear to the EPA Inspection Team if there was a potential for contaminants to enter the finished water supply at this location.

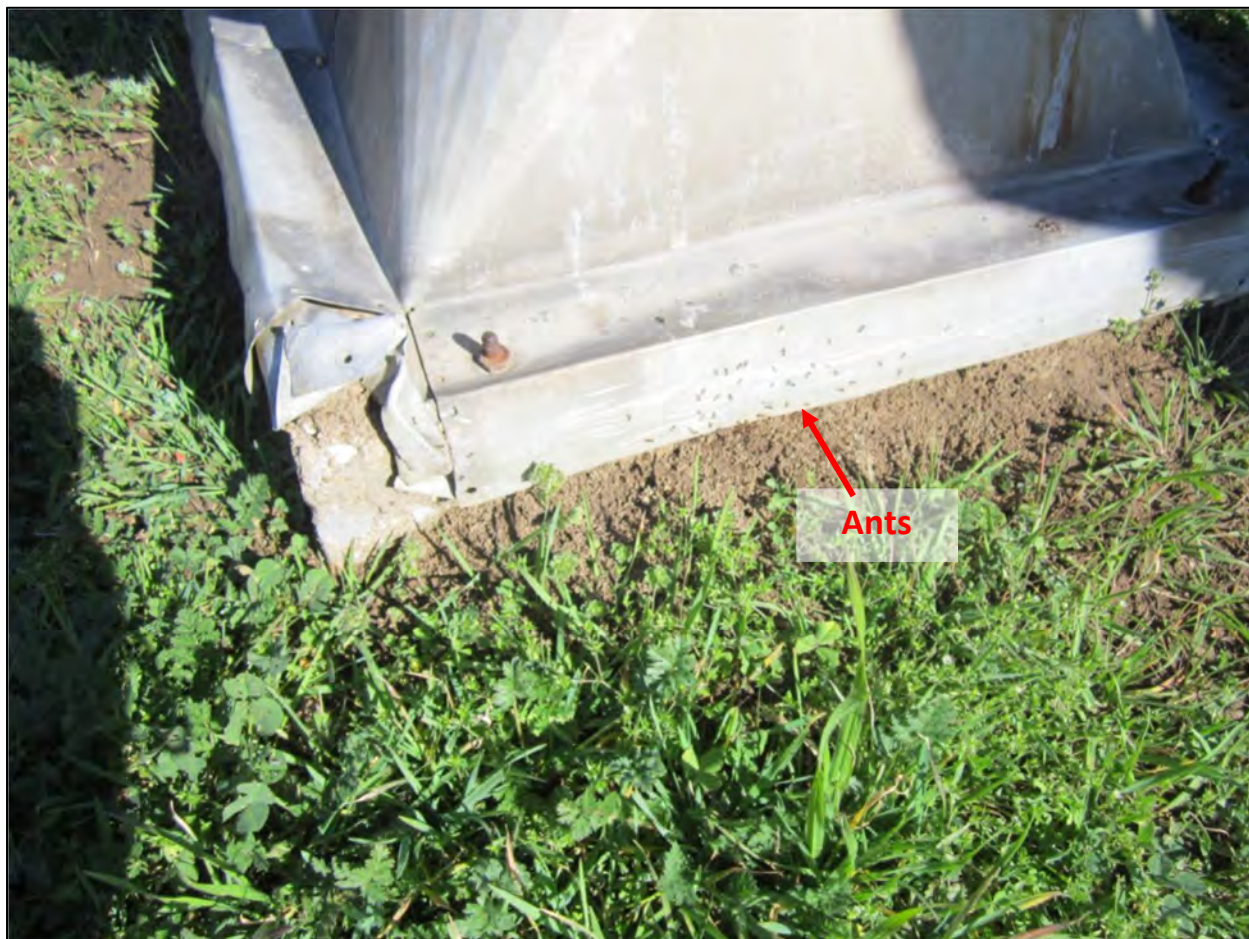
**Photograph 34. 2/14/2024 10:50 AM IMG\_0017.JPG**

**Fairview Tank** Additional view of the base of one of the vents on top of the Fairview Tank. Dirt had accumulated beneath the metal, and ants were observed crawling under the metal.

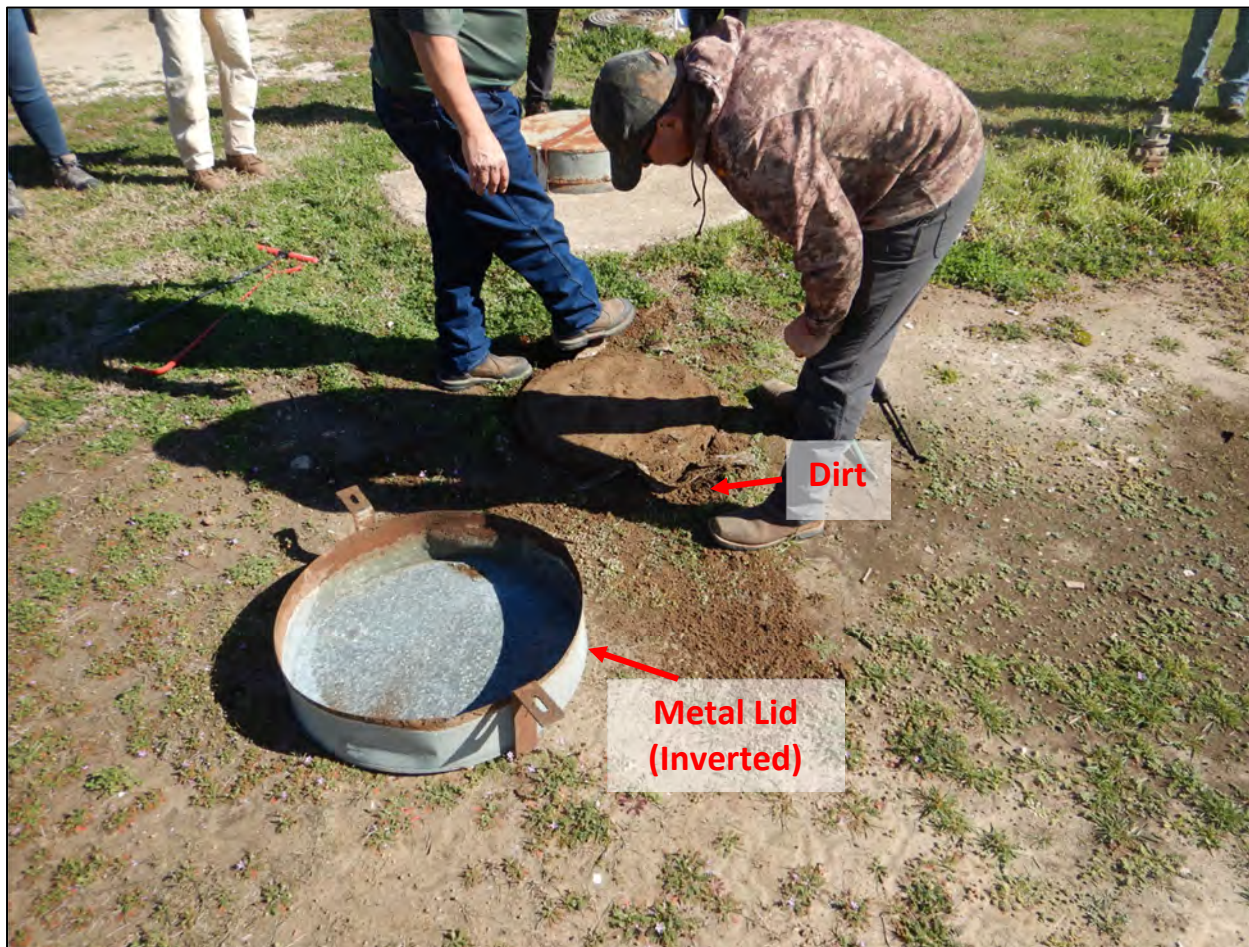
**Photograph 36. 2/14/2024 11:01 AM DSCN9426.JPG**

**Fairview Tank** View of one of the manhole structures that was covered in dirt. Also visible in this image is one of the metal lids that were covering the manhole structures. The lids lacked sealed gaskets. Ants were observed crawling under the lids.

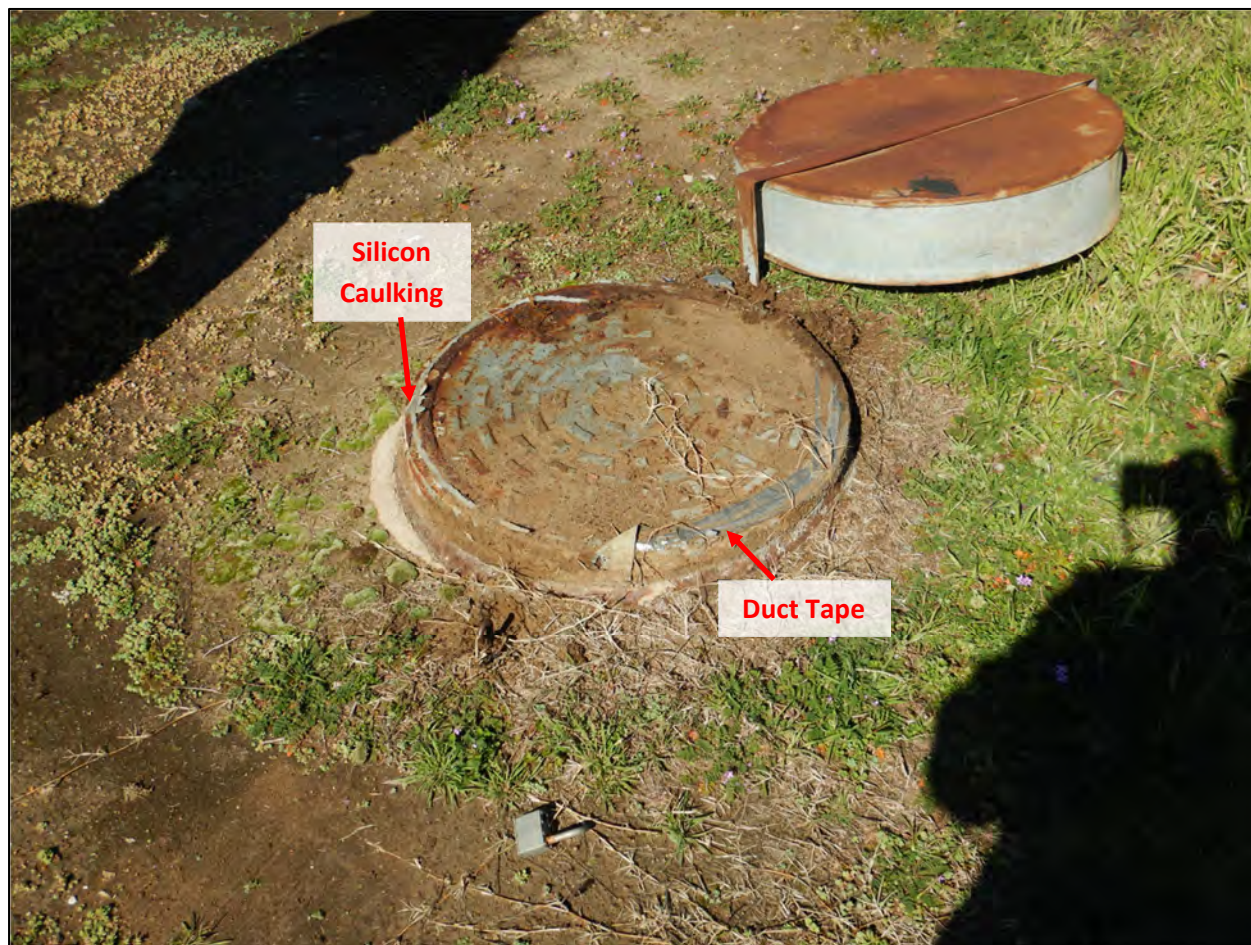
**Photograph 37. 2/14/2024 11:03 AM DSCN9429.JPG**

**Fairview Tank** View of one of the manholes that provided access to the interior of the Fairview Tank. A silicon caulking had been used around the rim of the manhole covers, but it was deteriorated in some places. Duct tape was also used in some areas around the manhole crown but was peeling off during the inspection.

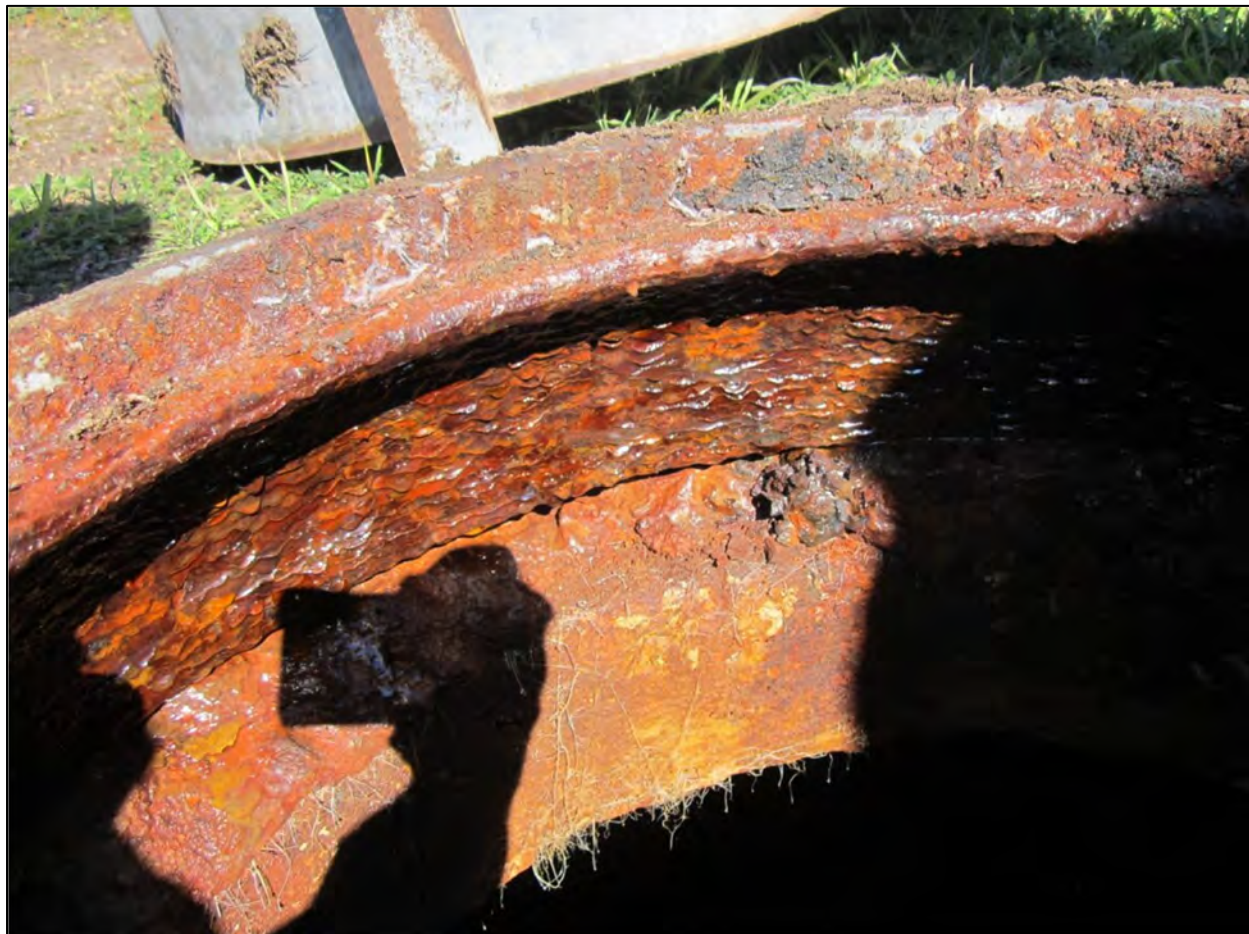
**Photograph 38. 2/14/2024 11:19 AM IMG\_0037.JPG**

**Fairview Tank** View inside of one of the manholes at the Fairview Tank. Corrosion, moisture, and roots were observed on the interior surface of the manhole structures.

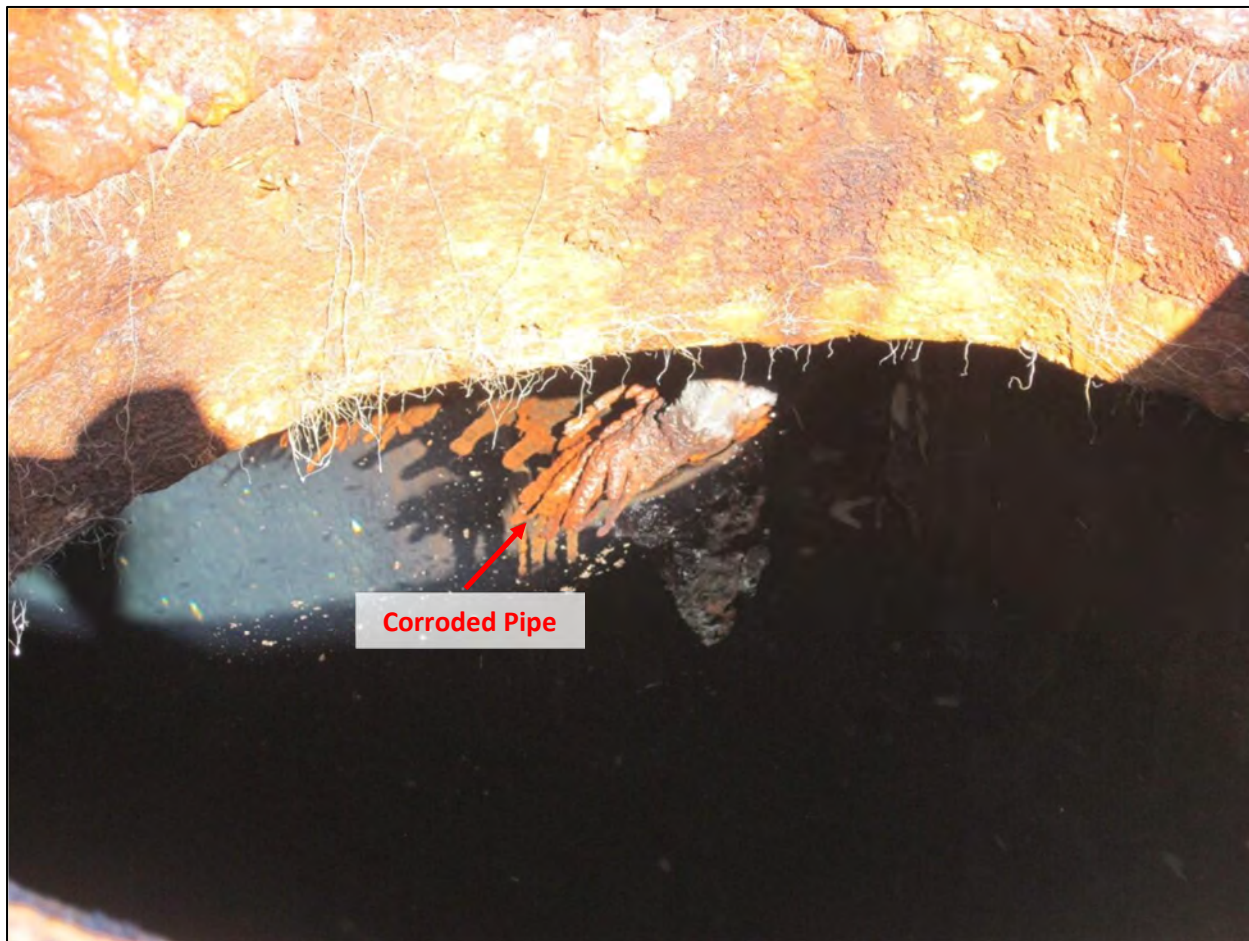
**Photograph 41. 2/14/2024 11:19 AM IMG\_0044.JPG**

The EPA Inspection Team observed a heavily corroded pipe inside the tank that was visible from one of the manhole structures (refer to [Appendix 1, Photograph 41](#)). Operators indicated that the metal pipe was the end of an old line that extended from a small surge tank that used to be fed by a groundwater well that was no longer present at the site. The pipe did not appear to be plugged, leaving an open pipe into the tank. Therefore, there is potential for contaminants to enter through the pipe from the old surge tank. There was also a void surrounding the pipe and it was unclear if the void was from the pipe settling or if there was a failure in the tank wall (refer to [Appendix 1, Photograph 42](#)). There was a metal cap covering a cylindrical concrete structure next to the manhole from which the corroded metal pipe was observed. System representatives were unsure what this asset was (refer to [Appendix 1, Photograph 43](#)).

**Fairview Tank** View of a heavily corroded metal pipe inside of the Fairview Tank that was visible from inside one the manholes. Operators indicated that the metal pipe was the end of an old line that extended from a small surge tank that used to be fed by a groundwater well that was no longer present at the site. The pipe did not appear to be plugged, leaving an open pipe into the tank.

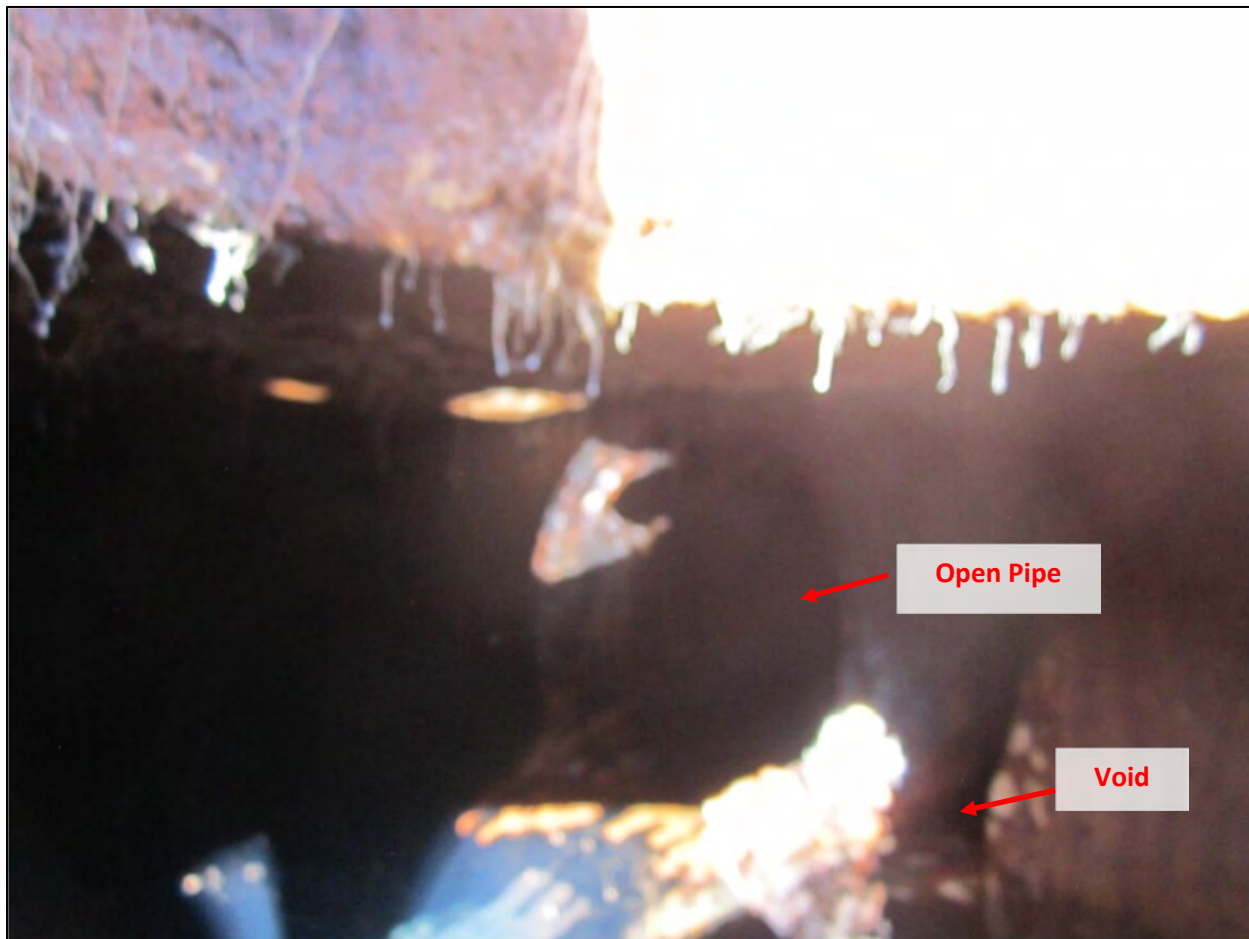
**Photograph 42. 2/14/2024 11:19 AM IMG\_0043.JPG**

**Fairview Tank** View of a void in the tank wall next to the corroded metal pipe. It was unclear if the void was a wall failure or situation where the historic pipe settled, creating the void. The void provided direct access to the finished water supply.

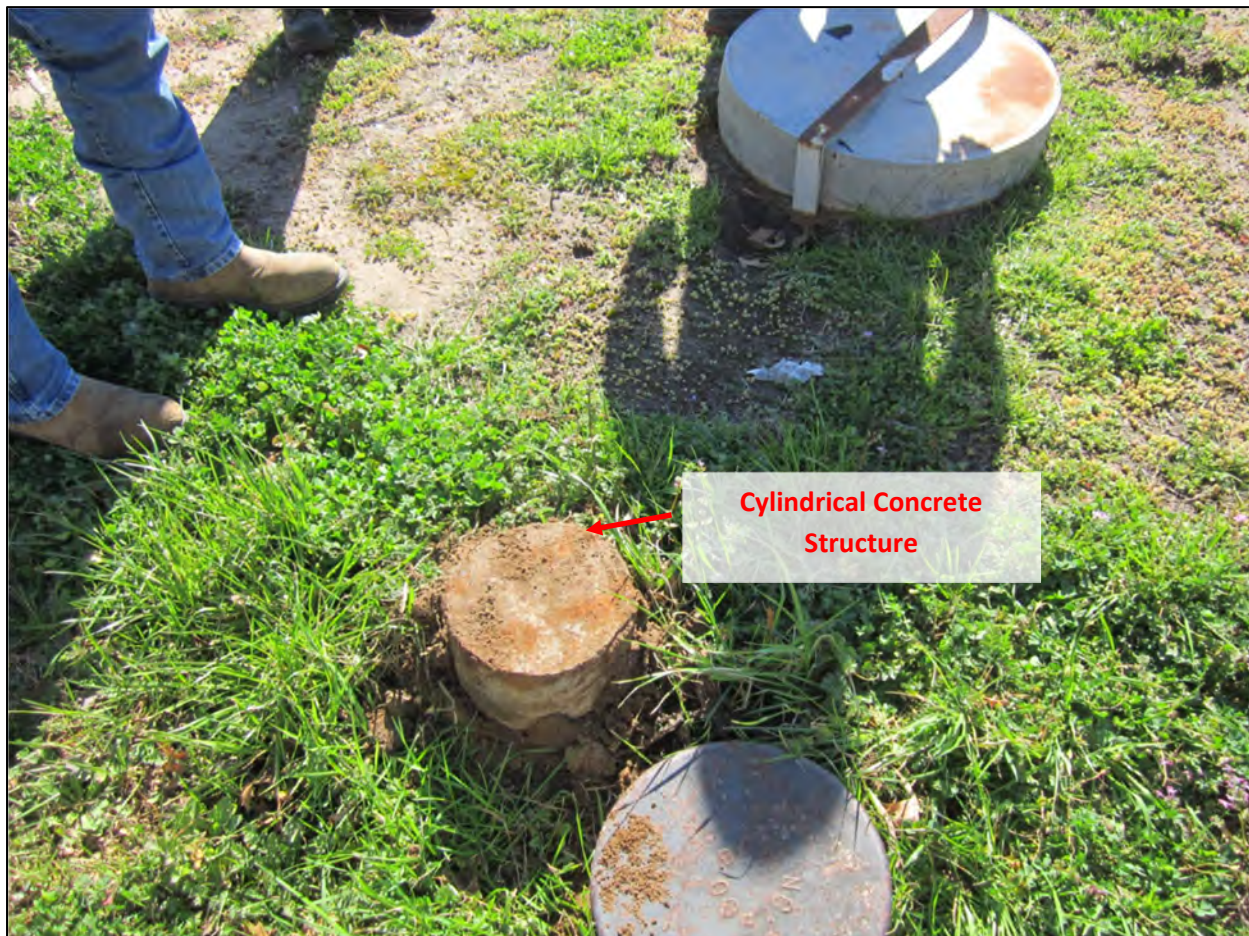
**Photograph 43. 2/14/2024 11:03 AM IMG\_0028.JPG**

**Fairview Tank** View of an unknown cylindrical concrete structure that is covered by a metal cap. The structure was positioned near the manhole at the Fairview Tank that contained the heavily corroded metal pipe.

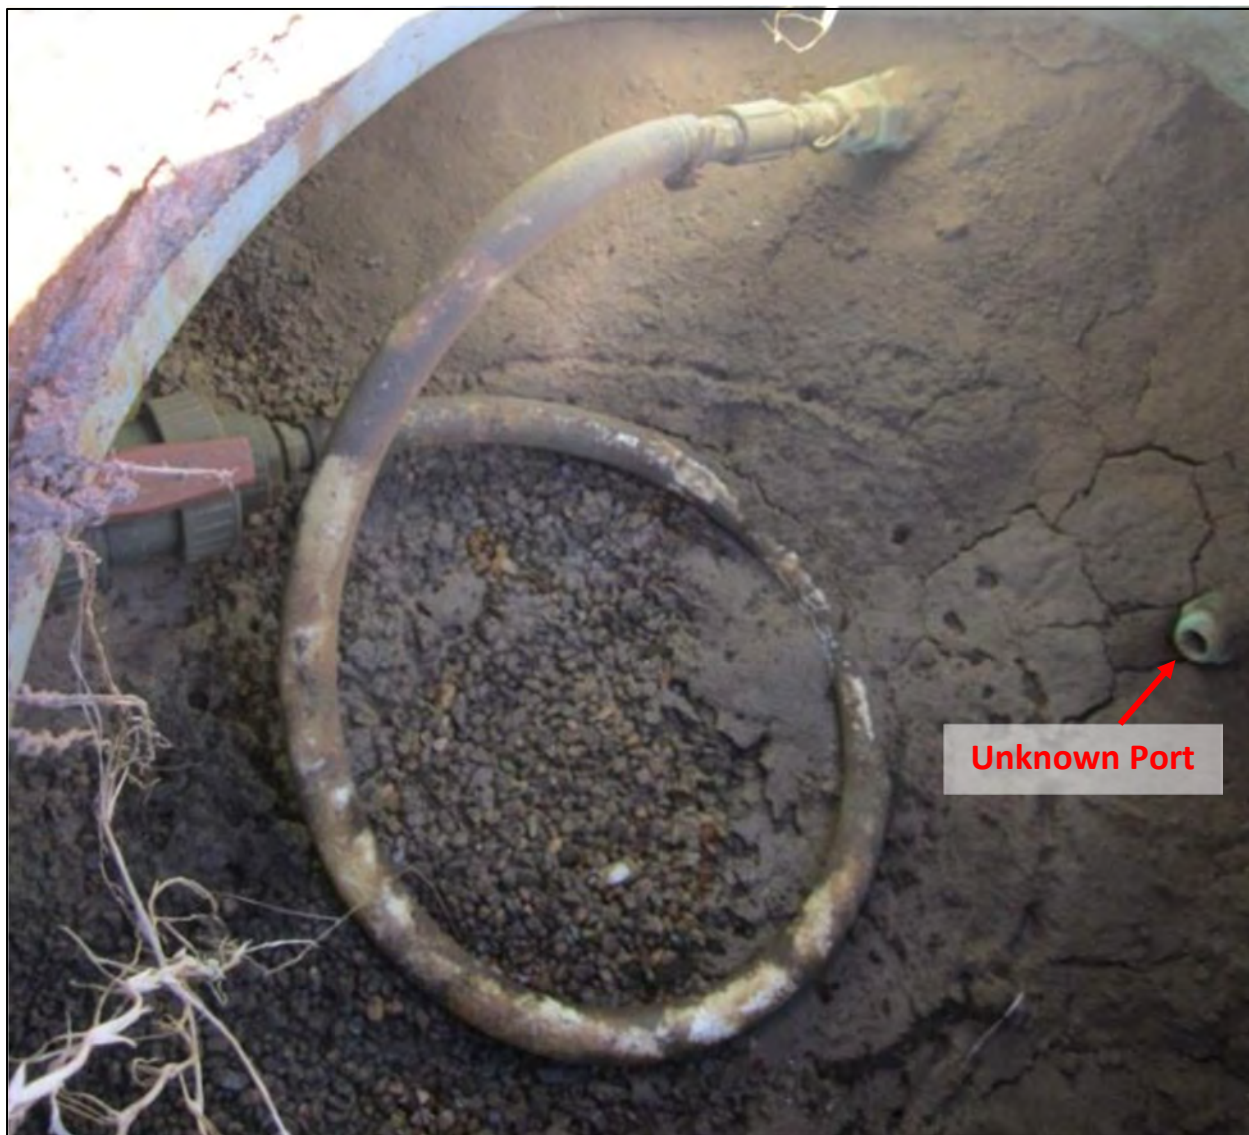
**Photograph 48. 2/14/2024 11:30 AM IMG\_0053.JPG**

past flooding and/or water accumulation inside of the vault (i.e., water marks, mud cracks). There was also an unattached port leading into the vault, and System representatives were unsure of the port's purpose (refer to [Appendix 1, Photograph 48](#)).

**Fairview Site, Chlorine Injection Vault** View of the vault housing the chlorination injection line. There was an additional unknown port without a hose inside of the vault. The bottom of the vault was lined with dirt that appeared to be wet.
