## Region 6 - Enforcement & Compliance Assurance Division

### INSPECTION REPORT

| <b>System Owner:</b> | City of Sherman | |
| <b>System Name:</b> | City of Sherman Public Water System (PWS) | |

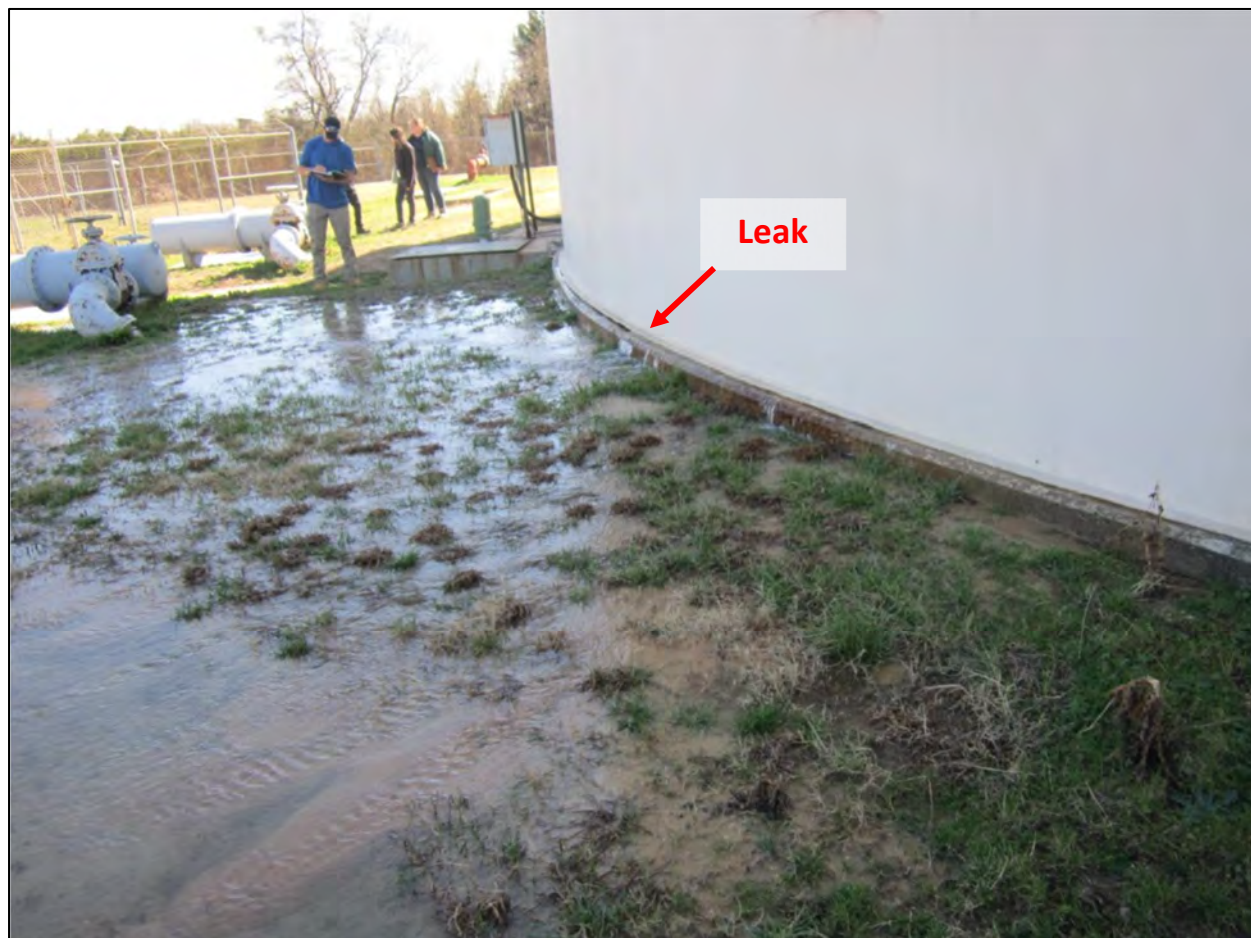
**Photograph 50. 2/14/2024 1:50 PM IMG\_0085.JPG**

**Stephens Tank** View of a leak from the Stephens Tank caused by a structural failure that occurred on the morning of February 14, 2024. The tank was leaking water from under the bottom plate onto the ground adjacent to the tank foundation at an estimated rate of several gallons per minute during the inspection. The EPA Inspection Team received follow-up communication from the System on March 5, 2024 indicating that the tank had been drained and inspected, and that the source of the leak was due to corrosion between the steel floor/plate of the tank and the “mud valve” seal. The mud valve is used to drain the tank.

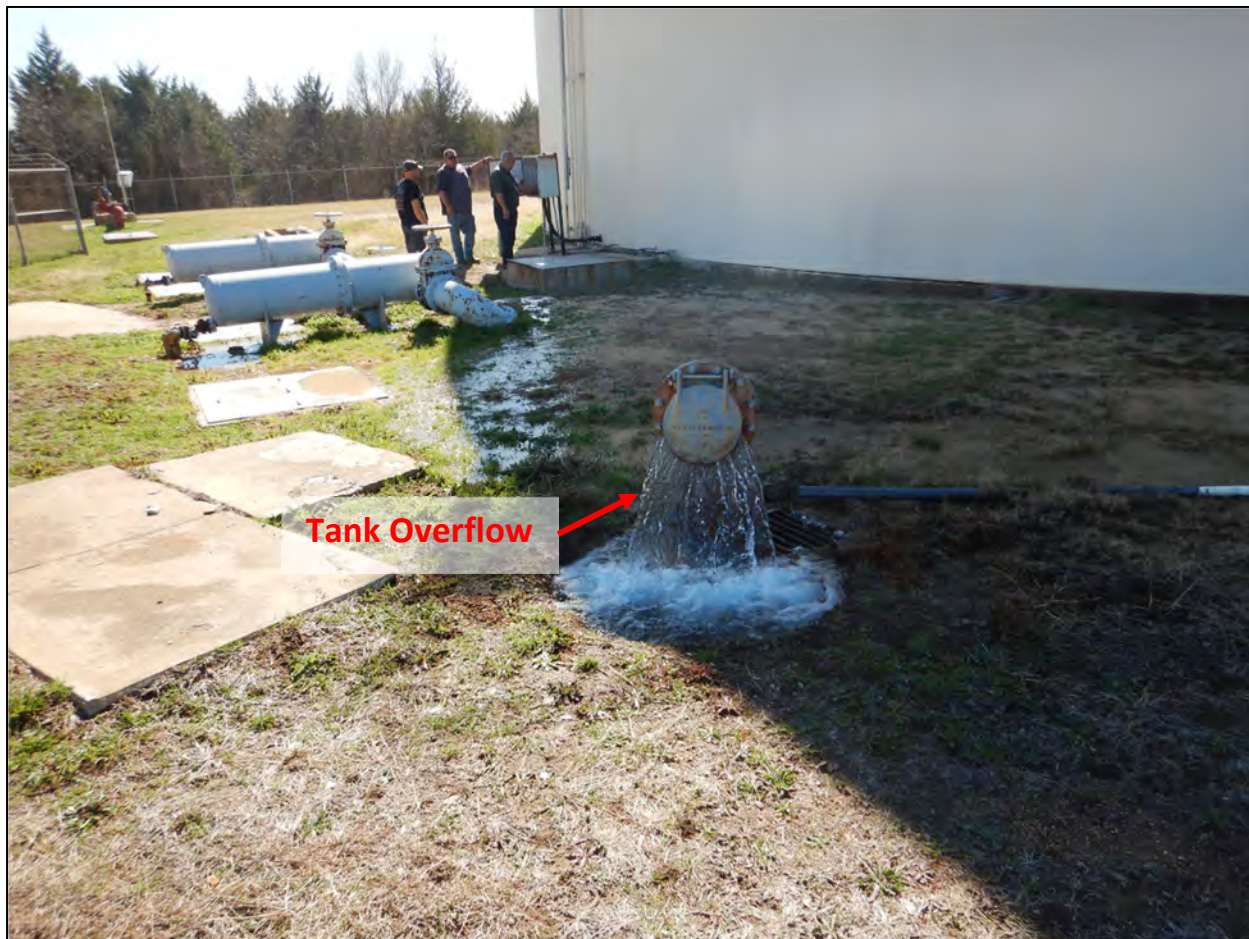
**Photograph 51. 2/14/2024 1:50 PM DSCN9504.JPG**

**Stephens Tank** View of finished water from the Stephens Tank that was flowing into an overflow drain that ultimately discharged into a storm sewer. Due to the leak, operators had opened the drain valve in the bottom of the tank which also discharged to the overflow drain. Water was also being pumped into the distribution system while the tank was draining.

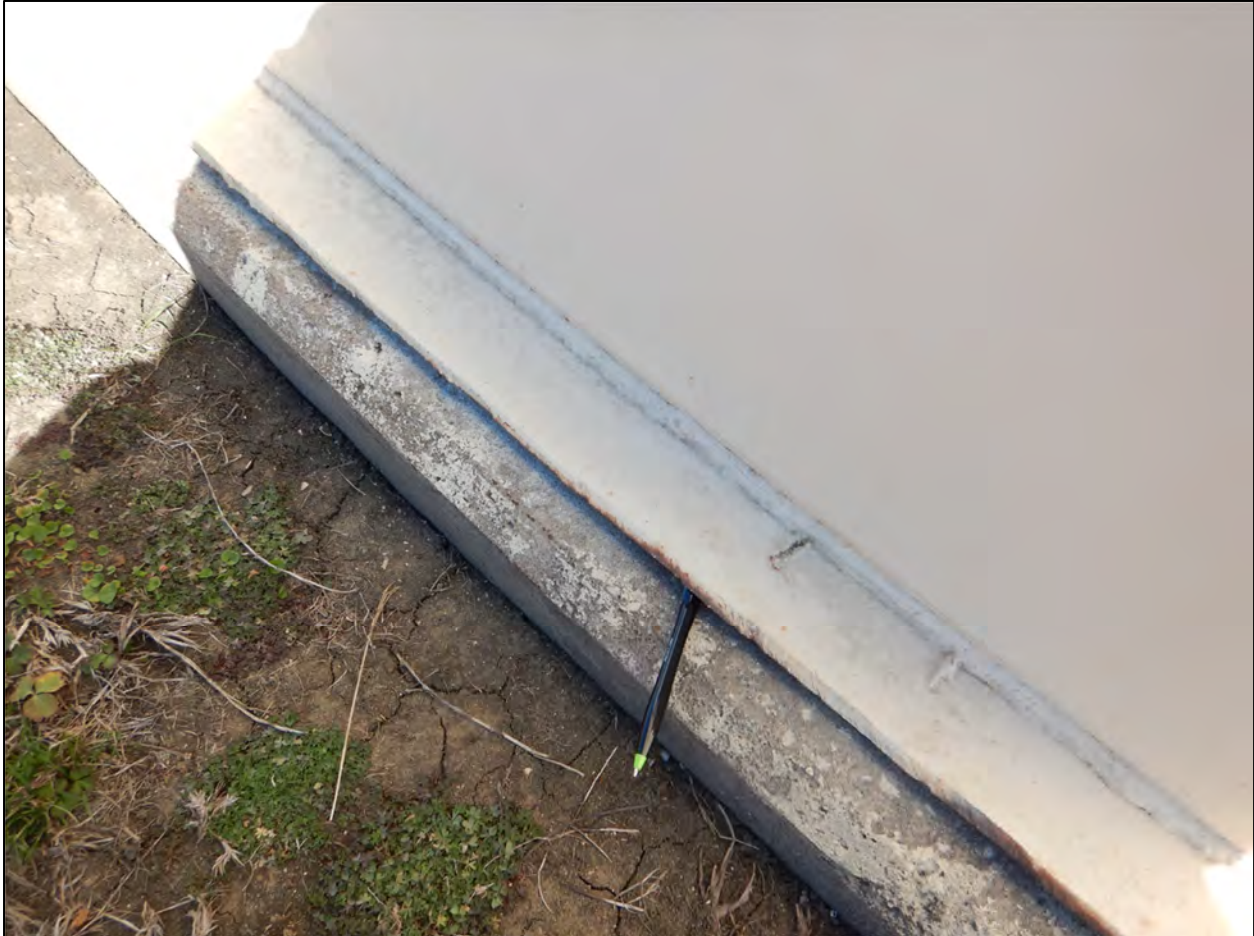
**Photograph 52. 2/14/2024 1:47 PM DSCN9513.JPG**

**Stephens Tank** View of an approximately inch-wide void between the bottom plate of the Stephens Tank and the concrete foundation. Similar voids were present in various areas around the base of the tank.

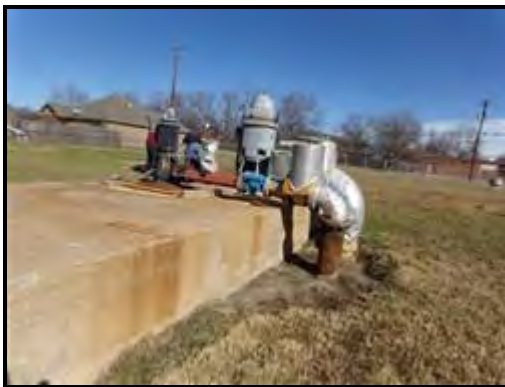
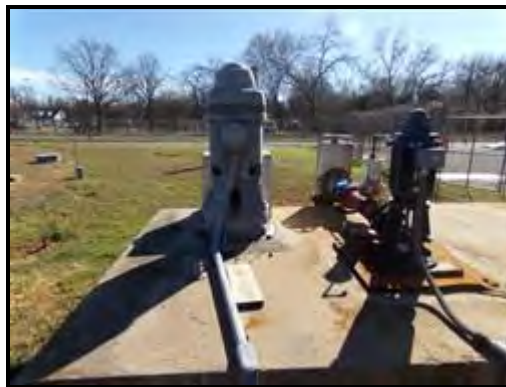
The two pumps were in fair condition at the time of inspection. Moderate corrosion was reported on one pump. No other abnormalities were reported. **TEXAS TANK SERVICES** recommends machines prepping the corroded areas of the pumps and adding a new protective coating.

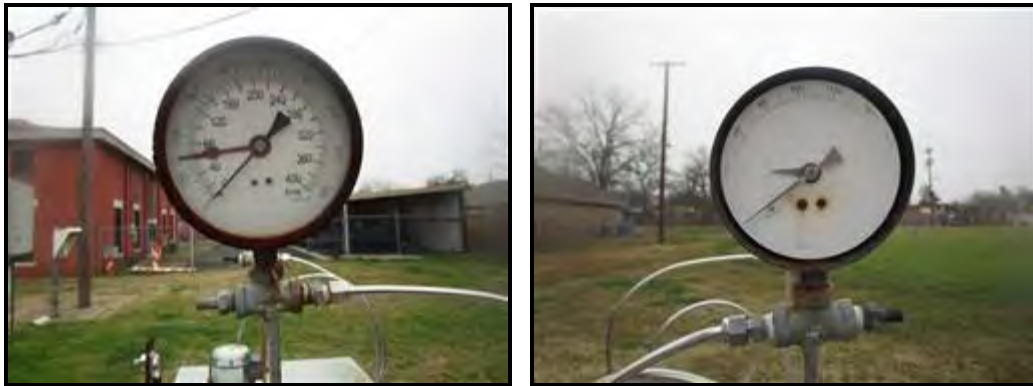
The one water level indicator was operable and in good condition. The other gauge was fading and unreadable. **TEXAS TANK SERVICES** recommends replacing the one water pressure gauge to bring the component back to fully functional status.

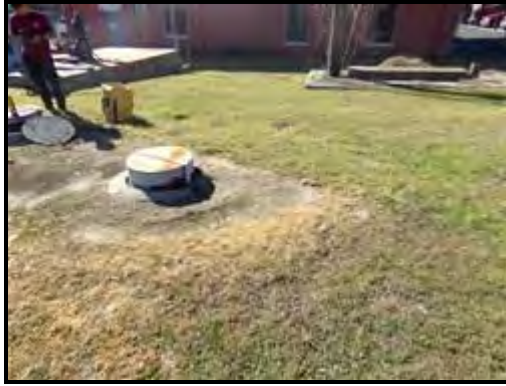
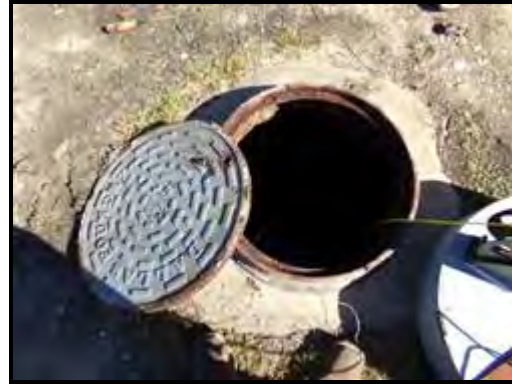
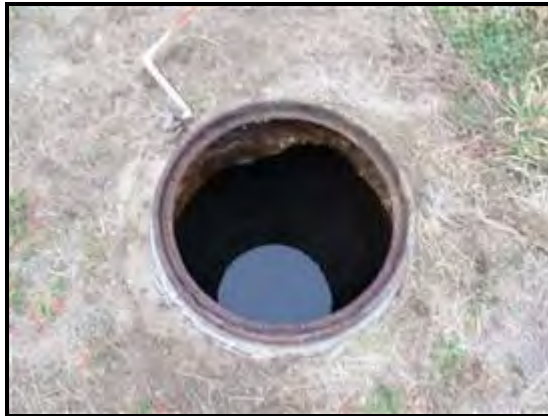
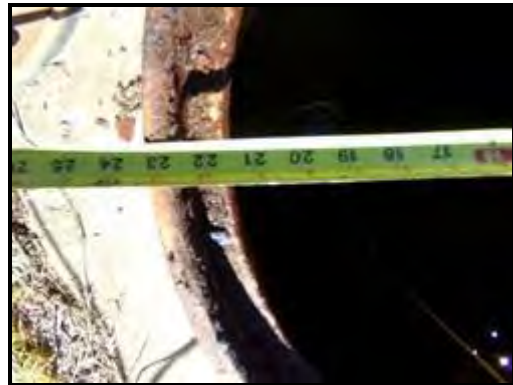
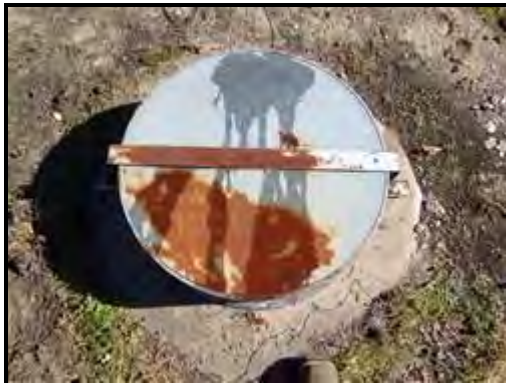
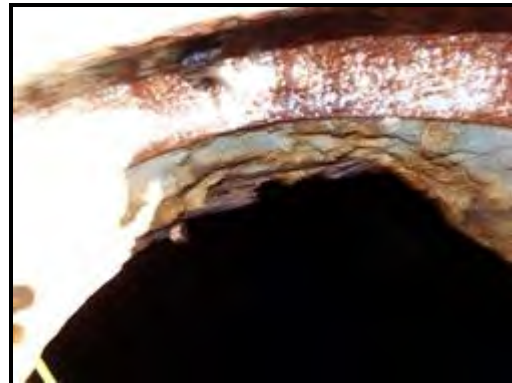
The nine water access hatches were in poor condition. The hatches measured 24 inches in diameter. The hatches were locked with a keyed lock upon arrival of the inspection crew. However, they were not labeled as a “Confined Space” entry. Heavy surface corrosion was reported on all of the hatches. **TEXAS TANK SERVICES** recommends replacing and enlarging the water access hatch to at least 30 x 30 square inches or 30 inches in diameter. Enlarging the hatch would enable safety equipment to enter the facility if anyone was ever in need of medical attention inside the structure. **TEXAS TANK SERVICES** also recommends installing “Confined Space” entry placards to the hatch. **TEXAS TANK SERVICES further** recommends machine prepping the corroded areas of the water access hatches and adding a new protective coating

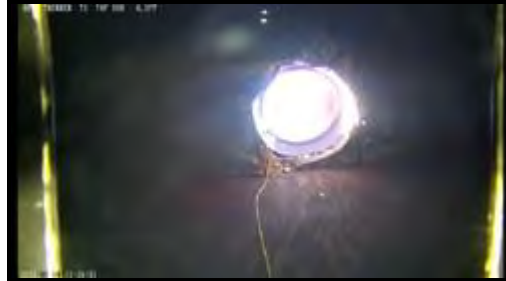
The water access hatch was in poor condition upon internal inspections. Heavy surface corrosion was reported. **TEXAS TANK SERVICES** recommends replacing and enlarging the water access hatch to at least 30 x 30 square inches or 30 inches in diameter. Enlarging the hatch would enable safety equipment to enter the facility if anyone was ever in need of medical attention inside the structure.

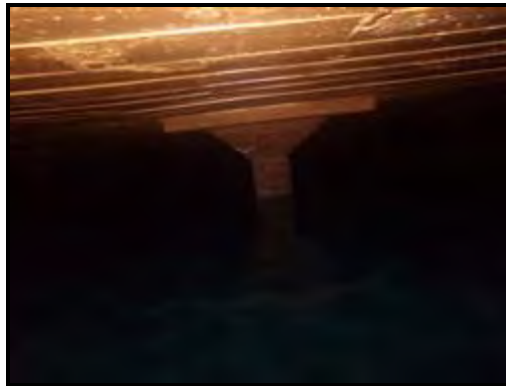
The internal sidewall plates were in fair condition above the water line. Light condensation and heavy staining were reported. **TEXAS TANK SERVICES** recommends performing a chemical power wash of the interior of the facility, utilizing Blue Earth Labs' product Floran, to remove staining and extend the life of this structure.

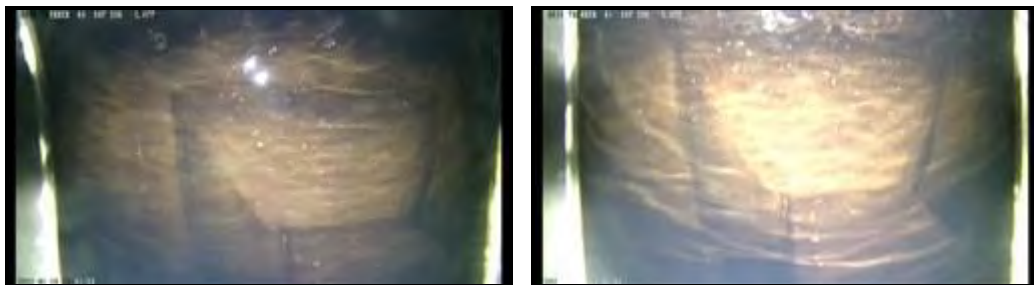
The support columns were in fair to good condition above the water line. Moderate staining was reported. **TEXAS TANK SERVICES** recommends performing a chemical power wash of the interior of the facility, utilizing Blue Earth Labs' product Floran, to remove staining and extend the life of this structure.

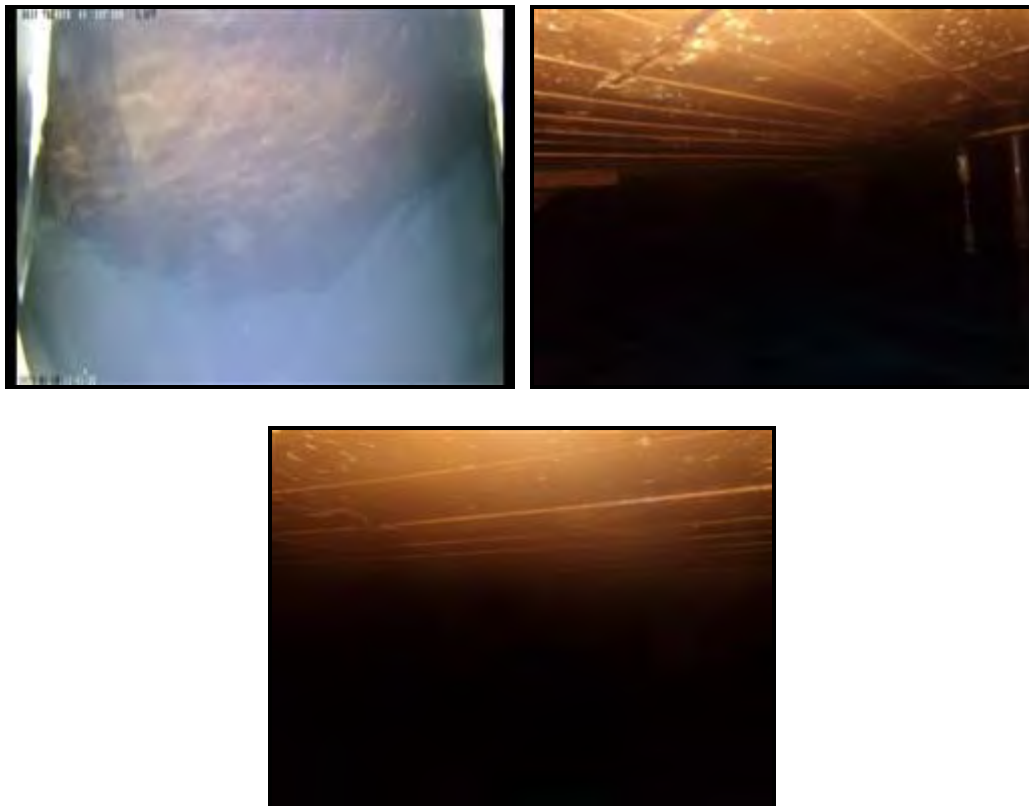
The internal roof plates were in good condition upon internal inspection. Heavy condensation and staining were reported. **TEXAS TANK SERVICES** recommends performing a chemical power wash of the interior of the facility, utilizing Blue Earth Labs' product Floran, to remove staining and extend the life of this structure.

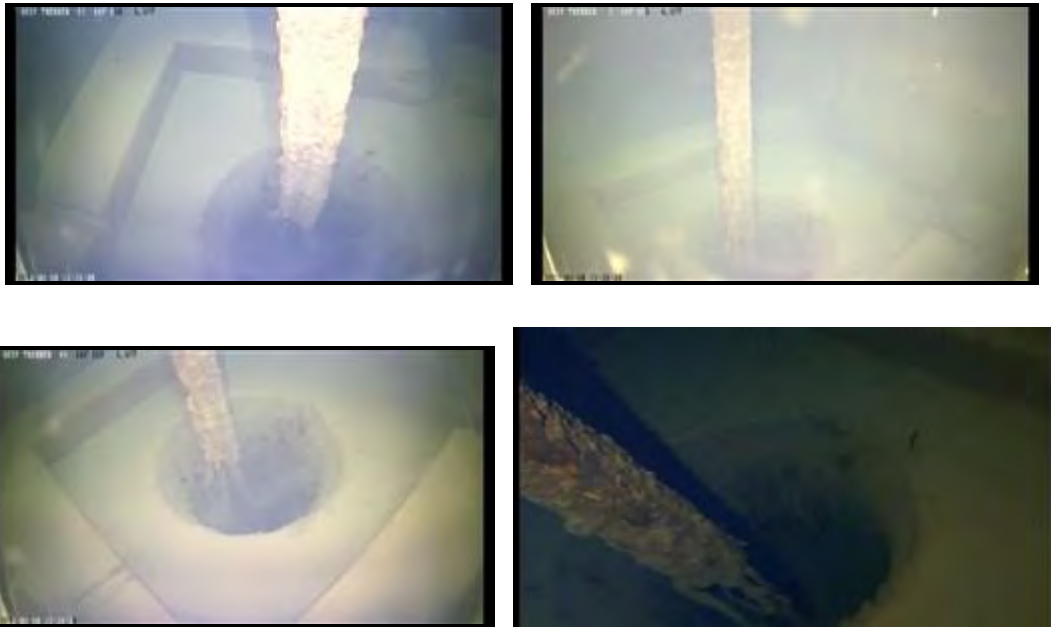
The pumps were in poor condition. Heavy corrosion and heavy staining and calcium growth were reported. **TEXAS TANK SERVICES** recommends performing a chemical power wash of the interior of the facility, utilizing Blue Earth Labs' product Floran, to remove staining and extend the life of this structure. **TEXAS TANK SERVICES** recommends machine prepping the corroded areas of the pumps and adding a new protective coating.

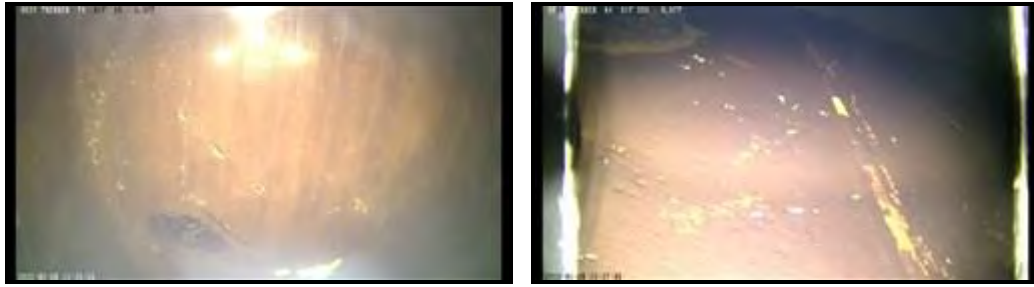
The internal sidewall plates were in fair condition. Heavy staining was reported. **TEXAS TANK SERVICES** recommends performing a chemical power wash of the interior of the facility, utilizing Blue Earth Labs' product Floran, to remove staining and extend the life of this structure.

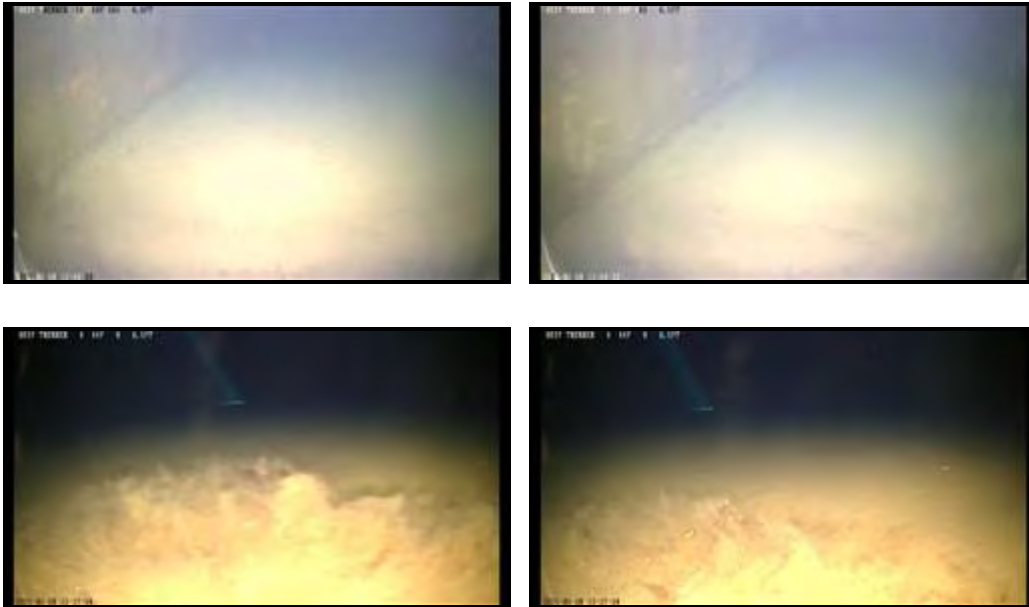
The internal floor plates were not seen due to 100% coverage of sedimentation. **TEXAS TANK SERVICES** recommends an in-service cleaning to remove this sediment in order to better evaluate the floor plates, as well as improve the quality of the water in this tank.

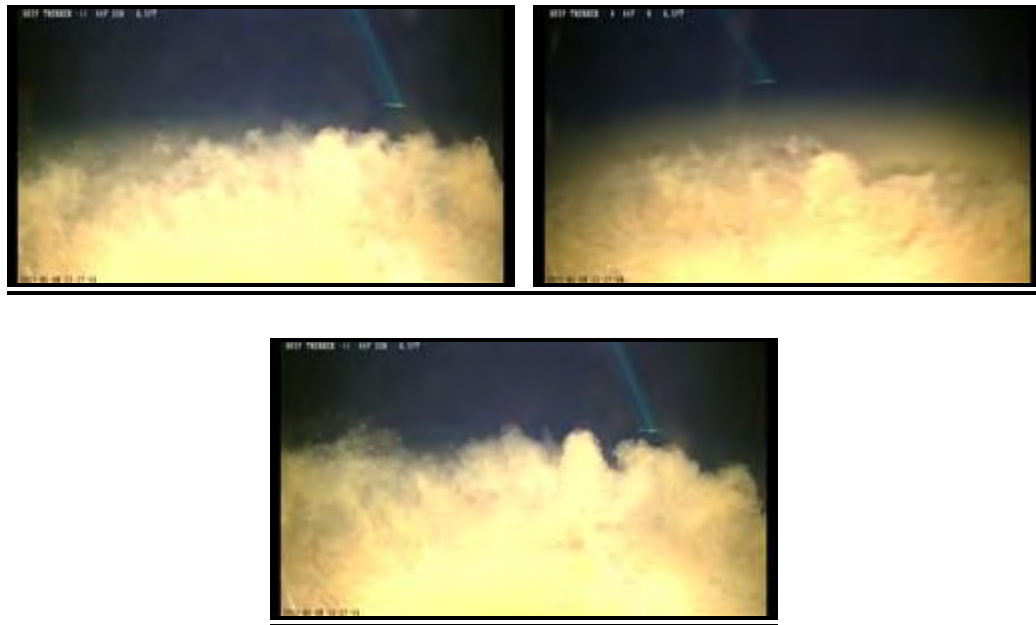
The sediment depth was reported to be  $\frac{1}{2}$  of an inch and consisting of sand. **TEXAS TANK SERVICES** recommends an in-service cleaning to remove this sediment in order to better evaluate the floor plates, as well as improve the quality of the water in this tank.
