## RCRA COMPLIANCE EVALUATION INSPECTION REPORT

TAV Holdings, Inc.  
3311 Empire Boulevard SW  
Atlanta, Georgia 30354  
EPA ID # GAD033537663

October 6, 2021

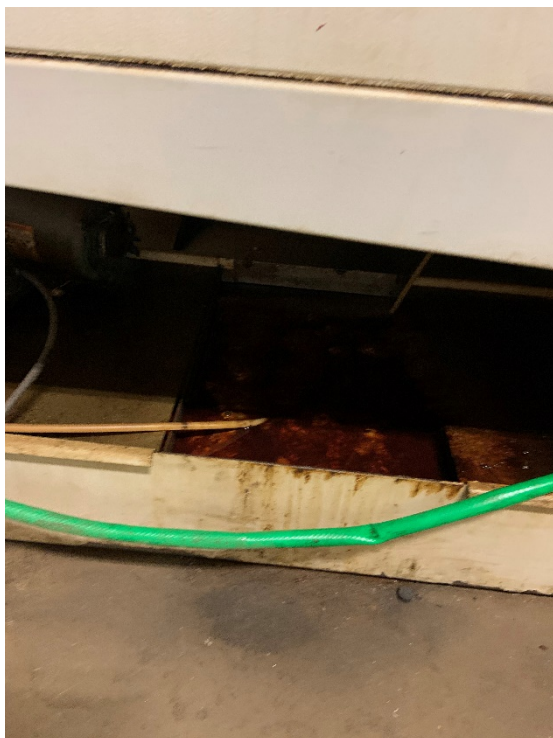
*Figure 3: IMG\_3072.jpg – oil under the CNC machine in the Shipping Building*

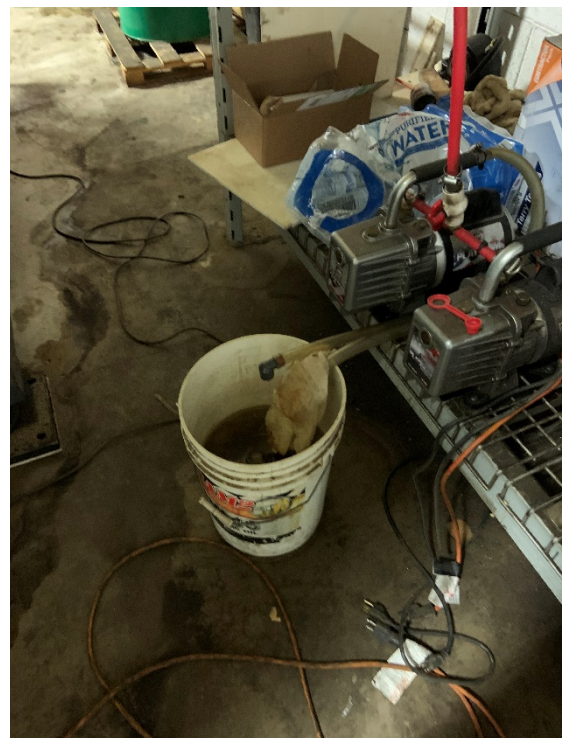
*Figure 4: IMG\_3073.jpg – Pump oil in a bucket in the Shipping Building*

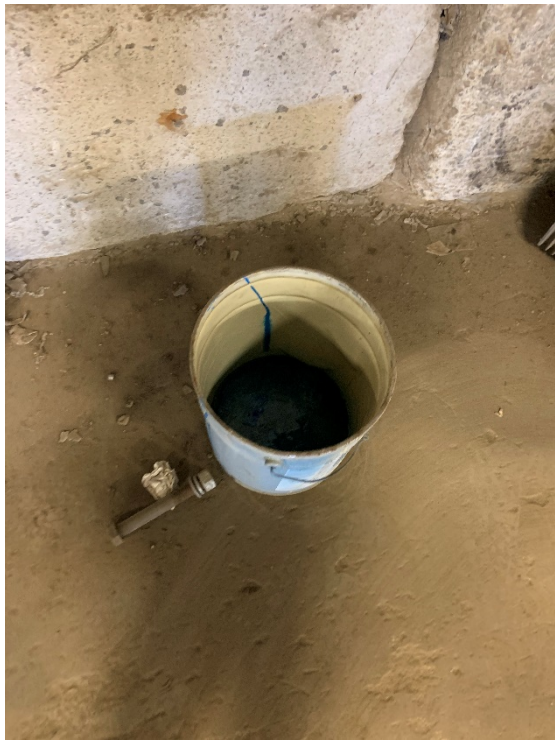
*Figure 9: IMG\_3078.jpg – Paint bucket with liquid in it in the Fabrication Building*

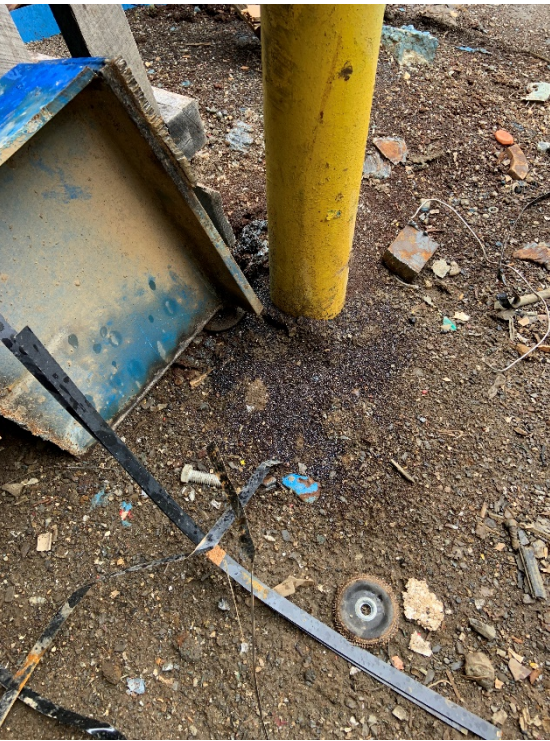
*Figure 13: IMG\_3082.jpg – Staining on ground of Fabrication*

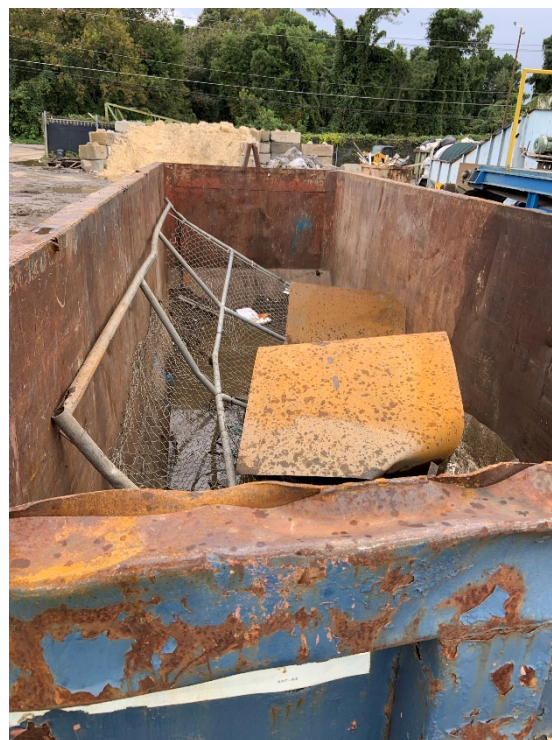
*Figure 18: IMG\_3087.jpg- Contents of Dumpster in rear of Fabrication Building*

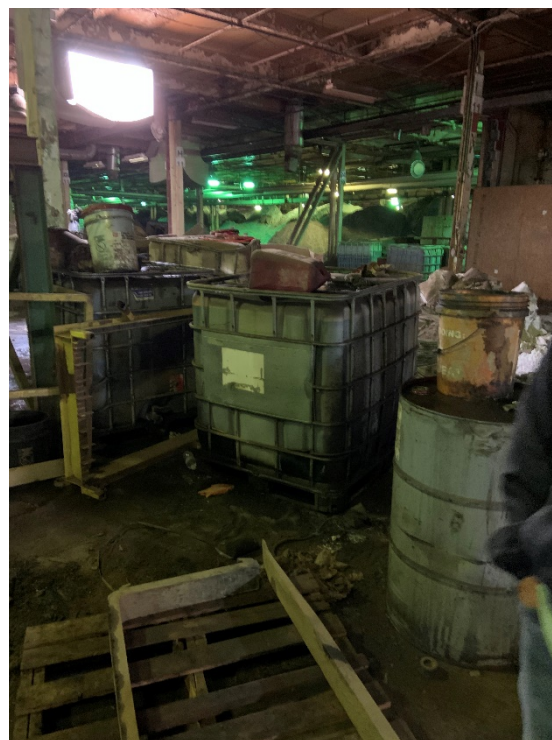
*Figure 26: IMG\_3095.jpg – Containers of unknown waste in the Keebler Building*

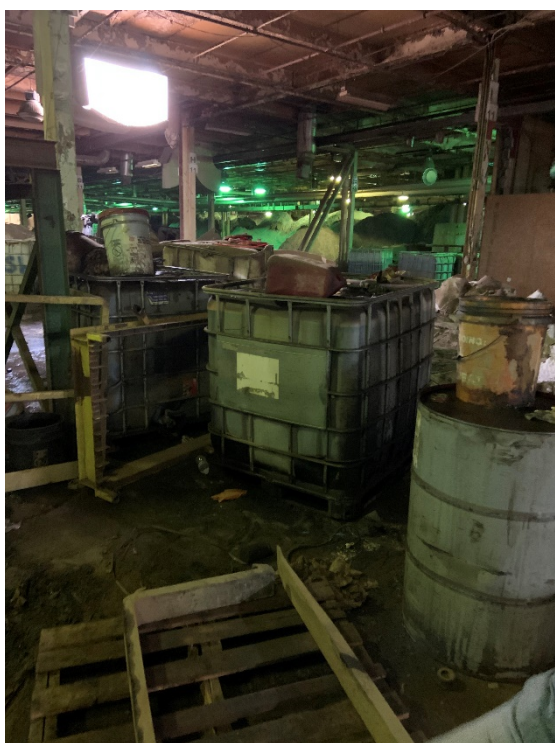
*Figure 27: IMG\_3096.jpg – Containers of unknown waste in the Keebler Building*

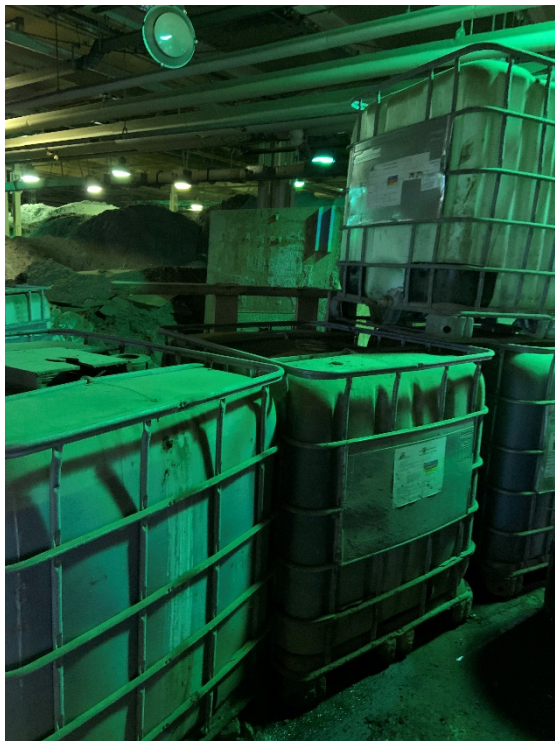
*Figure 31: IMG\_3100.jpg - Containers of unknown waste in the Keebler Building*

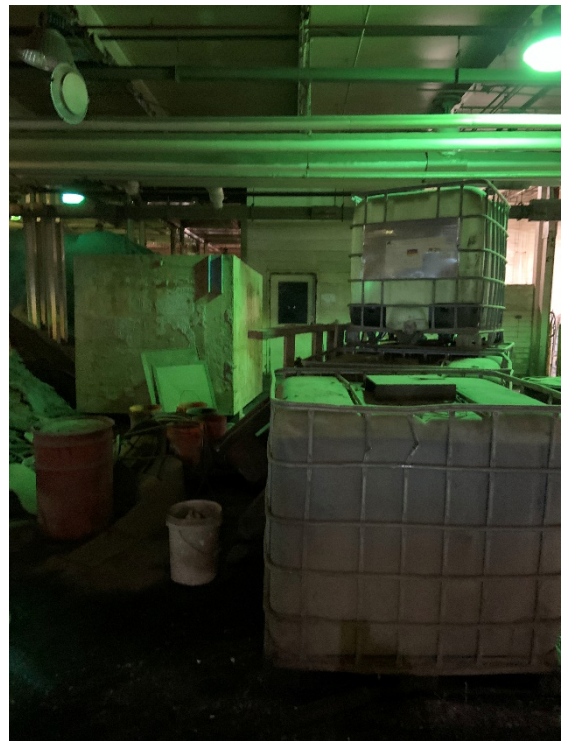
*Figure 32: IMG\_3101.jpg - Containers of unknown waste in the Keebler Building*

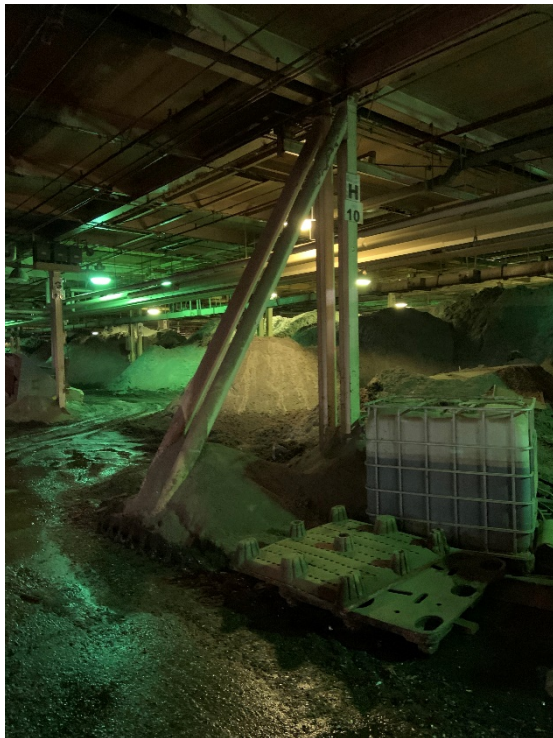
*Figure 33: IMG\_3102.jpg – Containers of unknown waste and pile of solid waste in the Keebler Building*

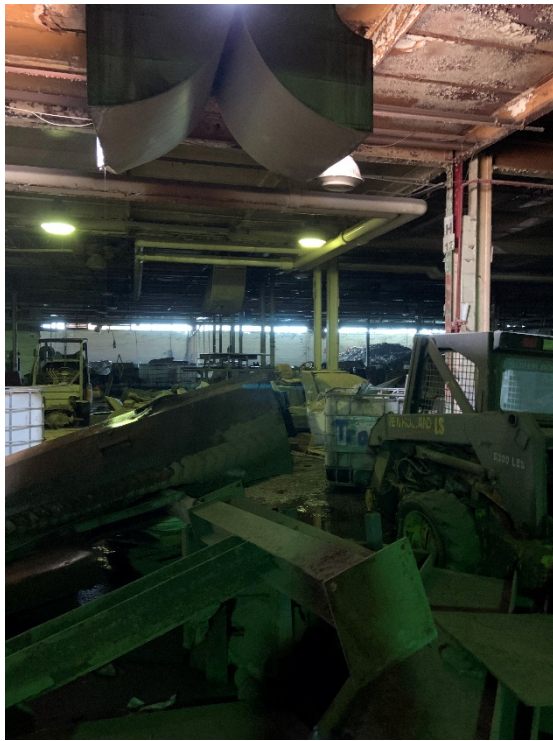
The inspectors reviewed the sources of the water and found that stormwater and operation process water, from the processing of the solid waste, was being swept out of the building. Due to holes in the roof and inadequate containment, both sources of water flow through the facility from south to north and collect in the asphalt area seen in Figures 87 and 88.

*Figure 37: IMG\_3106.jpg – Keebler Building showing holes in roof*

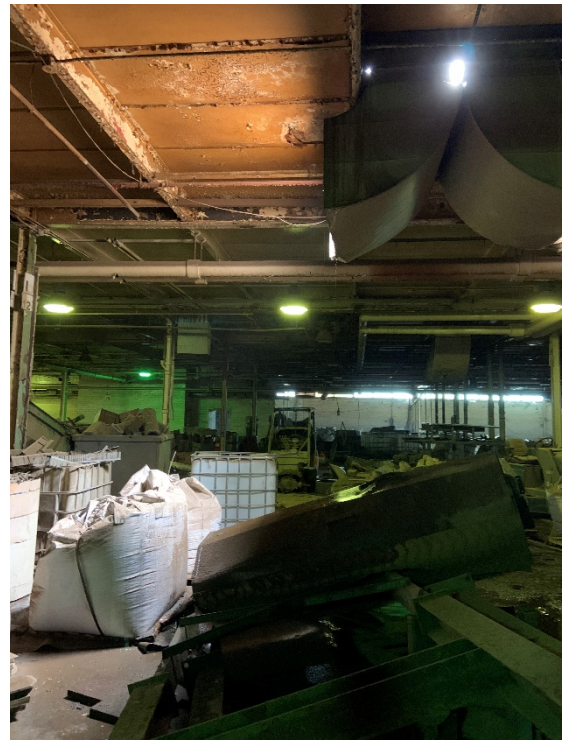
*Figure 38: IMG\_3107.jpg– Keebler Building showing holes in roof*

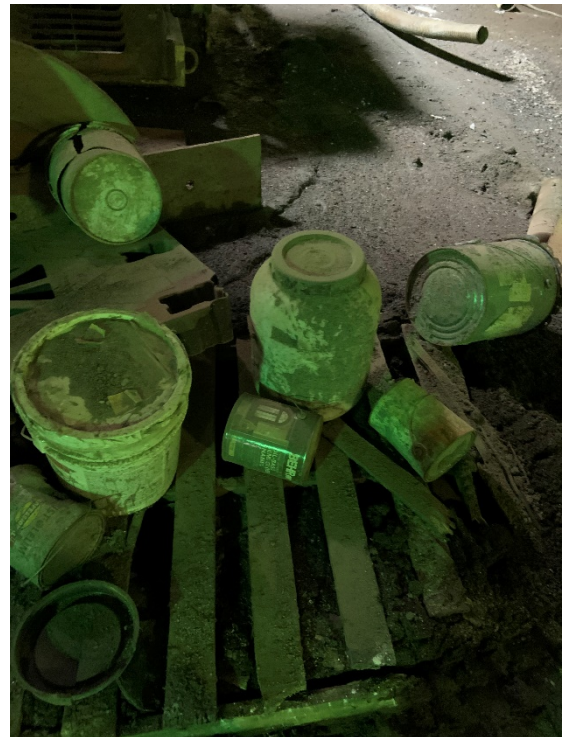
*Figure 40: IMG\_3109.jpg - Containers of unknown waste in the Keebler Building*

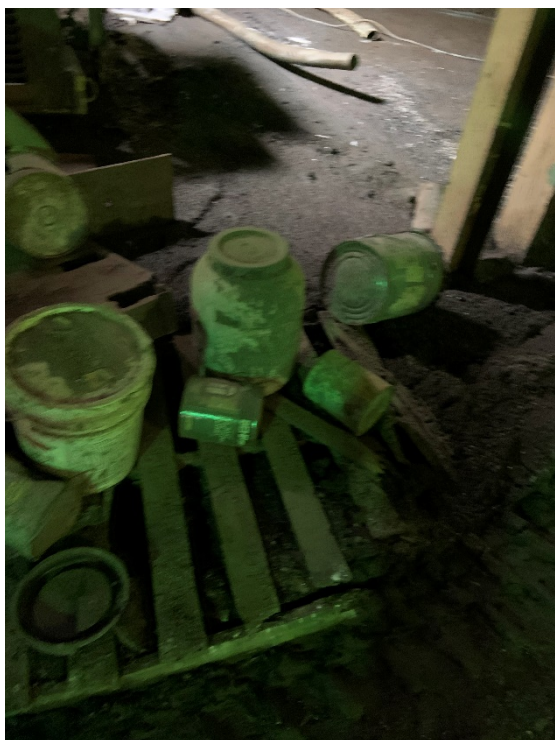
*Figure 41: IMG\_3110.jpg- Containers of unknown waste in the Keebler Building*

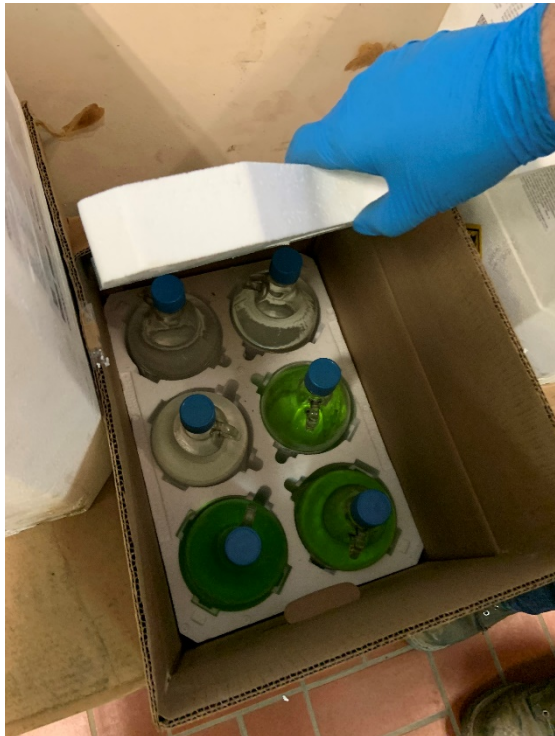
Figure 47: IMG\_3116.jpg – Acid waste in the lab

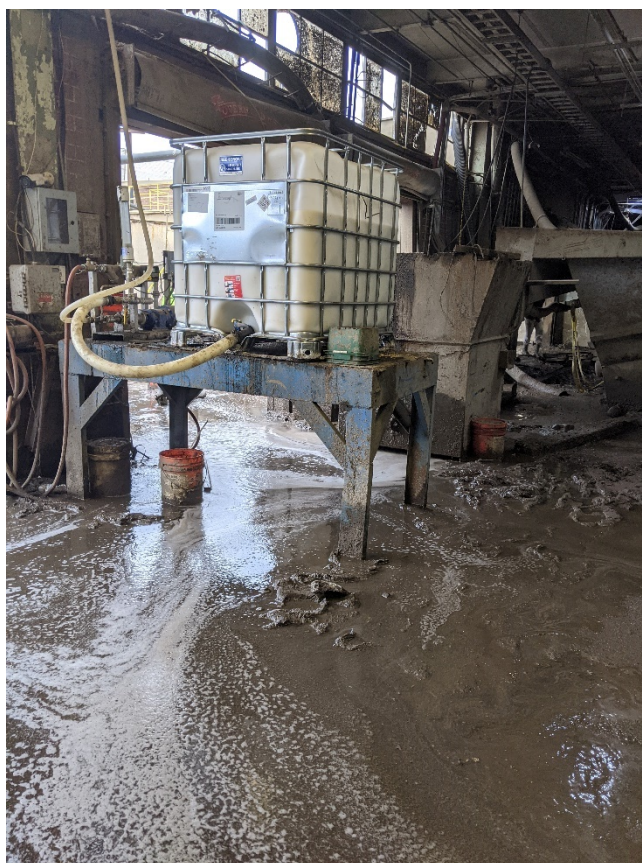
*Figure 64: PXL\_20211006\_145902126.jpg – Sludge flowing across the floor.*

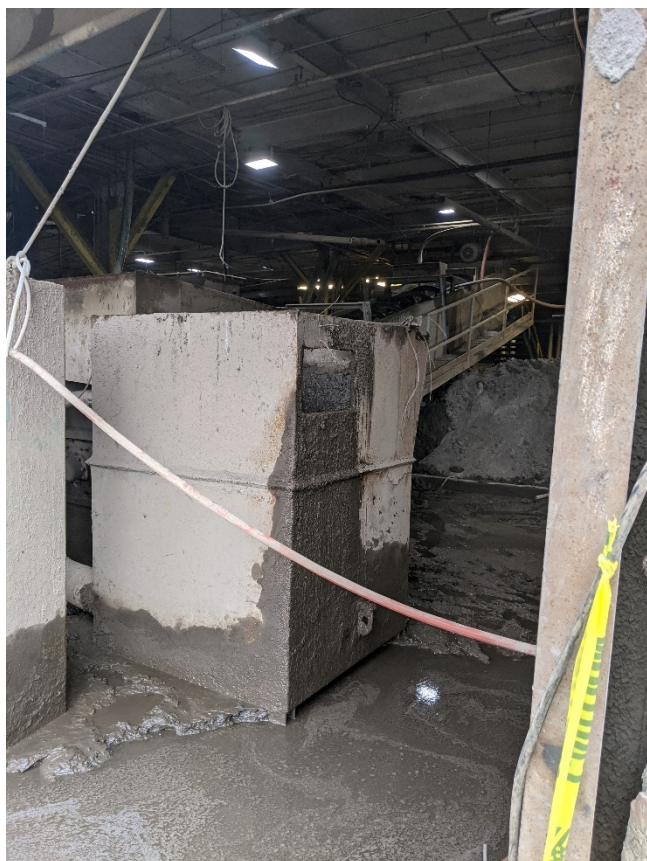
*Figure 65: PXL\_20211006\_145919867.jpg – Tank receiving process wastewater and sludge/wastewater overflow on the floor*

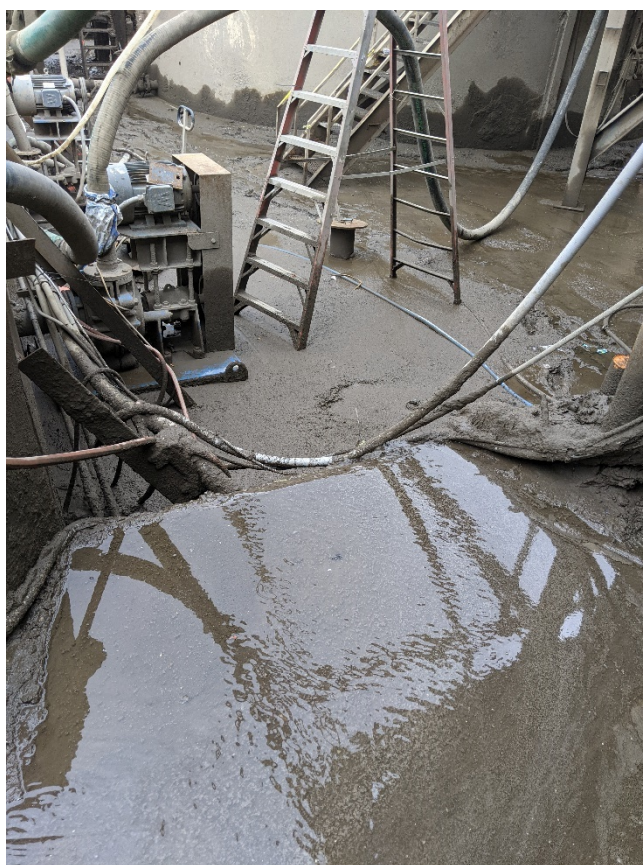
*Figure 66: PXL\_20211006\_145946590.jpg – Process wastewater and sludge flowing from the process onto the ground in the wastewater treatment area*

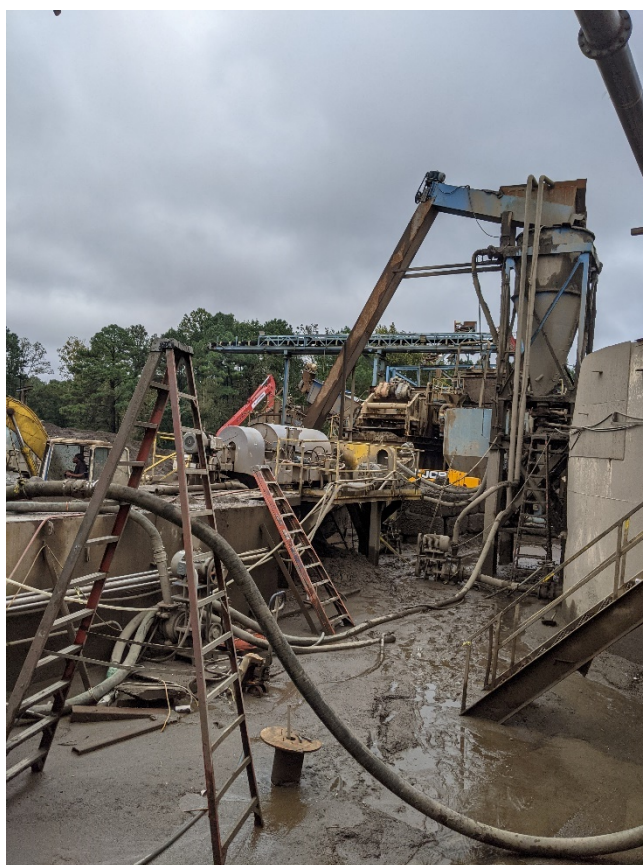
*Figure 72: PXL\_20211006\_151016463.jpg - Wastewater Treatment Area*

The processes all include the use of water. The facility collects stormwater in several areas at the facility and uses it in the processes. Much of the process water is swept out the doors of the process building, where it accumulates in low lying areas and it is pumped to a tank where flocculant is added to aid in the precipitation of solids from the water. The solids are removed by a backhoe and placed back into the processing. From the clarifier the water is pumped to a large tank. At the time of the CEI, the clarifier and the tank were observed to be overflowing. The secondary containment in the Wastewater Treatment (WWT) Area could not be properly inspected due to the accumulation of sludge on the surface. Figures 71 – 79 illustrate the condition of this area at the time of the CEI.

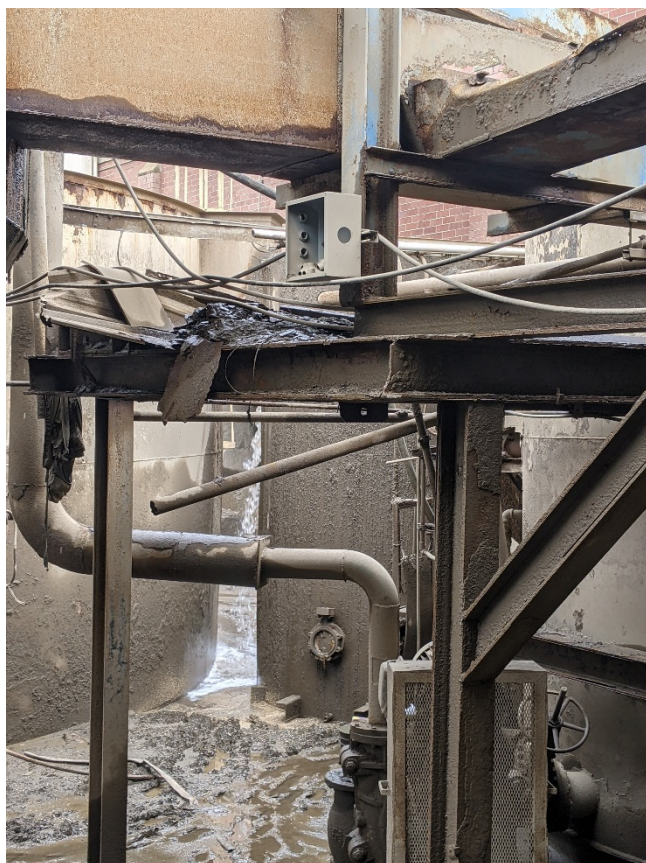
*Figure 77: PXL\_20211006\_151059043.MP.jpg –  
Process water overflowing from Wastewater  
Treatment Area tanks*

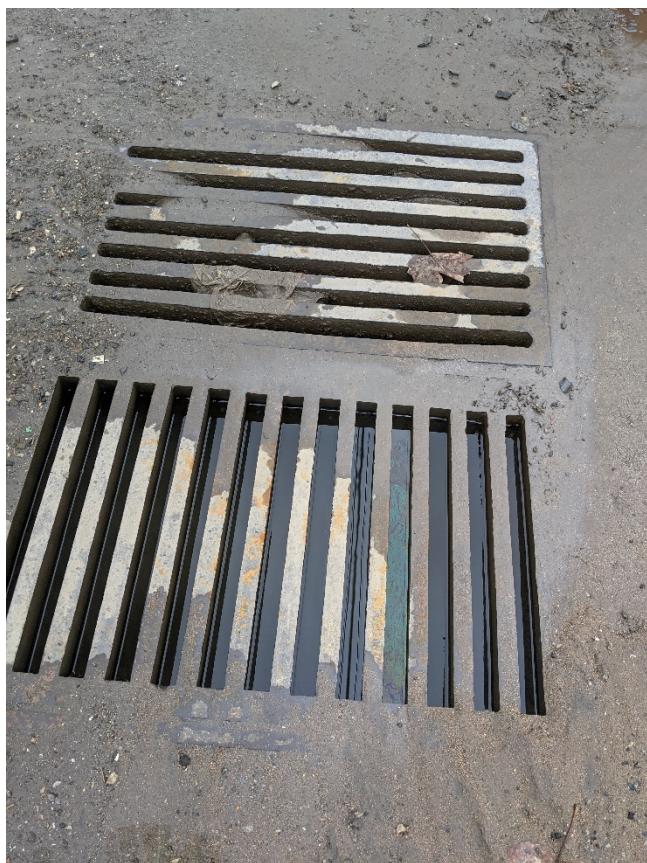
*Figure 83: PXL\_20211006\_151632795.jpg –  
Plugged up Stormwater drain*

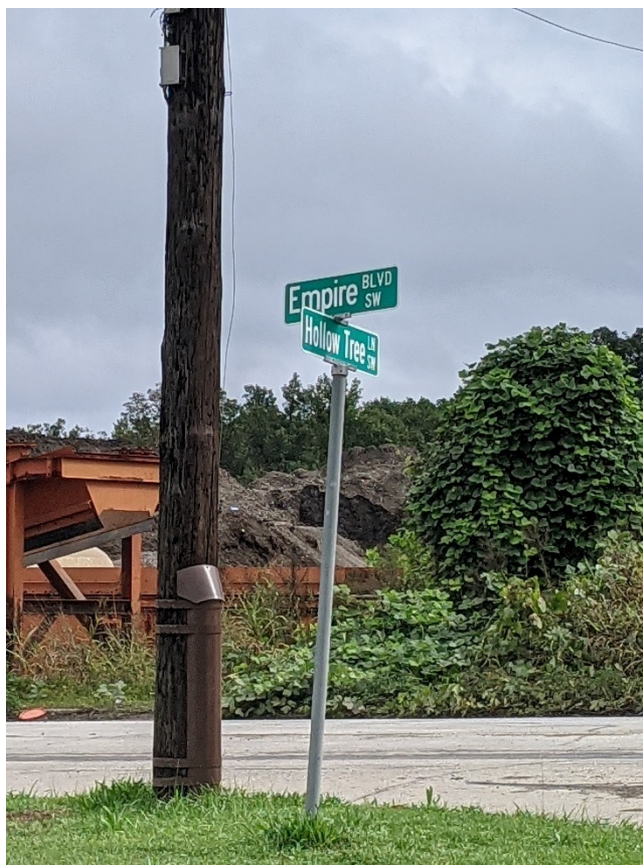
The parcel across the street from 3311 Empire Boulevard was observed to be used for storing old equipment and process solid waste material. The waste is piled in a landfill-like fashion as seen in Figures 84 and 112.

*Figure 84:  
PXL\_20211006\_151955923.PORTRAIT.jpg –  
Landfilled solid waste across the street*

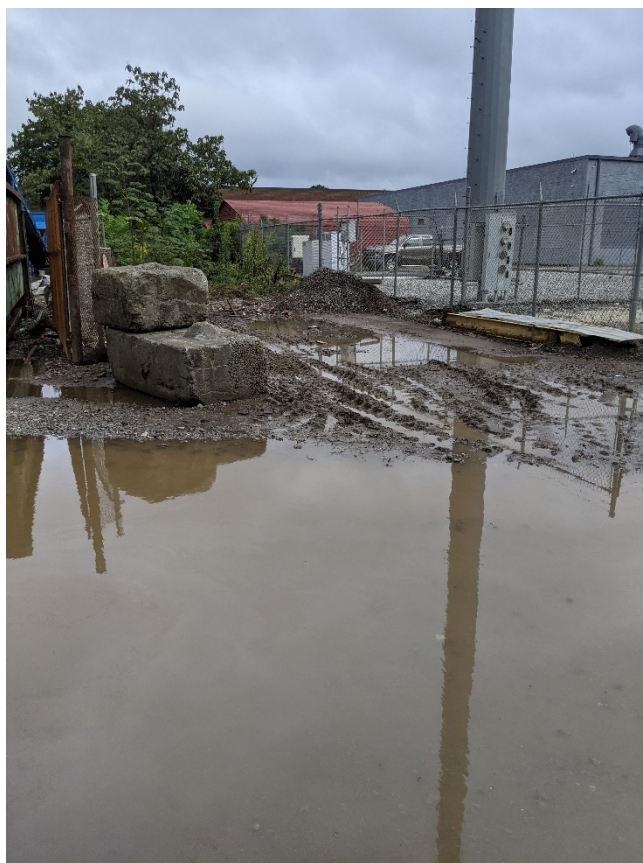
*Figure 86: PXL\_20211006\_152333693.jpg –  
Plugged up Stormwater drain*

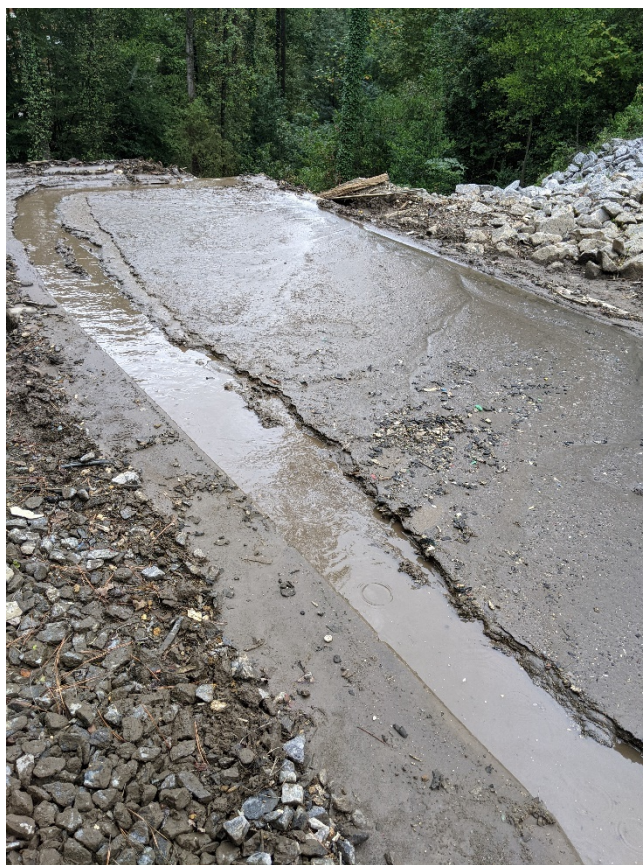
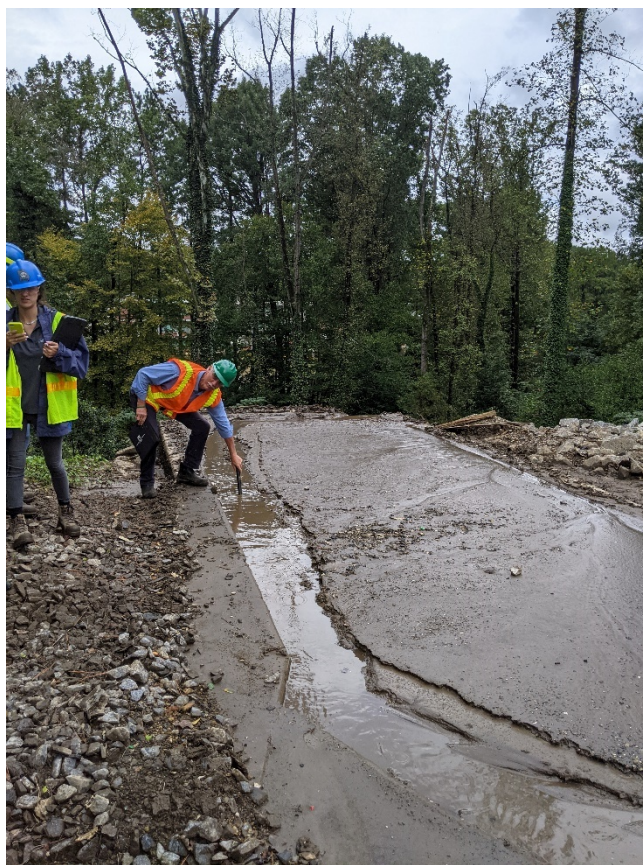
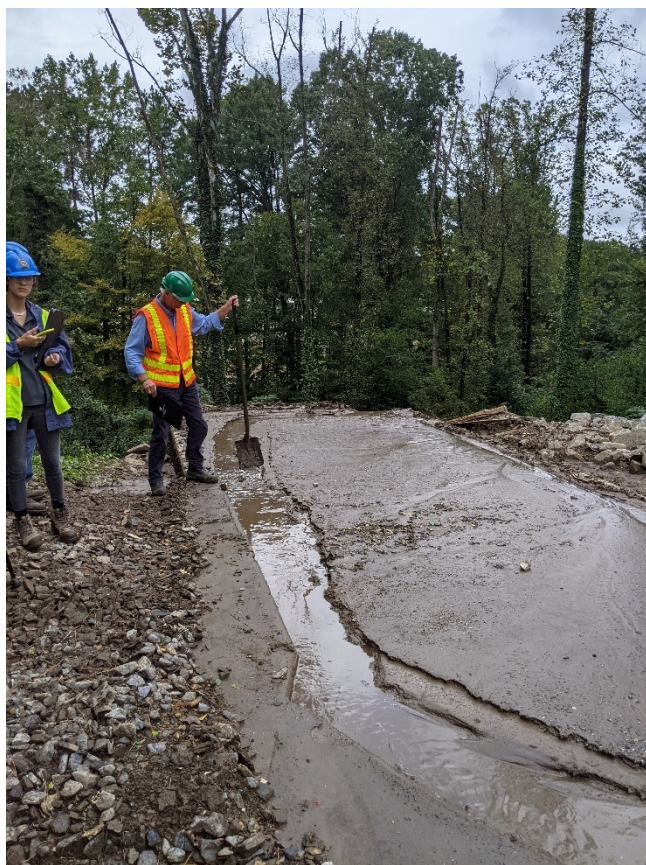
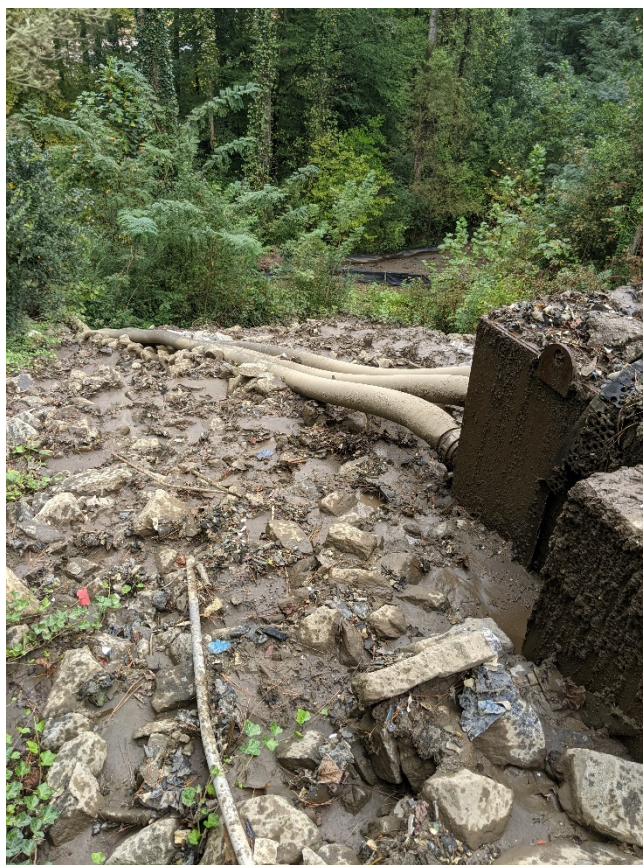
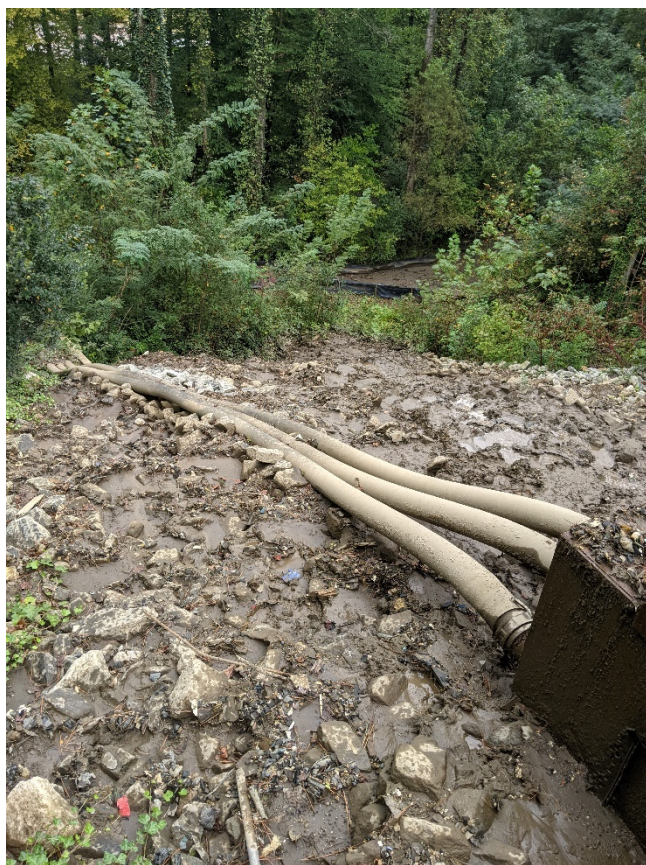
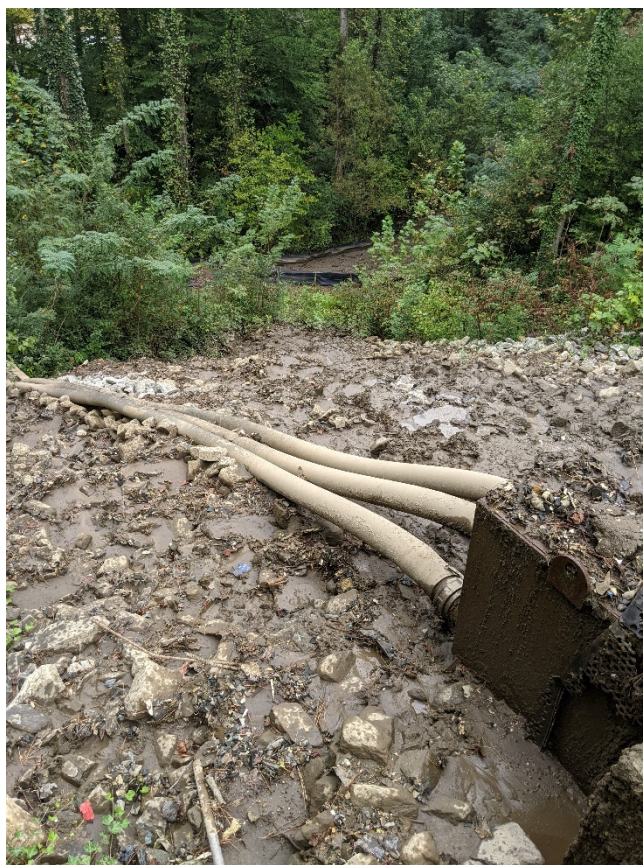
The inspectors observed Outfall 003. The area had a large concrete tank/settling basin that appeared to be used to separate solids from liquids. At the time of the CEI the basin was completely full of sludge. Evidence of stormwater and sludge overflowing the basin and by-passing the Outfall can be seen in Figures 100-106.

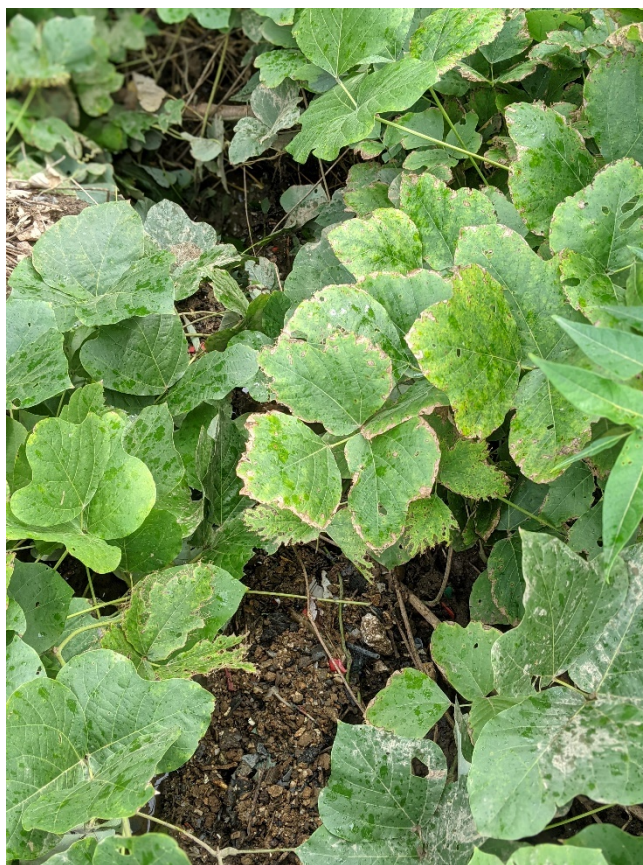
*Figure 108:  
PXL\_20211006\_183631146.PORTRAIT.jpg –  
Stormwater Runoff from Solid Waste Pile/Landfill  
in Laydown Yard*

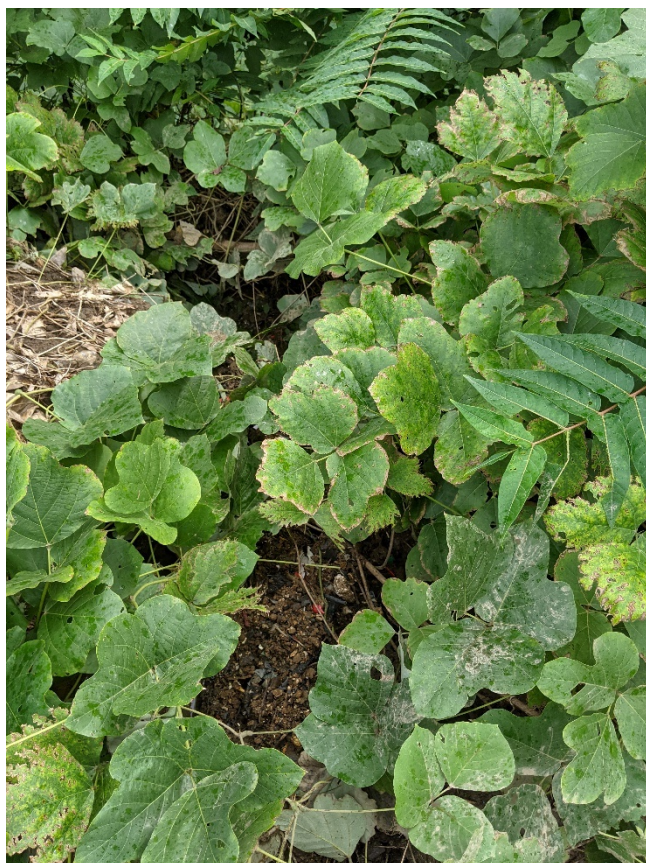
*Figure 109: PXL\_20211006\_183635073.MP.jpg  
– Stormwater Runoff from Solid Waste  
Pile/Landfill Laydown yard*

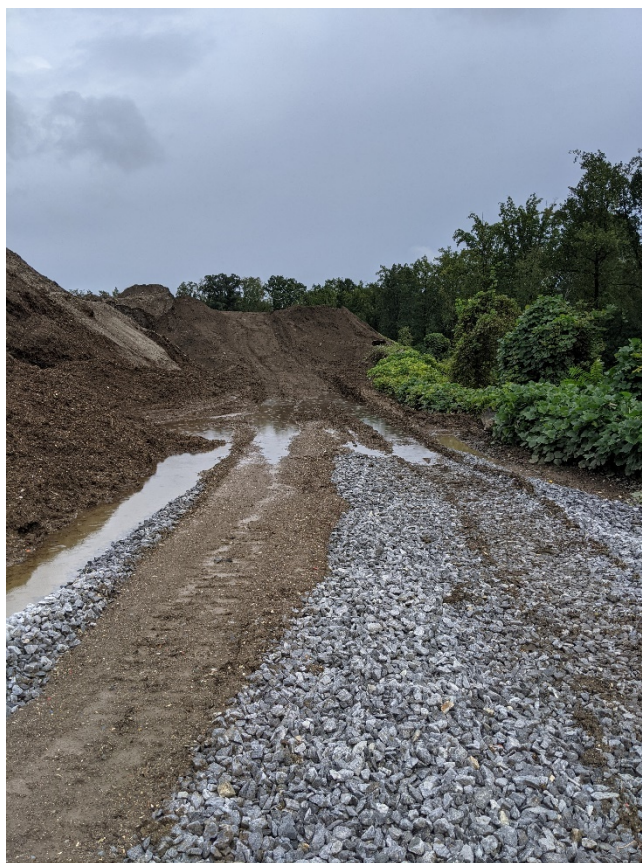
*Figure 110: PXL\_20211006\_183813827.jpg –  
Solid Waste Pile/Landfill Laydown Yard*
