**Region 6 Compliance Assurance and Enforcement Division  
INSPECTION REPORT**

| Inspection Date(s): | 4/25/2024 | | |
| Company Name: | <b>Entergy Louisiana, LLC</b> | | |
| Facility Name: | <b>Perryville Generating Station (PGP)</b> | | |

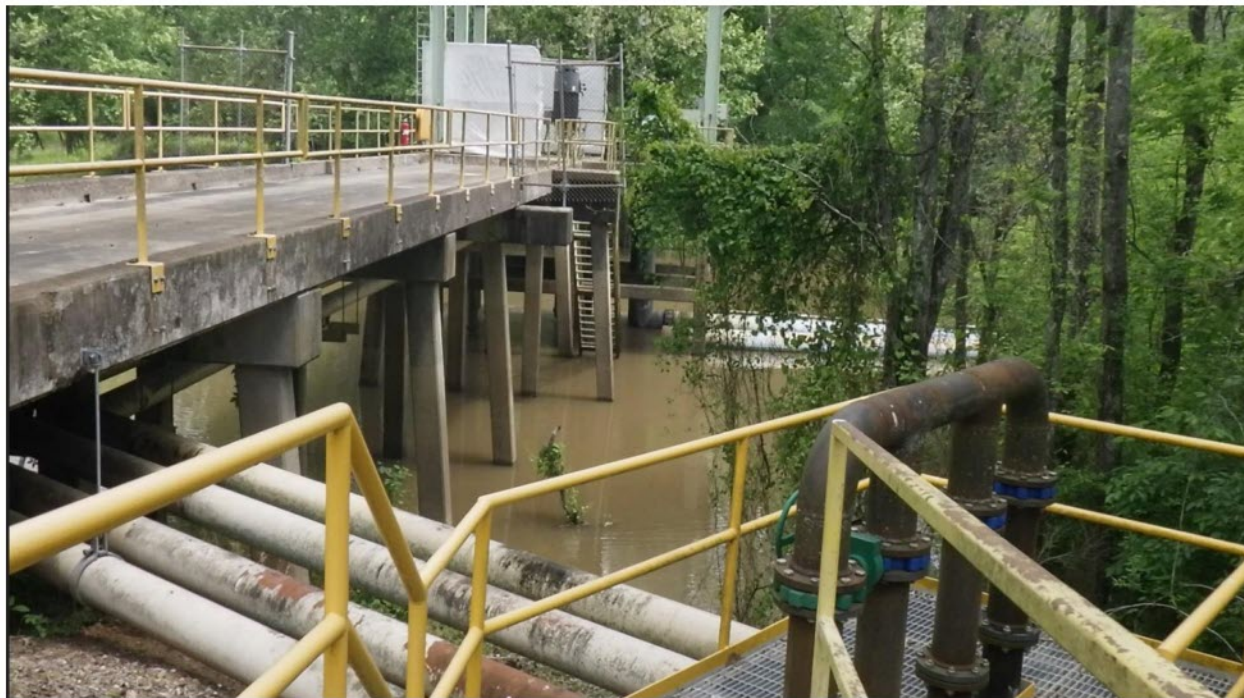
Photo No. 2

PGP withdraws water from Bayou Bartholomew through a CWIS located approximately 1.5 miles upstream of the confluence with the Ouachita River and uses at least 25 percent of the water they withdraw exclusively for cooling purposes; and is, therefore, subject to requirements under section 316(b) of the CWA for existing power generating facilities (See Photo Nos. 2 – 4 in Appendix 1).

Bayou Bartholomew is considered a freshwater river system. The CWIS is located approximately three miles northeast of the City of Sterlington (32° 43' 19.27" N: 92° 02' 18. 79"W) and is situated on a shared concrete platform within a man-made embayment extending roughly 315 feet from Bayou Bartholomew. The man-made embayment is approximately 150 feet across at the surface of the Perryville CWIS with a 40-foot width at the channel bottom and 47 feet from the channel bottom to top of bank. Three pumps and two city-owned pumps are situated on the structure. The pump intakes are located at a depth of approximately 43 feet below the surface of the CWIS deck and 4 feet above the channel bottom (See Photo Nos. 2 – 3 in Appendix 1).

Description: This image shows the Water Intake Structure that intake fresh water from Bayou Bartholomew for the cooling and industrial processes at the facility. The facility actual intake inflow and withdraws from a freshwater river (Bayou Bartholomew) is 8.8 MGD.

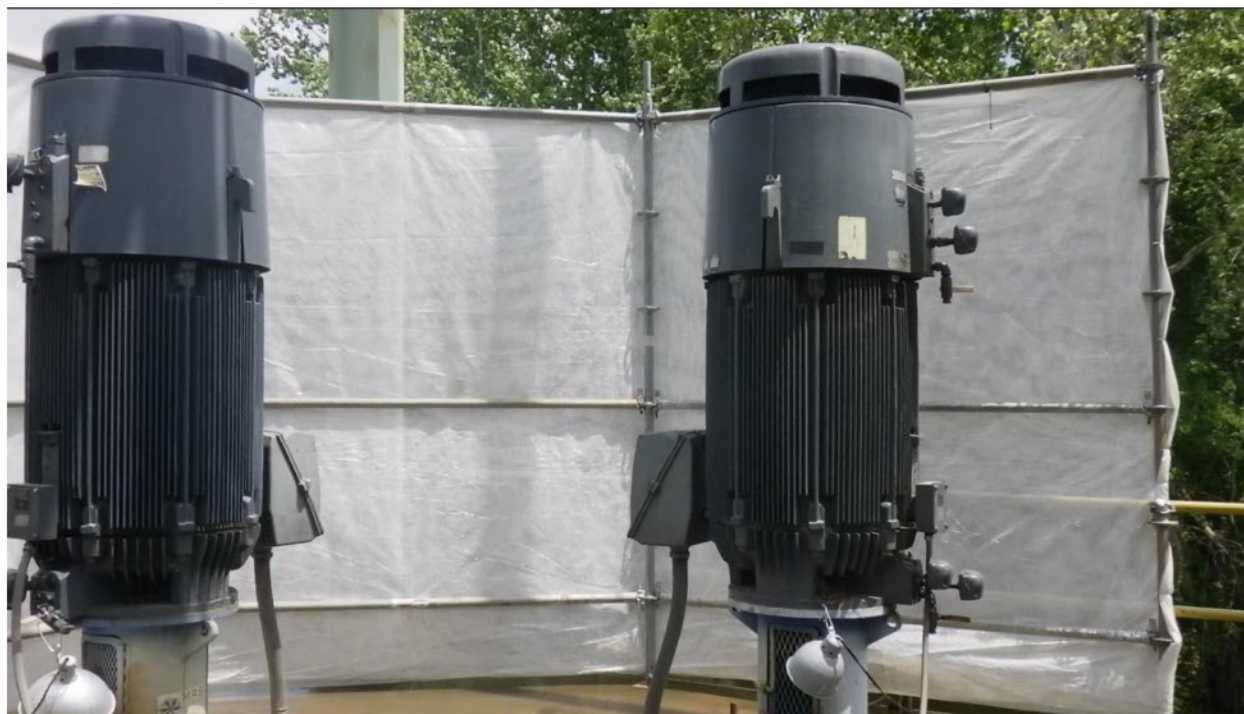
Photo No. 3

The pump intakes are set in a screened caisson structure designed to prevent large debris from entering the system with a smaller mesh screened structure inside of it further restricting smaller debris. A manual back-flush system is utilized to clear the screens of debris. At the time of the inspection, we could not see the screened structure (to prevent large debris from entering the system) and the smaller mesh screened structure inside of it (to prevent smaller debris).

Description: This image shows the water pumps that are used to intake fresh water from Bayou Bartholomew for the cooling and industrial processes at the facility. The water passes through intake units through vertical pumps withdrawing source water from the bayou.

1. Facility should provide more information about the manual back-flush system to clear the screens of debris, the screened structure (to prevent large debris from entering the system) and the smaller mesh screened structure inside of it (to prevent smaller debris) at the pumps intake area.
2. Facility needs to correct the overflow of foam material because of built up and low flow of material at the corner of the cooling water system.
3. Facility will update and provide a photo of missing label of outfall 005.
4. Facility will provide updates about SWPPP and SPCC plans.

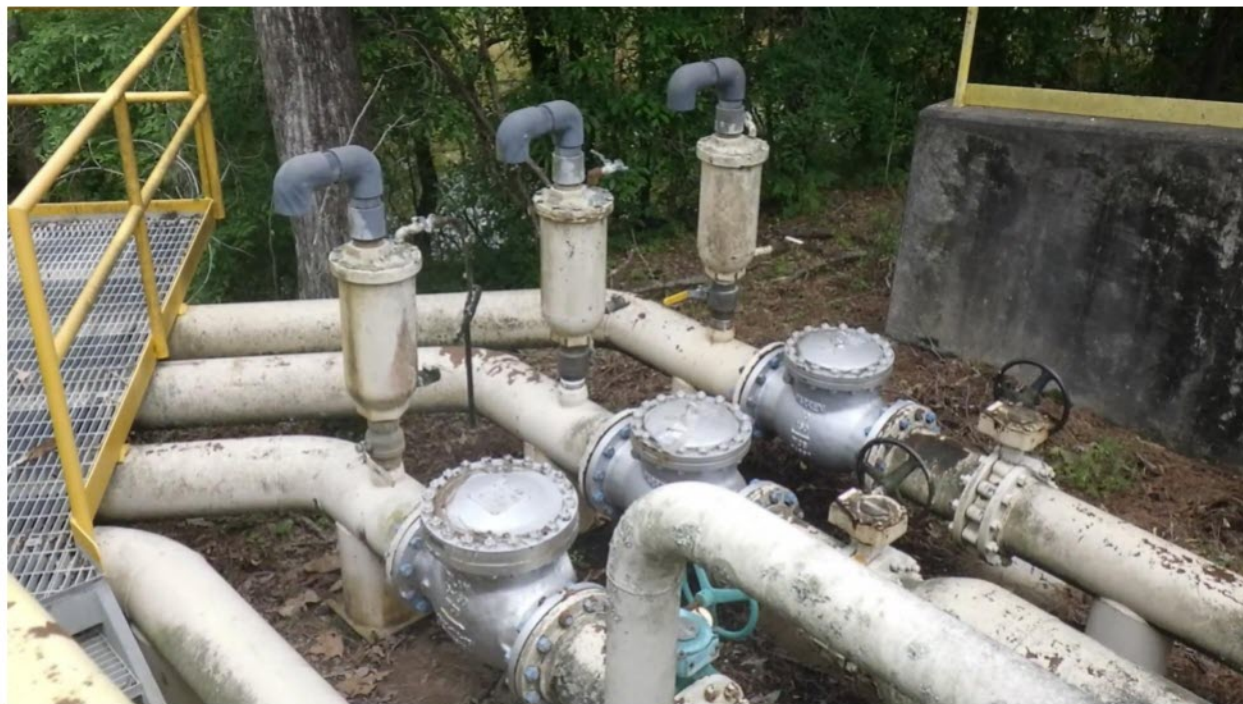
Photo No. 4

This image shows the intake pipe system. The water passes through the intake pipes because of the vertical pumps withdrawing source water from the bayou.

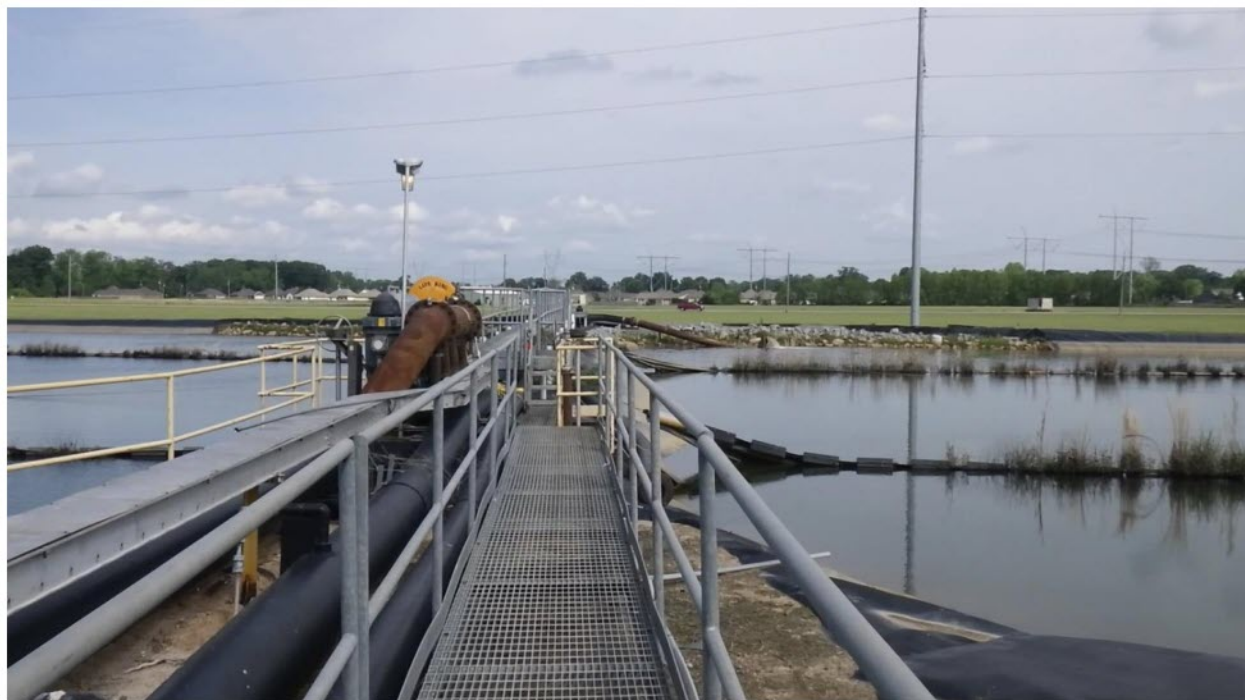
Photo No. 5

Raw water from the bayou is routed via an onshore manifold adjacent to the intake platform, thence to a common collector pipe, and subsequently to the facility raw water pond. At the time of the inspection, I did not observe any deficiencies on the intake, transfer, and discharge of the water to a water supply pond (See Photo Nos. 5 – 7 in Appendix 1).

This image shows the raw water pond receiving raw water from the bayou. The water is routed by pumps via an onshore manifold adjacent to the intake platform at the bayou, thence to a common collector intake pipe, and subsequently to the facility pond.

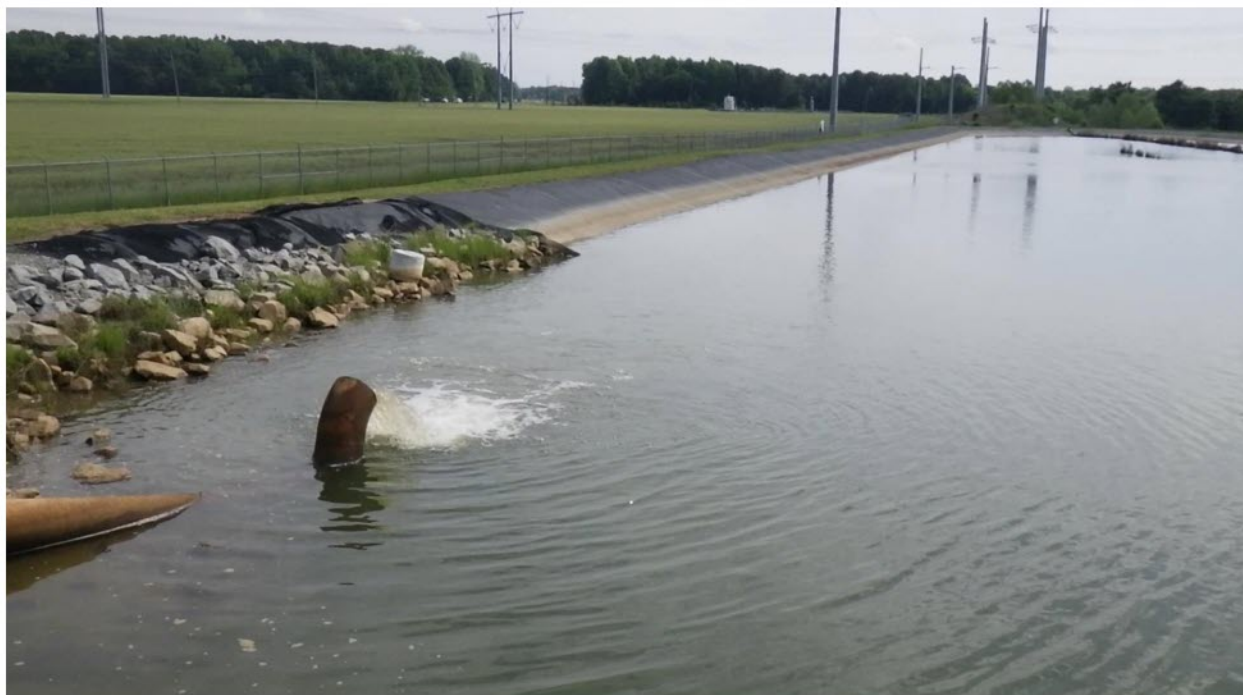
Photo No. 6

Description: This image shows the intake pipe discharging raw water from the bayou at the facility pond. The water is routed by pumps via an onshore manifold adjacent to the intake platform at the bayou, thence to a common collector intake pipe, and subsequently to the facility pond.

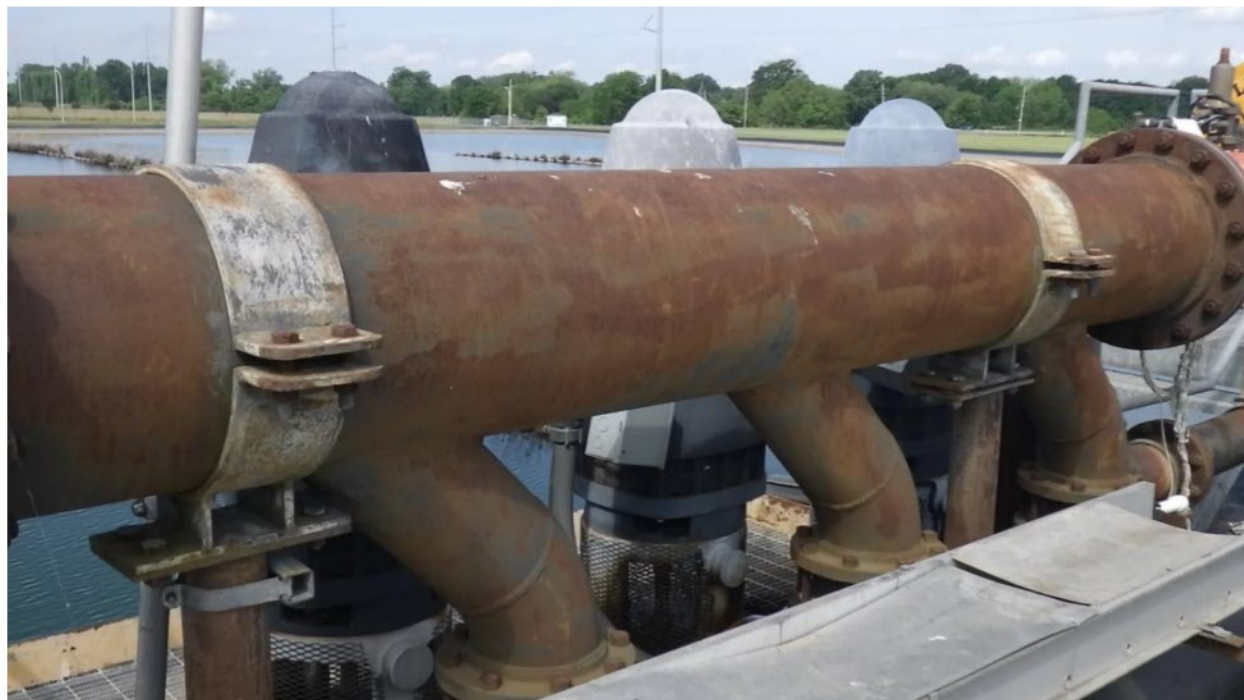
Photo No. 7

Description: This image shows three single-speed vertical industrial turbine circulating pumps (each with a pump rate of 3,080 GPM = 4.4 MGD). The third pump is redundant and utilized for back-up purposes only.

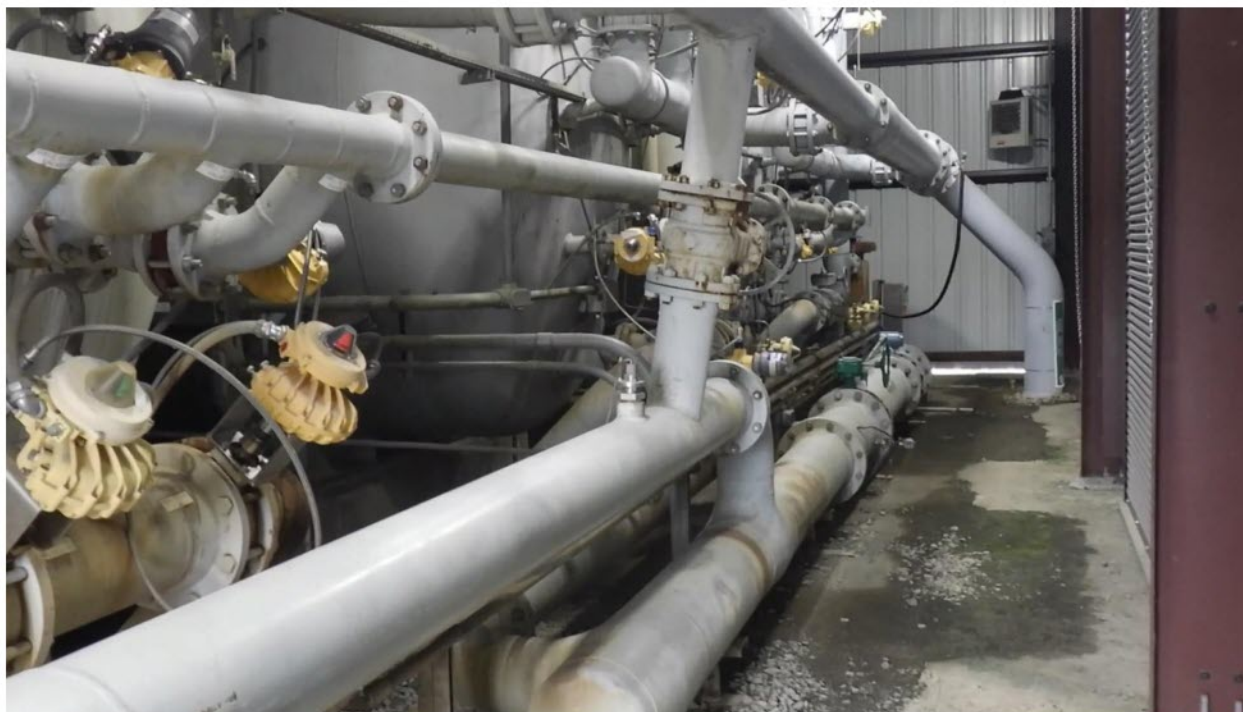
Photo No. 8

The purpose of the water sand filtration system is to remove solids from the river water (water intake procedure from Bayou Bartholomew connected to Quachita River) through sand filtration procedures. These procedures consist of filtration treatments through sand and pipe systems. These treatments improve the removal of solids from the river water. At the time of the inspection, I did not observe any deficiencies on the intake, filtration, and transfer of the water to a water supply tank system (See Photo Nos. 8 – 9 in Appendix 1).

Photograph File Name: SandFilter.JPG  
Date of Photograph: 04/25/2024  
Latitude and Longitude: 32.690174 -92.01887  
Orientation: SW  
Map Datum: WGS-84  
Time of Photo: 10:24 AM  
Photographer: Jack Arias  
Description: This image shows the water sand filtration system that remove solids from the river water through sand filtration procedures.

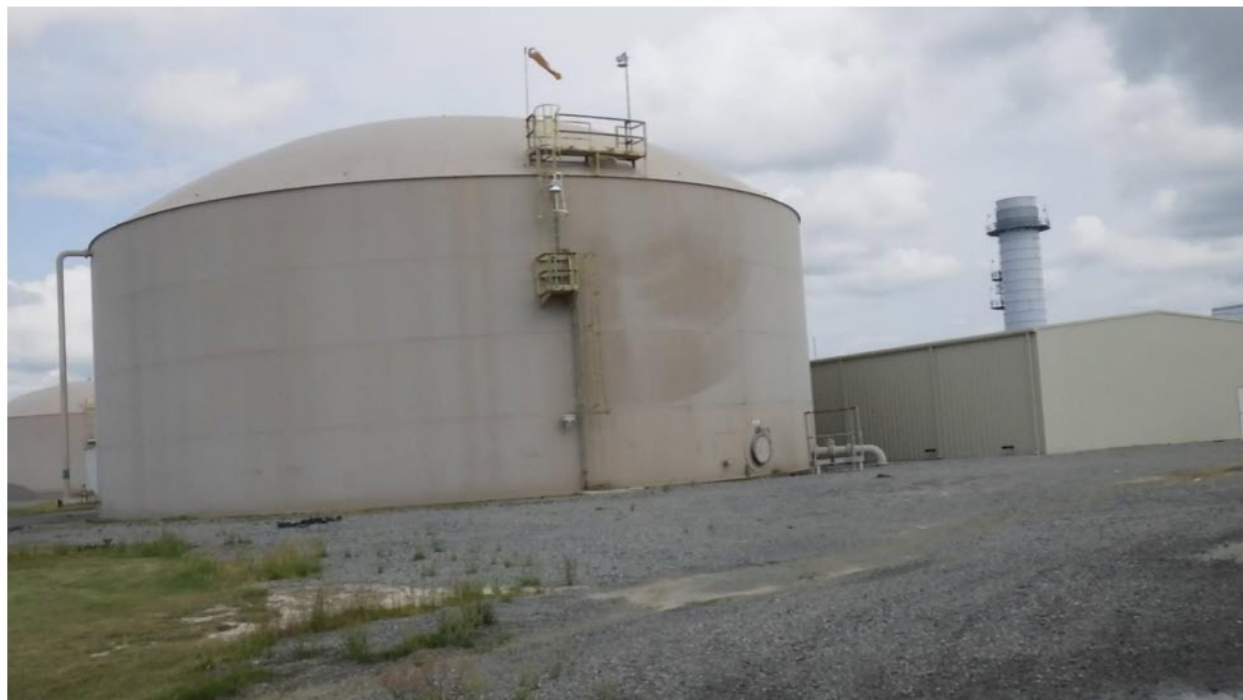
The facility water supply tank is approximately 1.00 MM gallon capacity holding reservoir. Its purpose is to provide capacity water to maintain facility operations for specific period of times. At the time of the inspection, I did not observe leaks on the tank and over other structures that form part of the supply tank (See Photo No. 9 in Appendix 1).

Photograph File Name: WaterSupplyTank.JPG  
Date of Photograph: 04/25/2024  
Latitude and Longitud: 32.689786 -92.018688  
Orientation: SW  
Map Datum: WGS-84  
Time of Photo: 10:30 PM  
Photographer: Jack Arias  
Description: This image shows the water supply tank. Its purpose is to provide capacity water to maintain facility operations for specific period of times.

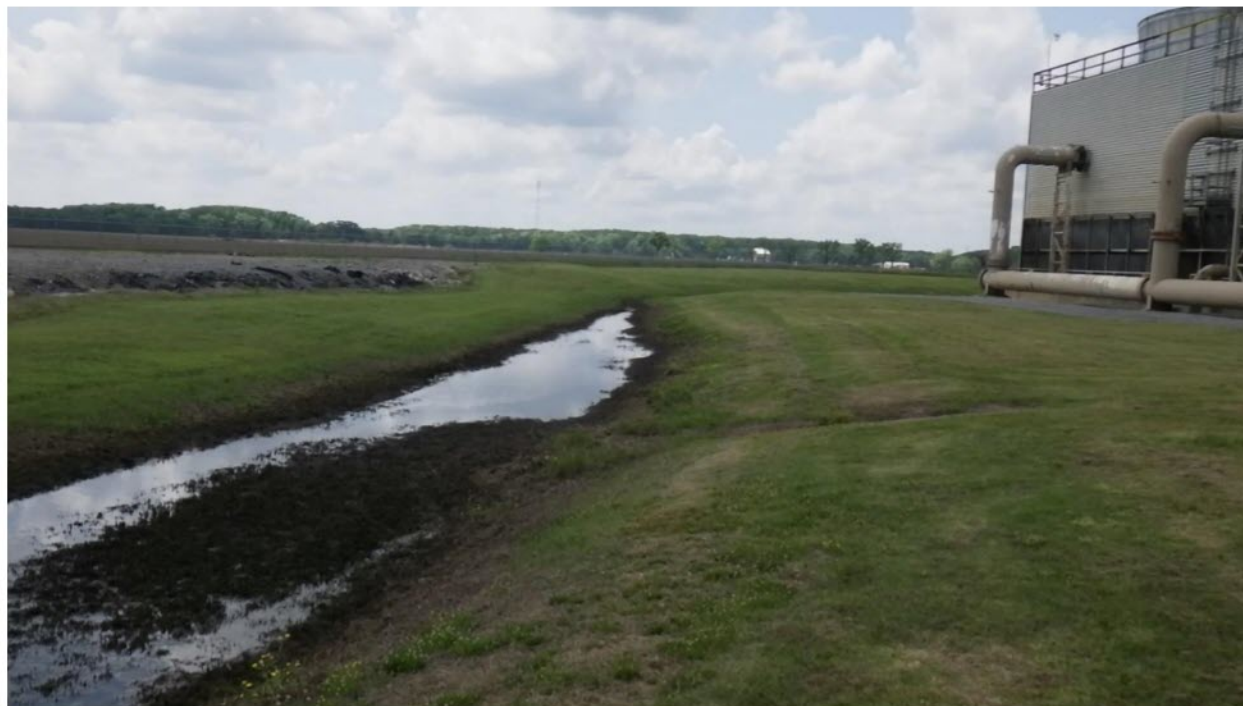
Photo No. 10

Photograph File Name: Canal.JPG  
Date of Photograph: 04/25/2024  
Latitude and Longitud: 32.689569 -92.017883  
Orientation: SW  
Map Datum: WGS-84  
Time of Photo: 10:40 AM  
Photographer: Jack Arias  
Description: This image shows a canal near the cooling water system.

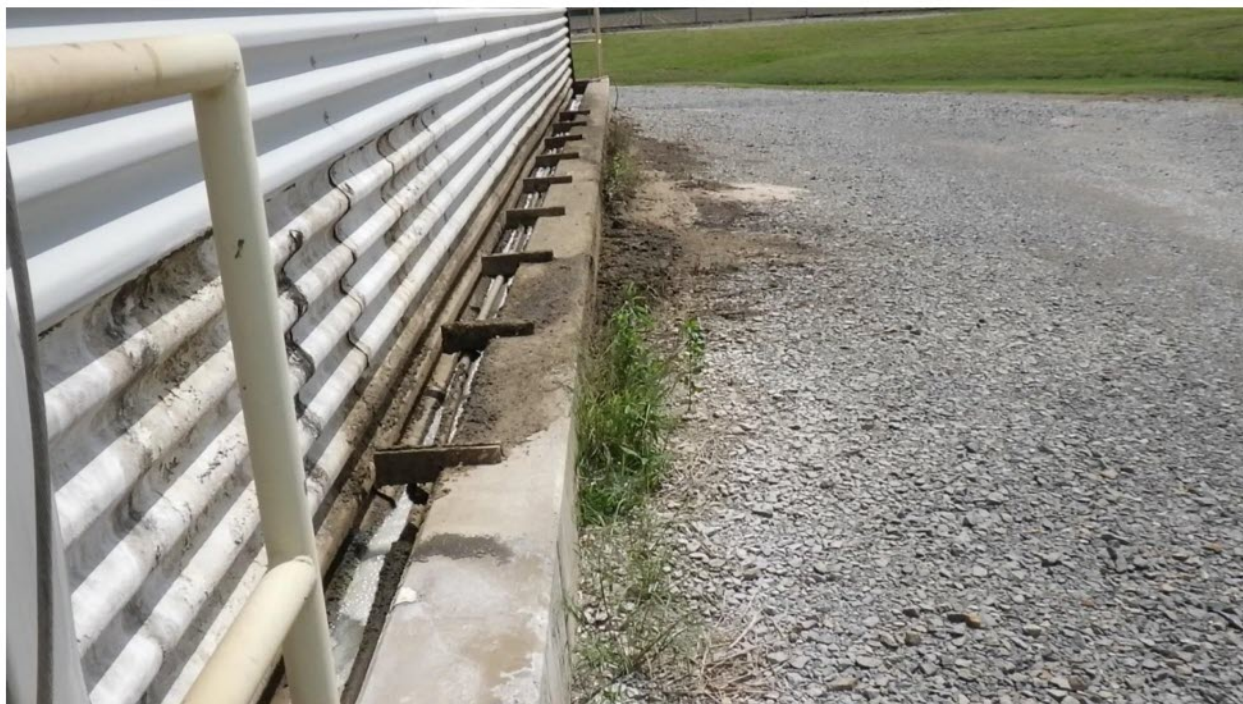
Photo No. 11

The Cooling Water Systems (GPI) operates several cooling tower systems. They are evaporative cooling designs, fan-induced upward draft with water falling over high surface area poly/fiberglass fill. The water is cooled in tower and circulated to the surface condensers, inter coolers, and after coolers on evaporator trains and concentrators. Water is then returned to the cooling tower. The water is recirculated for multiple cycles for water conservation. Water make-up is added, as needed, to account for blowdown and evaporation. There was not a problem or malfunctions on the recirculating system. However, I observed an overflow of foam material potentially because of built up and low flow of material at the corner of the cooling water system (See Photo Nos. 10 - 12 in Appendix 1).

Photograph File Name: OverflowFoam.JPG  
Date of Photograph: 04/25/2024  
Latitude and Longitud: 32.688937 -92.018291  
Orientation: SW  
Map Datum: WGS-84  
Time of Photo: 10:45 PM  
Photographer: Jack Arias  
Description: This image shows overflow of foam material because of built up and low flow at the corner of the cooling water system.

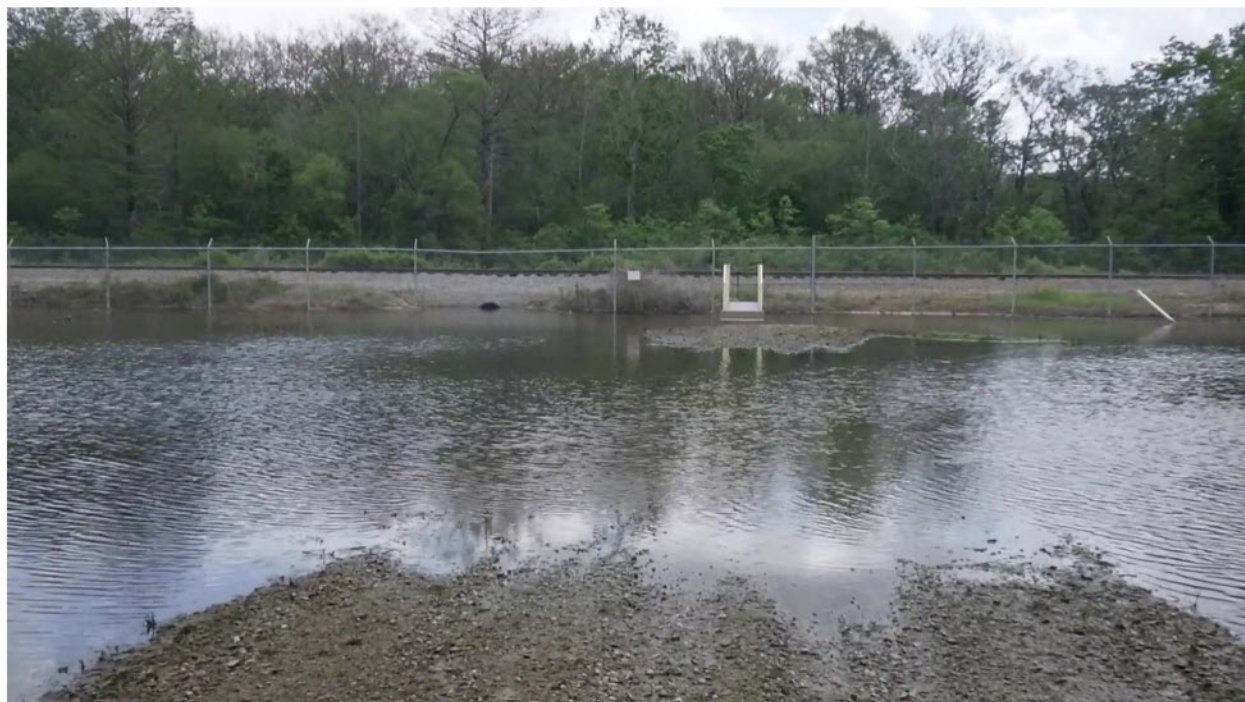
This outfall includes a continuous discharge of cooling tower blowdown, (including RO reject and backwash from the microfiltration units and HRSG blowdown). Outfall 102 discharges into outfall 001, thence to unnamed tributary and little Bayou Boeuf. There was flow and discharge at the time of the inspection and the water was brown tint (See Photo No. 13 in Appendix 1).

This outfall includes intermittent discharge of stormwater runoff from the cooling tower area and the area south of the facility power block, de minimus amounts of maintenance wastewaters, and previously monitored hydrostatic test water from Outfall 003. Outfall 001 discharges to an unnamed tributary and thence little Bayou Boeuf. There was flow and discharge at the time of the inspection and the water had a brown tint (See Photo No. 13 in Appendix 1).

Description: This image shows the internal outfall 102. This outfall includes a continues discharge of cooling tower blowdown, RO reject, and backwash from the microfiltration units and blowdown system.

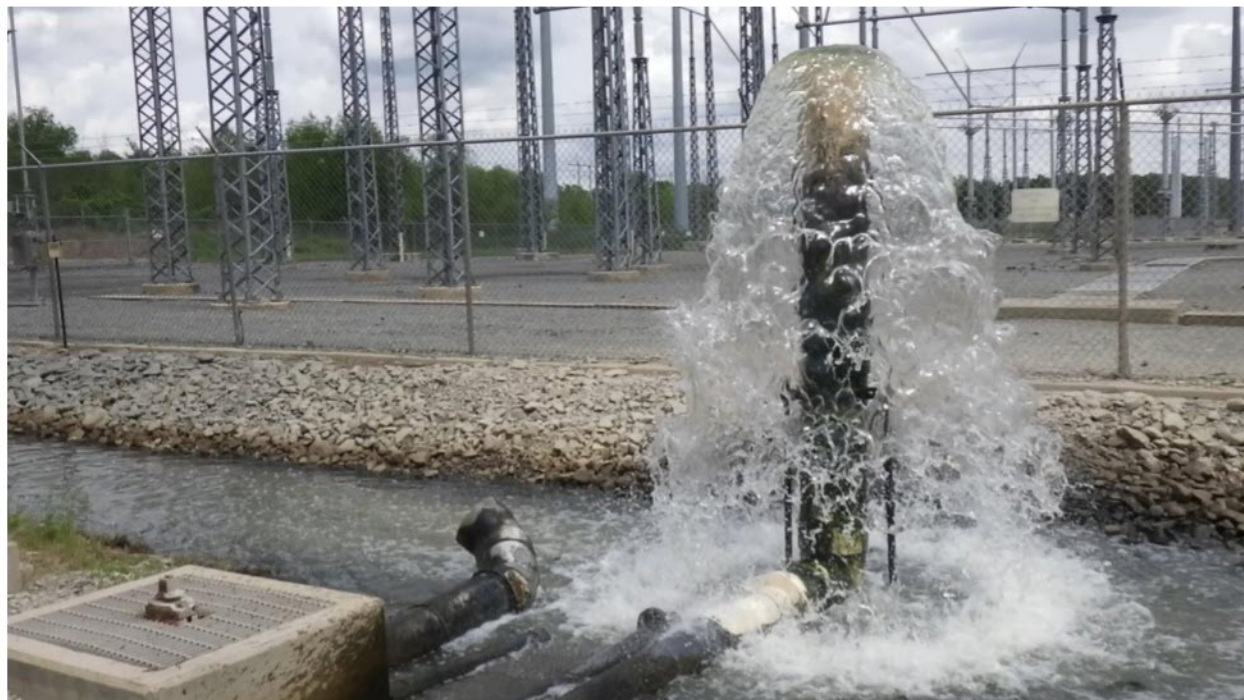
This outfall includes an intermittent discharge of low volume wastewaters and miscellaneous non-process Wastewaters. Outfall 202 is in the southeast corner of the site, near Outfall 101. Outfall 202 discharges into outfall 002, thence to unnamed tributary, and little Bayou Boeuf. There was flow and discharge at the time of the inspection and the water was clear (See Photo No. 14 in Appendix 1).

Description: This image shows the internal outfall 202 with an intermittent discharge of low volume wastewaters and miscellaneous non-process wastewaters.

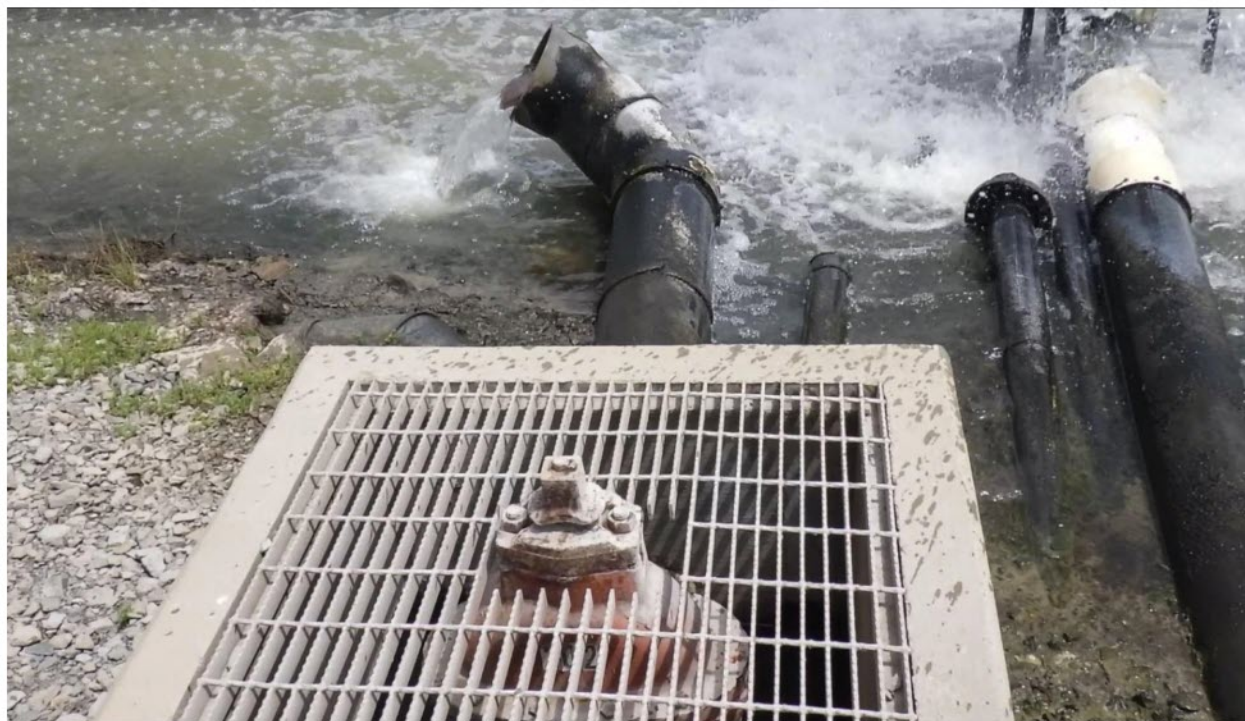
Photo No. 15

This outfall includes an intermittent discharge of oily wastewater and hydrostatic test water. Outfall 101 discharges into outfall 002, thence to unnamed tributary and little Bayou Boeuf. There was flow and discharge at the time of the inspection and the water was clear (See Photo Nos. 15 - 16 in Appendix 1).

Photograph File Name: InternalOutfall101.JPG  
Date of Photograph: 04/25/2024  
Latitude and Longitud: 32.692154 -92.018361  
Orientation: SE  
Map Datum: WGS-84  
Time of Photo: 11:35 AM  
Photographer: Jack Arias  
Description: This image shows the internal outfall 101 with an intermittent discharge of oily wastewaters and hydrostatic test water.

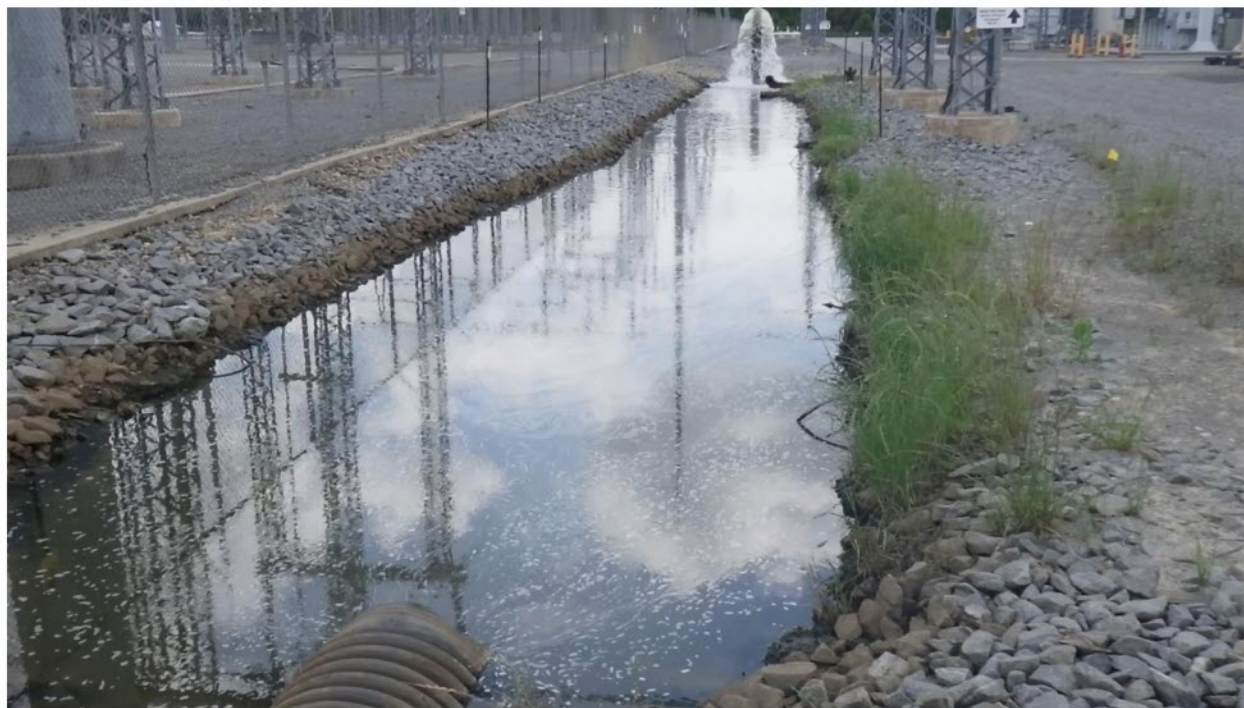
Photo No. 16

Photograph File Name: IntOutfalls.JPG  
Date of Photograph: 04/25/2024  
Latitude and Longitud: 32.692399 -92.018928  
Orientation: NE  
Map Datum: WGS-84  
Time of Photo: 11:45 AM  
Photographer: Jack Arias  
Description: This image shows the wastewater flow coming from internal outfalls 202 and 101.

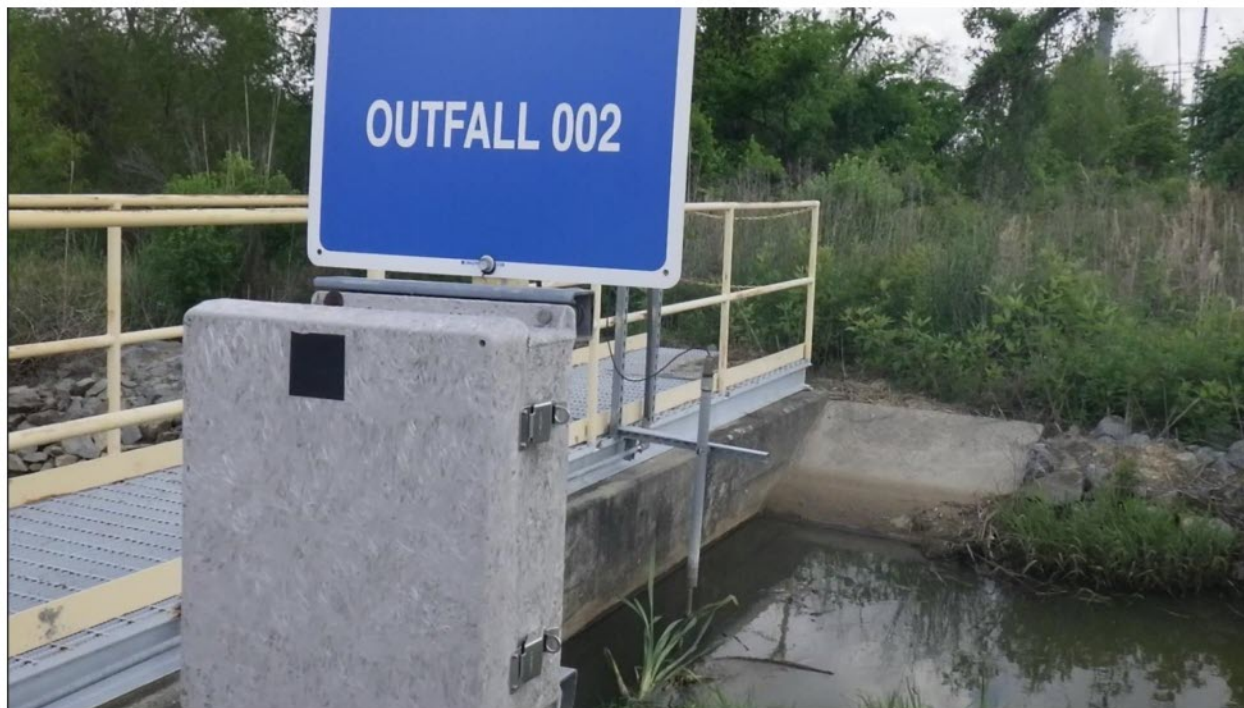
Photo No. 17

This outfall receives and includes continuous discharge of stormwater runoff from the facility power block area, previously monitored wastewaters from Outfalls 102, 202, and 003, and de minimus amounts of maintenance wastewaters. Outfall 002 is in the northeast portion of the property prior to discharge into unnamed tributary thence little Bayou Boeuf. I observed outfall 002 where there was flow and discharge at the time of the inspection and the water had a brown tint (See Photo Nos. 17 - 18 in Appendix 1).

Description: This image shows the outfall 002. This outfall is receiving continuous discharge of stormwater runoff from the facility power block area, wastewaters from Outfalls 102, 202, and 003, and maintenance wastewaters.

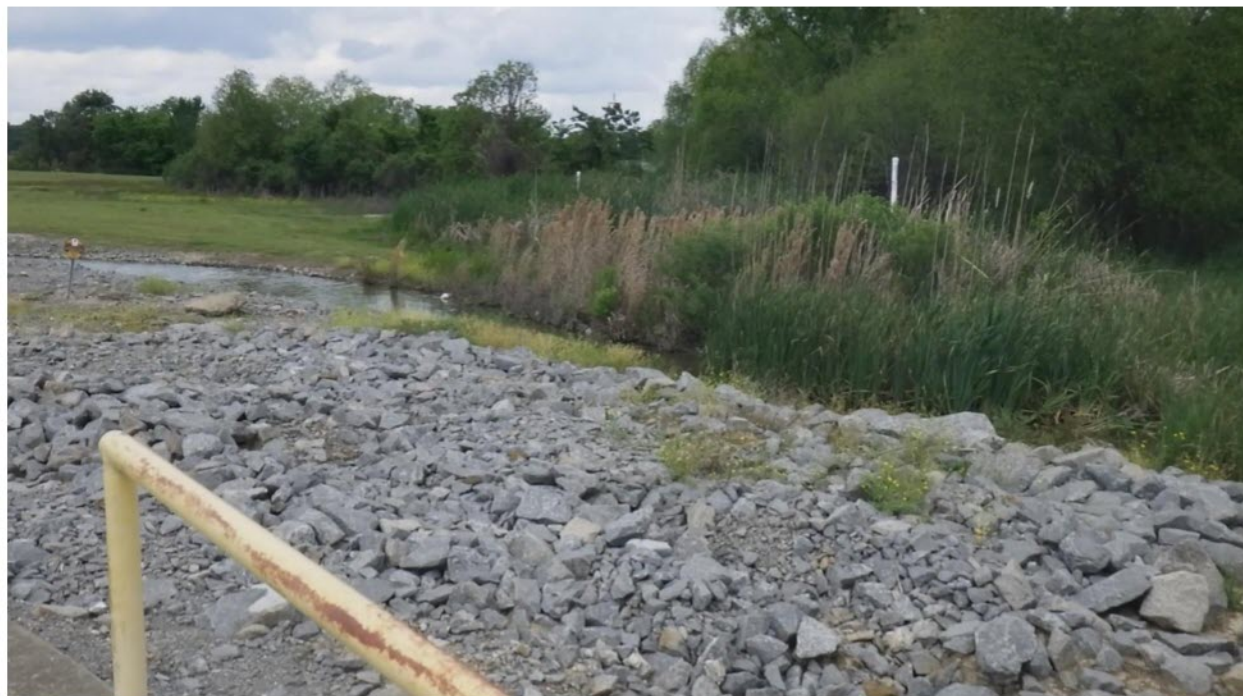
Photo No. 18

Photograph File Name: UpstreamOutfall002.JPG  
Date of Photograph: 04/25/2024  
Latitude and Longitude: 32.692668 -92.019553  
Orientation: NE  
Map Datum: WGS-84  
Time of Photo: 12:25 PM  
Photographer: Jack Arias  
Description: This image shows upstream of outfall 002. This stream receives discharge of stormwater runoff from the external areas around the facility.

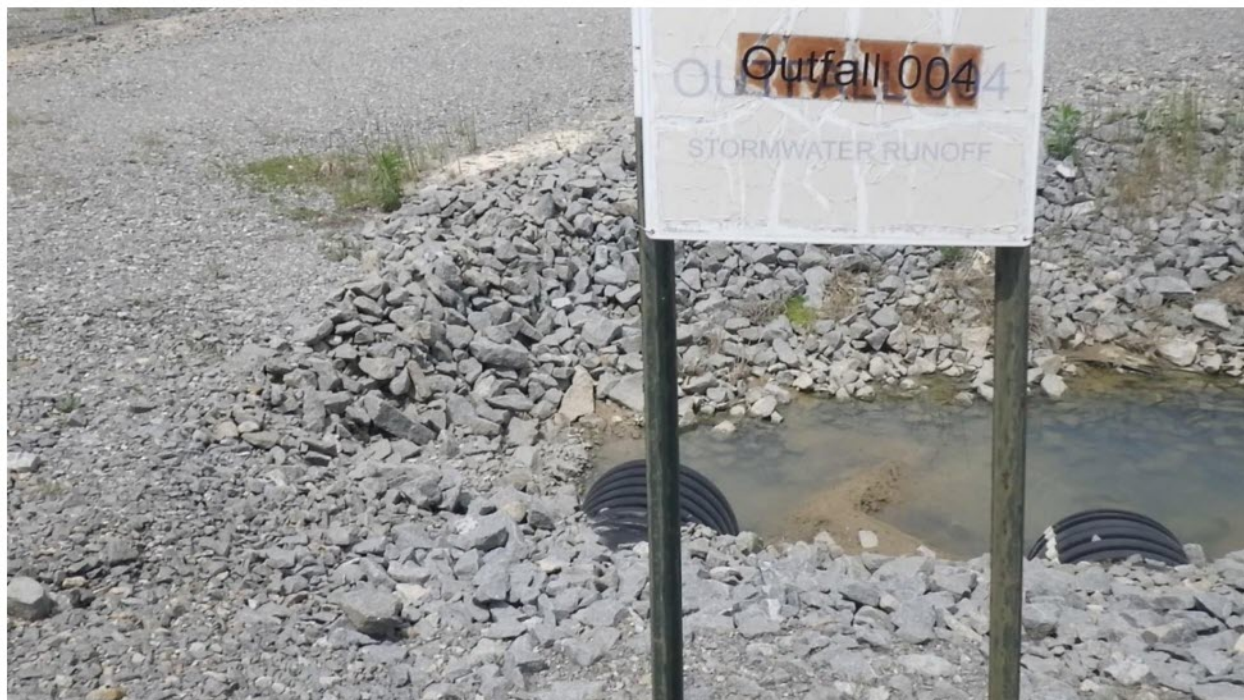
This outfall includes intermittent discharge of stormwater runoff from the glycol scrubber area and the western area of the facility power block, previously monitored wastewater from Outfall 003, and de minimus amounts of maintenance wastewaters. Outfall 004 is centrally located within the facility and discharges into unnamed tributary, thence little Bayou Boeuf. I observed outfall 004 where there was not flow or discharge at the time of the inspection and the water had a green-brown tint (See Photo No. 19 in Appendix 1).

This image shows outfall 004. This outfall includes intermittent discharge of stormwater runoff from the glycol scrubber area and the western area of the facility power block, wastewater from Outfall 003, and de minimus amounts of maintenance wastewaters.

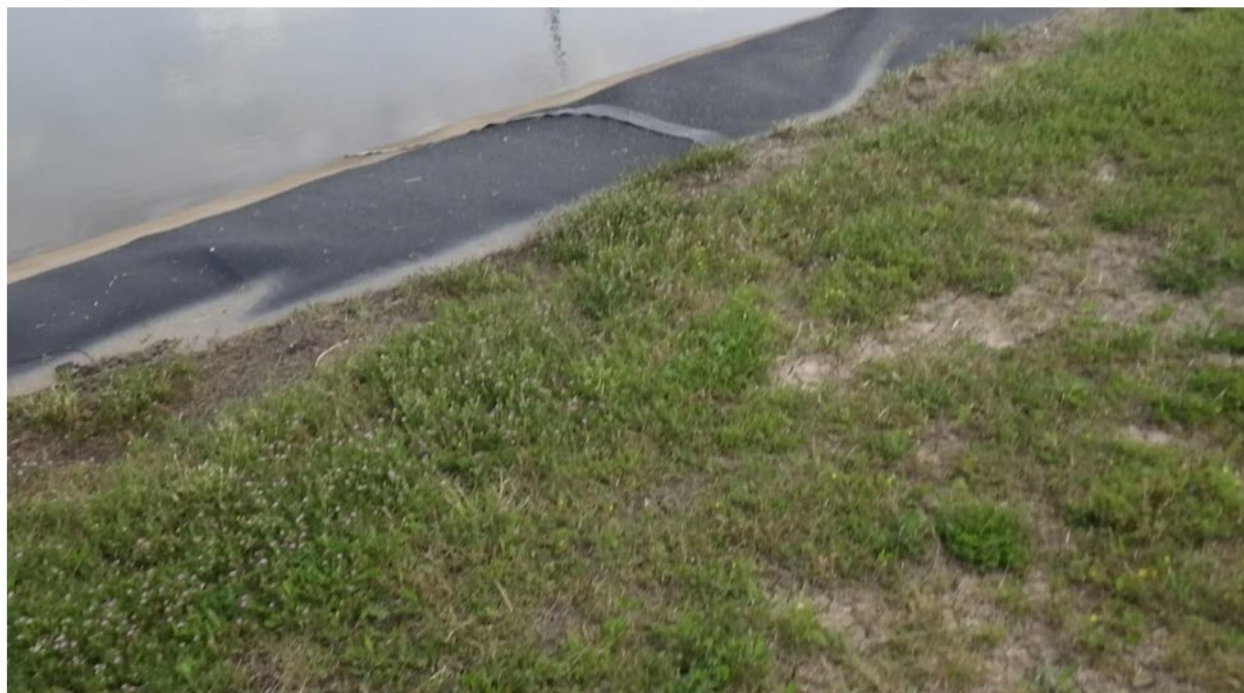
This outfall includes intermittent discharge of water from the raw water pond. I observed outfall 005 did not have an identification tag and there was no flow or discharge at the time of the inspection. (See Photo No. 20 in Appendix 1).

Photograph File Name: Outfall005.JPG  
Date of Photograph: 04/25/2024  
Latitude and Longitud: 32.693495 -92.021497  
Orientation: N  
Map Datum: WGS-84  
Time of Photo: 1:20 PM  
Photographer: Jack Arias  
Description: This image shows the Outfall 005 (near the pond area). This is an intermittent discharge of water from the raw water pond.
