**U.S. ENVIRONMENTAL PROTECTION AGENCY  
REGION III WATER BRANCH, ENFORCEMENT  
AND COMPLIANCE ASSURANCE DIVISION  
CLEAN WATER ACT  
COMPLIANCE INSPECTION REPORT**

**Name of Facility:** Shenandoah Wastewater Treatment Plant  
**Facility Address:** 3 Mount Olive Blvd. Shenandoah, PA 17976  
**Mailing Address:** 424 Raven Run Rd. Shenandoah, PA 17976

Report Prepared on: December 21, 2023 By: Mike Beck,  
Date Signature

**DSB-ID:** ECAD-5366

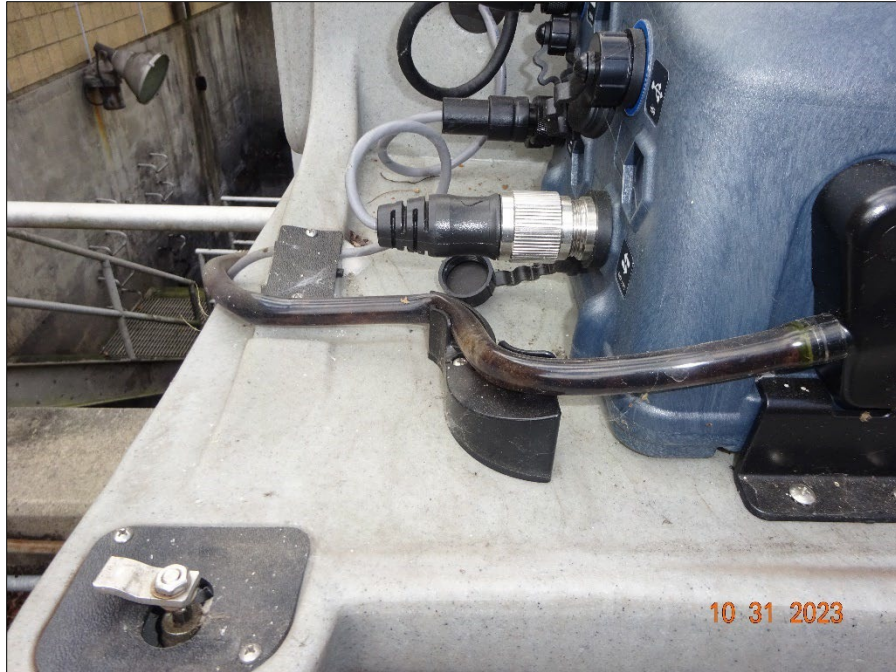
Photograph 7. DSC04755.JPG

**Observation 4.** The influent and effluent composite sampler intake tubing was fouled with biological growth and needed replacement/cleaning (see Appendix B Photograph 7 and

Description: Biological growth in the composite sampler intake tubing.

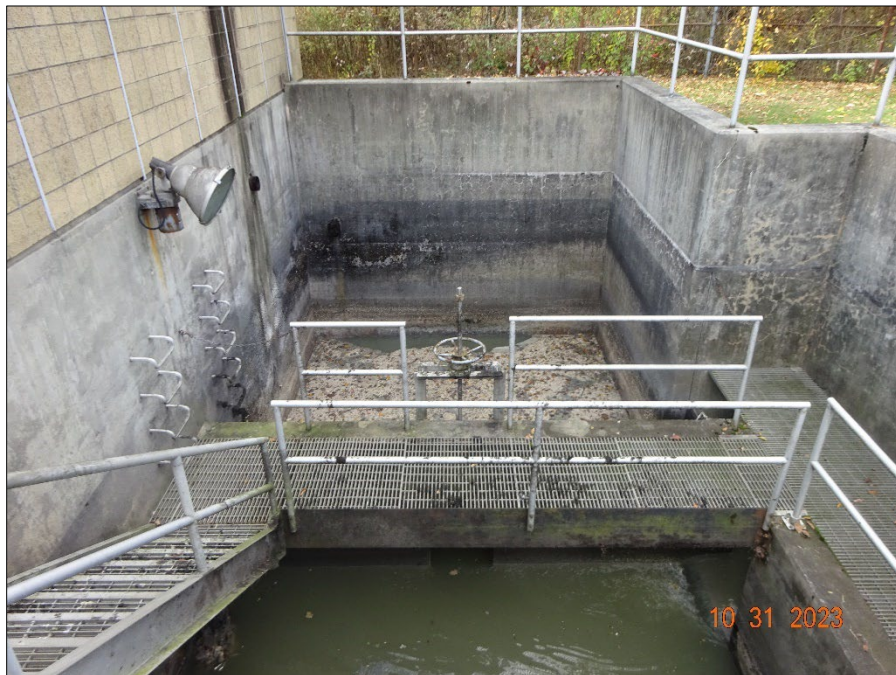
Photograph 8. DSC04757.JPG

From the wet well, the wastewater flows to the pumphouse. At the time of inspection, there was substantial grease accumulation on the water surface (see Appendix B Photograph 8). The operation team stated that the basin is cleaned about twice a year. It is at this location where magnesium hydroxide is injected to control alkalinity and pH (see Appendix B Photograph 10). However, the operations team was applying soda ash (sodium carbonate) premixed with water as an alternative to magnesium hydroxide due to the reliability concerns of the feed system. Soda ash is applied at a rate of one to two bags at a time per the results of the pH test to maintain a pH of 6.6 or higher (see Appendix B Photograph 11). All influent pumps were reported to be operational with two new valves installed in 2023 (see Appendix B Photograph 9). From the pumphouse, the wastewater flows to the primary clarifier. The primary clarifier was offline at the time of inspection and was reported to be down since summer (see Appendix B Photograph 12). From the primary clarifier, wastewater flows to the aeration basins.

Description: Grease accumulation in the influent wet well.

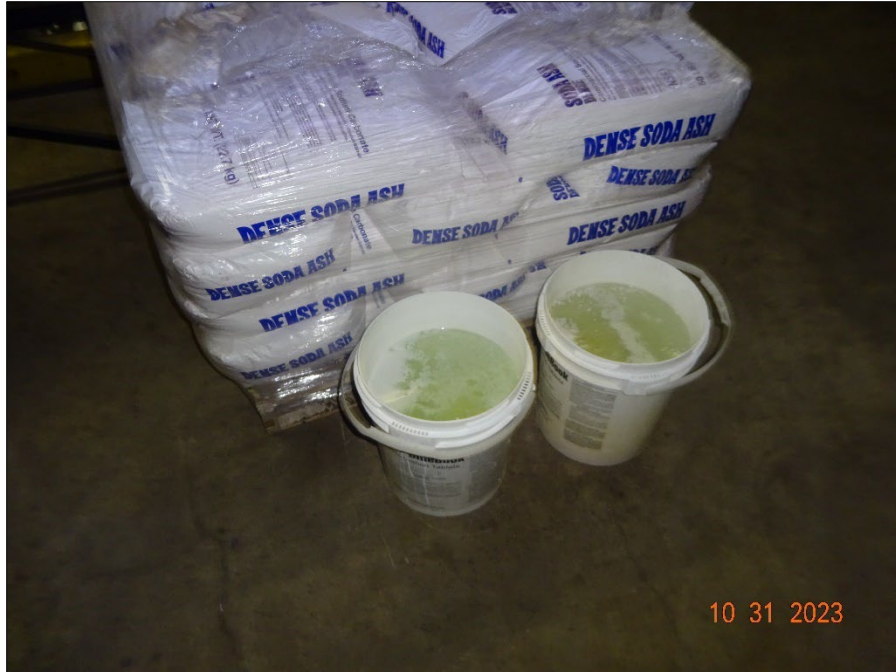
Photograph 11. DSC04836.JPG

- Photograph 27). The operator had no record of the last time the tubing was replaced at either location.
- Observation 5.** The Plant did not have secondary containment for bulk storage of soda ash, used oil drums, and a variety of other liquids stored across site. The Inspection Team did not observe spill containment equipment at any of these locations (see Appendix B Photograph 11 and Photograph 43).

Description: Soda ash storage and premixed bucket of the solutions ready to be applied.

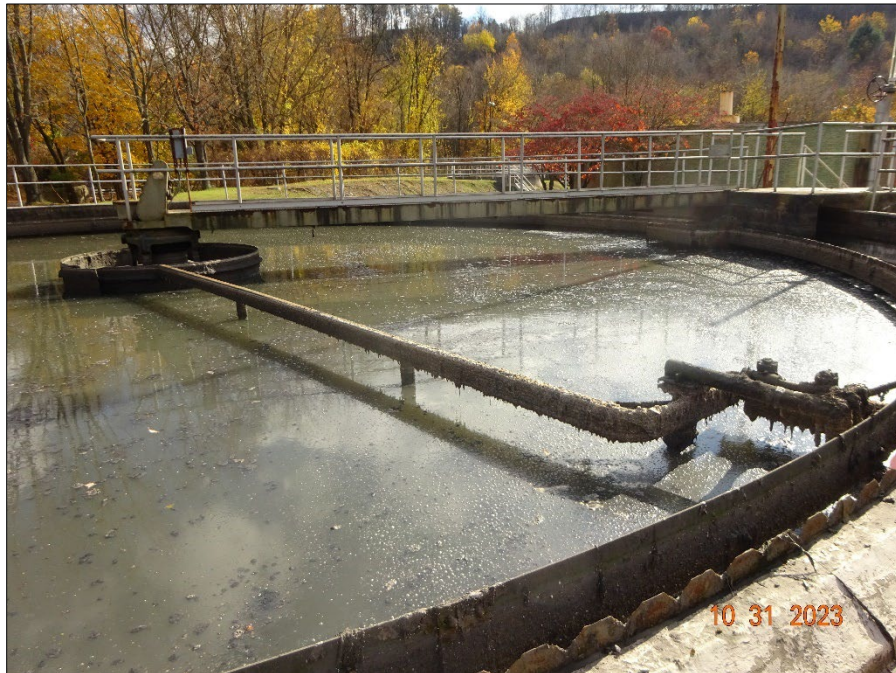
Photograph 12. DSC04767.JPG

**Observation 2.** Multiple critical pieces of equipment were out of service at the time of inspection including the primary clarifier and sludge press. With the primary clarifier offline, the wastewater bypassed the clarifier and flowed directly to Aeration Basin 1. Operational staff said they are waiting on a replacement feed pump for the sludge press (see Appendix B Photograph 12, Photograph 18).

Description: Offline primary clarifier.

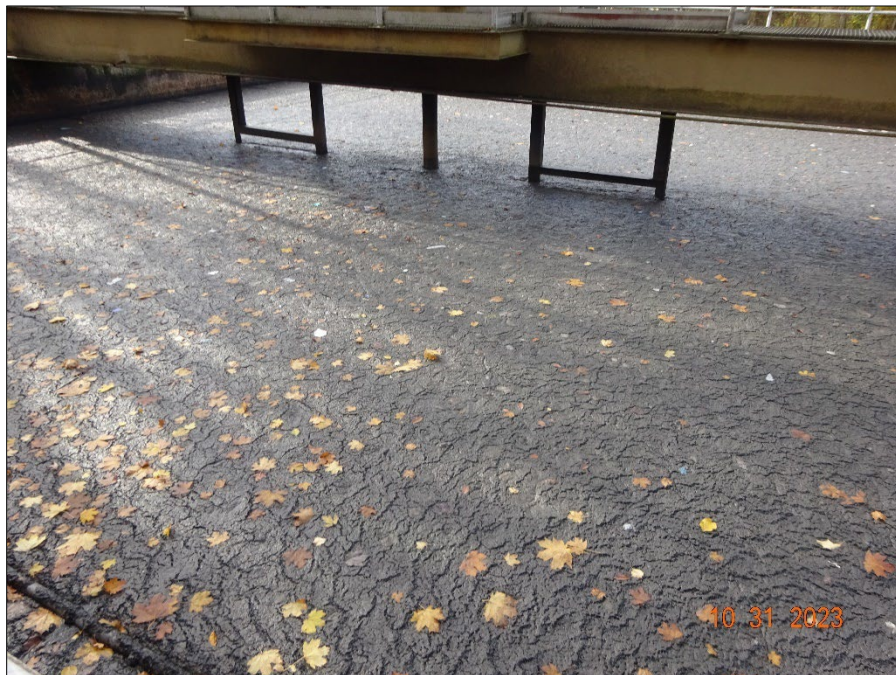
**Observation 3.** At the time of inspection, the sludge press was offline, Aeration Basin 2 was currently being used for sludge holding and decant thickening before the sludge is sent to the anaerobic digesters or hauled offsite (see Appendix B Photograph 14). Portable pumps and temporary lines were used to move wastewater and sludge to the digesters and Aeration Basin 2. Per the operational staff, both digester units have been reported to be down since the summer.

Photograph 14. DSC04784.JPG  
Description: Aeration Basin 2, currently being used for sludge storage and liquid decanting.

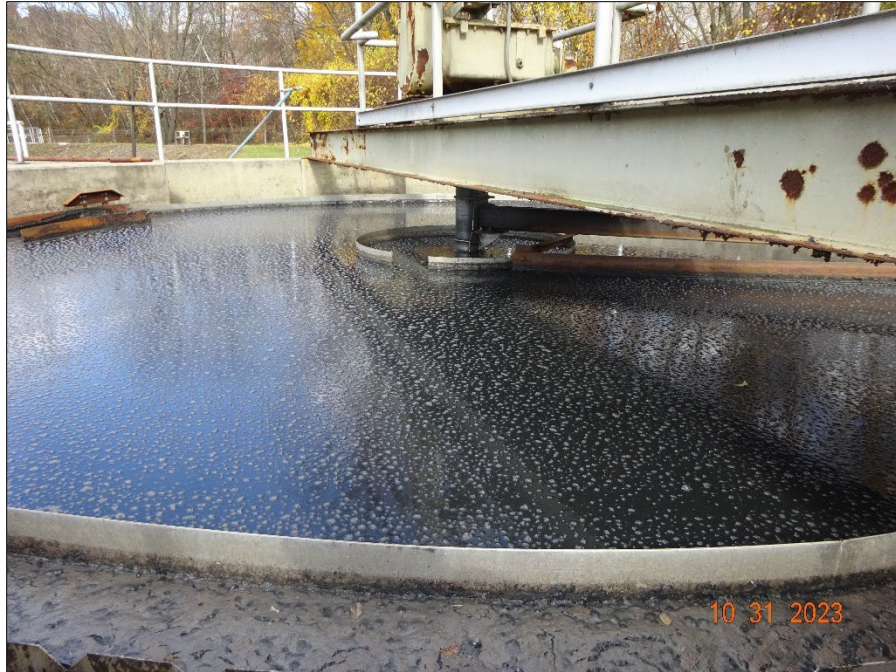
The sludge thickener was also reported to be offline since summer. The Inspection team observed significant sludge had accumulated on the surface and compacted in the weirs (see Appendix B Photograph 17). From the sludge thickener, sludge is then sent to the two sequential digesters and finally to the sludge press for dewatering (see Appendix B Photograph 18). However, at the time of the inspection, the sludge press was out of service, and sludge was currently being removed by sludge haulers from Aeration Basin 2 and sent to Hazelton for disposal.

Photograph 17. DSC04774.JPG  
Description: Sludge Thickener, currently offline.

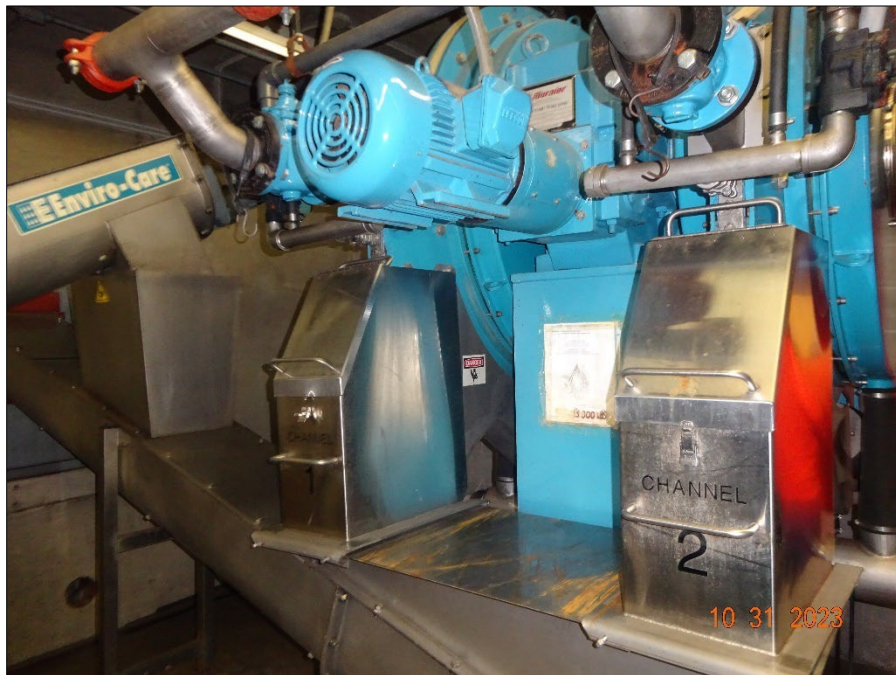
Photograph 18. DSC04828.JPG  
Description: Sludge press, currently offline.

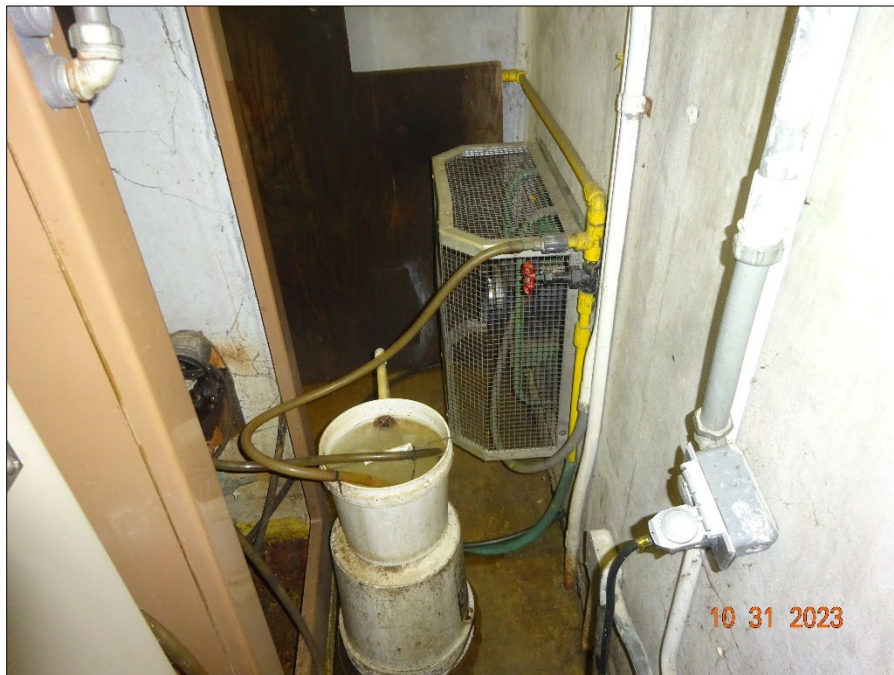
- Observation 7.** The thermometer inside the Effluent Composite Sampler was reporting above 11°C at the time of inspection (see Appendix B Photograph 29). Furthermore, the sample was collected into a 5-gallon bucket before being collected into the sampler; the sample aliquot in the 5-gallon bucket was not under any refrigeration (see Appendix B Photograph 26).

Photograph 26. DSC04810.JPG  
Description: Five-gallon buck for effluent composite sampler withdraw.

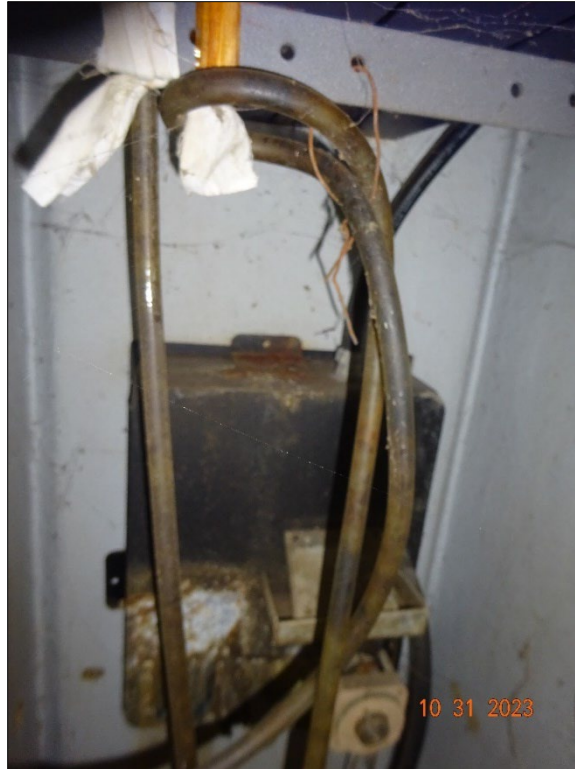
Photograph 27. DSC04811.JPG  
Description: Fouled effluent composite sample line.

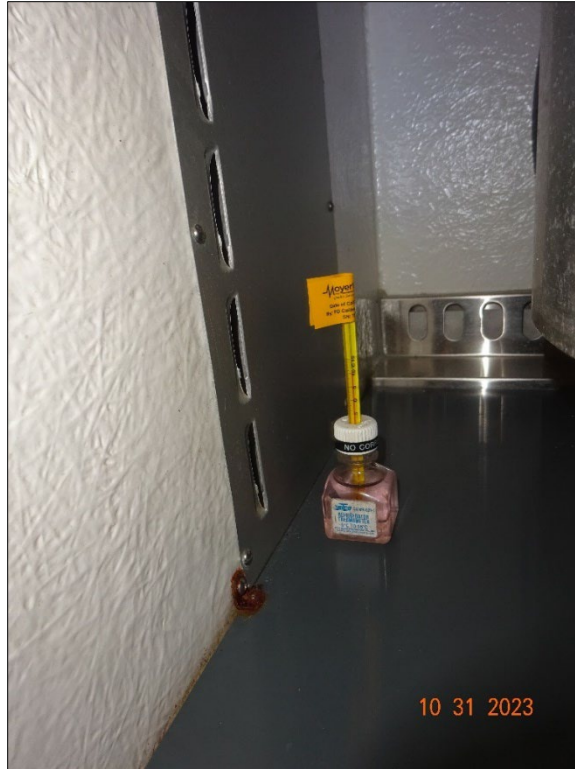
Photograph 29. DSC04809.JPG

Description: Thermometer inside the Effluent Composite Sampler, thermometer was reading  $> 10^{\circ}\text{C}$ .

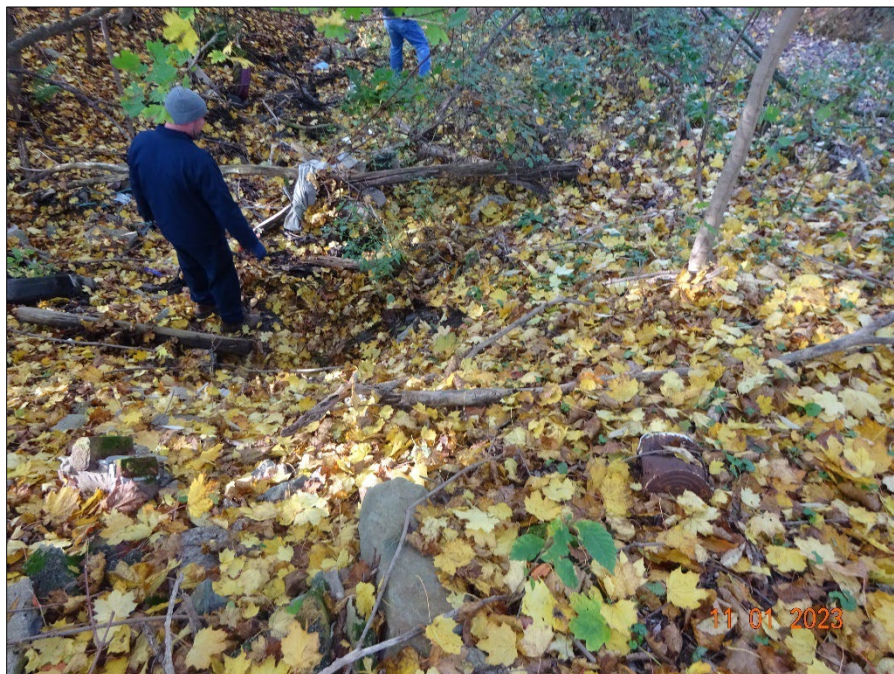
**Observation 13.** SMSA staff were not able to physically locate 014, 008, 009 and therefore cannot confirm discharge status at the time of monitoring as required by the permit (see Appendix B. Photograph 38, Photograph 40, Photograph 42). Discharge observations were being made from the nearest manhole upstream and not where it enters the receiving water.

Photograph 38. DSC04894.JPG  
Description: CSO Outfall 014 anticipated location, pipe was not able to be located.

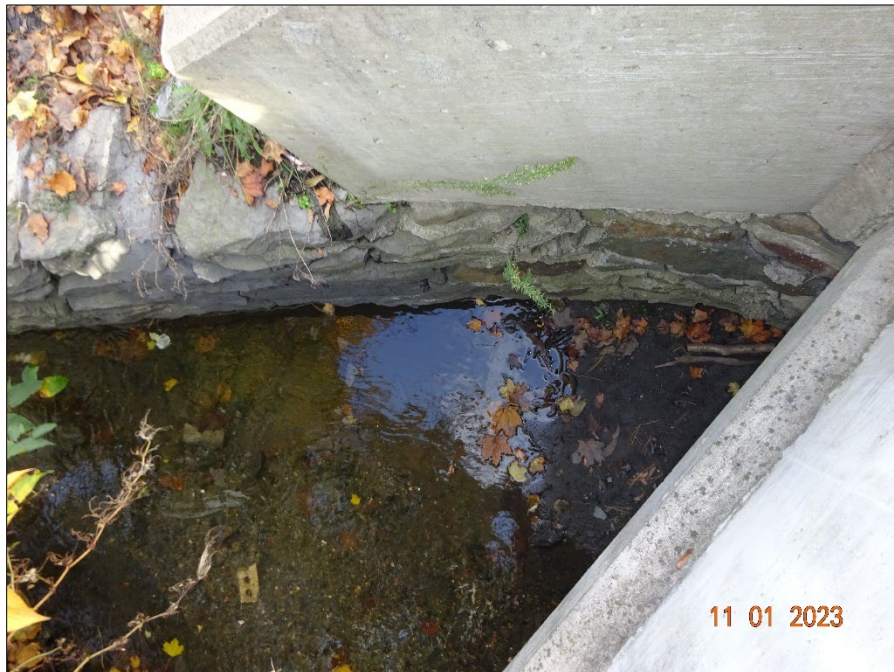
Photograph 40. DSC04904.JPG  
Description: CSO Outfall 008 anticipated location, the outlet was not able to be located.

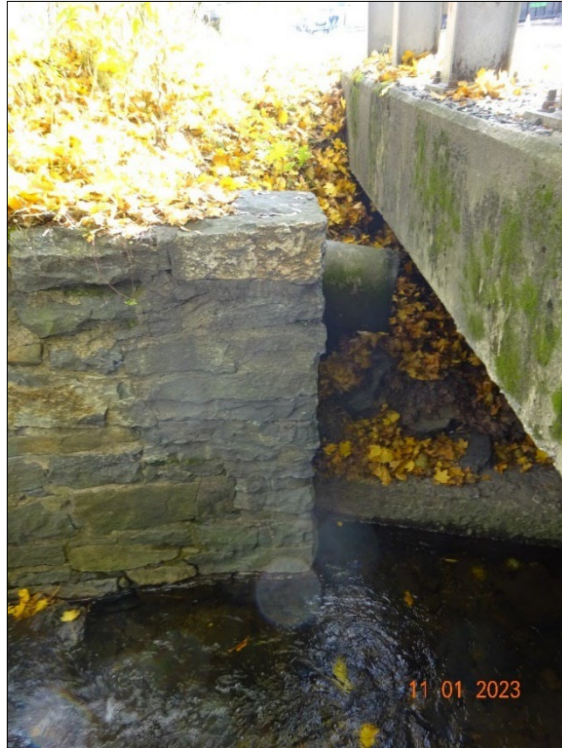
Photograph 42. DSC04917.JPG  
Description: CSO 009 anticipated location, the outlet was not able to be located.

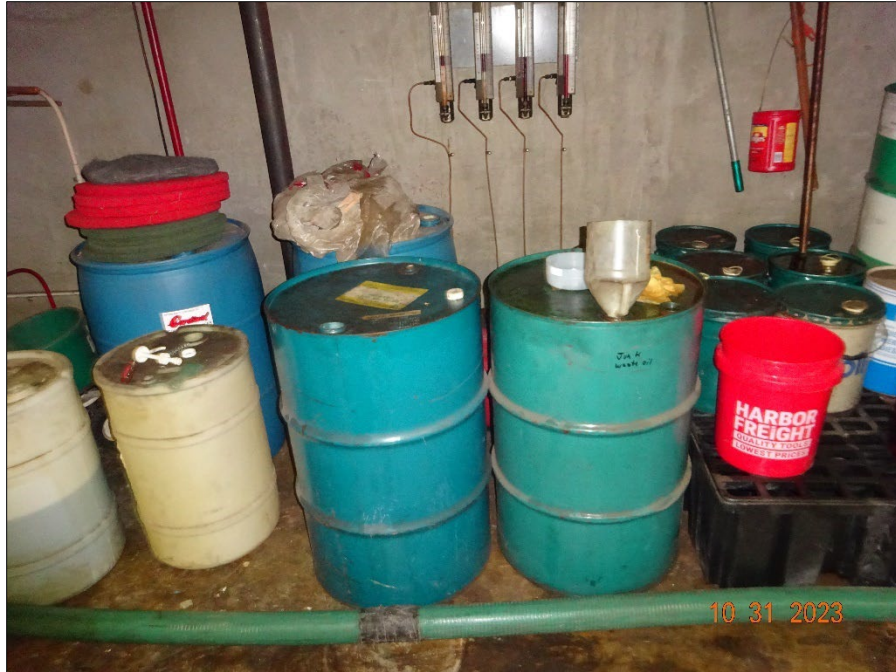
Photograph 43. DSC04838.JPG

Description: Oil and chemical storage area, note; not all drums and containers are in secondary containment.

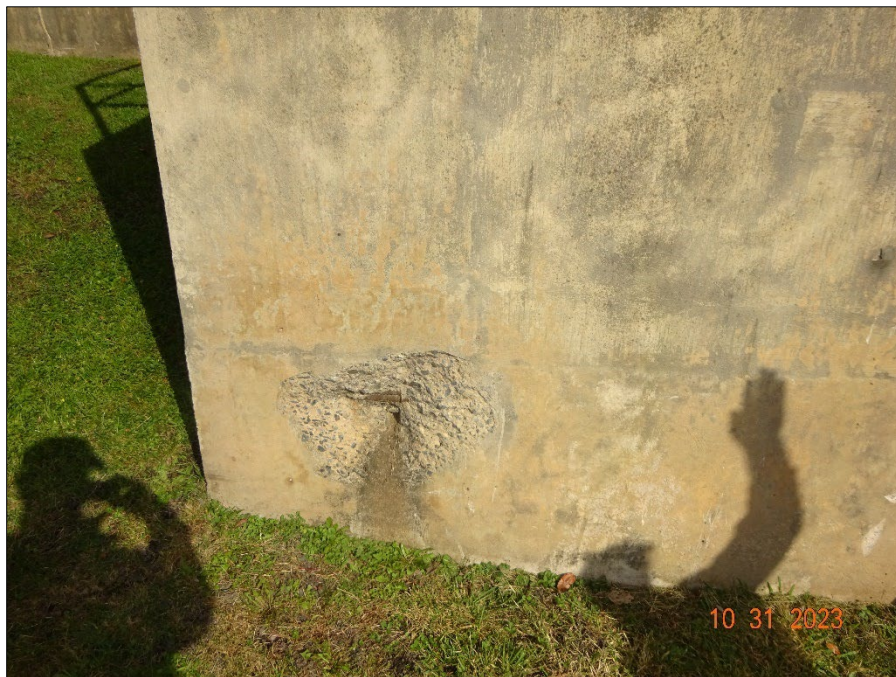
Photograph 44. DSC04769.JPG

- Observation 8.** Spalling concrete was observed in multiple areas across the Plant, with some spalling exposing the rebar underneath (see Appendix B Photograph 44 and Photograph 45).

Description: Spalling concrete observed at the Primary Clarifier.

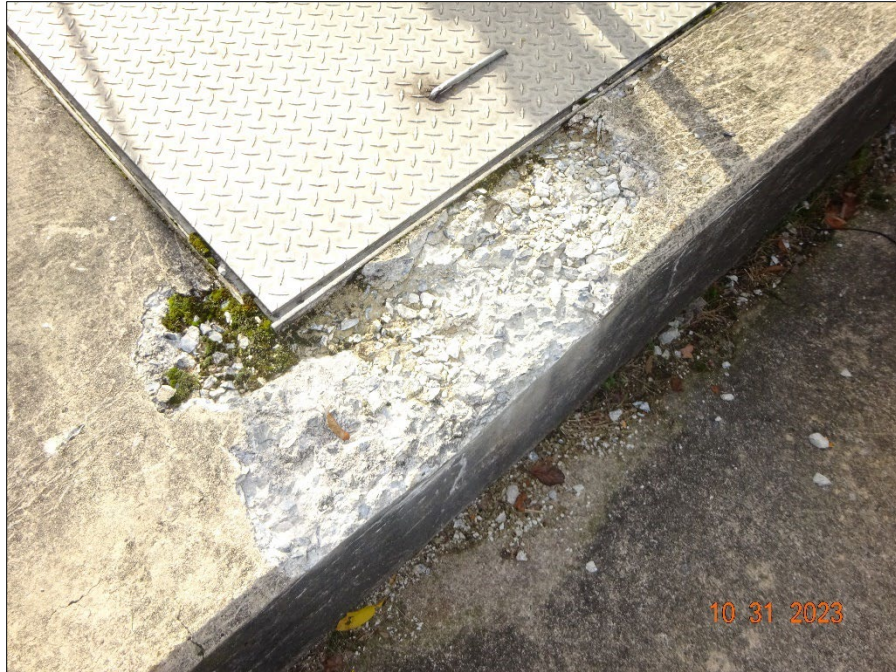
Photograph 45. DSC04791.JPG

Description: Spalling concrete observed near the secondary clarifiers.

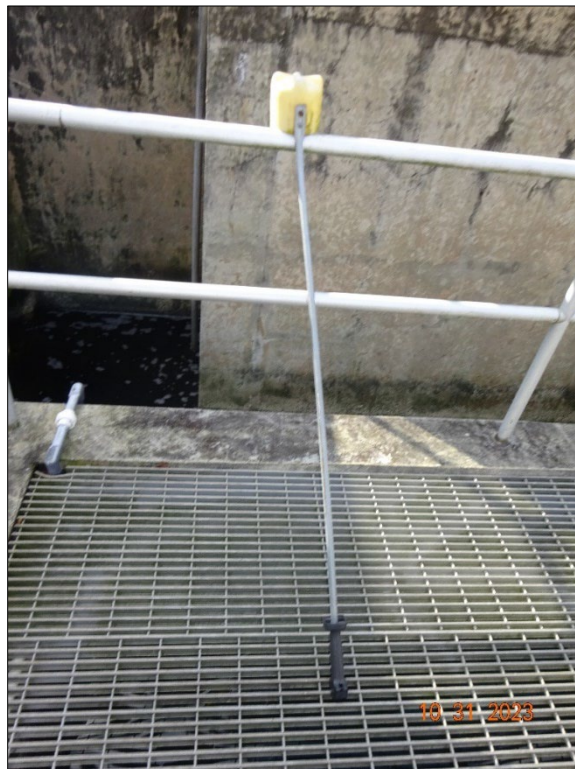
Photograph 46. DSC04823.JPG

- Observation 9.** The effluent sampling equipment storage location provides an opportunity for cross-contamination between effluent grab samples. The sampler pole/cup is stored outside and not decontaminated between samples (see Appendix B Photograph 46). This pole was being used to collect pH, TRC, and fecal coliform.

Description: Effluent sampling pole storage location near the end of the Chlorine Contact Basin.
