**UNITED STATES ENVIRONMENTAL PROTECTION AGENCY
REGION 5
77 WEST JACKSON BOULEVARD
CHICAGO, ILLINOIS 60604**

SUBJECT: CLEAN AIR ACT INSPECTION REPORT
Waste Connections Brent Run Landfill, Montrose Township, MI

Date of Inspection: August 16, 2021

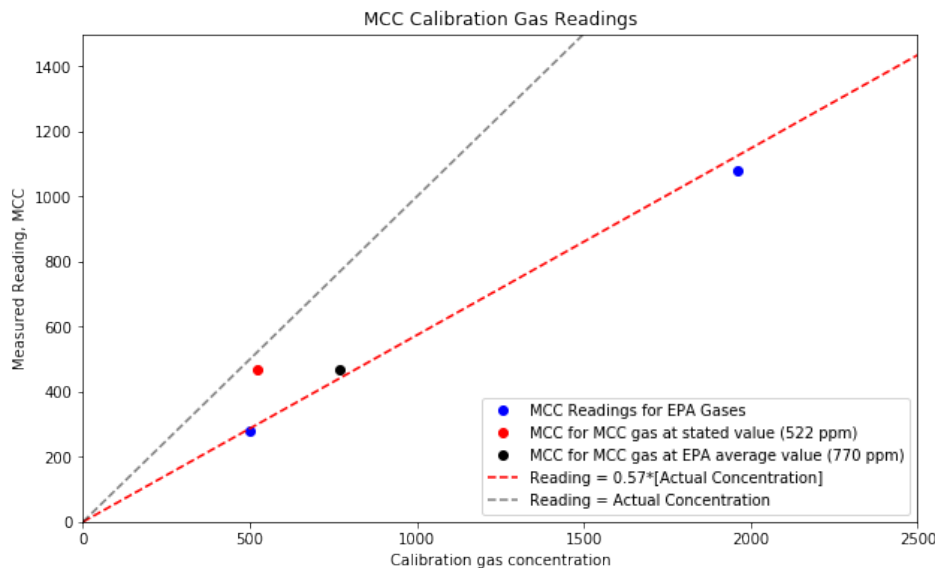
Based off the comparative readings of the calibration gases with each of the instruments, there appeared to be an issue with MCC’s calibration gas, which impeded MCC’s ability to take accurate readings of methane concentration.

Cal Gas Source	Cal Gas Stated PPM	Instrument	Instrument Reading
MCC	522	EPA – A56584	784
MCC	522	EPA – C09562	782
MCC	522	EPA – A56575	745
MCC	522	MCC Elkins IRwin	470
EPA	500	MCC Elkins IRwin	280
EPA	1960	MCC Elkins IRwin	1082

Average EPA reading for MCC gas: 770 ppm

Average ratio of MCC reading to calibration gas concentration, using EPA average instead of stated for MCC’s gas: 0.57

In the below figure, the grey dashed line shows where a properly calibrated instrument should read for a given concentration of calibration gas. The red line shows the actual relationship between the MCC measurements and the EPA calibration gases, where on average it detects 57% of the actual concentration. When comparing against the average EPA reading for the MCC calibration gas, the response of the MCC instrument is consistent in behavior with its incorrect readings for the EPA calibration gases. Together, this indicates that the MCC calibration gas was actually approximately 770 ppm methane, rather than 522 ppm methane as stated.

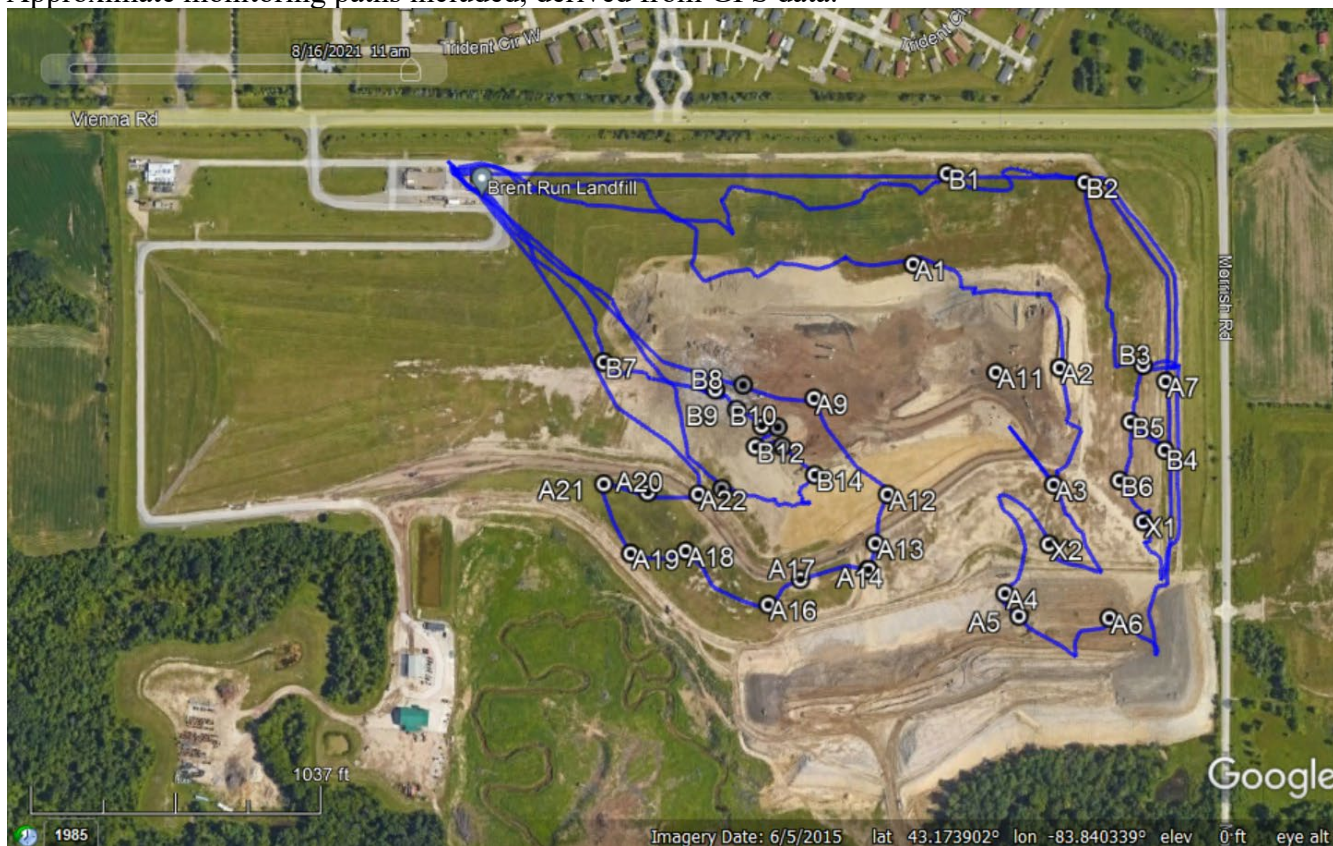
Map of Detected Hits

EPA inspectors detected and documented 38 points on the landfill with concentrations of methane above 500 ppm. Some documented points involved multiple exceedances in close proximity, such as at clustered wellheads. Multiple exceedances were at locations flagged from prior surveys that Waste Connections stated had already seen corrective action. Throughout the landfill, and particularly on the southern slope of the intermediate cover area, EPA observed recurring areas of distressed vegetation and erosion gullies. Many of these areas are documented in the Appendices A and B. EPA observed cracks, tears, and holes in GCCS equipment, as documented in Appendix A. Towards the end of the day, EPA found an increasing frequency of exceedances on the south central side of the landfill, but was only able to conduct a cursory survey of this area in the interest of concluding the inspection out of respect for the time of the site employees. Some exceedances were found at marker pipes, which were found to be effectively serving as a conduit for landfill gas to escape through the cover.

SEM hit locations plotted over satellite imagery from June 7, 2015 as depicted on Google Earth. Approximate monitoring paths included, derived from GPS data.
