DATE February 7, 1984

**SUBJECT** Incident at VCM-II

SUBJECT VCM Plant Absorber Upset

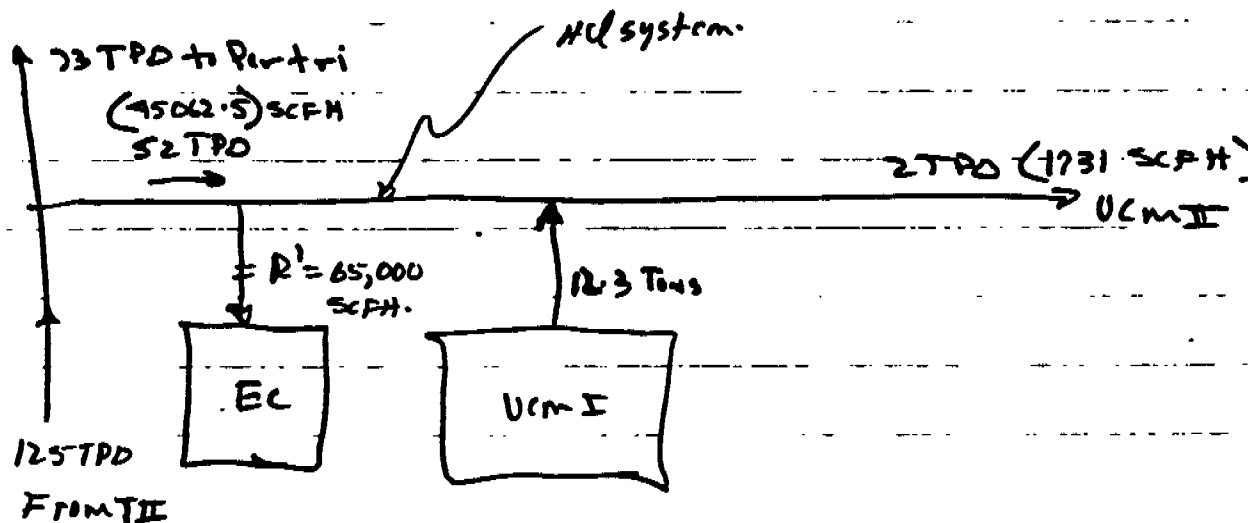
How much went to EC plant and how much to Ucm II.

For the 6th the balance look like follow.

~~Flow~~ Flow to EC HCl + Ucm =  $6.5 \times 10,000 = 65,000$    
↑   
Per-ch.

So VCM that stay in loader was  
Approximately 5.19 Tons.

Is Impossible to say how much went  
to the scribbles. No more than 5.19 T.
