INSPECTION REPORT

| Media: | Stormwater | |
| Type of inspection: | CEI - Compliance Evaluation Inspection | |
| Permittee Name: Republic Services, Inc. | | |

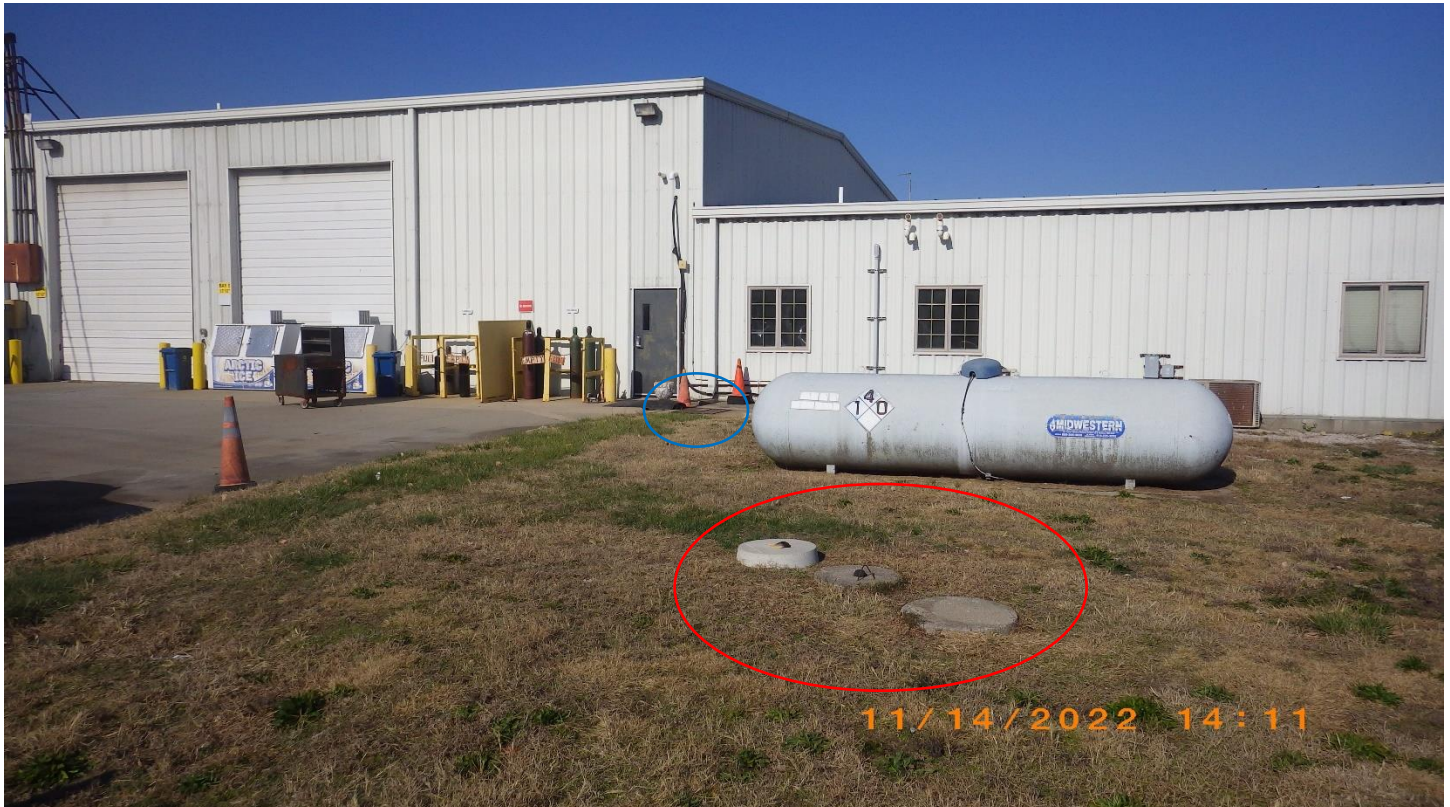
1: RIMG0070

| Unique Identifying No. | Observation | Area of Concern? |
|---|---|---|
| TF-OB-006 | South of the administration/maintenance building is a septic tank. The tank has 3 access ports, see Photo 1. | No |
| TF-OB-007 | Immediately adjacent to the southeast exterior door of the administration/maintenance building is the access point for an oil-water separator. Mr. Moreno stated that the oil-water services the floor drains in the maintenance portion of the building. | No |

Description: Overview of septic tank access points, located in the red circle. The blue circle shows the access point for the oil-water separator that services the floor drains in the maintenance portion of the building

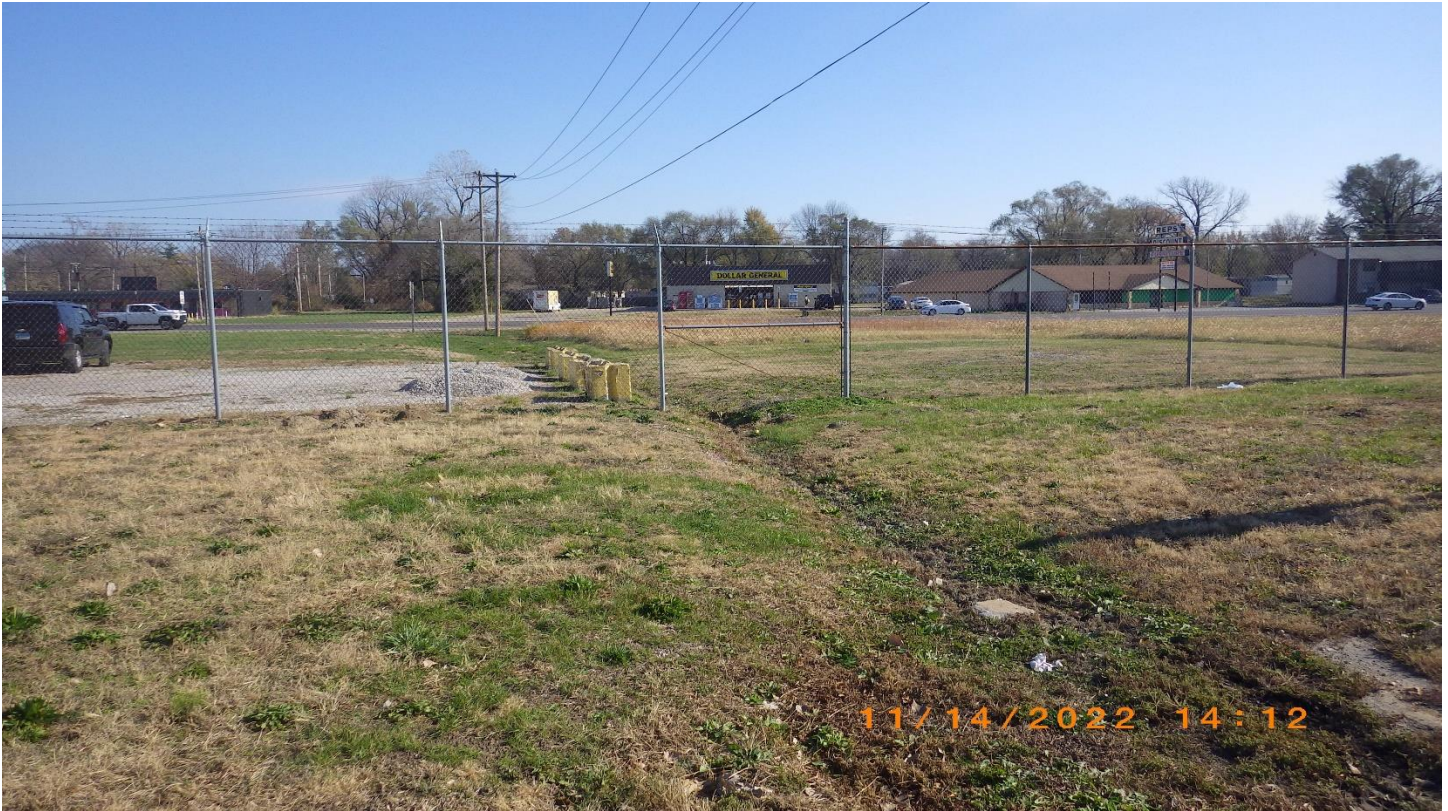
2: RIMG0071

| Unique Identifying No. | Observation | Area of Concern? |
|---|---|---|
| TF-OB-008 | There is an indentation in the ground in the Southeast corner of the property. The indentation appears to be from water drainage, with the water flowing from the Facility east, through the fence line, to Mississippi Avenue. Inspectors observed standing water in the indentation outside the Facility fence line. See Photo 2. | No |

Description: Draining from the Facility. Erosion pattern indicates flow of water from the Facility, through the fence line, east to Mississippi Avenue. Standing water was observed in the indentation outside of the Facility fence line.
