**Region 6 - Enforcement & Compliance Assurance Division**  
**INSPECTION REPORT**

| Inspection Date(s): | 01-21-2026 | |
| Regulatory Program(s) | NPDES CAFO | |
| Company Name: | <b>Bouma Dairy Farm</b> | |

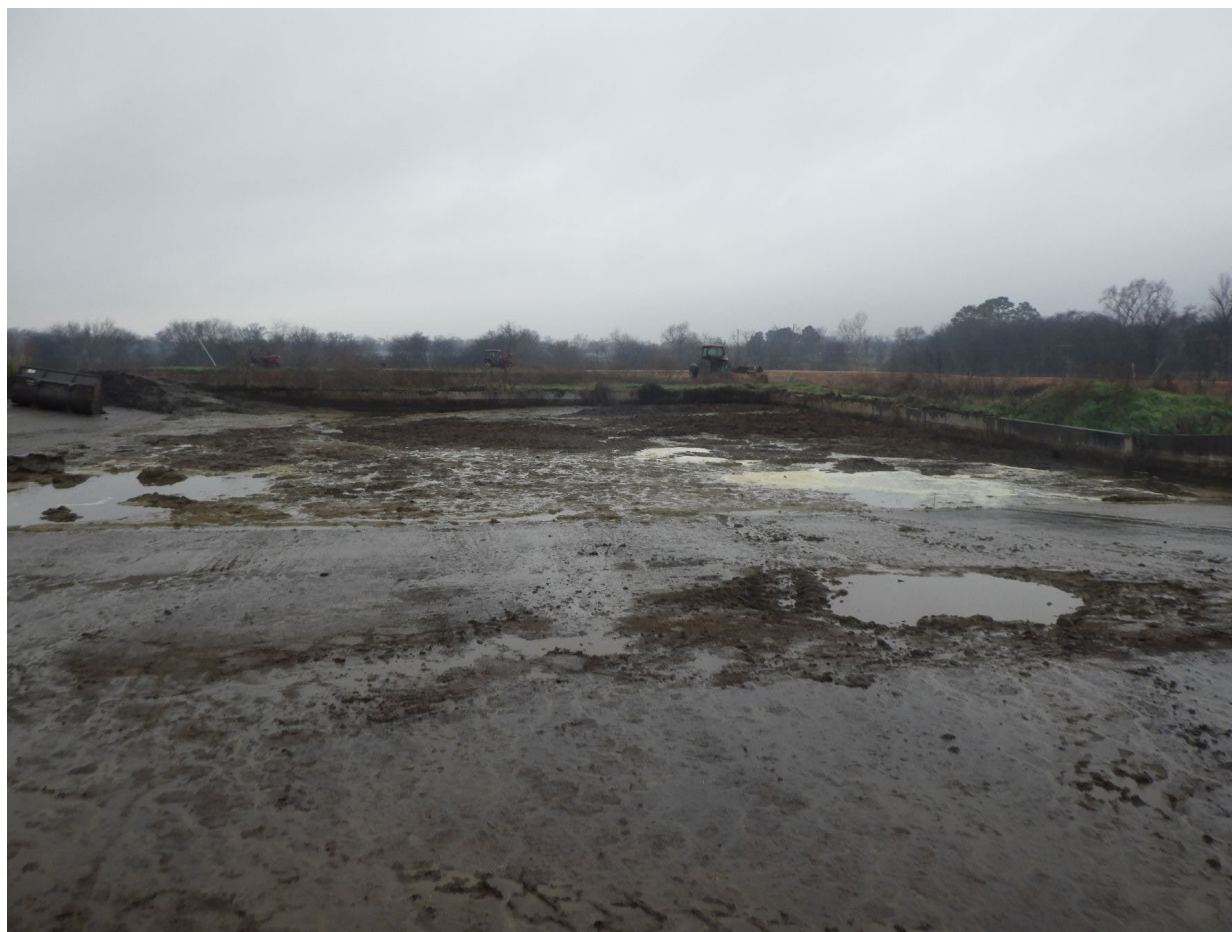
Photo No. 1

There is one concrete lined settling basin downgrade on the west side of the freestalls that leads to RCS 1 via gravity flow (Appendix 1, Photos 1-2). In addition, the facility is currently constructing an additional RCS named RCS 2. (Appendix 1, Photo 3). RCS 2 borders an unnamed creek that feeds Big Sandy Creek (Appendix 1, Photo 4). The facility has seven LMUs (Land Management Unit): 1 - 75 acres, 2 - 44 acres, 3 - 39 acres, 4 - 64 acres, 5 - 30 acres, 6 - 41 acres, 7 - 113 acres. The facility plants ryegrass and bermudagrass used for hay, silage, and grazing dry cows. Center pivots are used for clean water application and drag hose for wastewater and manure application. No manure or wastewater is transferred off-site.

| Description: | View to the west. Settling basin downgrade of west end of the freestalls. | | |

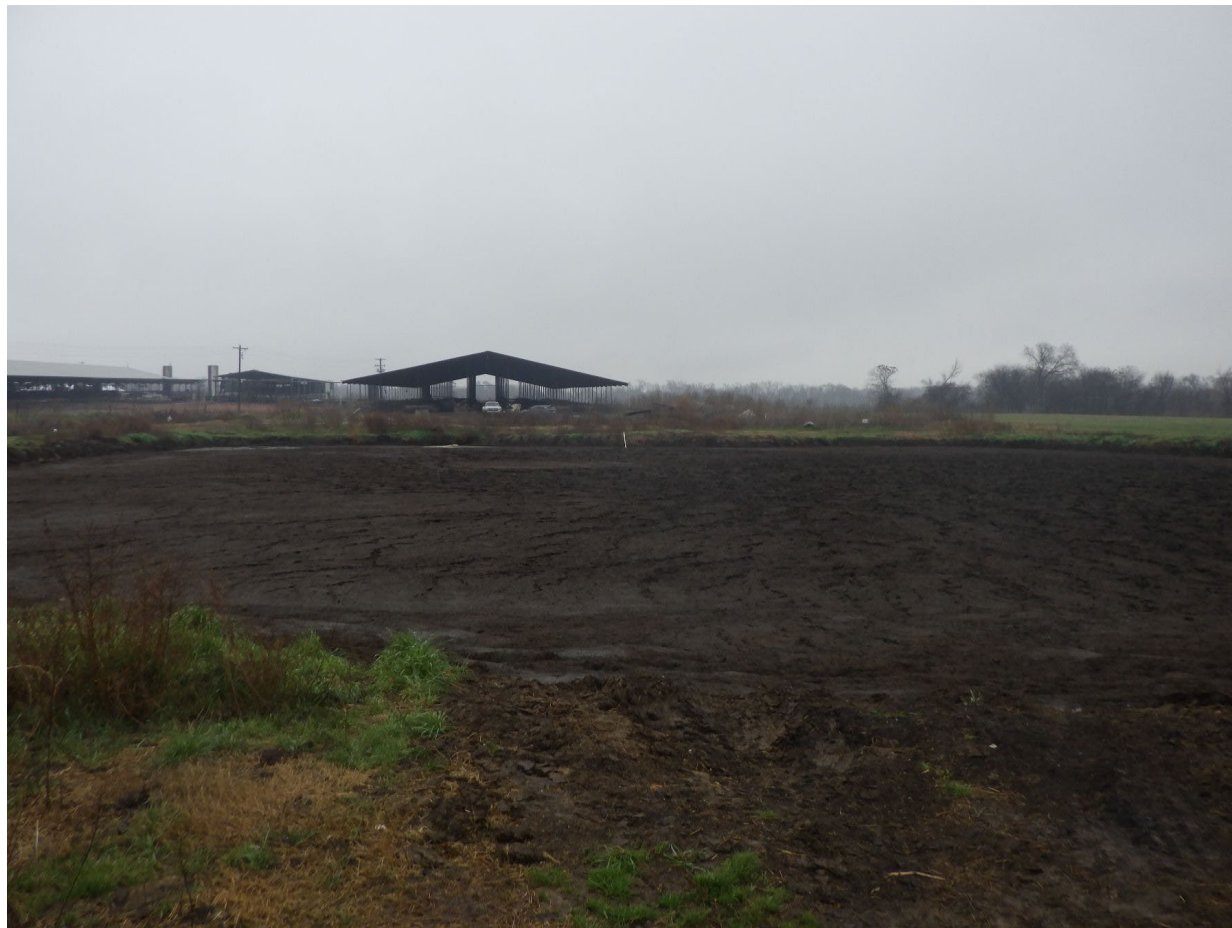
Photo No. 2

All the RCSs for the facility are designed to receive the production area wastewater runoff. RCS 1 capacity is 5.56 acre/ft certified on 01-06-2000. The liner and hydraulic conductivity were certified by James Winn, P.E. on 03-01-2007. RCS 1 met the required conductivity rating greater than  $1 \times 10^{-7}$  cm/sec. RCS 2 is currently being constructed. The measured capacity is 32.44 acre/ft and also met the required conductivity rating greater than  $1 \times 10^{-7}$  cm/sec certified by Noel Courts, P.G. on 01-03-2026. There were no signs of erosion in the embankments and cattle are unable to access the lagoons. All pole markers showed adequate freeboard and are below the 25-yr/24-hr rain event mark. The facility uses gravity flow and drainage channels to route all runoff to RCS.

| Description: | View to the east. RCS#1 with settling basin and freestalls in background. | | |

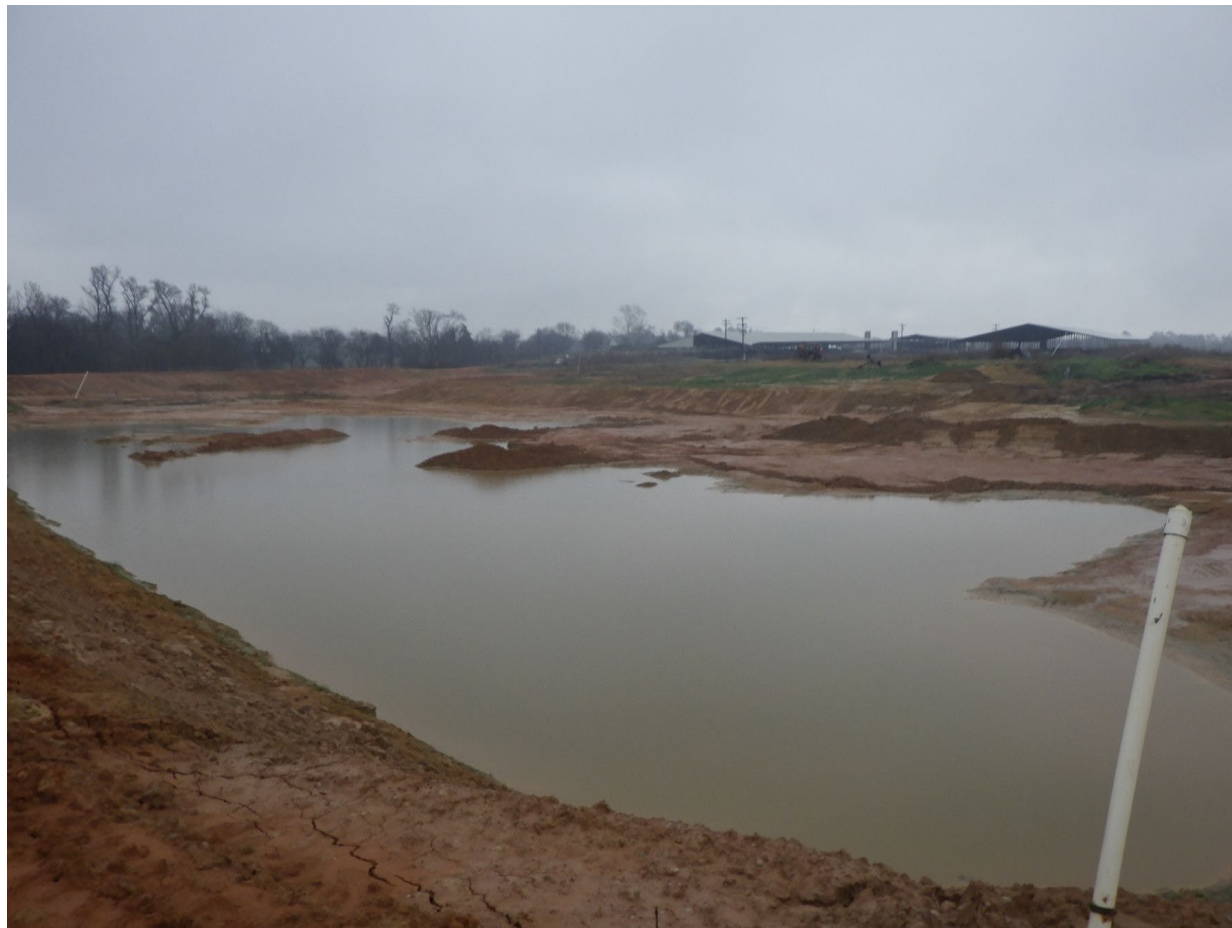
Photo No. 3

| Description: | View to the northeast. On berm of RCS#2 (under construction) with freestalls and RCS#1 in background. | | |

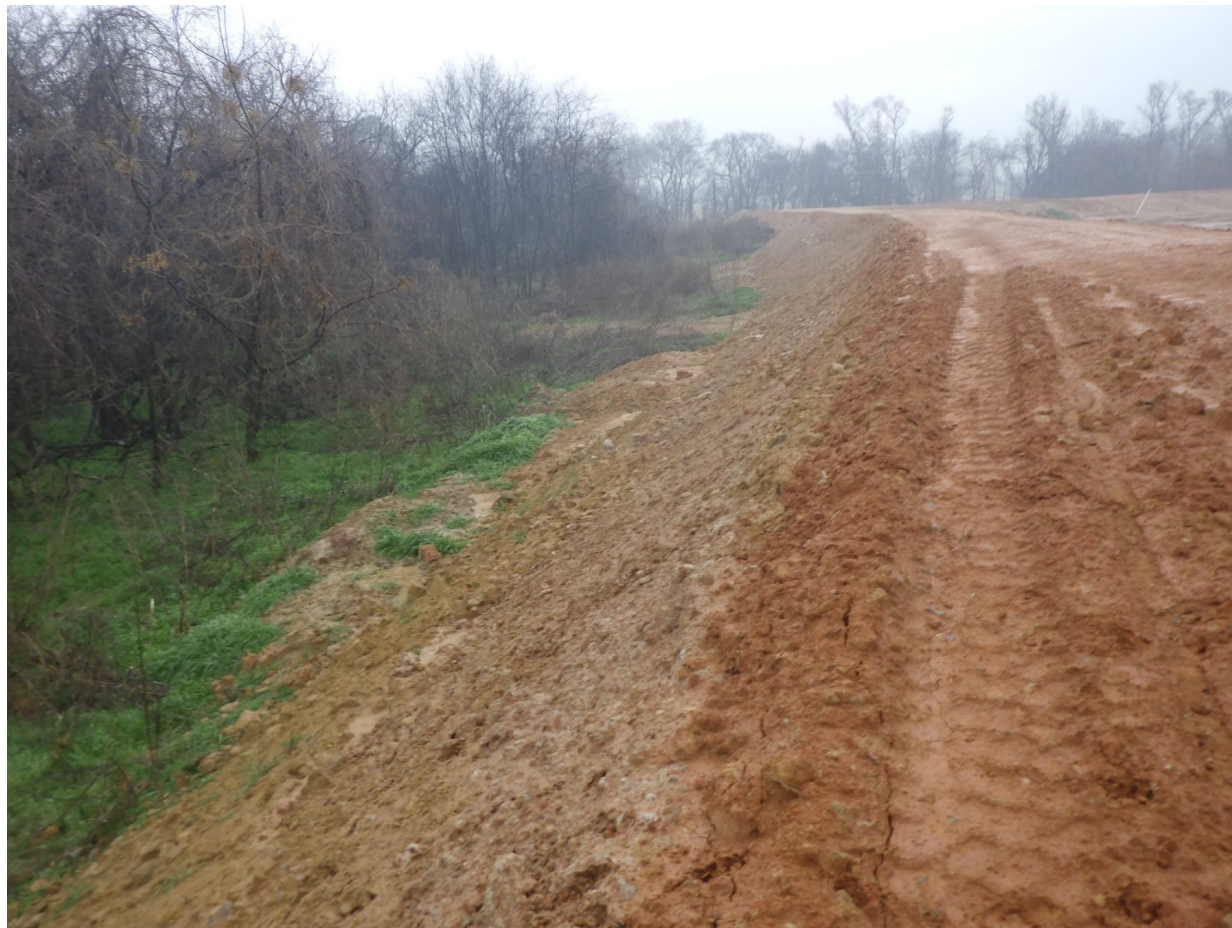
Photo No. 4

| Description: | View to the north. Berm between RCS#2 and creek. | | |

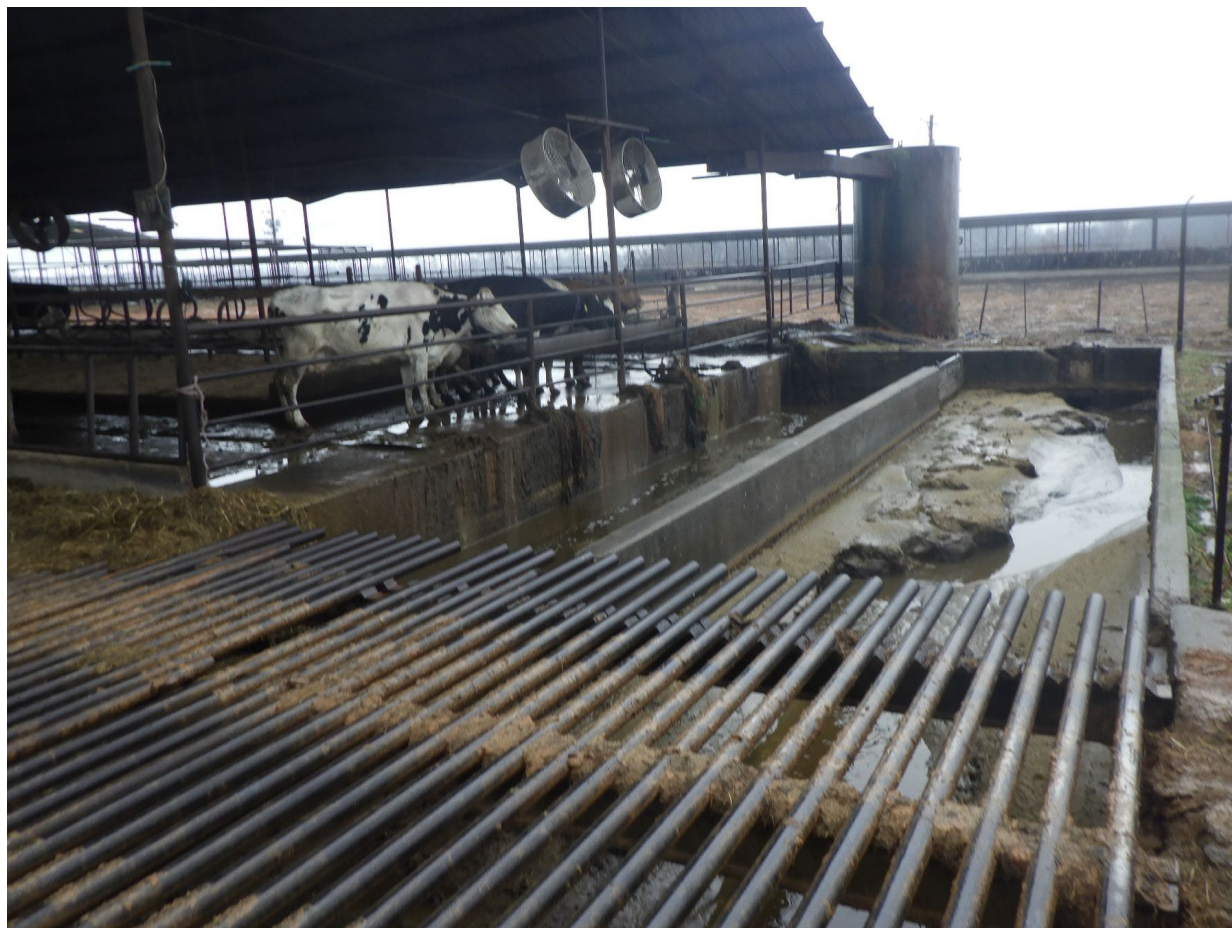
Photo No. 5

| Description: | View to the south. Channel at end of maternity barn that routes to settling basin, | | |

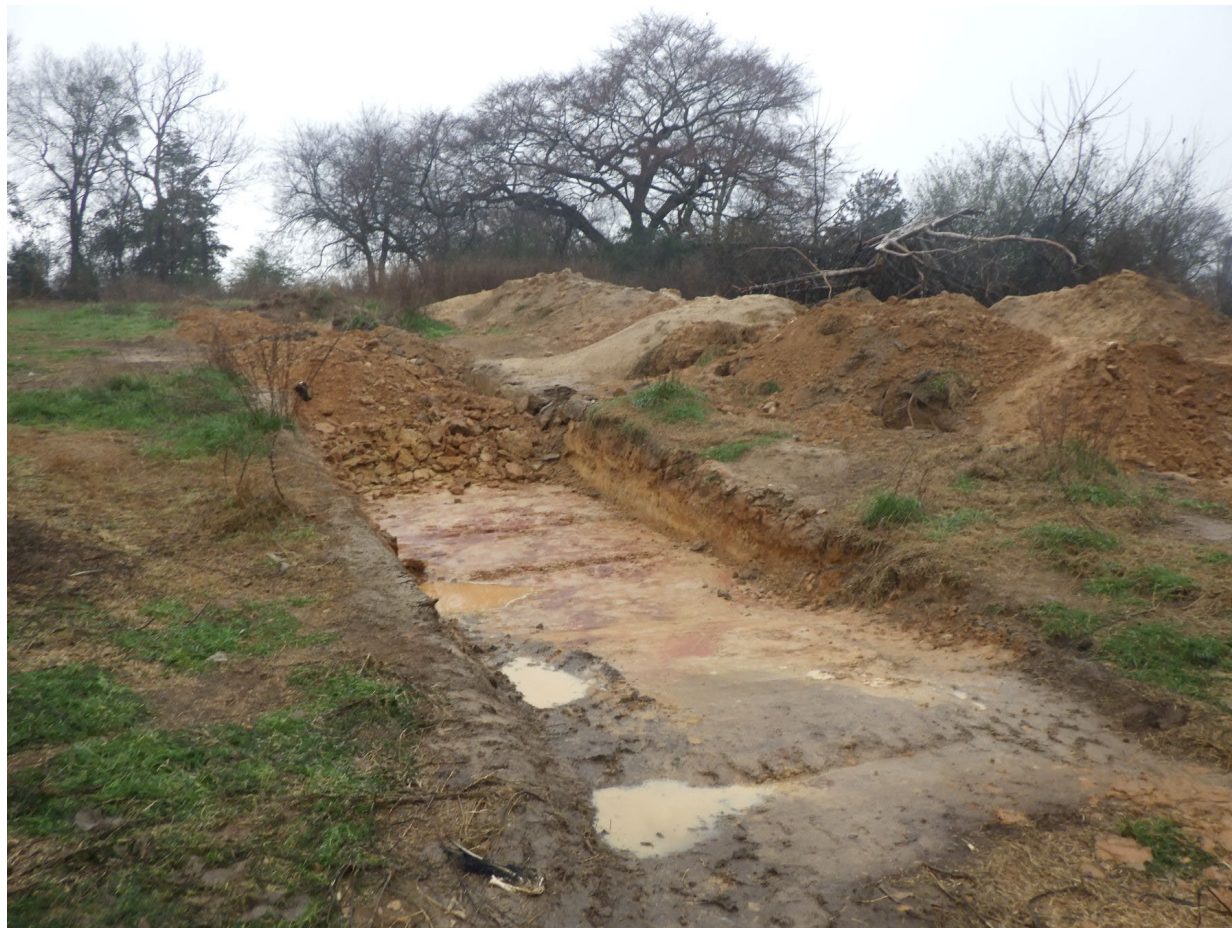
Photo No. 6

Mortalities are buried on site west of the poultry barns (Appendix 1, Photo 6). There were no signs of exposed carcasses at the burial site or dead cows in the production area at the time of the inspection.

| Description: | View to the southwest. Mortality burial pit. | | |
