**Clean Water Act (CWA) Inspection Report**

| <b>Permittee Name:</b> North Country Dairy, LLC | <b>NPDES/ICIS No.:</b> NY0002763 |
| <b>Facility Inspected:</b><br>North Country Dairy<br>22 County Route 52<br>North Lawrence, NY 12967 | |

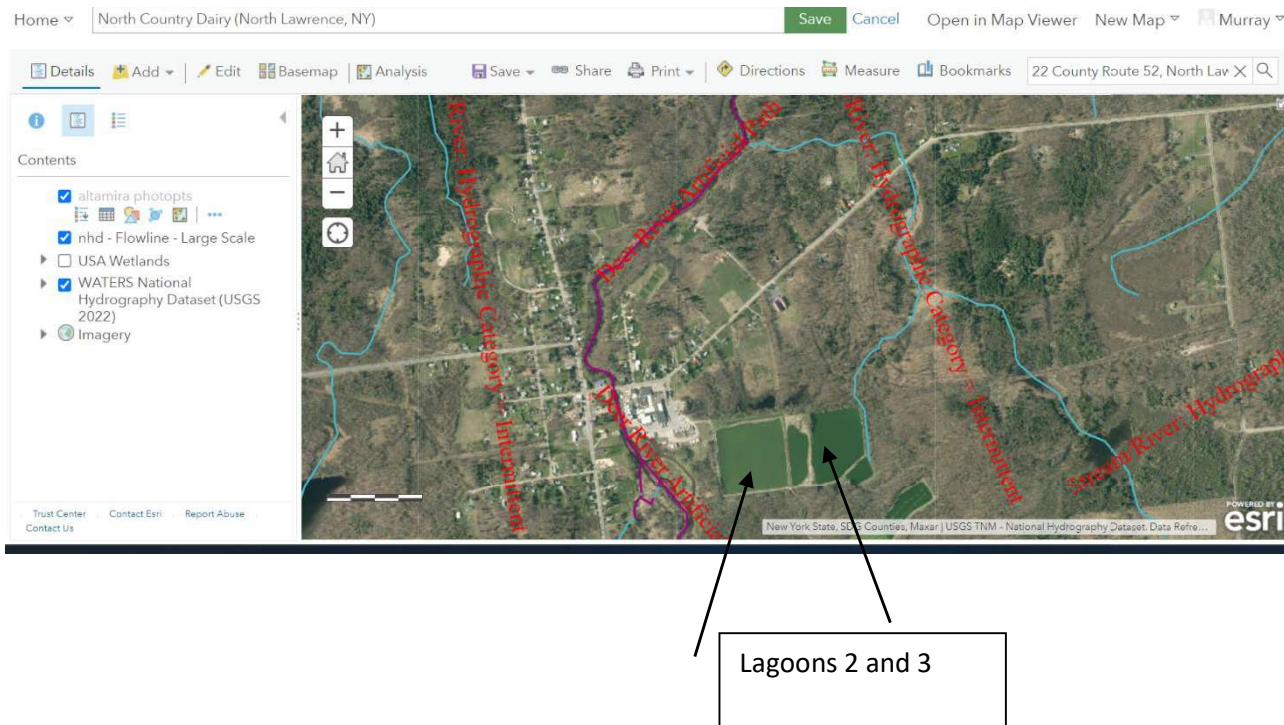
- i. As shown in photos 859 to 872 there were breaches in the berm along the northern side of Lagoons 2 and 3 and there was and had been an overflow that could reach the Deer River via a network of channels and streams as shown in the GIS Map below. Discharges via the breaches do not flow through the permitted monitoring point, Outfall 001, and are unauthorized. Discharges from point sources to a "navigable" water without a SPDES Permit are not in conformance with Section 301 and 402 of the Clean Water Act.

The dividing berm between Lagoons 3 and 4 also had evidence of overland flow on the berm, and an erosion pathway formed that would lead to short circuiting of the berm and demonstrates improper operation and maintenance.

The Facility representative said that NCD does conduct routine walks on the old rail bed (north of Lagoons 2,3, and 4) to inspect the berm integrity, but it appears that routine inspections had not taken place recently. The Facility must conduct routine inspections of the lagoon berms, make logs of the inspections, and include this lagoon inspection provision in the Facility's Written Procedures for Operation and Maintenance (Per the Permit which cites 6 NYCRR Part 750-2.8(a)(2)(ii)) and/or its BMP Plan in accordance with Special Condition 2 of the Permit.

Based on the April 30, 2024, email from NCD (Att. 2) a Purchase Order for \$16,408 has been approved for the restoration of the lagoon berms. A May 29, 2024, email from Mr. Matthew Thompson to Mr. Lantner of EPA stated that the contractor had to wait until the area was drier, but as of the 5/29/24 email, the lagoon berm repair project was said to be nearly completed and NCD would provide photos to EPA upon completion.

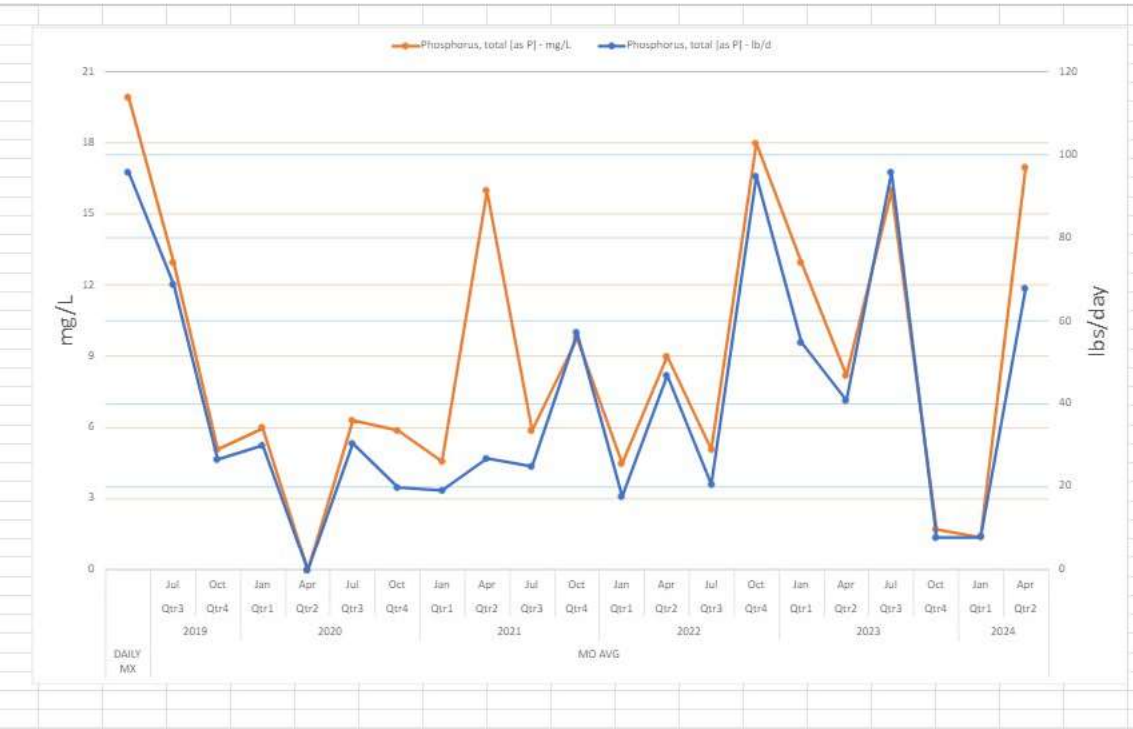
**Figure 1** - North Country Dairy Outfall 001, self-reported Quarterly Total Phosphorus Monitoring (mg/l and pounds per day) from EPA ECHO 3<sup>rd</sup> quarter 2019 to first quarter 2024

Review of the Quarterly Phosphorus monitoring data provided by the Facility in EPA’s Enforcement and Compliance History (ECHO) online database for the past 5 years shows a wide fluctuation in effluent phosphorus concentrations with concentrations up to 20 mg/L and discharges of phosphorus up to 96 pounds per day. Average phosphorus concentrations during this period were 23 mg/L and loads Also shown in the graphs below are reported Ammonia, BOD as well as phosphorus loads over the past 5 years.
