## **RCRA Inspection Report**

Safety-Kleen Systems, Inc.  
120 Richardson Drive  
Jackson, Mississippi 39209

February 25, 2025, 9:15 a.m.

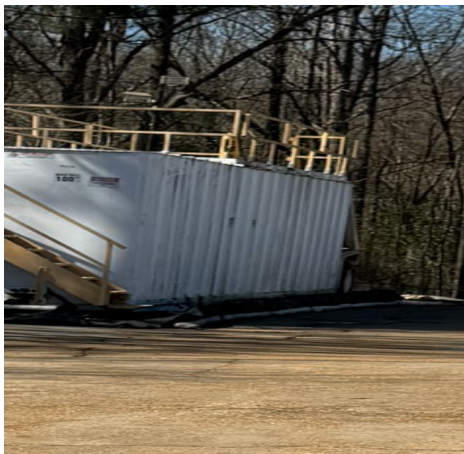
Photo-1 21,000-gallon Frac Tank

The inspectors observed a 20,000-gallon double-walled Frac Tank (Photo-1) used to store petroleum based oily water mixture that is not regulated as a RCRA hazardous waste. The outer wall of the tank provides a secondary containment. The tank is enclosed with a modular polyethylene spill containment creating a tertiary containment as well as serving as a secondary containment.

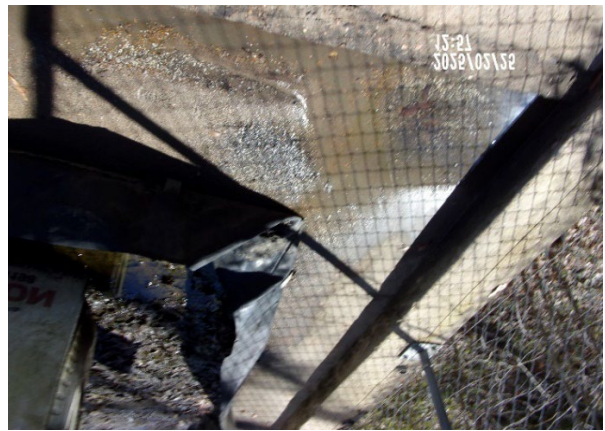
The inspection team inspected the spill containment unit enclosing the Frac Tank to verify that it was continuous and impervious. The inspectors observed oily debris and oil-stained water puddles, which appeared to be from a recent rain event, inside the containment unit (Photo-2, Photo-3, Photo-4 and Photo-5). The inspectors also observed the spill containment unit to be in disrepair in several places, including two flattened corners that indicated visual signs of breaches in the containment system. The inspectors also observed absorbent socks placed in the outer perimeter of the spill containment system not completely enclosing the Frac Tank (Photo-6 and Photo-7).

Photo-4 Sec. Containment in Disrepair

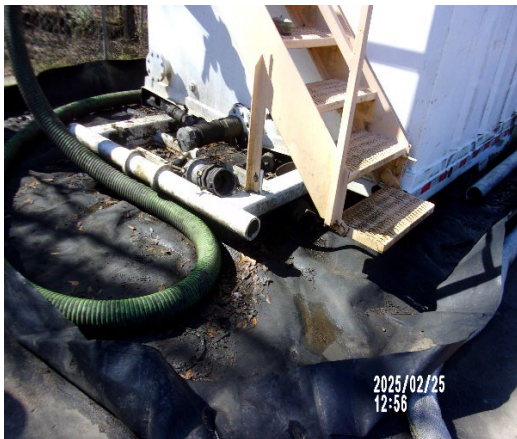
Photo-2 Secondary Containment in Disrepair

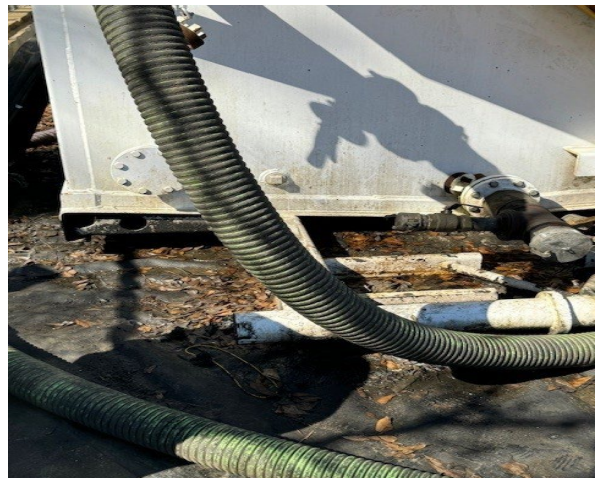
Photo-5 Debris in Secondary Containment

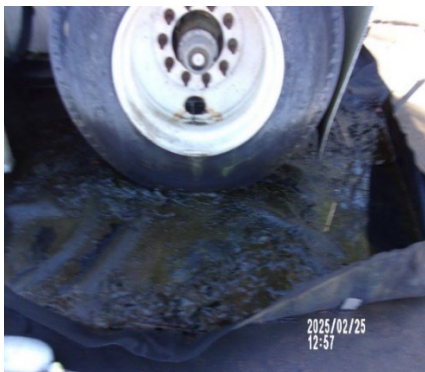
Photo-3 Oily Debris in Secondary Containment

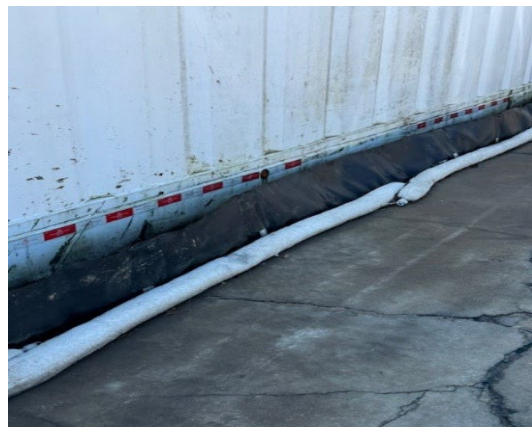
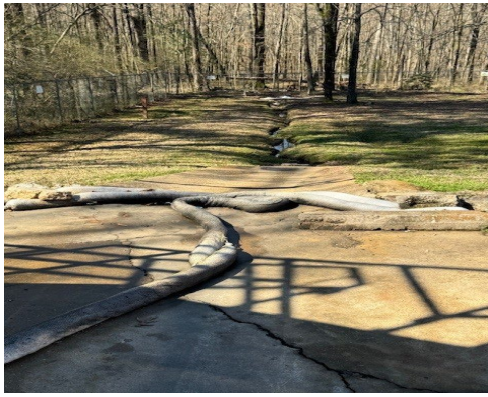
Photo-6 Spill Boom near Frac Tank

Photo-7 Spill Boom near Frac Tank

SK provided additional response via email on April 2, 2025, stating that the SK Branch will conduct employee training on housekeeping to ensure that the area around the Frac Tank is kept orderly and that all incidental drips during the loading/unloading process are fully captured and contained. In addition, the Frac Tank enclosure area will be cleaned, and all absorbent socks will be replaced on a regular basis. Facility staff will monitor this area as part of their daily inspection and will clean the area and replace the absorbent socks, as needed. These requirements will be reviewed on an annual basis to ensure ongoing compliance.

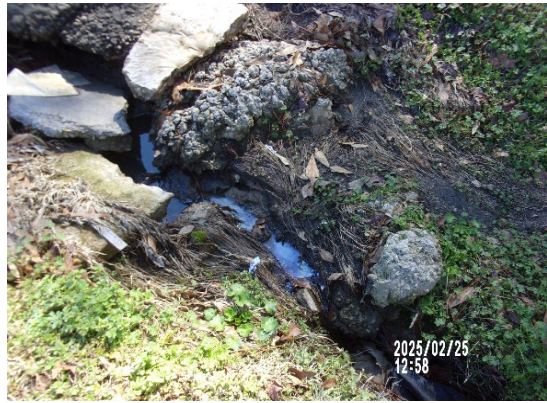
Downgradient from the Frac Tank, the inspectors observed a stormwater concrete channel (Photo-8) that drains into a drainage ditch (Photo-9, Photo-10, Photo-11 and Photo-12) which subsequently discharges to an unnamed tributary of a creek on the west side of the property. The inspectors observed oily water in the drainage ditch at several locations down gradient from the Frac Tank containment system. SK claimed in their response that the Frac Tank was a

Photo-10 Oily Sheen in the drainage ditch

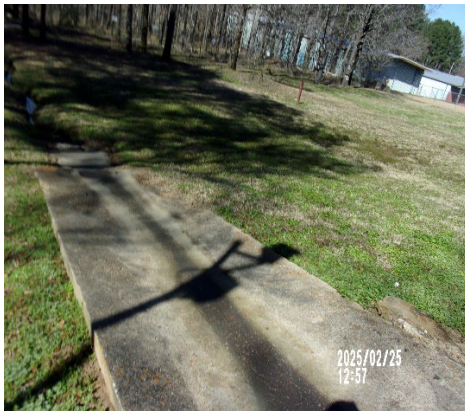
Photo-8 Concrete Stormwater Channel

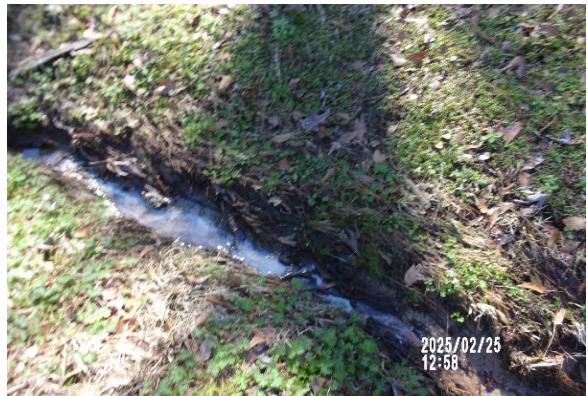
Photo-11 Oily Sheen in the drainage ditch

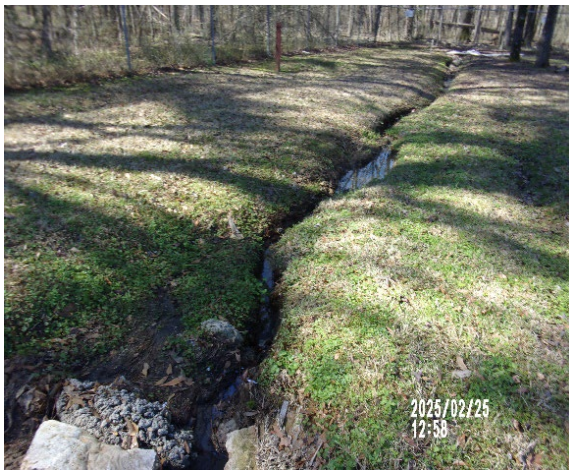
Photo-9 Drainage ditch

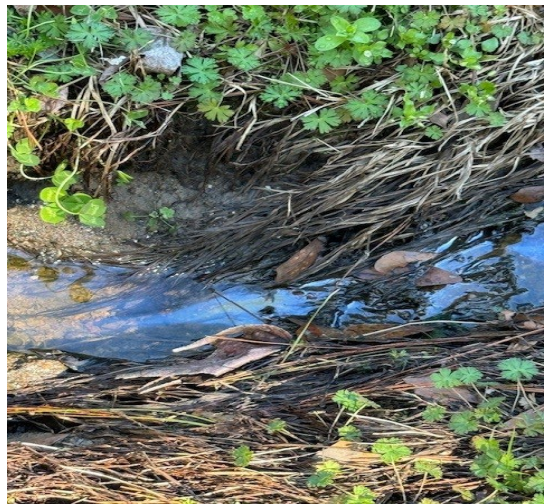
Photo-12 Oily sheen in the drainage ditch

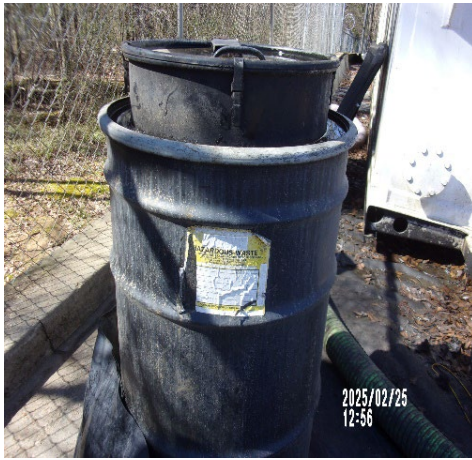
A hazardous waste satellite accumulation area (SAA) (Photo-13) was located adjacent to the front of the Frac Tank. During the inspection, the inspectors asked if the waste accumulated in the satellite accumulation area (SAA) is nonhazardous then why is the content of the SAA drum managed as hazardous and this was further followed up via email to SK on March 27, 2025. Safety Kleen responded via email on April 2, 2025, that “Wastes accumulated in the satellite drum are not strictly limited to the oily water program. The satellite accumulation area drum located near the frac tank may also be used for facility-generated waste including debris, PPE, absorbent, and other materials, and is sent for disposal rather than oil recovery. Due to wide range of wastes managed at the site and to ensure any hazardous waste is properly managed and handled, the contents are conservatively managed as hazardous waste.” On April 12, 2025, additional follow-up was conducted by EPA regarding the SAA stating that waste generated facility-wide being put in the satellite container may not be at point of generation or under the control of the operator. SK responded via an email on April 15, 2025, that “The Jackson facility maintains satellite accumulation areas in several different locations for collection of wastes, such as wipes, PPE and other debris, generated in proximity to the satellite accumulation container. Facility personnel will use the satellite container nearest the point of generation of the wastes as matter of convenience. Each satellite accumulation area is monitored during operating hours on closed-circuit television, so control of the area is maintained when an operator is not near or does not have eyes on the satellite container” wastes accumulated in

**Pursuant to 11 Miss. Admin. Code Pt. 3, R. 1.3 [40 C.F.R. § 262.15(a)(5)], which is a condition of the SAA Permit Exemption, a generator is required to mark or label its containers with an indication of the hazards of the contents.**

Photo-13 SAA Drum near Frac tank with no IOH

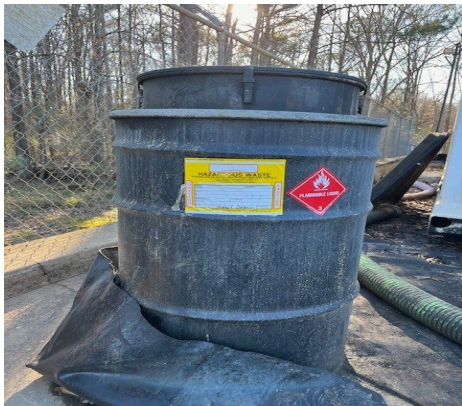
Photo-14 SAA Drum with IOH near Frac tank

On April 1, 2025, the Facility sent a photo of the container which showed that the hazardous waste label had been replaced and that the container was marked with indication that the contents are "Flammable" (Photo-14).

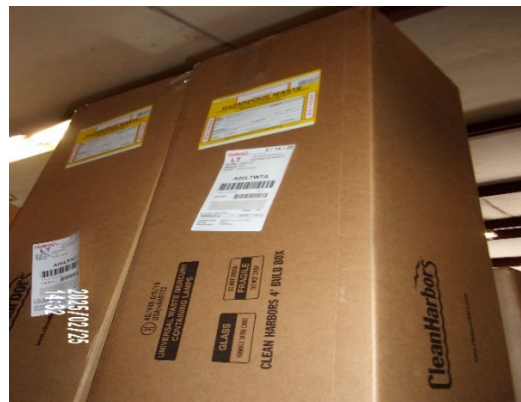
The inspectors observed three closed fiberboard boxes labeled “universal lamps containing mercury”: one 8-foot box; and two 4-foot boxes. However, the same boxes had “Hazardous Waste” labels and accumulation start date(s) (Photo-17). The inspectors asked whether the contents of the boxes containing waste lamps were managed as universal waste and/or as RCRA hazardous waste. SK responded via email dated February 28, 2025, indicating that the broken waste lamps had been characterized by the generator as hazardous waste for the purpose of storage and disposal. SK provided a copy of a manifest (020399926) dated February 14, 2025, as an example demonstrating that broken waste lamps were typically managed as hazardous waste shipped to another Clean Harbors facility for disposal.

Based on SK’s email response on February 28, 2025, it was confirmed that the contents in the three fiberboard boxes were managed as hazardous waste and not as universal waste. Although the fiberboard boxes appeared to be intact and nonleaking at the time of inspection, there were concerns regarding the integrity and compatibility of the container with the hazard waste stored in the container made of or lined with materials which will not react with, and compatible with the hazardous waste stored such that there is no release of the hazardous waste to the environment during storage and transportation.

Photo-17 Universal Waste Lamps

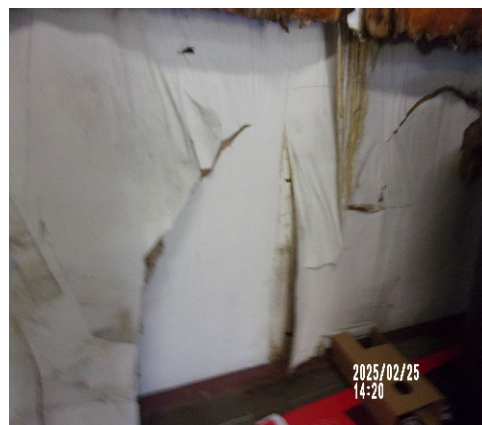
The inspectors observed the insulation of the north wall in the CSW in disrepair (Photo-18). In addition, the inspectors observed insulation in other parts of the building also in disrepair (Photo-19 and Photo-20). The inspectors observed several large tears of insulation in the permitted storage area and near the eye wash station showing deterioration of the general facility conditions. Since ignitable wastes (D001) were being stored in the permitted storage area, the inspectors were concerned that the deteriorating Facility condition may lead to a potential environmental or human health hazard.

**Pursuant to RCRA Permit MSD000776765 Module II.-General Facility Conditions, RCRA Permit Condition II.E. General Inspection Requirements and 11 Miss. Admin. Code Pt. 3, R. 1.22 [40 C.F.R. § 264.15(c)], an owner or operator must remedy any deterioration or malfunction of equipment or structures which the inspection reveals on a schedule which ensures that the problem does not lead to an environmental or human health hazard where a hazard is imminent or has already occurred, remedial action must be taken.**

Photo-18 Insulation in disrepair (Permitted Storage Area)

On March 10, 2025, the Facility sent a picture of the repaired insulation in the CSW (Photo-21). However, based on the picture, a temporary repair appeared to have been made. The repair did not appear to be completed in its entirety. SK needs to evaluate the entire warehouse building for appropriate repair and scheduled maintenance as part of complying with the SK's Permit condition as per the attached plans and specifications. The CSW was equipped with spill kit, fire extinguisher and an eye wash station.

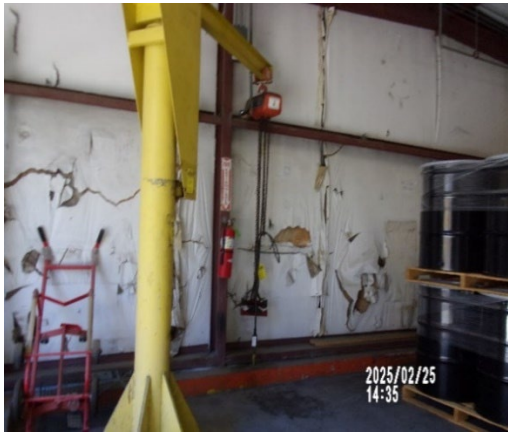
Photo-19 Insulation in Disrepair  
(Permitted Storage Area)

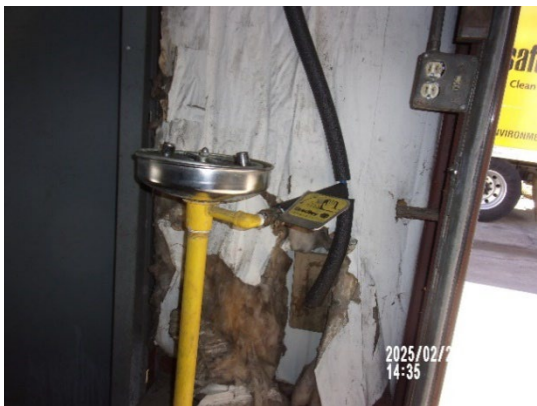
Photo-20 Insulation in Disrepair  
(Permitted Storage Area)

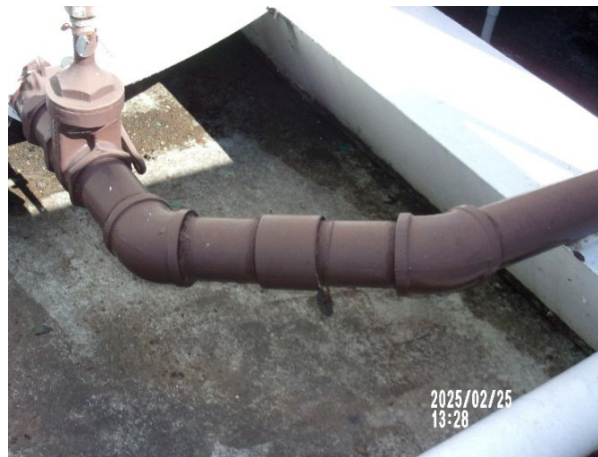
Photo-23 illegible tags

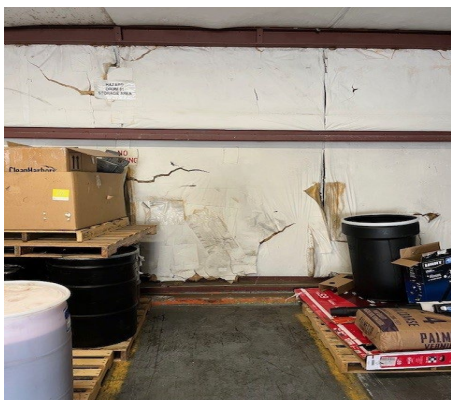
Photo-21 Insulation Repaired (Permitted  
Storage Area)

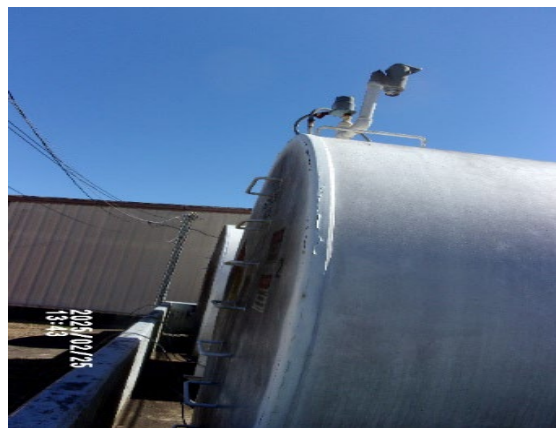
The inspector observed that the north end of Tank #1 (8000-gallon permitted hazardous waste tank) had paint peeling and paint blisters (Photo-24 and Photo-25). In addition, the inspectors observed paint peeling and signs of rust on the ancillary piping associated with Tank #4 (an out of service tank) (Photo-26), and signs of rust and corrosion on the valve of Tank #1 (Photo-27). These conditions were not noted on the Daily Tank Inspection Log and repairs were not made immediately. (See Daily and Weekly Tank Inspections under the Records Review section below.)

**Pursuant to RCRA Permit MSD000776765 Module IV.F. – Inspection Schedule and Procedures, Section IV.F.1., the permittee shall inspect the tank systems, in accordance with the inspection schedule, Permit Attachment II-3, and shall complete the items in Permit Conditions IV.F.3 as part of those in inspection. Pursuant to Permit Attachment II-3. 3.0 Preparedness and Prevention Plan, 3.2 Inspection Procedures, a. Tank Inspections, the piping and secondary containment for tanks will be checked for leaks, cracks, or other deterioration. Any damage to the tanks, piping (such as rust, seepage or loose fixtures) or secondary containment must be noted and repairs initiated immediately.**

Photo-24 Tank #1 Coating Peeling

On March 10, 2025, the Facility sent a photo of the hazardous waste storage Tank #1 repainted (Photo-28).

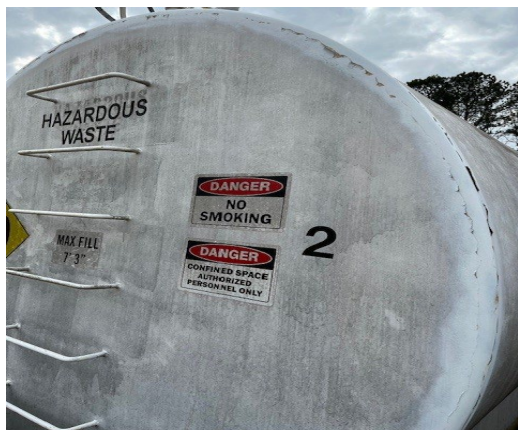
Photo-25 Tank #1 Coating Peeling

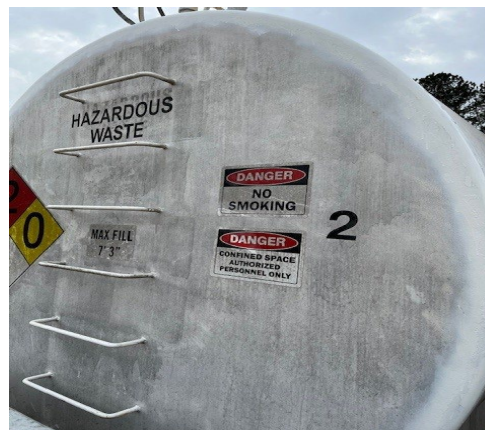
Photo-28 Tank #1 Repainted

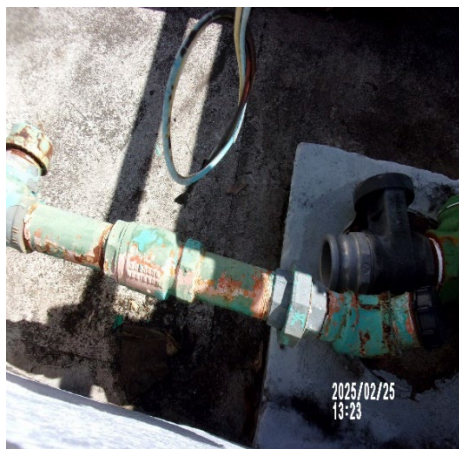
Photo-26 paint peeling and signs of rust

On April 2, 2025, SK responded via email indicating that the only ancillary piping with surface rust was on an out of service tank and stated that necessary repair would be conducted prior to putting the tank back in service. SK further indicated that because the surface rust was not at a level causing concern over the integrity of the tank/equipment, the items were not “failed” on the inspection forms. SK also mentioned that when an item is failed, it is flagged and tracked electronically through completion and monitored regularly by the onsite personnel.

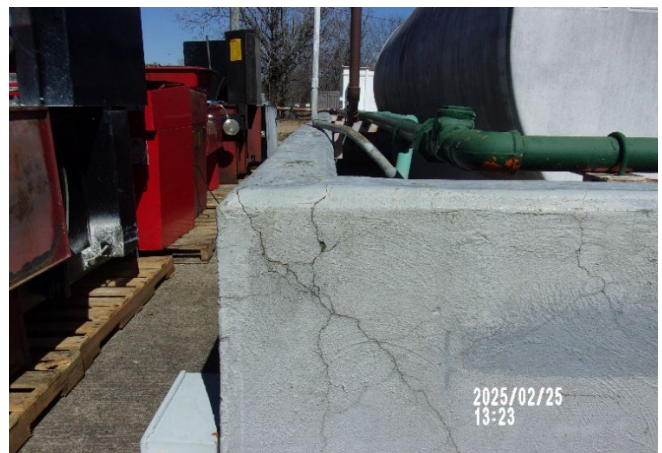
The inspectors next observed the secondary containment system of the Tank Farm. The inspectors observed surface cracks along parts of the concrete containment (Photo-29 and Photo-30), there appeared to be damages to the sealants. The inspectors observed cracks, paint disrepair (e.g. chips, cracks etc.), rust, corrosion, damage to the sealant and weathering. These conditions were not noted on the Daily Tank Inspection Log and repairs were not made immediately. Both the tank system and the containment wall appear to need a fresh coat of paint and/or sealant. The inspectors recommended the cracks in the secondary containment should be cleaned, prepped and properly sealed.

Photo-29 Cracked Secondary Containment

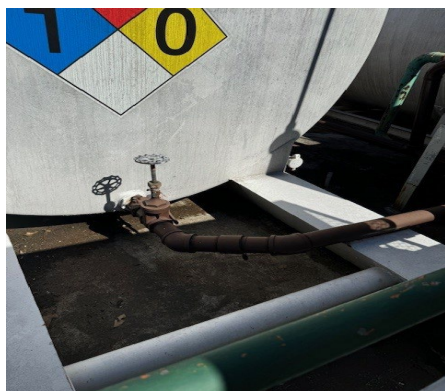
Photo-27 Signs of Rust on the Tank Valve

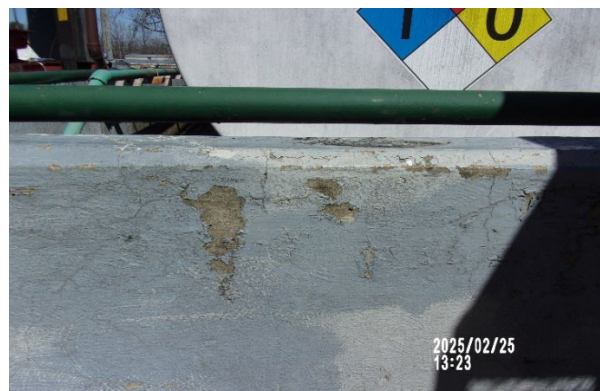
Photo-30 Cracked Secondary Containment

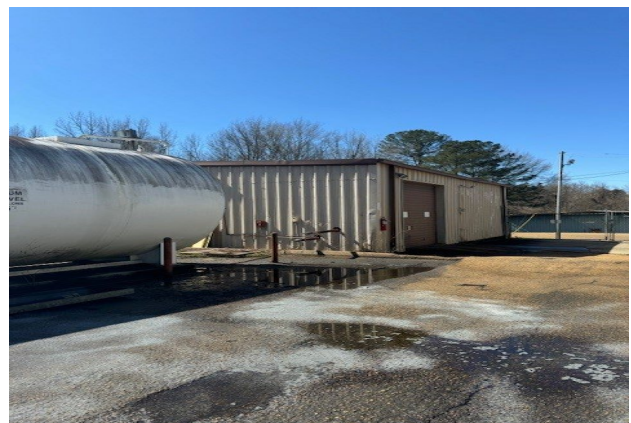
Photo-39 Absorbent Material on the gravel

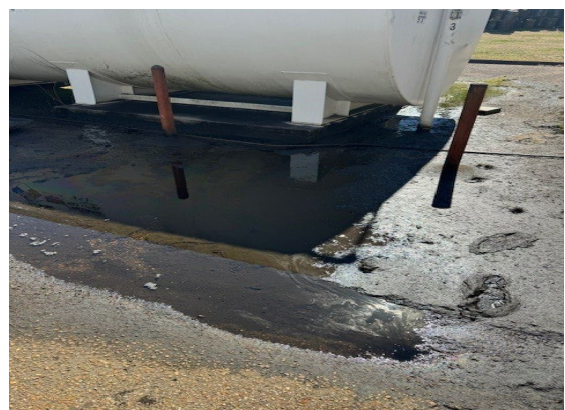
Photo-40 Stormwater Puddle with Oily Sheen

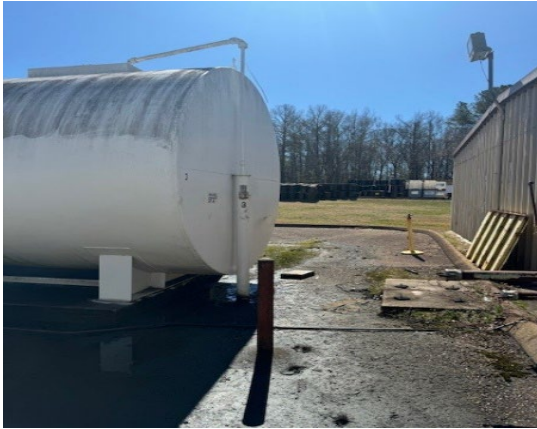
Photo-41 Oily Debris on the West Side

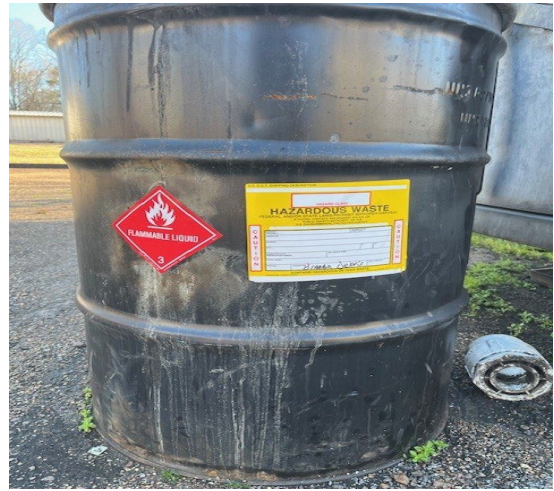
Photo-43 SAA Container with Flammable Label

On February 28, 2025, the Facility sent a photo of the corrected label along with indication of the hazards of the contents as "Flammable" (Photo-43).

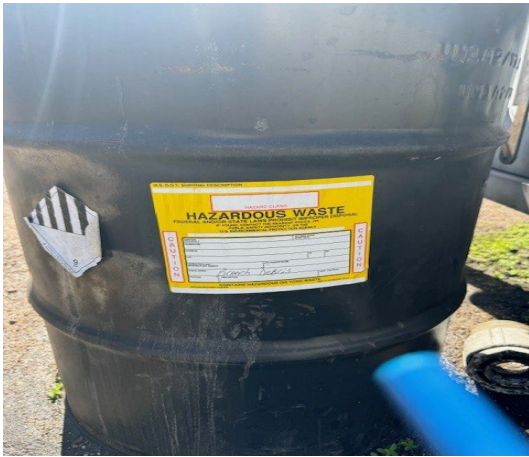
Near the Used Oil Tank, the inspectors observed one 55-gallon container of oily rags and debris (Photo-42). The container was observed to be closed and labeled as "Hazardous Waste" and with indication of the hazards of the contents as a "DOT Class 9" miscellaneous label. The inspectors asked why the waste is managed as hazardous waste, when the tank contains used oil. SK personnel stated that they conservatively manage the waste as hazardous waste. The inspectors further stated that the DOT Class 9 label does not indicate any specific hazards associated with the waste.

**Pursuant to 11 Miss. Admin. Code Pt. 3, R. 1.3 [40 C.F.R. § 262.15(a)(5)(ii)], which is a condition of the SAA Permit Exemption, a generator is required to mark or label its containers with an indication of the hazards of the contents.**

Photo-42 SAA Container with a DOT Class 9 Label
