## Region 6 - Enforcement & Compliance Assurance Division

### INSPECTION REPORT

| Company Name: | <b>R&amp;D Resources</b> | |
| Facility Name: | <b>Stoney #1</b> | |

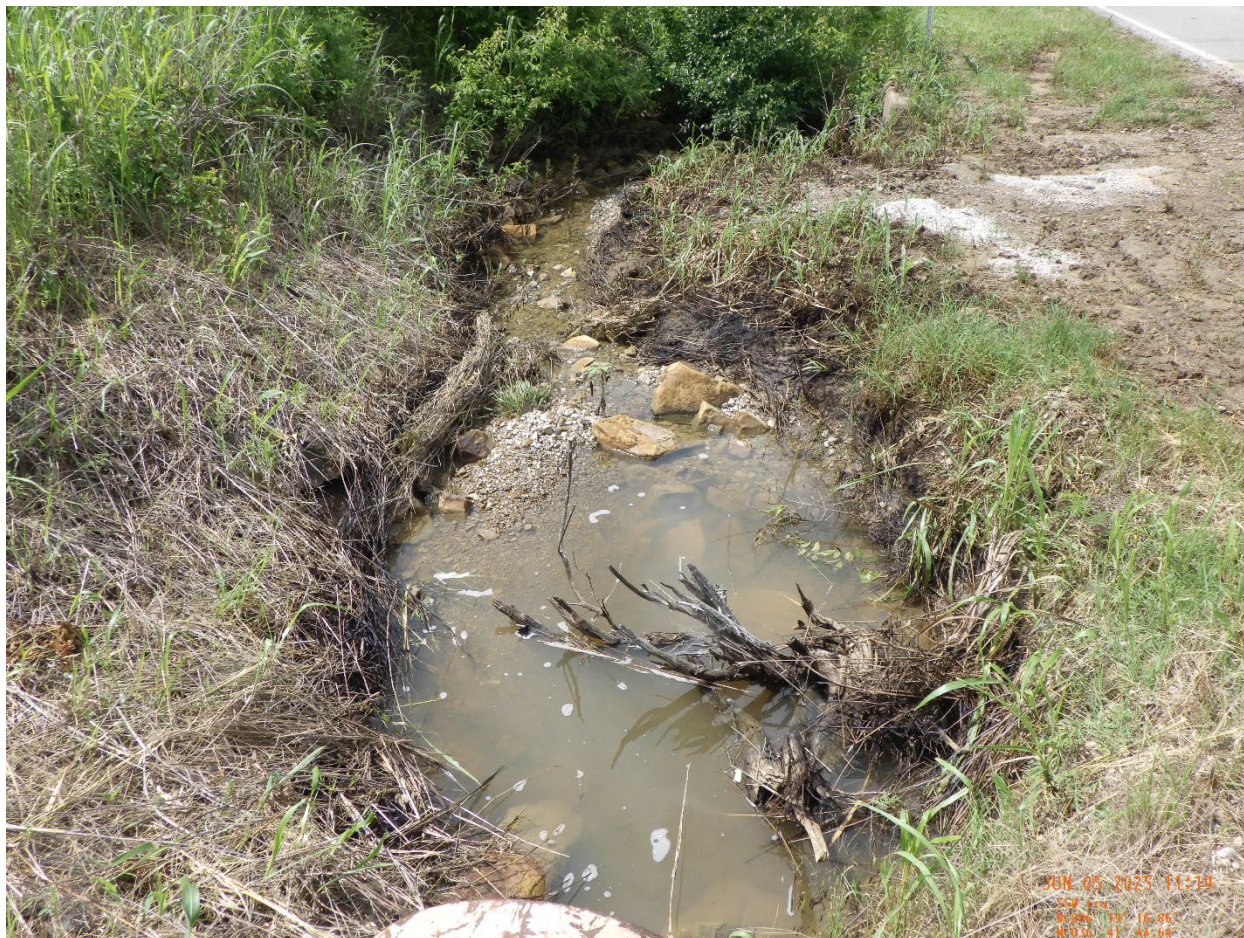
Photo No. 1

I observed oil-stained soil and vegetation in the conveyance along the east side of Lynn Avenue, near the point of entry, see Photo No. 1. For additional GPS location information and photo metadata, please see Appendix 1 (photo log) attached to this report.

**Description:** Looking SSW, showing oil staining present on vegetation near the point of entry into the conveyance along Lynn Avenue.

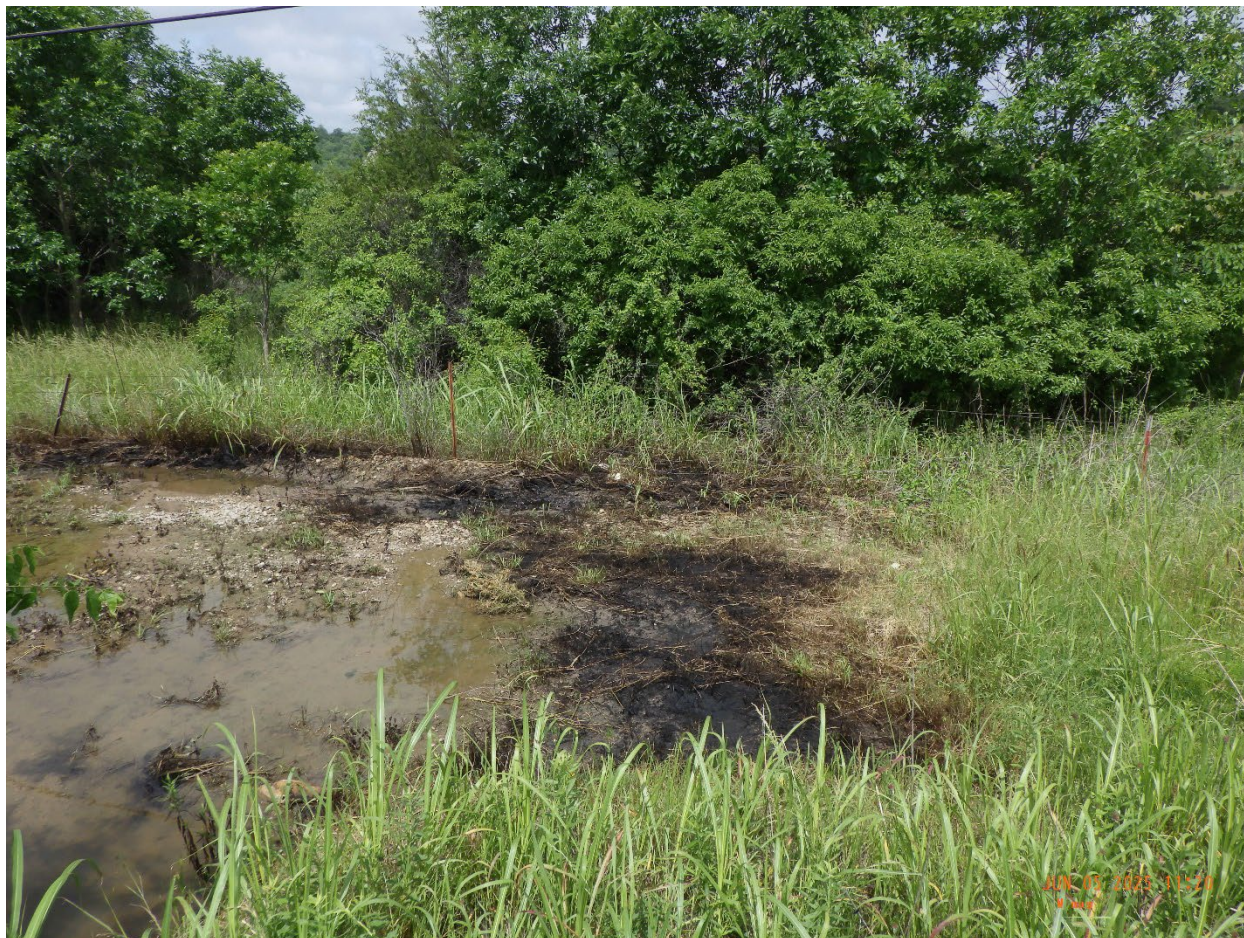
Photo No. 2

In the conveyance along the westside of Lynn Avenue, I observed significant oil-stained soil and vegetation, see Photo No.2.

**Description:** Looking W, showing oil-stained soil and vegetation present in the conveyance along Lynn Avenue.
