**Well Inspection**  
**Osage DNR / Environmental Protection Agency**  
**1201 Elm Street, Suite 500**  
**Dallas, Texas 75270**

| | | <b>Well ID</b> | 13W7-3 | | |
| <b>Inspection Reason</b> | Plugging Witnessed | <b>Responsible Company at Time of Inspection</b> | Bandwheel Production Company | | |

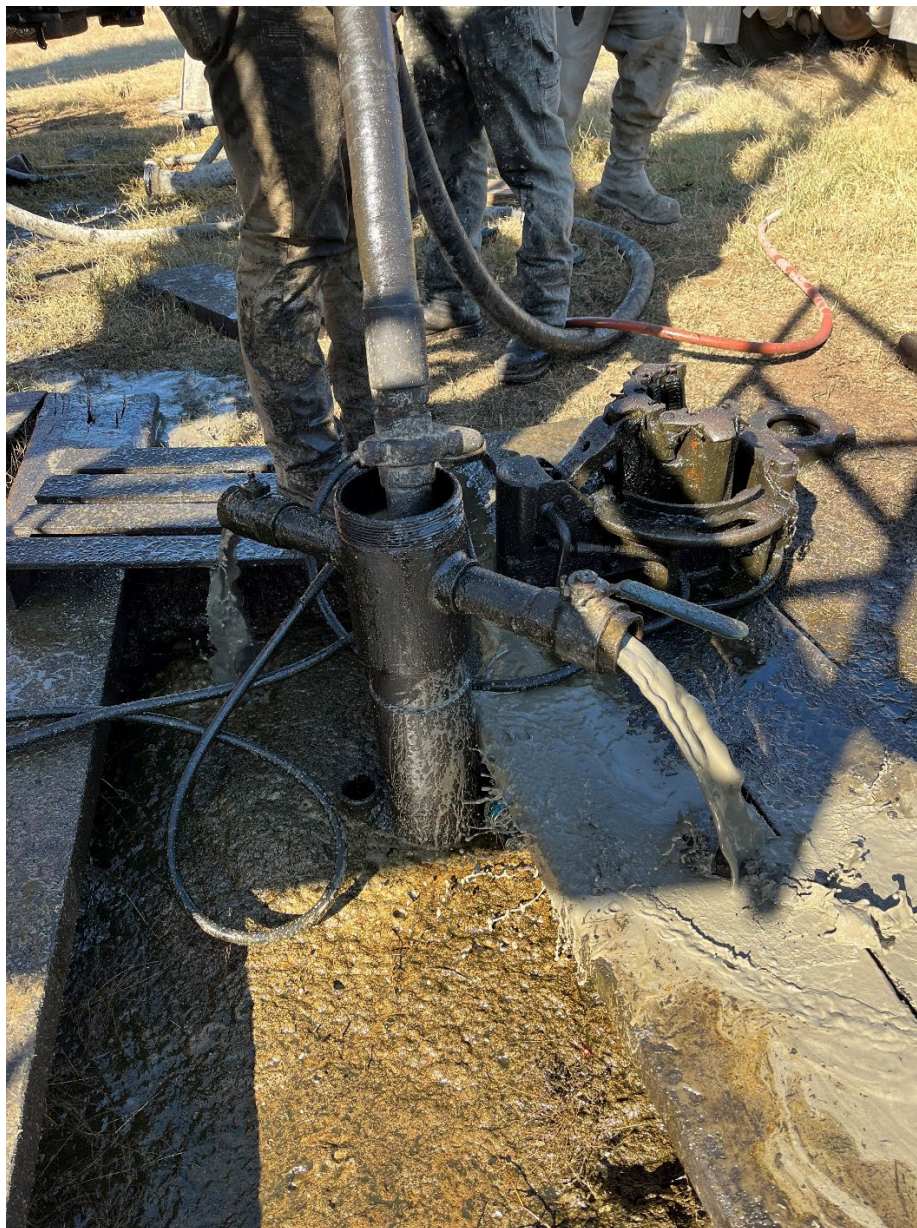
Photo No. 1

**Description:** This was well OS1014000 with cement circulating to the surface.

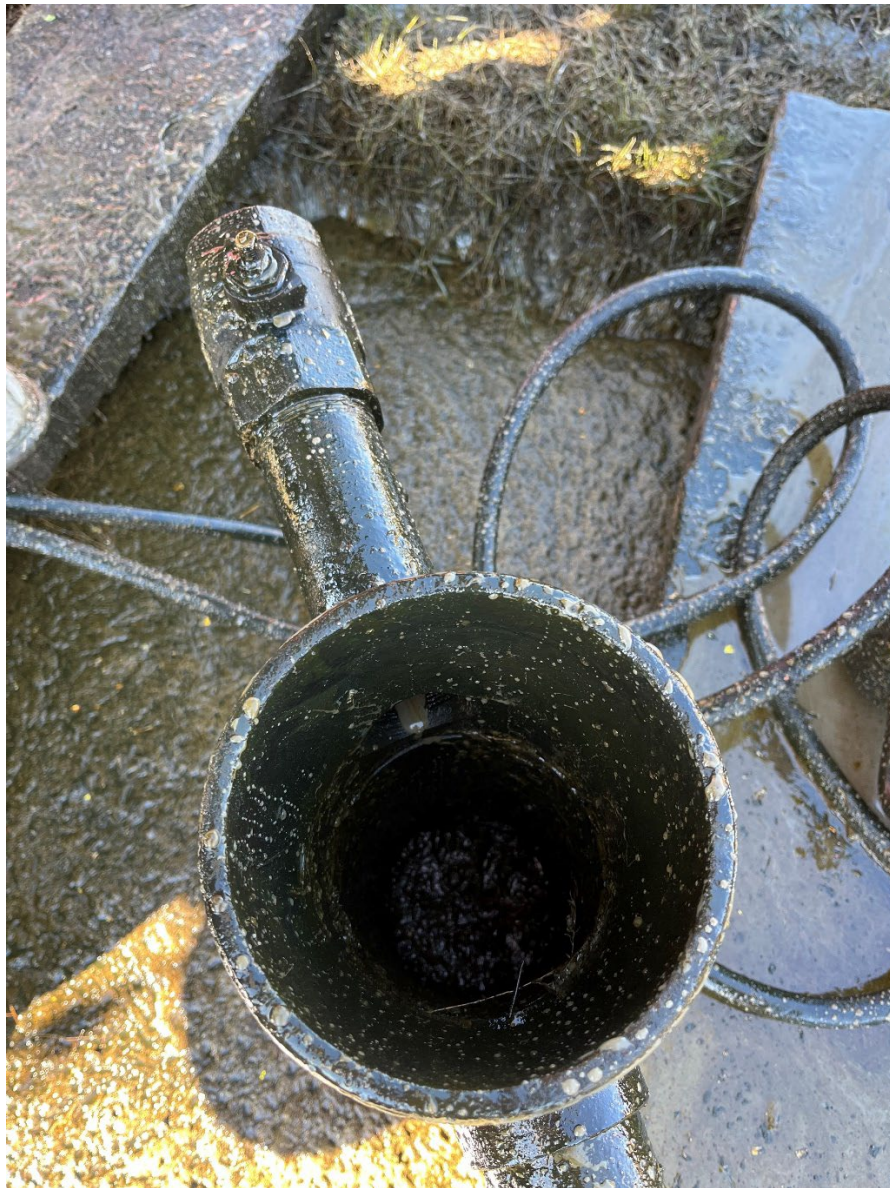
Photo No. 2

**Description:** This was well OS1014000 standing full of cement, 1 foot below surface with no fallback.
