**Region 6 Compliance Assurance and Enforcement Division  
INSPECTION REPORT**

| Company Name: | International Paper Co | | |
| Facility Name: | Mansfield Mill | | |
| Identification/Permit Number: | LA0056651 (AI No. 328) | | |

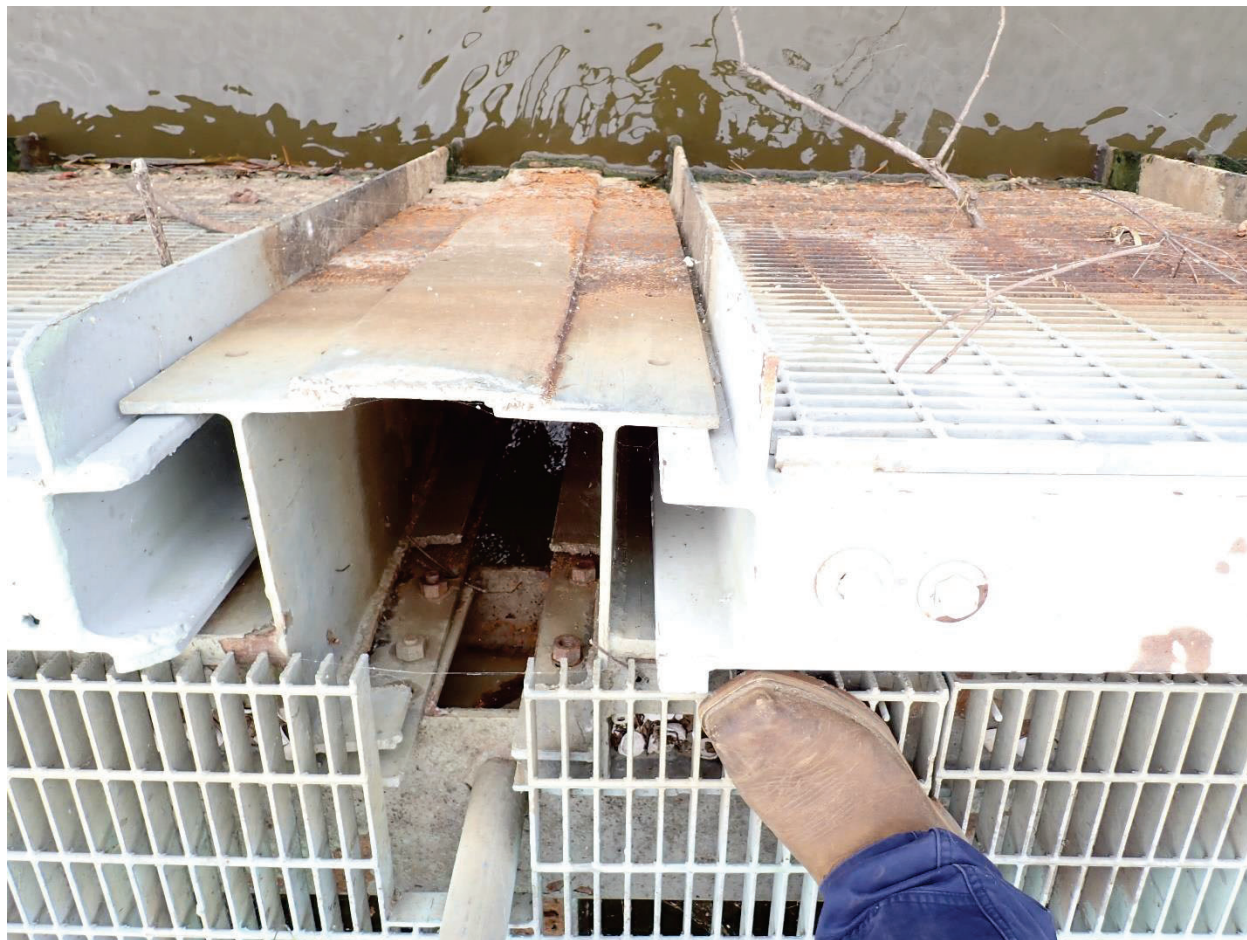
Photo No. 5

This image shows corrosion on the stainless-steel trash rack wall structures that contain and protect the intake pipes connected to the pumps.

1. Facility should provide the 316b application file that includes information about the integrity and maintenance of the cooling water intake structure (CWIS). This file should include intake structure dimensions, maintenance records in case of corrosion (stainless-steel trash rack wall structures) and others, drawings and maintenance records of screened caisson structure that prevent large organism or debris from entering the system, drawings and maintenance records of smaller mesh screened structure that reduce impingement of small organism or further restrict smaller debris manual backflush.

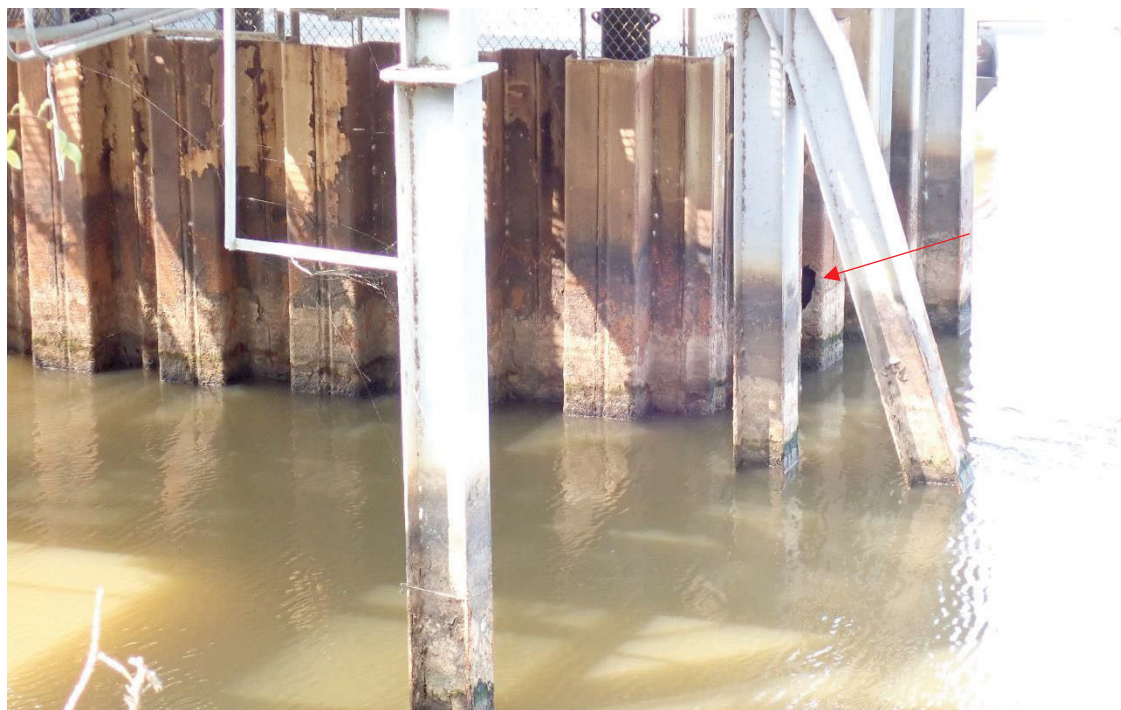
Photo No. 6

This image shows a large hole (red arrow) on the stainless-steel trash rack wall structures that contain and protect the intake pipes connected to the pumps.

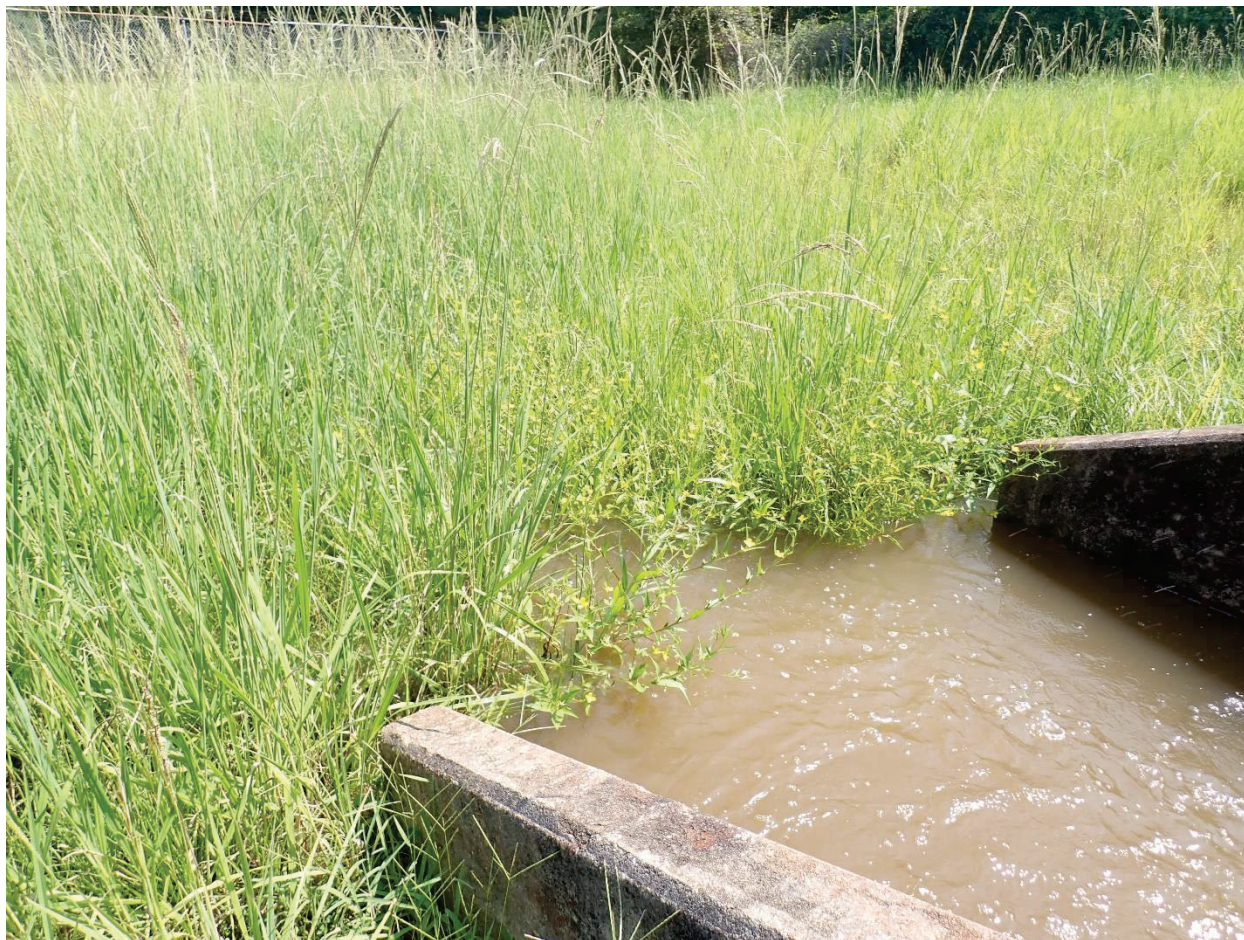
Photo No. 8

The head tank is part of the water intake structure system (CWIS). Its purpose is to store water and provide capacity to maintain facility operations for specific periods of time. Intake water is stored at this location and transferred to the mill. The tank is connected to nine pumps prior to the mill (four intake pumps at Toledo Bend Reservoir, two push pumps between Toledo and Head Tank, and three push pumps between head tank and the mill). At the time of the inspection, we observed intake water overflowing from the tank to ground surface next to the tank (See Photo Nos. 7 – 8 in Appendix 1).

Photograph File Name: P8220150.JPG  
Date of Photograph: 08/22/2024  
Latitude and Longitud: 32.023692 -93.759556  
Orientation: SW  
Map Datum: WGS-84  
Time of Photo: 10:47 AM  
Photographer: Jack Arias  
Description: This image shows the intake water overflowing from the tank to ground surface next to the tank.

2. Facility needs to provide information about a permit that allows them to release water from the head tank into the surface area next to the tank. Also, the facility needs to explain how they will control the volume and flow rate of water going to the head tank and discharge into the surface.

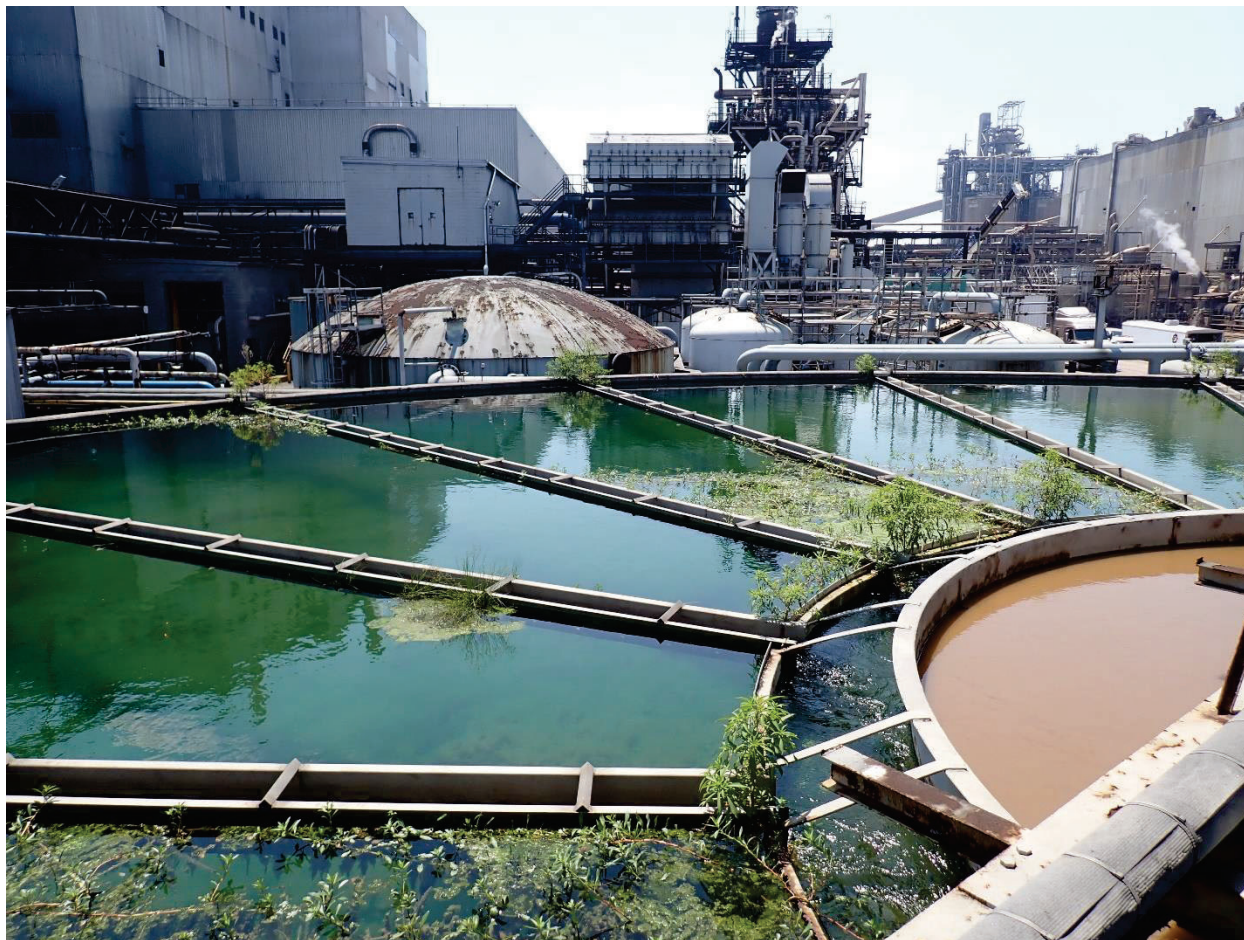
Photo No. 10

Photograph File Name: P8210065.JPG  
Date of Photograph: 08/21/2024  
Latitude and Longitude: 32.1592963 -93.5568618  
Orientation: E  
Map Datum: WGS-84  
Time of Photo: 11:39 AM  
Photographer: Jack Arias  
Description: This image shows plants and algae beds inside the south clarifier system. These plants and algae layers could potentially impact the treatment process and integrity of the clarifier system.

3. Facility needs to control the plants and algae growth inside the south and north clarifier systems and further explain how the plants and algae potentially impact the treatment process and integrity of the clarifier systems.

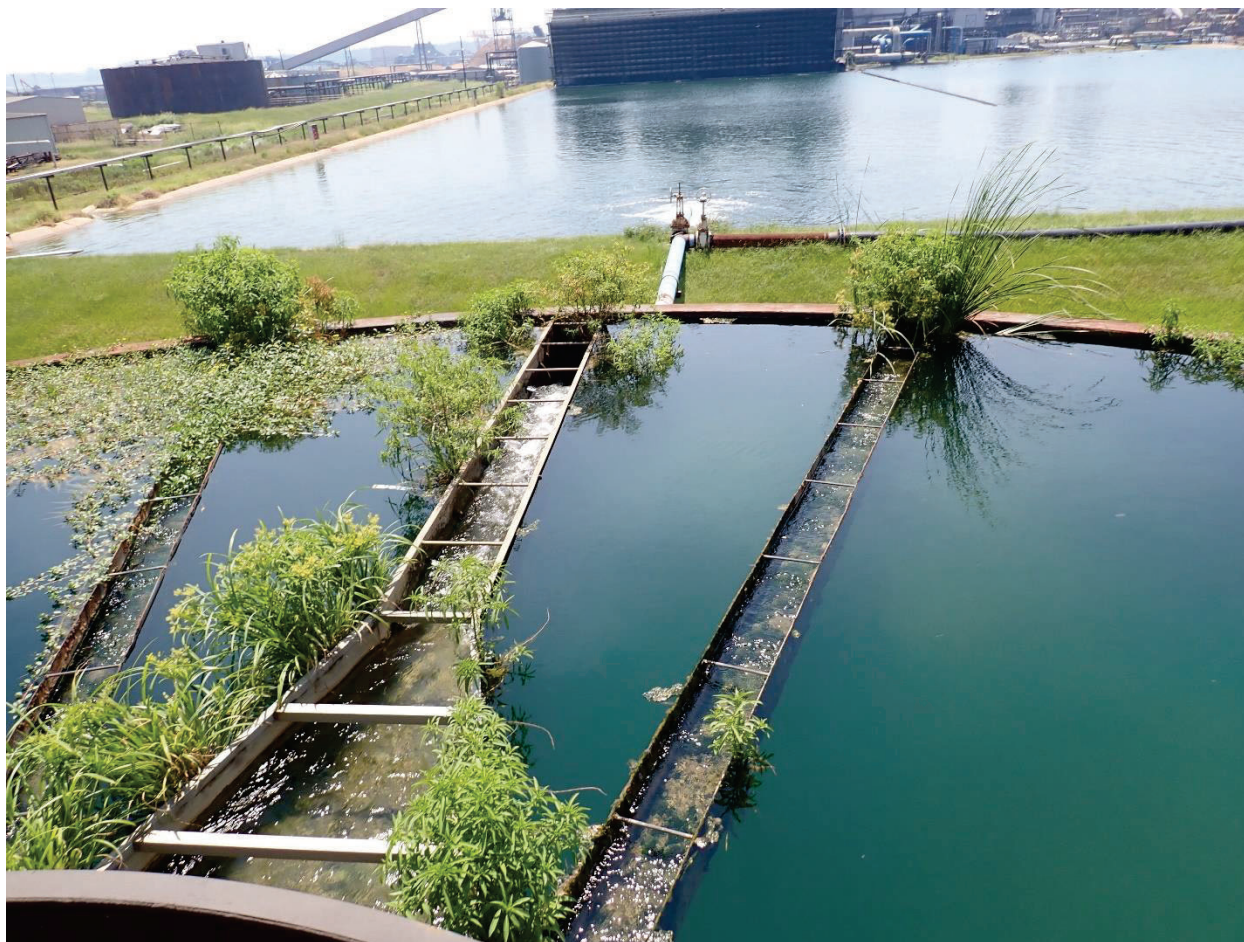
Photo No. 11

This image shows plants and algae beds inside the north clarifier system. These plants and algae beds could potentially impact the treatment process and integrity of the clarifier system.

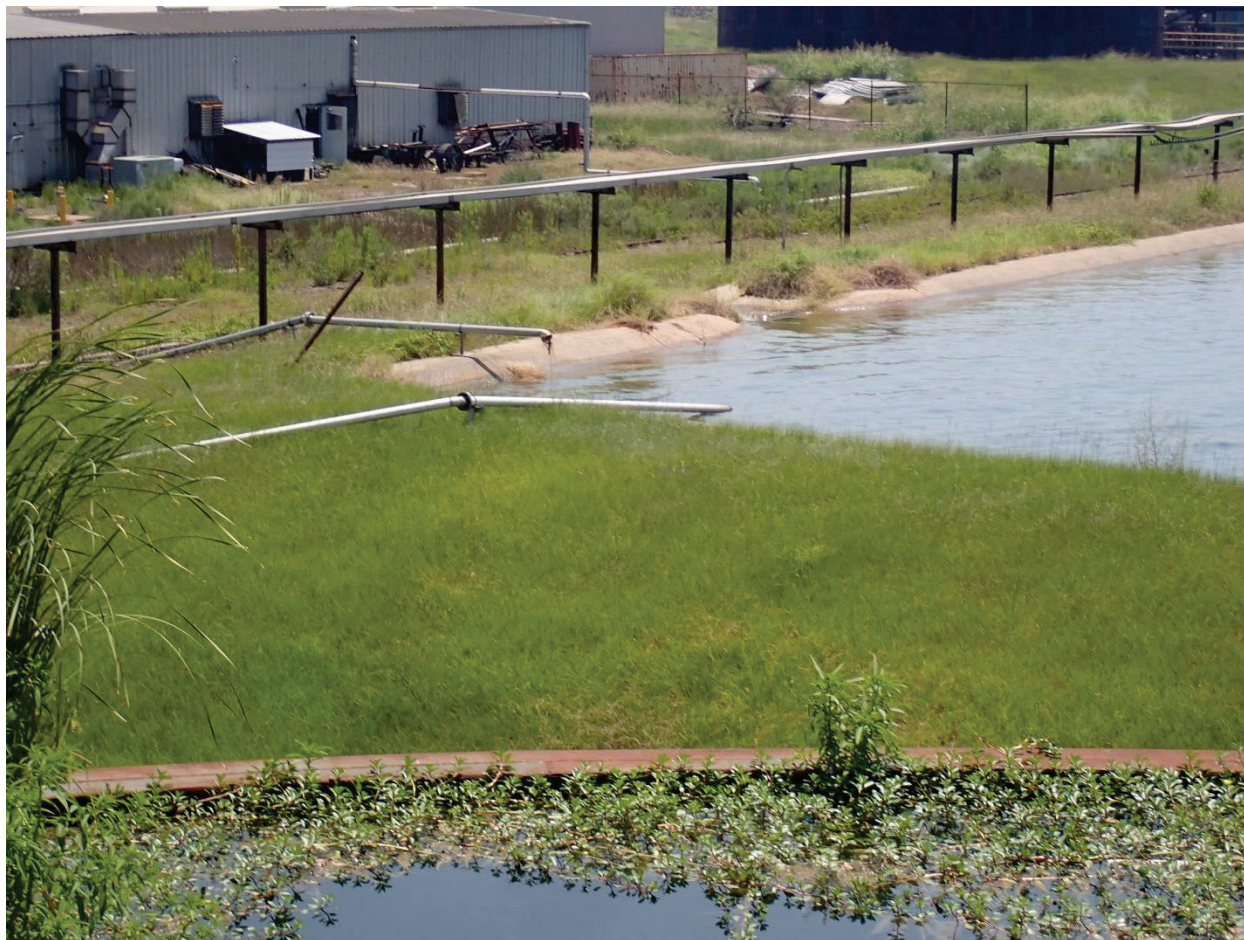
Photo No. 15

The treated water reservoir received water from Toledo Bend Reservoir. The water is treated through two clarifiers (south and north clarifiers) systems and discharge into the treated water reservoir for use in utilities and mill process units. Its main purpose is to provide capacity water to maintain facility operations for specific periods of time. At the time of the inspection, we observed the presence of fish and small formation of algae. Also, we observed large amounts of treated water overflowing (north right corner of

reservoir) from the reservoir directly into a ditch system next to the reservoir area leading to Outfall 003 (See Photo Nos. 12 – 20 in Appendix 1).

This image shows large amounts of treated water overflowing (north right corner of reservoir) from the reservoir directly into a ditch system next to the reservoir area leading to Outfall 003.

4. Facility needs to provide information about the chemical composition of the treated water at the reservoir, wastewater from mill processes redirected and recirculated to the treated water reservoir, and cooling water redirected to the reservoir. This will help to determine the potential

impacts of treated water that was overflowing (north right corner of reservoir) from the reservoir directly into a ditch system next to the reservoir and directed to Outfall 003.

5. Facility needs to provide an explanation of the treated water overflowing and discharging from the reservoir into a ditch system, thence to Outfall 003.
6. Facility needs to provide an updated wastewater flow balance diagram and photos of missing labels or identification tags for external and internal outfalls.
7. Also, facility needs to provide information about the inactivity and potential activation of outfall 201 (under maintenance).
8. Facility needs to provide copies of updated SWPP3 and SPCC plans.

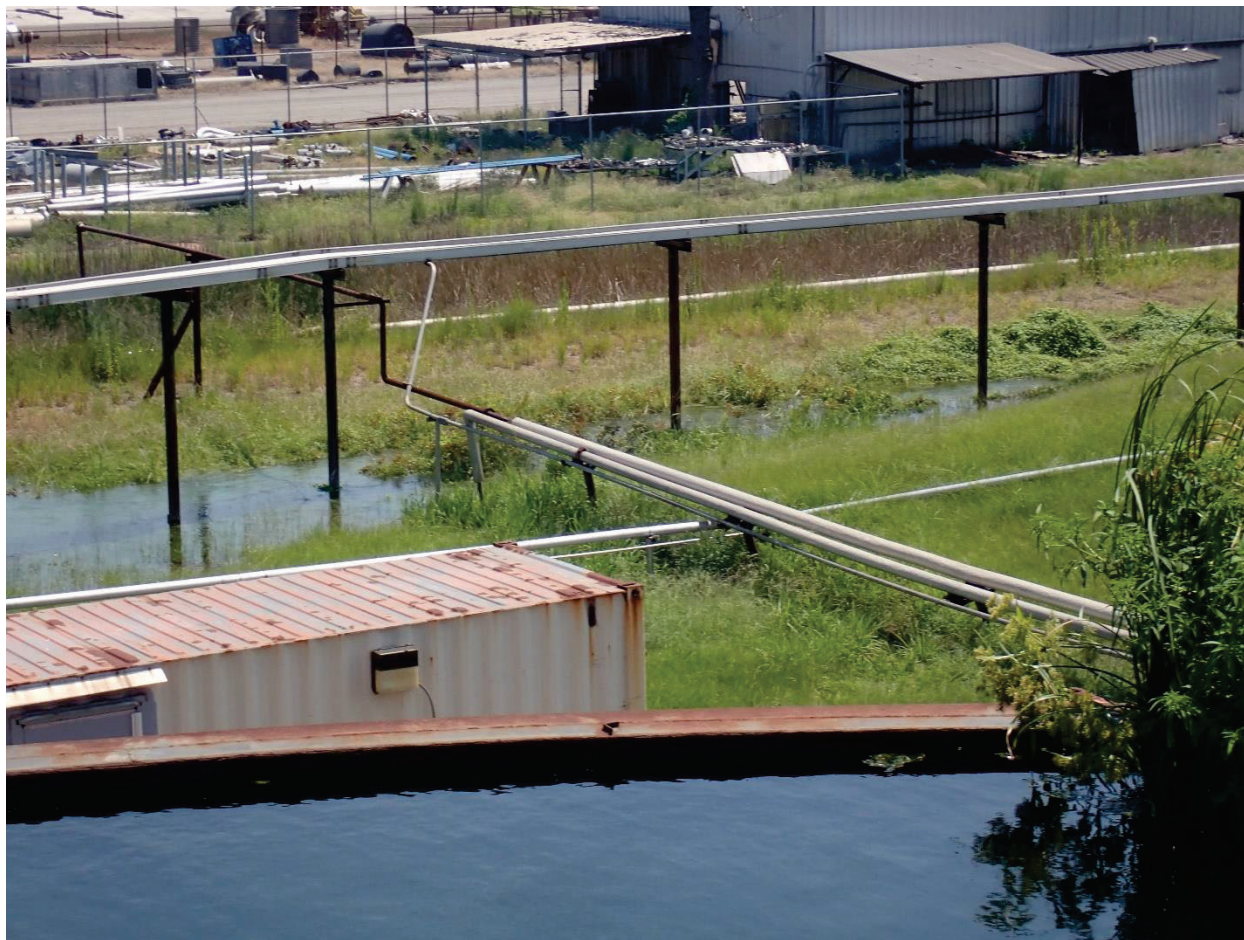
Photo No. 16

Description: This image shows the ditch system next to the reservoir area directing treated water to Outfall 003.

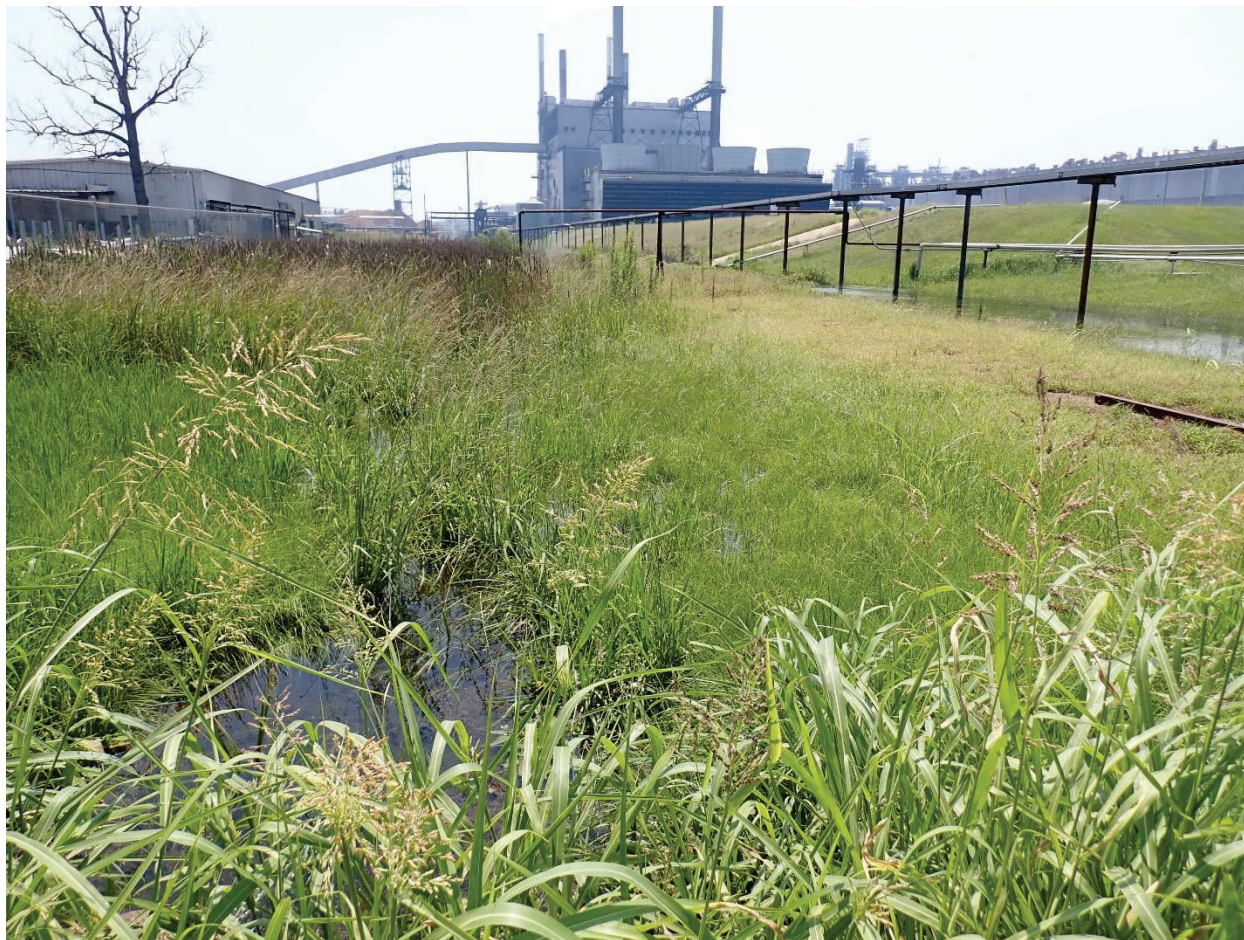
Photo No. 17

Photograph File Name: P8210091.JPG  
Date of Photograph: 08/21/2024  
Latitude and Longitude: 32.161234 -93.555356  
Orientation: NE  
Map Datum: WGS-84  
Time of Photo: 12:20 PM  
Photographer: Jack Arias  
Description: This image shows the ditch system next to the reservoir area directing treated water to Outfall 003.

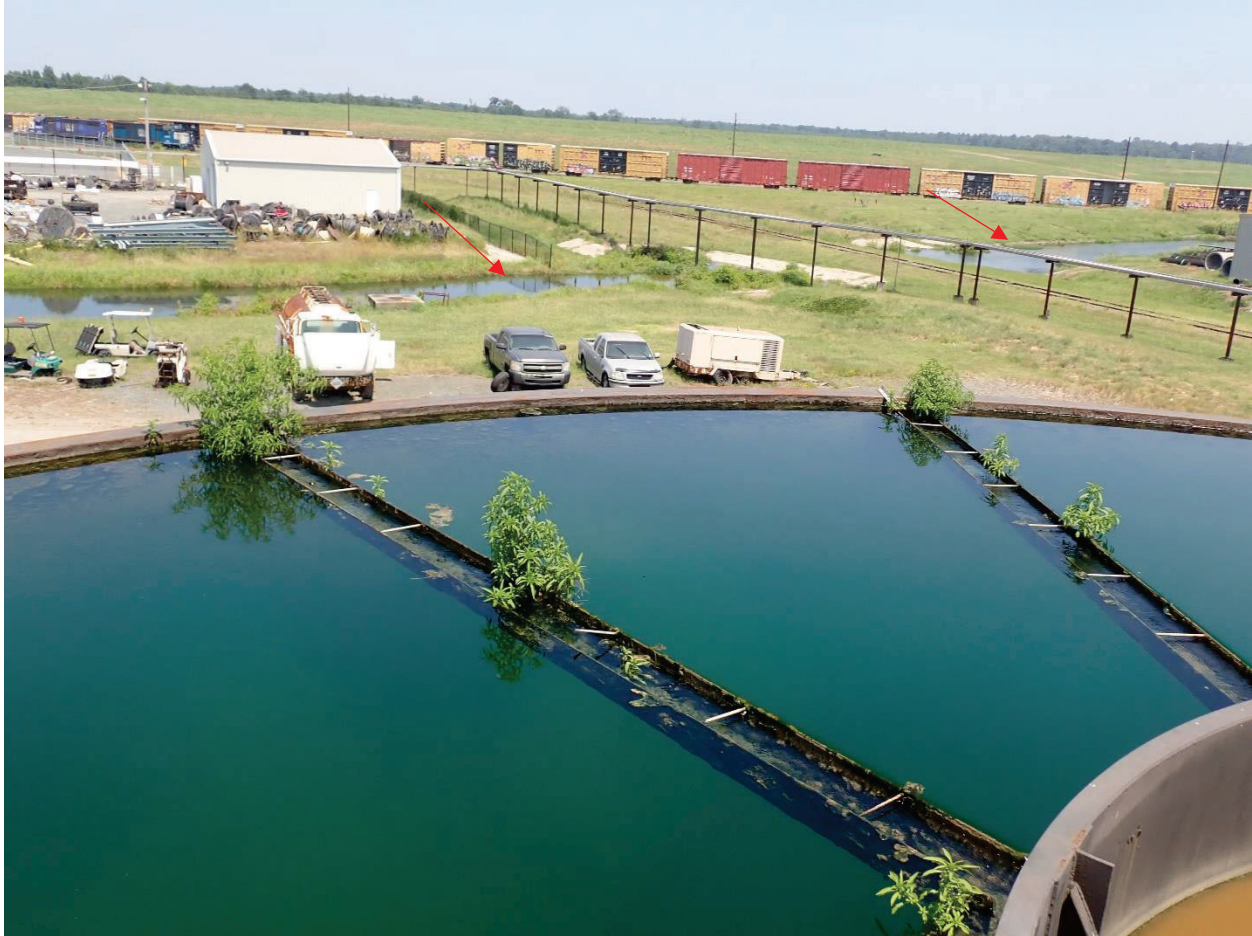
Photograph File Name: P8210086.JPG  
Date of Photograph: 08/21/2024  
Latitude and Longitud: 32.161994 -93.555272  
Orientation: NE  
Map Datum: WGS-84  
Time of Photo: 12:11 PM  
Photographer: Jack Arias  
Description: This image shows the ditch system (red arrows) next to the reservoir area directing treated water to Outfall 003.

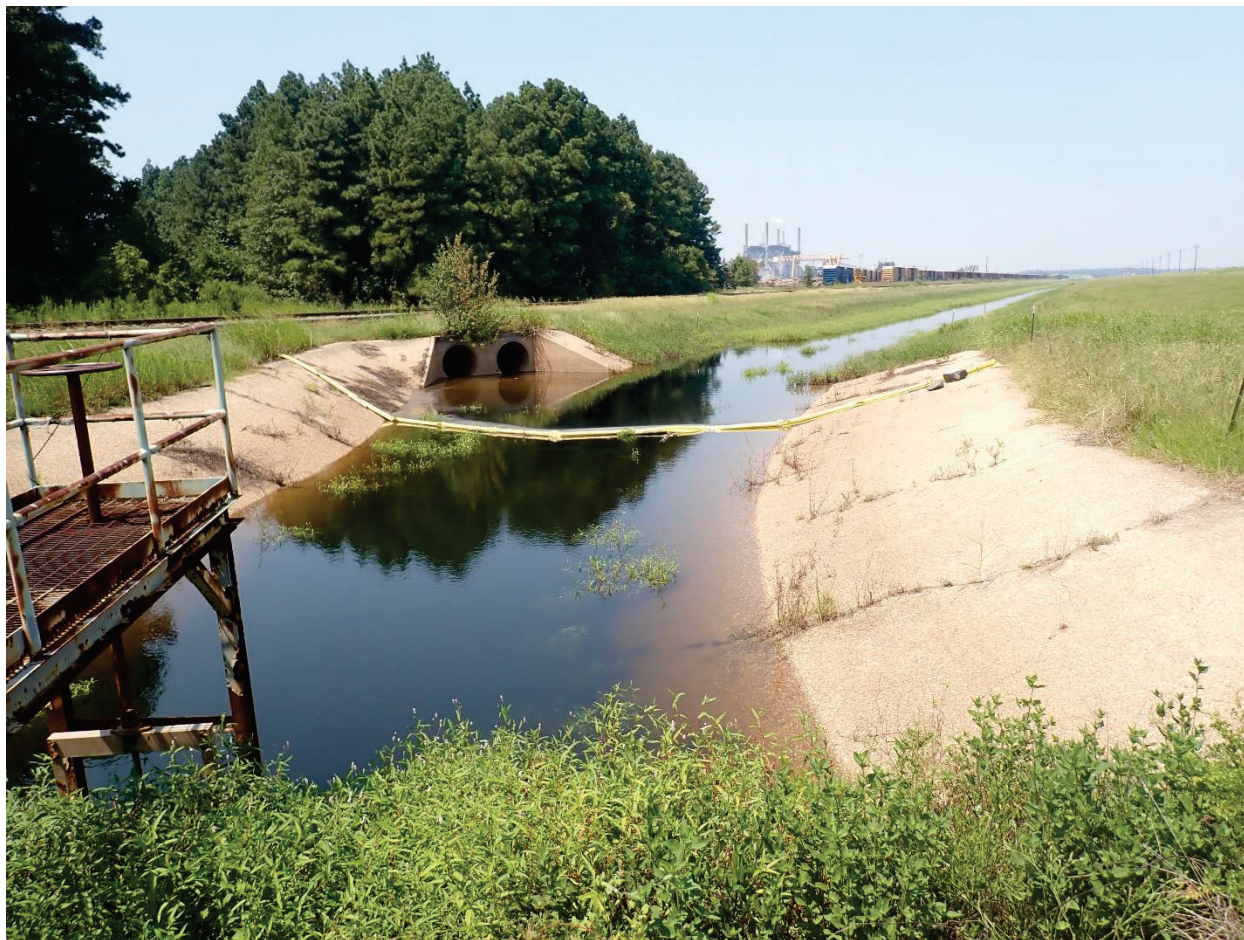
Photograph File Name: P8210110.JPG  
Date of Photograph: 08/21/2024  
Latitude and Longitude: 32.156566 -93.551936  
Orientation: NE  
Map Datum: WGS-84  
Time of Photo: 1:10 PM  
Photographer: Jack Arias  
Description: This image shows the ditch system and Outfall 003. We did not observe the proper label or identification tag.

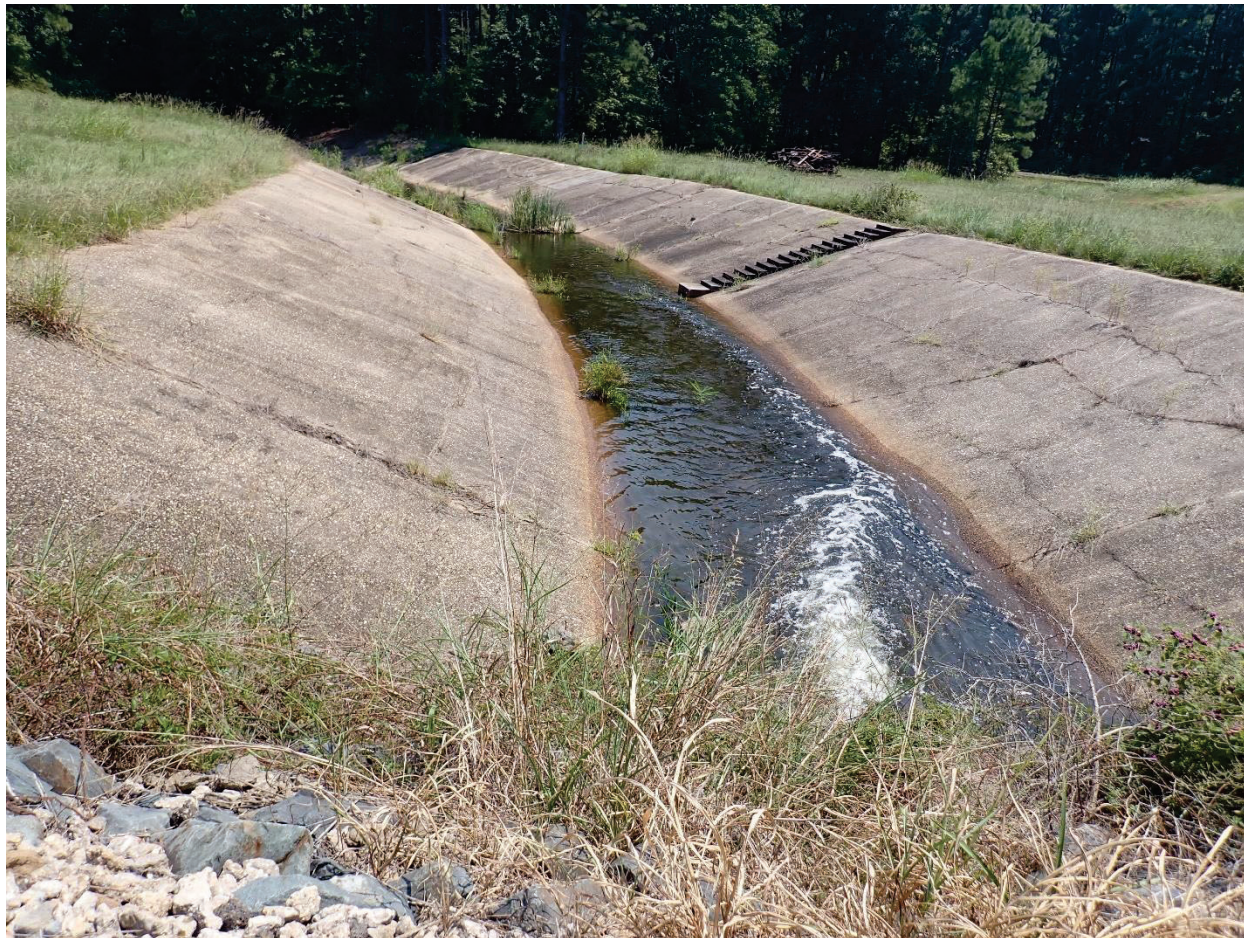
This outfall includes intermittent discharge of low contamination potential stormwater runoff and treated water reservoir overflow. Outfall 003 discharges into Bayou Pierre. At the time of the inspection, we observed large amounts of treated water overflowing and discharging (north right corner of reservoir) from the reservoir into a ditch system next to the reservoir area and directed to Outfall 003. Also, we did not observe the proper label or identification tag. There was flow and discharge into Bayou Pierre (See Photo Nos. 15 - 21 in Appendix 1).

Photograph File Name: P8210111.JPG  
Date of Photograph: 08/21/2024  
Latitude and Longitude: 32.156279 -93.552007  
Orientation: NE  
Map Datum: WGS-84  
Time of Photo: 1:10 PM  
Photographer: Jack Arias  
Description: This image shows a downstream flow and discharge from Outfall 003.

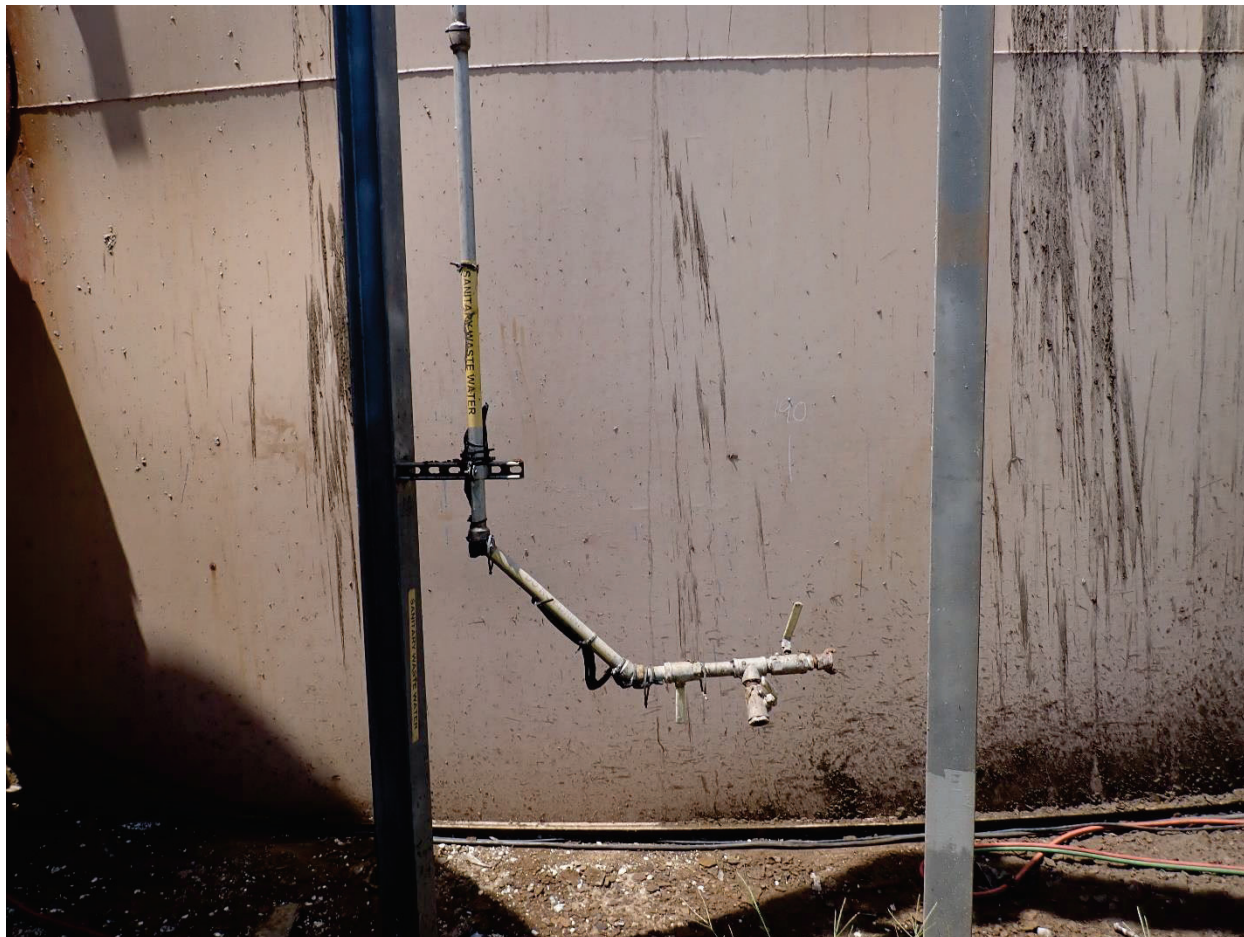
This image shows internal outfall 201 that discharge into lift Pit and is directed to the wastewater treatment system, and thence to outfalls 001 (Red River) and 002 (Bayou Pierre). We did not observe the proper label or identification tag.

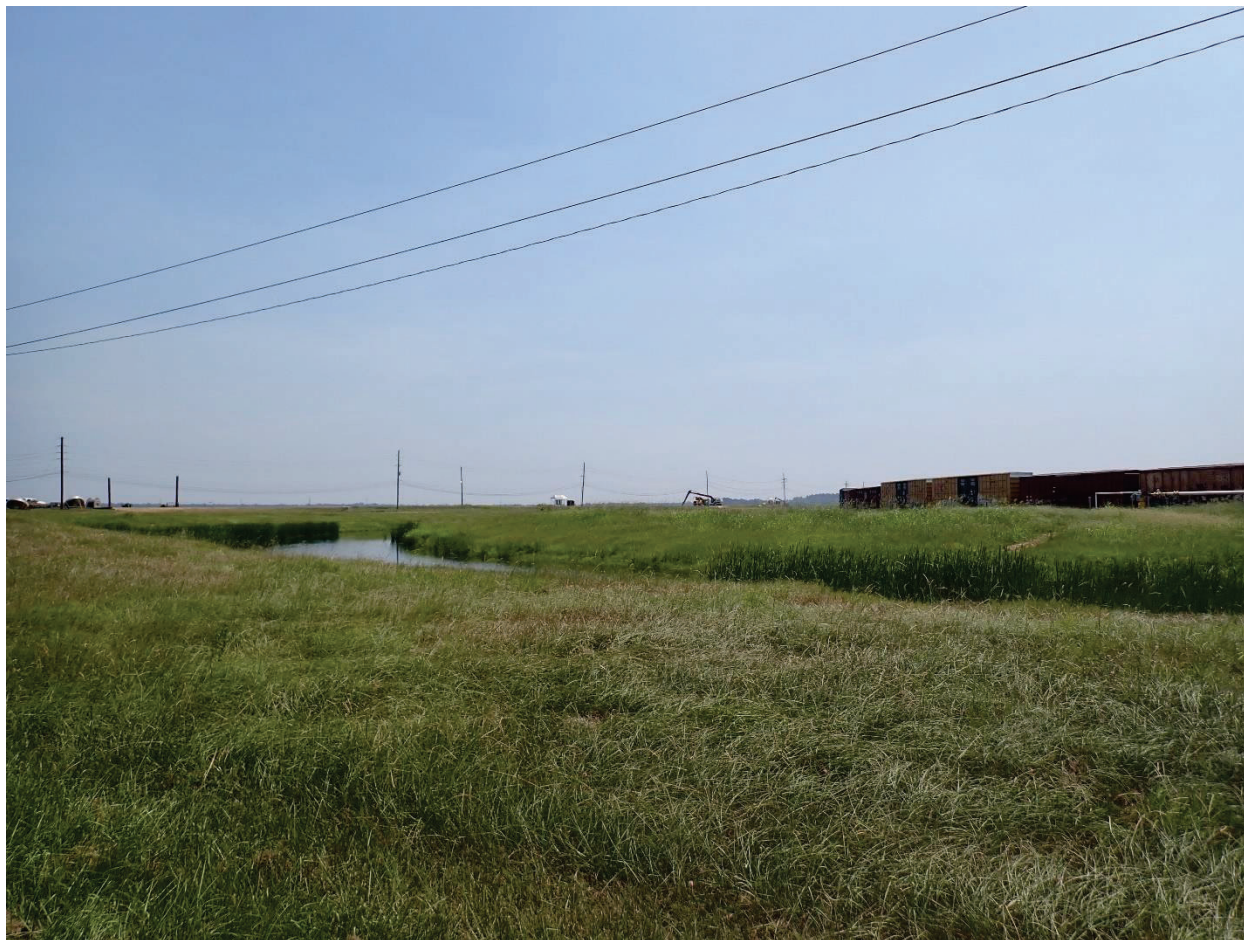
These outfalls 005 and 006 includes intermittent discharge of low contamination potential stormwater runoff from the northern (005) and southern (006) sections of the solid waste disposal facility (low contamination potential stormwater runoff from rail yard and rail tracks in the case of outfall 006). At the time of the inspection, we observed that both outfalls did not have an identification tag (See Photo No. 30 in Appendix 1).

This image shows pathways to outfalls 005 and 006. These outfalls have intermittent discharge of low contamination potential stormwater runoff from the northern (005) and southern (006) sections of the solid waste disposal facility (low contamination potential stormwater runoff from rail yard and rail tracks in the case of outfall 006).
