# Photographs for St. Marys Wastewater Treatment Lagoon

Inspection Type: Compliance Evaluation Inspection

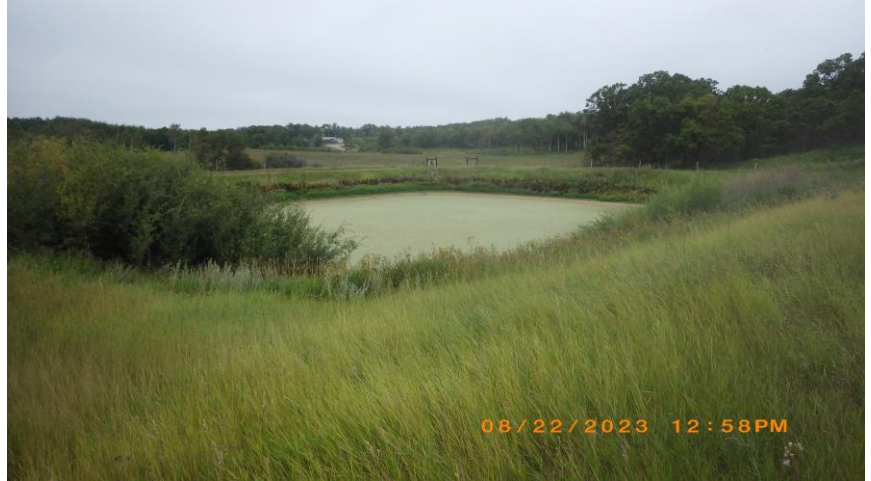
Photo number 463 taken by **Privacy** on 8/22/2023.

Overview of cell 2. Empty with exposed sludge.

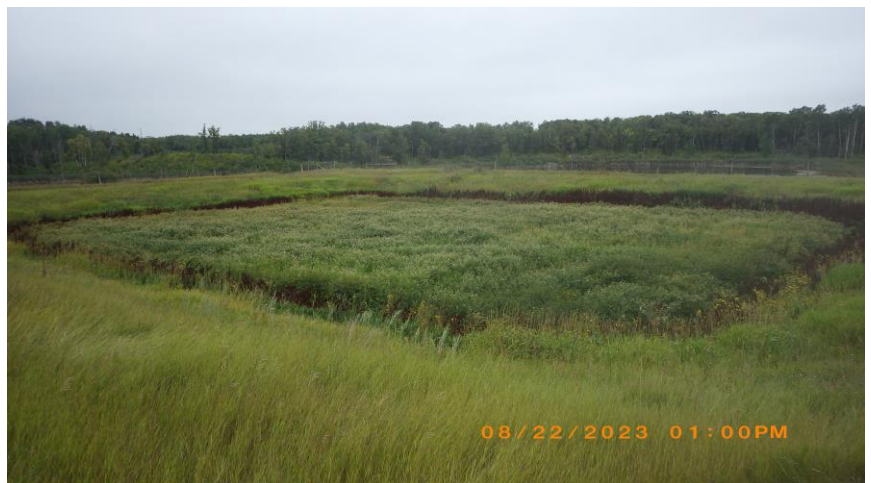
Photo number 464 taken by **Privacy** on 8/22/2023.

Overview of cell 3. Empty with vegetation growing inside cell.

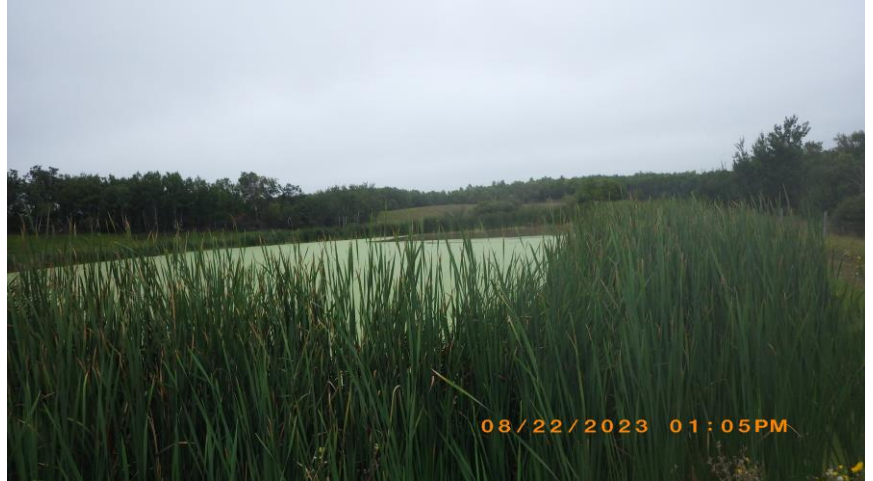
Photo number 465 taken by **Privacy** on 8/22/2023.

Overview of cell 1. Cell was very full and had cattails and algae inside.

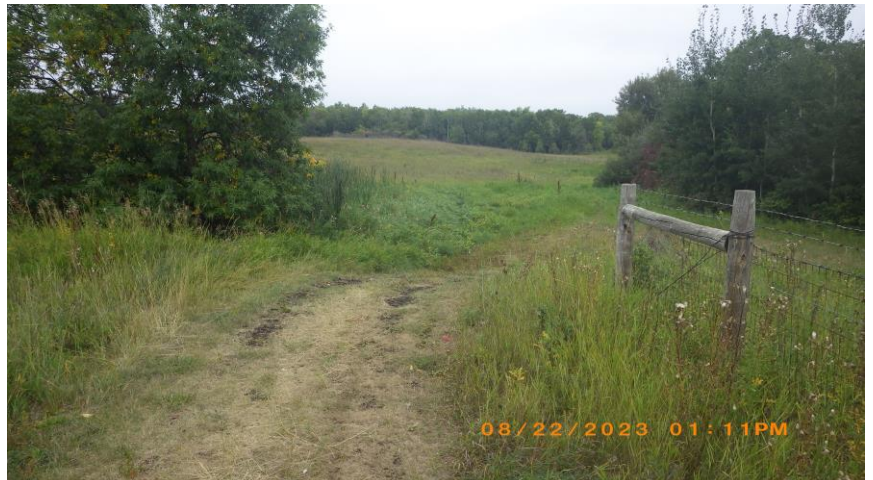
Photo number 466 taken by **Privacy** on 8/22/2023.

No gate and missing fence at NE corner of cell 1.

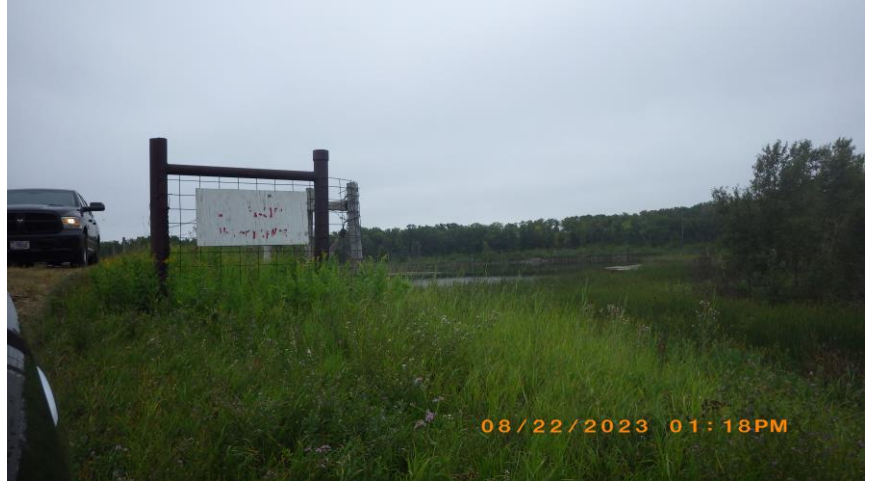
Photo number 467 taken by **Privacy** on 8/22/2023.

Lack of gate and faded sign at entrance to lagoon.
