# NPDES Compliance Inspection Report

**Darigold – Issaquah  
Spokane, Washington**

**Permit #: WAR000497**

**Inspection Date: January 24, 2022**

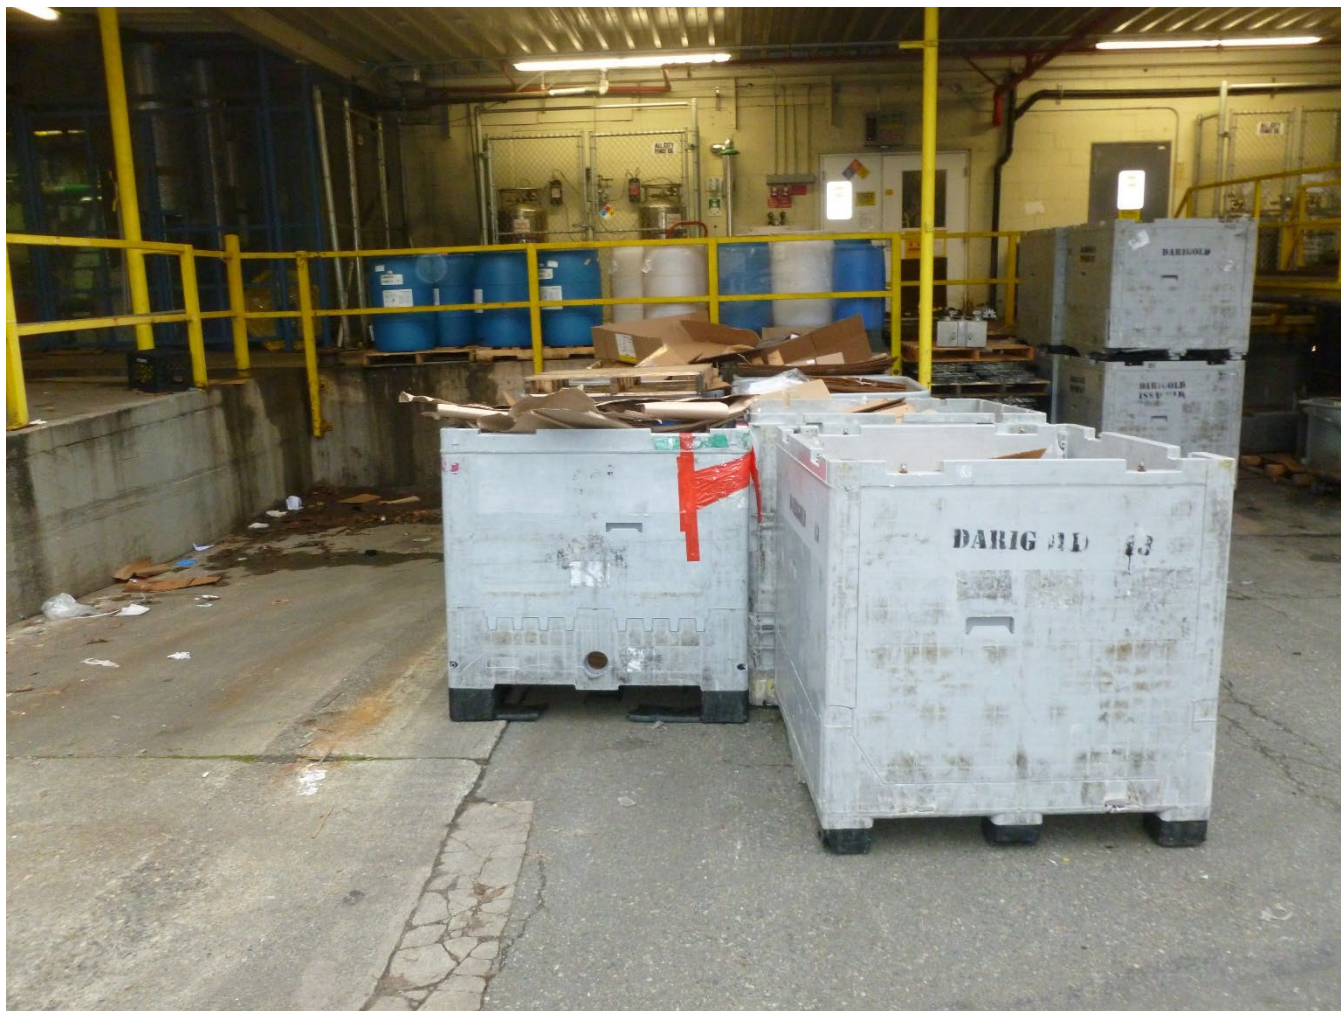
We started the tour on the southwestern side of the site where I observed plastic bins of recyclable cardboard (**Photo 1**) under cover of an awning. The cardboard bins were next to a loading dock (**Photo 2**), which was no longer in service. The loading dock had an accumulation of trash and debris.

**Photo 1 / P1010198** – Recyclable Cardboard Bins

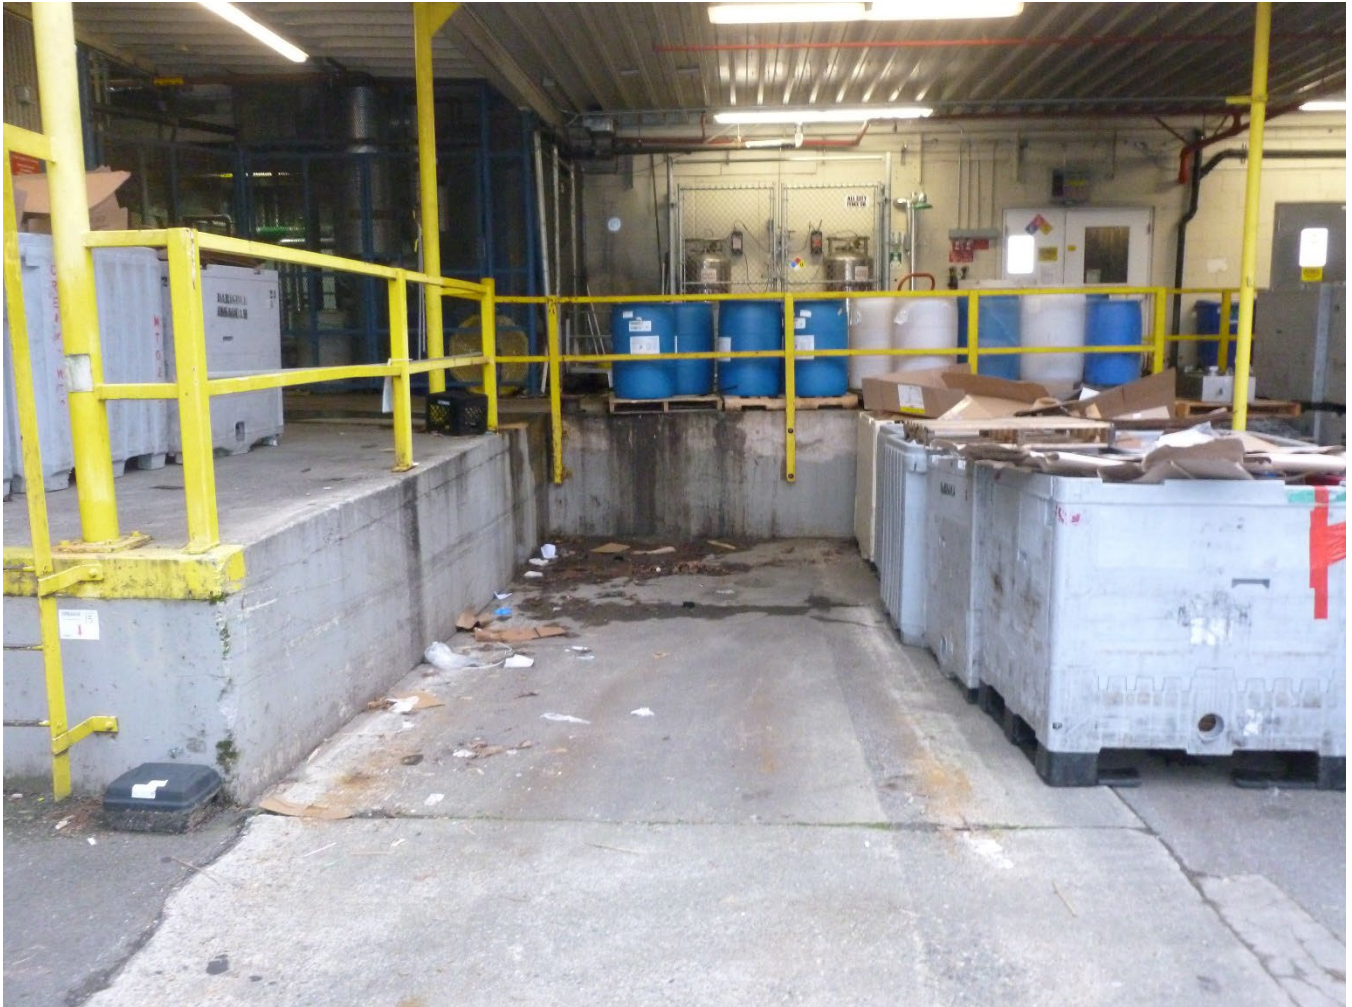
**Photo 2 / P1010199** – Dock, Out of Service

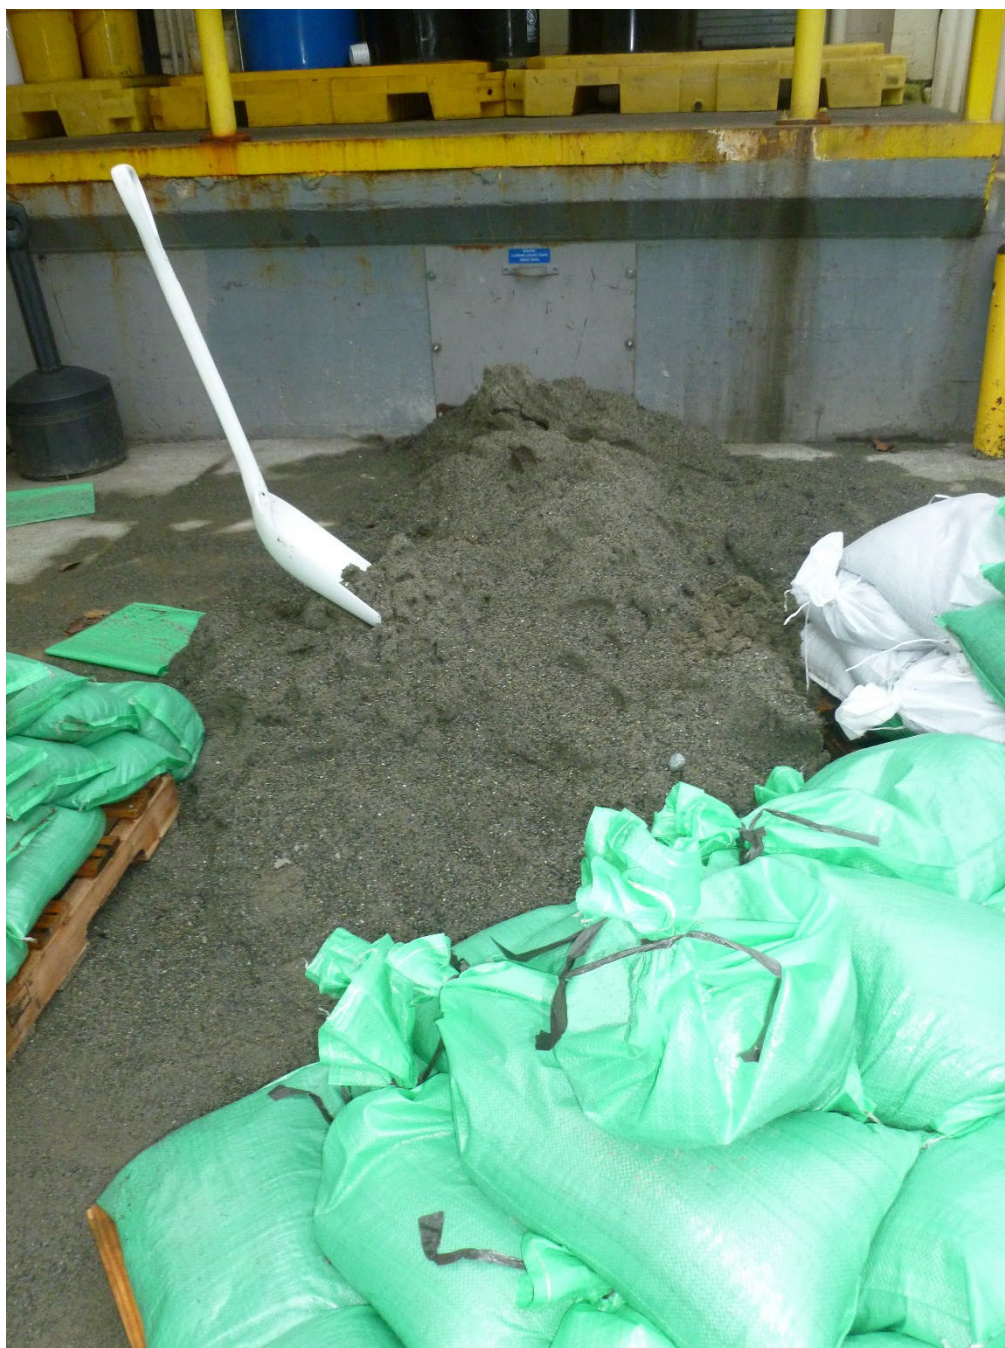
Near the loading dock, I observed a pile of sand and pallets of filled sandbags (**Photos 3 & 4**). Per Mr. Babcock, the sand and sandbags were pre-staged in the event the nearby East Fork of Issaquah Creek overflowed its banks. Directly adjacent to the sandbags was one of the facility's three lift

**Photo 3 / P1010201** – Sandbags and sand, close up

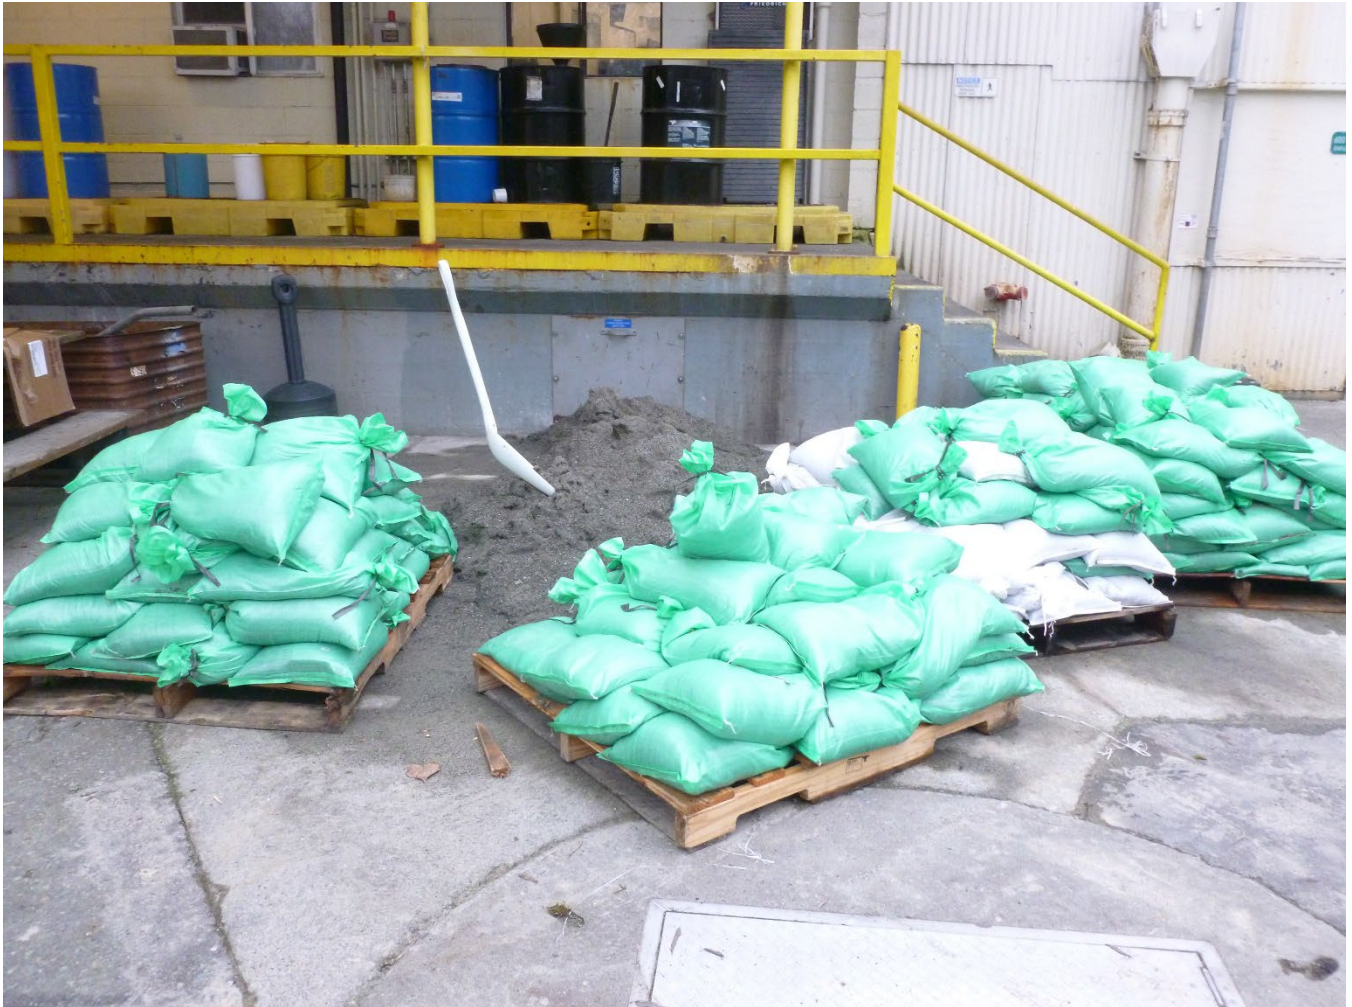
**Photo 4 / P1010200 – Sandbags and Sand**

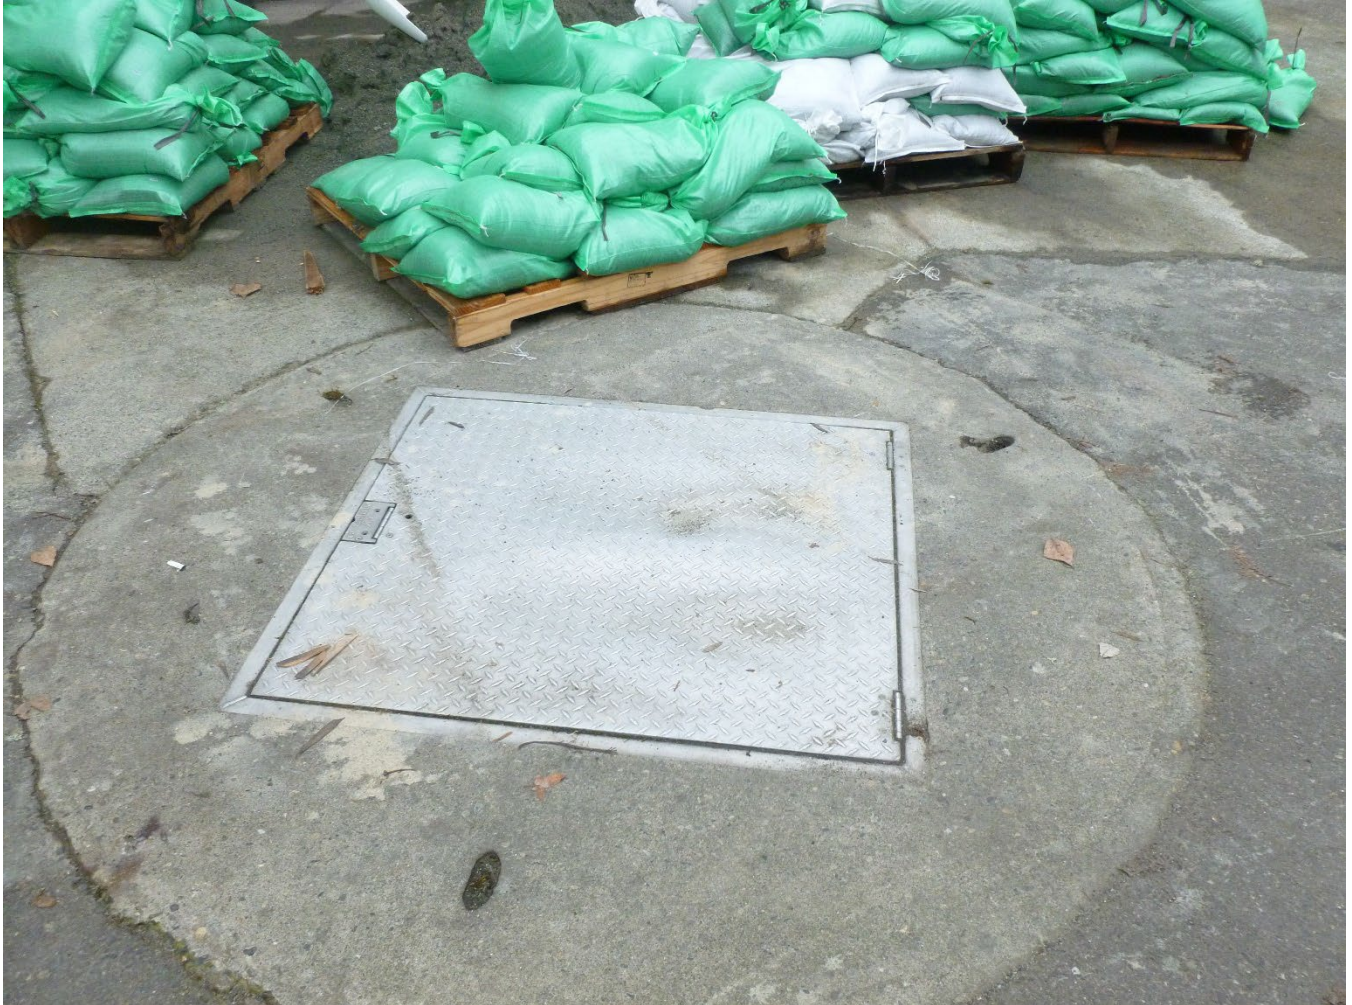
**Photo 5 / P1010202** – Lift Station, Southwest Side of Site

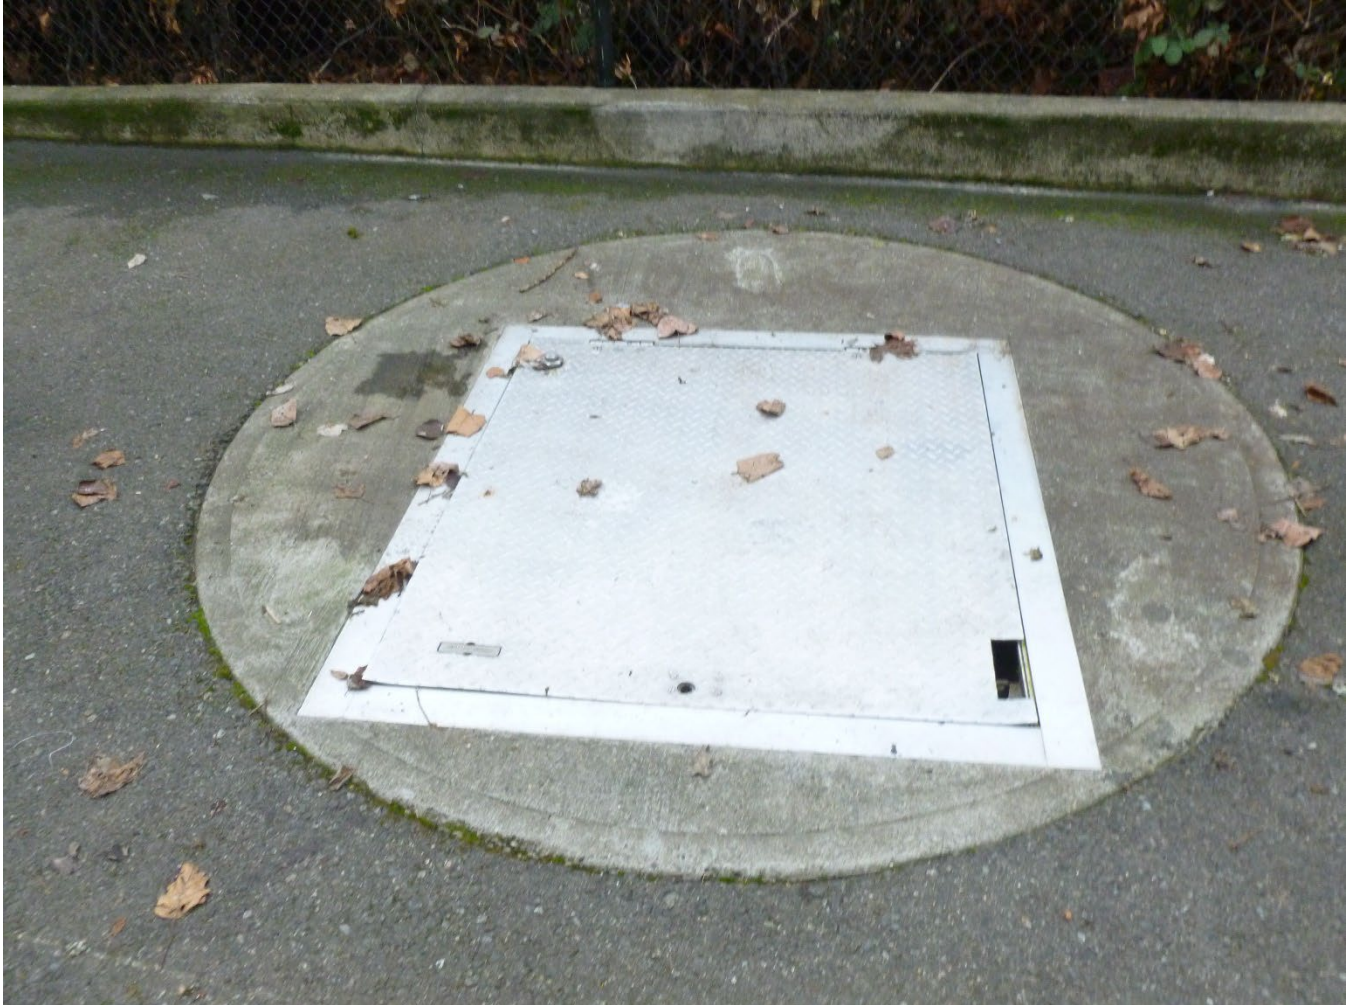
**Photo 6 / P1010203** – Lift Station, facing west

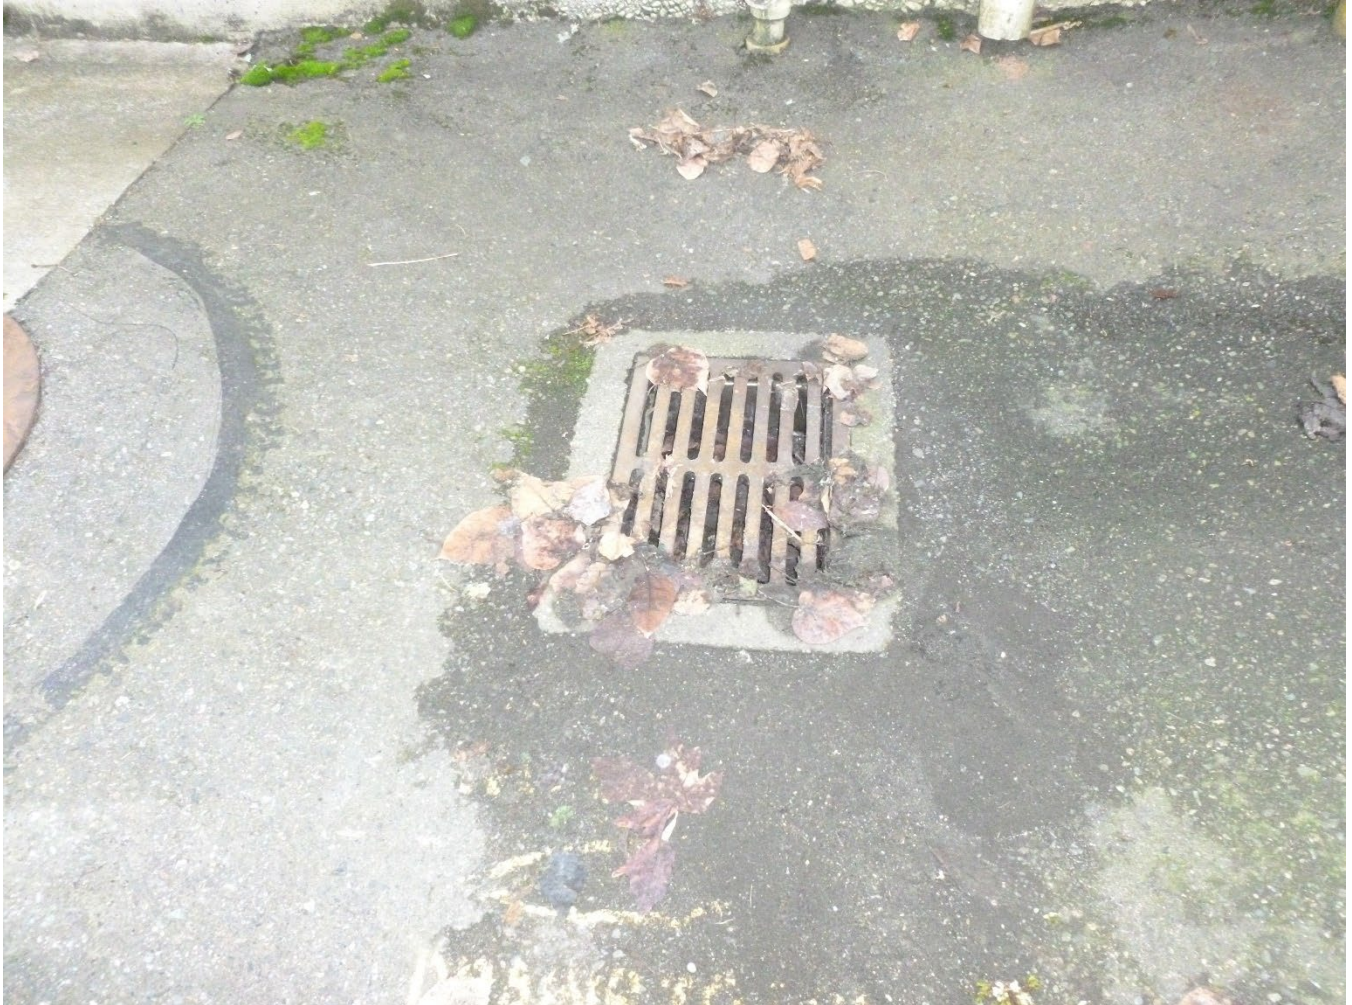
We proceeded north. I observed a catch basin (**Photo 7**), CB12, which was one of 12 named catch basins located throughout the site. As stated in Section VI of this report, the facility has the filter socks changed in February and September. Based on my observations, the catch basin grates should be cleaned of debris more frequently.

**Photo 7 / P1010204** – Catch Basin, CB12

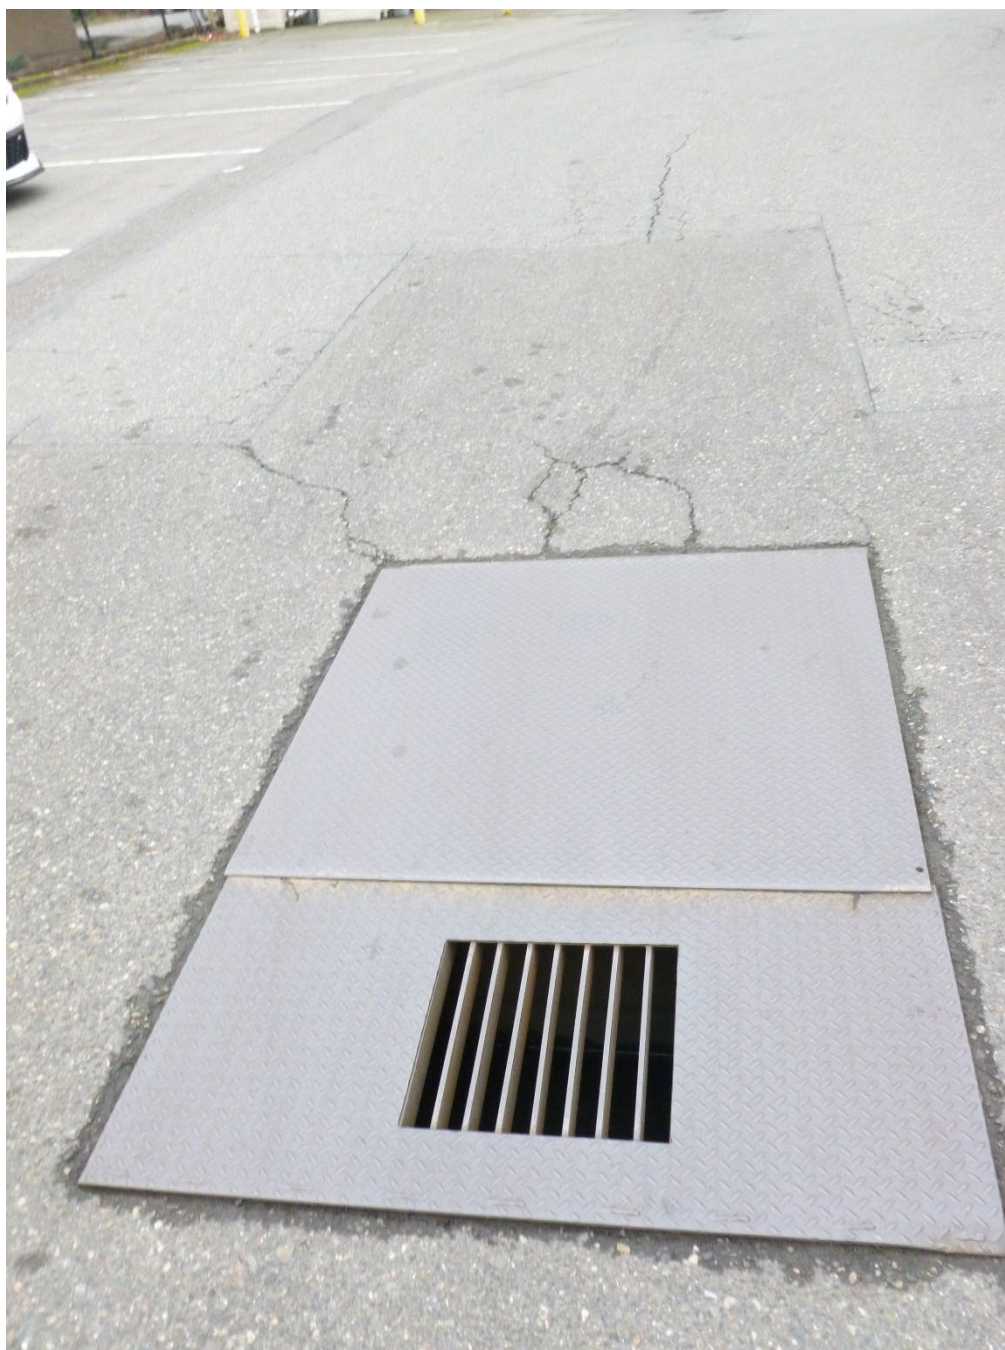
We continued in the direction of the facility's filtration system located in the northeast corner of the site. As we walked, we came to the oil/water separator (**Photo 8**). The oil/water separator is annotated as "Grease Trap/CB9" on the site diagram map. Per Mr. Babcock, the oil/water separator is also cleaned out twice per year.

**Photo 8 / P1010205 – Oil/Water Separator**

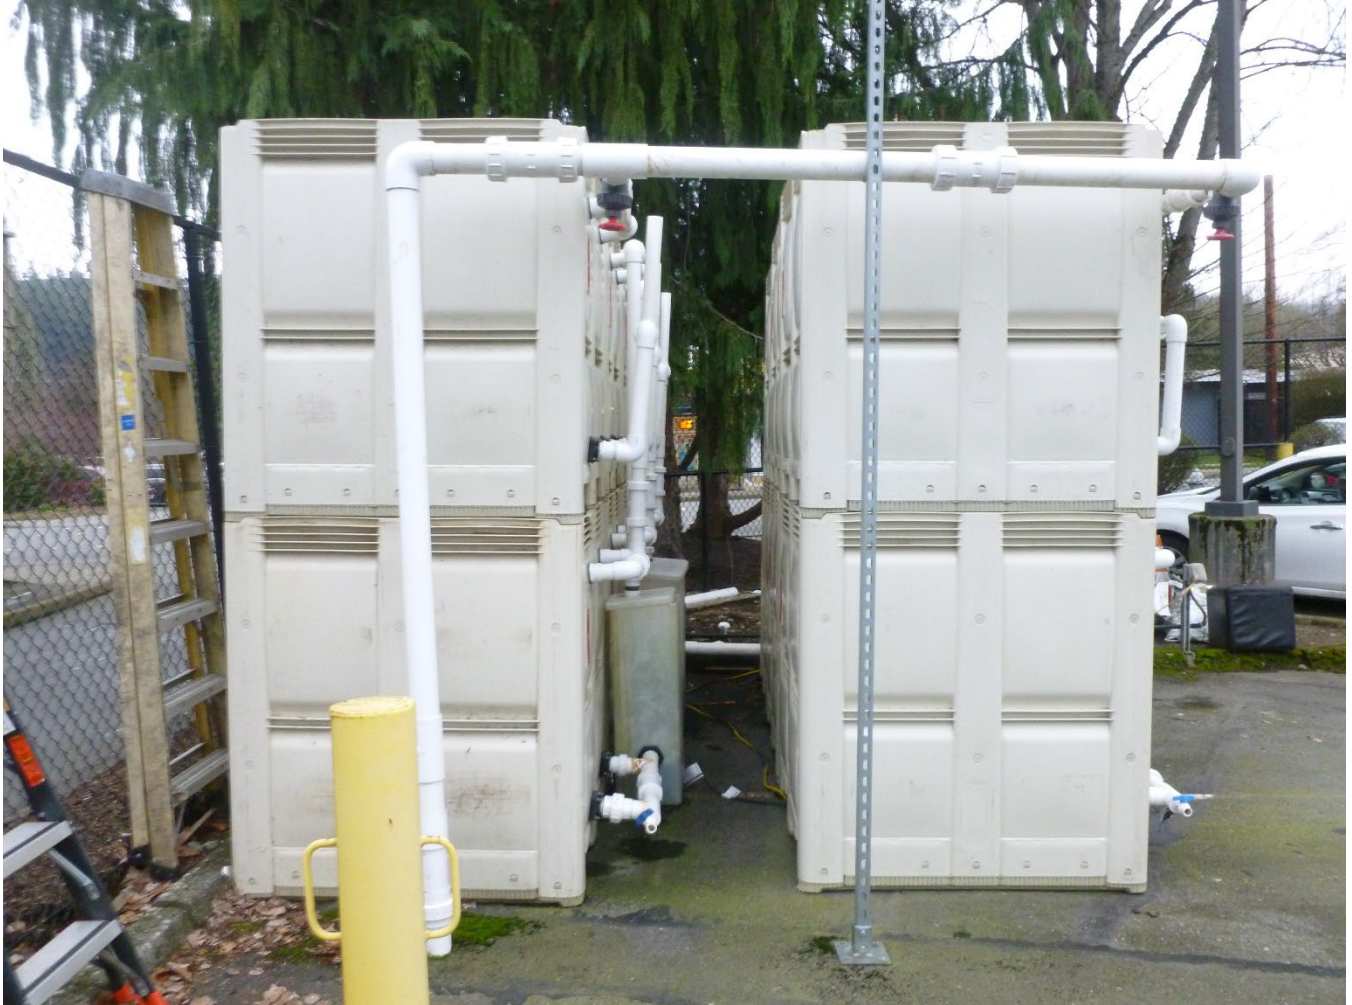
After the stormwater has passed through the oil/water separator, it flows to CB8. CB8 receives all stormwater flow from the site. Once the stormwater reaches CB8, it is pumped into the facility's Enpuriion <sup>TM</sup> Stormwater Treatment System (**Photos 9 & 10**).

**Photo 9 / P1010206 – Filtration System, west end**

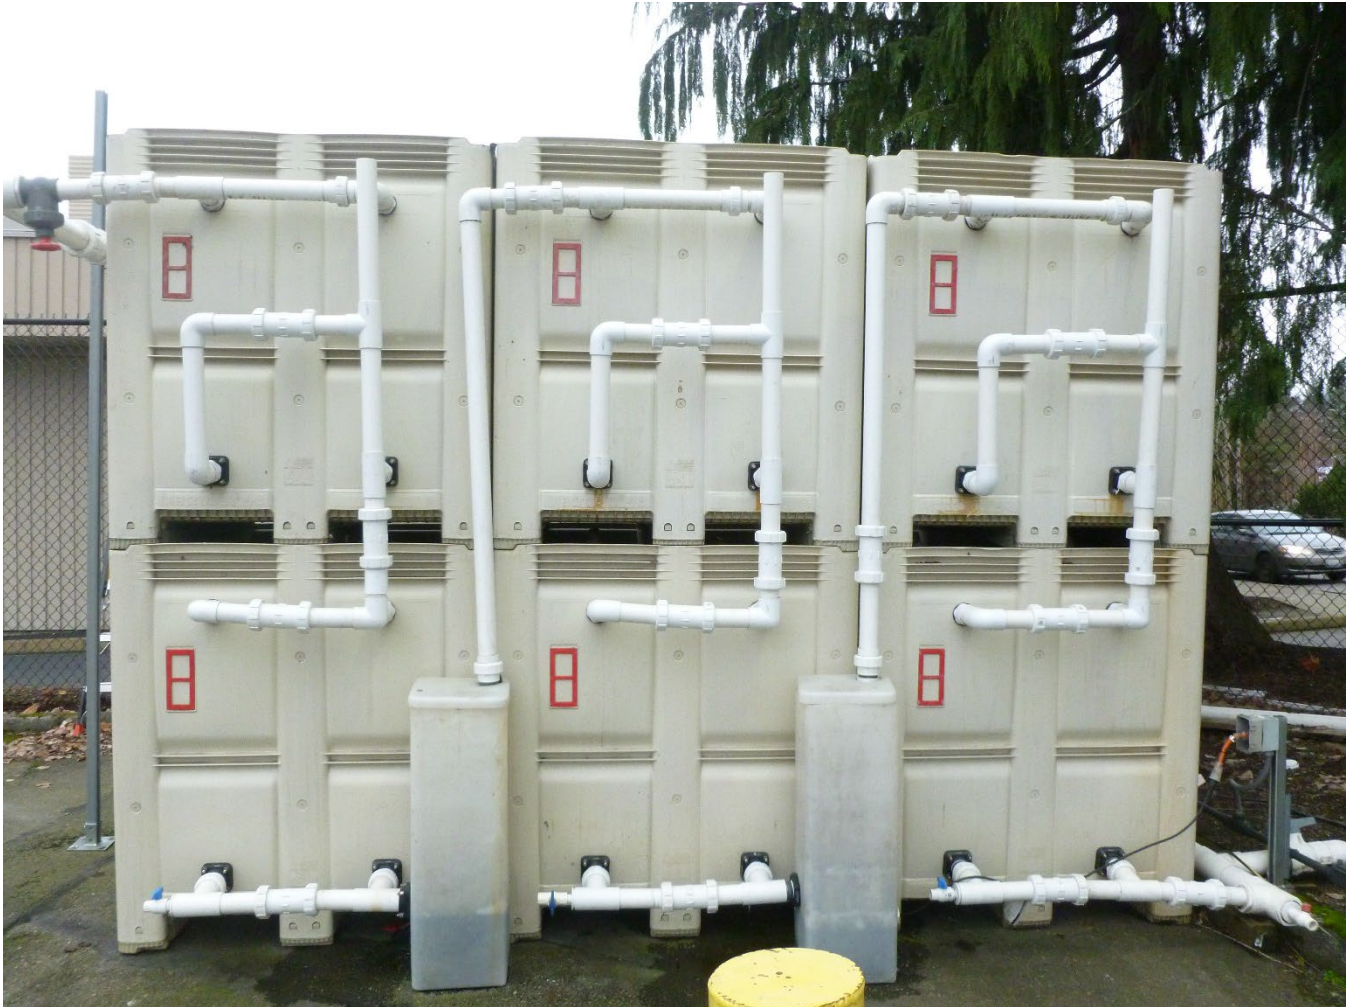
**Photo 10 / P1010207 – Filtration System, south side**

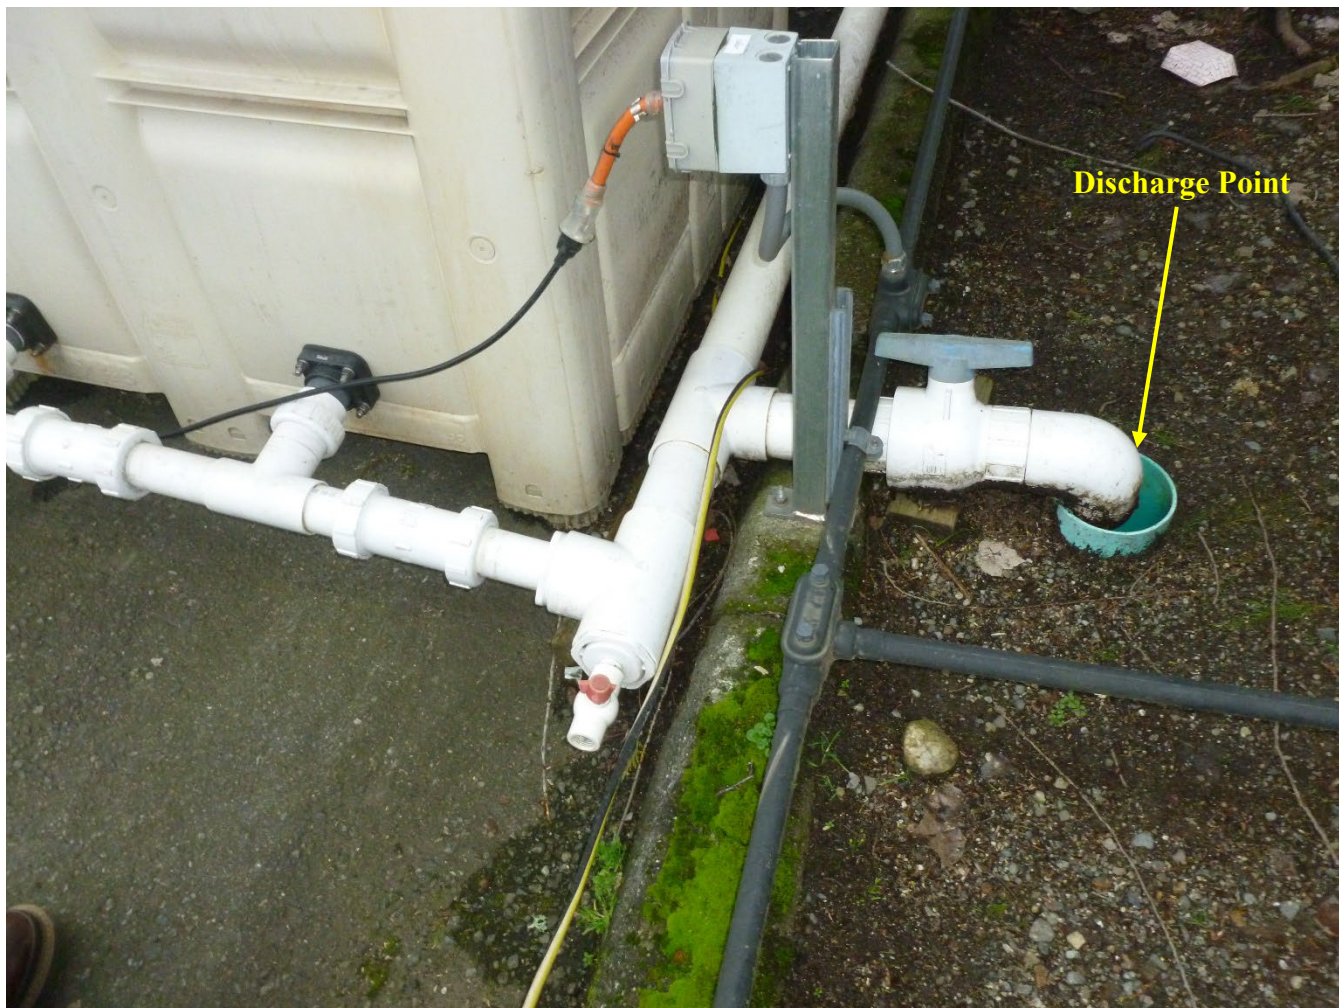
After the stormwater has completed its course through the filtration system, a water sample can be collected from a stopcock at the lower corner of the system (**Photo 11**). Stormwater is discharged into a pipe in the ground (**Photo 12**). From the pipe, the stormwater discharges through Outfall #3 to the City of Issaquah's stormwater system which leads to Issaquah Creek, a tributary of Lake Sammamish.

**Photo 11 / P1010208 – Sampling/Discharge Point**

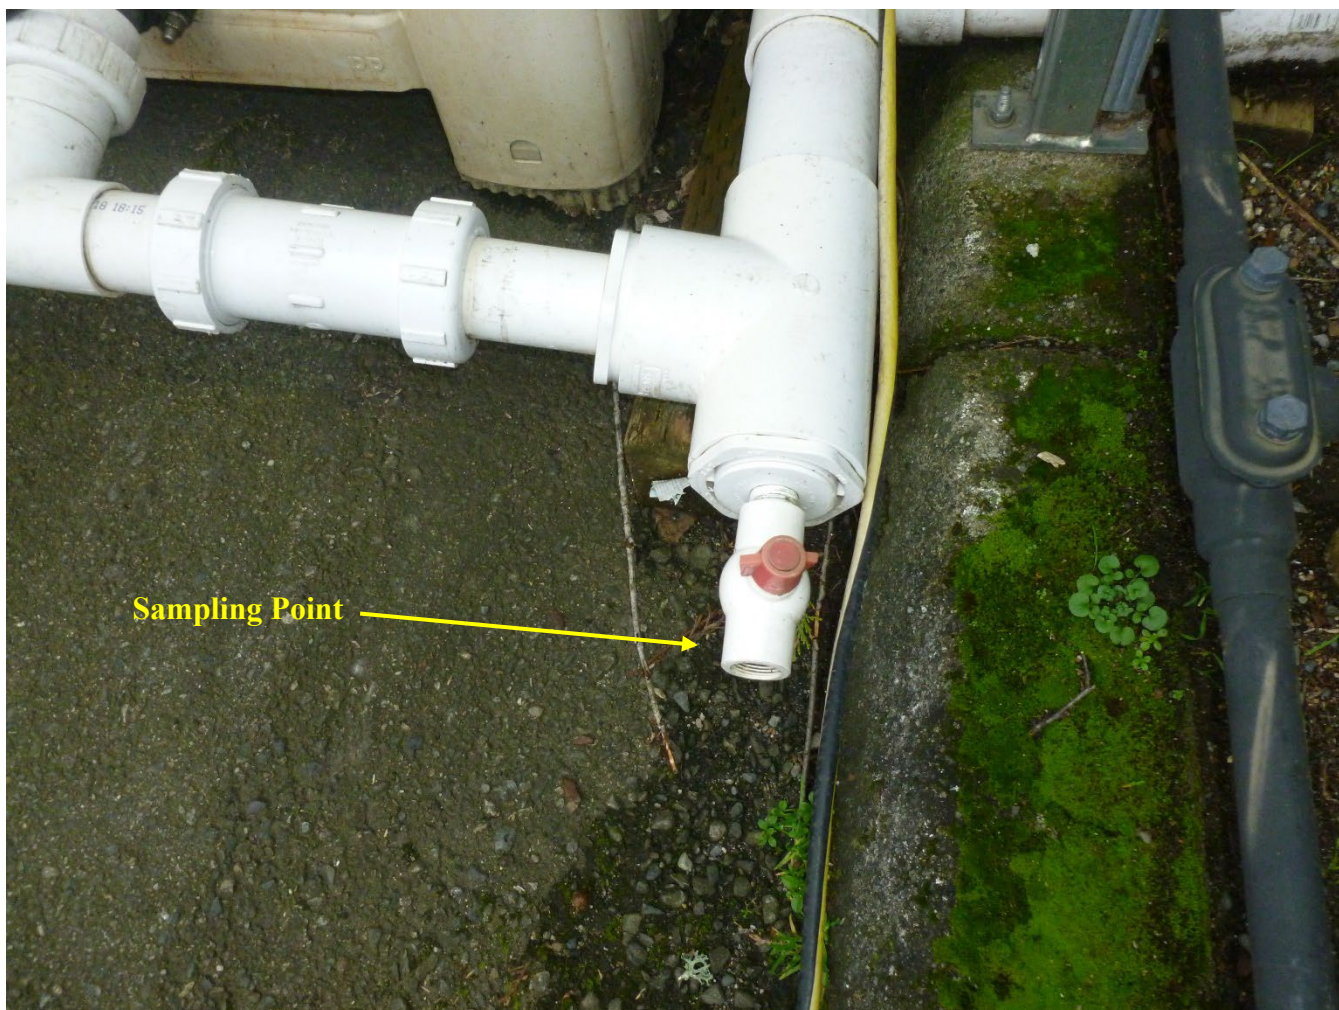
**Photo 12 / P1010209 – Sampling Point**
