**Well Inspection**  
**Osage DNR / Environmental Protection Agency**  
**1201 Elm Street, Suite 500**  
**Dallas, Texas 75270**

| <b>Operator Info</b> | Contango Resources, LLC<br>1717 South Boulder, Suite 900<br>Tulsa, OK 74119<br>Phone: 918-392-3396 | <b>Inventory ID</b> | OS2952000 | | |
| | | <b>Well ID</b> | NWN E13 | | |
| <b>Location</b> | NE 05 24N 07E | <b>Status</b> | Inactive | <b>Well Type</b> | Enhanced Recovery |

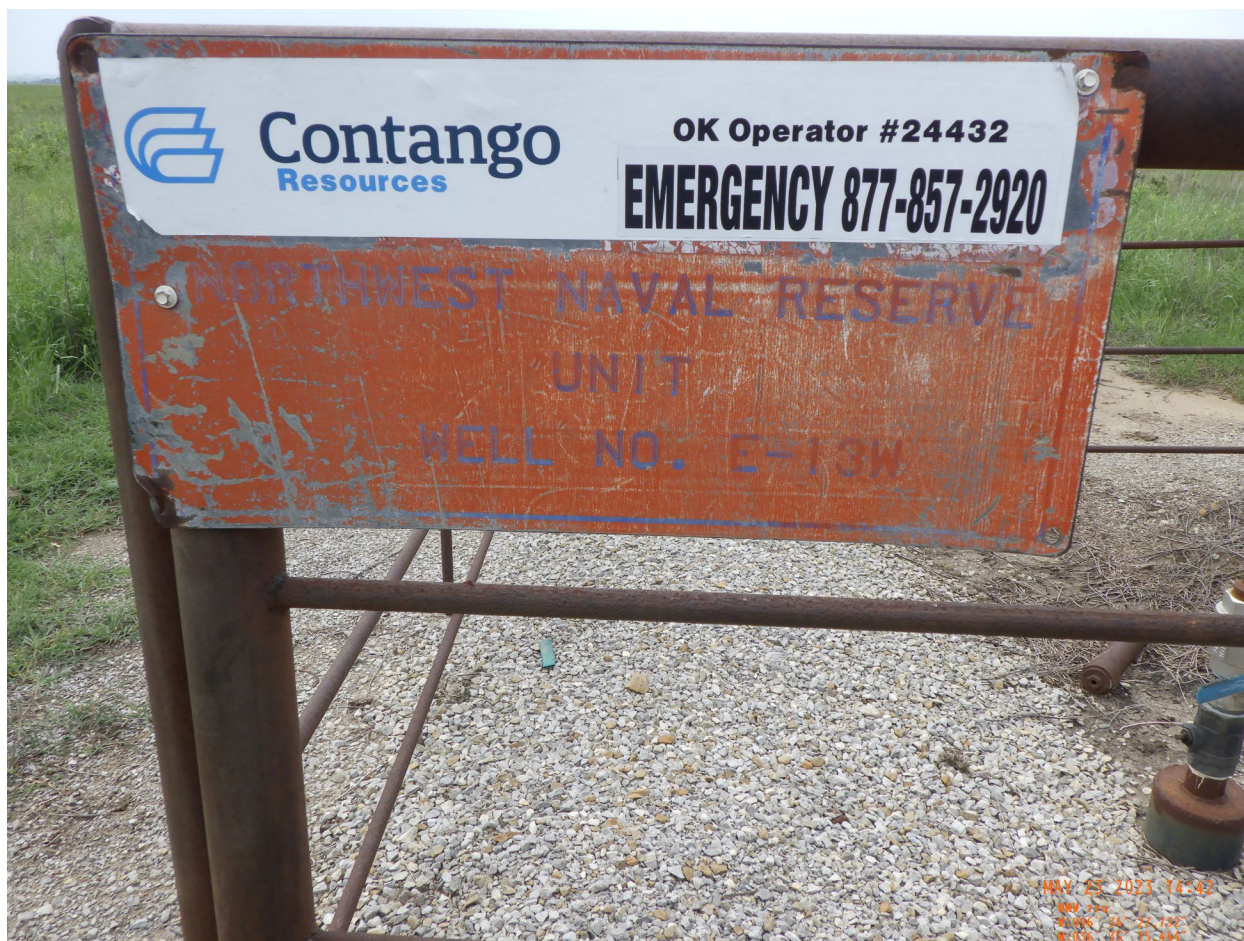
Photo No. 1

**Description:** This was the injection well OS2952000 sign at the time of the inspection.

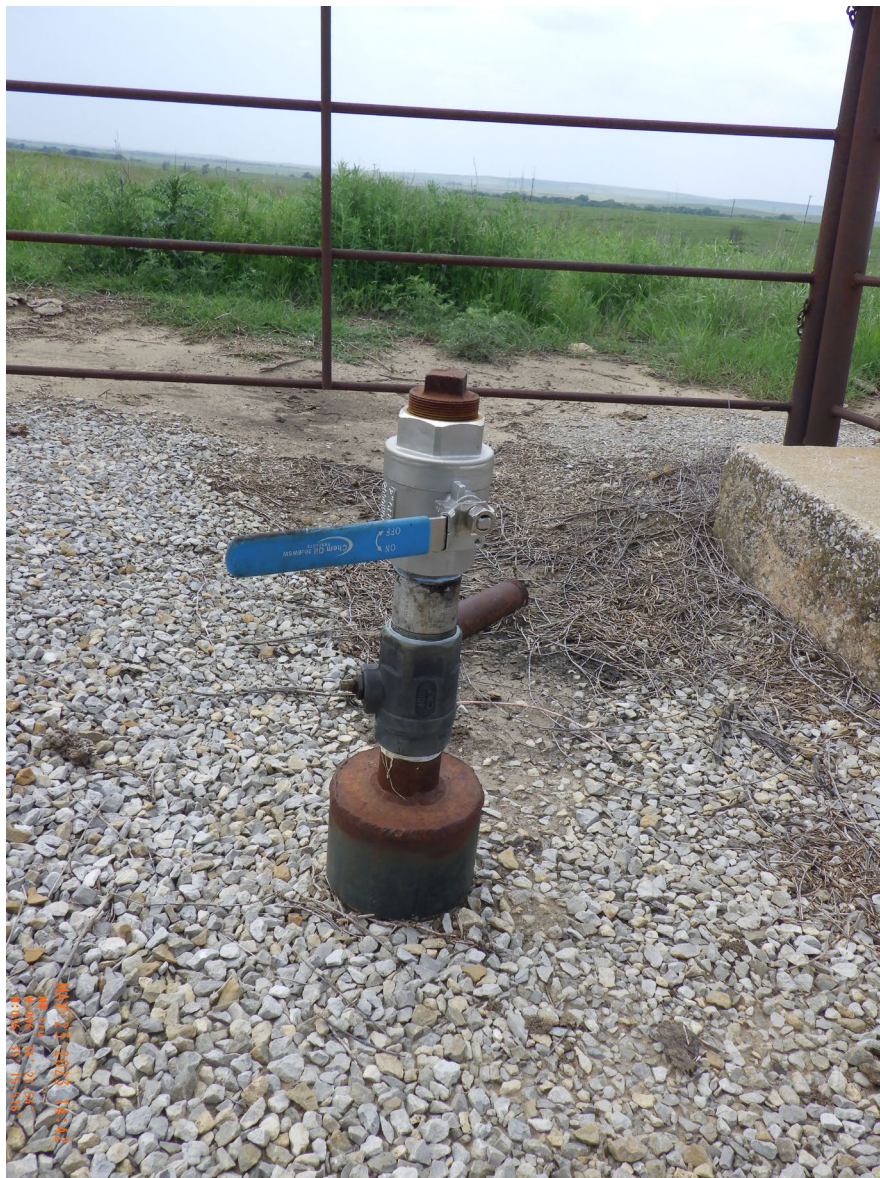
Photo No. 2

| <b>Inspection Comments</b> | A fluid level was taken with a properly calibrated EPA Echometer. The fluid level taken during the inspection was 368 feet deep. This well was not connected during the inspection. The casing size was approximately 4.5". Two photographs were taken during this inspection and can be seen in the Inspection Photo Log. | | | | |

**Description:** This was the injection well OS2952000 at the time of the inspection. The well was not connected during the inspection.
