| <b>Inspection Date(s):</b> | 2/13/2025 | |
| <b>Media Program:</b> | Drinking Water | |
| <b>System Owner:</b> | City of Galena Park | |
| <b>PWS ID:</b> | TX1010009 | |

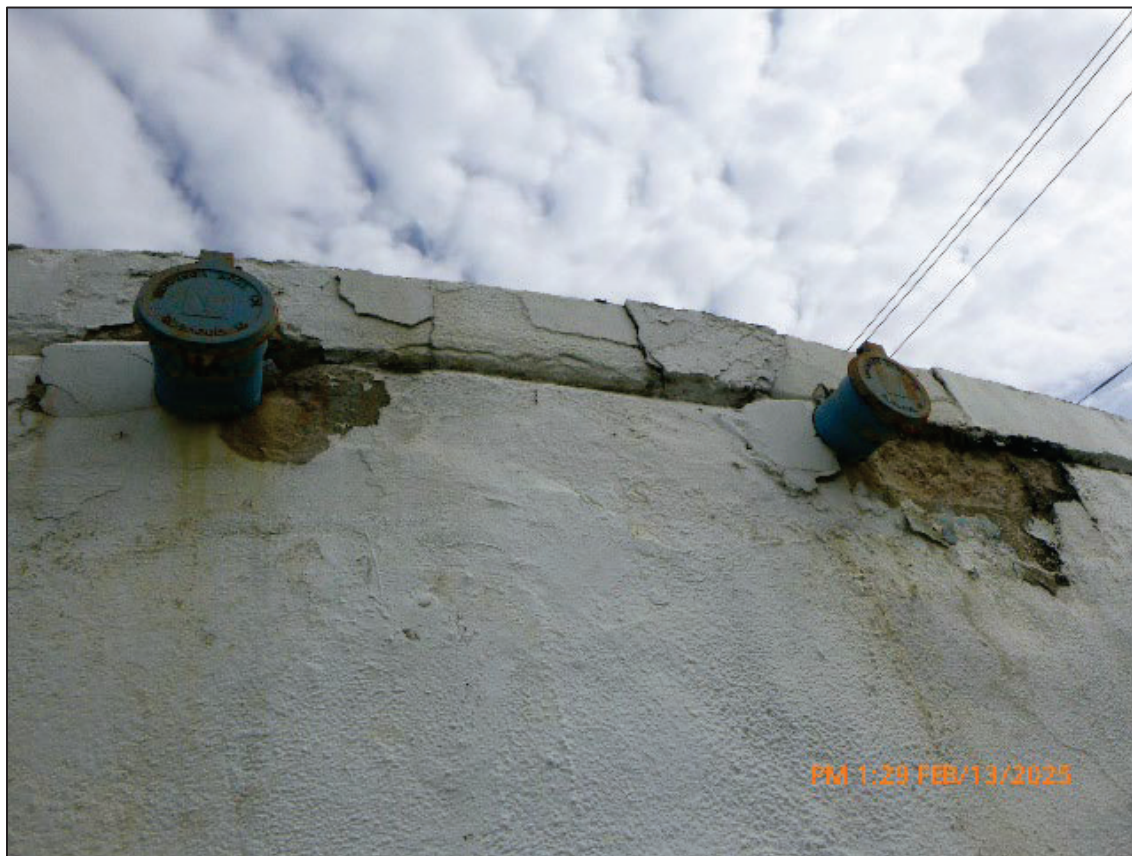
Photograph 10. 2/13/2025 1:29 pm P1010258.JPG

- **Inlet pipe** from City of Houston main.
- **180,000-gallon concrete ground-level storage tank.** Water from City of Houston discharges directly into this storage tank. The tank exterior exhibited numerous areas of spalling and the overflow pipes discharge near the top of the tank (see [Appendix 3, Photograph 10](#)). The access ladder was missing a cage lock (see [Appendix 3, Photograph 11](#)). This storage tank is scheduled for replacement within the next year.
- **Booster pump station.** Three parallel booster pumps pull water from the 180,000-gallon storage tank and pump into the System's distribution system. The pumps are manually operated. The booster pump station building had a broken window (see [Appendix 3, Photograph 12](#)). One

**EPA How to Conduct a Sanitary Survey of Drinking Water Systems (2019) Section 10.4.8** states, “Concrete foundations should be inspected to ensure that there is minimal spalling (ground level tanks) and no cracks (elevated tanks). Anchor bolts should not be rusted so much that their material strength has been compromised. Column shoes should be clean and painted, and grout under the shoes and riser plates should be in good condition. There should not be any pooled water, erosion, weeds, or shrubs around a tank’s foundation.”

**Observation 8.** The EPA inspection team observed excessive concrete spalling on the 180,000-gallon storage tank at Plant #1 (see [Appendix 3, Photograph 10](#)).

Description: Plant #1. Overflow pipes and spalling concrete on 180,000-gallon storage tank.

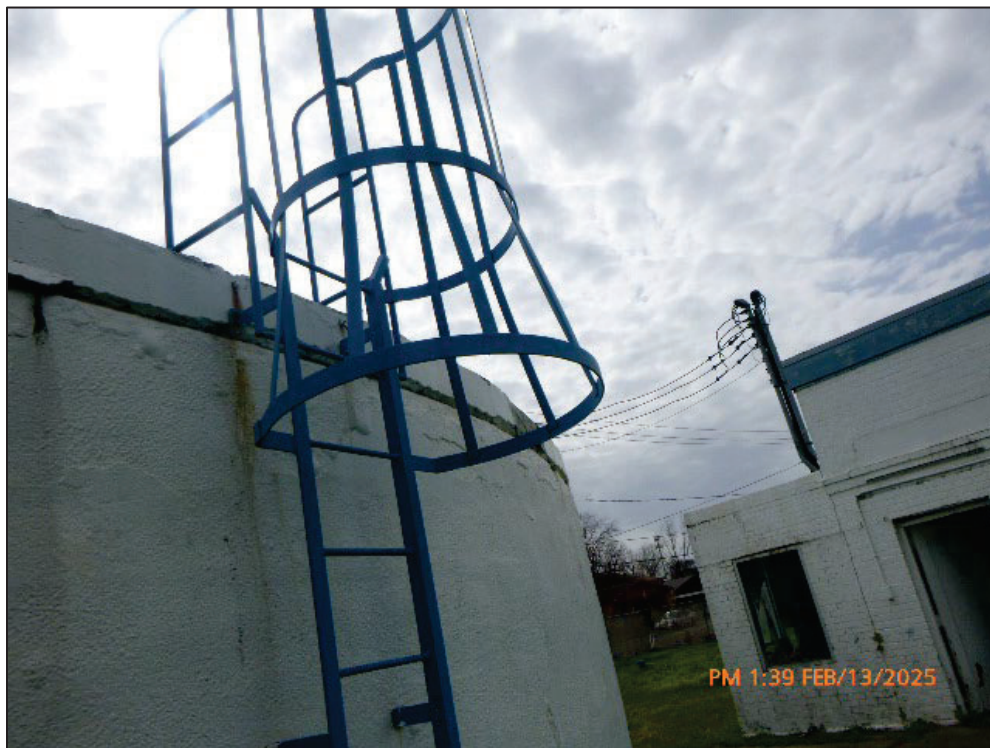
Photograph 11. 2/13/2025 1:39 pm P1010264.JPG

**Observation 16.** The EPA inspection observed the access ladder cage on the 180,000-gallon storage tank at Plant #1 lacks a locking mechanism (see [Appendix 3, Photograph 11](#)) and the 0.5-MG elevated storage tank at Plant #2 lacks a locked ladder cage (see [Appendix 3, Photograph 24](#)).

Description: Plant #1. Missing lock on ladder cage on 180,000-gallon storage tank.

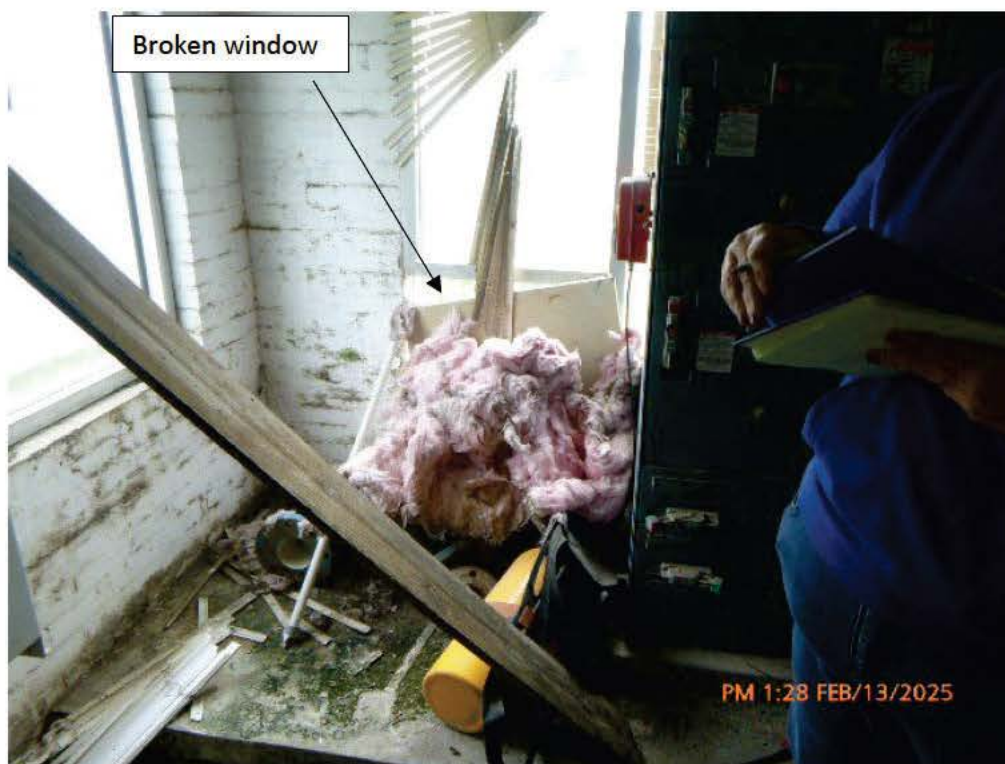
Photograph 12. 2/13/2025 1:28 pm P1010256.JPG

**Observation 15.** The EPA inspection team observed a broken window at the booster pump station at Plant #1 (see [Appendix 3, Photograph 12](#)).

Description: Plant #1. Booster pump station building with broken window.

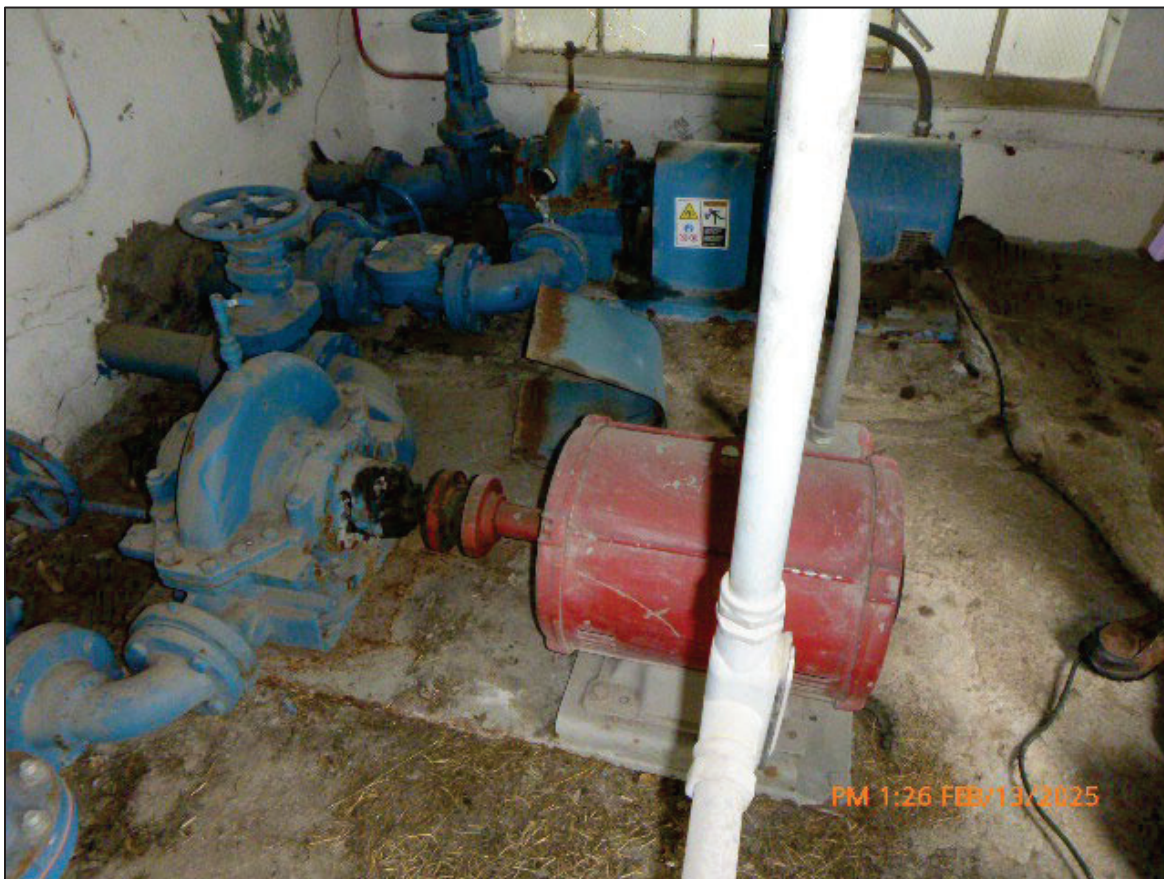
Photograph 13. 2/13/2025 1:26 pm P1010254.JPG

**Observation 12.** The EPA inspection team observed a missing motor shaft guard on the pump at the Plant #1 booster pump station (see [Appendix 3, Photograph 13](#)).

Description: Plant #1. Booster pumps; red pump is missing the motor shaft shield.

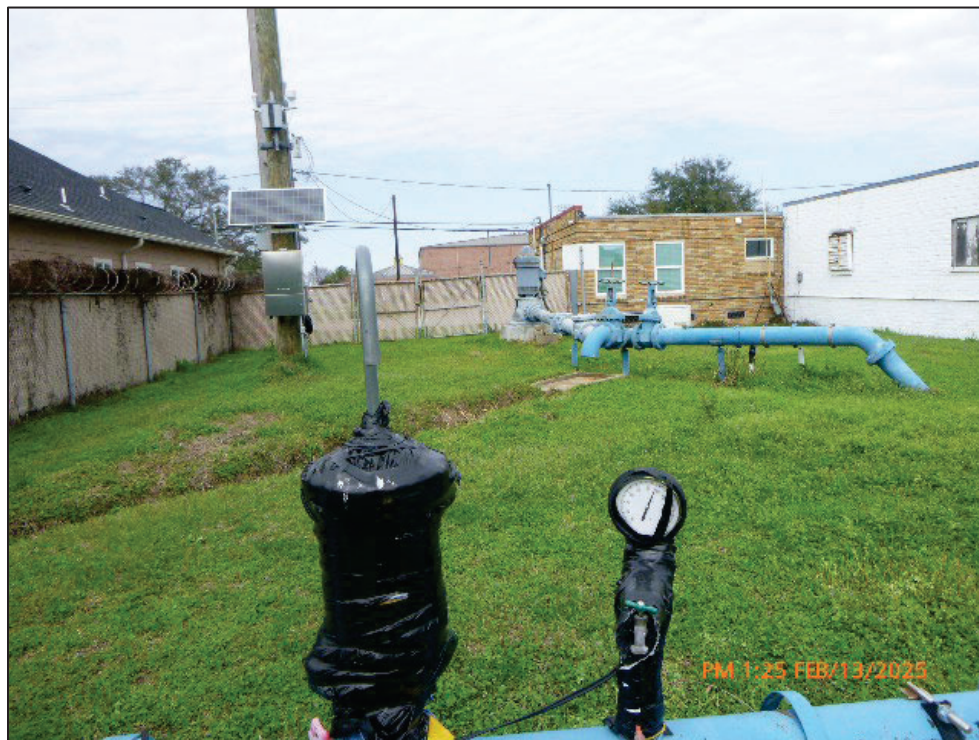
Photograph 14. 2/13/2025 1:25 pm P1010253.JPG

**Texas Administrative Code, Title 30, Part 1, §290.44 (c) (7)** states, "Air release devices on treated waterlines shall be installed in such a manner as to preclude the possibility of submergence or possible entrance of contaminants. In this respect, all openings to the atmosphere shall be covered with 16-mesh or finer corrosion-resistant screening material or an equivalent acceptable to the executive director."

**Observation 6.** The EPA inspection team observed a missing screen on the air release valve located on the discharge line to the distribution system at Plant #1 (see Appendix 3, Photograph 14).

Description: Plant #1. Booster pump discharge piping to distribution. Air release valve with missing screen and threaded sample tap.

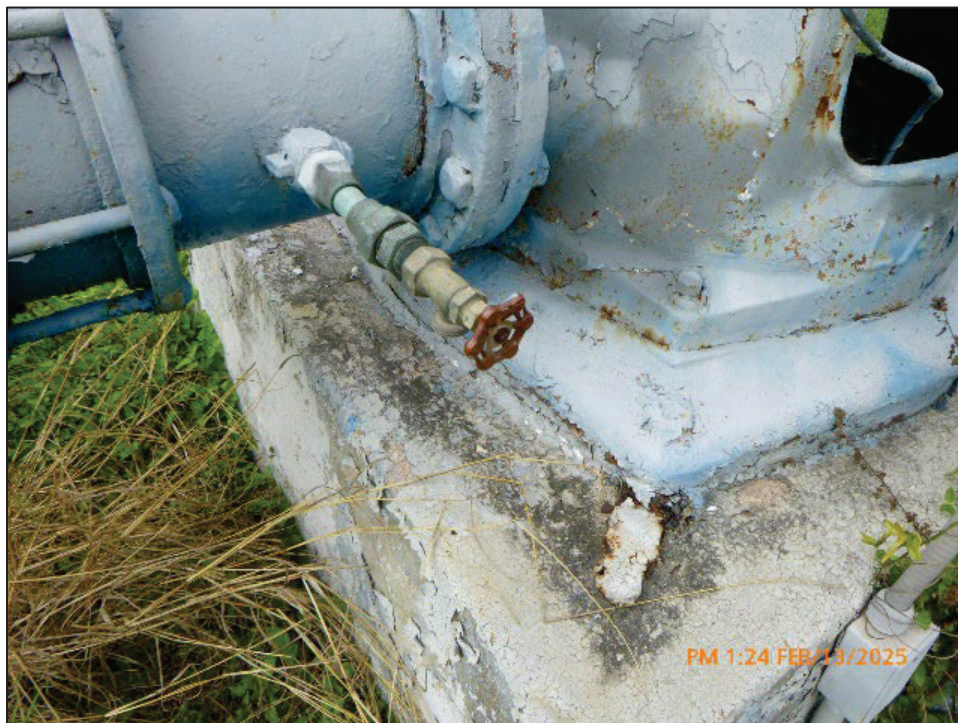
- **Well #3.** Operators exercise this well and pump to waste; water from this well has not been placed into the distribution system for years. The well discharge piping had a threaded raw water sample tap (see [Appendix 3, Photograph 15](#)) and a missing well vent screen (see [Appendix 3, Photograph 16](#)). The well discharge piping is connected to the 180,000-gallon storage tank. A house is located near the property line (approximately 30 feet west of Well #3) and the System representative does not know where the sewer service line for the house is located (see [Appendix 3, Photograph 17](#)). 3<sup>rd</sup> Street is approximately 70 feet north of the well and a sewer main resides in 3<sup>rd</sup> Street.

Photograph 15. 2/13/2025 1:24 pm P1010252.JPG  
Description: Plant #1. Well #3 with raw water threaded sample tap.

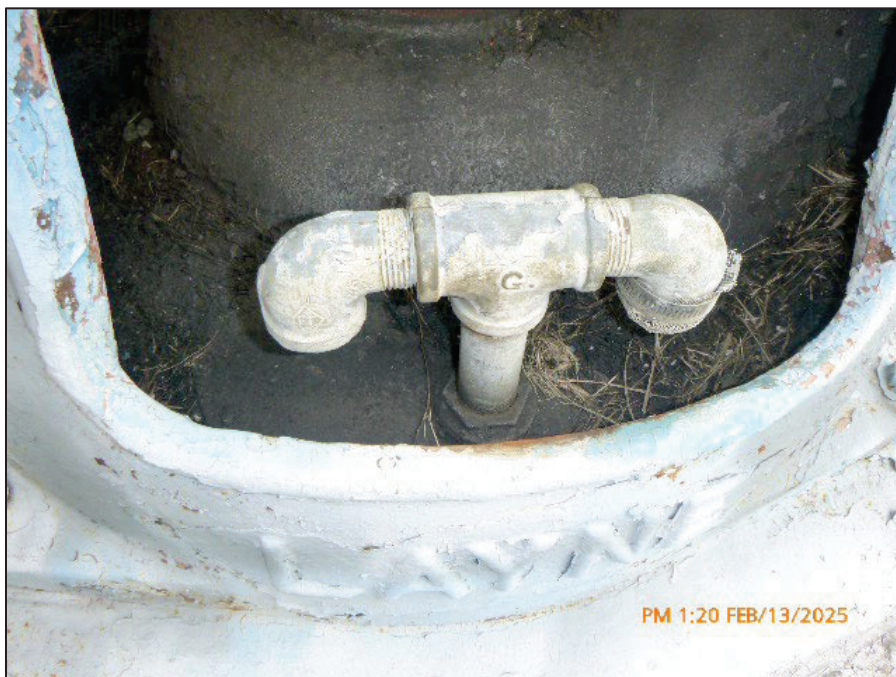
**Texas Administrative Code Title 30, Part 1, §290.41(c)(3)(K)** states, "A well casing vent shall be provided with an opening that is covered with 16-mesh or finer corrosion resistant screen, facing downward, elevated and located so as to minimize the drawing of contaminants into the well."

**Observation 5.** The EPA inspection team observed a missing screen on Well #3 vent (see Appendix 3, Photograph 16).

Photograph 16. 2/13/2025 1:20 pm P1010251.JPG  
Description: Plant #1. Well #3 vent with missing screen.

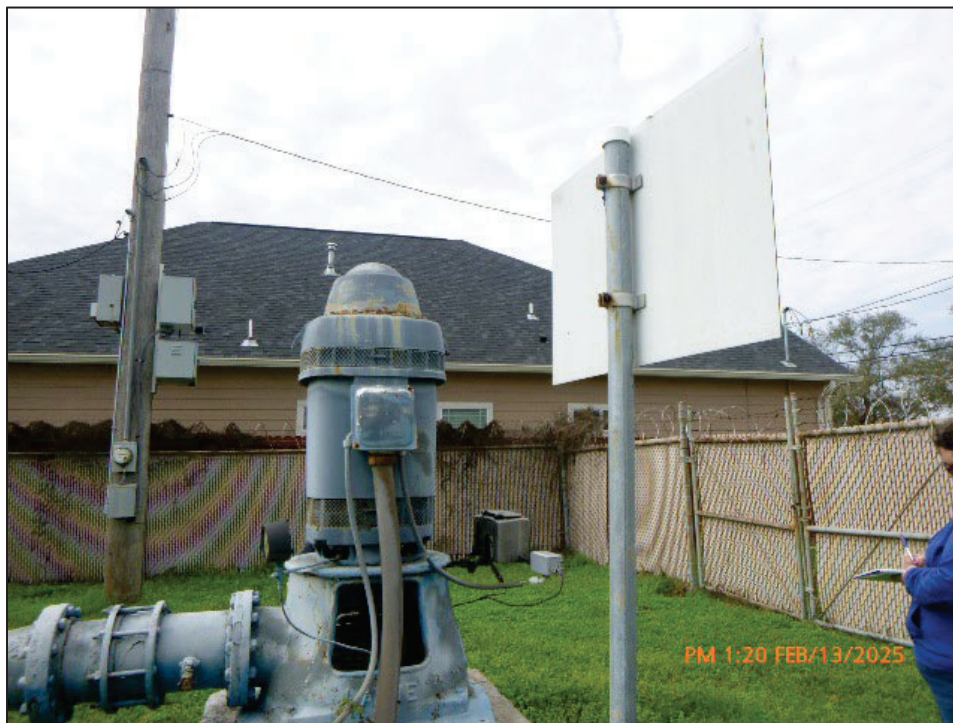
Photograph 17. 2/13/2025 1:20 pm P1010250.JPG

Description: Plant #1. Well #3 and house to the west, approximately 30 feet between the well and fence that borders the house. Approximately 70 feet between the well and 3<sup>rd</sup> Street.

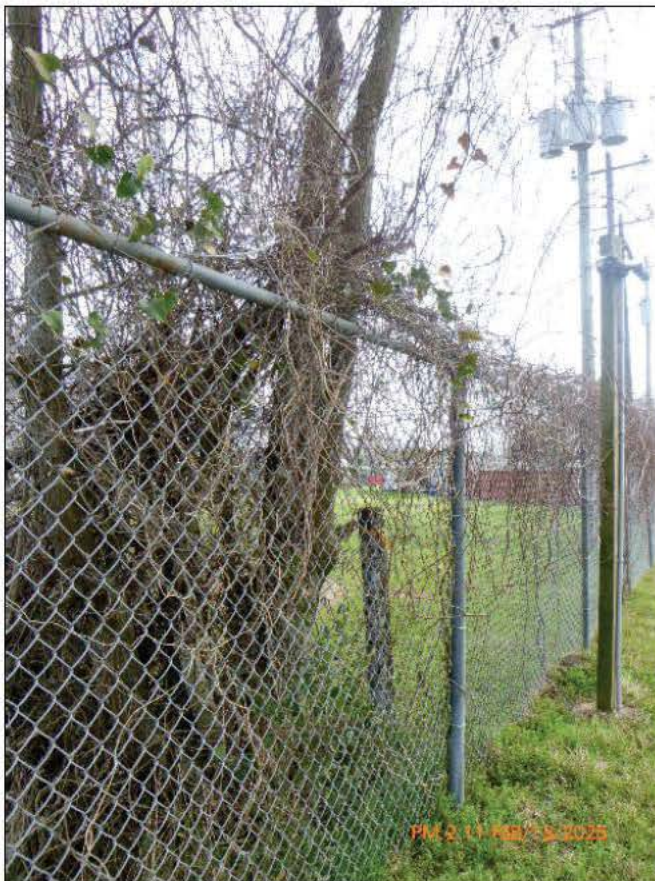
Photograph 20. 2/13/2025 2:11 pm P1010286.JPG

**Observation 17.** The EPA inspection team observed a tree adjacent to the fence that could damage the fence or provide access over the fence at Plant #2 (see [Appendix 3, Photograph 20](#)).

Description: Plant #2. Segment of fence near 1-MG storage tank with a nearby tree and overgrown vegetation.

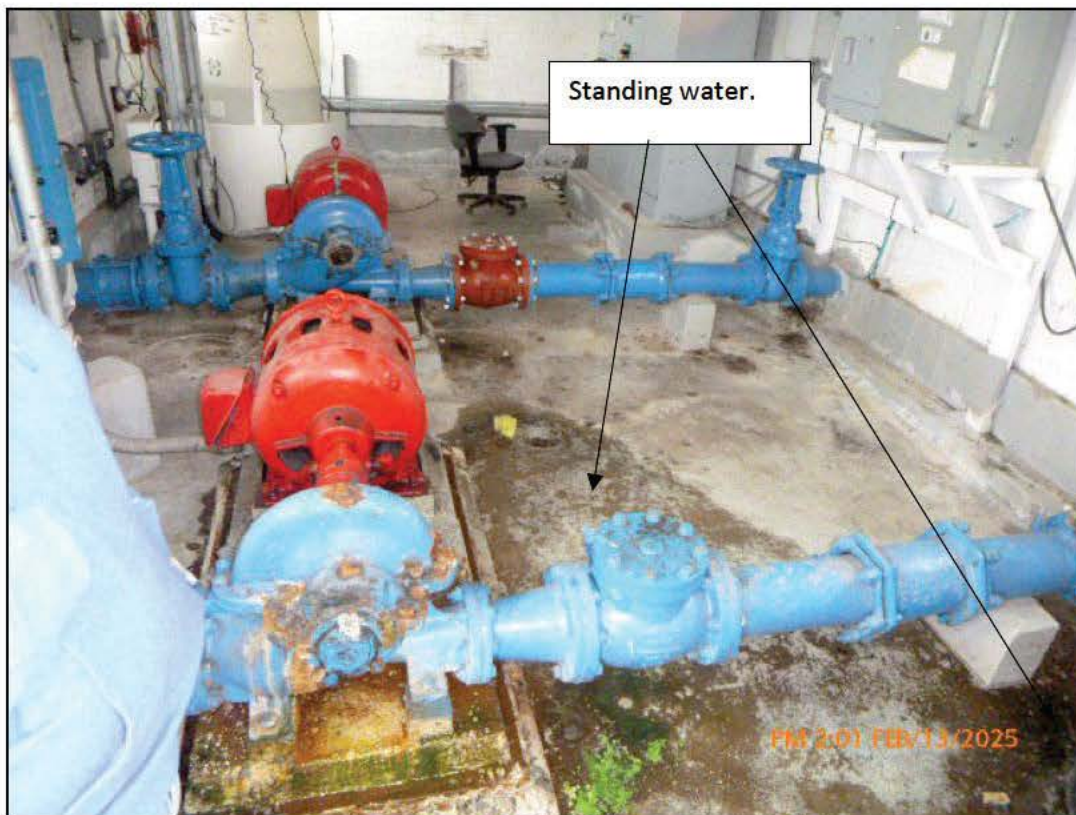
Photograph 21. 2/13/2025 2:01 pm P1010276.JPG

**Observation 11.** The EPA inspection team observed standing water on the floor at Plant #2 booster pump station building (see [Appendix 3, Photograph 21](#)).

Description: Plant #2. Booster pump station with standing water on the floor.

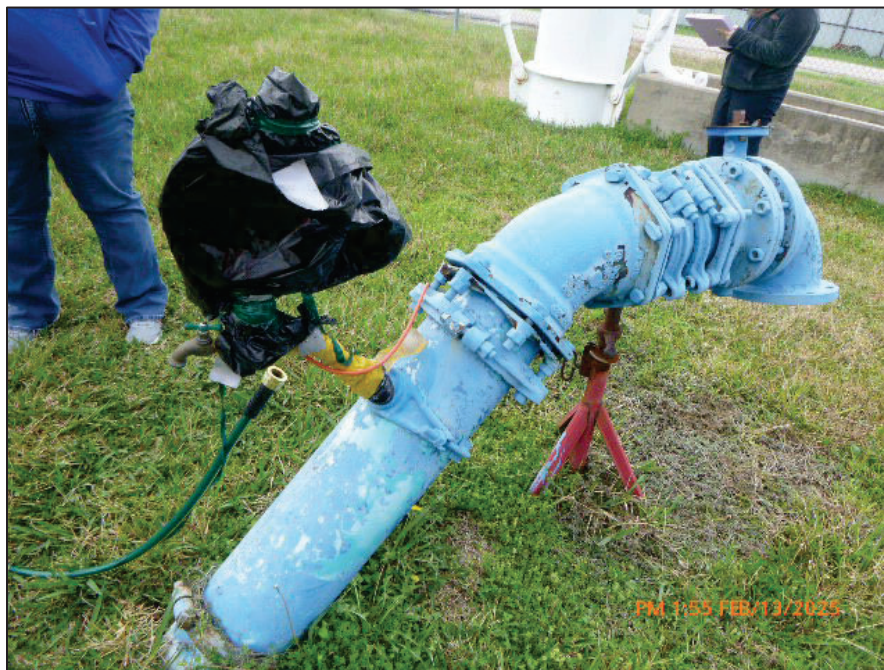
Photograph 22. 2/13/2025 1:55 pm P1010270.JPG

- **0.5-MG elevated storage tank.** The booster pumps feed the elevated storage tank. The storage tank drain line had a threaded sample tap with a hose connected at the time of the inspection. The System representative disconnected the hose during the inspection (see [Appendix 3, Photograph 22](#)). The hose allowed water to run constantly during the recent cold weather to prevent the pipe from freezing. The bolts on the support base of the tank were corroded (see [Appendix 3, Photograph 23](#)). The bolts are scheduled for replacement and cathodic protection is planned. The ladder cage was not locked and secured (see [Appendix 3, Photograph 24](#)).

**Observation 22.** The EPA inspection team observed a hose connected to the 0.5-MG elevated storage tank drain line to prevent freezing of the drain line (see [Appendix 3, Photograph 22](#)).

Description: Plant #2. 0.5-MG elevated tank drain line with threaded sample tap and hose (System representative disconnected hose during the inspection).

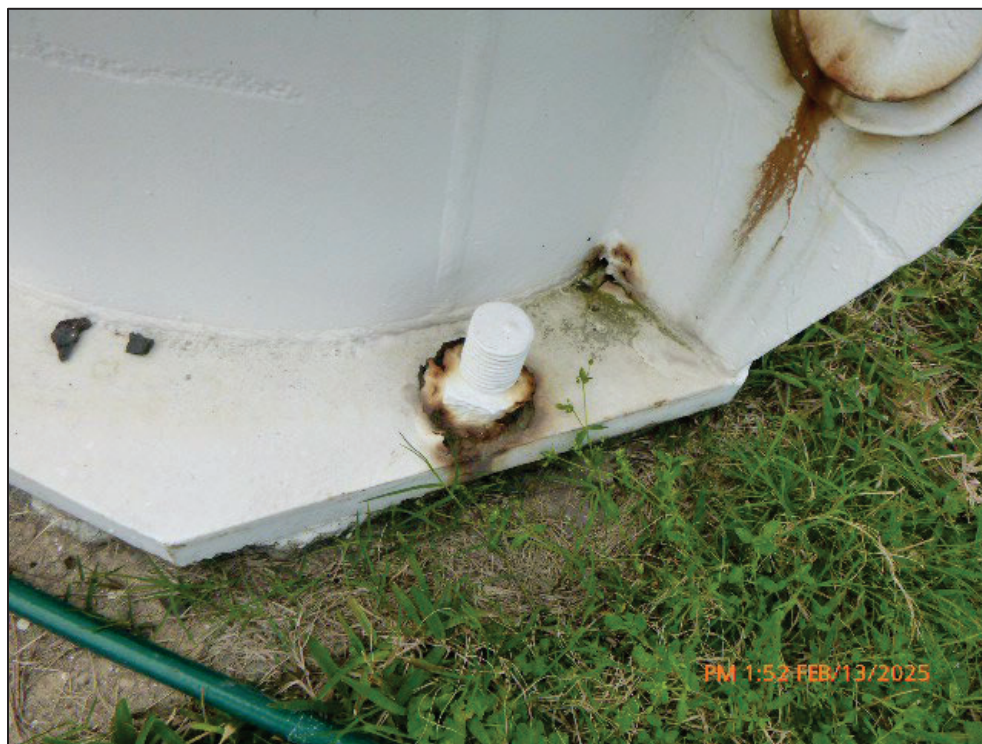
Photograph 23. 2/13/2025 1:52 pm P1010268.JPG

**Observation 9.** The EPA inspection team observed support base corrosion and corroded bolts on the 0.5-MG elevated storage tank at Plant #2 (see [Appendix 3, Photograph 23](#)).

Description: Plant #2. Corroded bolts and base on 0.5-MG elevated storage tank.

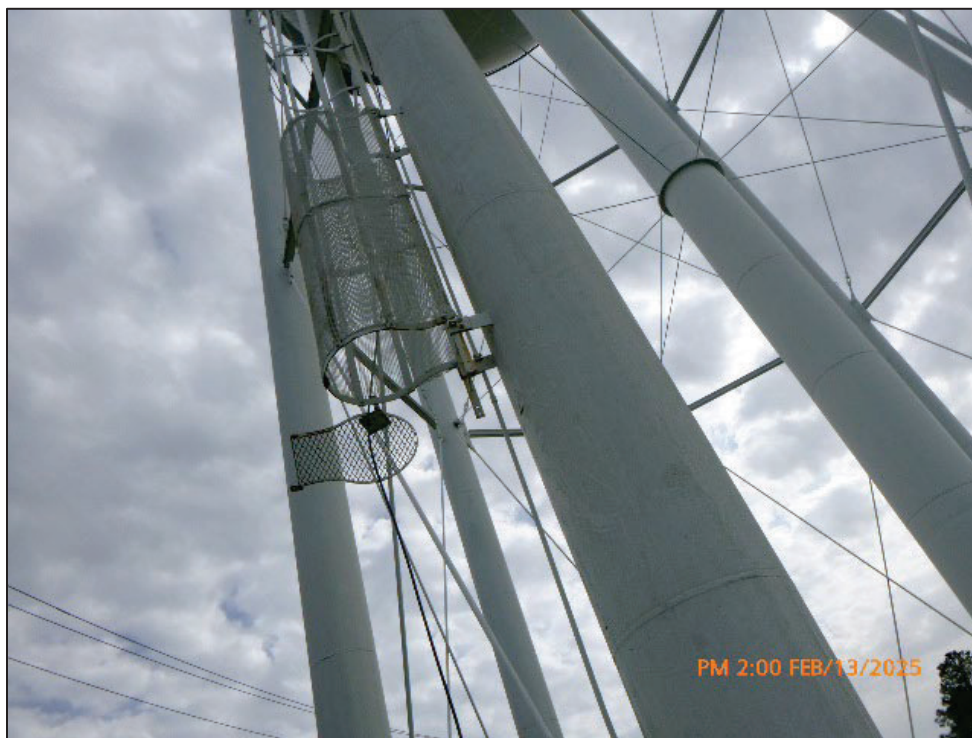
Photograph 24. 2/13/2025 2:00 pm P1010275.JPG

Description: Plant #2. Ladder cage lock not secured on the elevated tank.

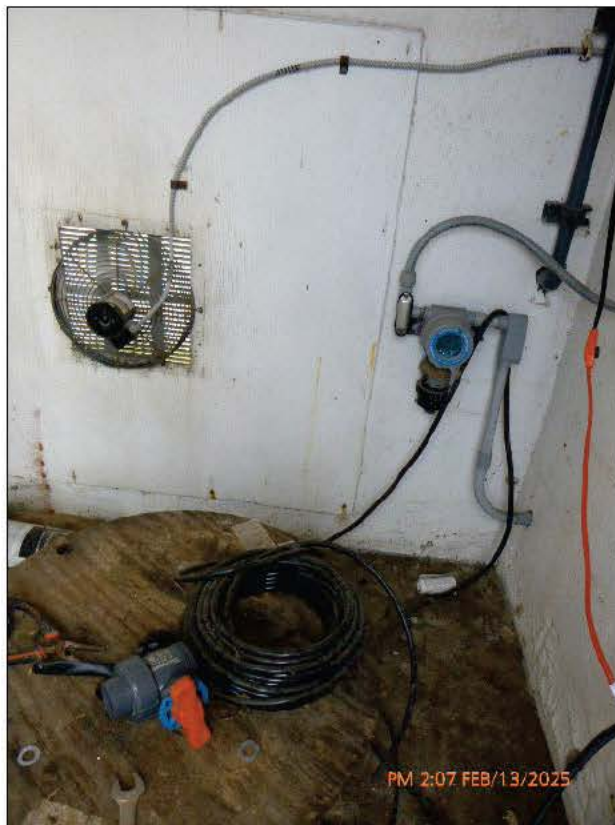
**Observation 14.** At the time of the inspection, the chlorine gas feed building and system were under repair (see [Appendix 3, Photographs 25 and 26](#)) and the chlorine gas sensor was only connected to an audible alarm, but there was no warning light.

Photograph 25. 2/13/2025 2:07 pm P1010282.JPG  
Description: Plant #2. Chlorine gas room with ongoing repairs.

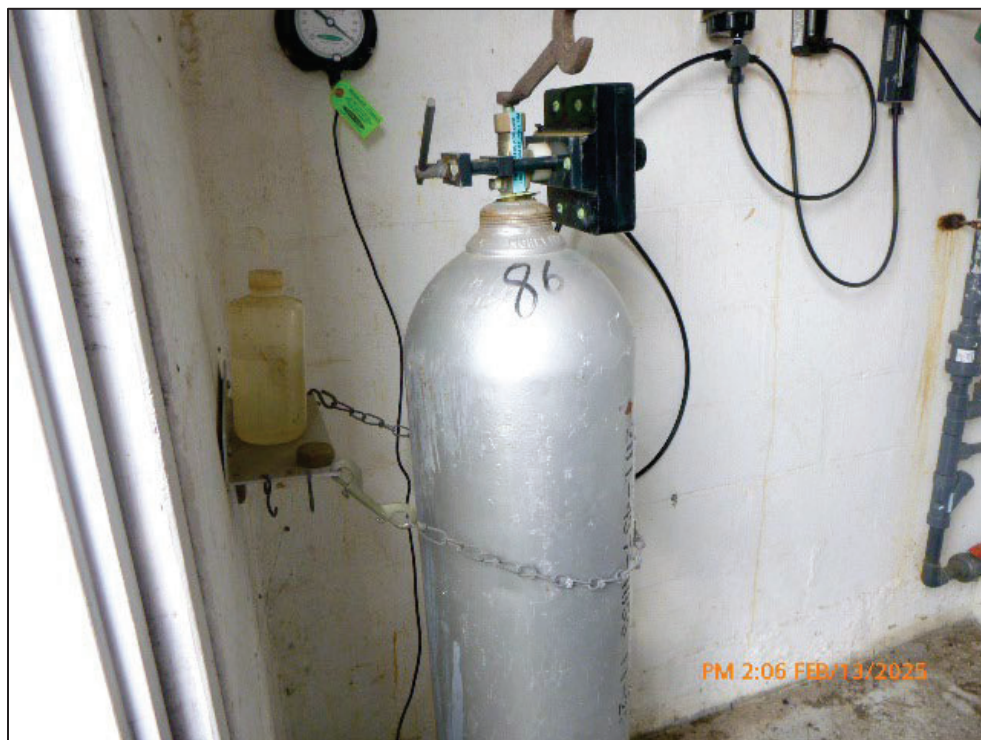
Photograph 26. 2/13/2025 2:06 pm P1010281.JPG  
Description: Plant #2. Partially-full chlorine gas cylinder.

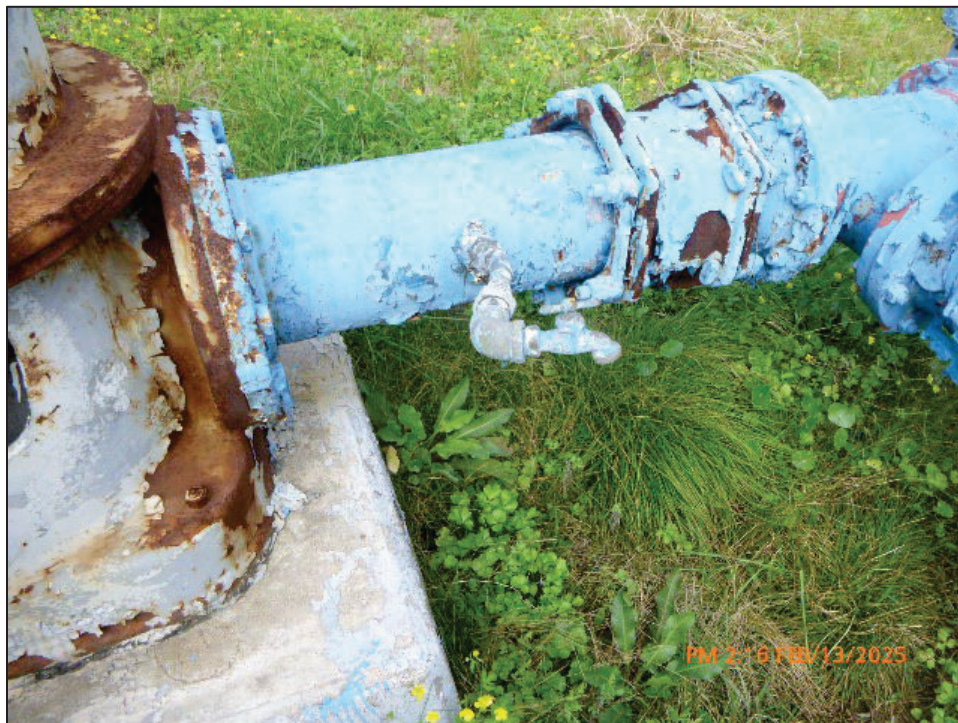
Photograph 28. 2/13/2025 2:16 pm P1010291.JPG

**Observation 10.** The EPA inspection team observed peeling paint and excessive corrosion on Well #5 motor, motor base, and discharge piping (see [Appendix 3, Photographs 28 and 29](#)).

Description: Well #5. Threaded raw water sample tap and corrosion on motor, motor base, and discharge piping.

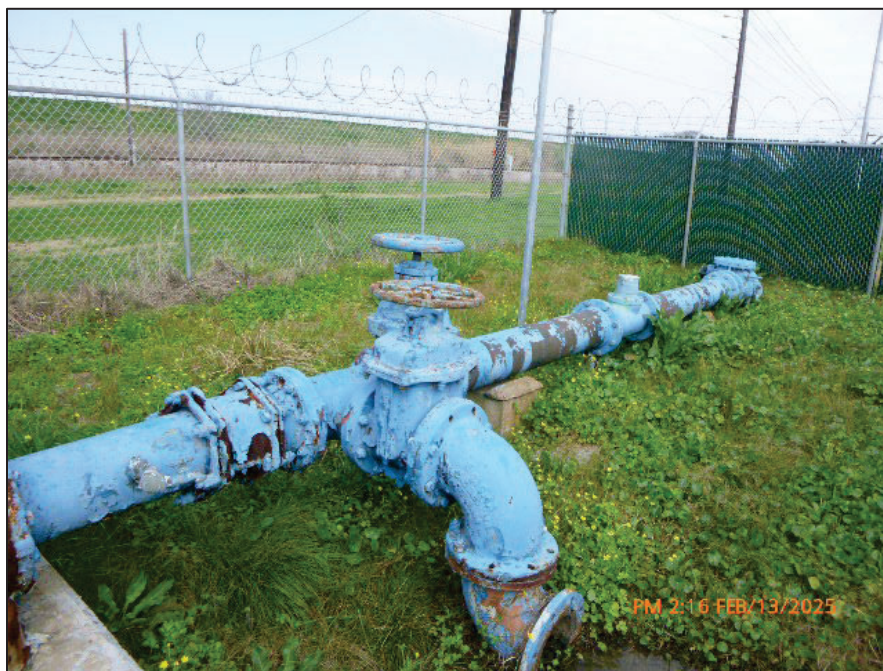
Photograph 29. 2/13/2025 2:16 pm P1010290.JPG

Description: Well #5. Corroded and peeling paint on well discharge piping.
