**Report Title:** Clean Air Act Inspection of Best Auto Shop  
**Inspection Date(s):** 12/06/2023  
**Regulatory Program(s):** NESHAP

**Company Name:** Best Auto Shop  
**Facility Name:** Best Auto Shop  
**Facility Location:** 1800 Adams St NE  
Washington, D.C. 20018  
**Latitude:** 38.92023 **Longitude:** -76.97867  
**County/Parish:** District of Columbia  
**AFS/ICIS-Air Number:** 03000DC00011  
**Permit Number:** N/A  
**NAICS Code:** 811111, 811121 **SIC:** 7532  
**DSBID #:** ECAD-80

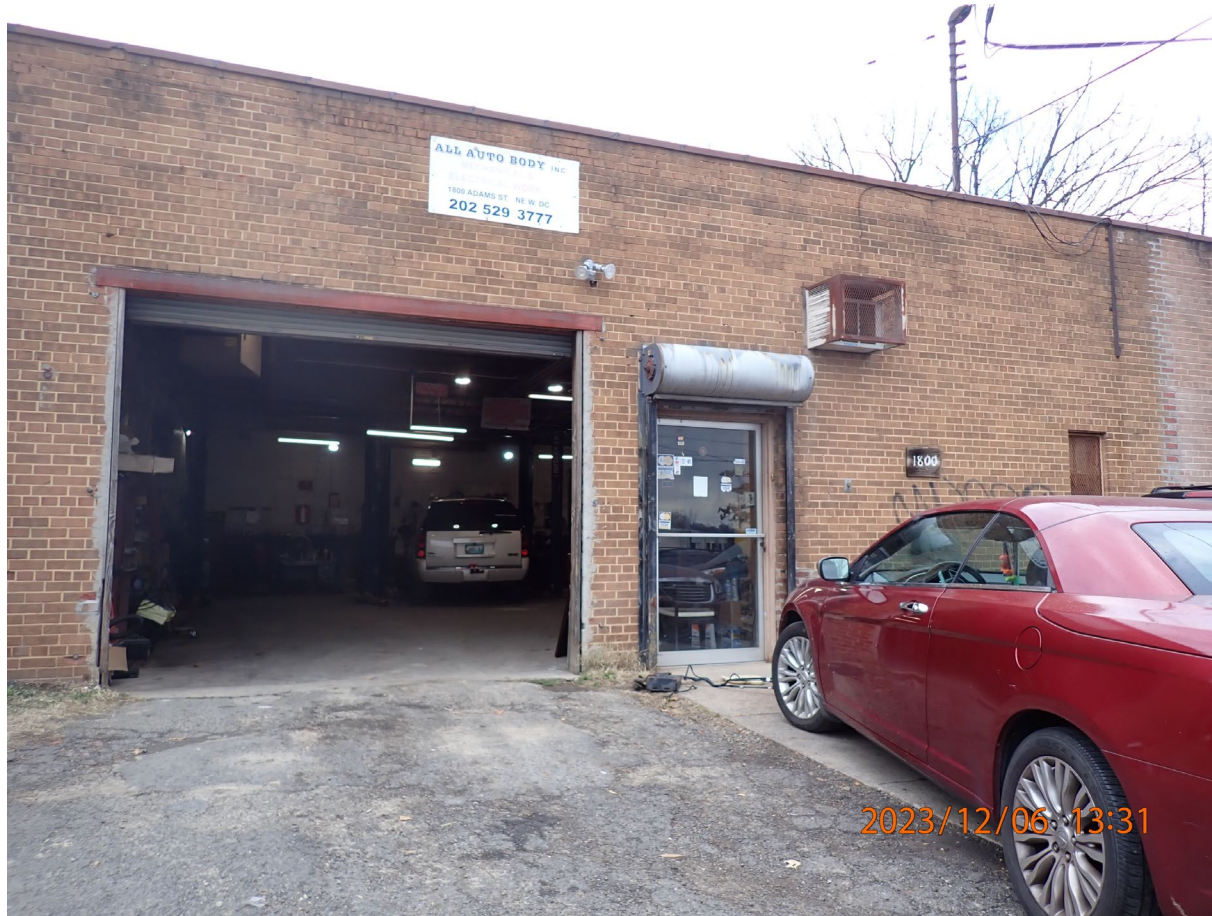
Photo Number: 82

Photo Description: Exterior of Best Auto Shop

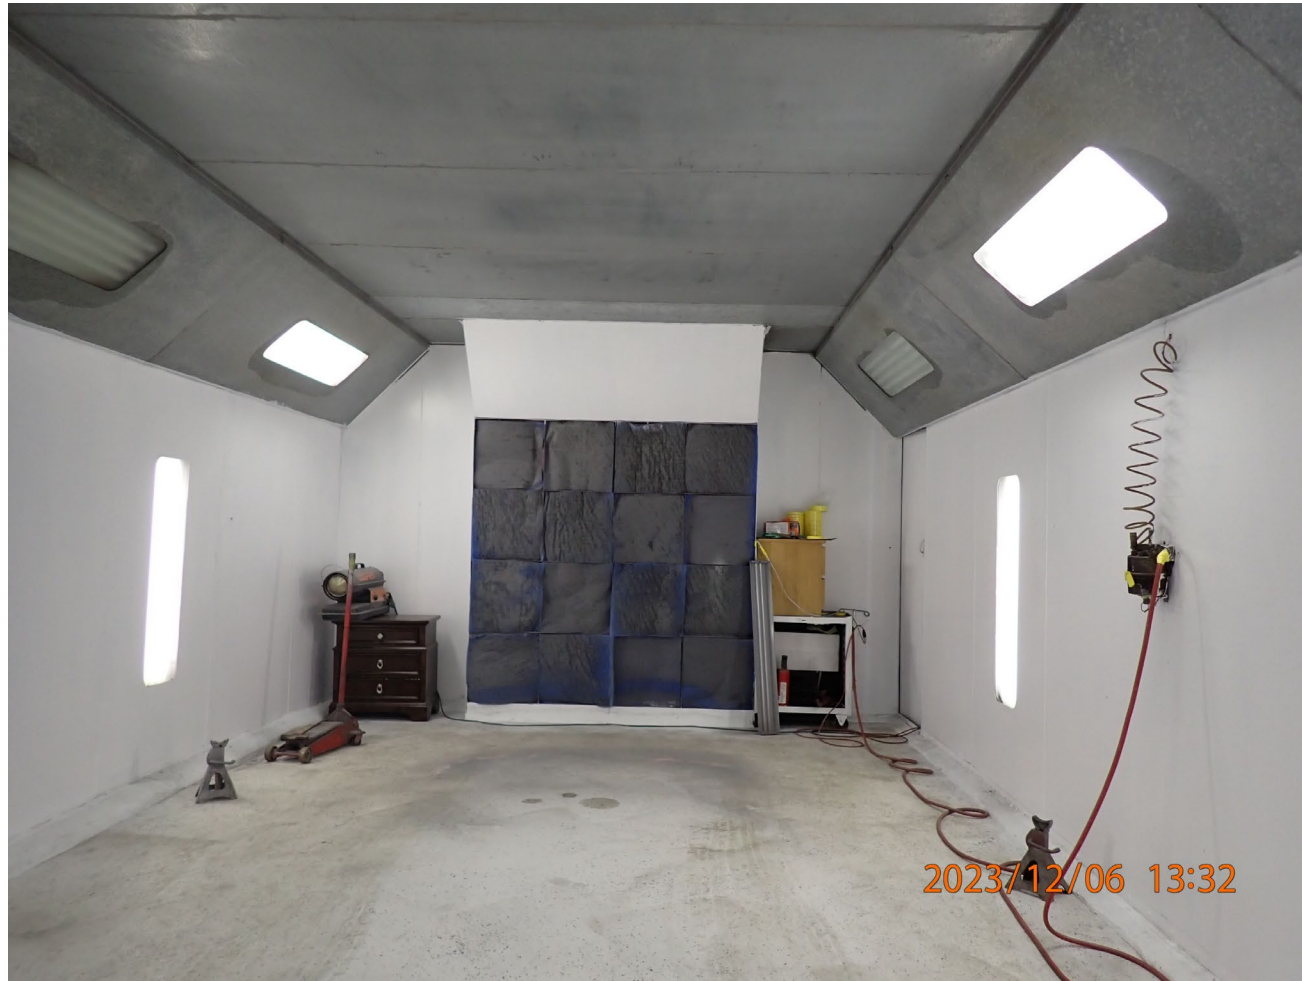
Photo Number: 83

The inspection team observed the outside of Best Auto from the parking lot. The facility consisted of one building with a few bays and an enclosed spray booth. A vehicle was observed inside the garage. The vehicle did not appear to be receiving maintenance during the time of the team's walkthrough. The team entered Best Auto garage through a bay. Mr. Gebreab led the inspection team to the enclosed spray booth. All filters appeared to be in place. Multiple filters were heavily covered in dirt, dust, or paint overspray. The inspection team asked the Facility to turn on the booth so they could see the airflow through the booth. At the time of the inspection, the booth was operating at a negative pressure and there were no indications that the booth had been operated recently.

Photo Description: Interior of Enclosed Paint Booth

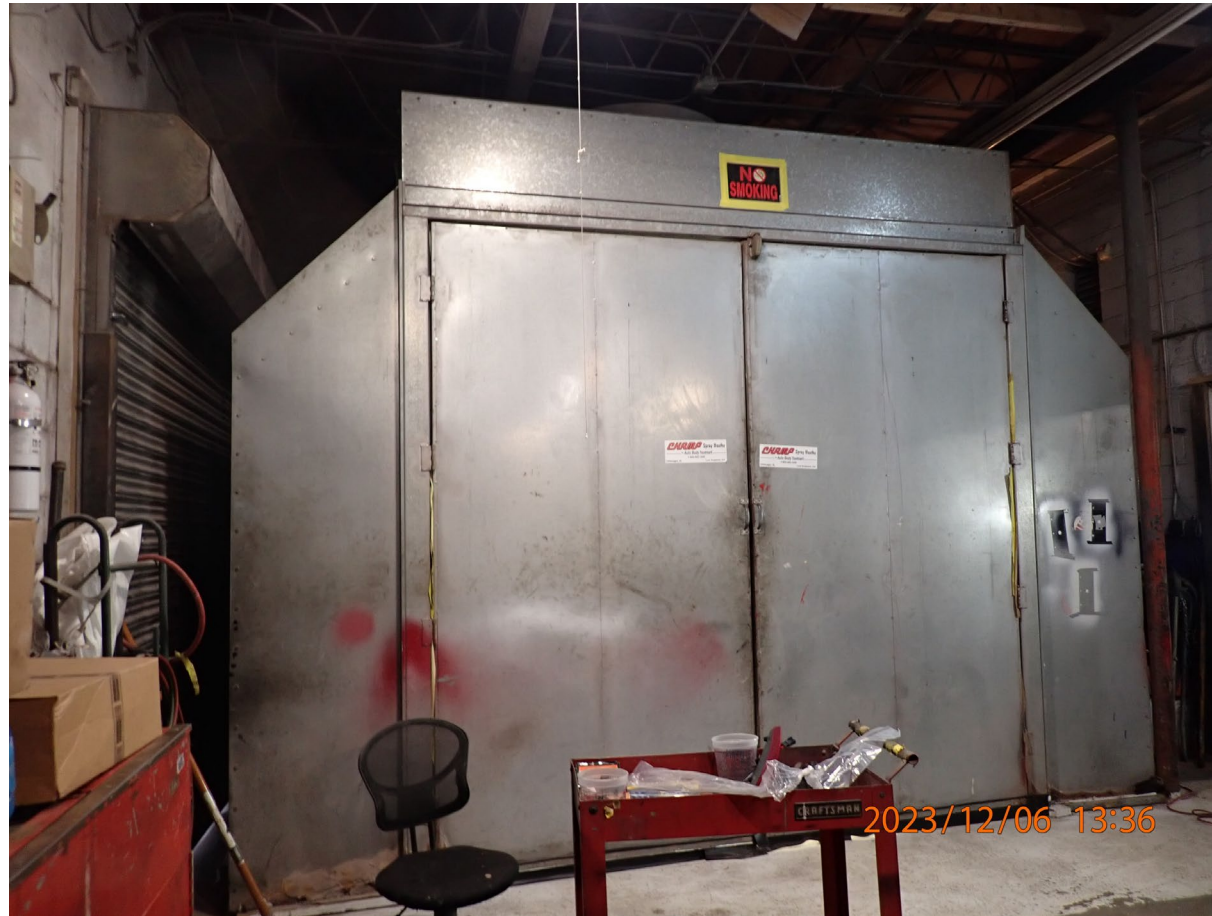
Photo Number: 84

Photo Description: Exterior of paint booth

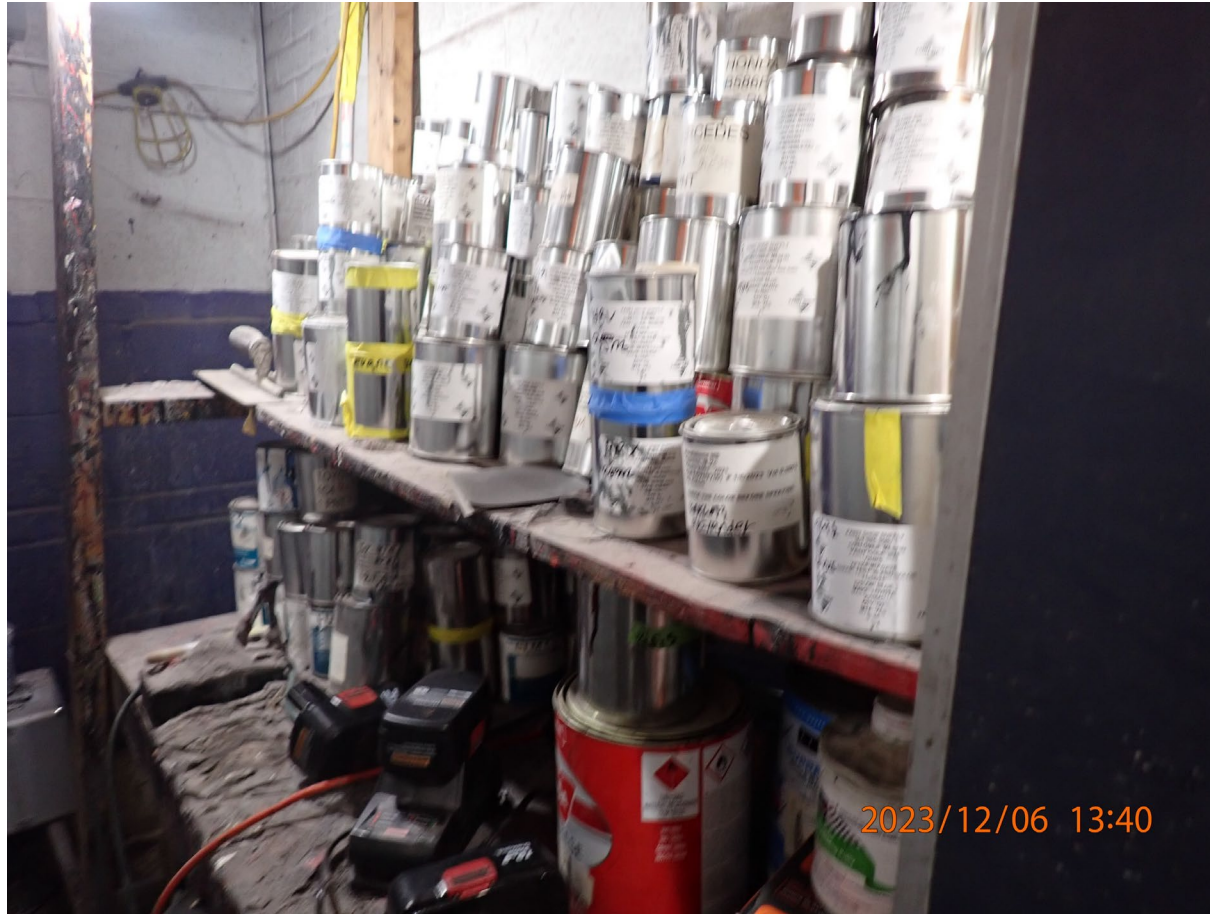
Photo Number: 85

Next, the team observed the Facility's paint storage area. Mr. Gebreab indicated that the paint was purchased by the previous owner and that the Facility has not purchased any of its own paint. Mr. Gebreab also indicated that Best Auto has a new storage container for all paint and supplies and will be converting the prior paint storage area to a parts storage area. Lastly, the inspection team observed the Facility's spray guns. One spray gun was an Devilbliss GTI and the other was a Kobalt SGY-Air70NB. The team also observed a box of Viskon-Aire Air filters, item number: 017-202.

Photo Description: Paint Storage Area
