**Region 6 Compliance Assurance and Enforcement Division  
INSPECTION REPORT**

| Media: | Water | | |
| Regulatory Program(s) | NPDES | | |
| Identification/Permit Number: | LAU000474 | | |

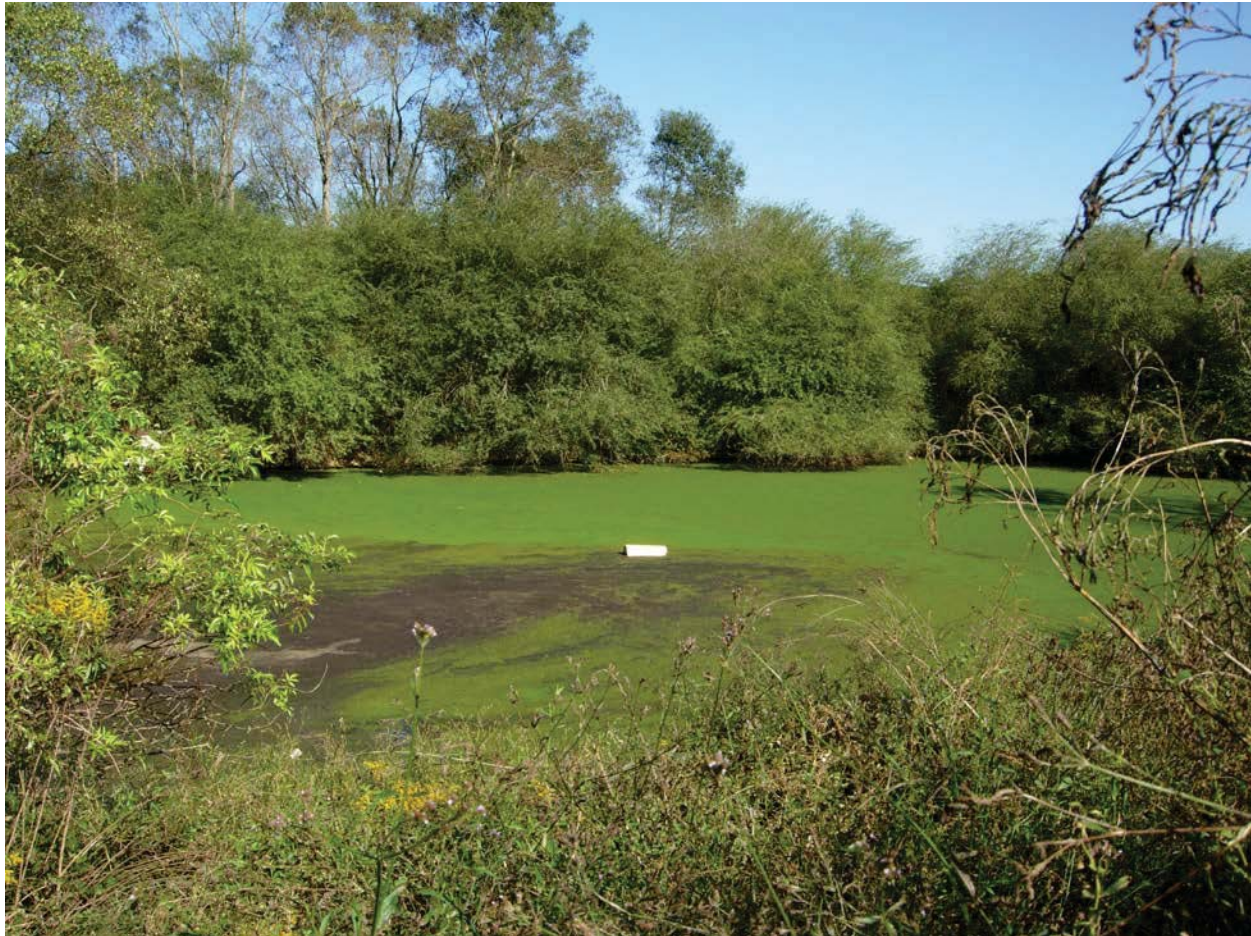
Photo No. 1

We observed the RCS to be largely overgrown with algae, surrounded by dense woody vegetation, and discharging at the time of our inspection (Appendix 1, Photos 1 & 2). We followed the discharge and determined that it stayed within dairy property and ultimately did not reach a water of the United States (Appendix 1, Photo 3).

- At the time of the inspection, we observed the RCS to be largely overgrown with algae, surrounded by dense woody vegetation, and discharging (Appendix 1, Photos 1 & 2).

Description: Photo taken facing southwest across RCS. Note the abundance of algae within the lagoon and woody vegetation rooted within the berm.

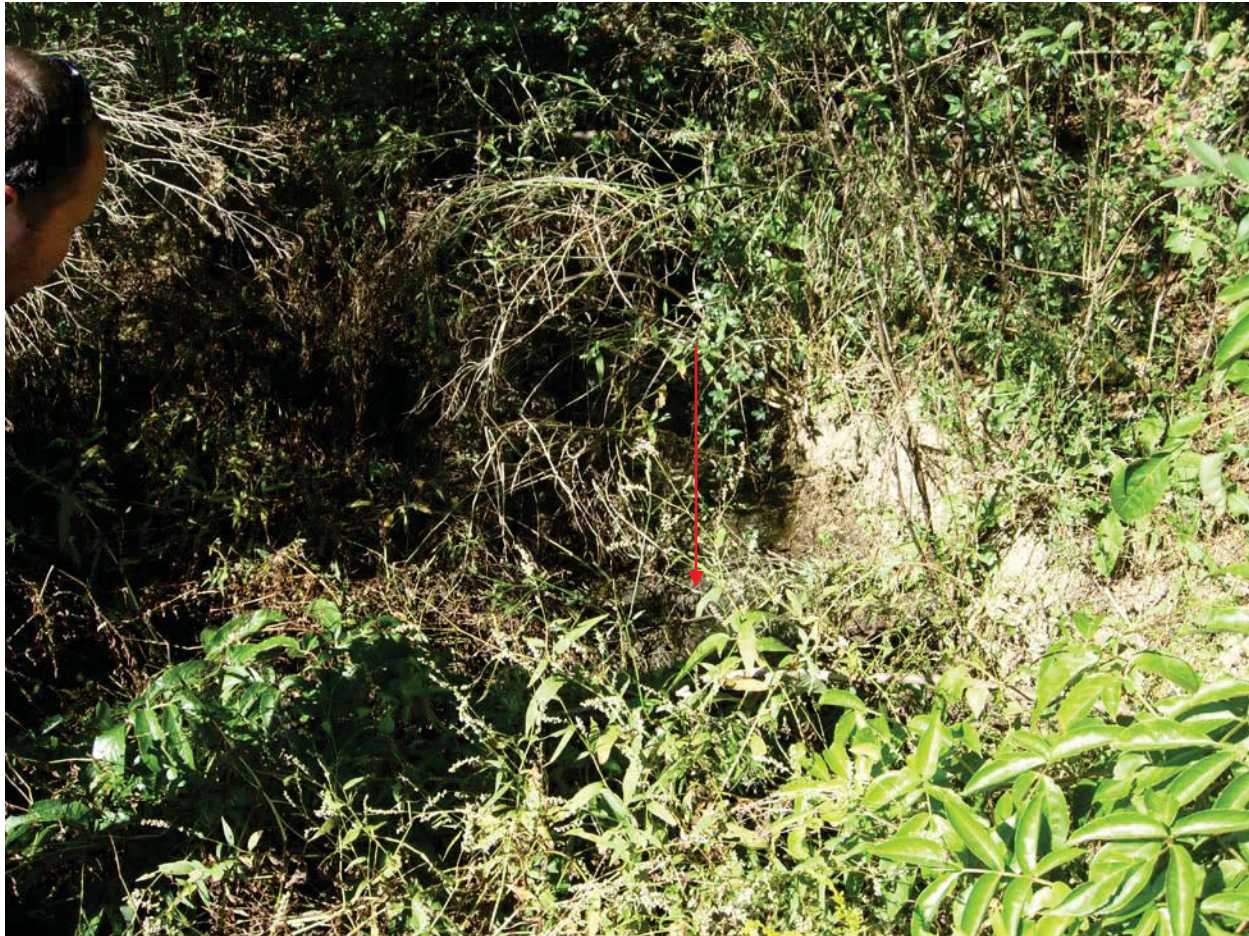
Photo No. 2

Description: Photo taken facing southwest toward the origin of the lagoon seep.

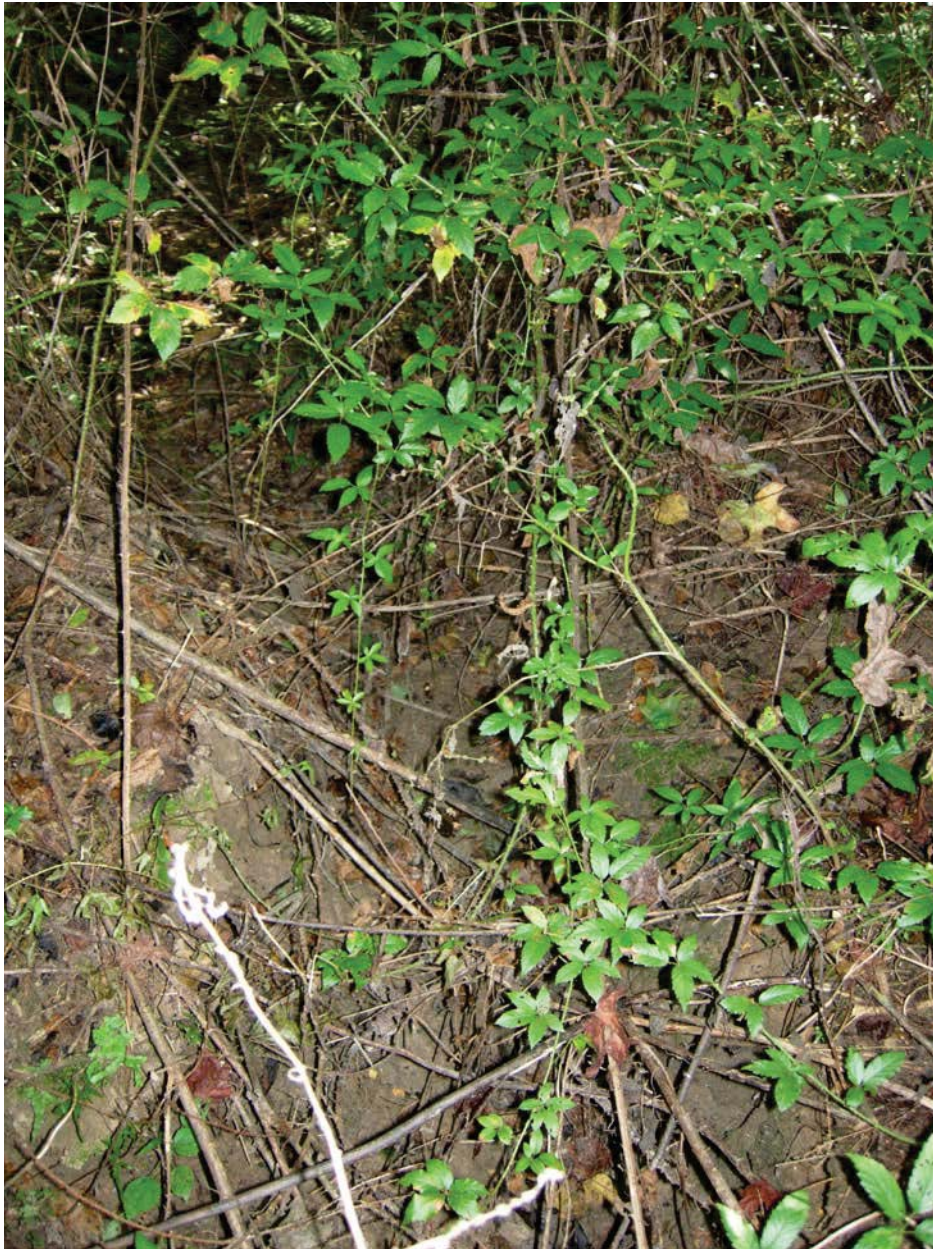
Photo No. 3

Description: Photo taken facing east toward the dry drainageway which would likely receive the wastewater under larger flows from the RCS.
