**UPR Mayagüez Campus, Mayagüez, Puerto Rico**

**PRD000691063**

**CEPD-RCRA-23-0440**

**Eduardo Gonzalez  
March 8 - 10, 2023**

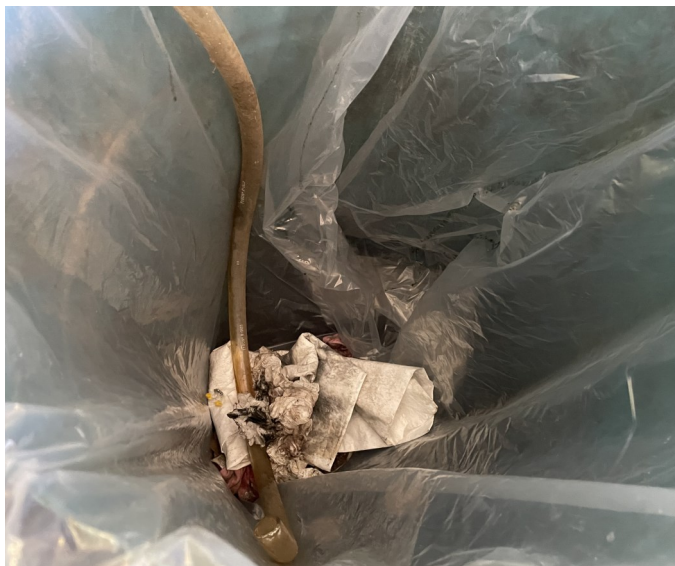
**Picture 97 - UPR BUILDINGS & LAND DEPARTMENT**– At the Mechanic Shop there was one (1) 55-gallon blue drum open with impacted material with used oil not marked with the words, "Used Oil."

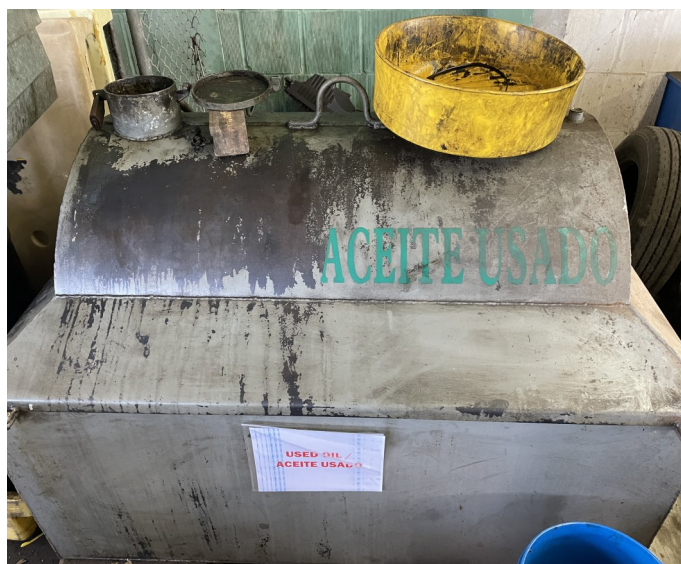
**Picture 99 - UPR BUILDINGS & LAND DEPARTMENT**- At the Mechanic Shop there was one (1) 200-gallon double wall Used Oil Steel Tank marked with the words, "Used Oil." However, there were old and new used oil spills and stains on the concrete floor of the used oil.

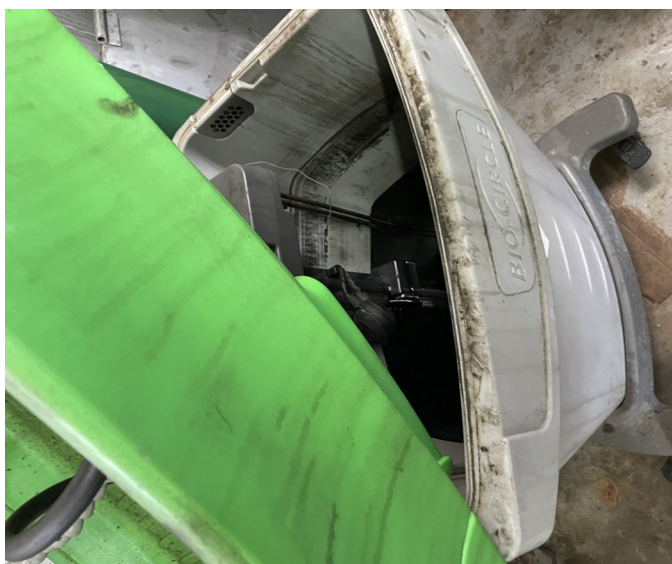
**Picture 100 - UPR BUILDINGS & LAND DEPARTMENT**– At the Mechanic Shop there was one (1) part-washer tray-container machine which uses CB-100 degreaser (e.g., biodegradable water-based cleaner and degreaser) to clean up auto parts, but diesel was used as a degreaser in the part-washer machine.

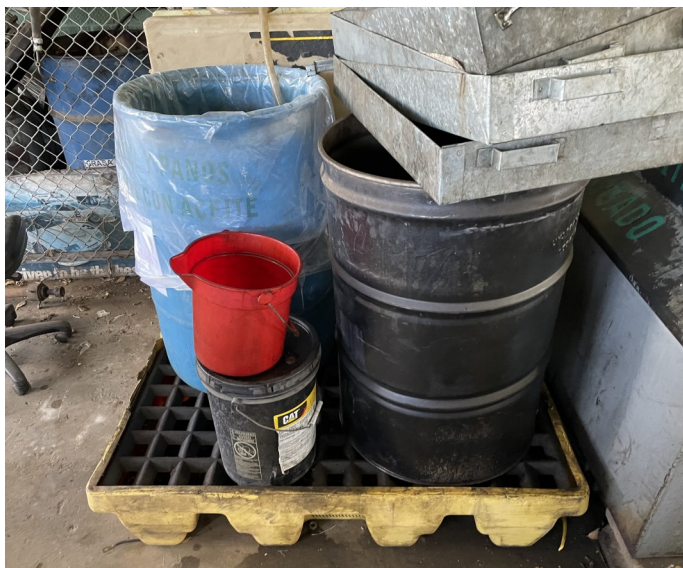
**Picture 101 - UPR BUILDINGS & LAND DEPARTMENT-** At the Mechanic Shop, there was one (1) 55-gallon black drum open on top with spent used oil filters impregnated with used oil not marked with the words , "Used Oil."

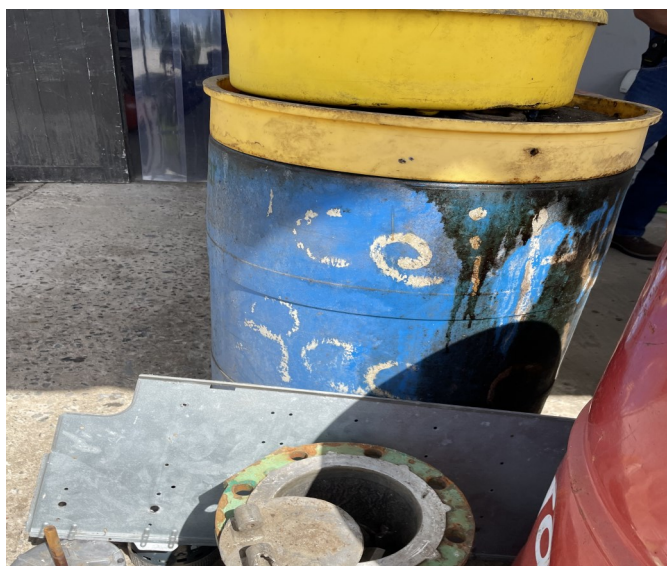
**Picture 102 - UPR BUILDINGS & LAND DEPARTMENT-** At the Refrigeration Shop, there was one (1) 55-gallon blue drum with a yellow drainage tray on top with used oil generated from draining compressors not marked with the words, "Used Oil"

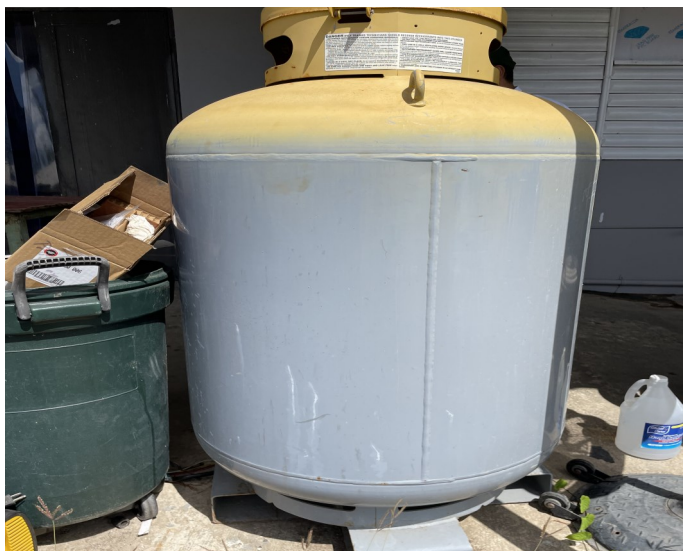
**Picture 103 - UPR BUILDINGS & LAND DEPARTMENT-** At the At the Refrigeration Shop, there were two (2) 1,000 pounds steel tanks with discarded refrigerants not marked with the words, "Used Refrigerant." No hazardous waste determination has been made nor recycling or reclaiming program evidenced.

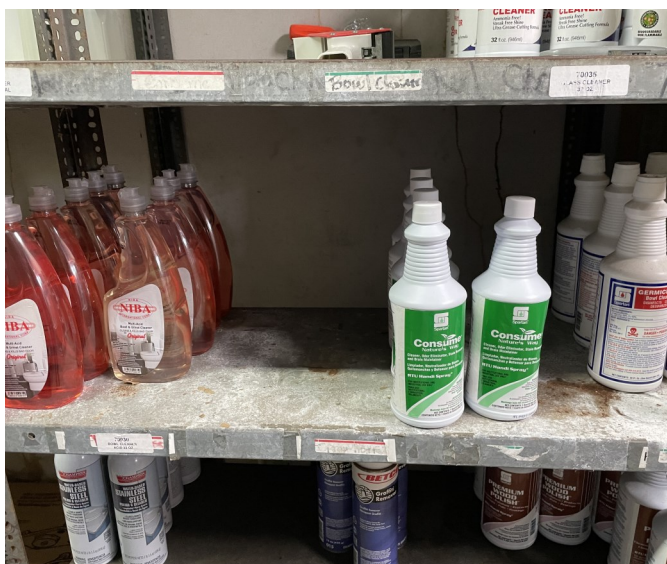
**Picture 104 - UPR BUILDINGS & LAND DEPARTMENT—** At the Cleaning Warehouse Shop, EPA inspectors requested the inventory of product purchased that has historically been used for cleaning purposes in the Campus which contain hazardous characteristics.

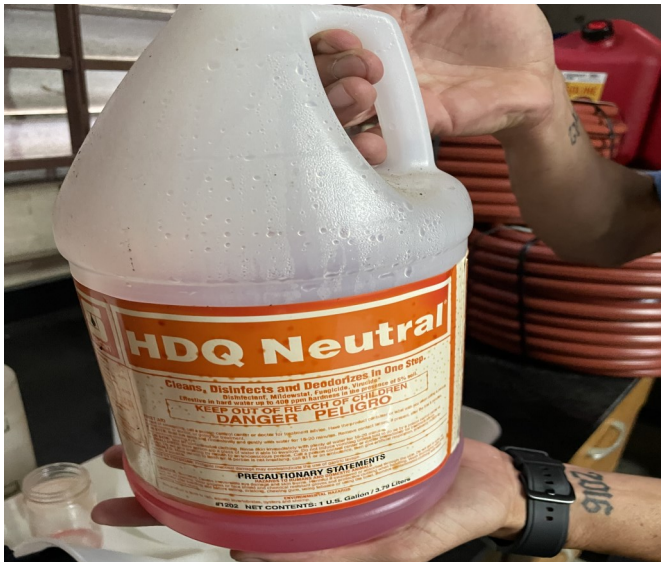
**Picture 105 - UPR BUILDINGS & LAND DEPARTMENT-** At the Cleaning Warehouse Shop, many of the cleaning solvent products were concentrated and contained hazardous substances as active ingredients after thorough evaluation of the products Safety Data Sheets (SDSs).

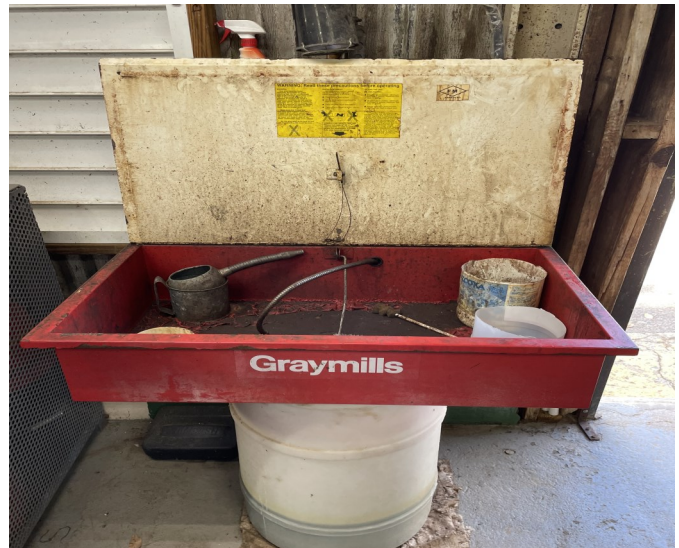
**Picture 106 - UPR BUILDINGS & LAND DEPARTMENT-** At the Fields and Roads Shop there was one (1) 30-gallon container part-washer machine which uses mineral spirit degreaser to clean up equipment parts served by Oil Energy System which was out of service for a long period of time.

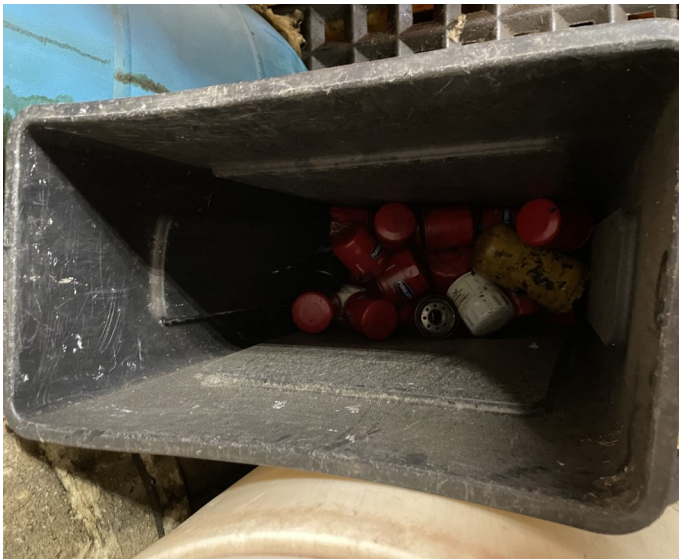
**Picture 107 - UPR BUILDINGS & LAND DEPARTMENT-** At the Fields and Roads Shop there was one (1) 20-gallon black container open on top with spent used oil filters impregnated with used oil not marked with the words, "Used Oil."

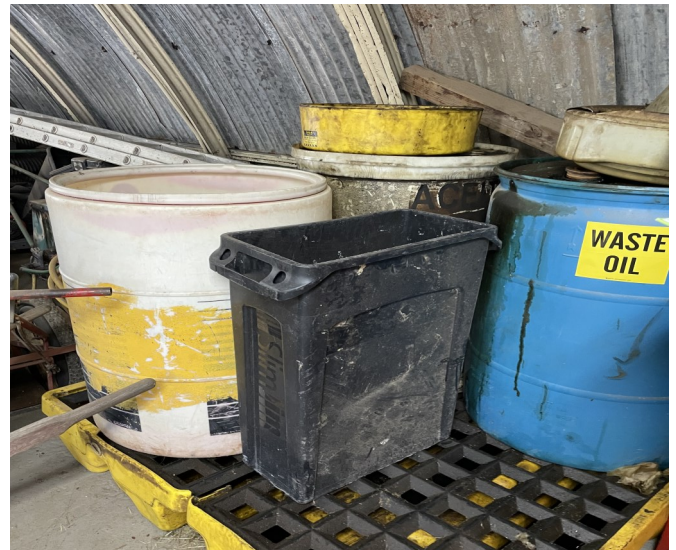
**Picture 108 - UPR BUILDINGS & LAND DEPARTMENT—** At the Fields and Roads Shop there was One (1) 55-gallon blue drum with a white drainage tray on top with used oil generated from draining landscape equipment not marked as "Waste Oil," and not with the words, "Used Oil."

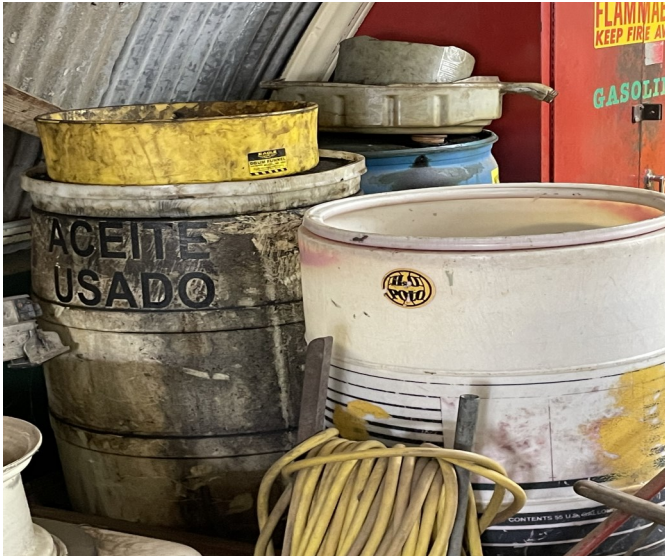
**Picture 109 - UPR BUILDINGS & LAND DEPARTMENT-** At the Fields and Roads Shop there was one (1) 55-gallon white drum with a yellow drainage tray on top with used oil generated from draining landscape equipment marked with the words, "Aceite Usado."

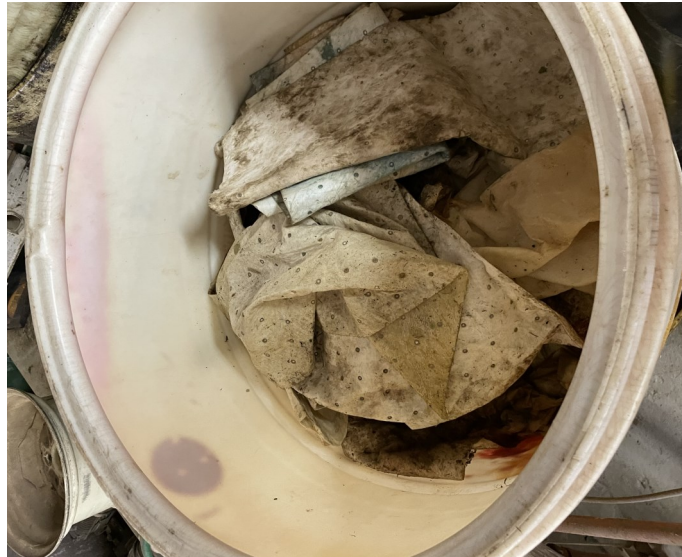
**Picture 110 - UPR BUILDINGS & LAND DEPARTMENT-** At the Fields and Roads Shop there was one (1) 55-gallon white drum with rags impregnated with used oil not marked with the words, "Used Oil."

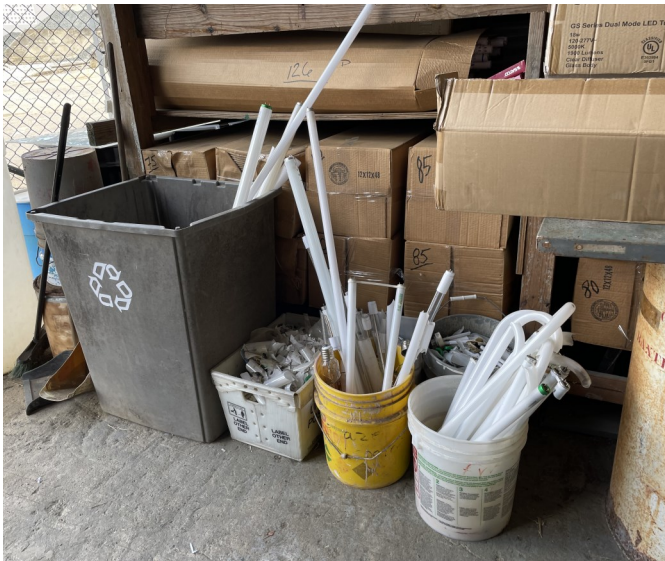
**Picture 111 - UPR BUILDINGS & LAND DEPARTMENT -** At the Universal Waste Storage Area there were one (1) 40-gallon container and three (3) 5-gallon pails all open with broken fluorescent lamps mixed with crushed fluorescent lamps and sodium bulbs showing evidence of mercury releases and breakage.

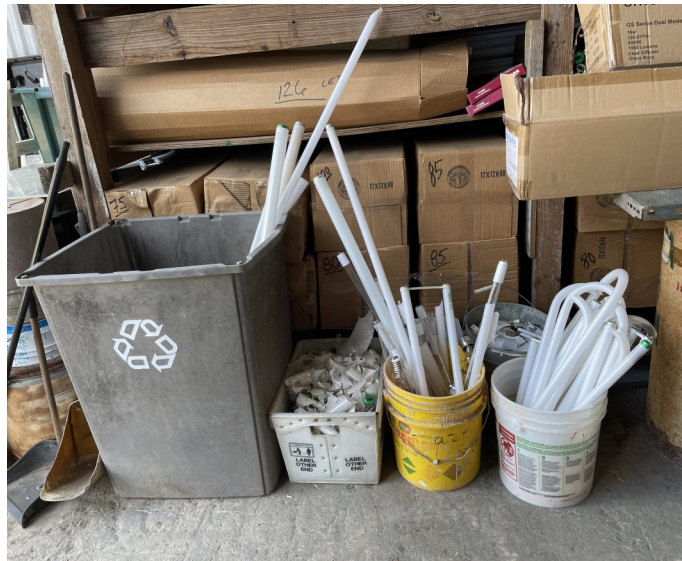
**Picture 112 - UPR BUILDINGS & LAND DEPARTMENT -** At the Universal Waste Storage Area there was one (1) white plastic tray (1'x1'x 2') with crushed fluorescent lamps and sodium bulbs showing evidence of breakage, leakage, and damage that caused releases of mercury or other hazardous constituents to the area.

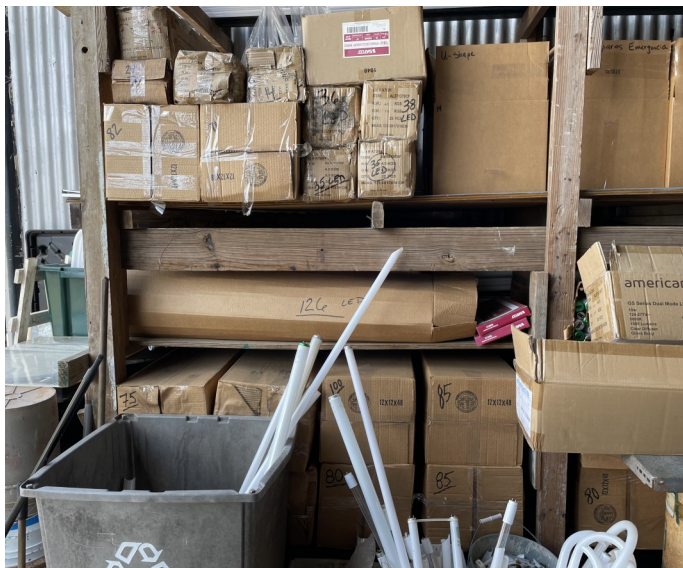
**Picture 113 - UPR BUILDINGS & LAND DEPARTMENT-** At the Universal Waste Storage Area there were sixty (60) square cardboard boxes (1'x1'x 4') packing over sixty (60) 4-foot spent fluorescent lamps, some open and not labeled with the words, "Universal Waste," or dated with their accumulation start dates.

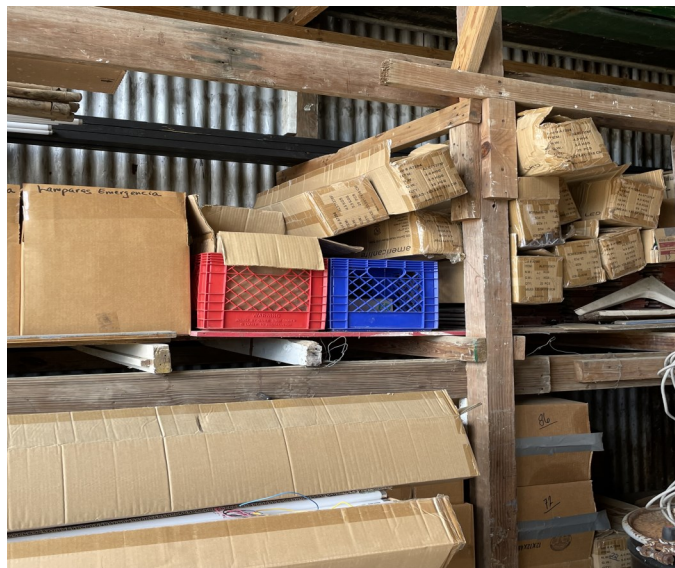
**Picture 114 - UPR BUILDINGS & LAND DEPARTMENT-** At the Universal Waste Storage Area there were thirty (30) square cardboard boxes (1'x1'x 8') containing broken 8-foot spent fluorescent lamps, open, not labeled with the words, "Universal Waste" or dated with their accumulation start dates.

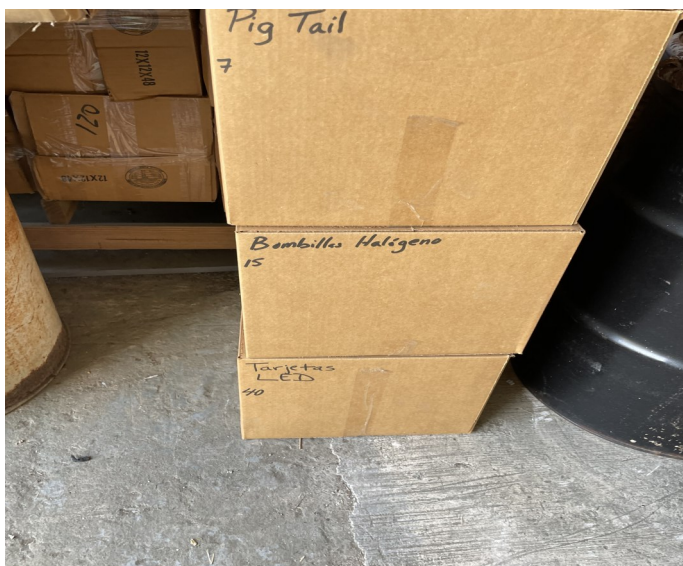
**Picture 115 - UPR BUILDINGS & LAND DEPARTMENT -** At the Universal Waste Storage Area there were three (3) cardboard boxes (1'x1'x 2') one with spent halogen bulbs, the other with pig tails, and another with LED light cards, not labeled with the words, "Universal Waste," or "Mercury Equipment," nor dated.

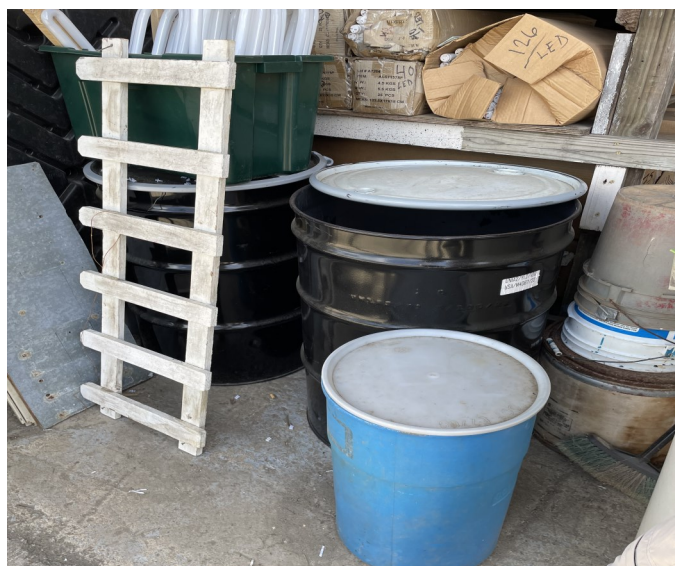
**Picture 116 - BUILDINGS & LAND DEPARTMENT —** At the Universal Waste Storage Area there were two (2) green plastic trays (2'x2'x2') packing over twenty-five (25) U-shaped spent fluorescent lamps, open and not labeled with the words, "Universal Waste," or dated with their accumulation start dates.

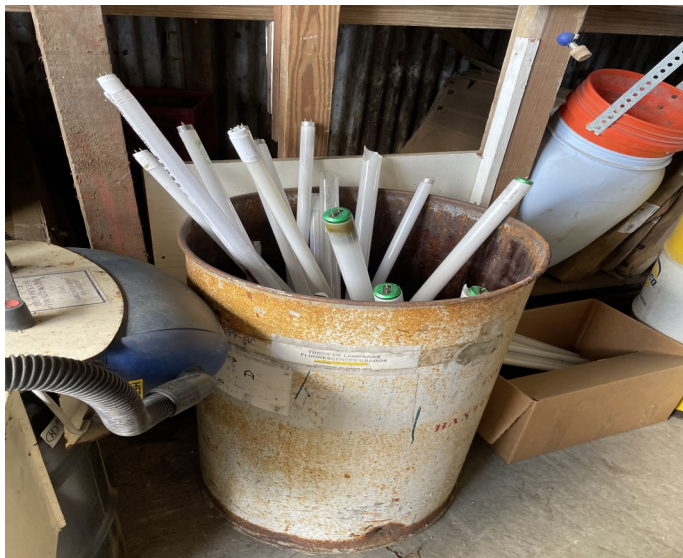
**Picture 117 - UPR BUILDINGS & LAND DEPARTMENT-** At the Universal Waste Storage Area there were one (1) 55-gallon white drum and one (1) square cardboard boxes (1'x1'x 4') packing over twenty (20) 4-foot and 8-foot spent fluorescent lamps, both open and not labeled with the words, "Universal Waste."

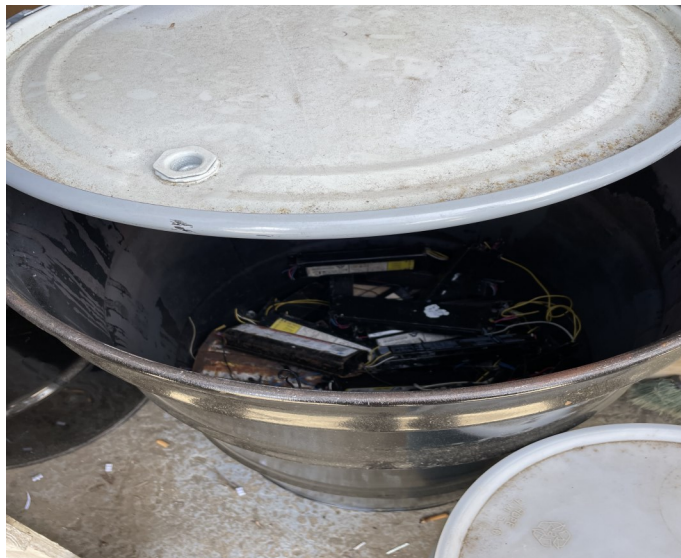
**Picture 118 - UPR BUILDINGS & LAND DEPARTMENT-** At the Universal Waste Storage Area there were two (2) 55-gallon black steel drums with lids containing "Ballast" which were removed from aluminum frames. None were clearly labeled with the words, "Universal Waste-Mercury Equipment," or dated.

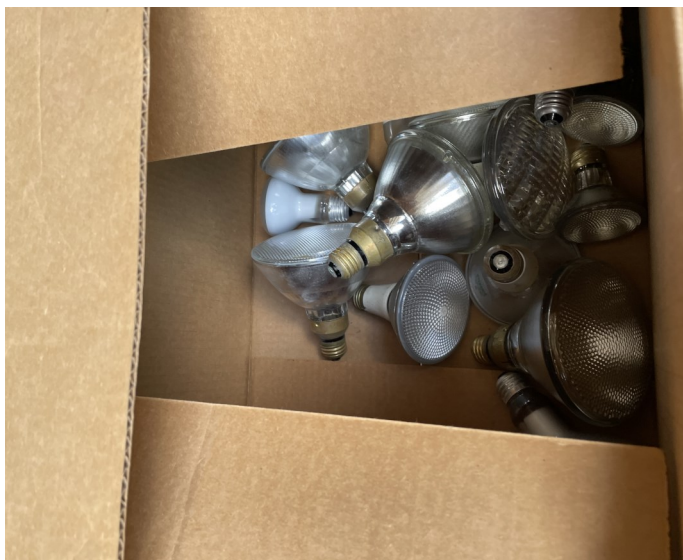
**Picture 119 - UPR BUILDINGS & LAND DEPARTMENT -** At the Universal Waste Storage Area there were two (2) cardboard box (1'x1'x 2') open with high-density halogen open and not labeled with the words, "Universal Waste," or dated with their accumulation start dates.

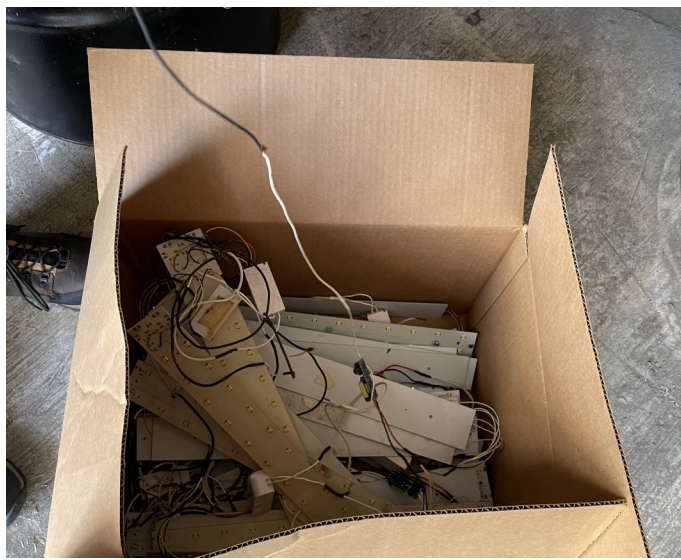
**Picture 120 - BUILDINGS & LAND DEPARTMENT —** At the Universal Waste Storage Area there was one (1) cardboard box (1'x1'x 2') open with LED light cards, and not labeled with the words, "Universal Waste-Mercury Containing Equipment," or dated.

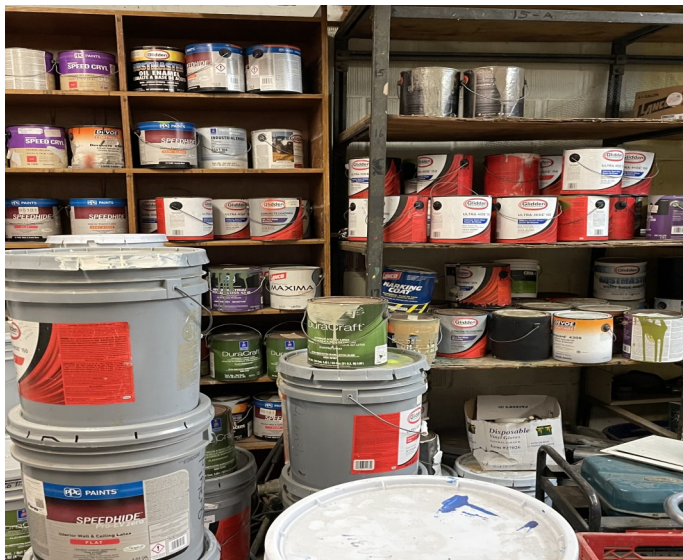
**Picture 121 - UPR BUILDINGS & LAND DEPARTMENT-** At the Paint Shop there were over 100 1-gallon paint pails decommissioned since were damaged due the time during the COVID-19 not in use No hazardous waste determination has been made on the contents of all 5-gallon paint pails at the Paint Shop.

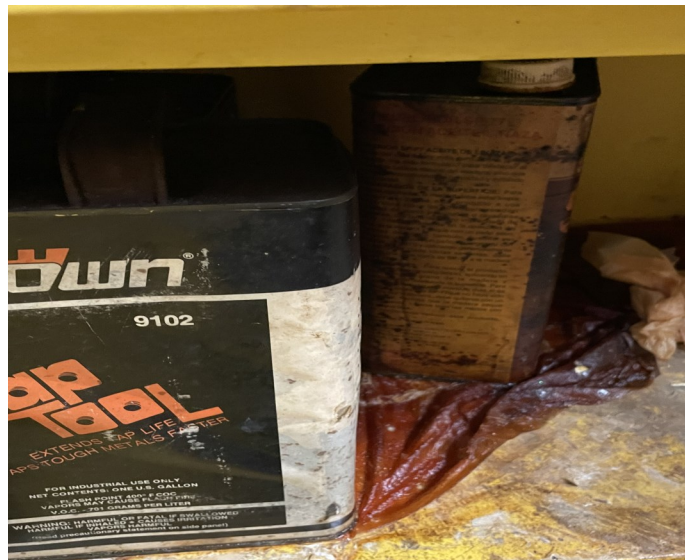
**Picture 122 - UPR BUILDINGS & LAND DEPARTMENT-** At the Paint Shop, it was noted that the practice to dispose of used brushes was to clean them up with solvent thinner, if it is no longer usable, they allow them to dry, and then dispose of with domestic garbage as illegal treatment of hazardous wastes.

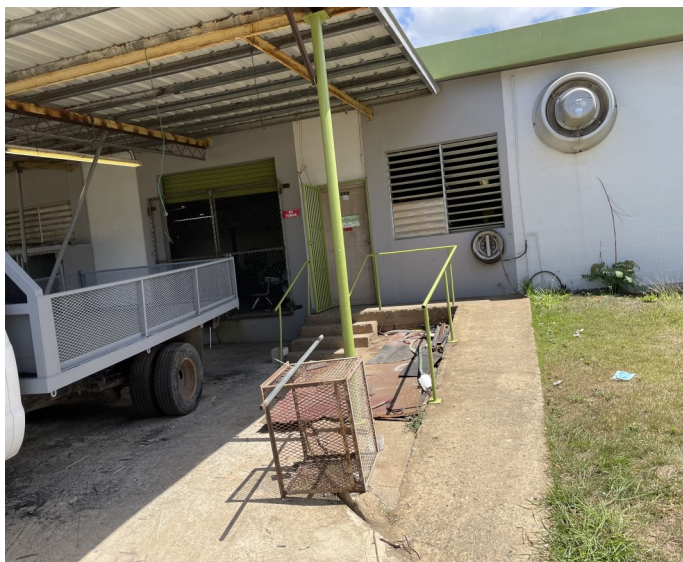
**Picture 123 - UPR BUILDINGS & LAND DEPARTMENT -** At the Welding Shop, the shop was closed at the time of the Inspection and EPA inspectors took an overlook view of the shop from the outside area.

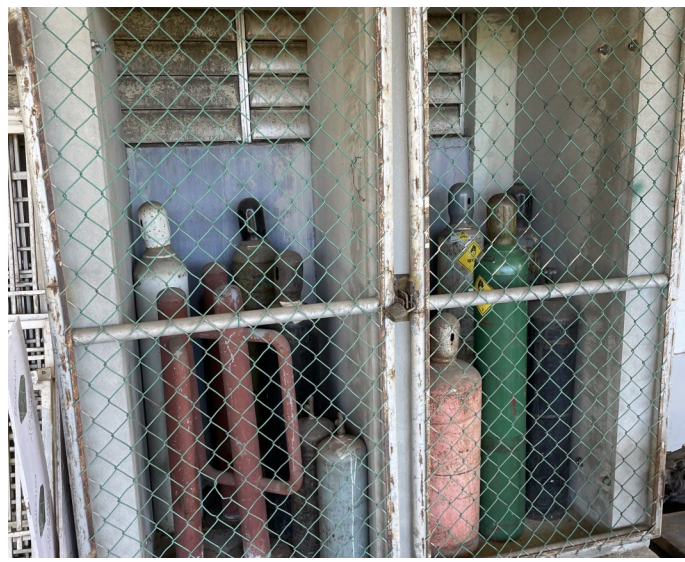
**Picture 124 - BUILDINGS & LAND DEPARTMENT —** At the Welding Shop, there were over ten (10) 100-lbs, 75-lbs and 25-lbs gas cylinders store in a concrete shed and secured with a cyclone fenced gates. There was oxygen, ethylene and other compressed gases stored in this shop and used for welding jobs.
