**Region 6 - Enforcement & Compliance Assurance Division**  
**INSPECTION REPORT**

| Inspection Date(s): | 3/12/2024 | |
| Company Name: | <b>RCP Production, LLC</b> | |
| Facility Name: | <b>TD Murphy B-3 SWD Tank Battery</b> | |

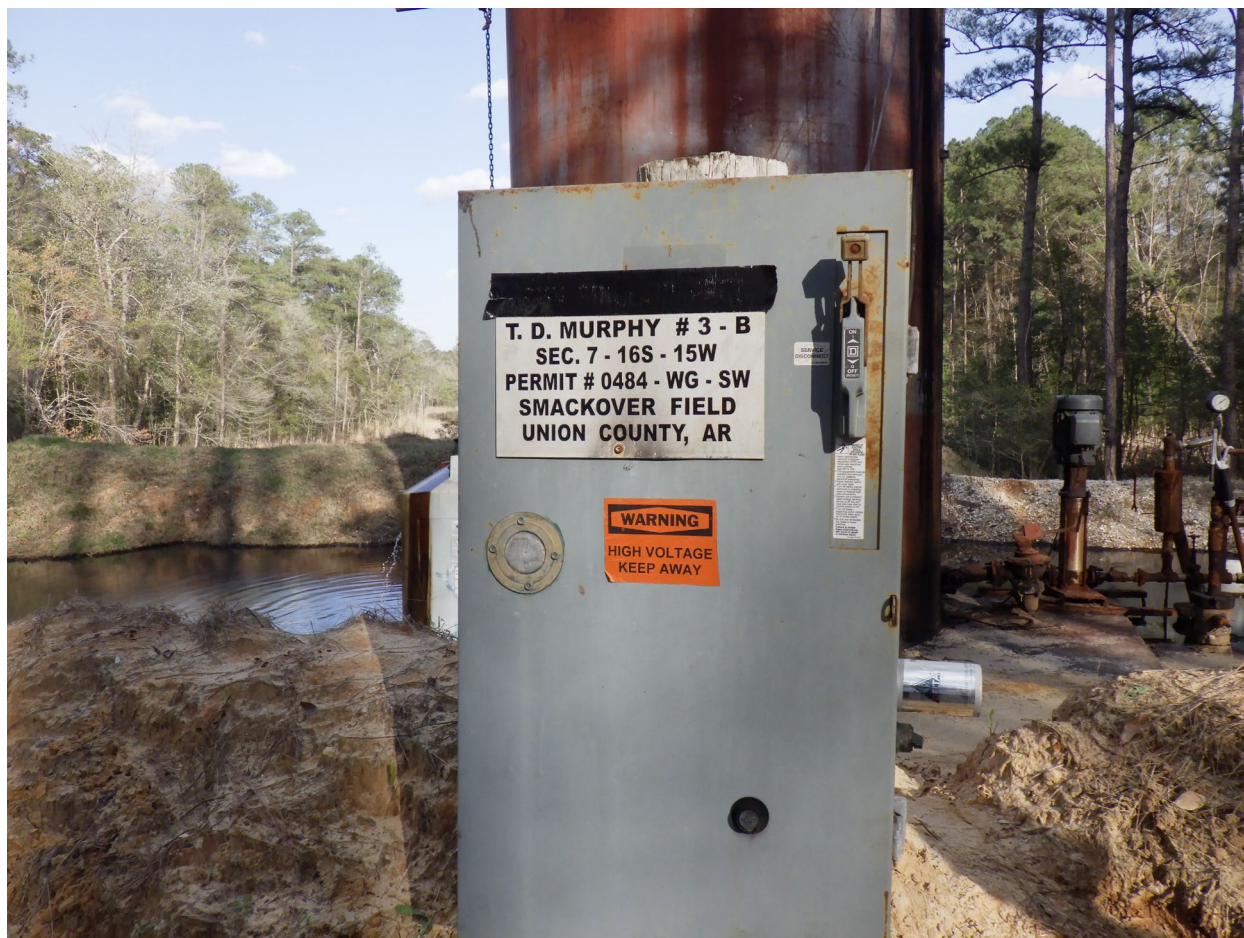
Photo No. 1

**Description:** This photo was taken looking ENE showing the facility sign.

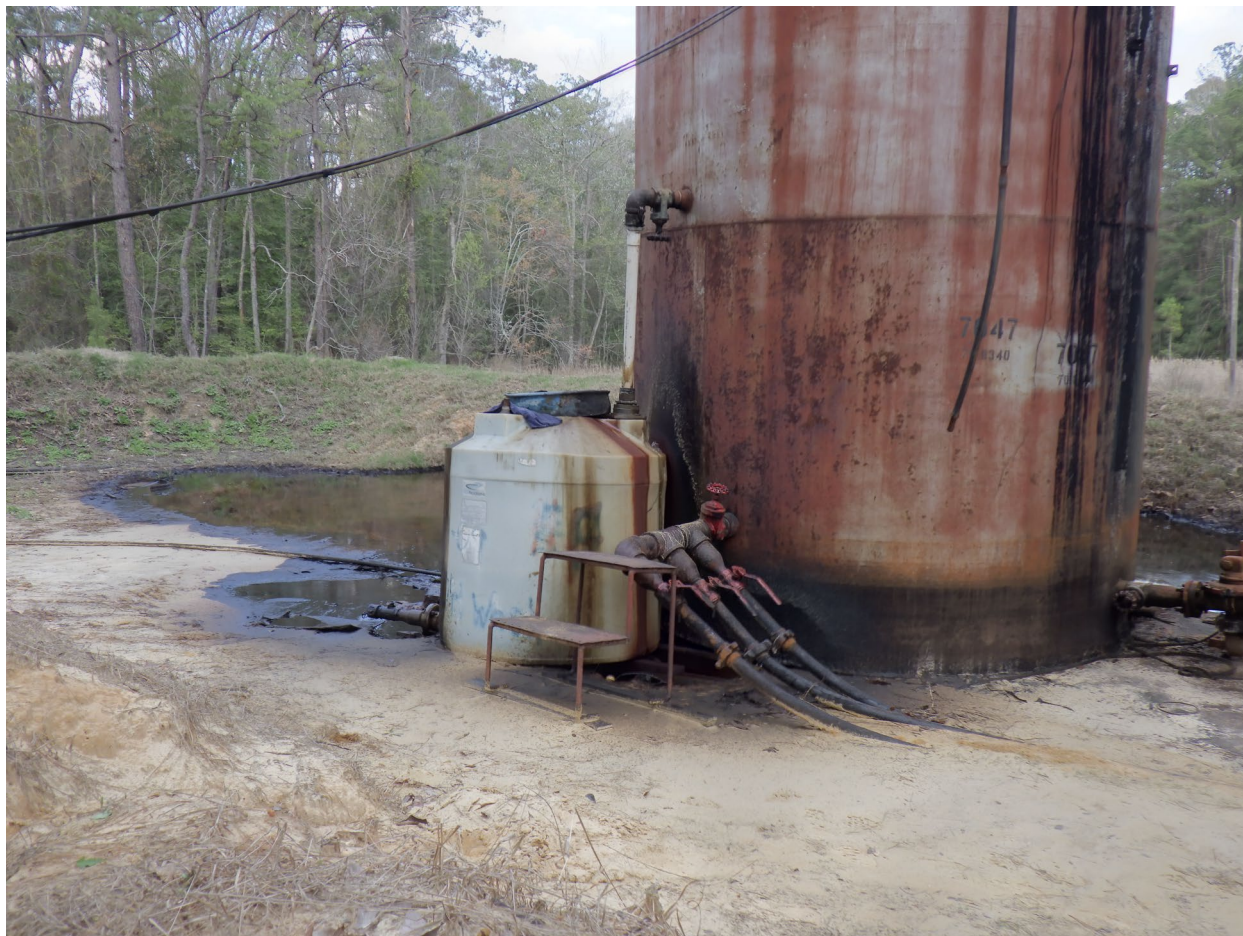
Photo No. 2

I observed a spill of oil and produced water from the tank inside secondary containment, see photo No. 2.

**Description:** This photo was taken looking NE at the facility showing an overview of the facility and the spill source.

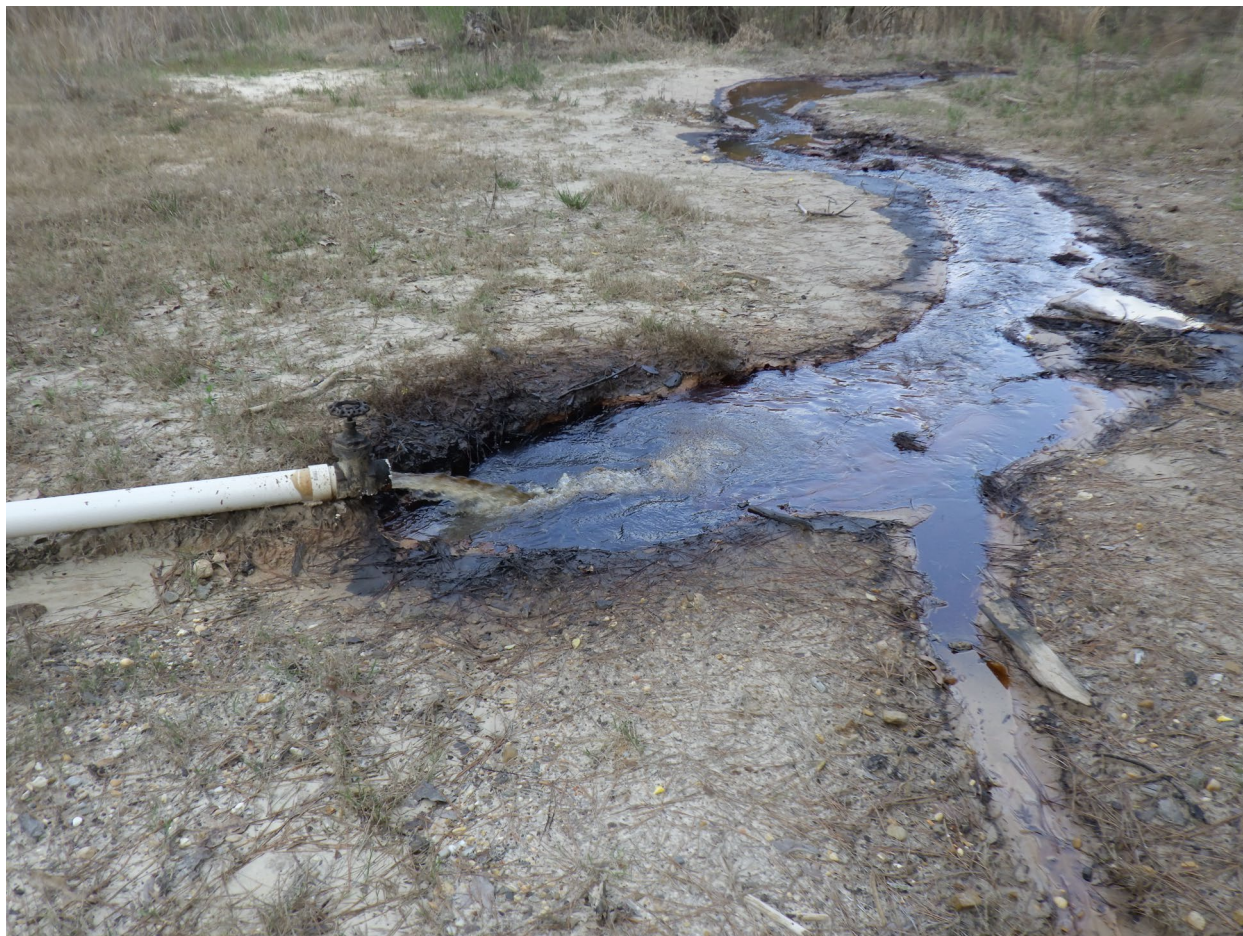
Photo No. 3

I observed the spill releasing from the open secondary containment drainage valve behind the facility, see photo No. 3 and Appendix 2, video No. 1 and 2.

**Description:** This photo was taken looking NE showing the secondary containment discharge pipe releasing the produced water and oil from secondary containment into the nearby wetland.

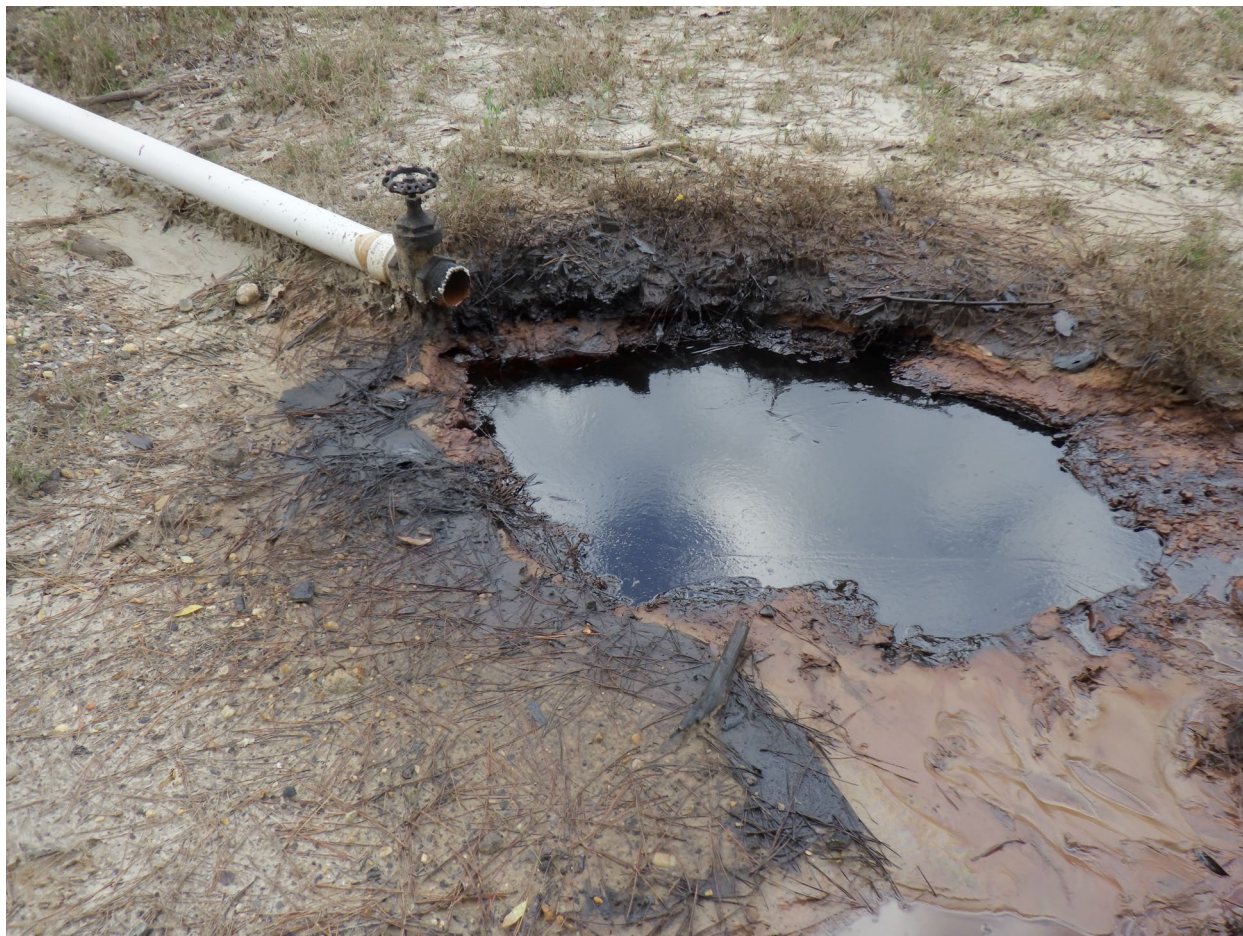
Photo No. 4

Approximately 19 minutes from the time we started the inspection, John Tarver arrived to shut the secondary containment valve stopping the release, see photo No. 4.

**Description:** This photo was taken looking N showing the secondary containment valve closed by John Tarver, stopping the release.

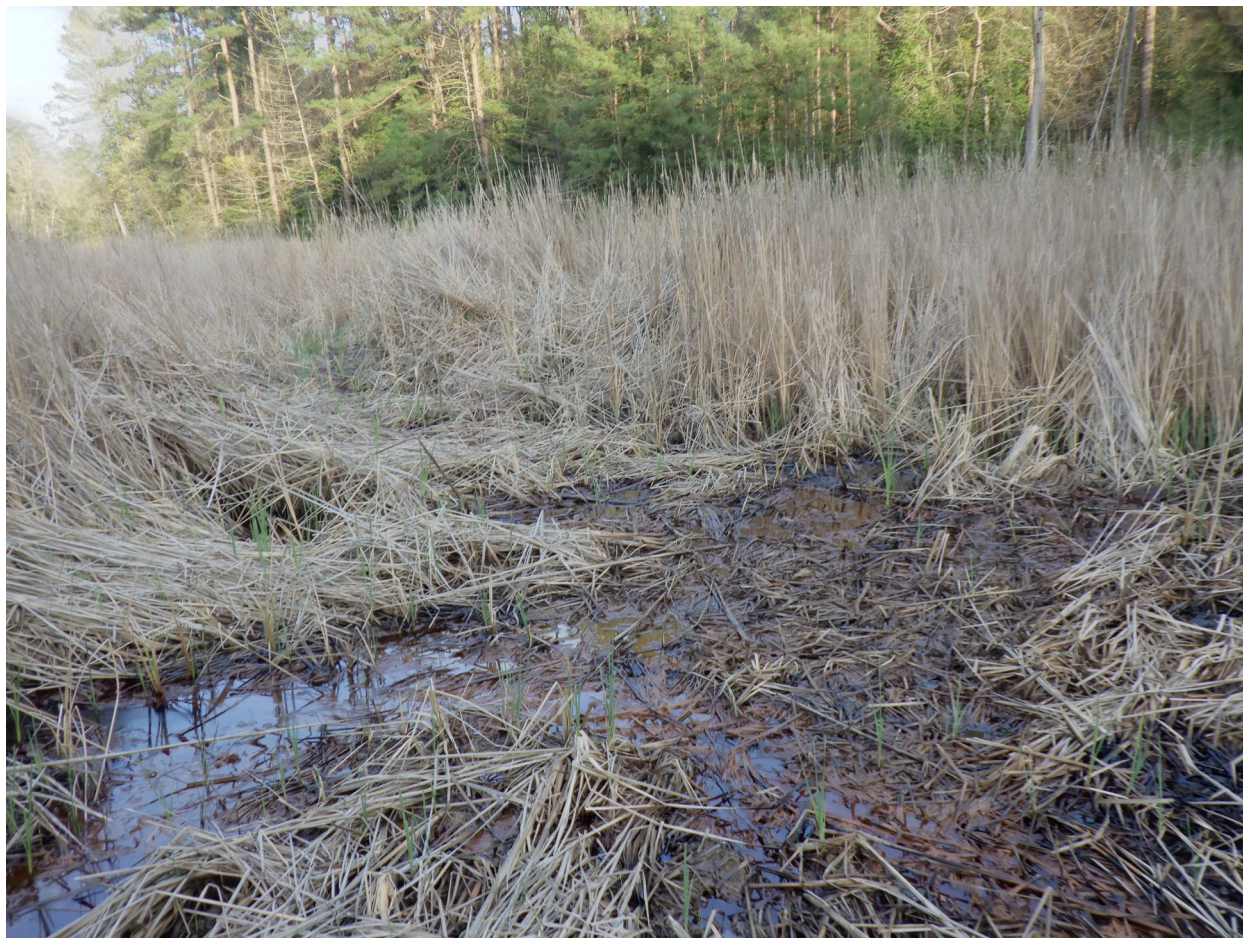
Photo No. 5

Behind the facility, I observed the impacted flowpath with produced water and oil in the wetland, see photo No. 5 and photo No. 6.

**Description:** This photo was taken looking downstream E showing sheen on the contaminated flowpath entering the wetland behind (E) the facility.

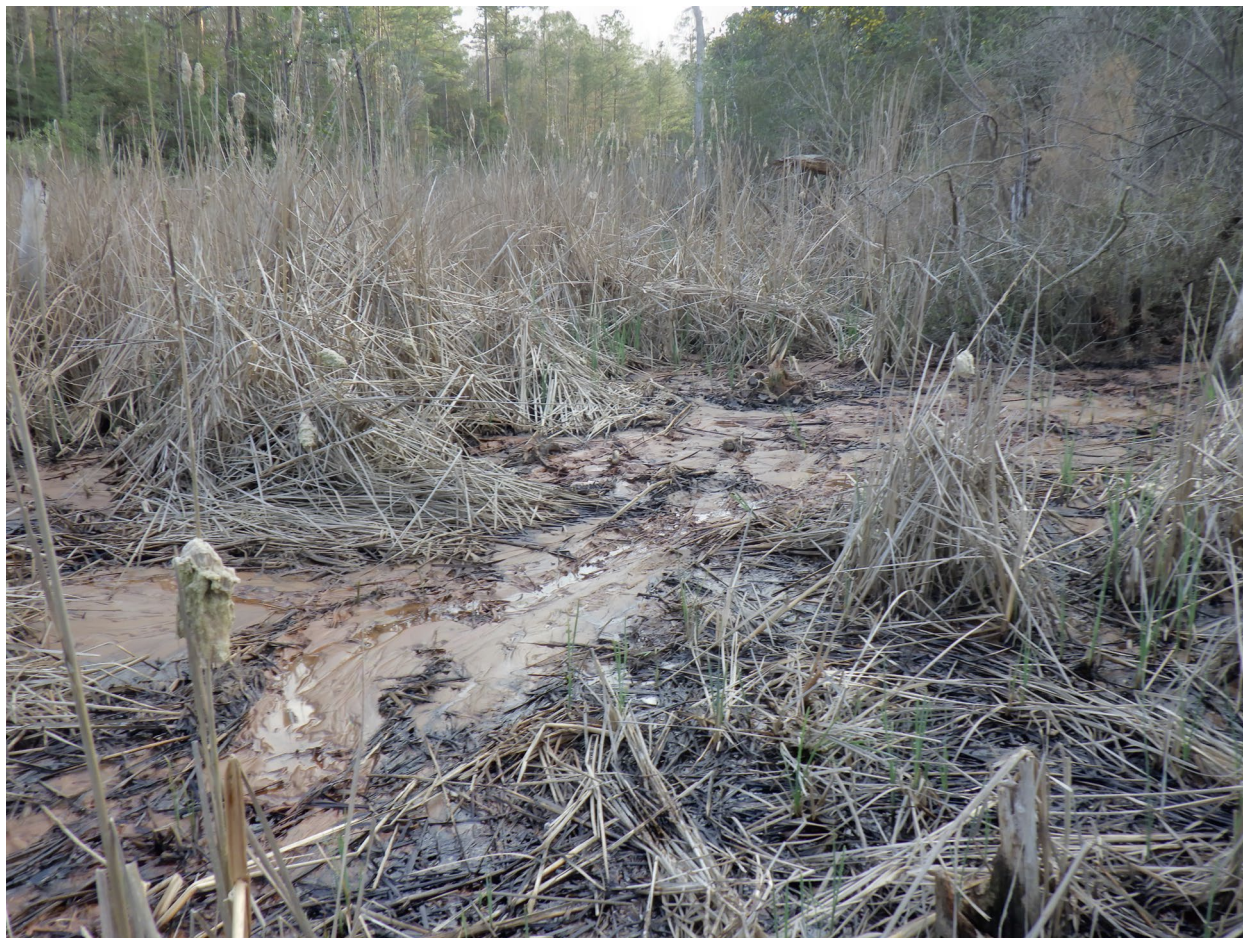
Photo No. 6

**Description:** This photo was taken looking SW showing the impacted flowpath through the wetland.

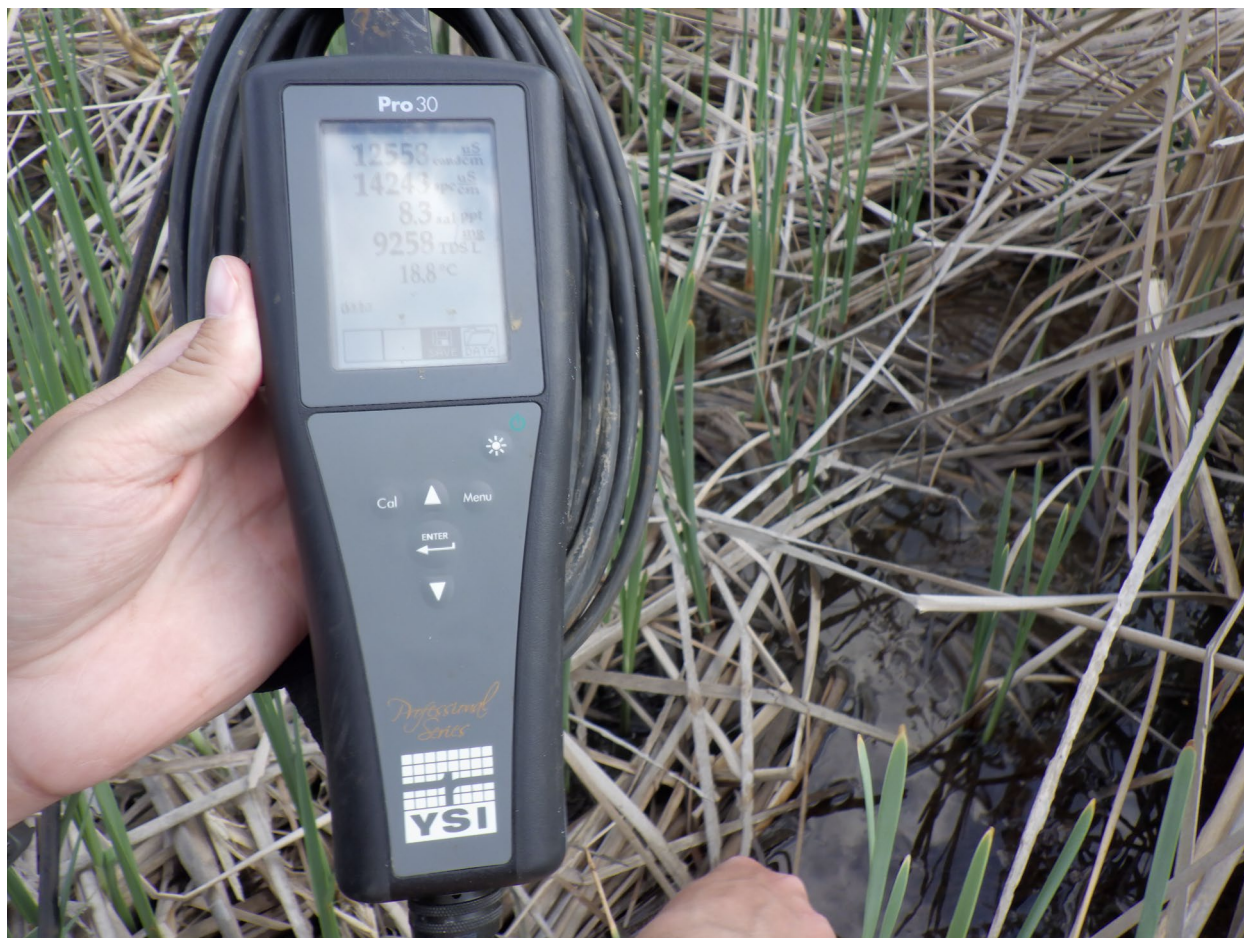
Photo No. 7

I observed a Total Dissolved Solids (TDS) reading of 9,258 mg/L in the wetland as well as upstream and downstream characteristics, see photo No. 7 and photo No. 9.

**Description:** This photo was taken showing a Total Dissolved Solids (TDS) reading of 9,256 mg/L in the wetland.

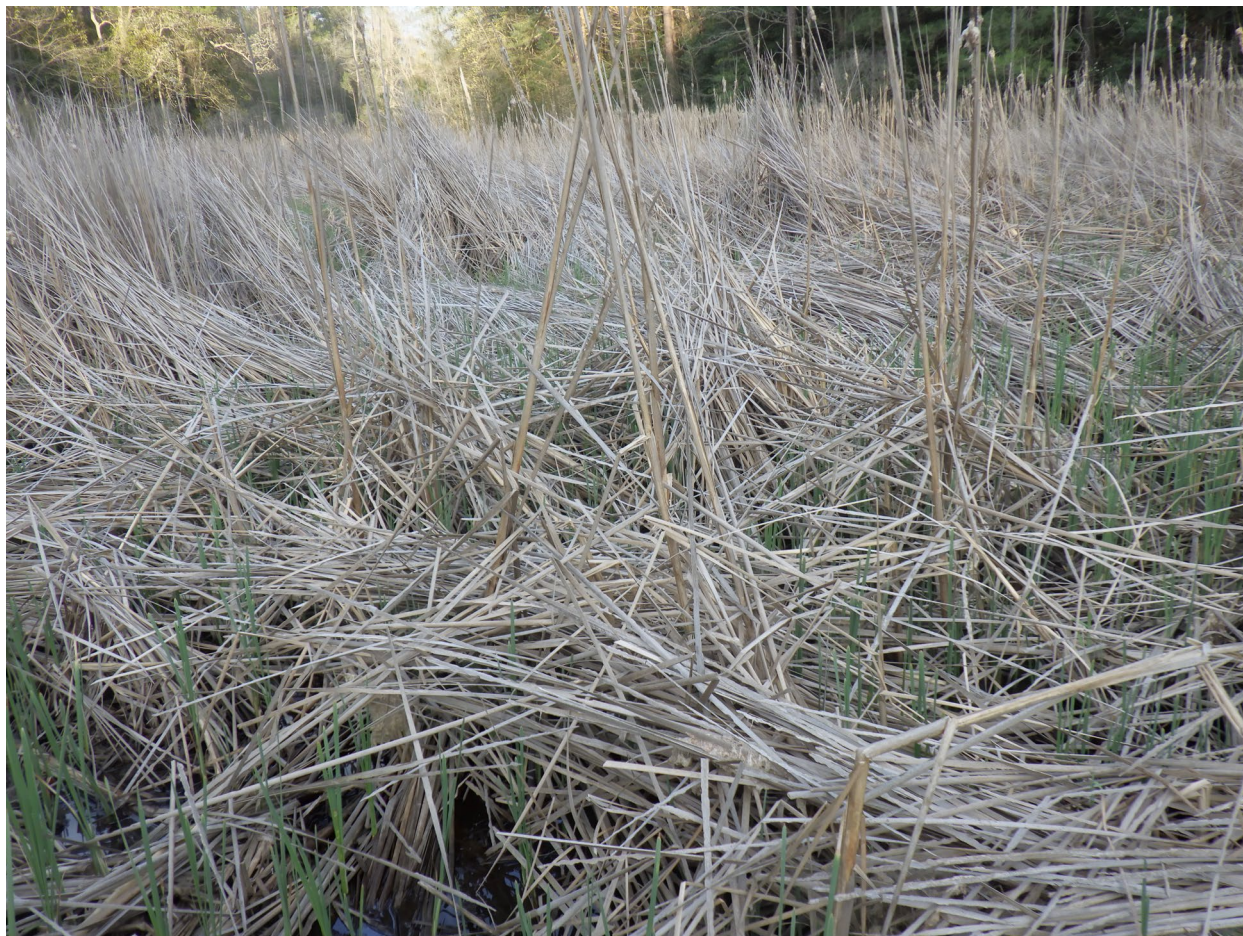
Photo No. 8

**Description:** This photo was taken at the same location as photo No. 7 looking downstream ENE showing vegetation and topography of the wetland.

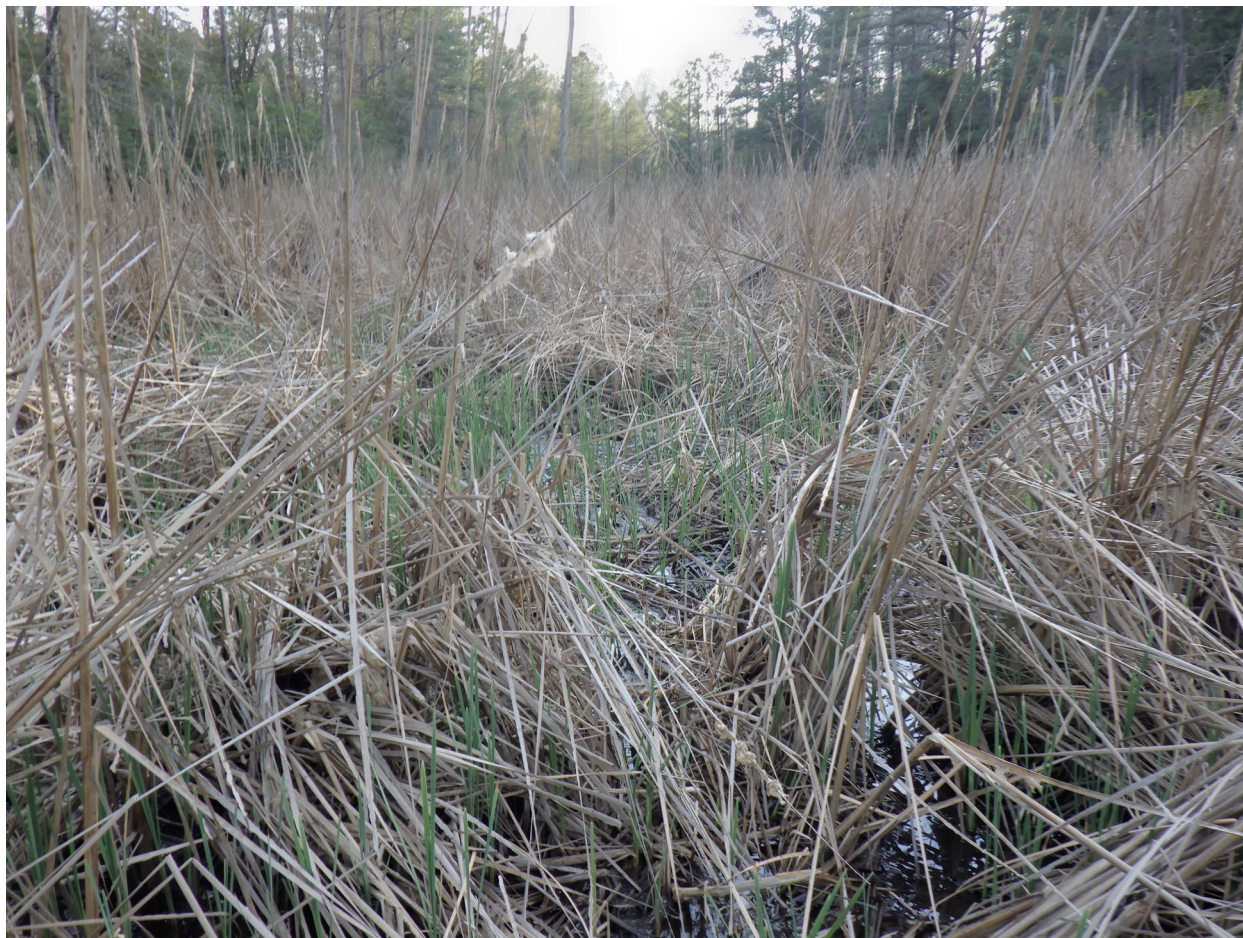
Photo No. 9

**Description:** This photo was taken at the same location as photo No. 7 looking upstream N showing vegetation and topography of the wetland.

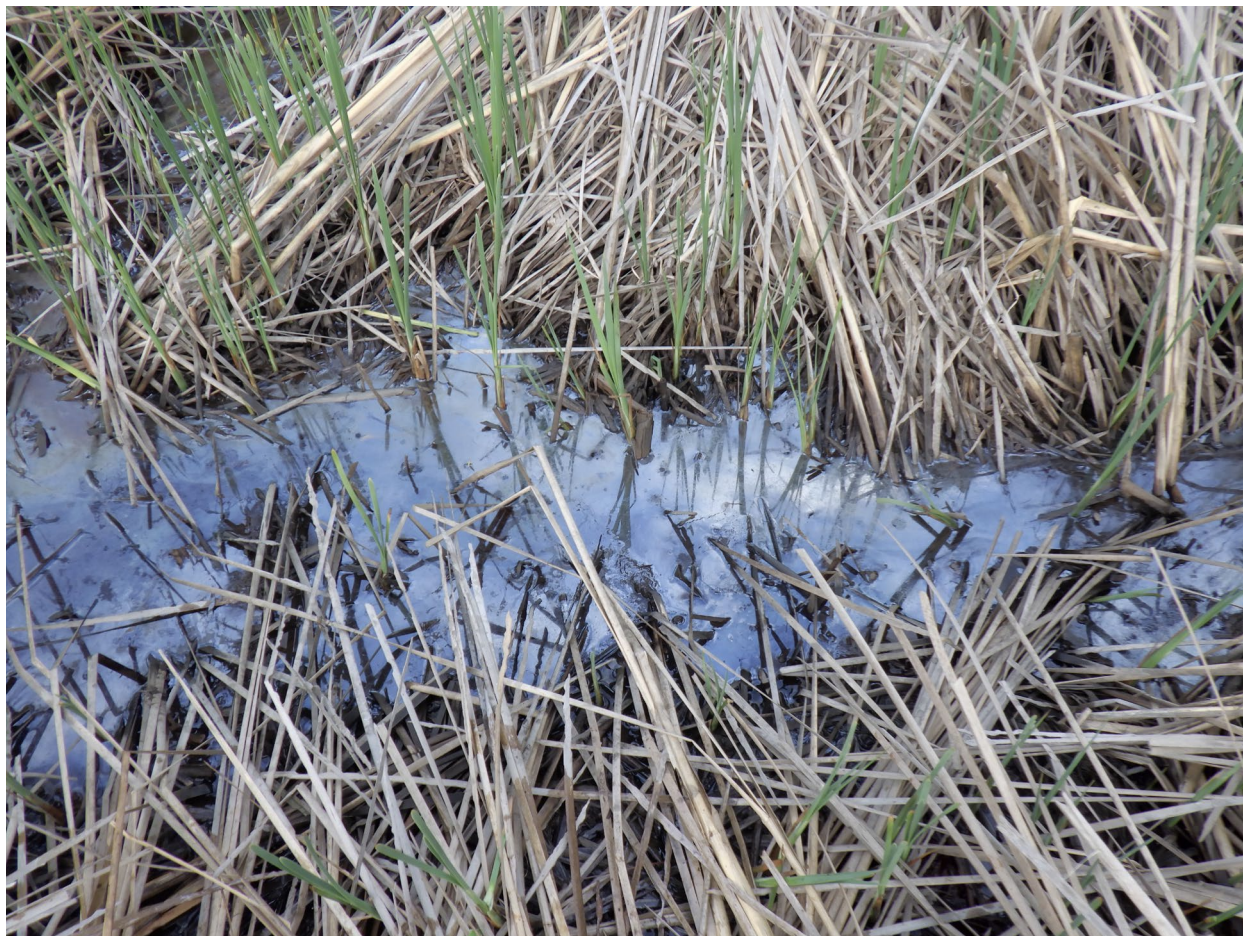
Photo No. 10

Working downstream in the wetland, I observed oil and sheen, see photo No. 10 and photo No. 11.

**Description:** This photo taken looking NE showing sheen in the wetland.

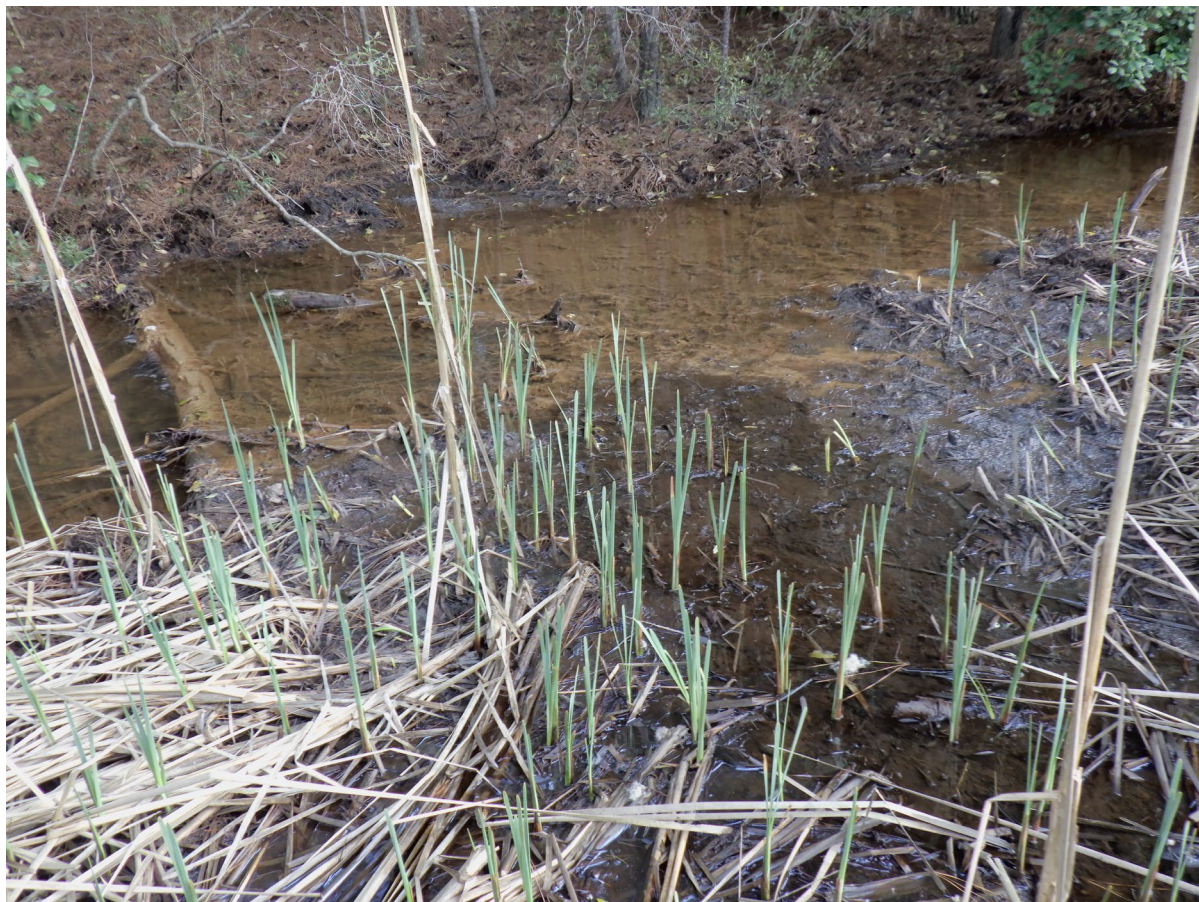
Photo No. 11

**Description:** This photo is looking S showing oil collecting in the wetland.

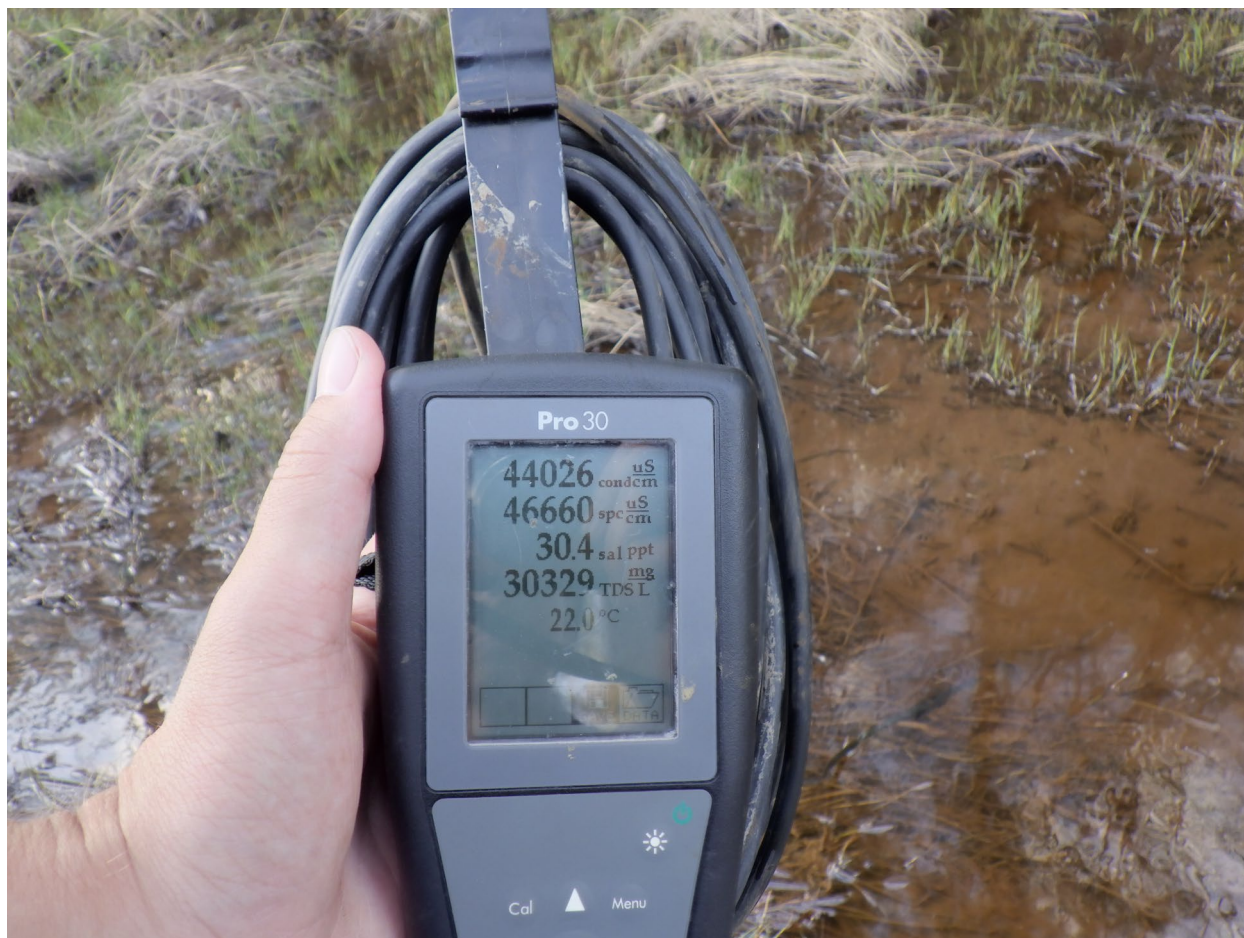
Photo No. 12

I observed a TDS reading of 30,329 mg/L in the main flowpath in the wetland as well as upstream and downstream characteristics, see photo No. 12 and photo No. 14.

**Description:** This photo was taken showing a TDS reading of 30,329 mg/L in the main flowpath in the wetland.

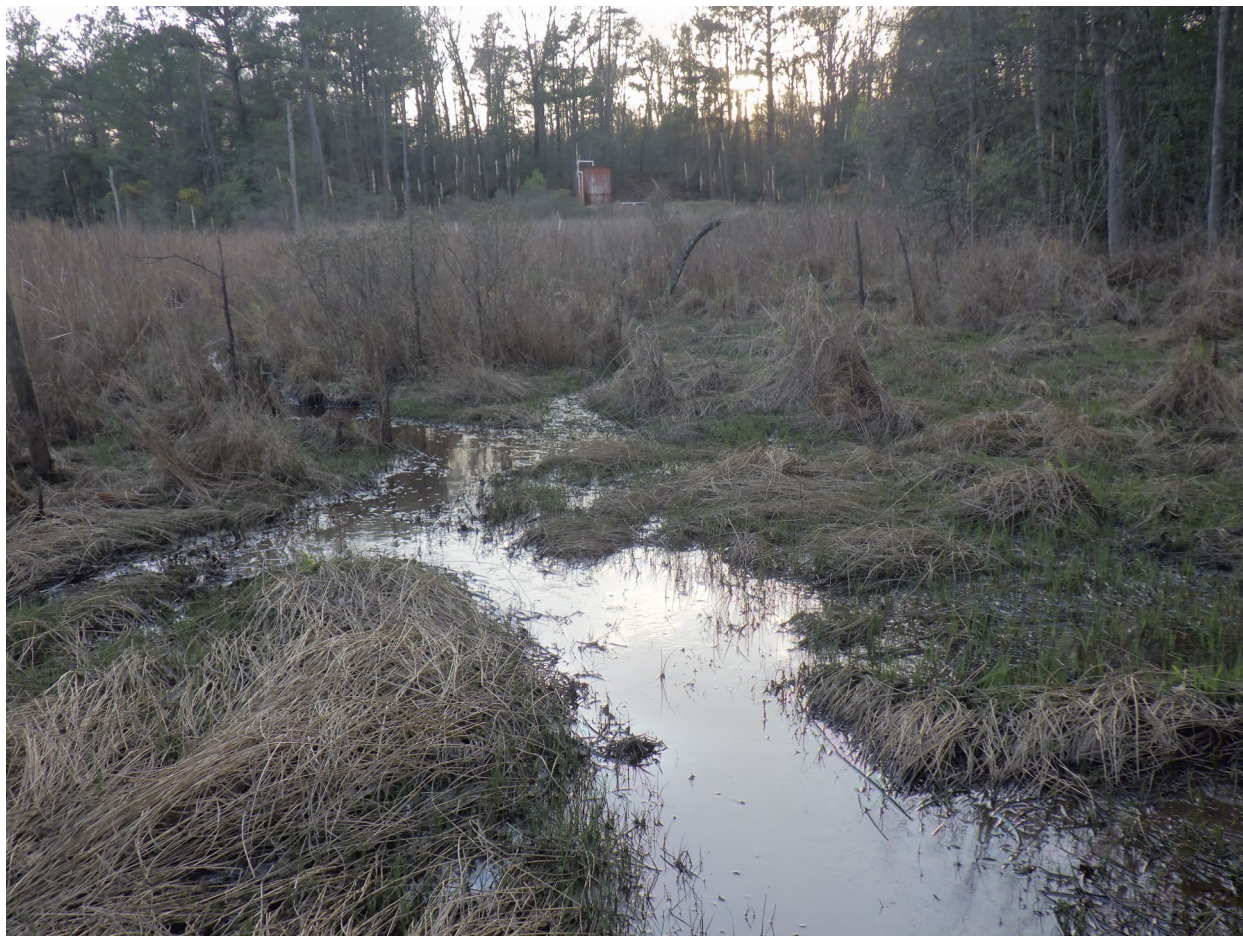
Photo No. 13

**Description:** This photo was taken at the same location as photo No. 12 looking upstream W showing vegetation and topography of the wetland.

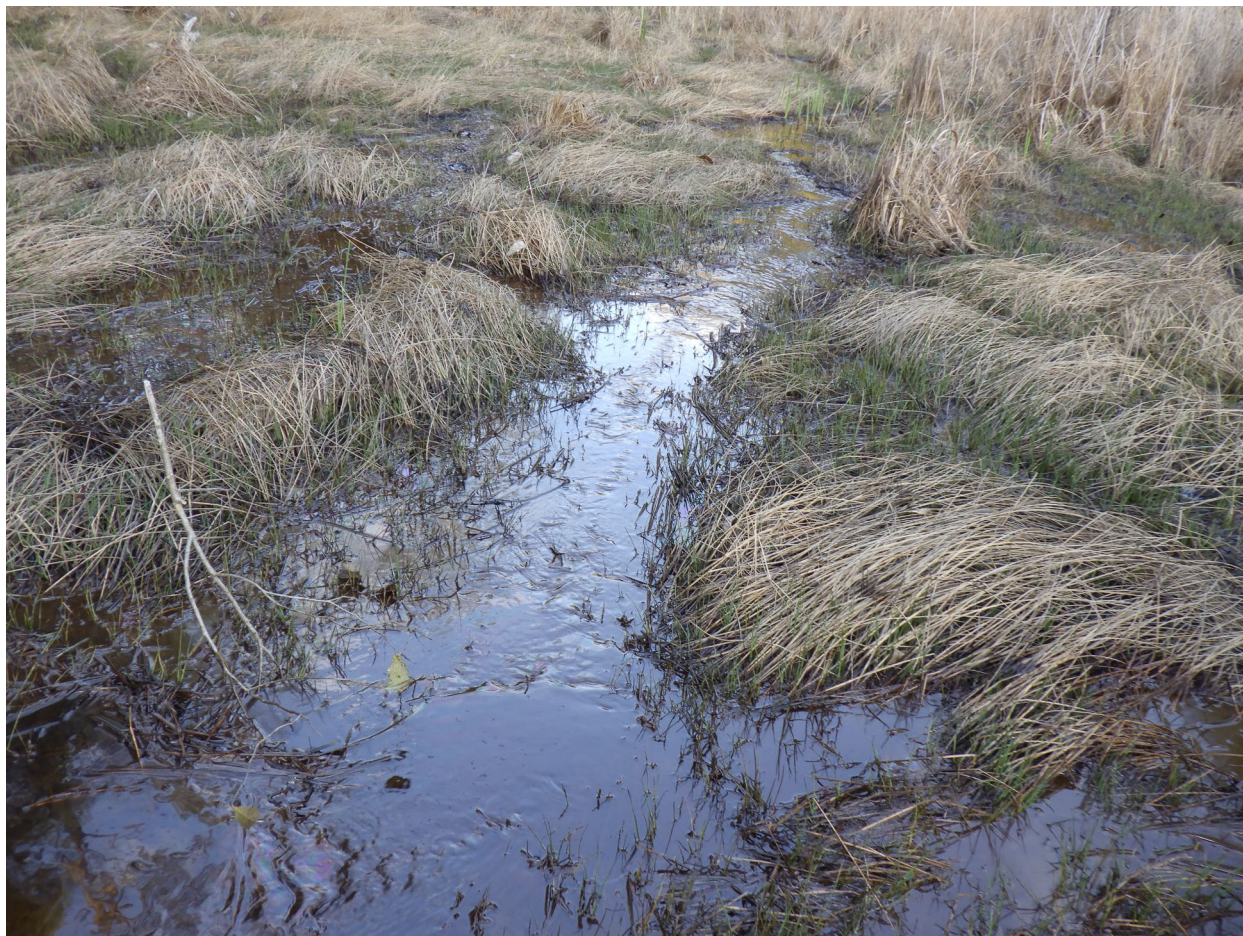
Photo No. 14

**Description:** This photo was taken at the same location as photo No. 12 looking downstream E showing vegetation, topography, and sheen in the wetland.

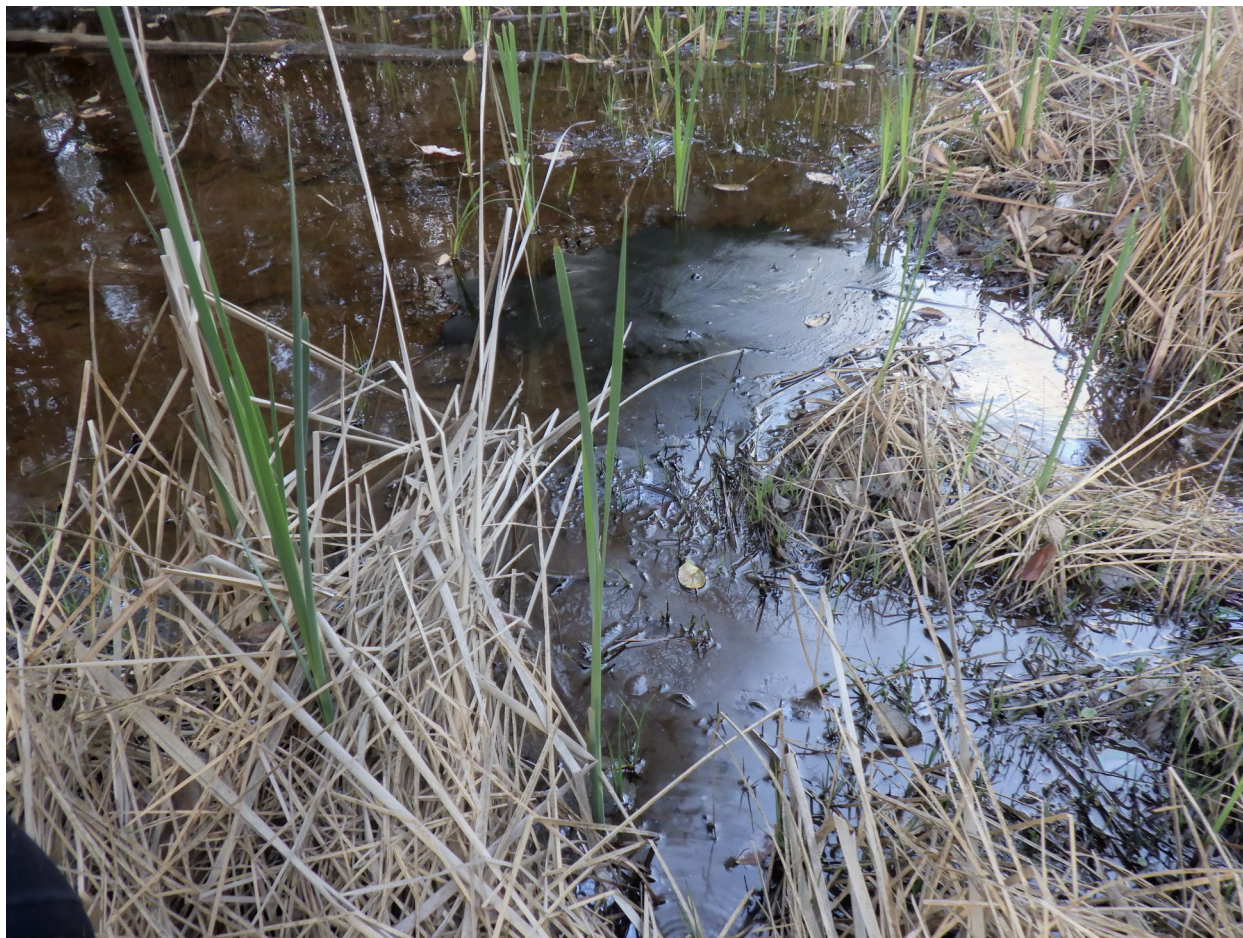
Photo No. 15

Further downstream in the wetland, I observed oil gathering and sheen, see photo No. 15 and photo No. 16.

**Description:** This photo was taken looking NE showing oil in the wetland.

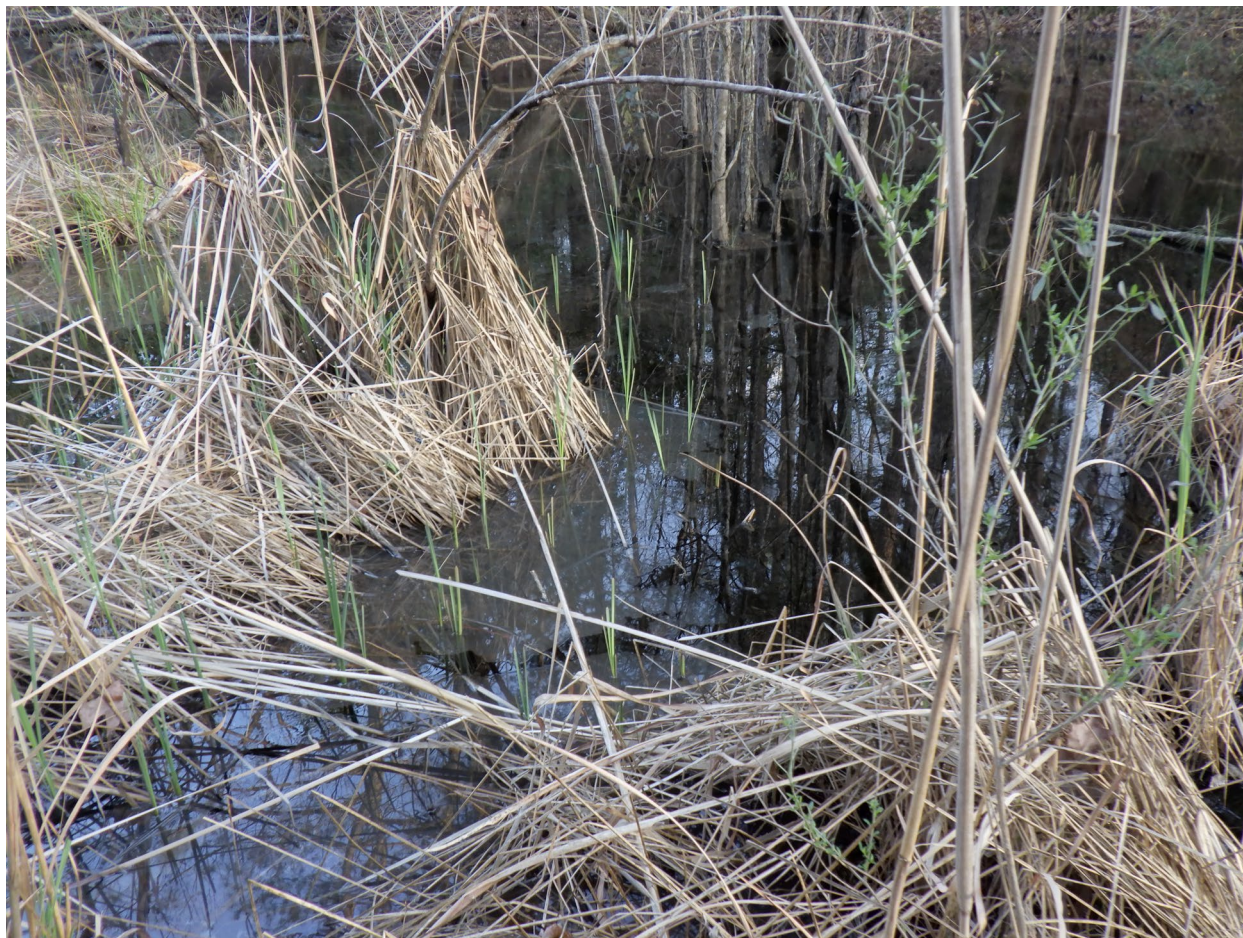
Photo No. 16

**Description:** This photo was taken looking SE showing where oil has collected in the wetland.

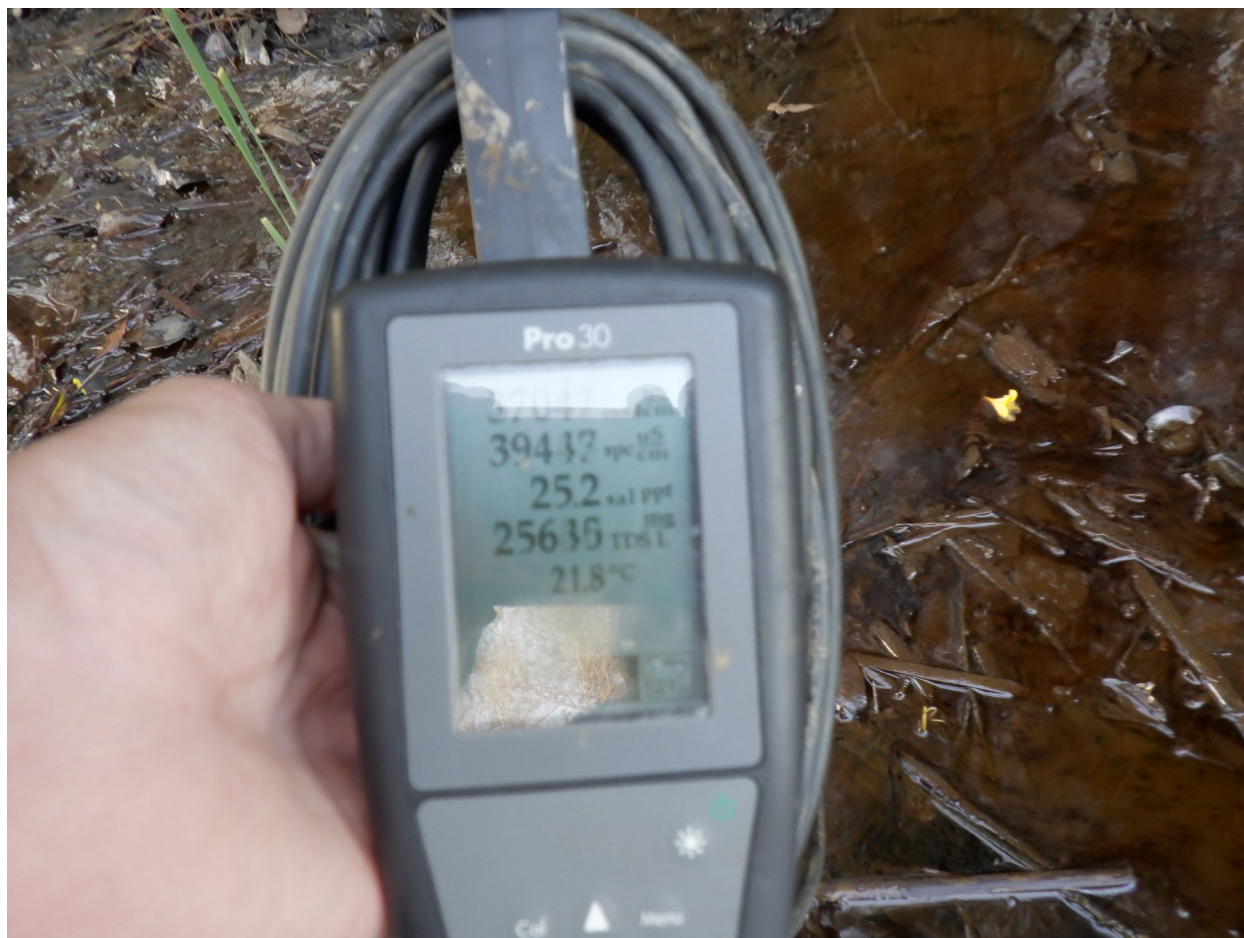
Photo No. 17

I observed a TDS reading of 25,635 mg/L further downstream in the main flowpath in the wetland, see photo No. 17.

**Description:** This photo was taken showing a TDS reading of 25,635 mg/L in the main flowpath in the wetland.

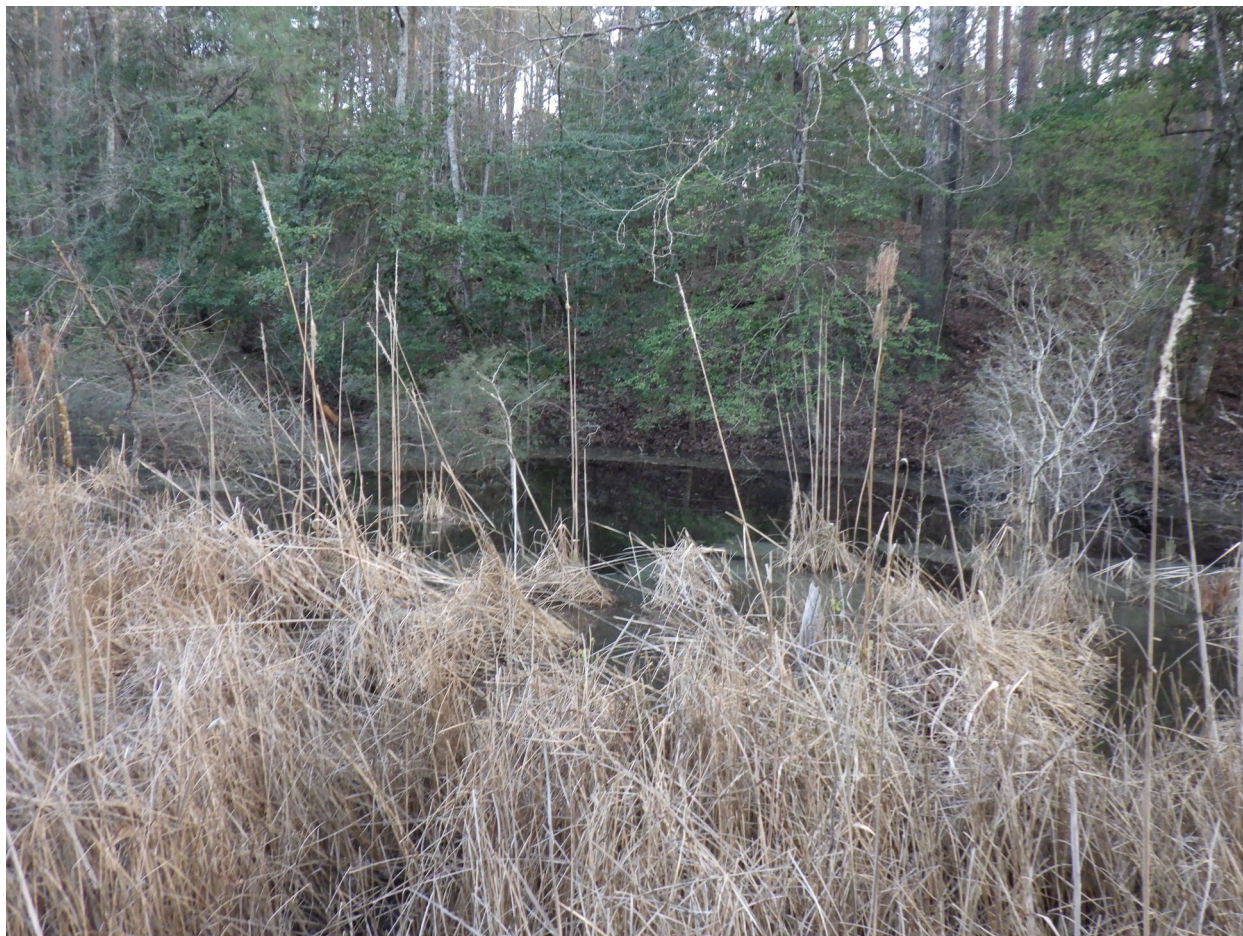
Photo No. 18

I observed oil gathering in the wetland and sheen, see photo No. 18.

**Description:** This photo was taken looking SSE showing oil collecting on water in the wetland.
