**Region 6 - Enforcement & Compliance Assurance Division**  
**INSPECTION REPORT**

| Inspection Date(s): | 3/12/2024 | |
| Company Name: | <b>RCP Production, LLC</b> | |
| Facility Name: | <b>TD Murphy B-3 SWD Tank Battery</b> | |

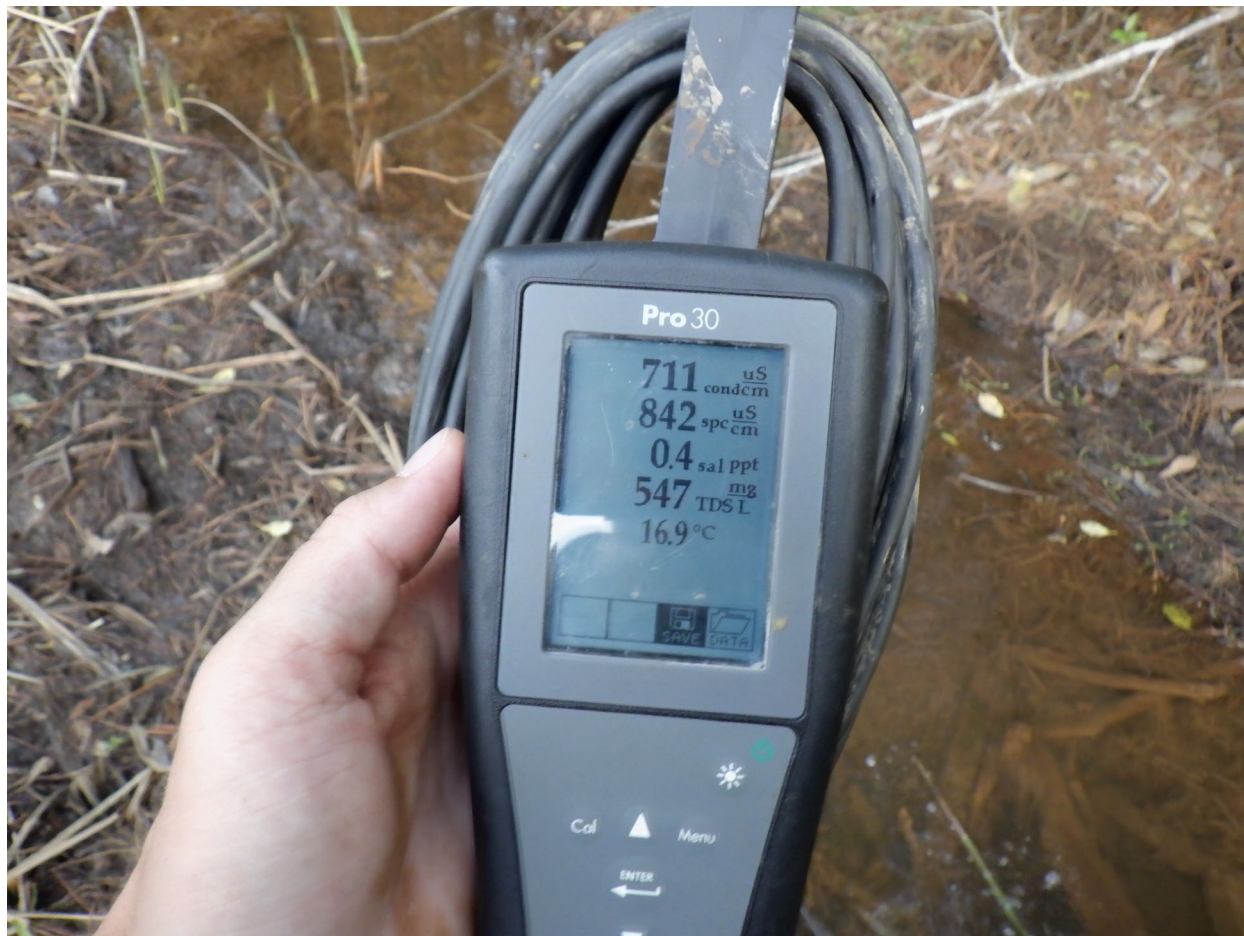
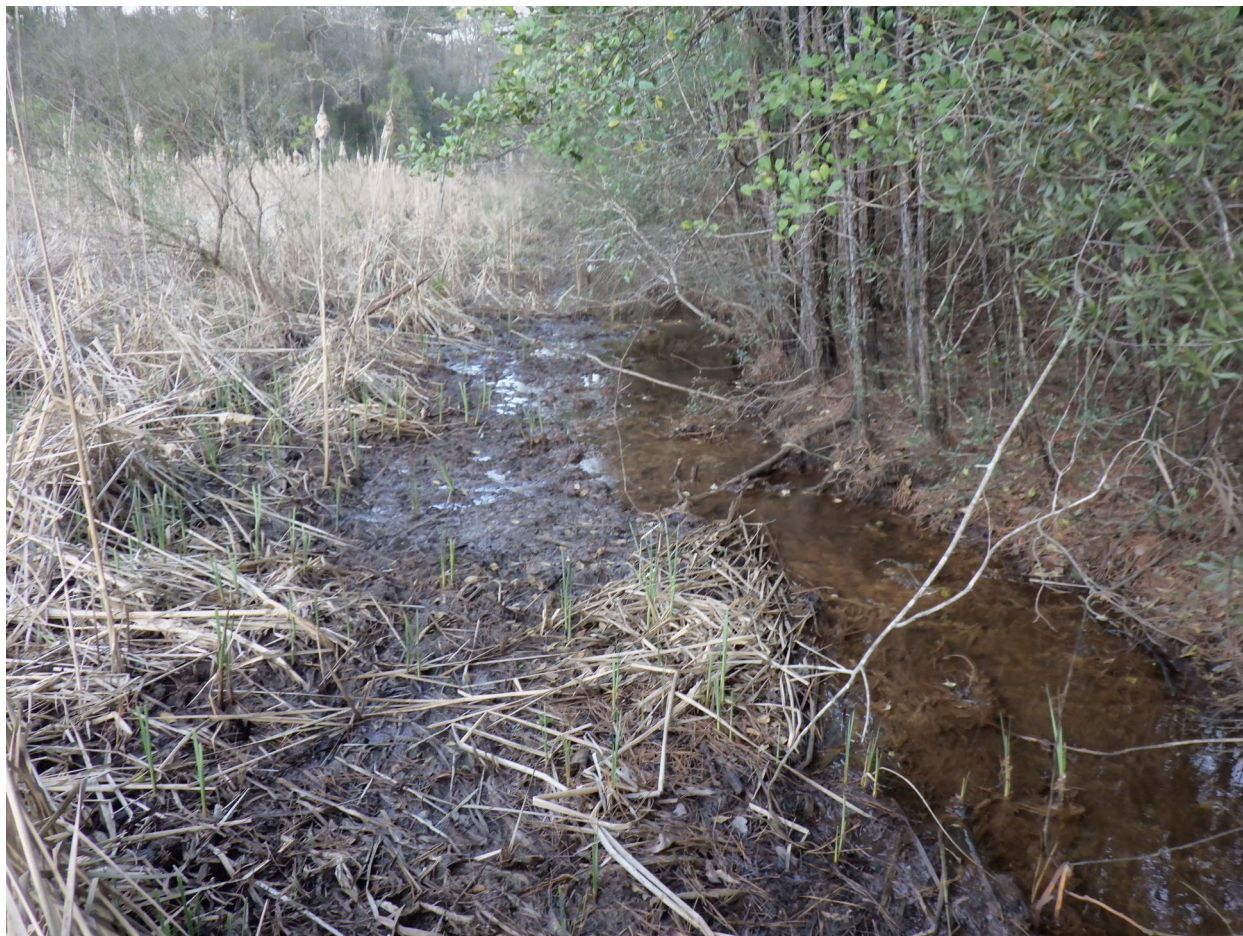
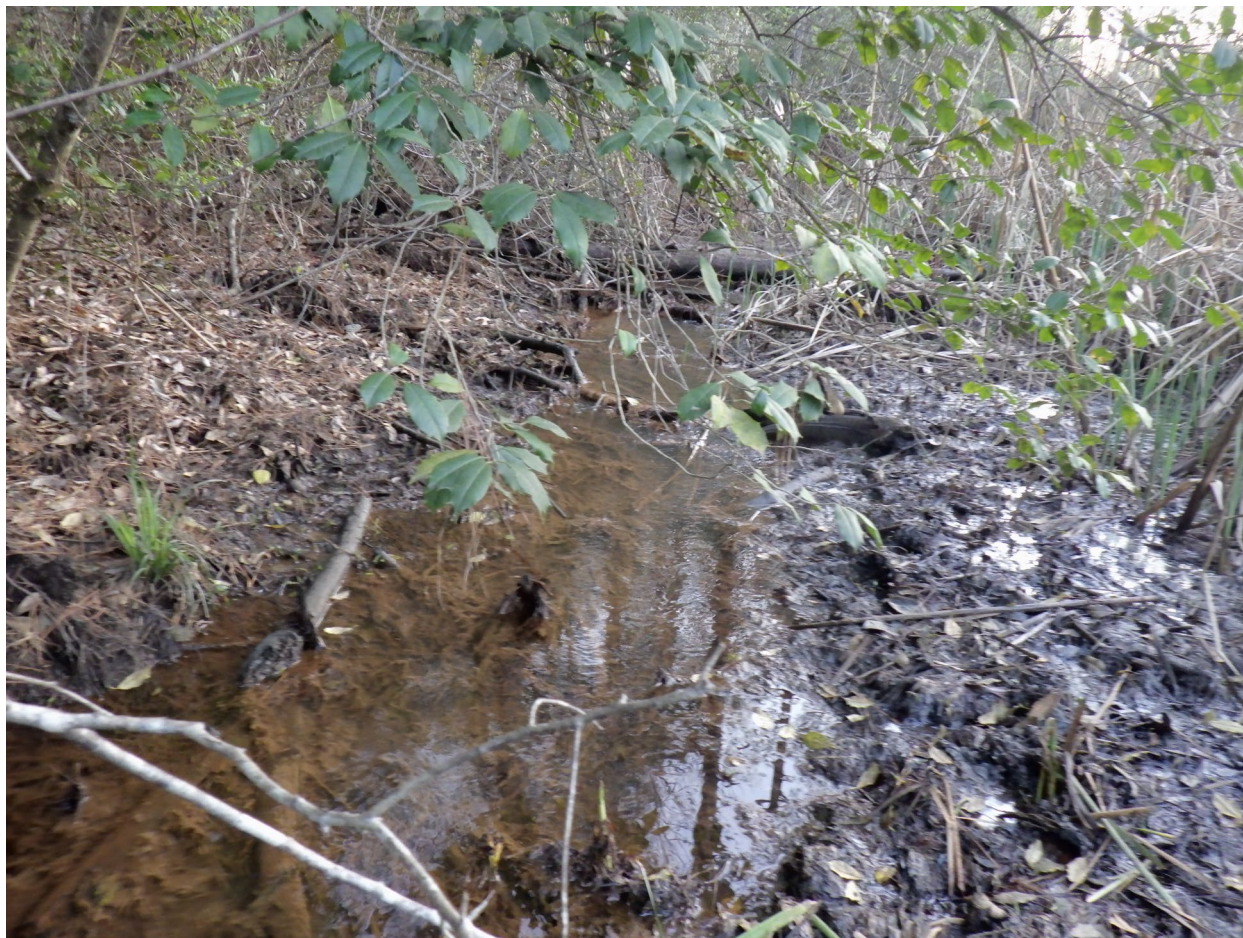
Photo No. 19

I observed the background level TDS reading of 547 mg/L upstream from the impacted water in the wetland as well as wetland characteristics, see photo No. 19 through photo No. 21.

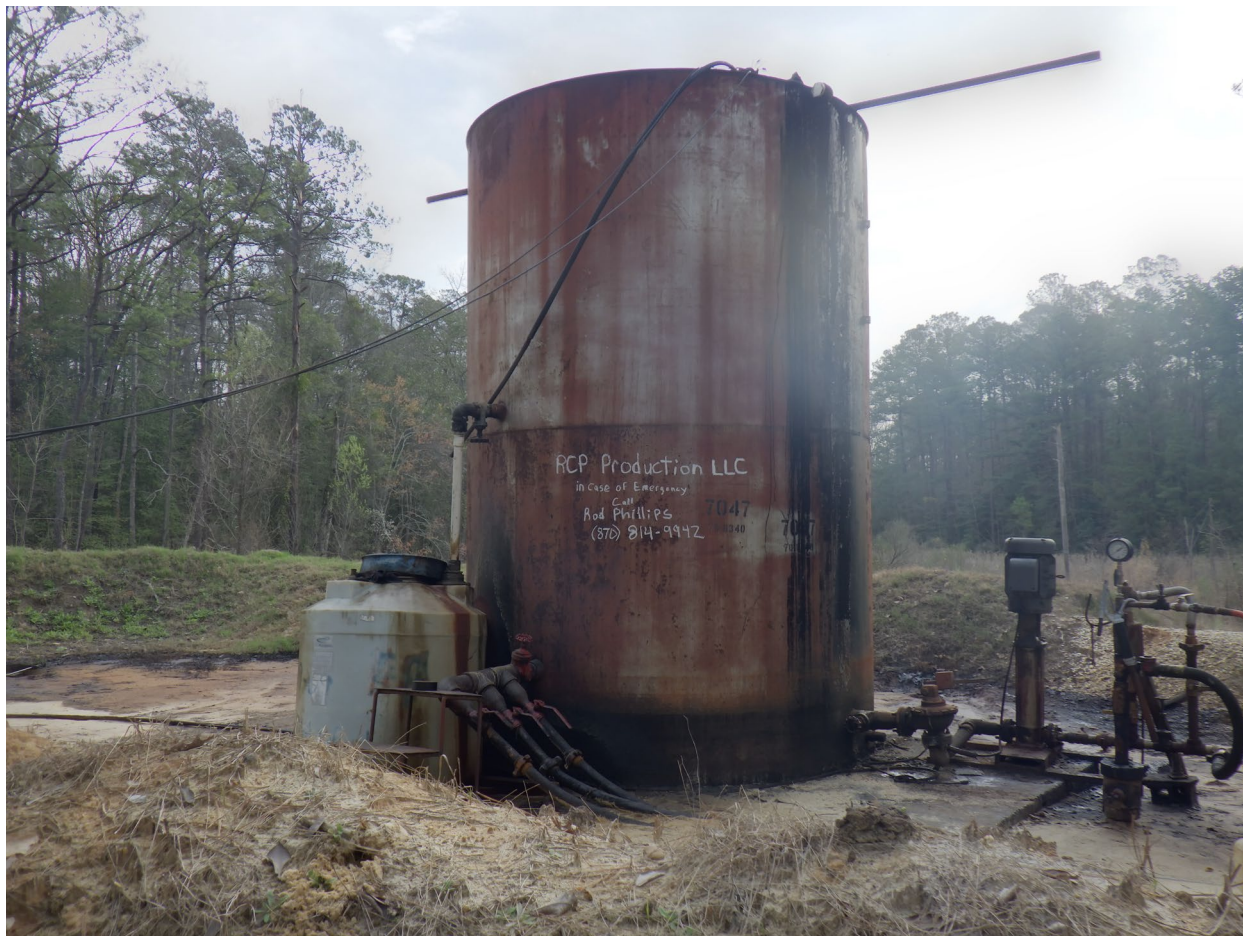
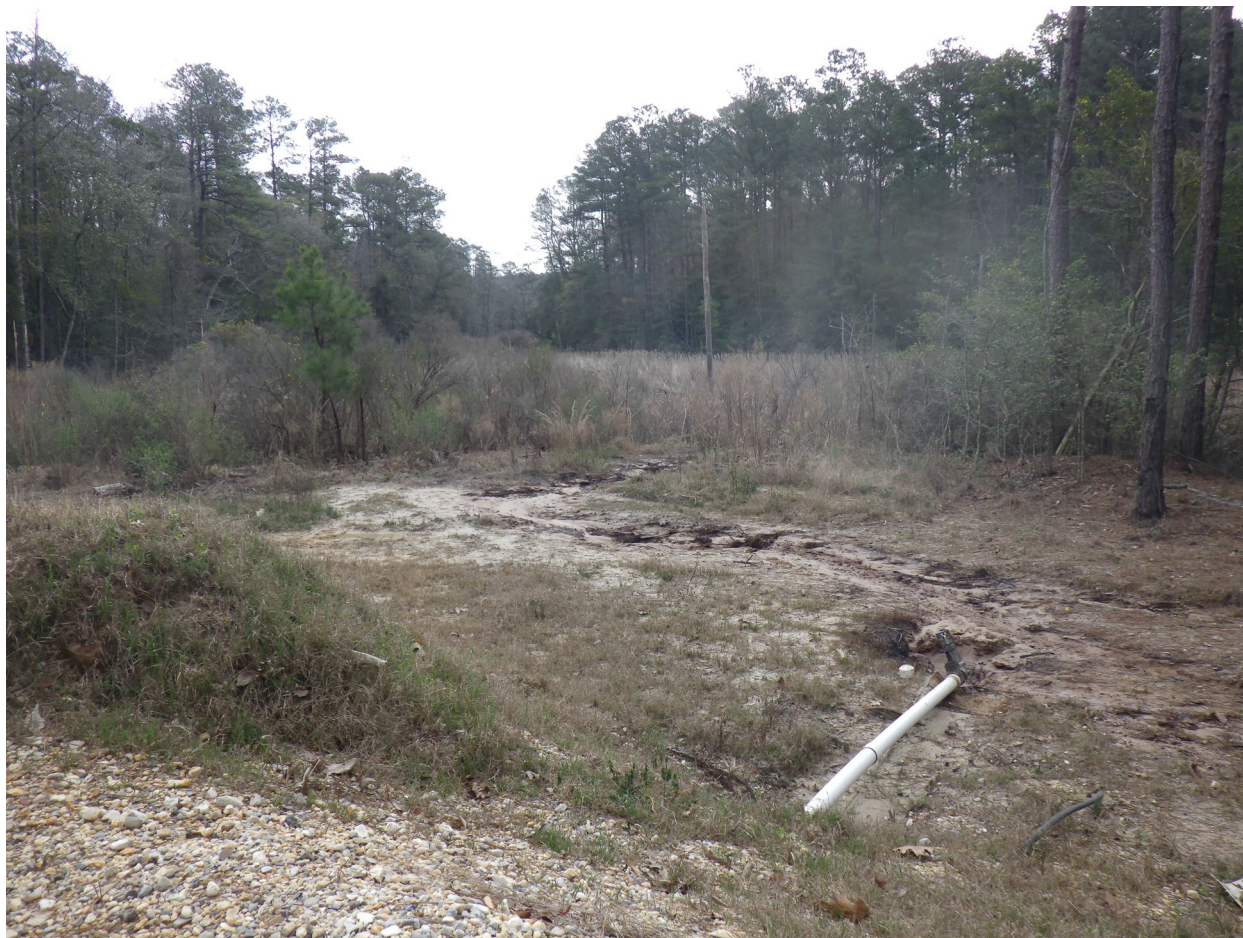
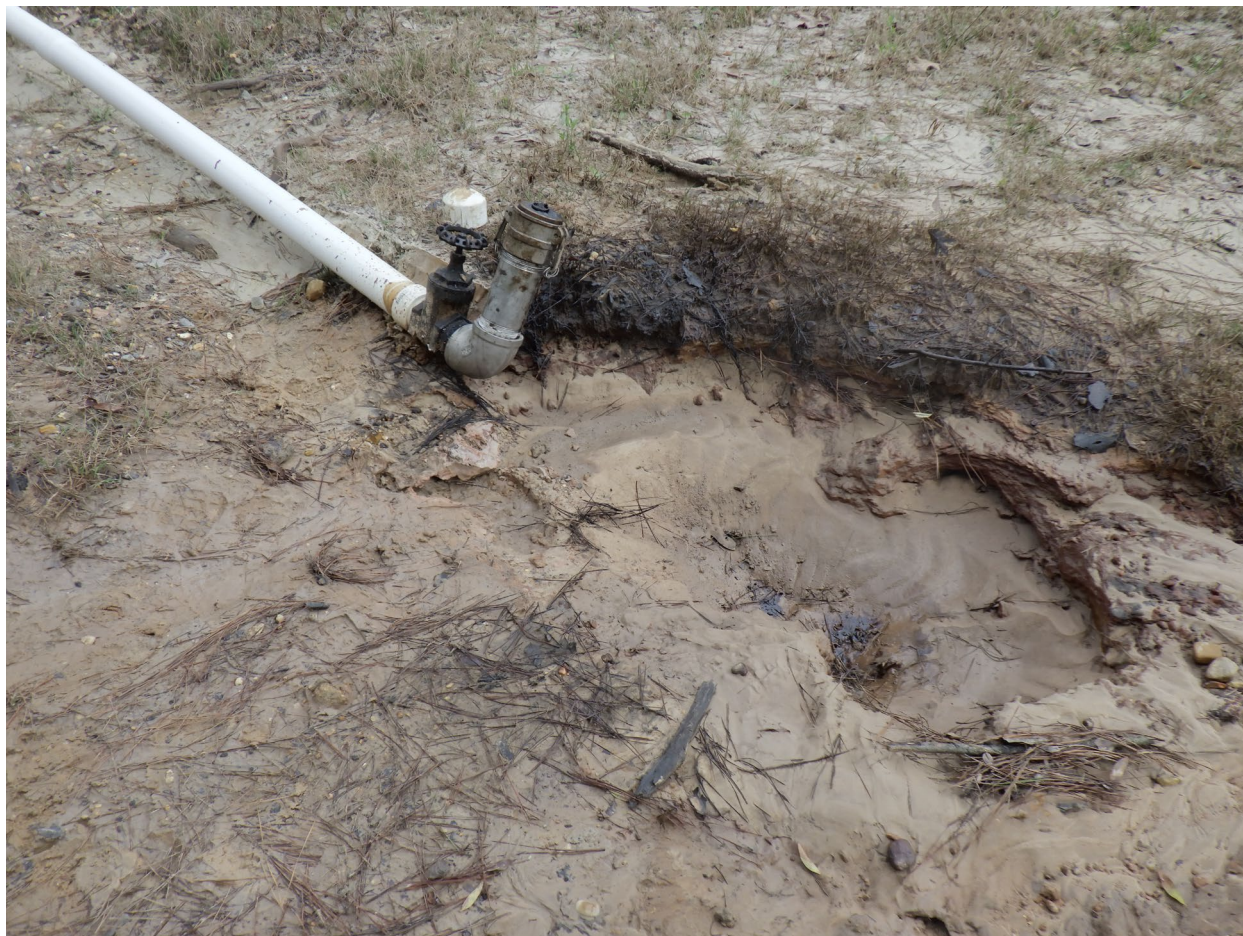
The day after the release on 3/13/2024, I observed the facility with the updated sign and closed secondary containment valve, see photo No. 22 through photo No. 24.

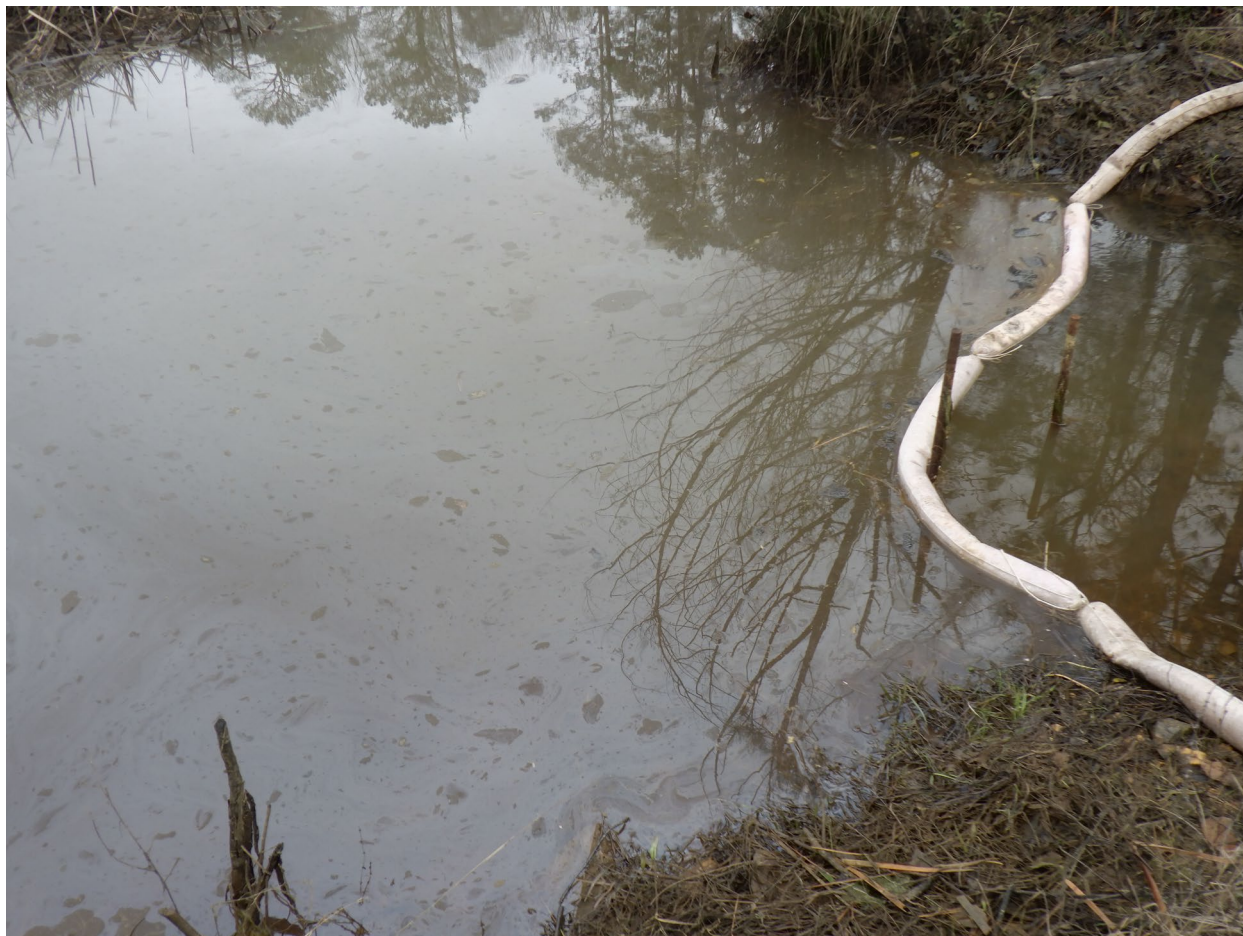
On 3/14/2024, I observed a boom and sheen at the oil lease road crossing, see photo No. 50.

On 3/13/2024, Rod Phillips placed a boom at the oil lease road crossing.

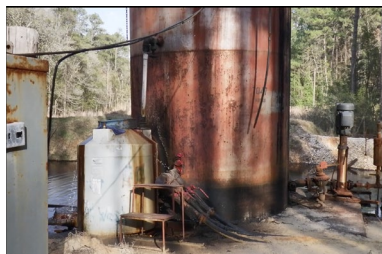
Description: This video was taken looking E showing produced water and oil flowing out of the tank into secondary containment. The secondary containment valve was left open releasing the spill outside of secondary containment.
