**UNITED STATES ENVIRONMENTAL PROTECTION AGENCY  
REGION 8  
RESOURCE CONSERVATION AND RECOVERY ACT**

**Facility Name:** US Magnesium, LLC

**Date of Inspection:** April 27, 2023

**Type and Purpose of Inspection:** Compliance Schedule Evaluation (CSE)

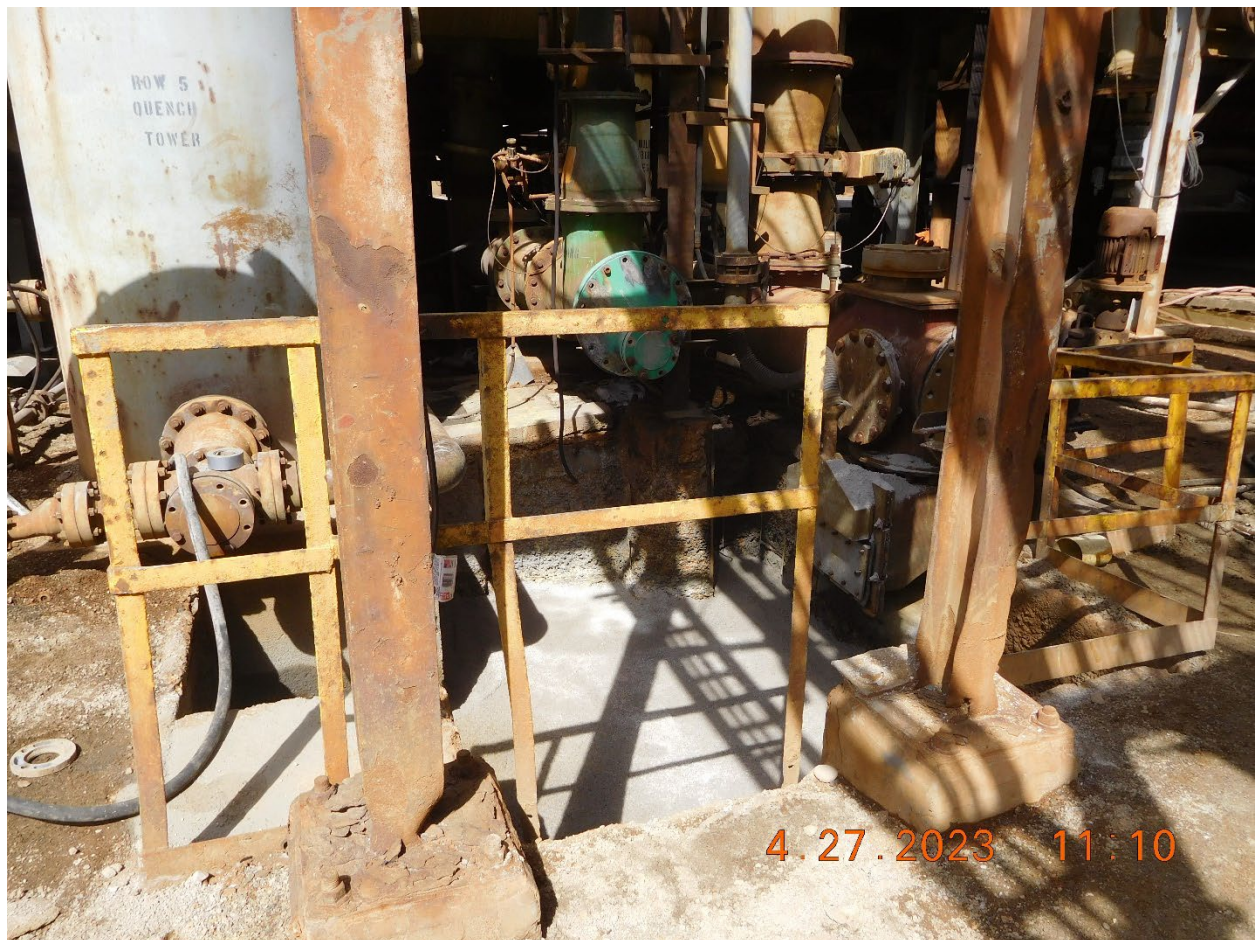
**Photo Number:** 1, DSCN1855.jpg

**Photo Description:** Photo of the grizzly box located adjacent to Cell Building 3 on the west side of the courtyard between Cell Buildings 2 and 3.

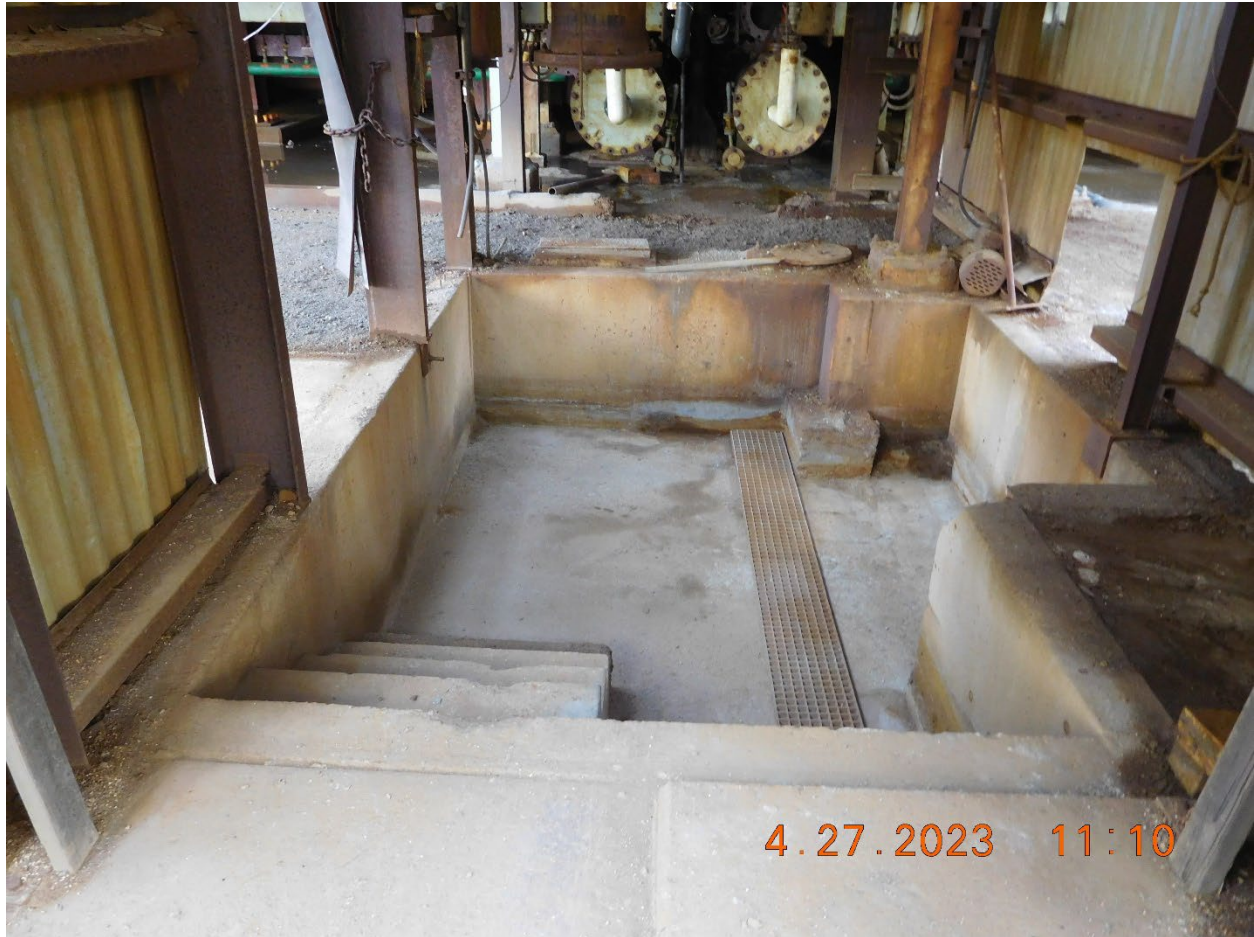
**Photo Number:** 2, DSCN1856.jpg

**Photo Description:** Photo of the grizzly box located adjacent to Cell Building 2 on the east side of the courtyard between Cell Buildings 2 and 3.

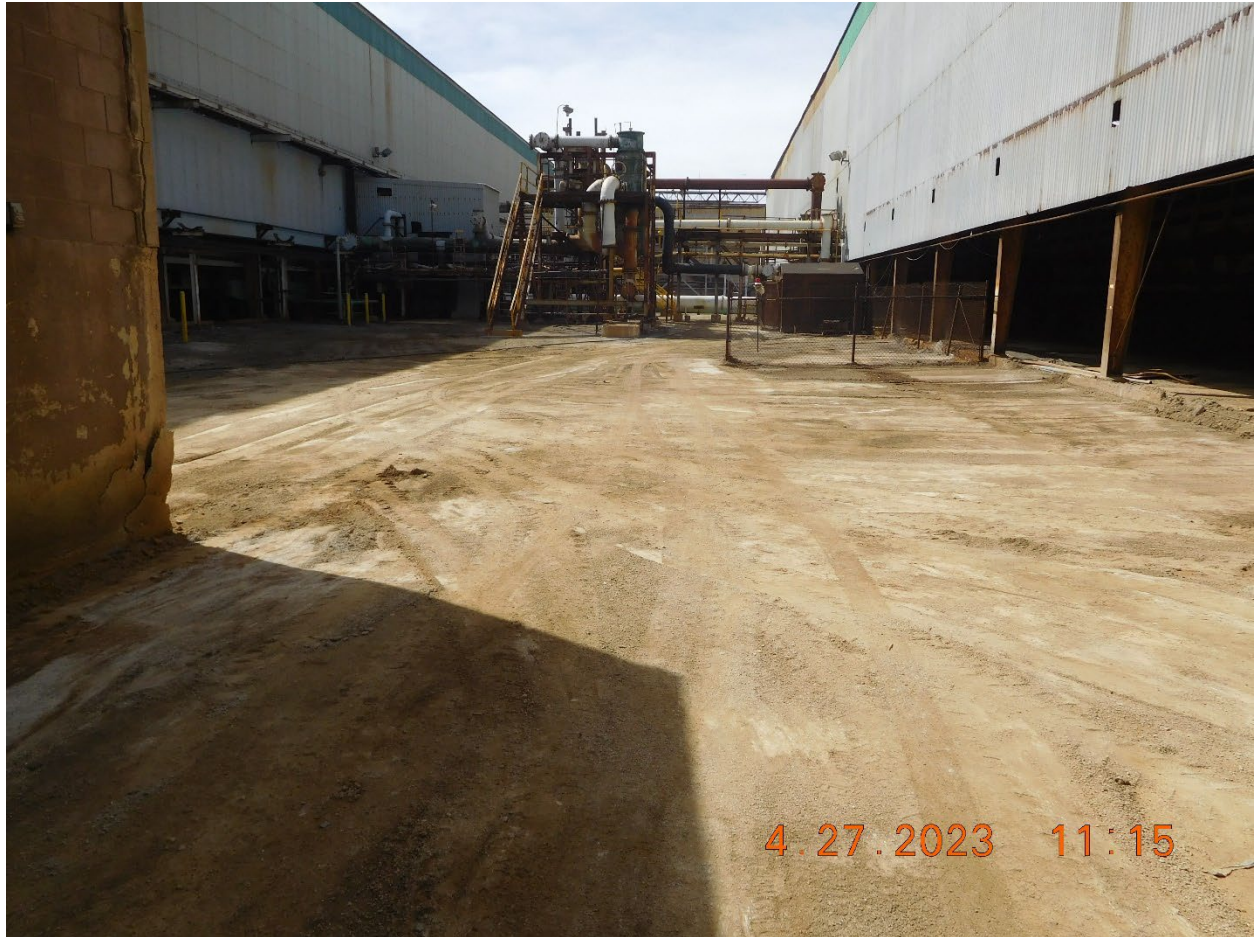
**Photo Number:** 3, DSCN1857.jpg

Regarding the courtyard located between Electrolytic Cell Buildings 2 and 3, the grizzly boxes will be filled in as part of the Courtyard Capping Project under the Consent Decree. Mr. Mensinger stated that there has been some difficulty getting a contractor to perform the work, and site conditions were still wet and spongy in a portion of the area due to the long period of frequent precipitation during the weeks leading up to the inspection. Most of the surface of the courtyard had been scraped to prepare it for the upcoming work.

**Photo Description:** Photo of the courtyard located between Cell Buildings 2 and 3, facing south toward the grizzly boxes and Ducon scrubber. Photo shows that initial area prep work for the courtyard capping project has begun, including scraping of top material.

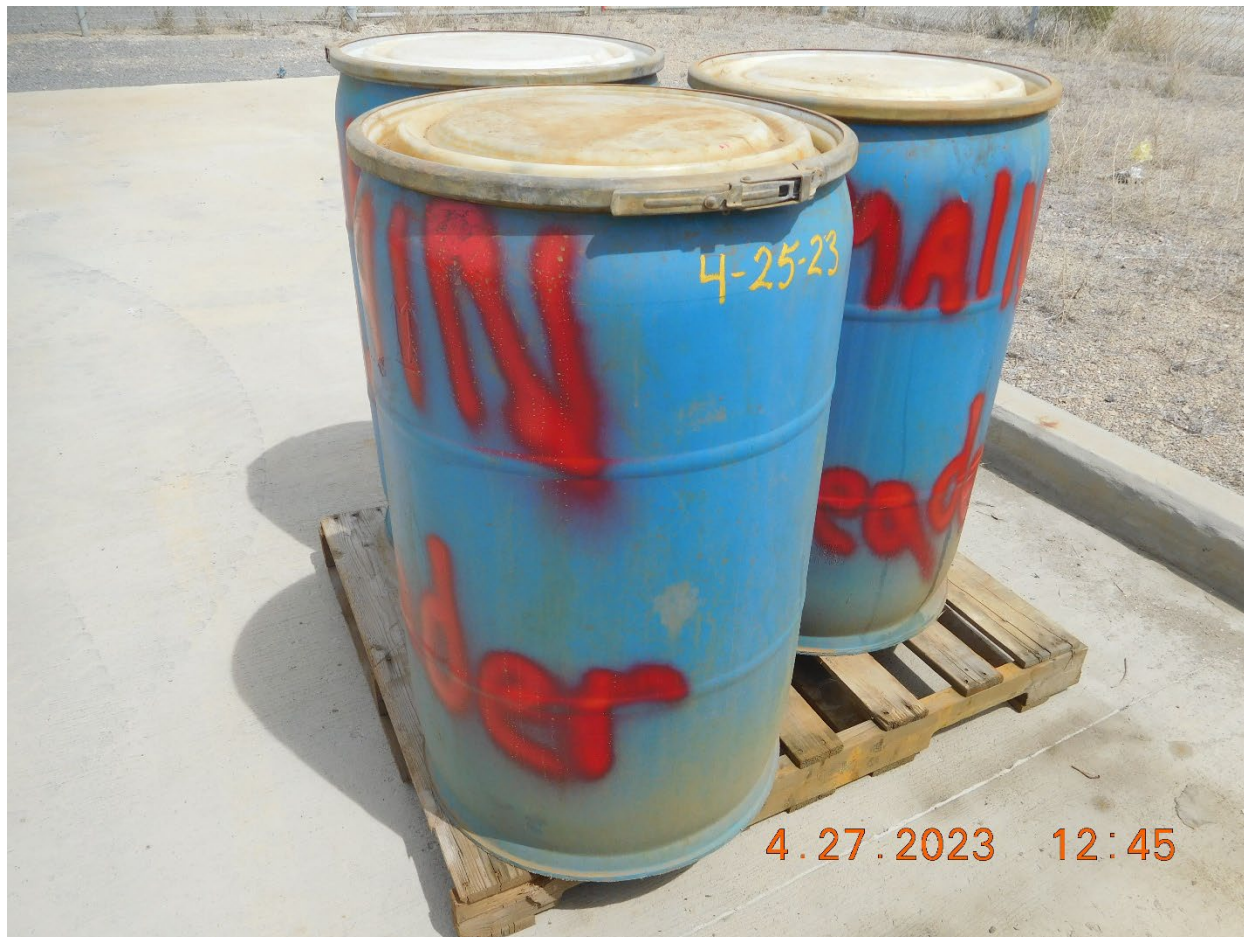
**Photo Number:** 5, DSCN1859.jpg

**Photo Description:** Photo of three blue poly drums labeled “Rec. Main Offgas Header” and dated 4-25-23.

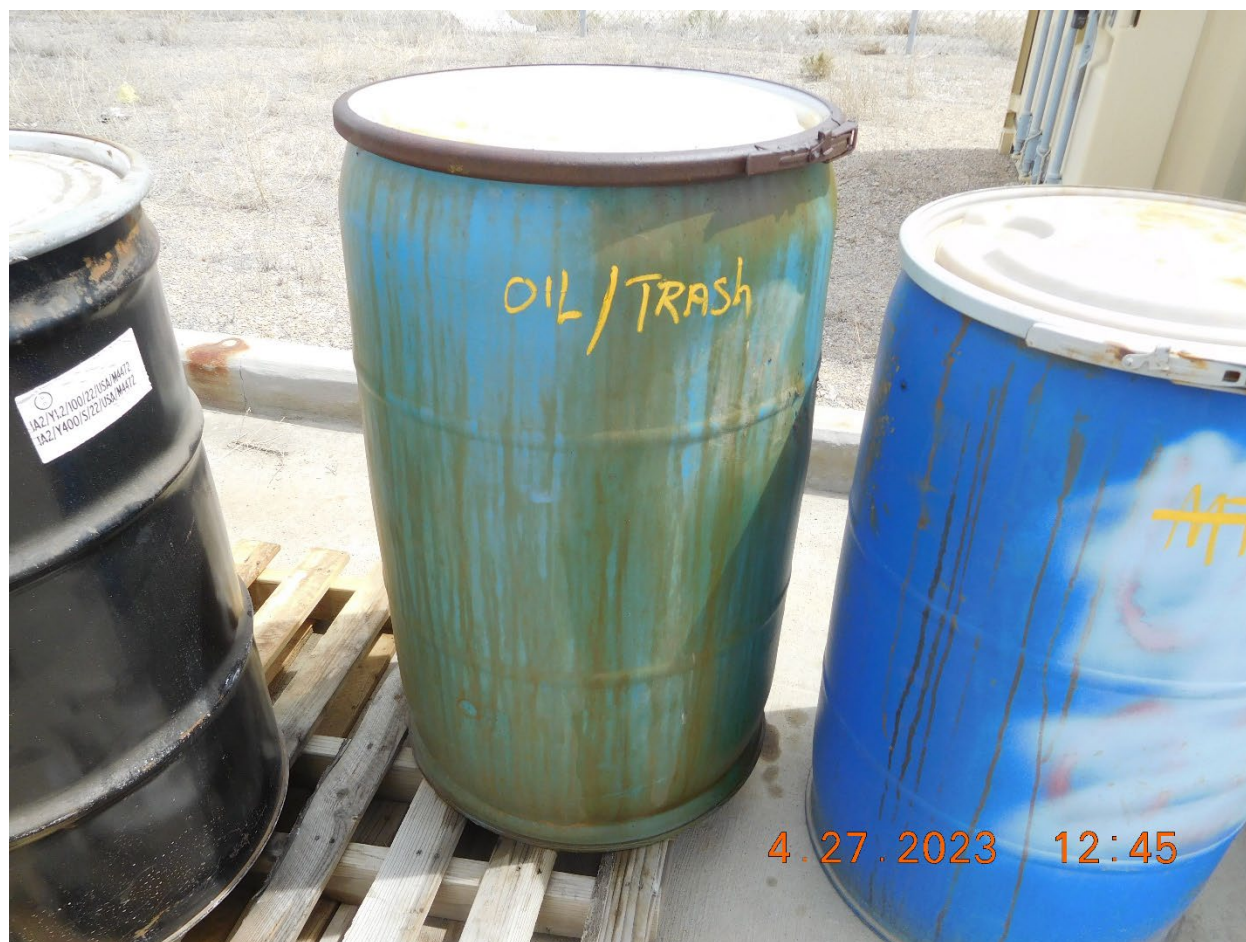
**Photo Number:** 8, DSCN1862.jpg

**Photo Description:** Photo of a drum containing parts, sludge and oil, analysis pending.

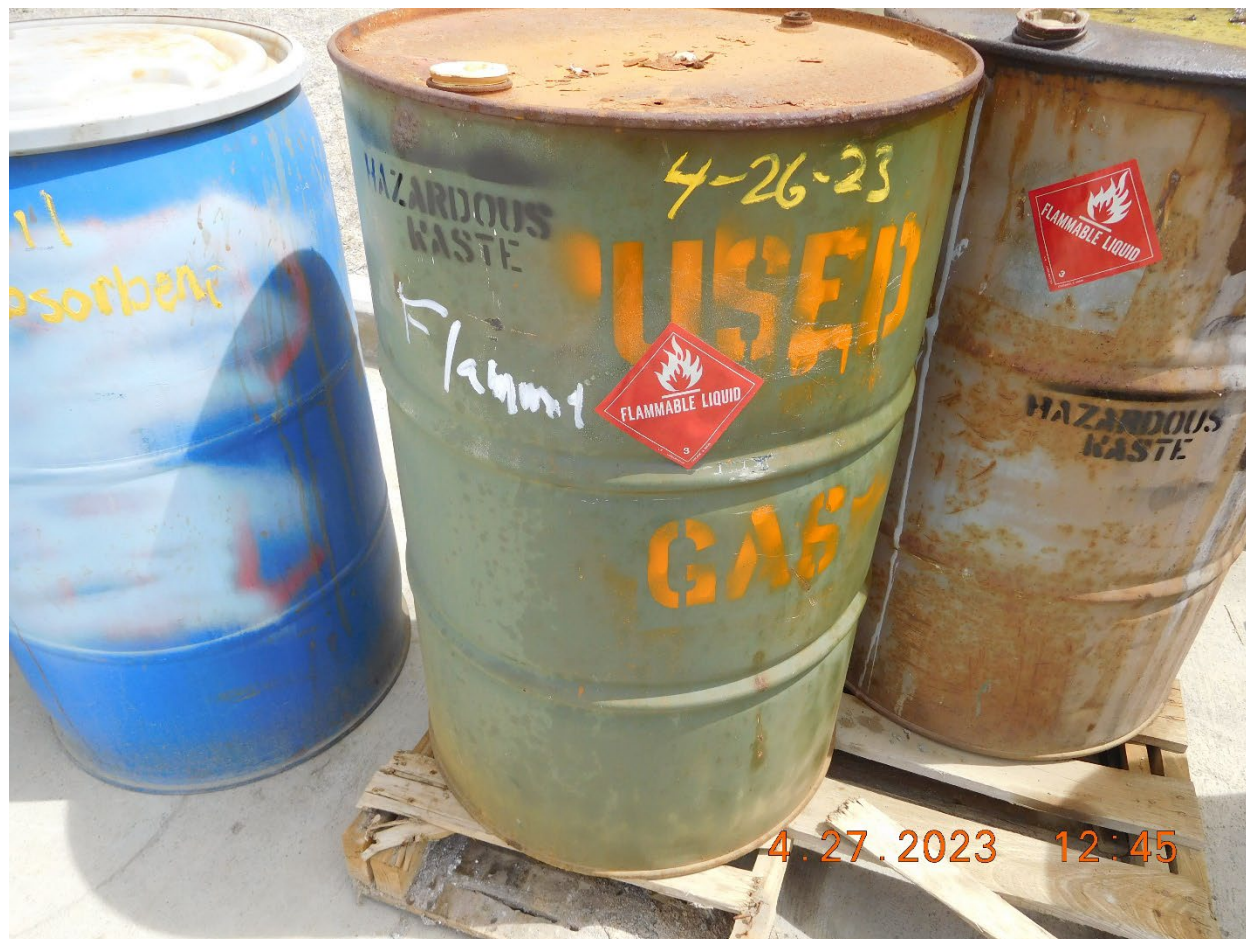
**Photo Number:** 10, DSCN1864.jpg

- 1 blue poly 55-gallon drum marked “Oil Absorbent” (photo 9)
- 1 green metal 55-gallon drum marked “Used Gas” and “Hazardous Waste” and placarded “Flammable Liquid” and dated 4-26-23 (photo 10); this drum had small holes in the top, which was rusty and degraded

**Photo Description:** Photo of a drum containing flammable hazardous waste gasoline. The top of the drum was degraded, including small holes.

During the closing conference, I stated a concern regarding the 55-gallon drum in the Waste Yard that had a degraded top, and Mr. Francom stated that he would repack the contents.

- Three drums marked “Water Treatment”
- An update on the status of the drum of waste gasoline that had holes in the rusty top of the drum.
- Copies of analytical results for drag-chain system-generated anode dust from Electrolytic Cell Building 4 that have been collected within the last three years, and a description of the sampling methodology used to collect representative samples.

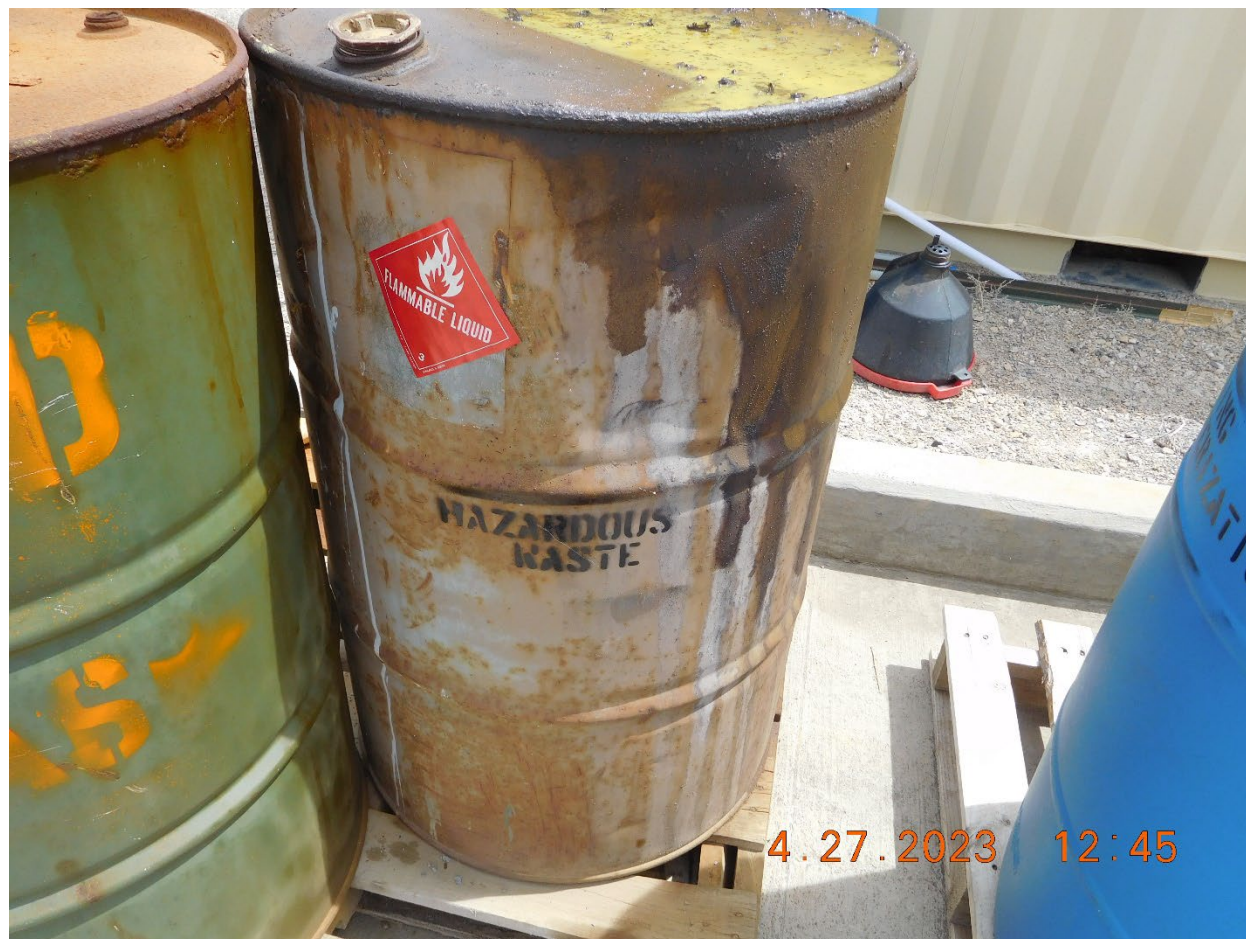
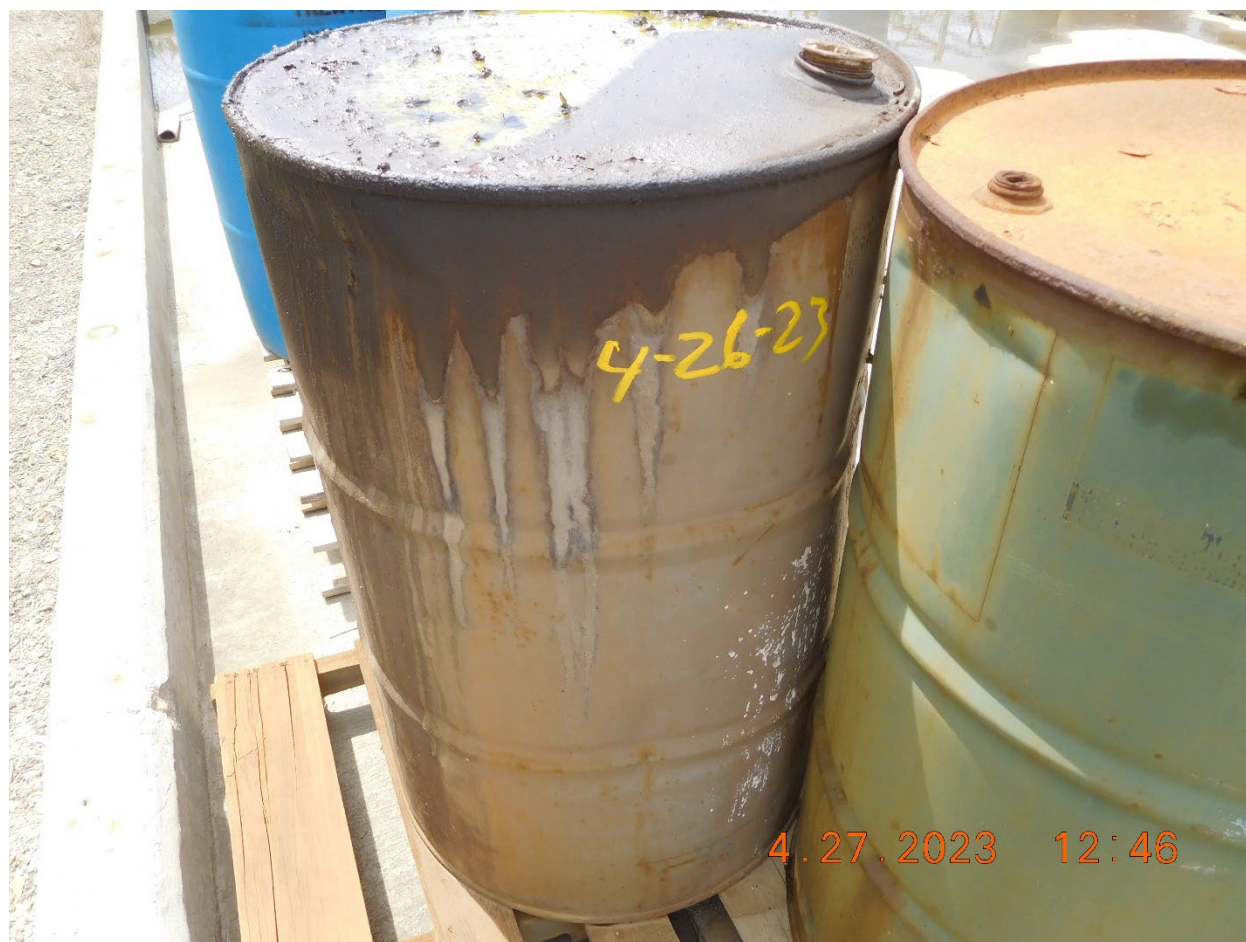
**Photo Number:** 11, DSCN1865.jpg

- 1 gray metal 55-gallon drum marked “Hazardous Waste” and placarded “Flammable Liquid” and dated 4-26-23 (photos 11 and 12)
- 3 blue poly 55-gallon drums marked “Water Treatment” and “Pending Characterization” (photo 13)

**Photo Description:** Photo of a drum containing suspected hazardous waste solvent, analysis pending.

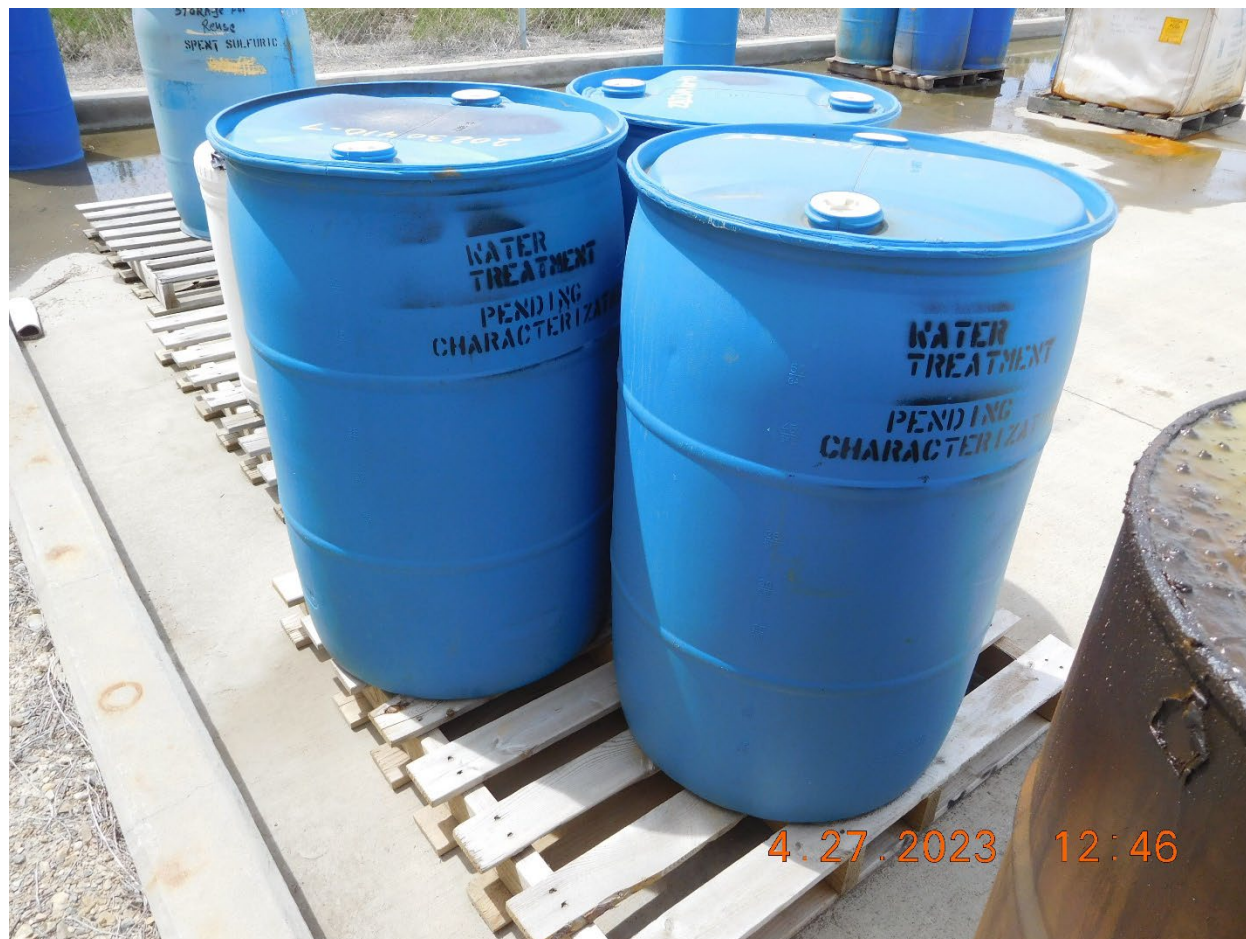
**Photo Description:** Photo of three drums marked “Water Treatment” and “Pending Characterization”.

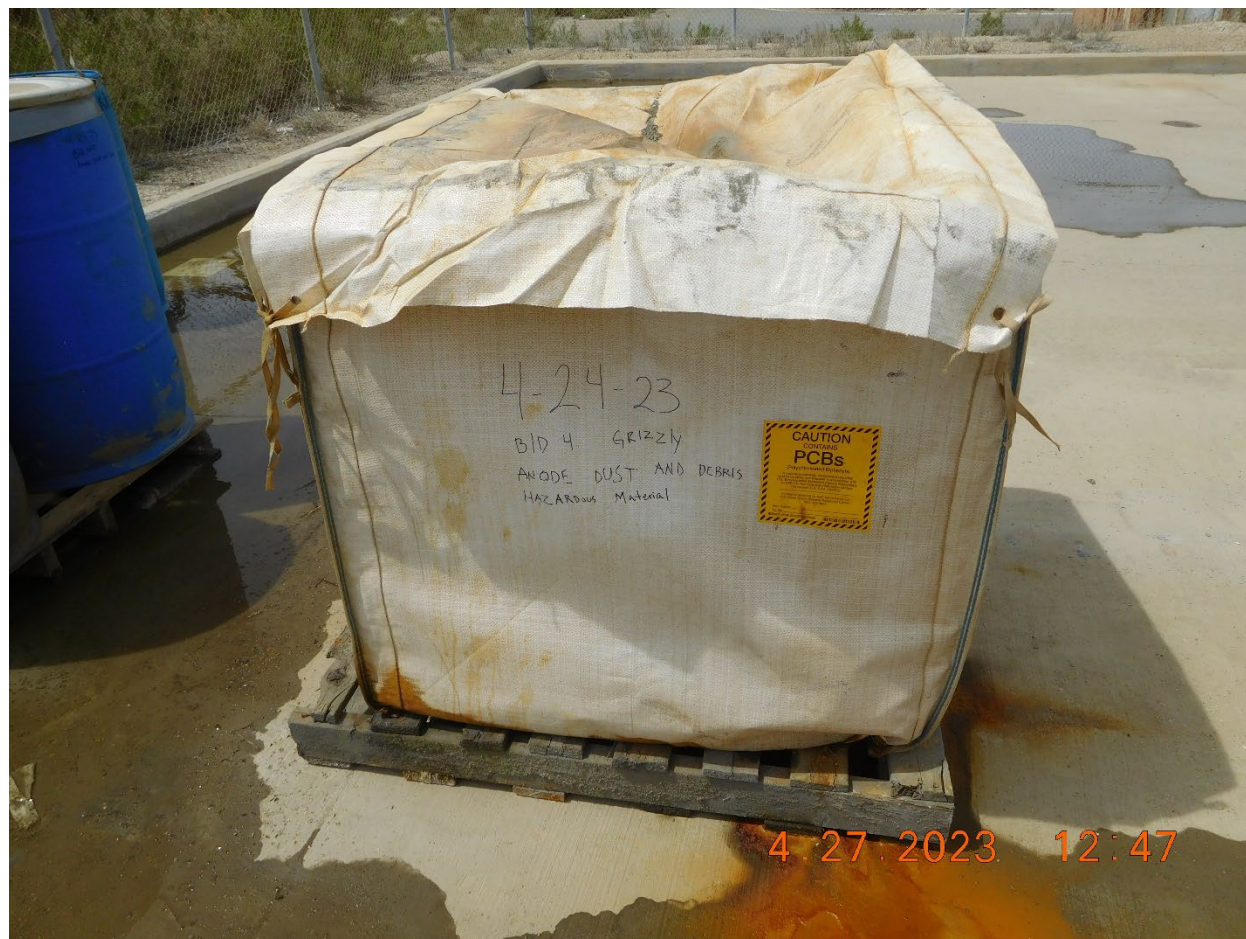
- 1 white supersack marked “Bld one anode dust and debris” and labeled “Caution Contains PCBs” (photos 16 and 17)
- 1 white supersack marked “Bldg 4 Grizzly Anode Dust and Debris Hazardous Material” and labeled “Caution Contains PCBs” (photo 18); this container appeared to be leaking

**Photo Description:** Photo of a supersack containing PCB-containing anode dust and PPE, marked "Bldg 4 Grizzly Anode Dust and Debris Hazardous Material".

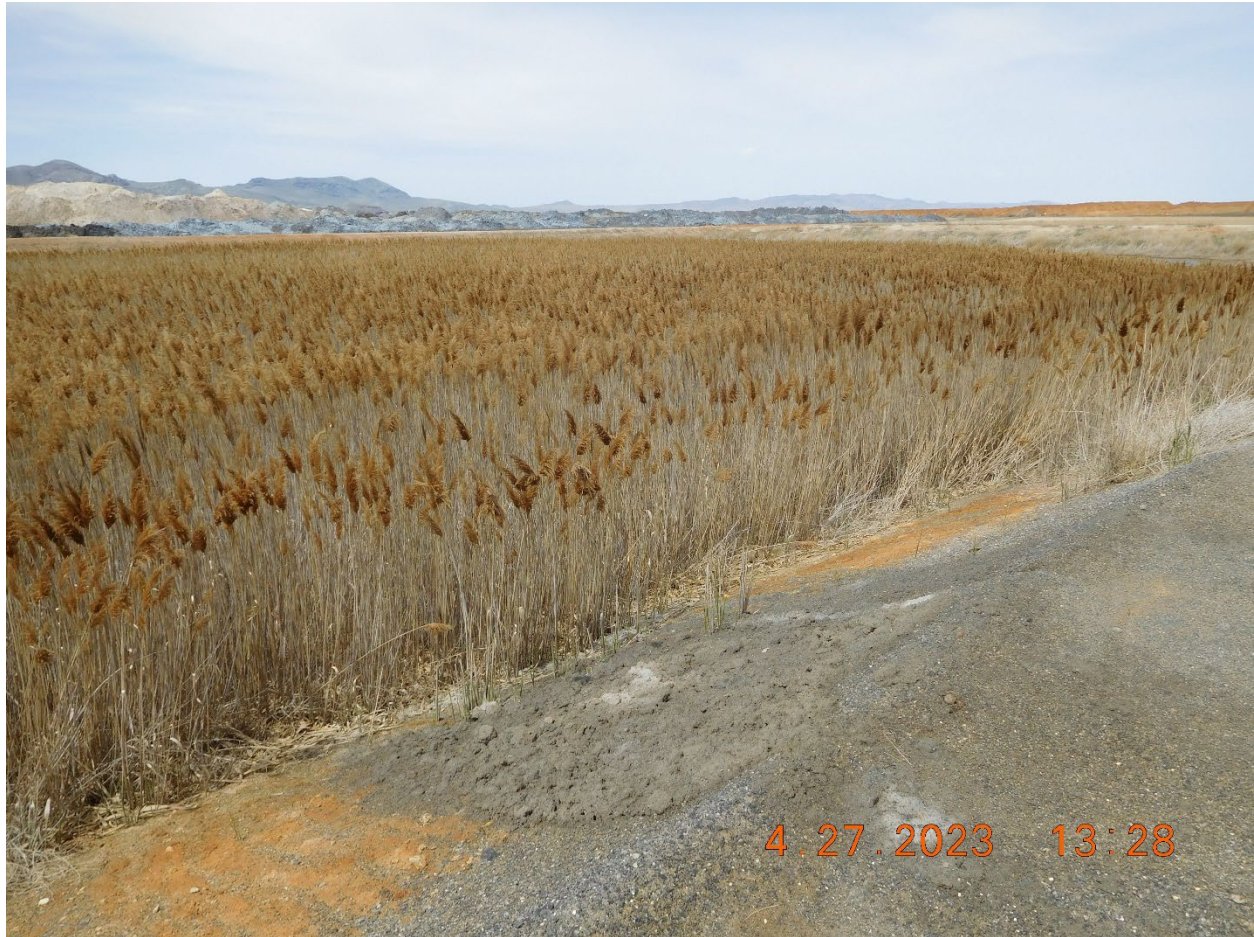
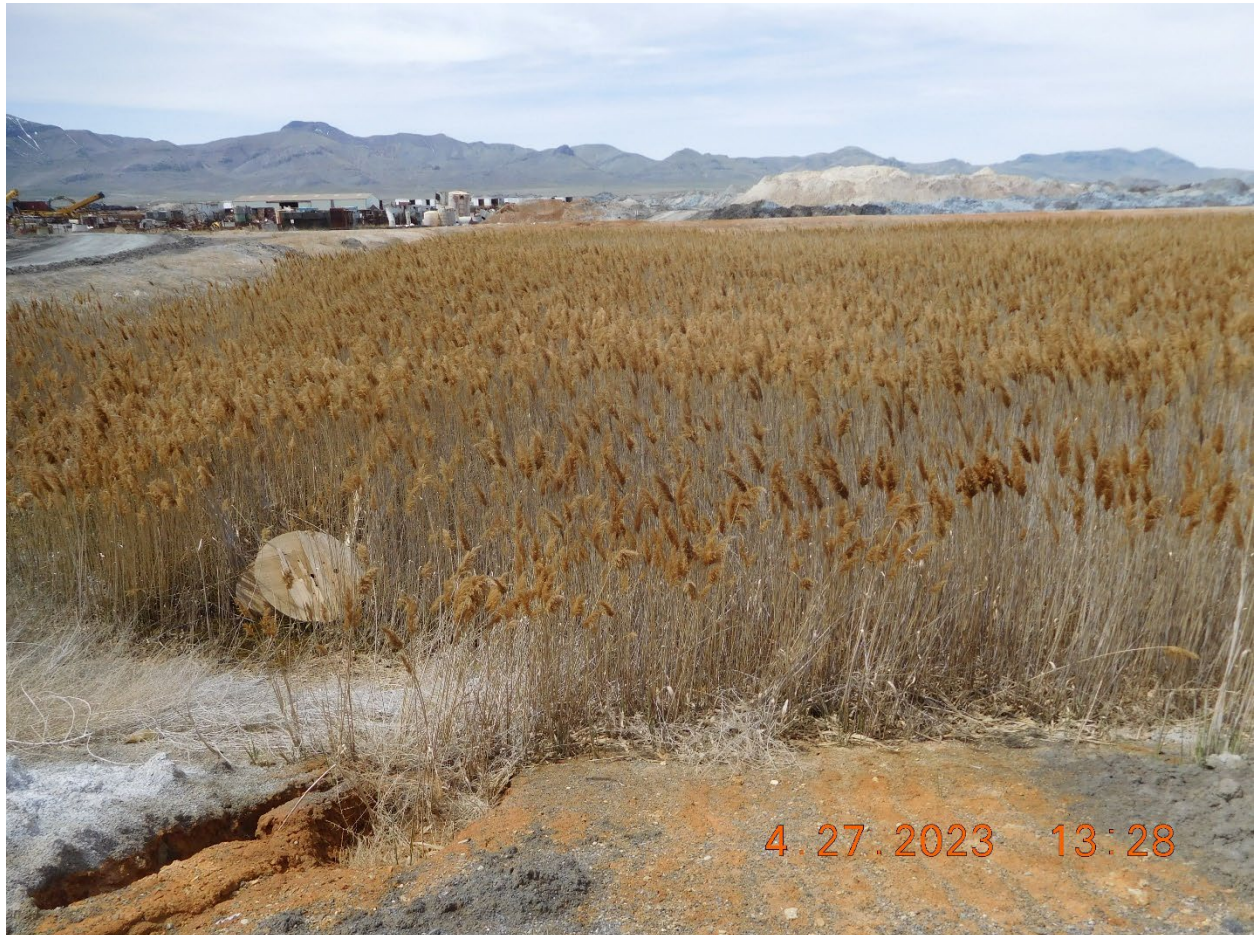
At the sanitary lagoon I observed that the surface was largely covered in phragmites (photos 27 and 28).

**Photo Description:** Photo of the sanitary lagoon with phragmites growth covering most of the lagoon. Photo taken facing northwest from the southeast area of the lagoon.

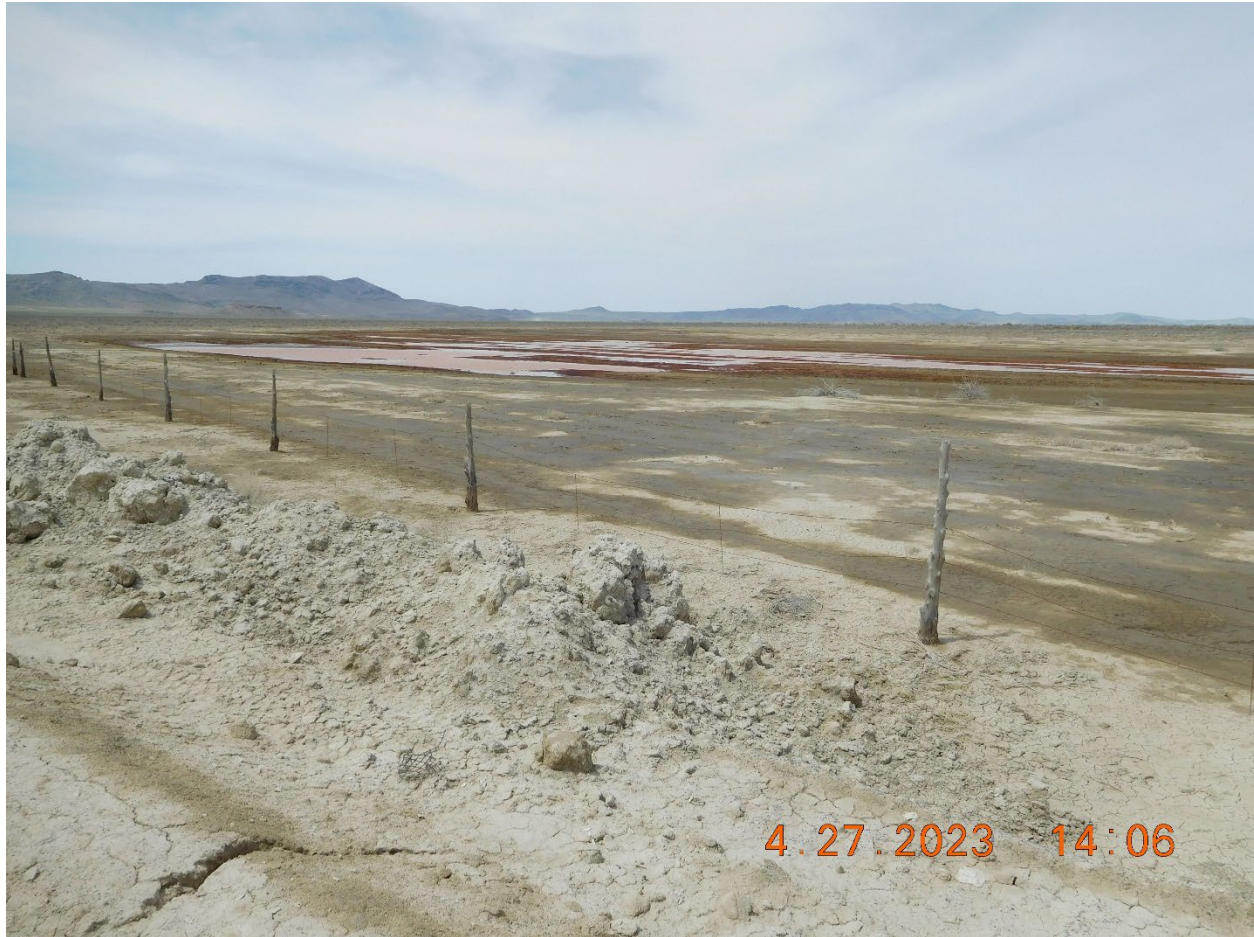
**Photo Description:** Photo of the same area shown in photos 38-41, panned left, facing northwest. Water visible in the photo appeared to be due to recent precipitation.
