**Region 6 - Enforcement & Compliance Assurance Division**  
**INSPECTION REPORT**

| Inspection Date(s): | February 26, 2020 | |
| Company Name: | <b>Cantrell Energy Corporation</b> | |
| Facility Name: | <b>SW Ardmore Tulip Creek Sand Unit (SWAT)</b> | |

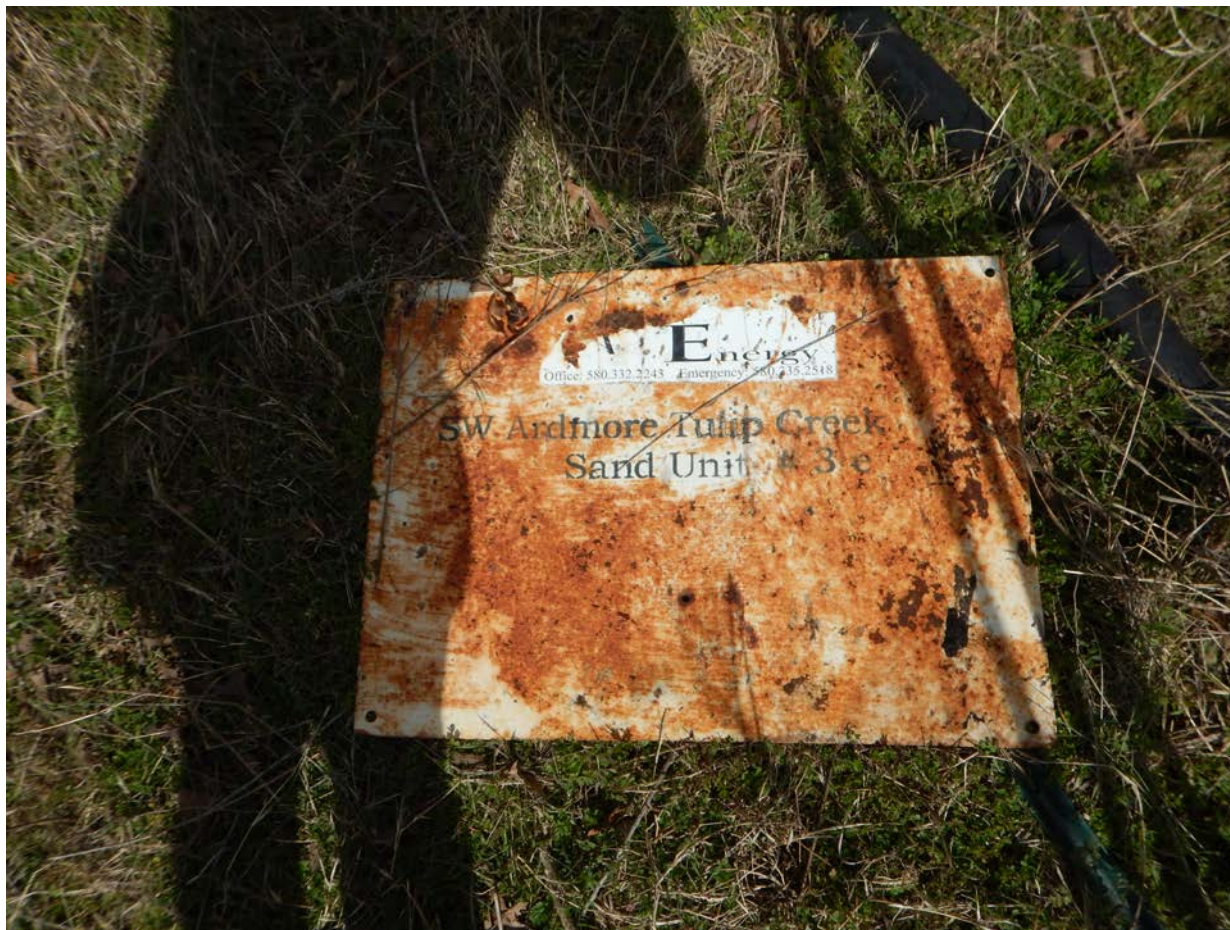
Photo No. 1

**Description:** The area of concern is located on and near the S.W. Ardmore Tulip Creek Sand Unit, shown on the sign pictured here.

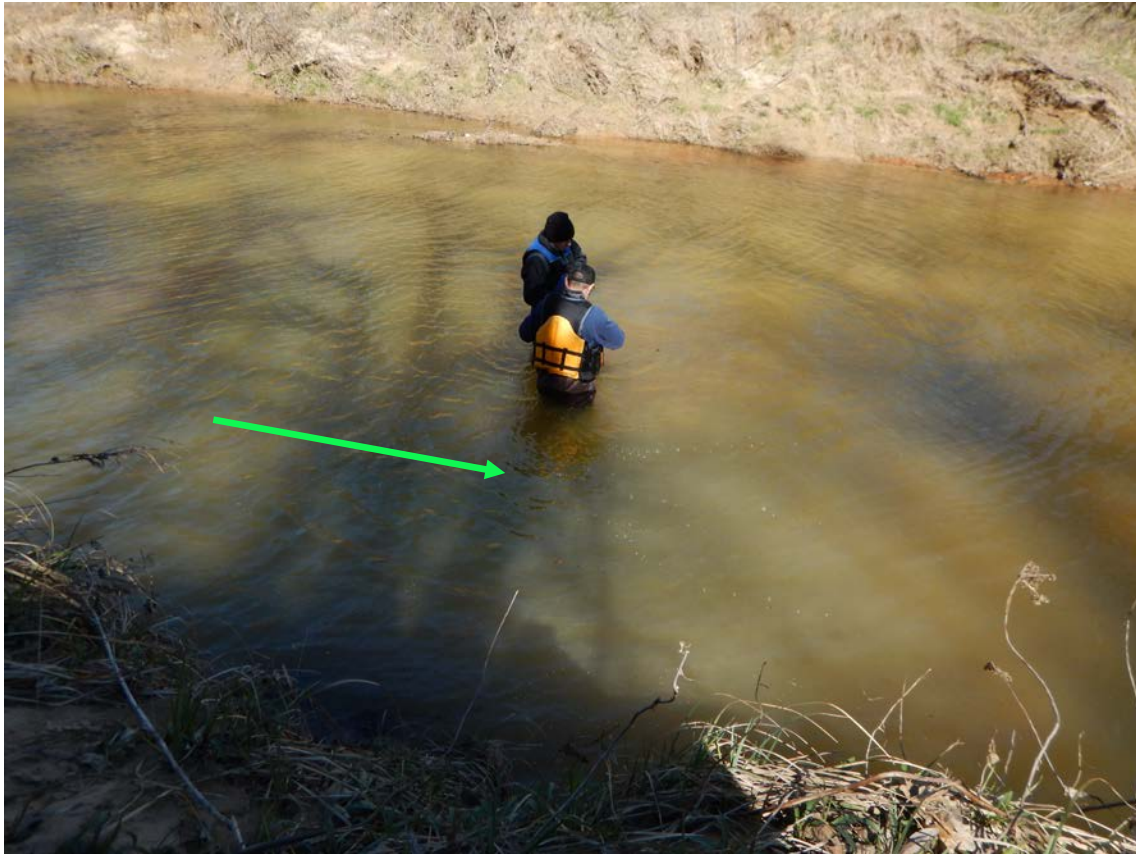
Photo No. 2

**Description:** Hickory Creek was observed during the inspection with constant and consistent bubbling seen on the surface (green arrow added to image to show the bubbling seen). Contaminants were identified by Oklahoma Department of Quality (ODEQ) representatives and were sampled at the bottom of the water column during the EPA inspection (sampling efforts seen here). The water was discolored with a red tint at this initial bubbling location. Downstream (within ~500 yards of this bubbling point), there were other bubbling points identified during the inspection in Hickory Creek. The depth of the stream here is approximately 3-5 feet.

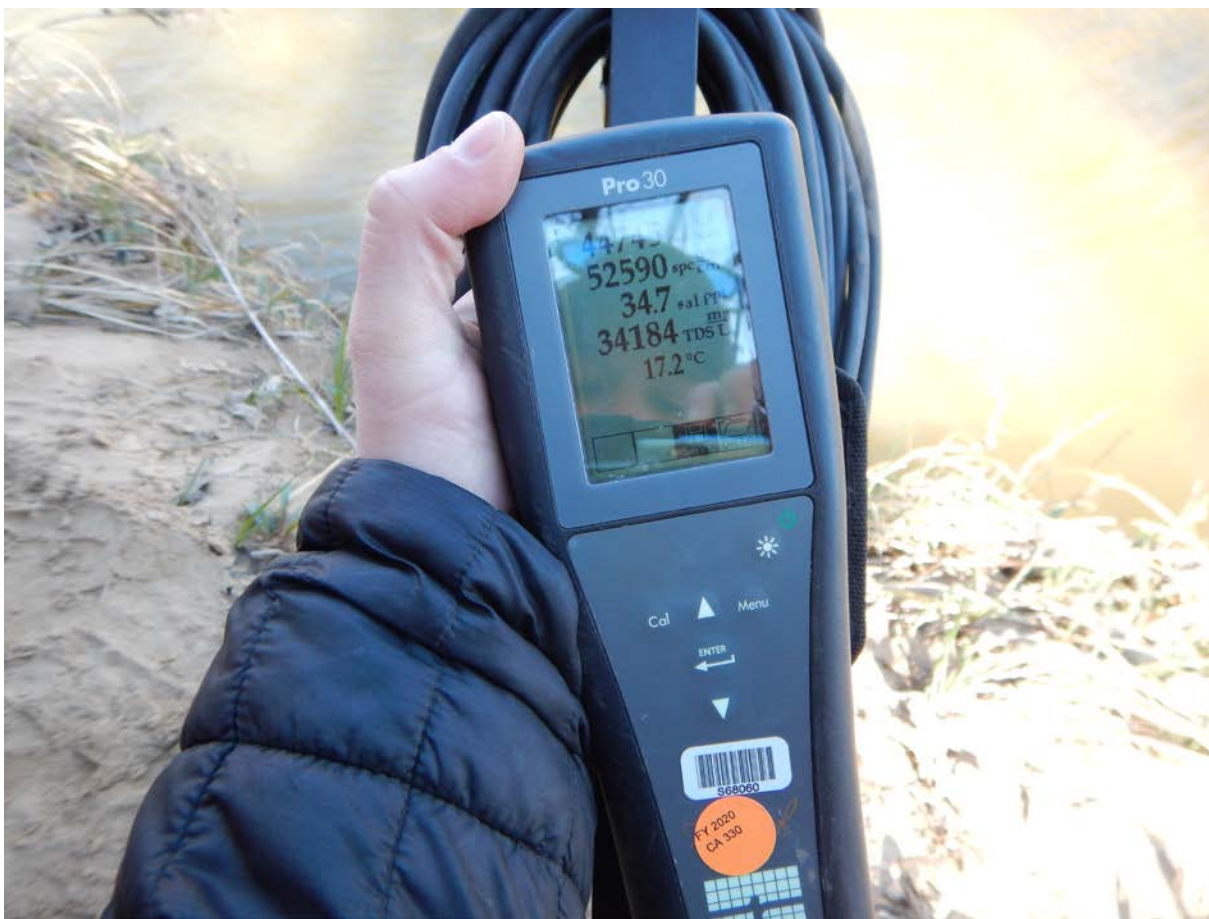
Photo No. 3

| Photo No.* | Latitude | Longitude | TDS (mg/L) | Temp (C ) | Position in Hickory Creek |
|---|---|---|---|---|---|
| 3 | 34.0954085 | -97.1705656 | 34,184 mg/L | 17.2 | Initial bubbling identified |

**Description:** Hickory Creek was observed during the inspection with constant and consistent bubbling seen on the surface. At the identified furthest upstream bubbling location, with a calibrated YSI Pro 30 conductivity meter, I measured 34,185 milligrams per liter (mg/L) Total Dissolved Solids (TDS) in the stream at 17.2 degrees Celsius. Downstream (within ~500 yards of this bubbling point), there were other bubbling points identified during the inspection in Hickory Creek and significant discoloration in the stream from these bubbling points.

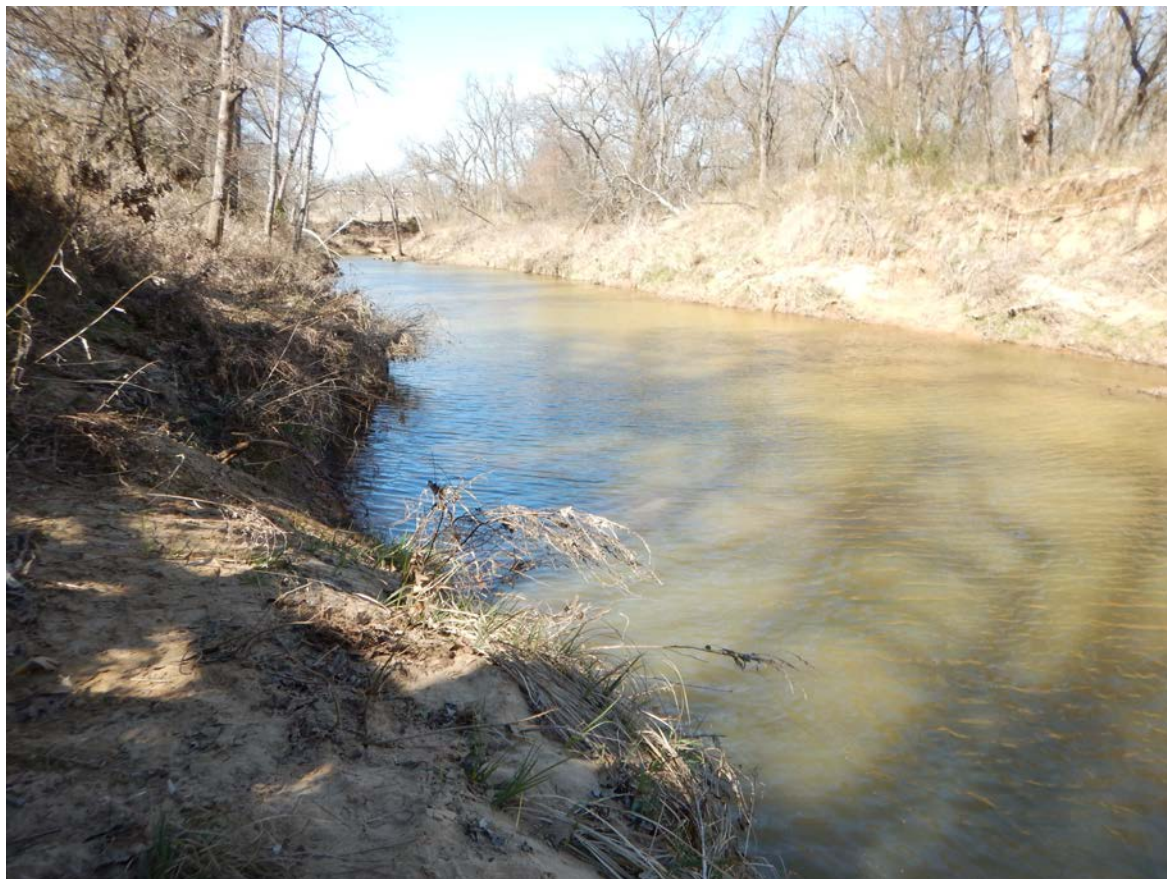
Photo No. 4

**Description:** Hickory Creek was observed during the inspection with constant and consistent bubbling seen on the surface, here. This image shows an upstream view of Hickory Creek from the initial bubbling location, where creek conditions can be observed. There was bed, bank, eroded features and active flowing conditions towards the south during the inspection. The creek was approximately 20-30 feet in width during the inspection. I observed facultative vegetation at this location along the banks, seen here.

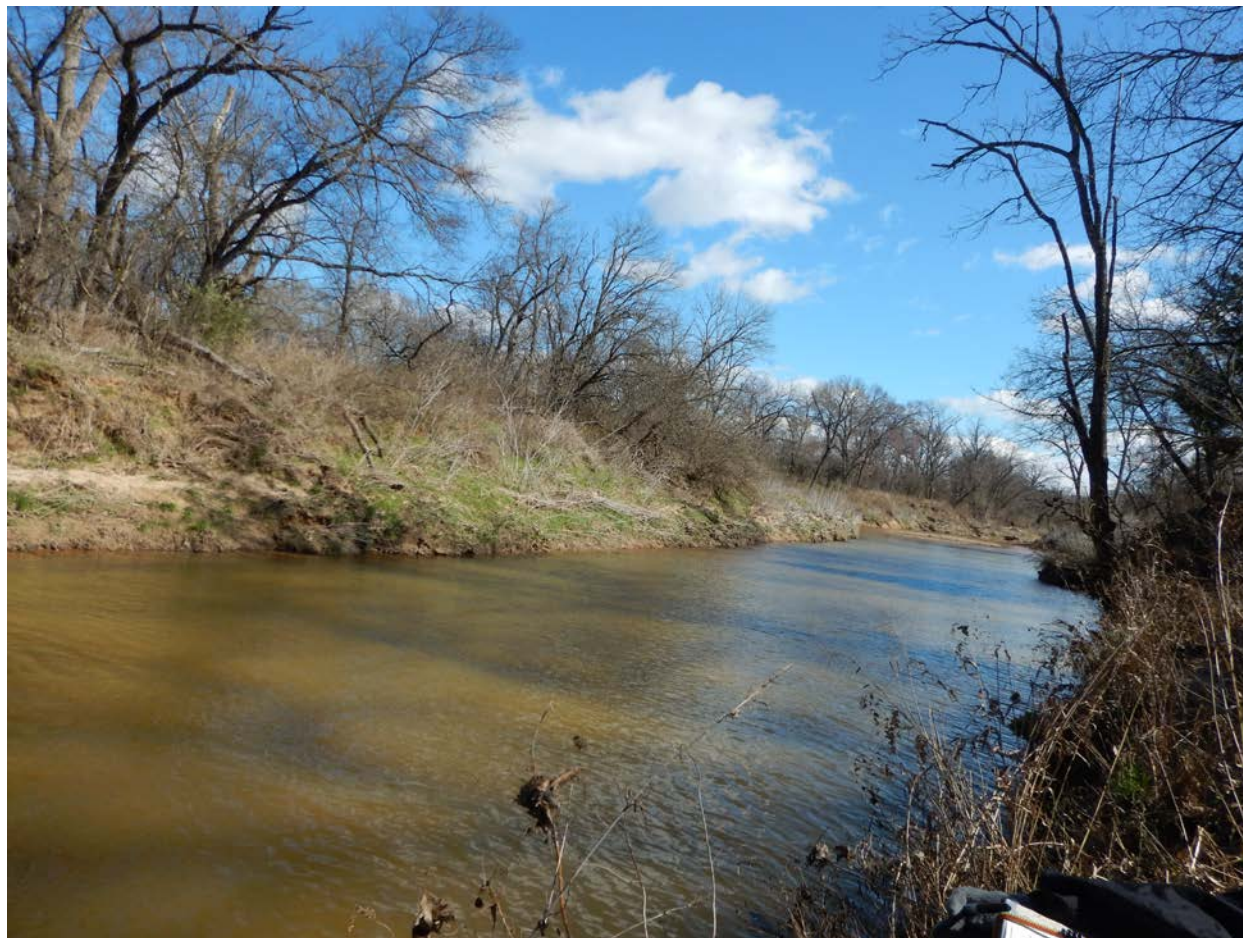
Photo No. 5

**Description:** Hickory Creek was observed during the inspection with constant and consistent bubbling seen on the surface, here. This image shows a downstream view of Hickory Creek from the initial bubbling location, where creek conditions can be observed. There was bed, bank, eroded features and active flowing conditions towards the south during the inspection. The creek was approximately 20-30 feet in width during the inspection. I observed facultative vegetation at this location along the banks, seen here. Some slight discoloration of the water can be seen here, and further downstream was observed as well.

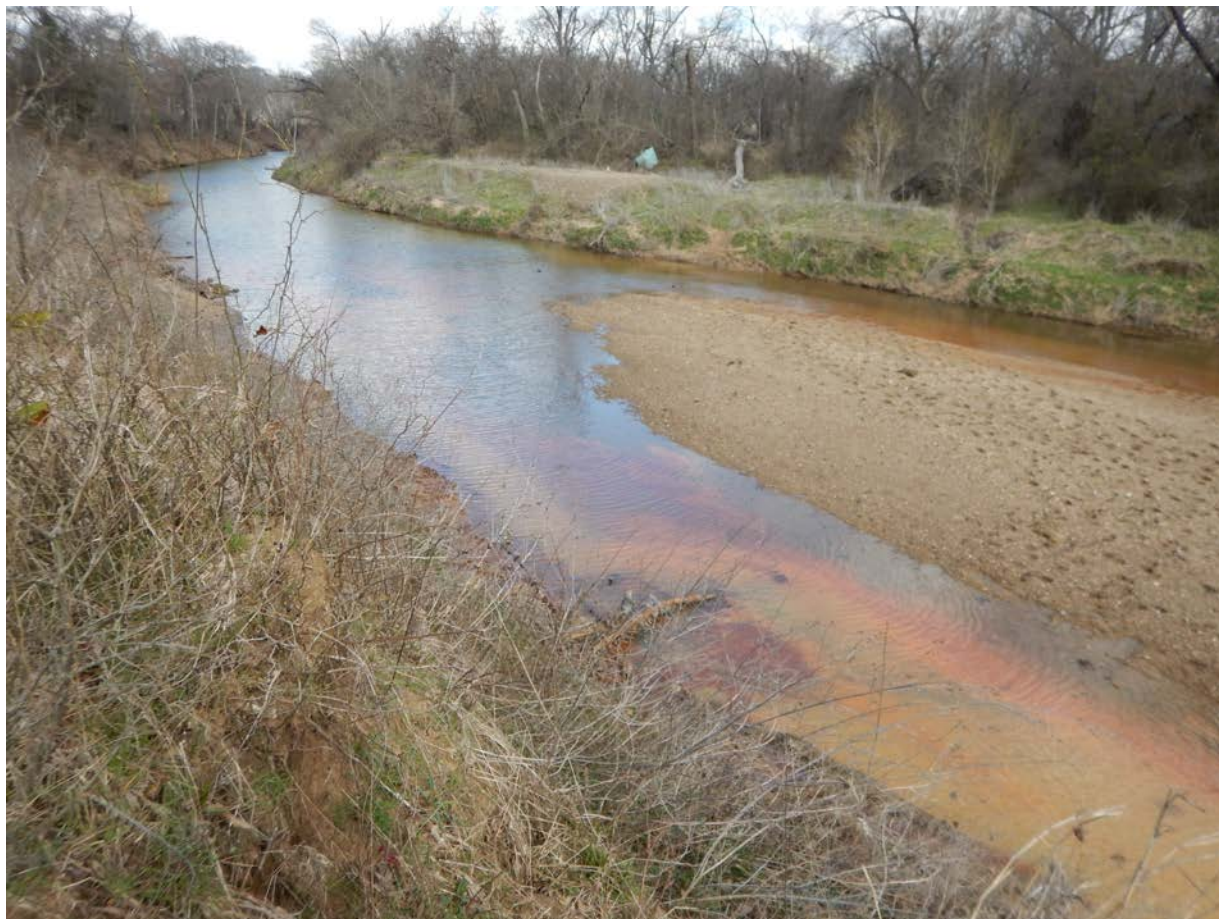
Photo No. 6

**Description:** Further downstream from the initial bubbling location (approximately 300 yards), this photo shows an upstream view of Hickory Creek where additional bubbling was observed during the inspection. A sand bar can be seen in the middle of the shallower portion of Hickory Creek at this main point of identified contamination. The water was discolored (orange and red tints) and had sheen in this area. There was bed, bank, and active flowing conditions towards the south during the inspection. The creek was approximately 20-30 feet in width and approximately 1-2 feet deep.

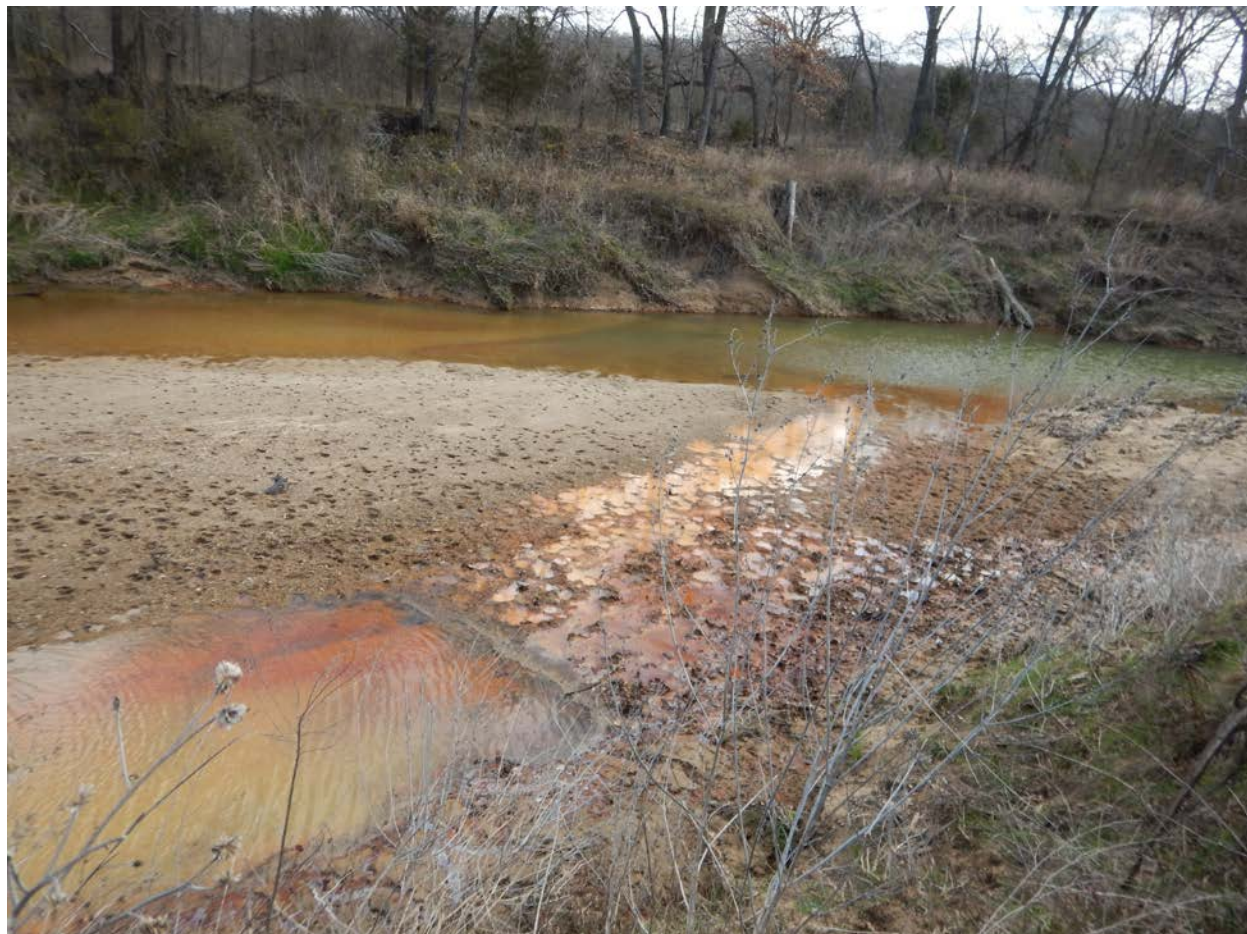
Photo No. 7

**Description:** Further downstream from the initial bubbling location (approximately 300 yards) seen in Photo 2, this photo shows a downstream view of Hickory Creek where additional bubbling was observed during the inspection. A sand bar can be seen in the middle of the shallower portion of Hickory Creek at this main point of identified contamination. The water was discolored (orange and red tints) and had sheen in this area. Seeping from the side of the creek beds were also observed at this location. There was bed, bank, and active flowing conditions towards the south in Hickory Creek during the inspection. The creek was approximately 20-30 feet in width and approximately 1-2 feet deep.

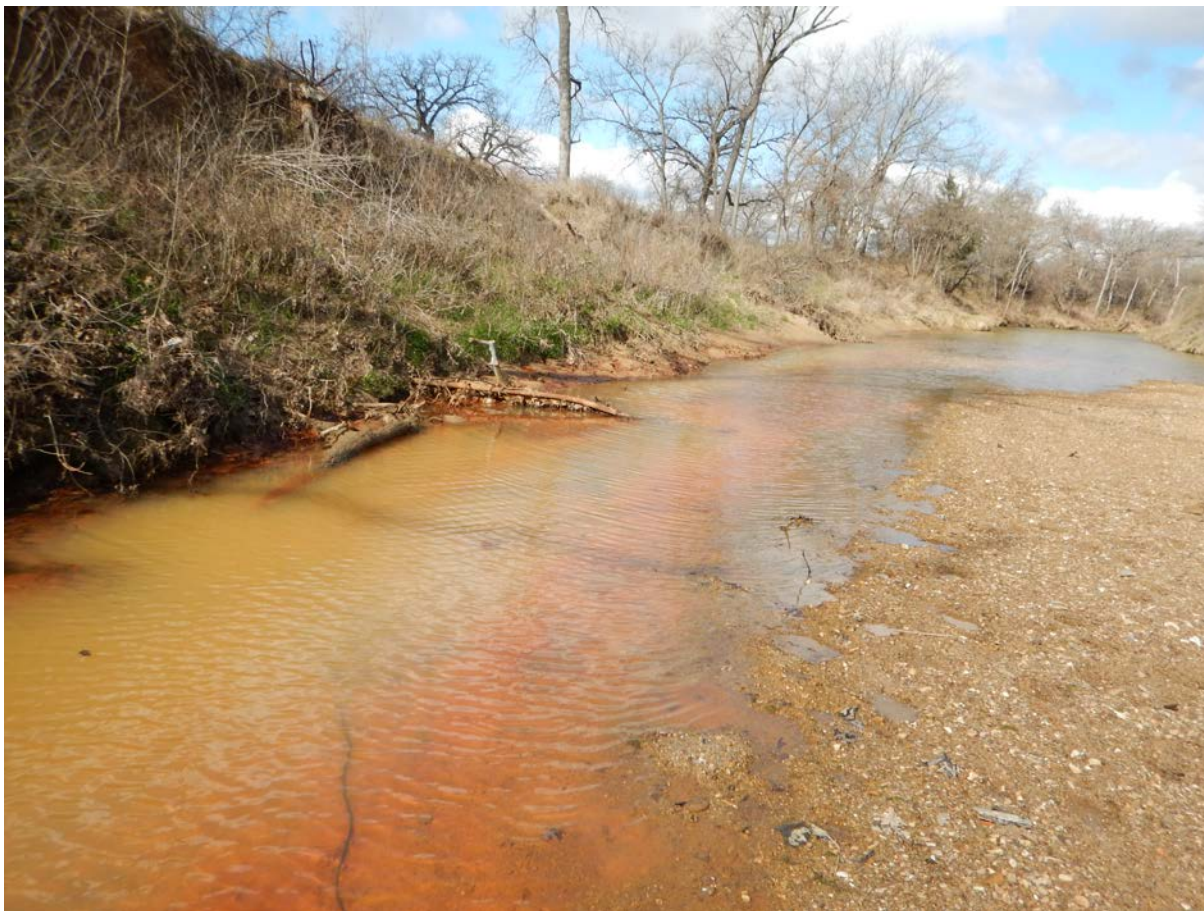
Photo No. 8

**Description:** At the same location Photos 6 & 7 were taken from higher up on the creek bank, this photo shows an upstream view of Hickory Creek where additional bubbling was observed. A sand bar can be seen in the middle of the shallower portion of Hickory Creek at this main point of identified contamination. The water was discolored (orange and red tints) and had sheen in this area. Seeping from the side of the creek beds were also observed at this location (western bank here). There was bed, bank, and active flowing conditions towards the south in Hickory Creek during the inspection. The creek was approximately 20-30 feet in width and approximately 1-2 feet deep.

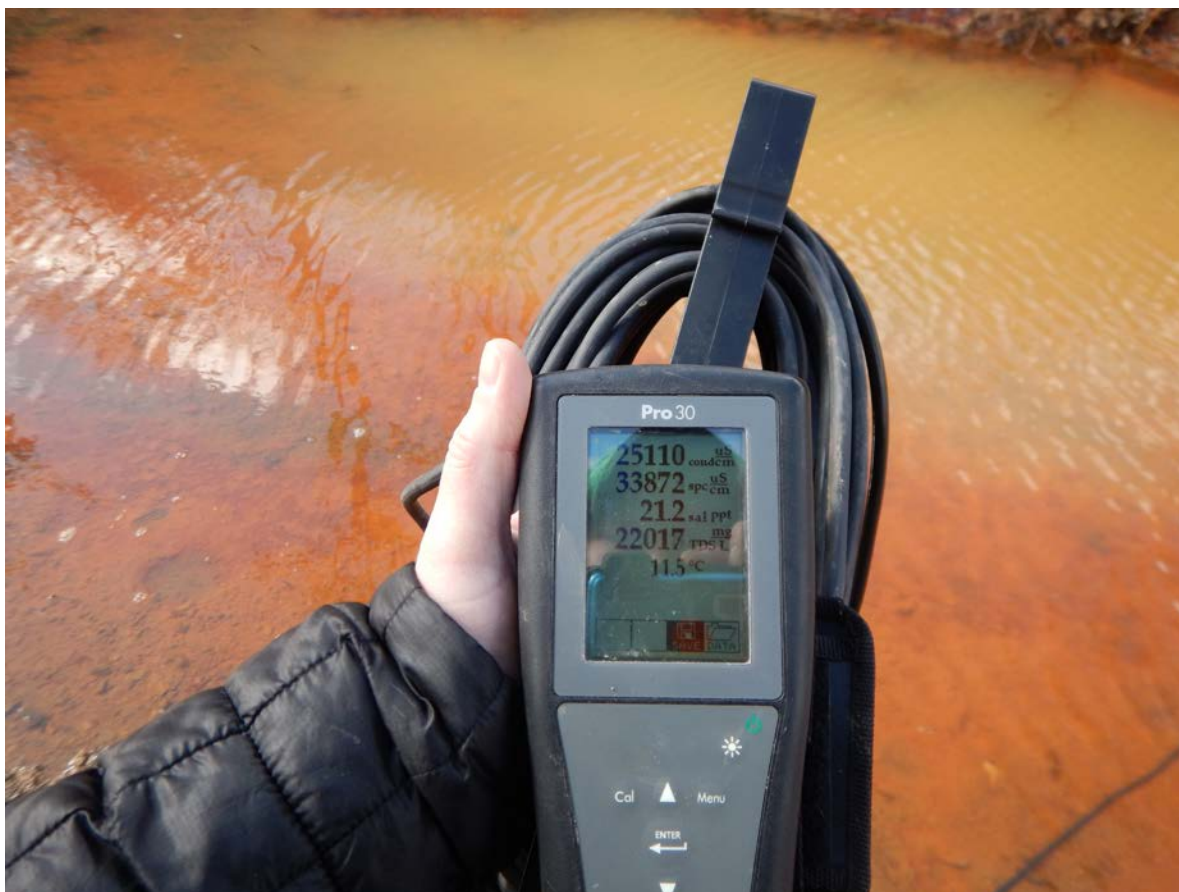
Photo No. 9

| Photo No.* | Latitude | Longitude | TDS (mg/L) | Temp (C ) | Position in Hickory Creek |
|---|---|---|---|---|---|
| 9 | 34.0947063 | -97.1696044 | 22,017 mg/L | 11.5 | Downstream from Photo 3 (~300 yards) |

**Description:** A TDS reading was taken at Photo 8's location during the inspection and measured 22,017 mg/L at 11.5 degrees Celsius. Hickory Creek was flowing south during the inspection and red coloration was affecting this portion of the stream from unidentified contaminants. I observed elevated TDS levels and a difference in water temperature here from upstream readings with elevated TDS levels.

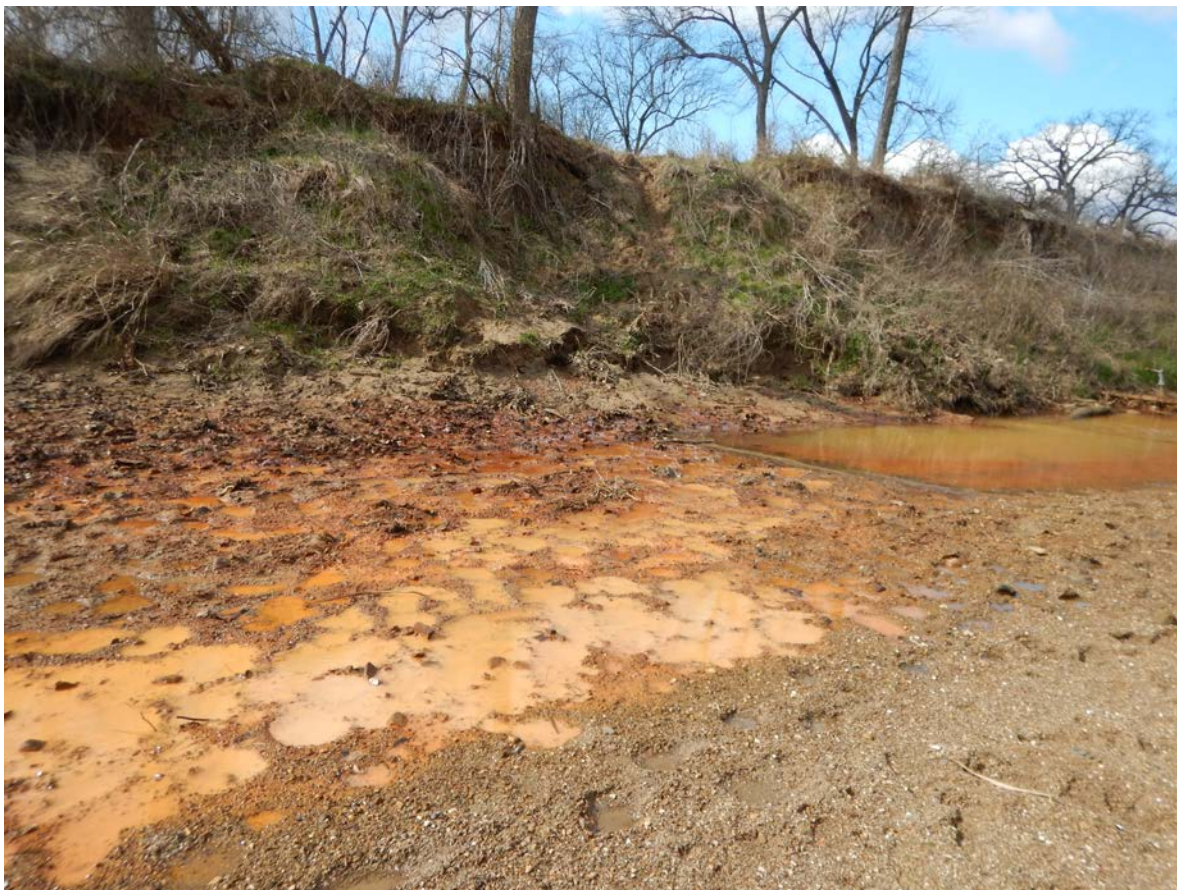
Photo No. 10

**Description:** Approximately 5 yards downstream from photos 8 & 9, this photo shows the western bank of Hickory Creek, where seepage and discolored fluids were observed. Sheen was observed at this location that was not vegetatively associated. No aquatic life or vegetation was observed where the contaminated fluids were present. Although, higher up on the banks of Hickory Creek, some facultative vegetation was observed. Evidence of cattle tracks can be seen here, in the creek at this point where discolored fluids and elevated TDS were observed.

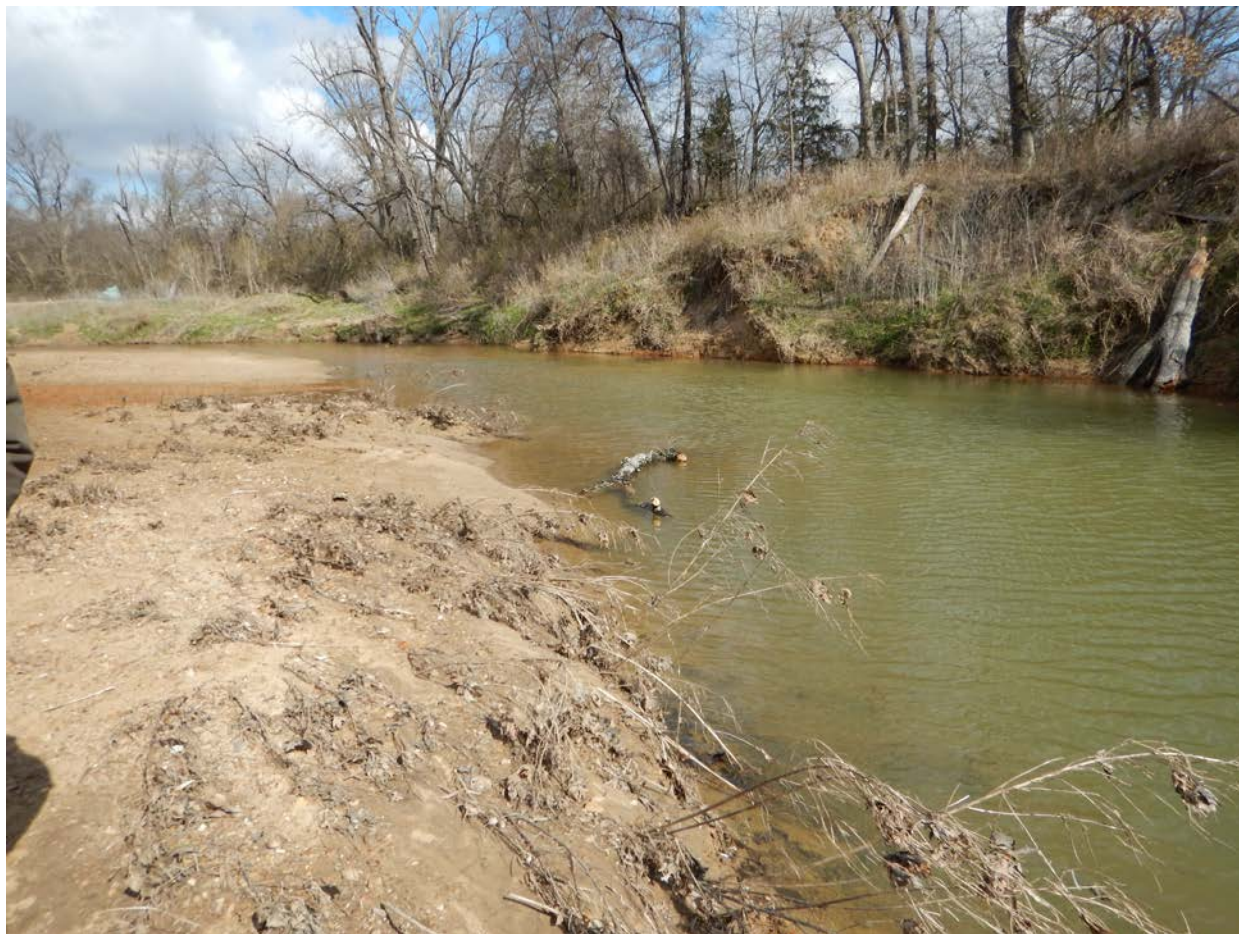
Photo No. 11

**Description:** Approximately 10 yards downstream from Photo 10, this photo shows Hickory Creek downstream from the sand bar observed previously. I observed some bubbling at this location. The water depth was over 3 feet here and flow had merged on the backside of the sand bar, flowing south. Some fluid discoloration was also observed here.

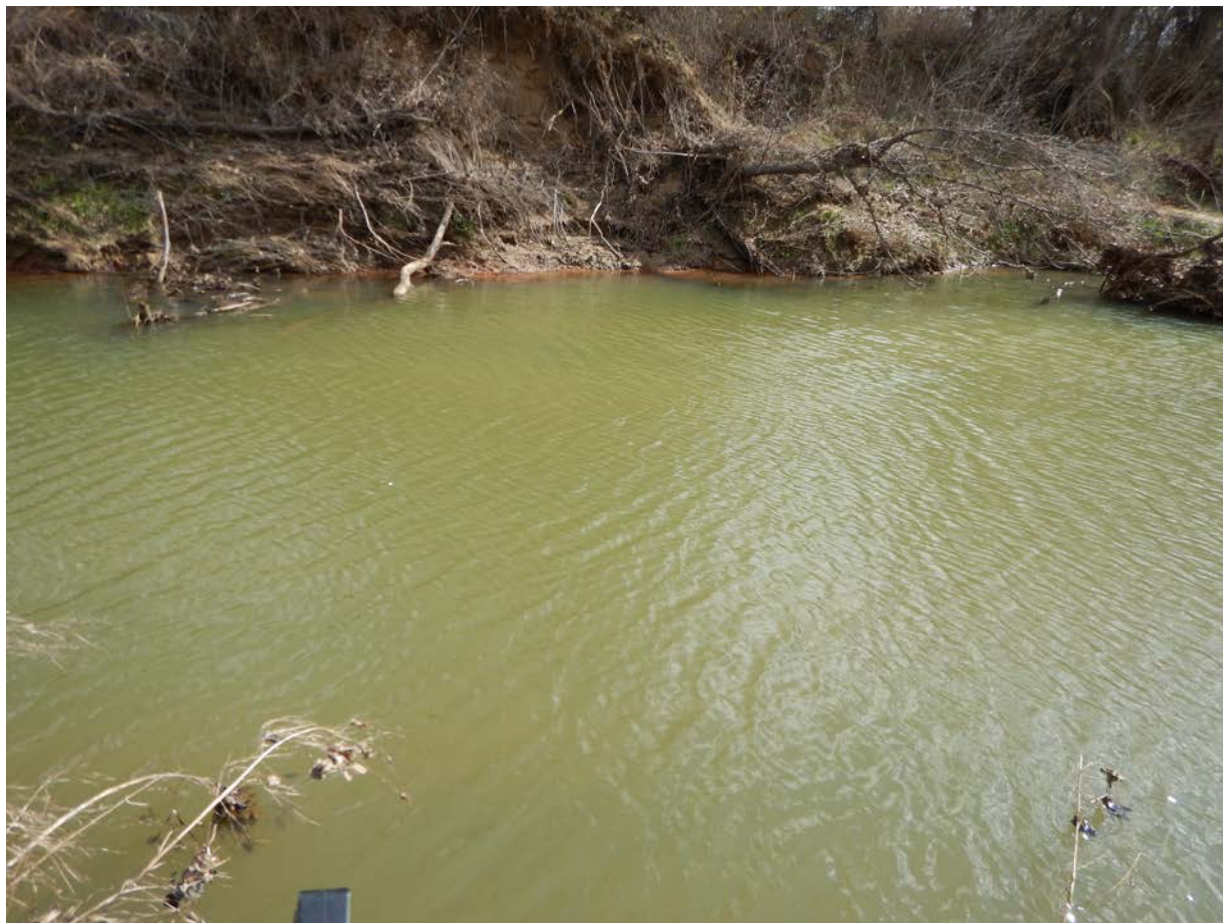
Photo No. 12

**Description:** In the same portion of Hickory Creek as shown in Photo 11, the eastern bank of Hickory Creek can be seen in this image. I observed some bubbling at this location. The water depth was over 3 feet here and flow had merged on the backside of the sand bar, flowing south. Some fluid discoloration was also observed here, including on the eastern bank of Hickory Creek. Additionally, seeping from the eastern bank was observed here as well.

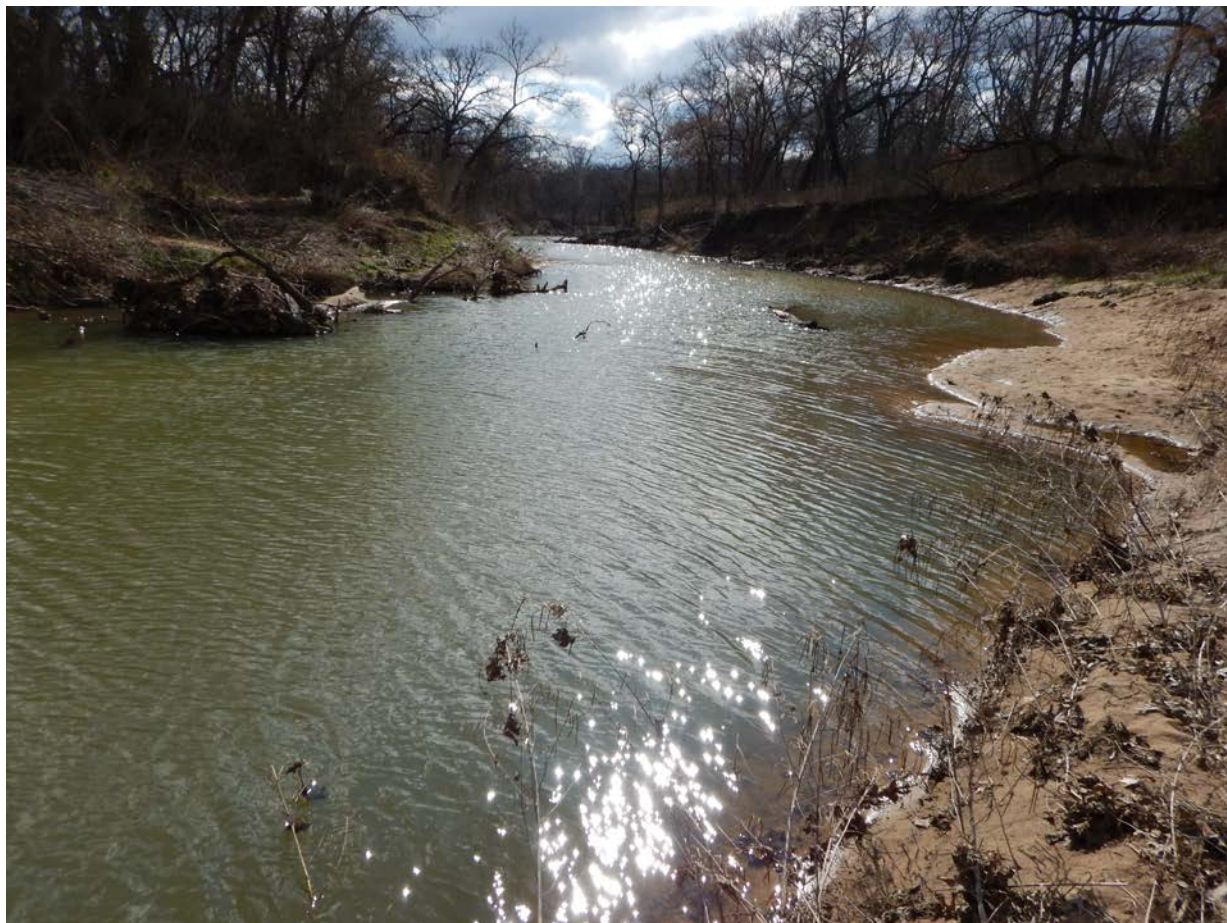
Photo No. 13

**Description:** In the same portion of Hickory Creek as shown in Photo 11, downstream on Hickory Creek can be seen in this image. I observed some bubbling at this location. The water depth was over 3 feet here and flow had merged on the backside of the sand bar, flowing south. Some fluid discoloration was also observed here. High banks, creek bed, flooding debris, and ordinary high-water marks were observed in Hickory Creek at this location.

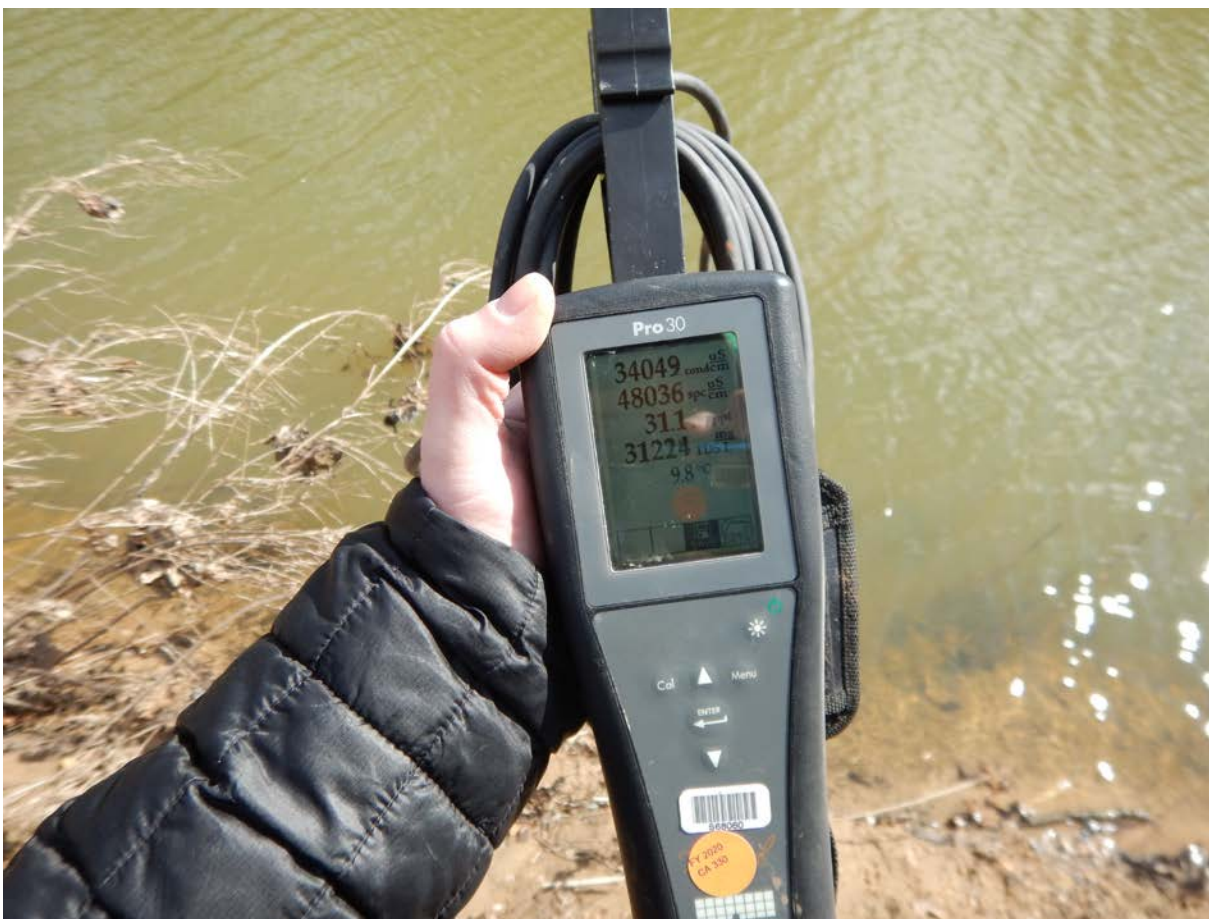
Photo No. 14

| Photo No.* | Latitude | Longitude | TDS (mg/L) | Temp (C ) | Position in Hickory Creek |
|---|---|---|---|---|---|
| 14 | 34.0944229 | -97.1693117 | 31,224 mg/L | 9.8 | Downstream from Photo 3 (~315 yards) |

**Description:** In the same portion of Hickory Creek as shown in Photos 11 – 13. With a calibrated YSI Pro 30 conductivity meter, TDS measured 31,224 mg/L at 9.8 degrees Celsius. I observed some bubbling at this location. The water depth was over 3 feet here and flow had merged on the backside of the sand bar, flowing south. Some fluid discoloration was also observed here.

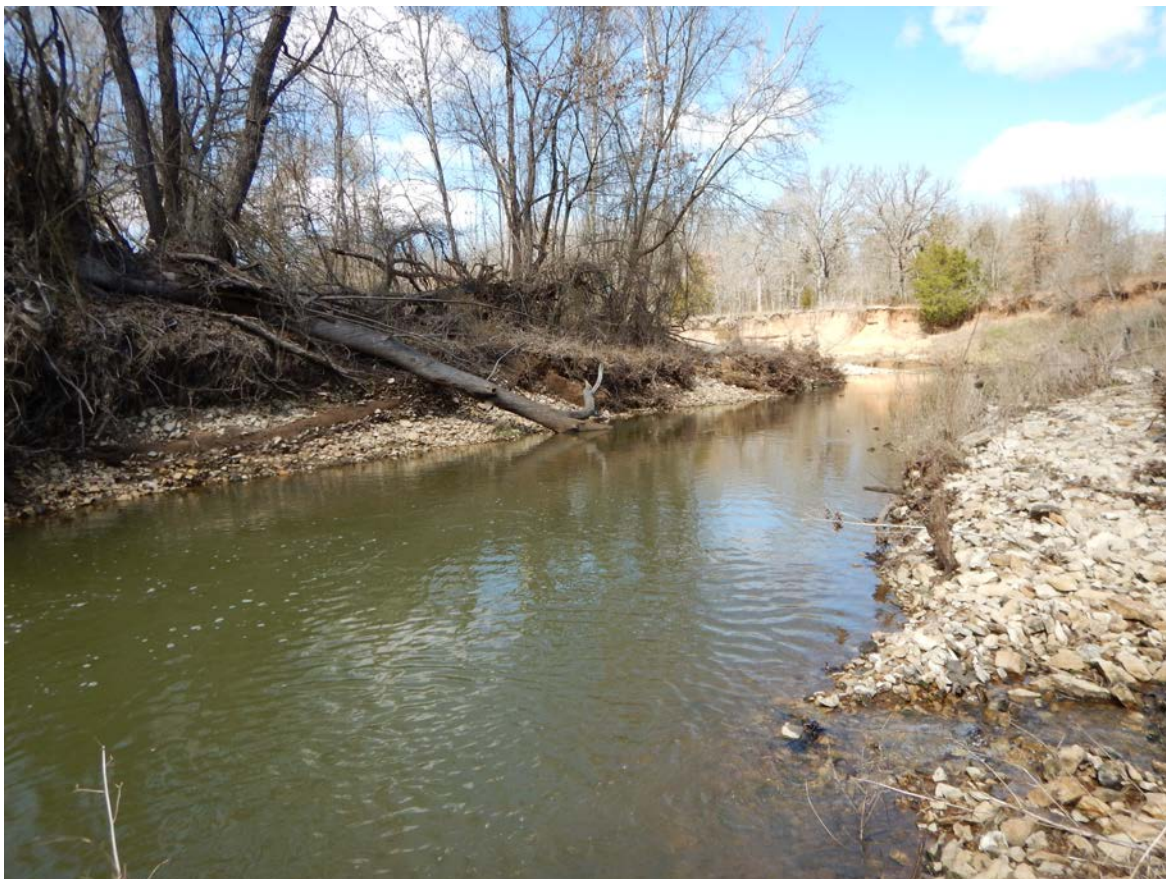
Photo No. 15

**Description:** Approximately 0.46 miles downstream in Hickory Creek from Photo 14, an additional Hickory Creek was observed. The water was flowing north in this part of the creek (bend of creek) and then turned south. I observed large amounts of flooded debris at this location. Bed rock, ordinary high-water marks, and facultative vegetation through out the creek area was observed. I observed a slight rotten egg odor while at this location.

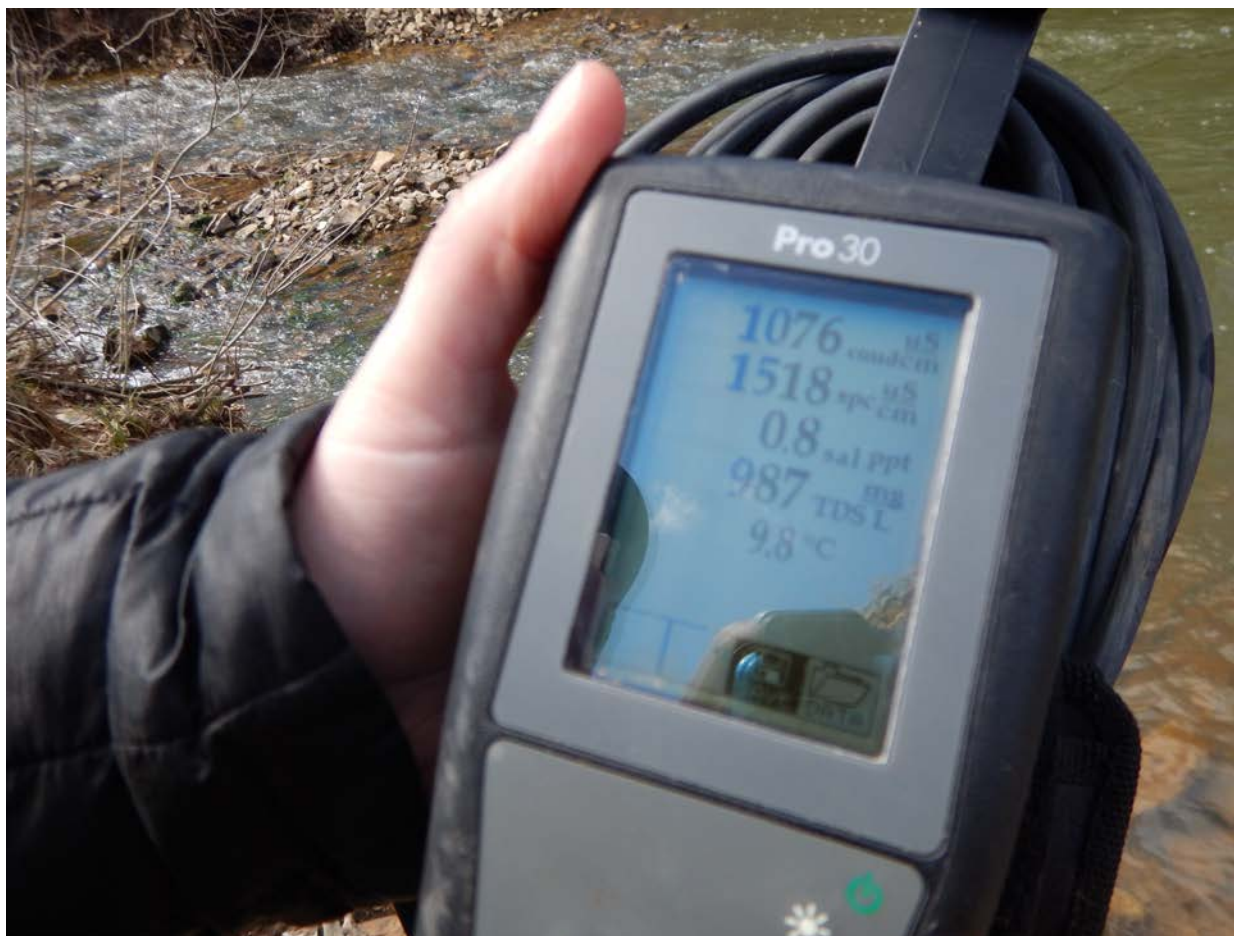
Photo No. 16

| Photo No.* | Latitude | Longitude | TDS (mg/L) | Temp (C ) | Position in Hickory Creek |
|---|---|---|---|---|---|
| 16 | 34.0910835 | -97.1705113 | 987 mg/L | 9.8 | Downstream from Photo 3 (~0.5 miles) |

**Description:** At the same location as Photo 15, TDS measured 987 mg/L at 9.8 degrees Celsius with a calibrated YSI Pro 30 conductivity meter.

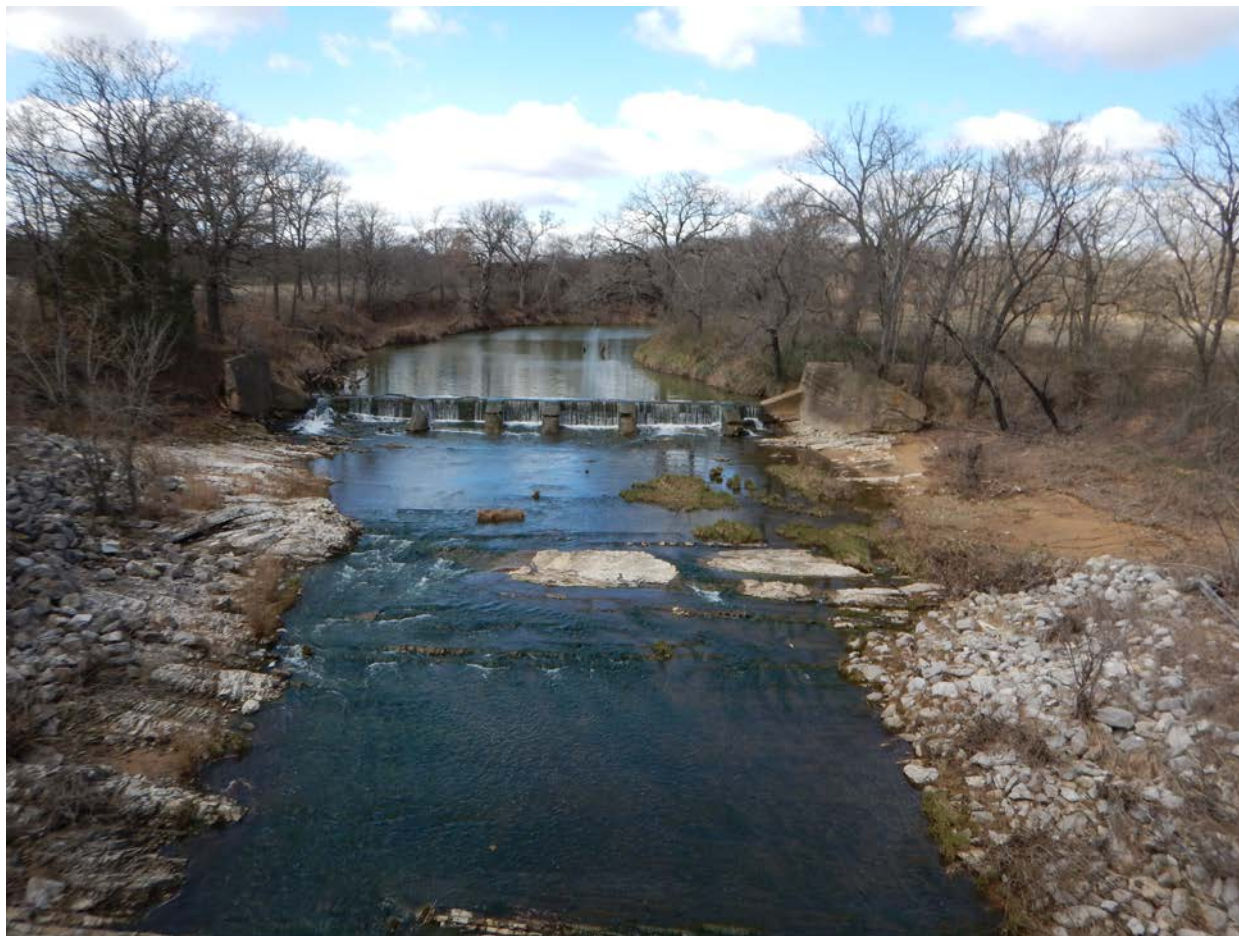
Photo No. 17

**Description:** Approximately 2 miles downstream in Hickory Creek from Photos 15 & 16 (approximately 2.5 miles downstream from first observed bubbling location) the creek was observed here. The water was flowing south and had a strong current. This upstream view shows a dam in place in Hickory Creek and bed rock on the downstream side of the dam. The water depth was over 5 feet deep on the upstream side of the dam and the creek was over 60 feet wide. I observed large amounts of flooded debris at this location. Bed rock, ordinary high-water marks, and facultative vegetation throughout the creek area were also observed.

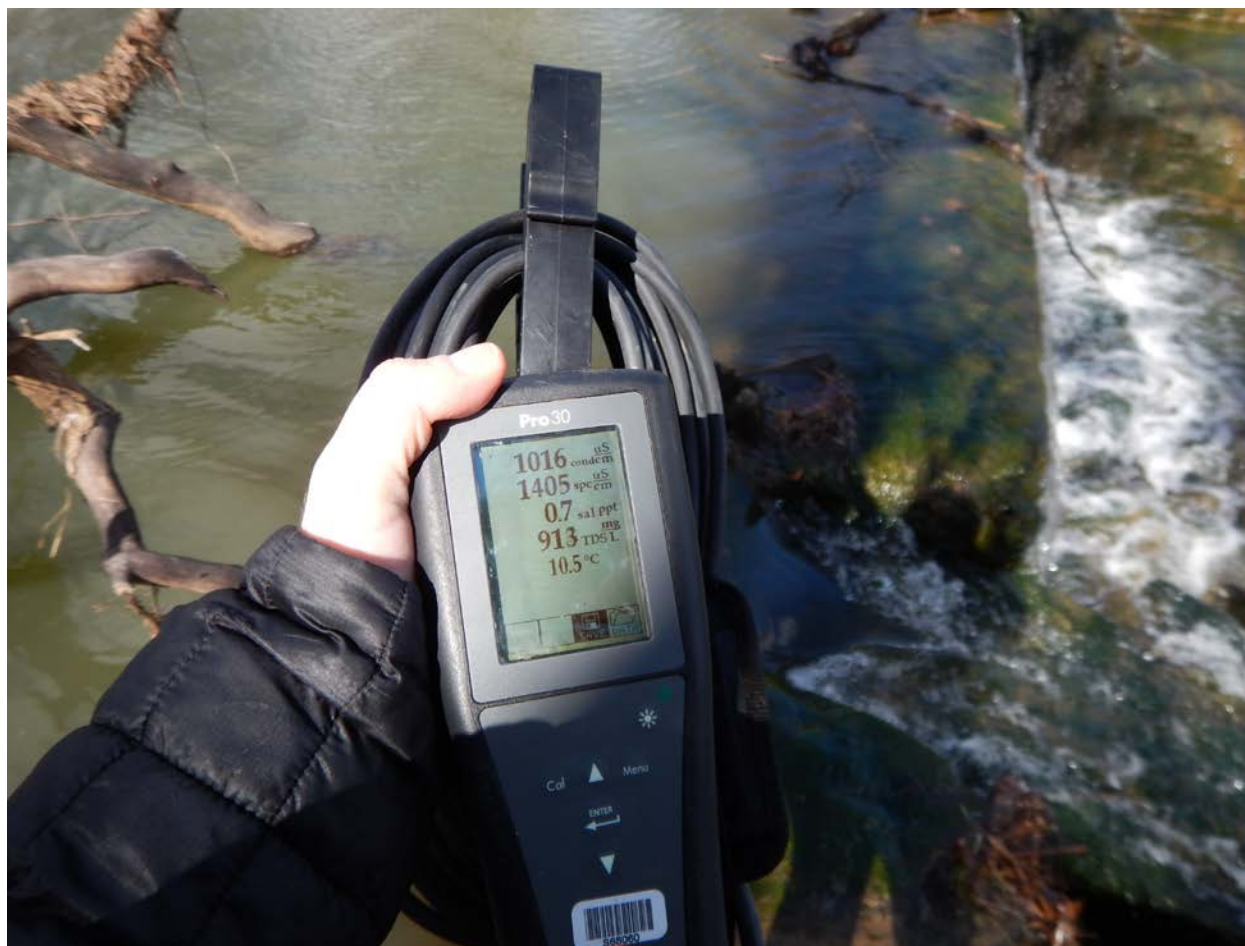
Photo No. 18

| Photo No.* | Latitude | Longitude | TDS (mg/L) | Temp (C ) | Position in Hickory Creek |
|---|---|---|---|---|---|
| 18 | 34.0766271 | -97.1699346 | 913 mg/L | 10.5 | Downstream from Photo 3 (~2.5 miles) |

**Description:** Upstream from the dam in Photo 17, TDS measured 913 mg/L at 10.5 degrees Celsius with a calibrated YSI Pro 30 conductivity meter. EPA also observed ODEQ take water quality grab samples from this location.
