**Region 6 - Enforcement & Compliance Assurance Division**  
**INSPECTION REPORT**

| Inspection Date(s): | February 26, 2020 | |
| Company Name: | <b>Cantrell Energy Corporation</b> | |
| Facility Name: | <b>SW Ardmore Tulip Creek Sand Unit (SWAT)</b> | |

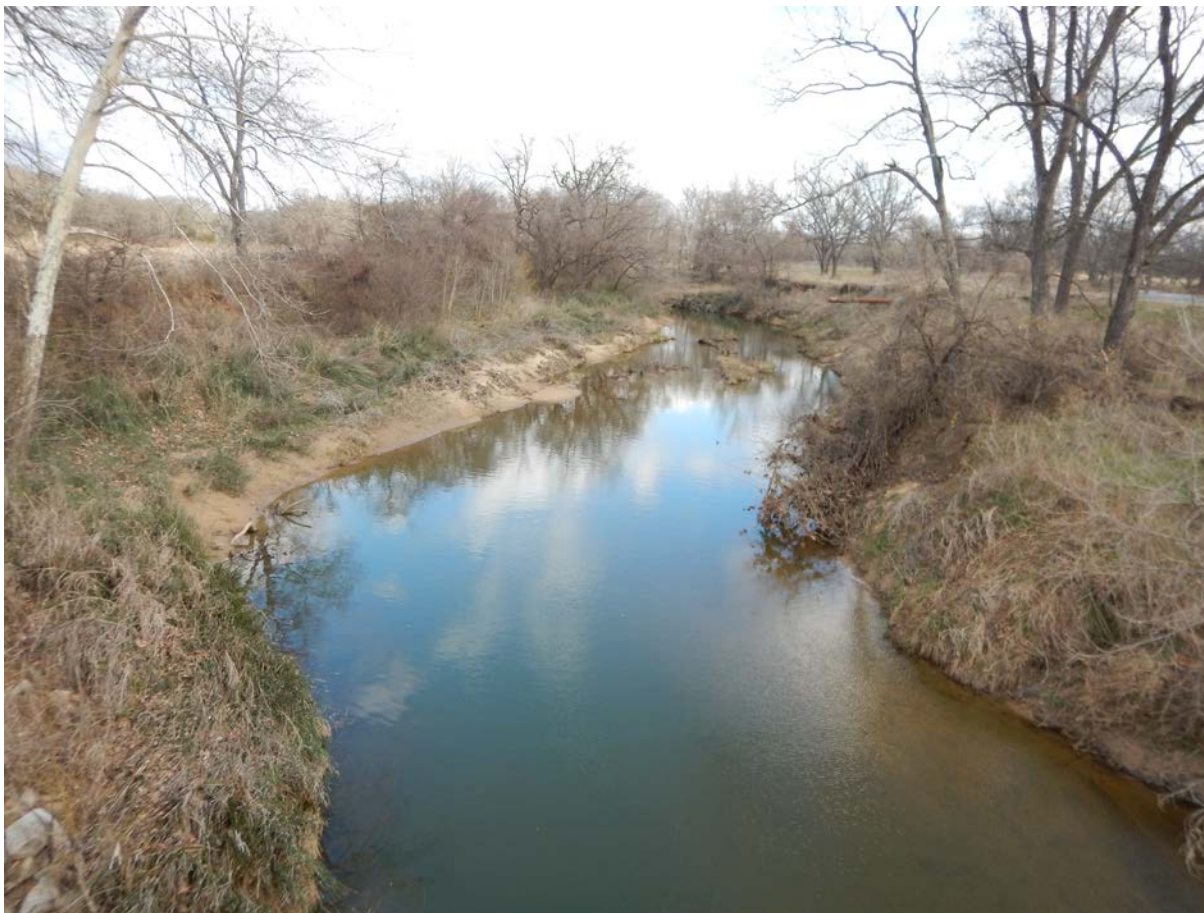
Photo No. 19

**Description:** This at a location upstream from the initial bubbling identified in Hickory Creek approximately 0.6 miles. This location was observed to document background, or non-affected stream conditions in Hickory Creek. There was visible bed, bank, and ordinary high-water marks seen at this location. Facultative vegetation and a defined channel were also observed here at Hickory Creek.

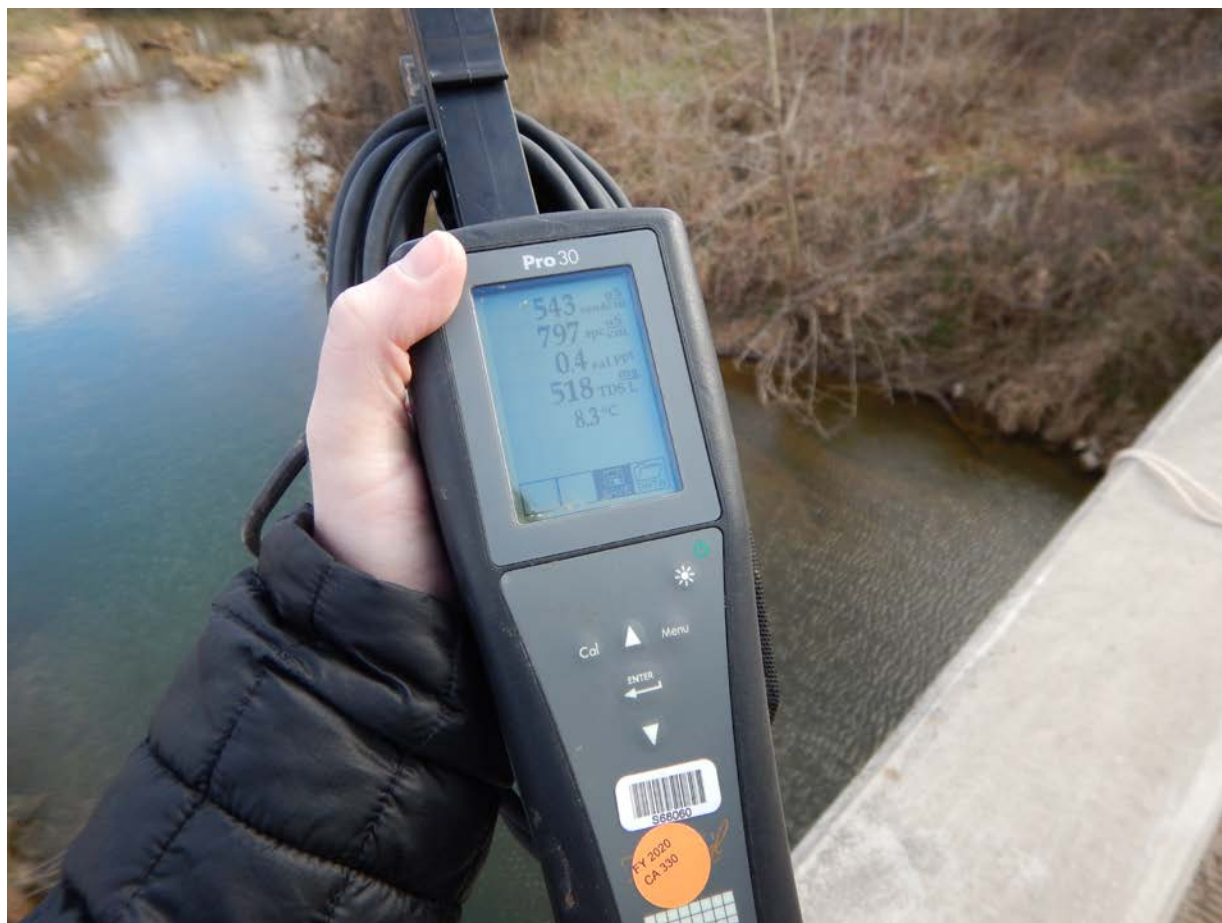
Photo No. 20

| Photo No.* | Latitude | Longitude | TDS (mg/L) | Temp (C ) | Position in Hickory Creek |
|---|---|---|---|---|---|
| 20 | 34.0999706 | -97.1660551 | 518 mg/L | 8.3 | Upstream from Photo 3 (~0.6 miles) |

**Description:** At the same location as Photo 19, TDS measured 518 mg/L at 8.3 degrees Celsius (background).
