INSPECTION REPORT

| Type of Inspection | Compliance Evaluation Inspection (CEI) | | |
| Company Name | PACCAR, Inc. | | |
| Facility or Site Name | Kenworth Truck Co Renton | | |

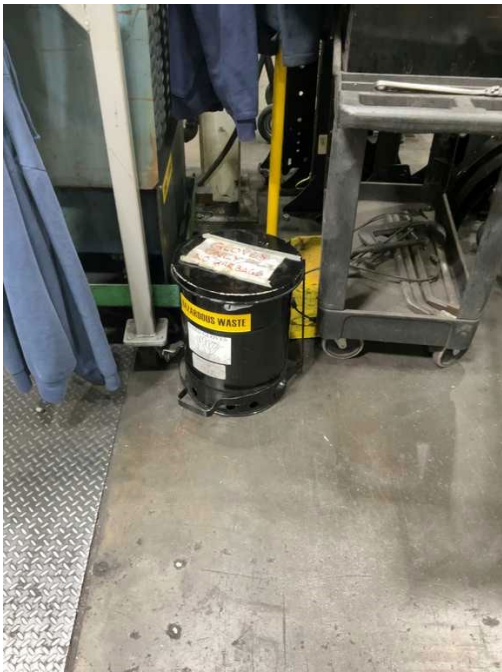
| [Title] | | | IMG-2023081810213021302323070.jpg |

| View of five-gallon SAA step-can with waste glove seen here preventing the lid from closing and making a complete seal with the container. | | | |

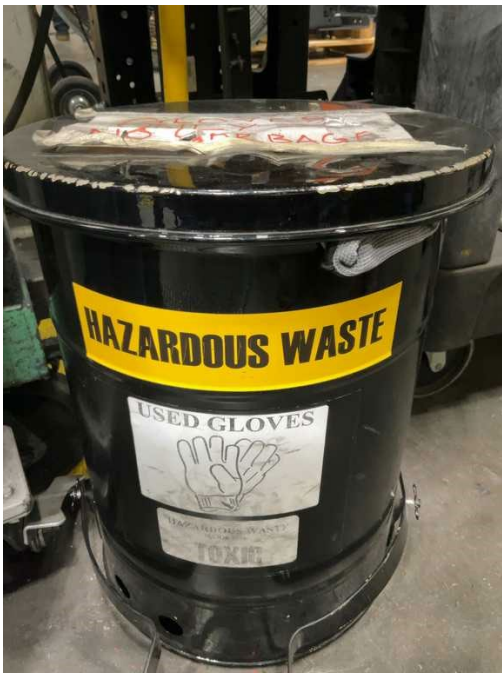
| [Title] | | | IMG-2023081810214021402345769.jpg |

| View (Blurry) of the five-gallon SAA step-can after being closed during the inspection. | | | |

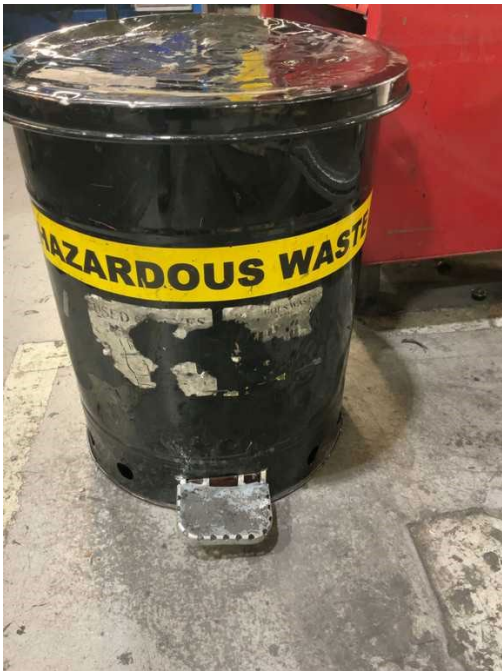
| [Title] | | | IMG-2023081810362636262455438.jpg |

| Close-up view of the SAA step-can, showing the bowed lid and lack of hazard/risk indicator. | | | |

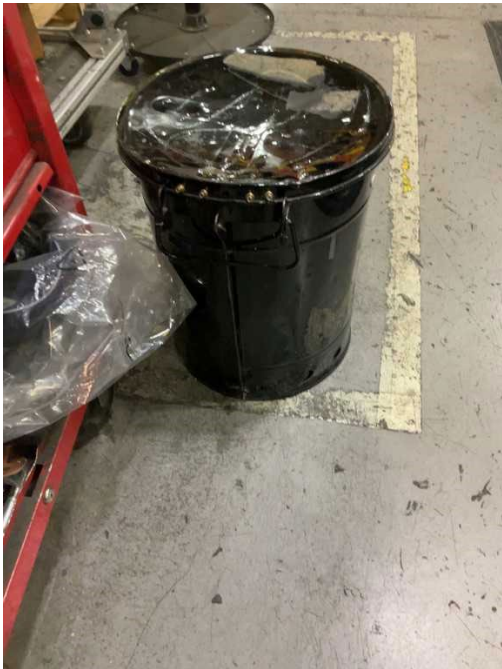
| [Title] | | | IMG-2023081810363436342440540.jpg |

| Another close-up view of the backside of the SAA step-can, showing the bowed lid and lack of hazard/risk indicator. | | | |

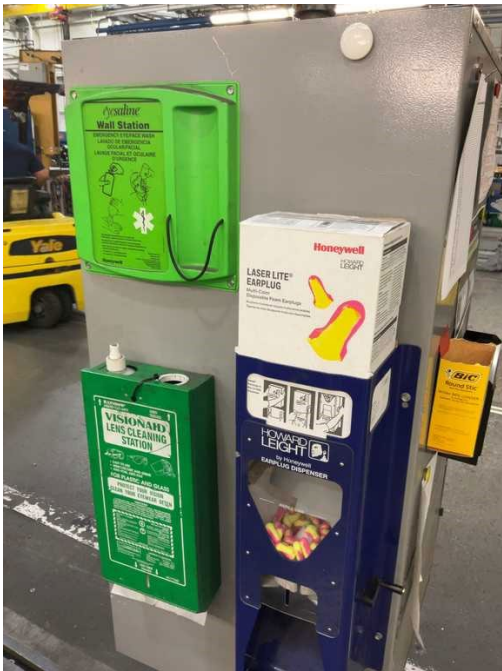
| [Title] | | | IMG-2023081810405840582590014.jpg |

| <p>While still on frame floor, we saw an emergency eye wash station between assembly lines that was a missing its eye wash bottle. According to facility personnel, they didn't know how long it had been missing.</p> <p>In the facility's "2023 EPA Areas of Concern" corrective action spreadsheet, Mr. Nelson stated, "Resolved during inspection - Fresh bottle of eye wash solution installed at the station." A photo was also included documenting this corrective action.</p> | | | |

| View of emergency eye wash station, seen here missing the bottle of eye wash. | | | |

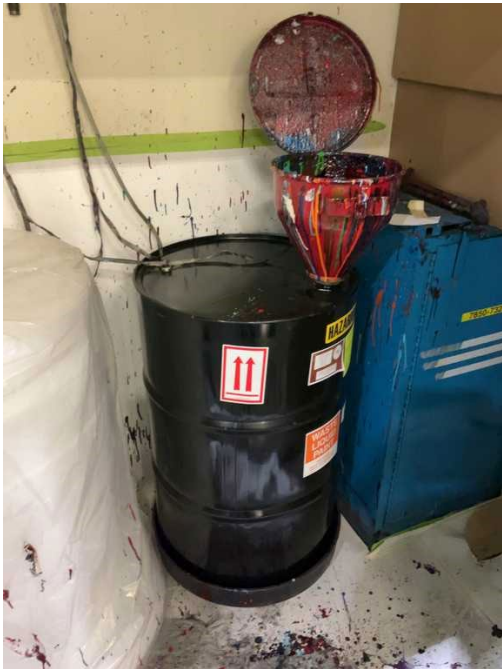
| [Title] | | | IMG-2023081810571457142155863.jpg |

| View of 55-gallon SAA container of waste liquid paint that has the funnel lid open, showing that the container was not closed. | | | |

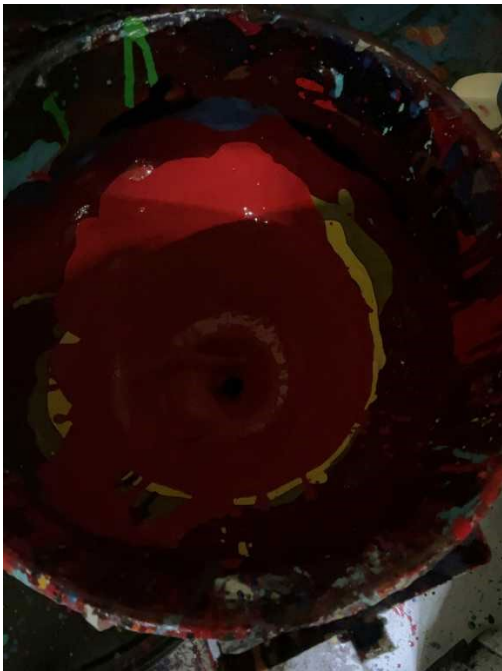
| [Title] | | | IMG-2023081810572957291988960.jpg |

| Close-up view of the labeling on the 55-gallon SAA container of waste liquid paint that was not closed. | | | |

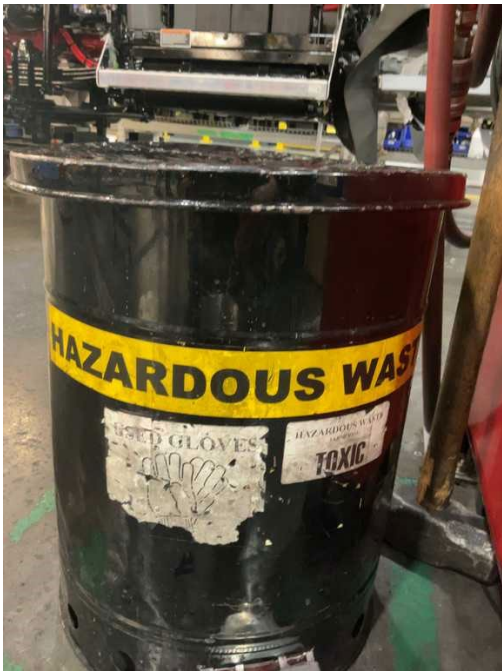
| [Title] | | | IMG-202308181110061062397778.jpg |

| Close-up view of five-gallon SAA for waste gloves was not closed. | | | |

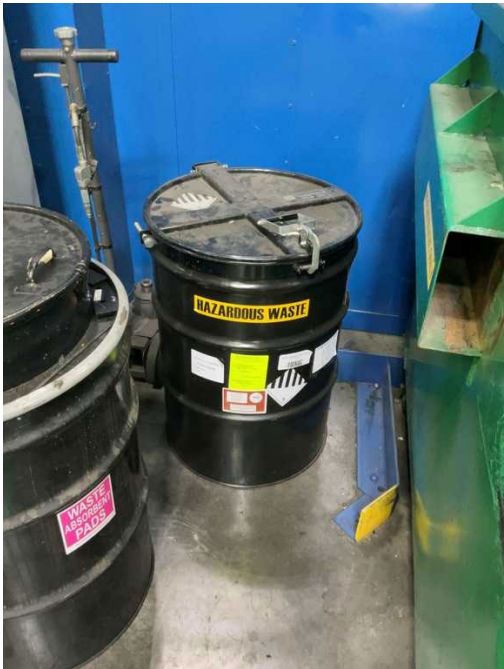
| [Title] | | | IMG-20230818112202222511799.jpg |

| View of 55-gallon accumulation container of waste gloves, on the south side of chassis oven, that was being mismanaged as a SAA container and was not marked with an accumulation start date or being inspected weekly. | | | |

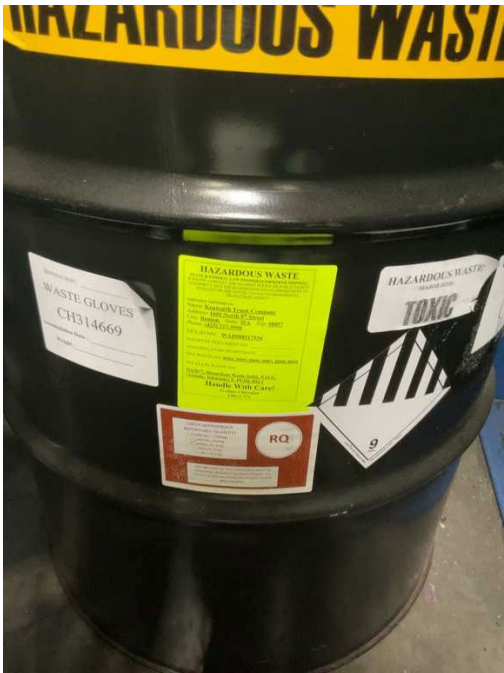
| [Title] | | | IMG-2023081811221222123029101.jpg |

| Another close-up view of the labeling on 55-gallon accumulation container of waste gloves, on the south side of chassis oven. | | | |

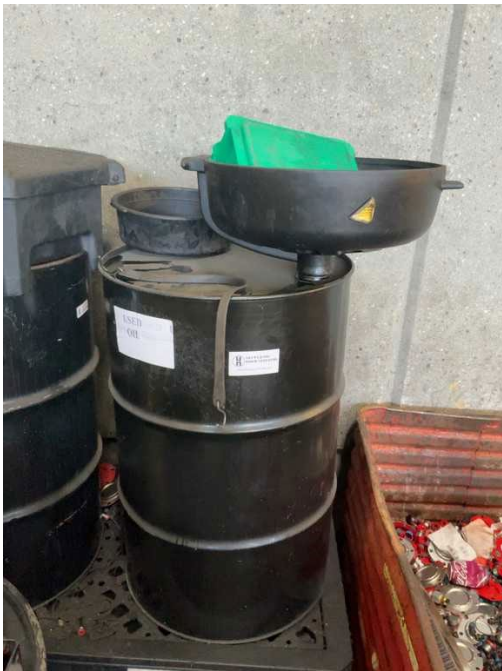
| [Title] | | | IMG-2023081811284528452868003.jpg |

While on loading Dock G, we saw a 55-gallon container the facility was using to collect used oil. At the time of the inspection, the 55-gallon used oil container was not closed. The container had a drum top funnel that was attached. The drum top funnel had a hinged lid at one time; however, at some point the lid had come off leaving the container open. Facility personnel searched the immediate area, trying to locate the lid, but it was nowhere to be found.

| View of 55-gallon used oil collection container that is seen here as not being closed. | | | |

In the facility's "2023 EPA Areas of Concern" corrective action spreadsheet, Mr. Nelson stated, "Funnel was replaced with one that has lid, lid was closed."

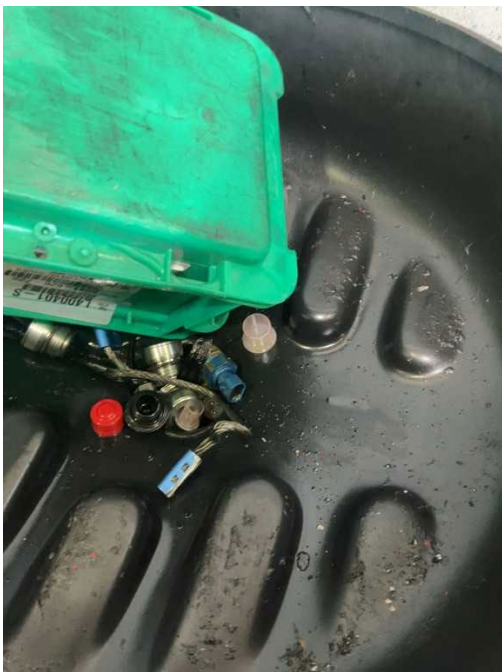
| [Title] | | | IMG-2023081811285728572364549.jpg |

| Close-up view into the attached funnel, showing that it is not closed. | | | |

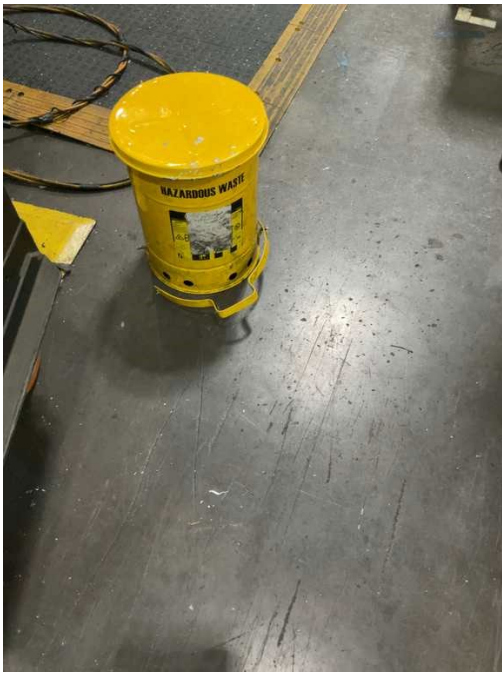
| [Title] | | | IMG-2023081811391139112452947.jpg |

| View of a five-gallon step-can containing a WA State only waste, designated as "Special Waste," that was mislabeled as "Hazardous Waste." | | | |

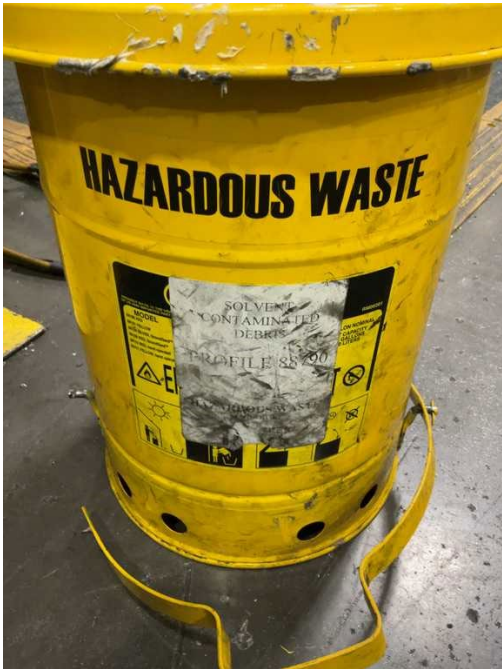
| [Title] | | | IMG-2023081811392139212443622.jpg |

| Close-up view of a five-gallon step-can containing a WA State only waste, designated as “Special Waste,” that was mislabeled as “Hazardous Waste.” | | | |

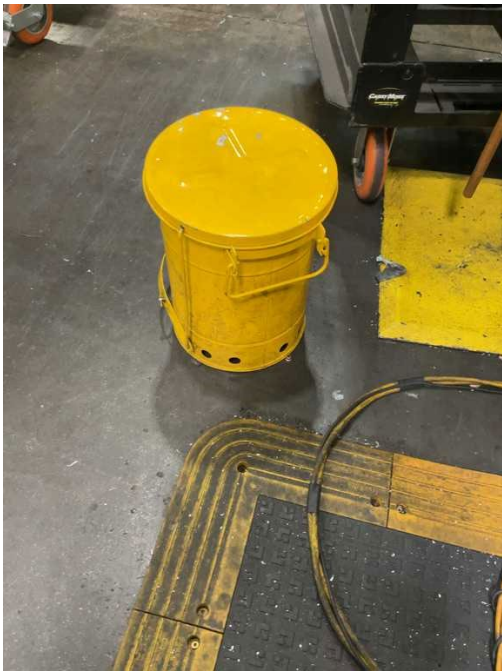
| [Title] | | | IMG-2023081811395939592518461.jpg |

| View of the back of the five-gallon step-can containing a WA State only waste, designated as “Special Waste,” that was mislabeled as “Hazardous Waste.” | | | |

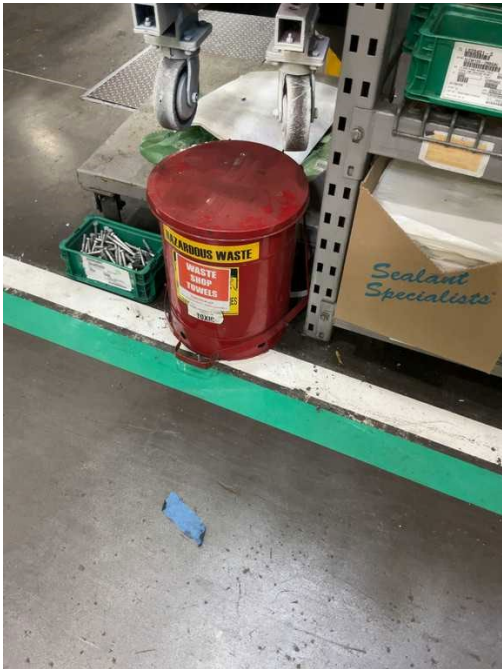
| [Title] | | | IMG-2023081811503450342827283.jpg |

| View of five-gallon SAA step-can container, holding waste shop towels, that is not closed. | | | |

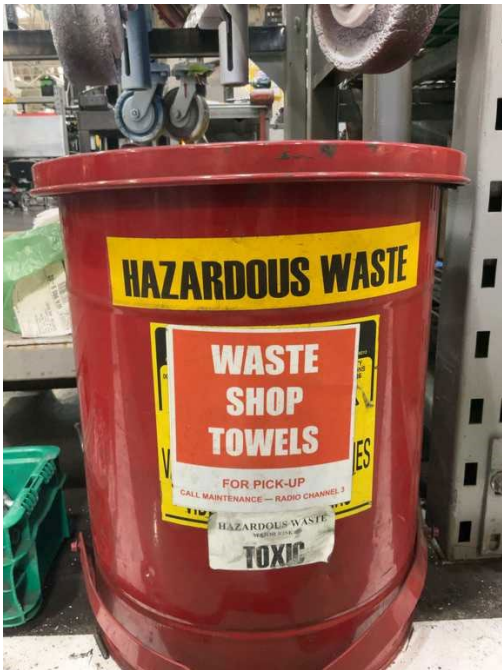
| [Title] | | | IMG-2023081811504150412530435.jpg |

| View of another five-gallon step-can that contains WA State only waste that is being managed as “Special Waste.” | | | |

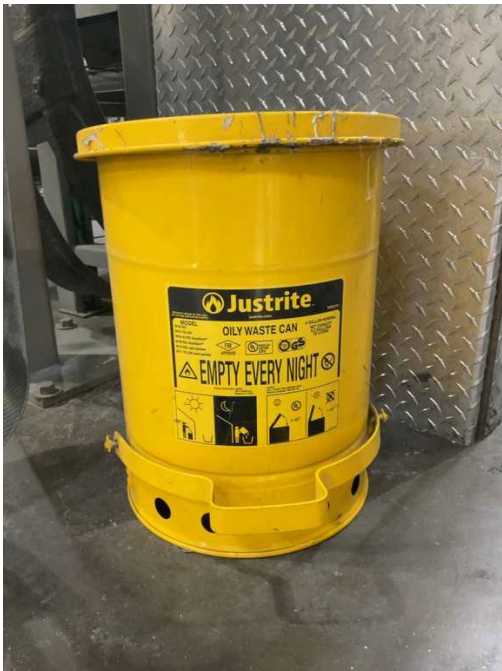
| [Title] | | | IMG-2023081811591659162383440.jpg |

| Close-up view of WA State only waste that is being managed as “Special Waste.” | | | |

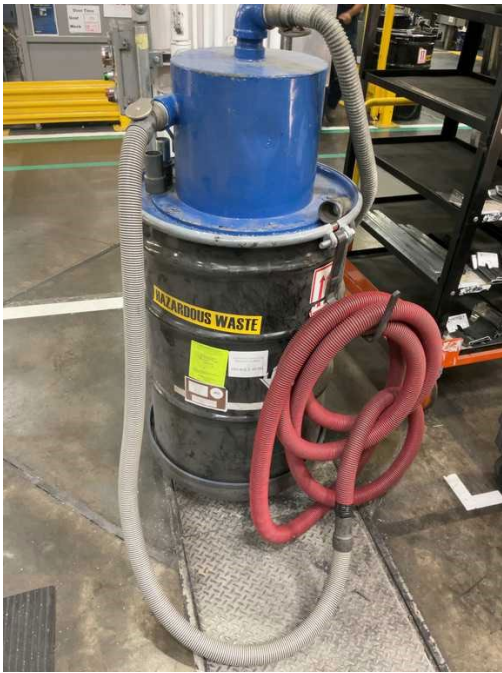
| [Title] | | | IMG-202308181203573572916199.jpg |

While in the Sleeper build line, we saw a 55-gallon SAA container that held waste central vacuum system debris (CVSD). At the time of the inspection, the container was not marked with a hazard/risk indicator.

| View of 55-gallon SAA container of waste central vacuum system debris (CVSD), seen here not marked with a hazard/risk indicator. | | | |

In the facility's "2023 EPA Areas of Concern" corrective action spreadsheet, Mr. Nelson stated, "Resolved during inspection. Toxic risk label added to drum." A photo was included to show that the facility had labeled the container with a hazard/risk indicator.

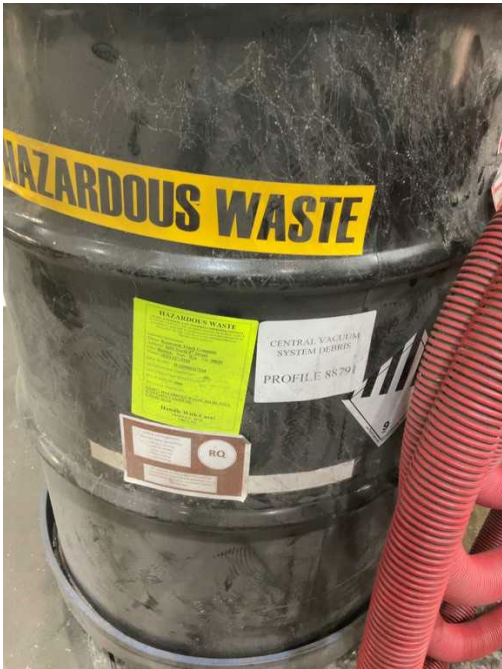
| [Title] | | | IMG-20230818120404442809167.jpg |

| Close-up view of 55-gallon SAA container of waste central vacuum system debris (CVSD), seen here not marked with a hazard/risk indicator. | | | |

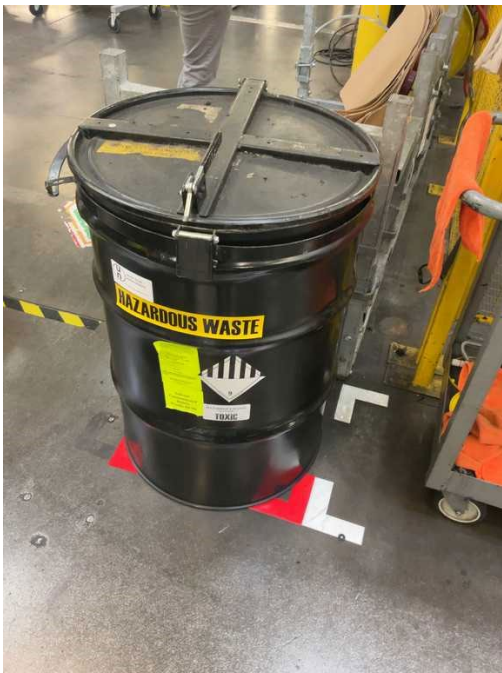
| [Title] | | | IMG-202308181224022422627685.jpg |

| Close-up view of 55-gallon SAA container of waste solvent contaminated debris showing that the lid is not fully closed. | | | |

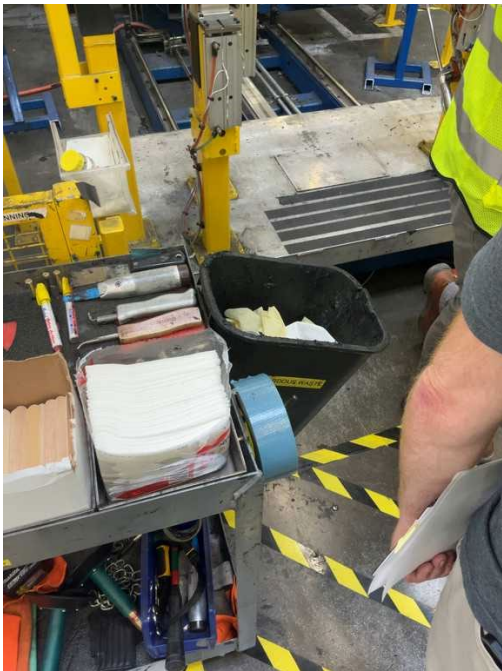
| [Title] | | | IMG-2023081812281328132751506.jpg |

While in the Cab Trim area of the Assembly Building, we saw a small black plastic trash receptacle with an approximately five-gallon capacity. Personnel in the area were using the trash receptacle as an SAA container. We could see that the container held some sort of used wipes. According to Mr. Nelson, the container held wipes that were contaminated with deodorized mineral spirits. At the time of the inspection, the container was labeled with the words, "Hazardous Waste," but the container was not closed and not marked with a hazard/risk indicator. At the time of the inspection, the contents of this SAA container (when full) were being transferred to another, larger (55-gallon) SAA container.

| View of small black plastic trash receptacle, seen here being used as a SAA container for waste solvent contaminated debris with no hazard/risk label and not closed. | | | |

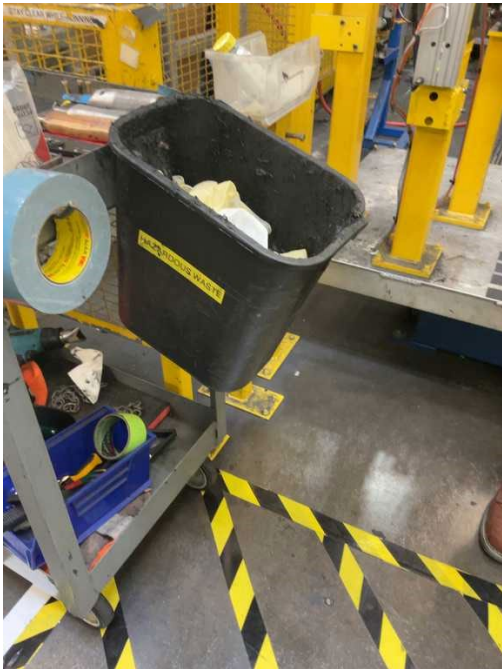
| [Title] | | | IMG-2023081812282528252165140.jpg |

| Another view of small black plastic trash receptacle, seen here being used as a SAA container for waste solvent contaminated debris with no hazard/risk label and not closed. | | | |

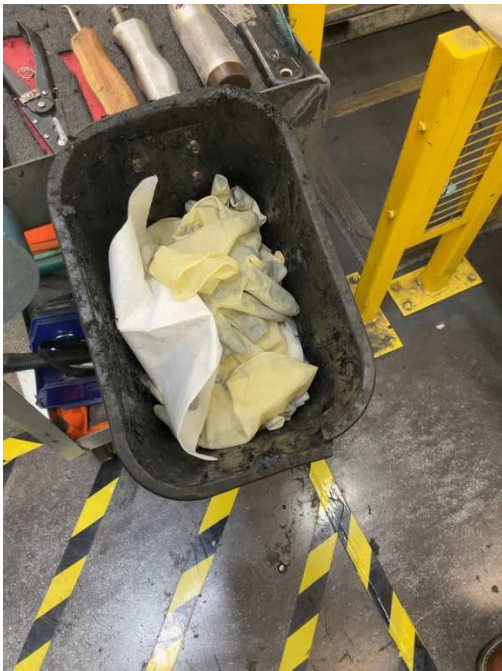
| [Title] | | | IMG-2023081812283128312873725.jpg |

| Another view of small black plastic trash receptacle, seen here being used as a SAA container for waste solvent contaminated debris with no hazard/risk label and not closed. | | | |

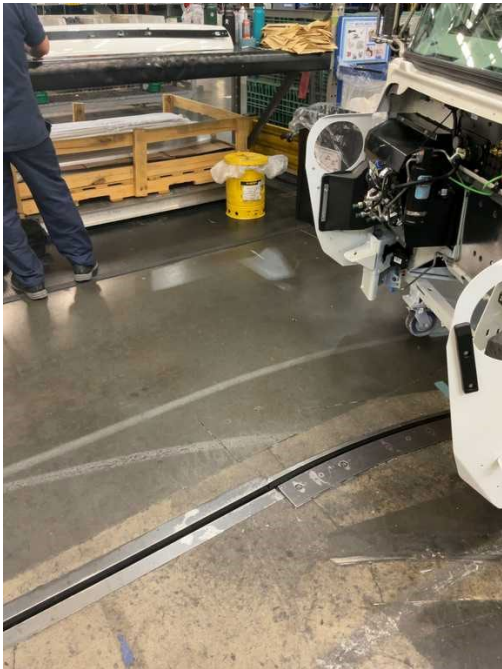
| [Title] | | | IMG-2023081812333933392594340.jpg |

| View of yellow, SAA step-can for waste solvent contaminated debris, but containing waste gloves and not closed. | | | |

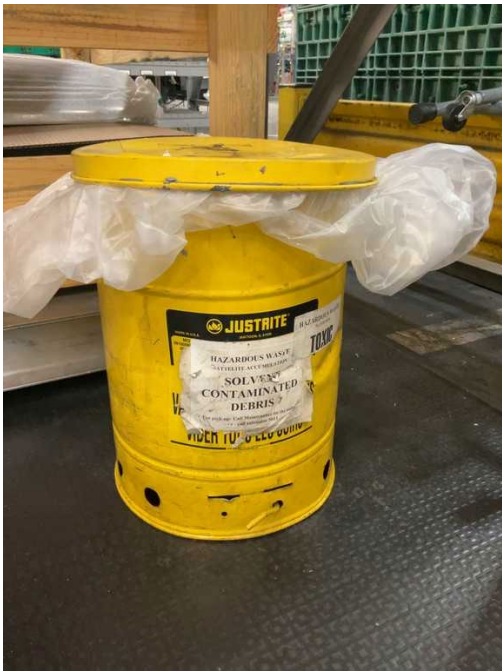
| [Title] | | | IMG-2023081812334633462510349.jpg |

| View of waste gloves in yellow, SAA step-can for waste solvent contaminated debris. | | | |

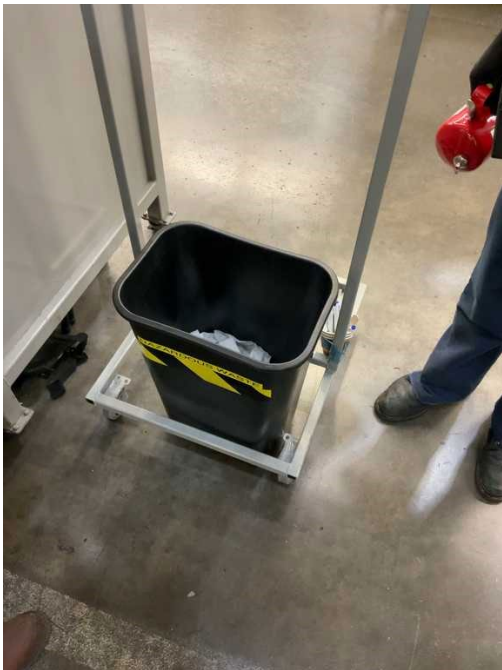
| [Title] | | | IMG-2023081812383138312219400.jpg |

| View of Plastic open-top (no lid) garbage can, being used as SAA container for waste solvent contaminated debris, seen here not closed and not marked with a hazard/risk indicator. | | | |

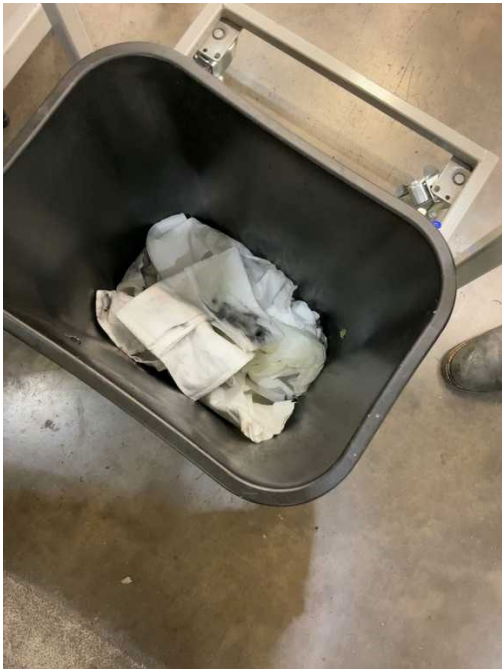
| [Title] | | | IMG-2023081812383538352262473.jpg |

| View of waste solvent contaminated debris in plastic open-top (no lid) garbage can, being used as SAA container, seen here not closed and not marked with a hazard/risk indicator. | | | |

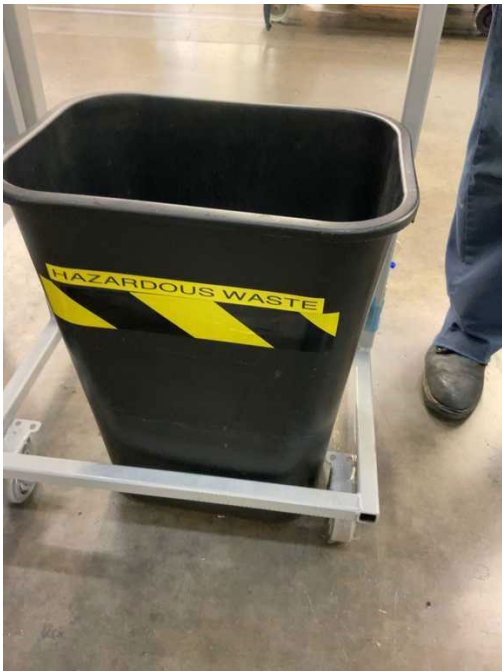
| [Title] | | | IMG-2023081812383938392236772.jpg |

| Another view of Plastic open-top (no lid) garbage can, being used as SAA container for waste solvent contaminated debris, seen here not closed and not marked with a hazard/risk indicator. | | | |

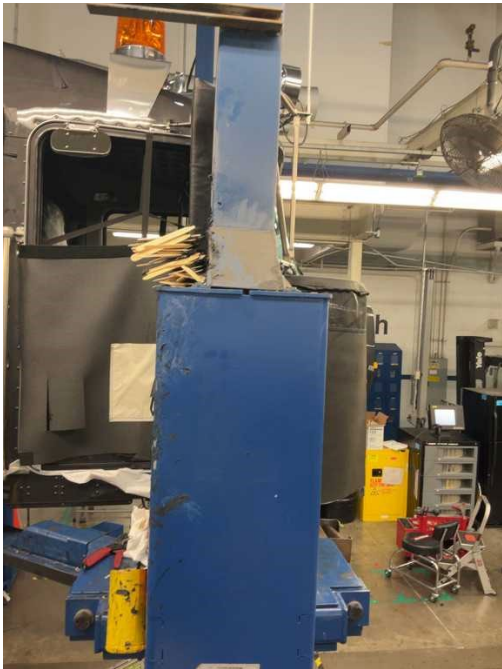
| [Title] | | | IMG-2023081812463846382371937.jpg |

| <p>While inspecting the West Cab Buck area we saw that facility personnel working in this area had been placing wooden popsicle sticks contaminated with hazardous waste sealant onto the cab buck. These wooden popsicle sticks contaminated with hazardous waste sealant were found stuck to the frame of the cab buck. We also saw that it looked as though waste sealant had been smeared/wiped onto the frame of the cab buck. At the time of the inspection, the waste was not containerized.</p> <p>In the facility's "2023 EPA Areas of Concern" corrective action spreadsheet, Mr. Nelson stated, "Operators were informed to dispose sealant sticks properly in the Solvent Contaminated Debris container, nearby."</p> | |

| View of wooden popsicle sticks contaminated with hazardous waste sealant found stuck to the frame of the cab buck. | | | |

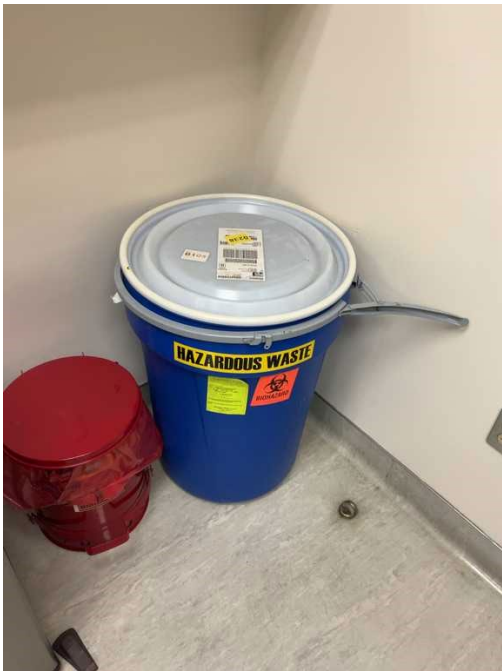
| [Title] | | | IMG-2023081812533453342228869.jpg |

| <p>While in the on-site medical clinic, we saw a blue, 10-to-12-gallon, poly container of dual waste in their SAA that was not marked with a hazard/risk indicator. The container ring was not attached and closed; however, the lid was attached and made a complete seal with the top of the container.</p> <p>In the facility's "2023 EPA Areas of Concern" corrective action spreadsheet, Mr. Nelson stated, "Risk label was put on." The spreadsheet also included a photo documenting the corrective action.</p> | | | |

| View of the SAA container for dual waste, in the medical clinic, seen here with no hazard/risk indicator. | | | |

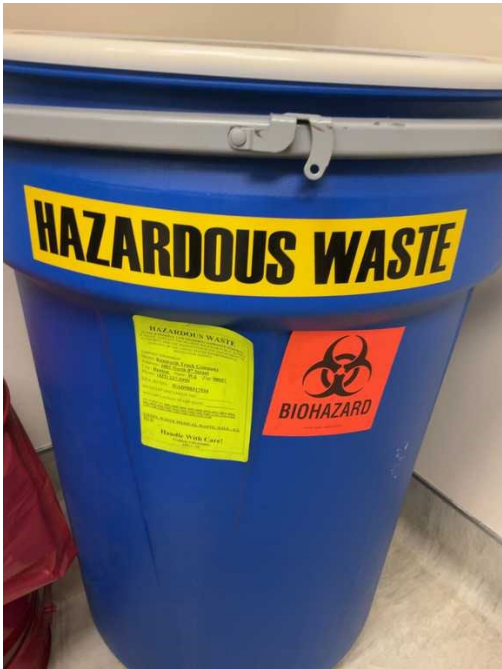
| [Title] | | | IMG-2023081812533953391993759.jpg |

| Close-up view of the SAA container for dual waste, in the medical clinic, seen here with no hazard/risk indicator. | | | |

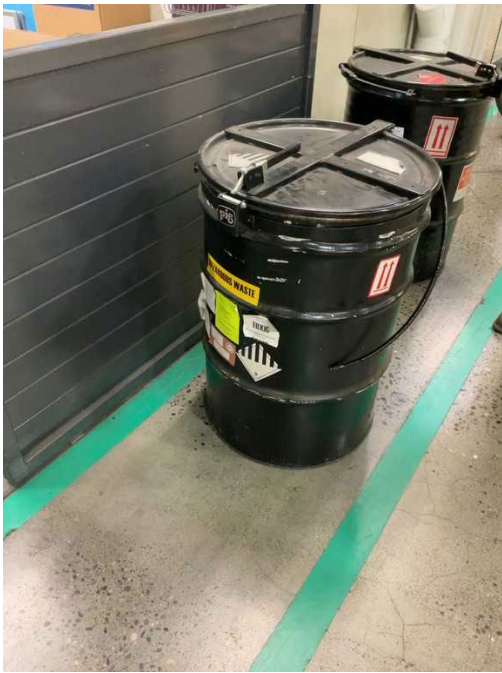
| [Title] | | | IMG-202308181305115112705145.jpg |

| Another view of 55-gallon waste glove accumulation container, seen here without an ASD and not closed. | | | |

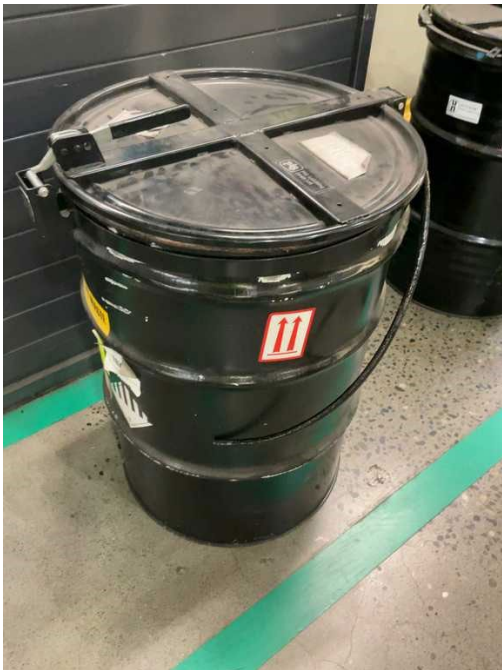
| [Title] | | | IMG-202308181305265262532627.jpg |

| View of 55-gallon waste glove accumulation container that is not marked with an ASD and not being inspected weekly. | | | |

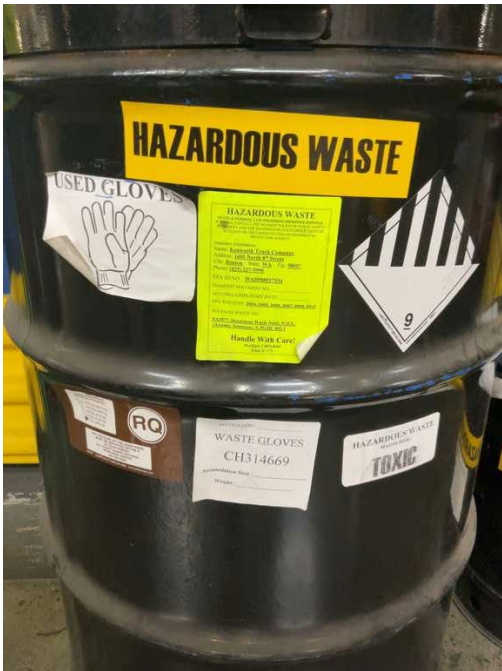
| [Title] | | | IMG-2023081813173917393016644.jpg |

| Another close-up view of 55-gallon waste glove accumulation container that is not marked with an ASD and not being inspected weekly. | | | |

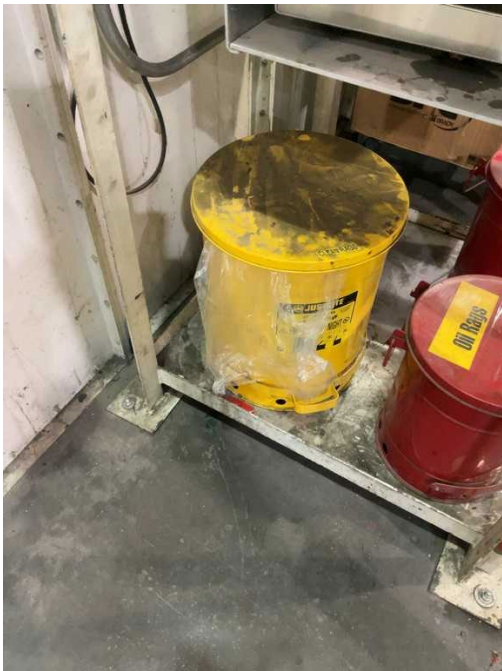
| [Title] | | | IMG-2023081813235823582641531.jpg |

While inspecting this area, we saw a yellow, 10-gallon step-can that held a pair of waste gloves. At the time of the inspection, step-can was labeled with the words "Clean Rags" and not labeled with the words "Hazardous Waste" or marked with a hazard/risk indicator.

| View of yellow five-gallon step-can that contains a pair of waste gloves. | | | |

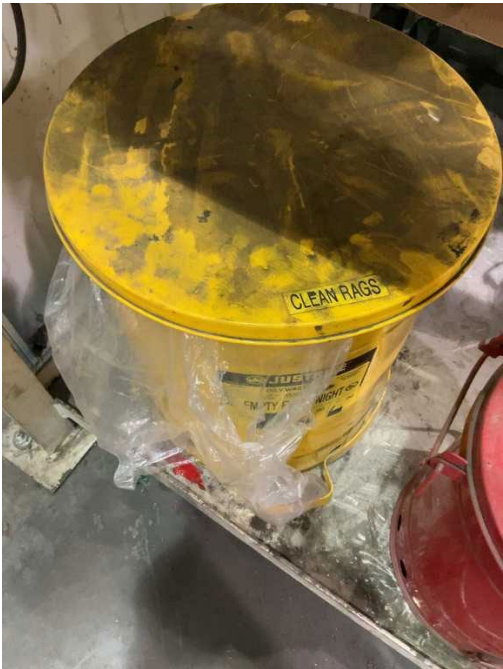
| [Title] | | | IMG-202308181324052452736139.jpg |

| Close-up view of yellow five-gallon step-can that contains a pair of waste gloves and is seen here labeled as "Clean Rags.". | | | |

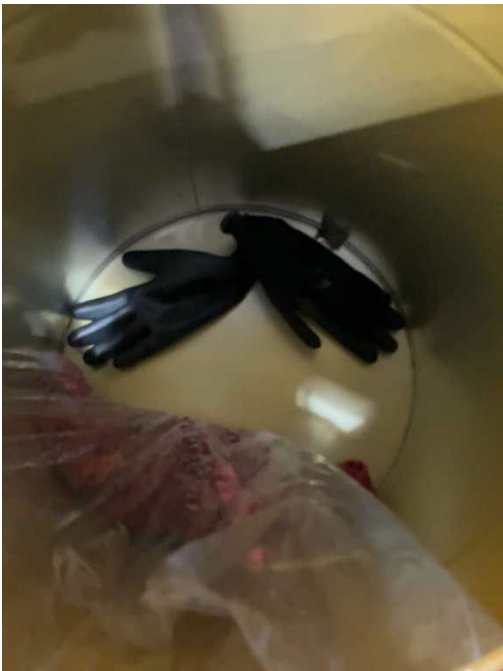
| [Title] | | | IMG-2023081813241324132128525.jpg |

| View of waste gloves in yellow five-gallon step-can. | | | |

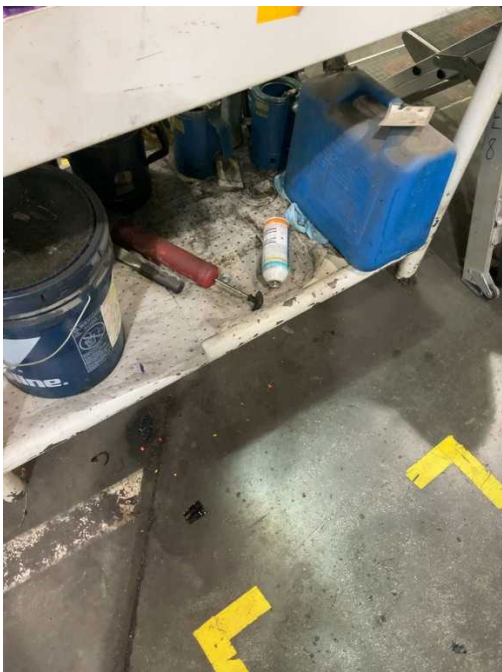
| [Title] | | | IMG-2023081813282428242591769.jpg |

| View of waste aerosol can. | | | |

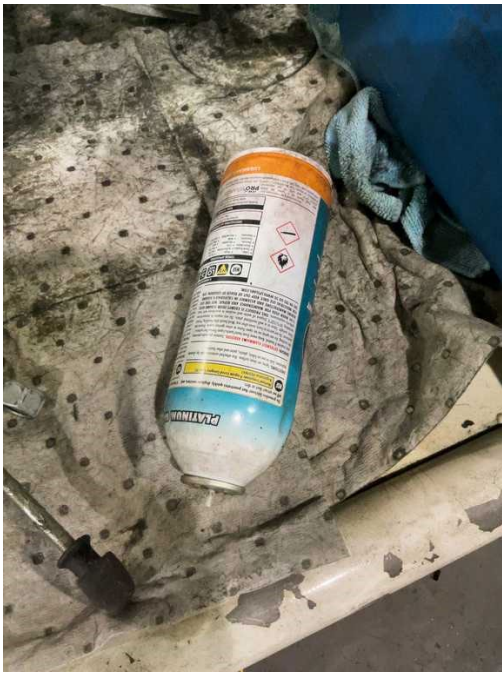
| [Title] | | | IMG-2023081813283128313081343.jpg |

| Another close-up view of waste aerosol can. | | | |

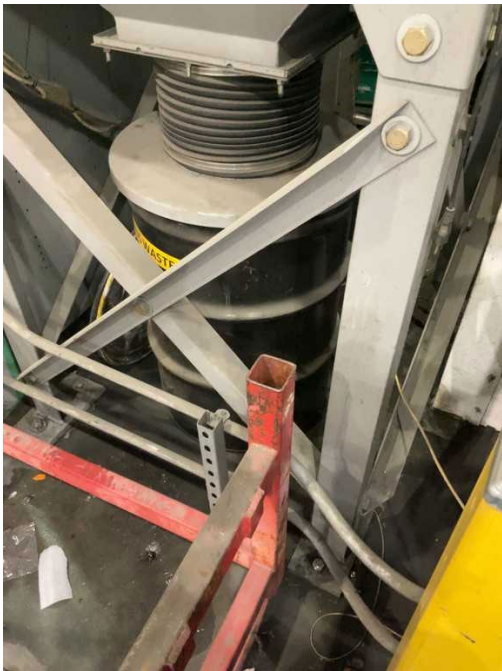
| [Title] | | | IMG-2023081813355235522446192.jpg |

| Another view of 55-gallon container labeled “Hazardous Waste” for collection of particulates from dust collector equipment, seen here with no hazard/risk indicator. | | | |

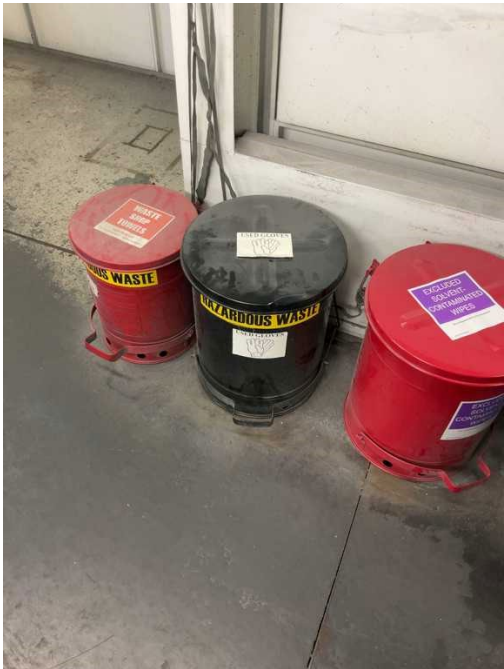
| [Title] | | | IMG-2023081813495149512453694.jpg |

| View of SAA step-can (Black) for waste gloves, seen here without a hazard/risk indicator. | | | |

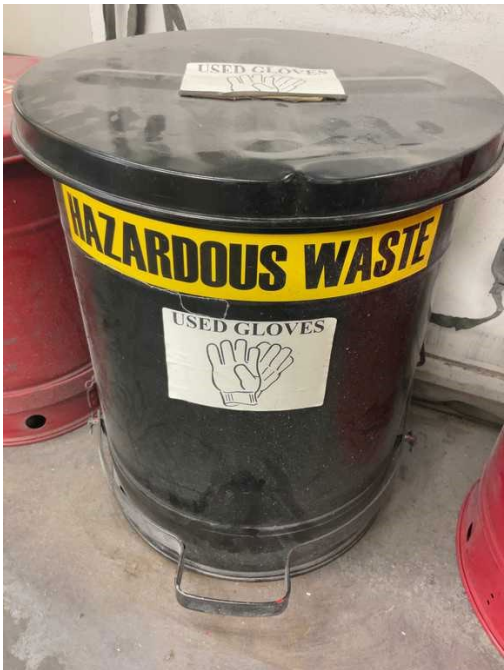
| [Title] | | | IMG-2023081813495649562334095.jpg |

| Close-up view of SAA step-can (Black) for waste gloves, seen here without a hazard/risk indicator. | | | |

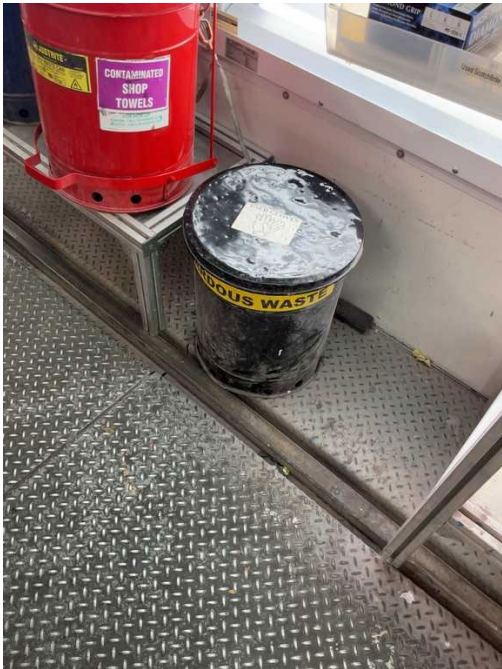
| [Title] | | | IMG-2023081813572157213300931.jpg |

| View of SAA step-can (Black) for waste gloves, seen here without a hazard/risk indicator. | | | |

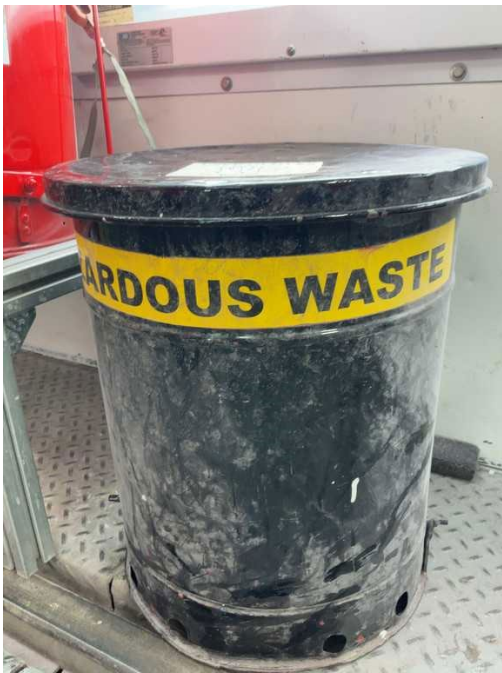
| [Title] | | | IMG-2023081813572757272843162.jpg |

| Close-up view of SAA step-can (Black) for waste gloves, seen here without a hazard/risk indicator. | | | |

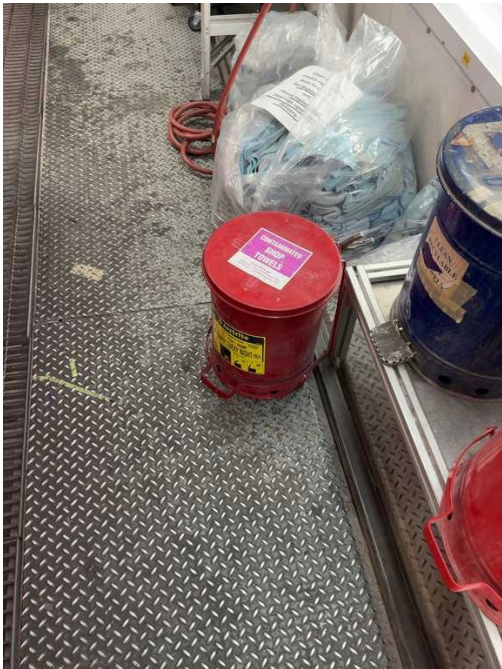
| [Title] | | | IMG-2023081813593459344019847.jpg |

We also saw a six-gallon SAA step-can container of waste shop towels that was not marked with the words "Hazardous Waste" or a hazard/risk indicator.

| View of SAA step-can (Red) for waste shop towels, seen here without “Hazardous Waste” and hazard/risk indicator labels. | | | |

In the facility's "2023 EPA Areas of Concern" corrective action spreadsheet, Mr. Nelson stated, "Waste glove can was replaced with functional lid that could be fully closed. The new container was labeled properly." For the Waste Shop Towel container, Mr. Nelson stated, "Proper labels were placed on the container." Photo documentation was also included, showing the corrective action taken.

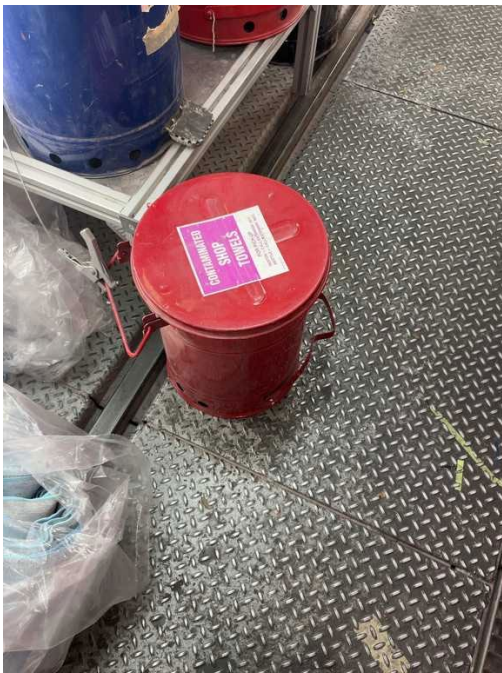
| [Title] | | | IMG-2023081813594259424436592.jpg |

| Another view of SAA step-can (Red) for waste shop towels, seen here without “Hazardous Waste” and hazard/risk indicator labels. | | | |

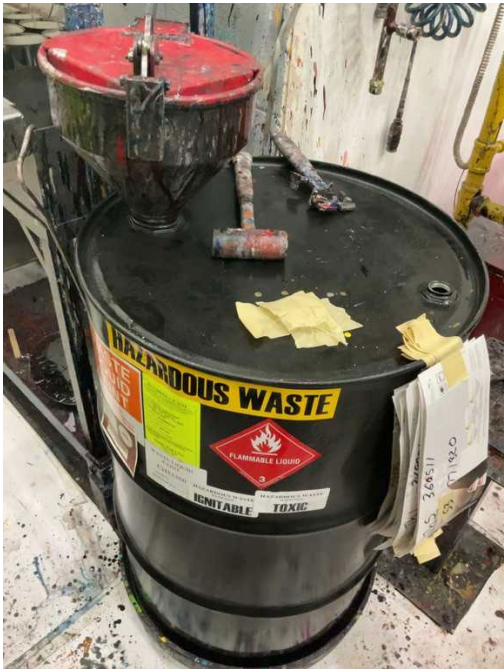
| [Title] | | | IMG-202308181410051052677016.jpg |

While inspecting this area, we saw a 55-gallon SAA container of waste liquid paint. At the time of the inspection, the container was not closed. The small bung plug was missing and not screwed into the bung.

| View of 55-gallon SAA container for waste liquid paint, seen here not closed with small bung wide open. | | | |

In the facility's "2023 EPA Areas of Concern" corrective action spreadsheet, Mr. Nelson stated, "The small bung was put back in position and closed. Informed employee and department manager to make sure all hazardous waste containers have to be fully closed."

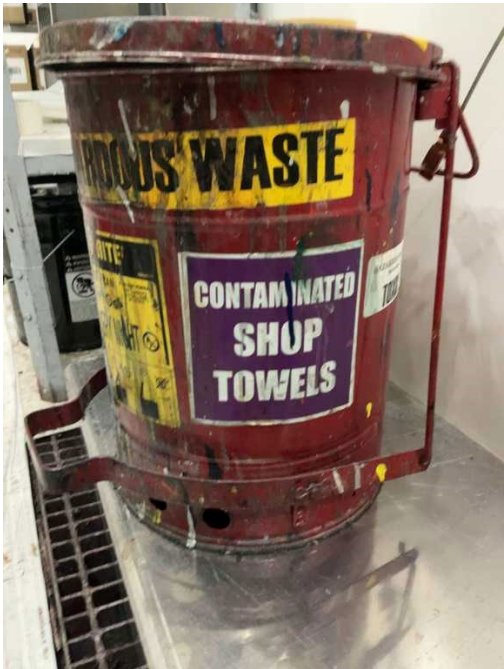
| [Title] | | | IMG-2023081814135513552285549.jpg |

| Close-up view of SAA step-can (Red), for waste solvent contaminated debris (shop towels), that is not closed. | | | |

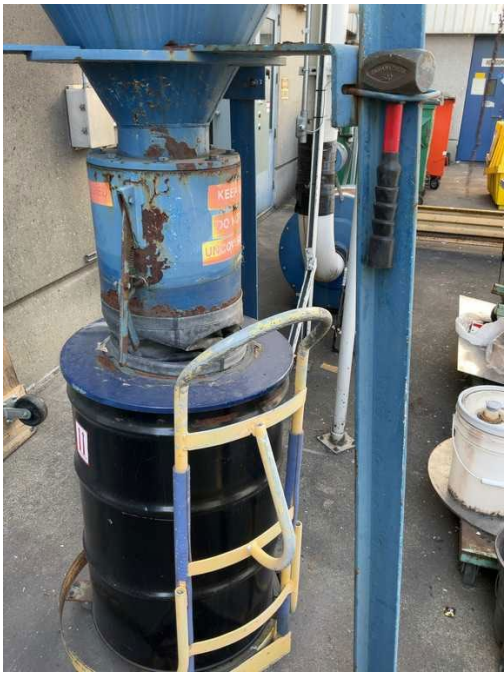
| [Title] | | | IMG-202308181423002303511107.jpg |

While in this area, just outside the building, we saw a 55-gallon SAA container for waste particulate that was connected to a cyclone separator. At the time of the inspection, the waste container was labeled with the words "Hazardous Waste," and a Class 9 DOT label, but was not marked with a hazard/risk indicator that was specific to the hazard/risk.

| View of 55-gallon SAA container for waste particulate under cyclone separator, seen here missing a hazard/risk indicator. | | | |

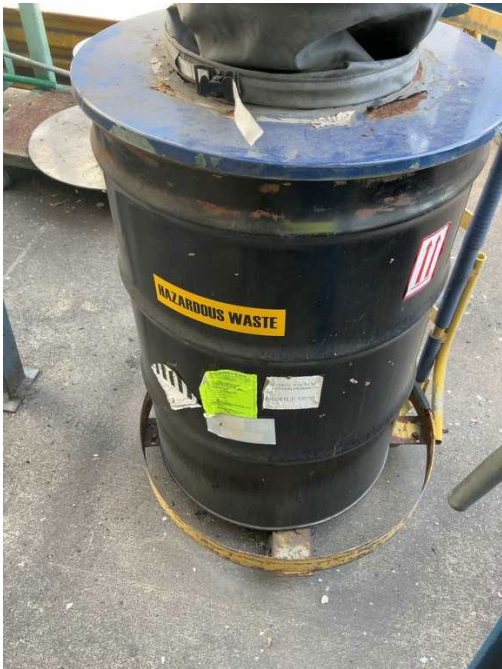
| [Title] | | | IMG-2023081814231023104042312.jpg |

| Another view of 55-gallon SAA container for waste particulate under cyclone separator, seen here missing a hazard/risk indicator. | | | |

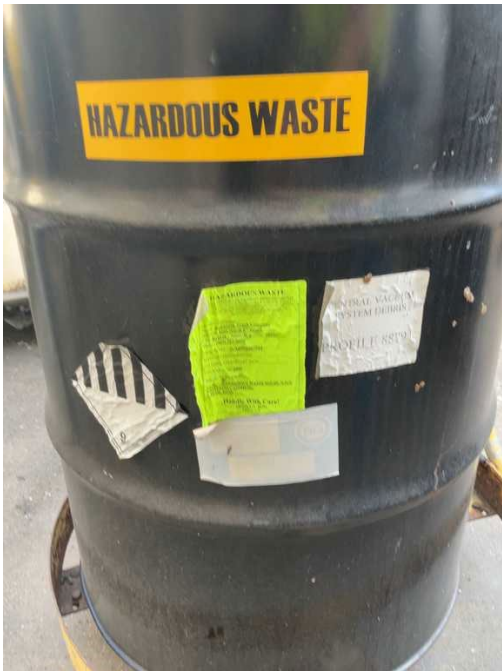
| [Title] | | | IMG-2023081814231723172754167.jpg |

| Close-up view of 55-gallon SAA container for waste particulate under cyclone separator, seen here missing a hazard/risk indicator. | | | |

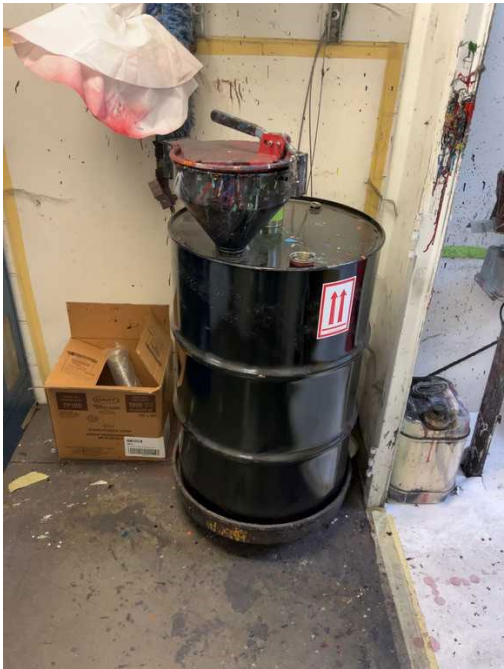
| [Title] | | | IMG-2023081814323632362448237.jpg |

| View of 55-gallon SAA container for waste liquid paint, seen here not closed (both small bung and funnel open). | | | |

In the facility's "2023 EPA Areas of Concern" corrective action spreadsheet, Mr. Nelson stated, "Resolved during inspection - Bung replaced and funnel closure device latched."

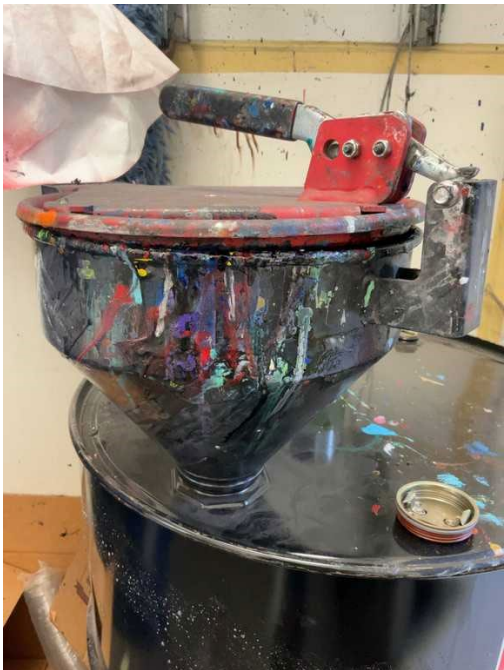
| [Title] | | | IMG-2023081814324232422534772.jpg |

| Another close-up view of 55-gallon SAA container for waste liquid paint, seen here with small bung not closed, due to bung plug being mis threaded. | | | |

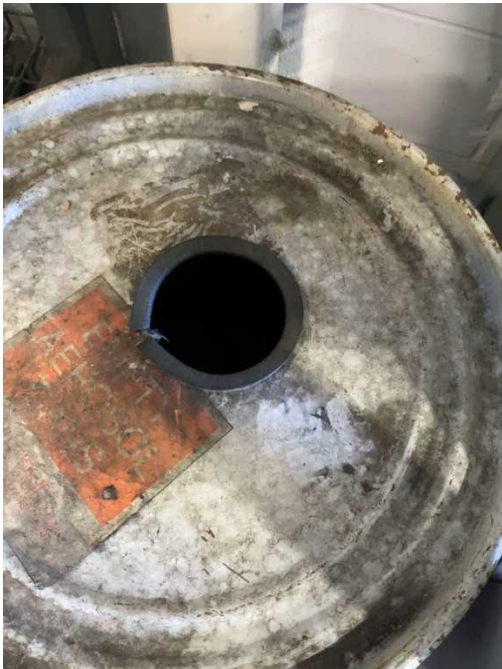
| [Title] | | | IMG-2023081814394639462496240.jpg |

| Close-up view of 20-gallon SAA container for waste aerosol cans, seen here not closed due to hole in lid. | | | |

“Hazardous Waste,” and not marked with a hazard/risk indicator. Mr. Nelson removed the waste aerosol can and placed it into another 55-gallon SAA container for that waste and removed the 15-gallon container from service during the inspection.
