INSPECTION REPORT

| Type of Inspection | Compliance Evaluation Inspection (CEI) | | |
| Company Name | PACCAR, Inc. | | |
| Facility or Site Name | Kenworth Truck Co Renton | | |

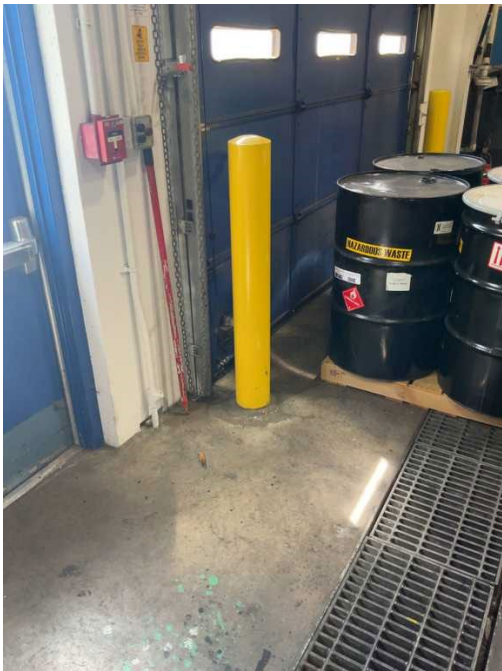
| [Title] | | | IMG-2023081814515751572488144.jpg |

| Another view of pallet with four hazardous waste containers seen here with two of the four containers outside of the containment area. | | | |
