**Region 6 - Enforcement & Compliance Assurance Division**  
**INSPECTION REPORT**

| Inspection Date(s): | 07/06/2022 | |
| Company Name: | McCann Resources, Inc | |
| Facility Name: | Bowring Lease | |

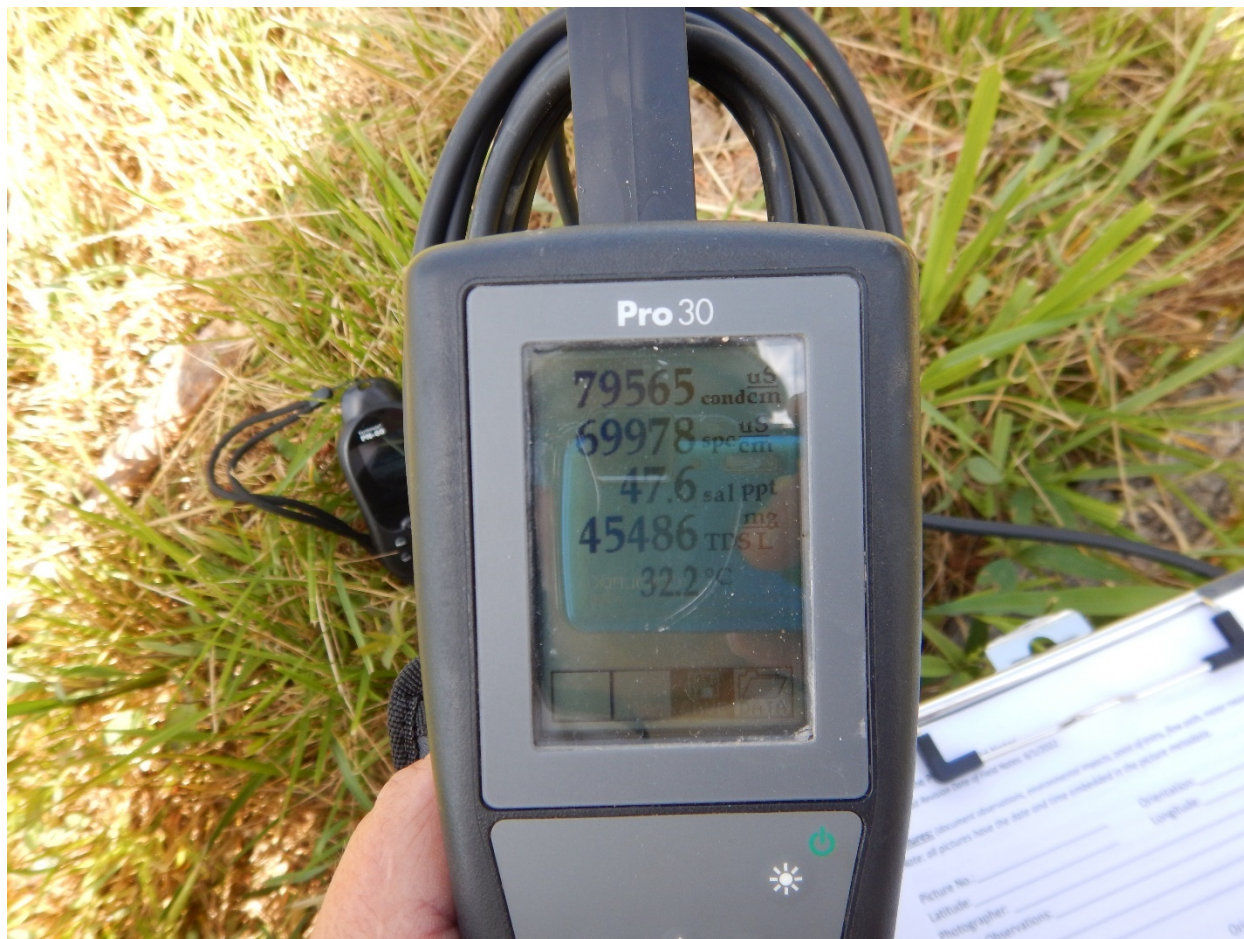
Photo No. 1

I observed the highest elevated TDS field reading of the inspection, 45,486 mg/L, in the main channel of the unnamed tributary at the POE, the field reading was documented in Photo No. 1. The POE and receiving pool of water were documented in Photo No. 2. I observed oil absorbent pads along the bank of the tributary as well as floating on the surface of the tributary. The oil absorbent pads were located approximately 25 feet downstream from the POE and were documented in Photo No. 3. I observed an elevated TDS field reading of 3,450 mg/L in the main channel of the impacted tributary, approximately 75 feet downstream (GPS 36.870960, -96.125361) from the POE, this was documented in Photo No. 4. I observed an elevated TDS field reading of 2,851 mg/L approximately 150 feet downstream (GPS 36.871103, -96.125060). I also observed oil absorbent pads and a floating, oil absorbent containment boom on the impacted tributary at the same location, observations from this location were documented in Photos No. 5 & 6.

**Description:** This was an elevated Total Dissolved Solids (TDS) field reading of 45,486 mg/L taken at the Release Point / Point of Entry (POE) in the pool where the produced water (brine and oil) entered the unnamed tributary of Mission Creek. This field reading and all others included in this report/photo log were taken with a properly calibrated YSI Pro 30 conductivity meter.

EPA Region 6 inspector conducted a conference call with Mark McCann which began at 1:52 PM on 07/06/2022. I conveyed my primary area of concern which was the removal of all water from the pool of water at the Point of Entry into the unnamed tributary which measured 45,486 mg/L during the inspection. I also conveyed the need to continue removing waters with elevated TDS from areas downstream from the POE. I requested Mr. McCann remove a small pool of trapped oil which was located near the POE on a small gravel bar and continue to clean areas of oil staining around the POE.

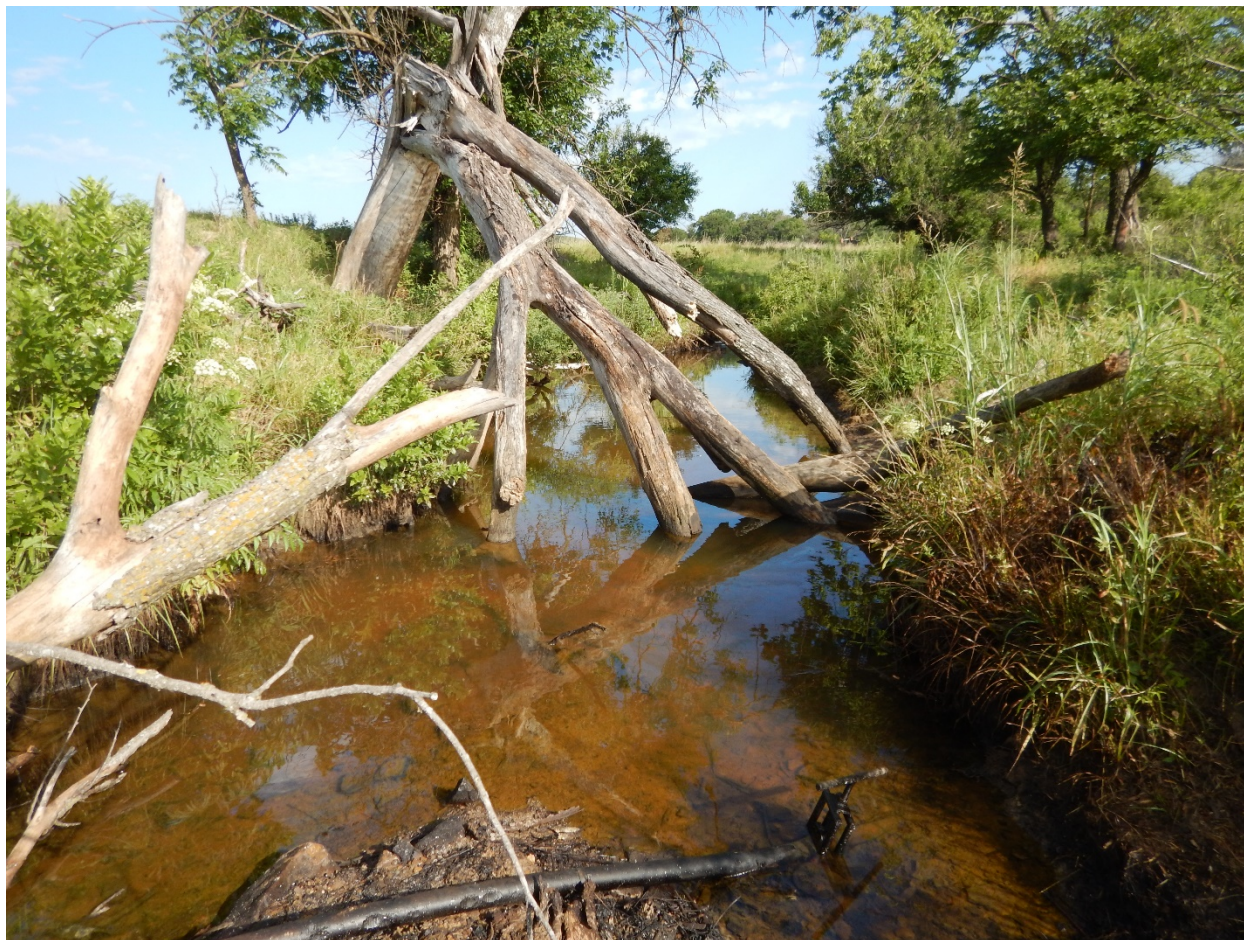
Photo No. 2

**Description:** This was a photo taken at the Release Point / POE, with a view looking toward the west (upstream). The pool of water pictured above was the location of the highest observed TDS field reading measuring 45,486 mg/L.

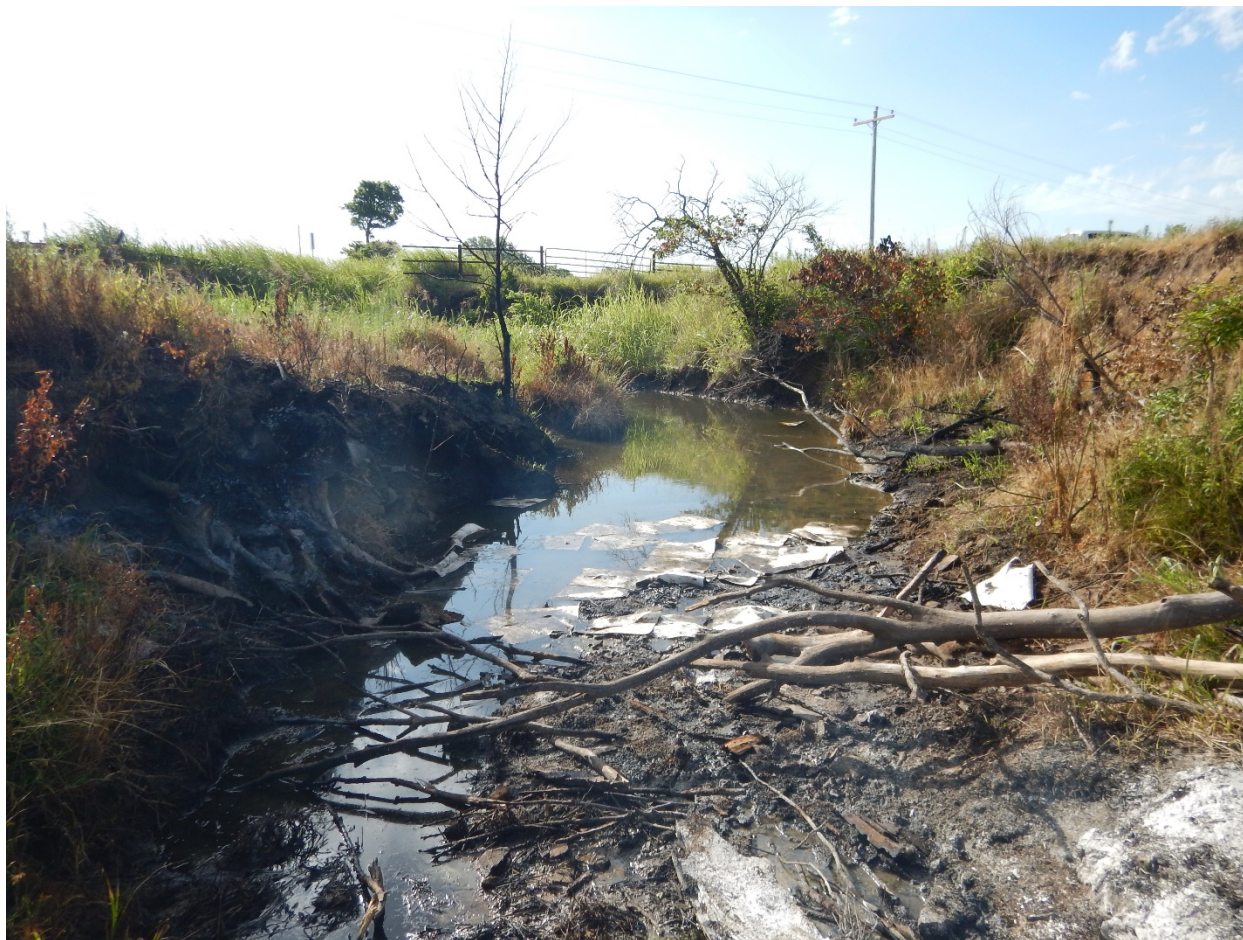
Photo No. 3

**Description:** This was a photo taken from the Release Point/POE, with a view looking downstream. Oil absorbent pads were observed on the water and bank.

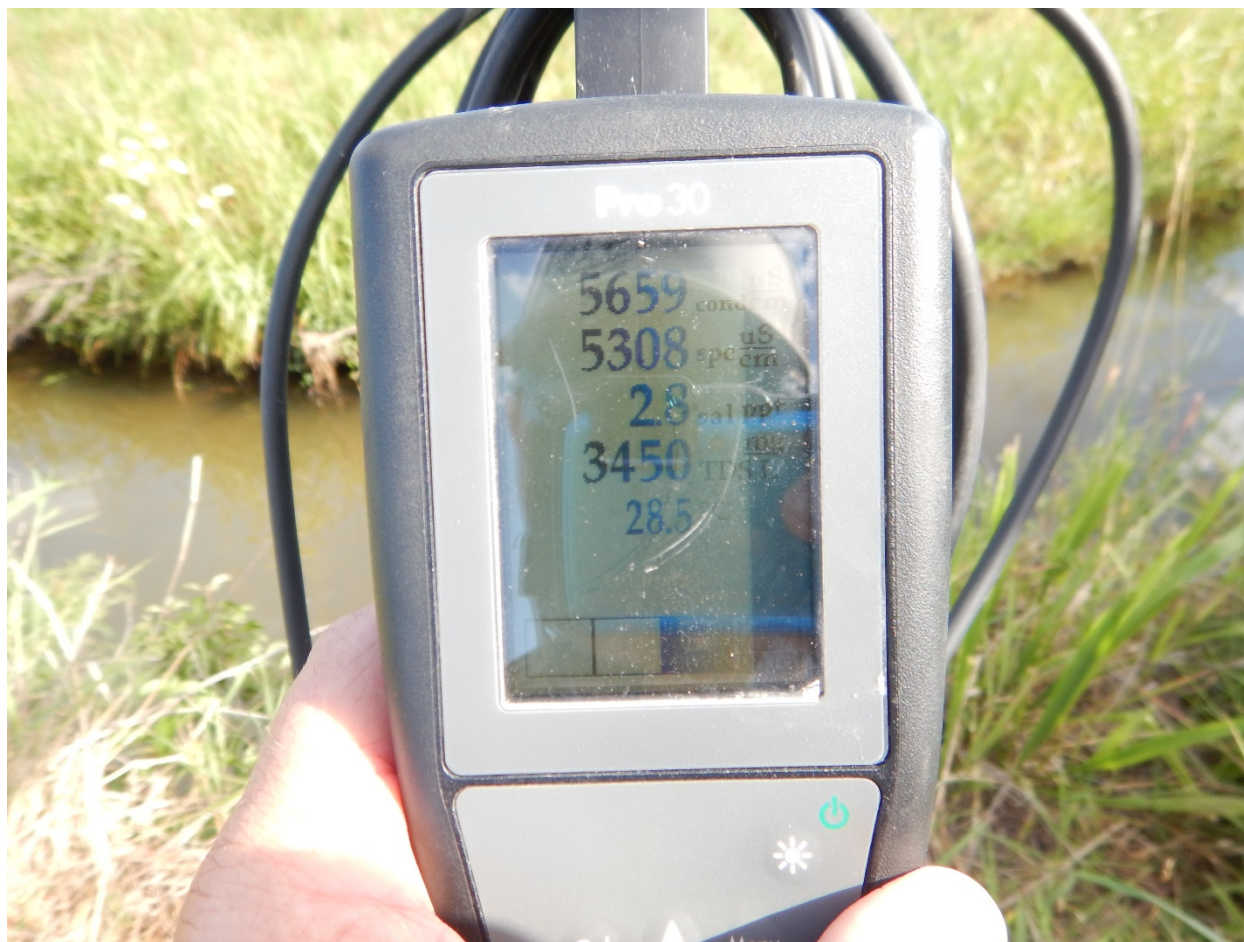
Photo No. 4

**Description:** This was an elevated TDS field reading of 3,450 mg/L taken in the main channel of the impacted tributary approximately 75 feet downstream from the POE.

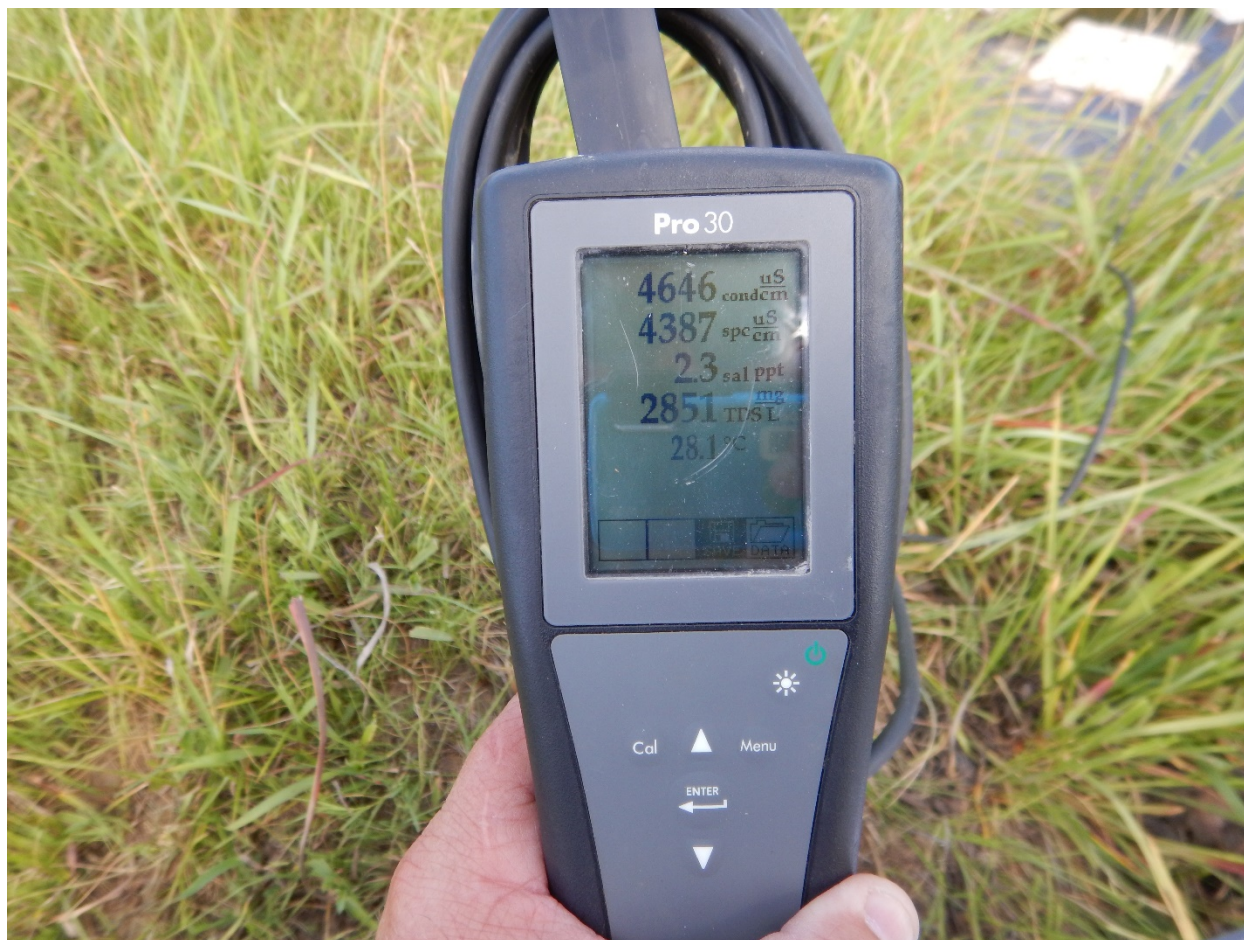
Photo No. 5

**Description:** This was an elevated TDS field reading of 2,851 mg/L taken in the main channel of the impacted tributary approximately 150 feet downstream from the POE.

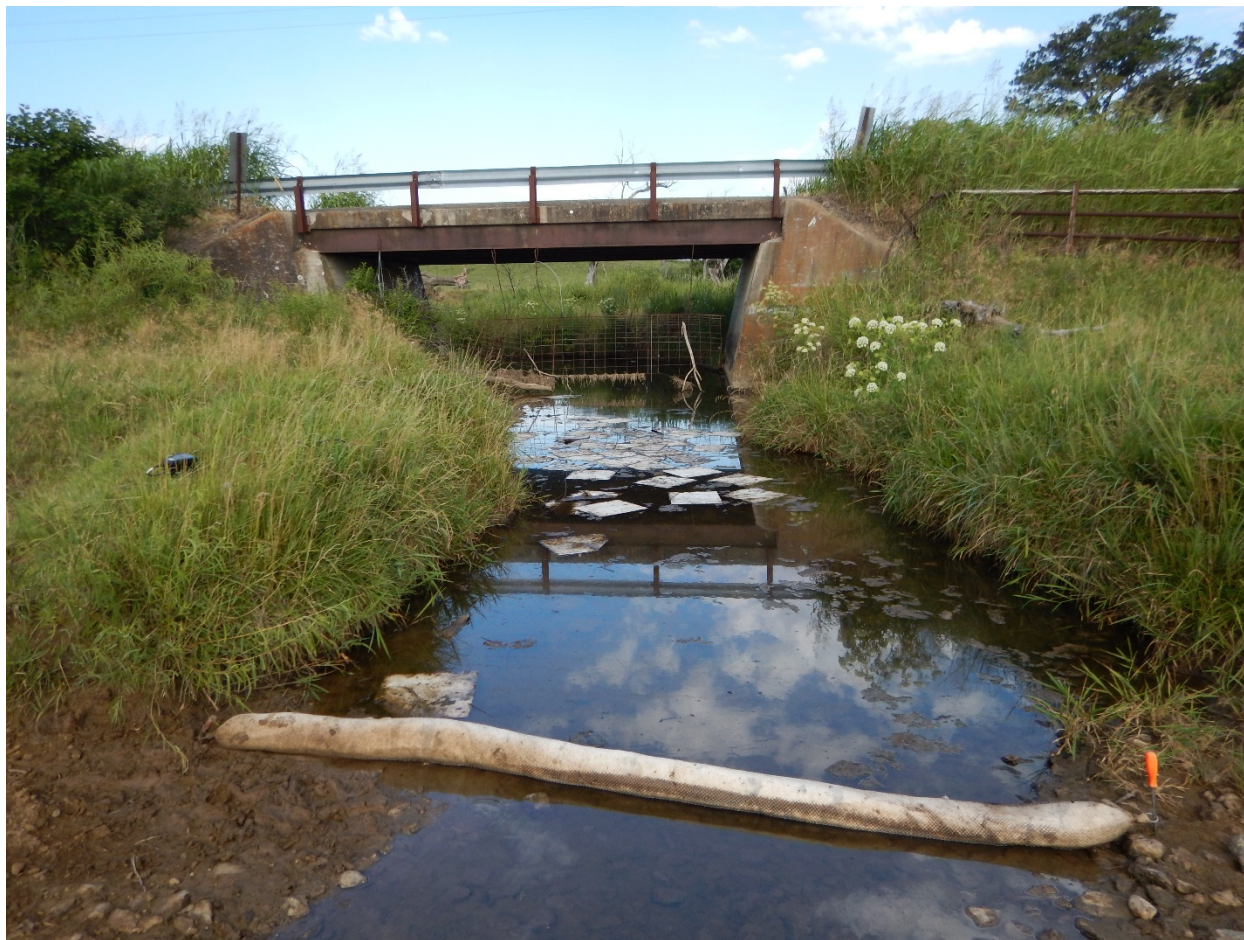
Photo No. 6

**Description:** This was a photo of oil absorbent pads floating on the surface of the impacted tributary. A floating, oil absorbent containment boom was also present at the location. There was no oil present in the pictured area at the time of the inspection.

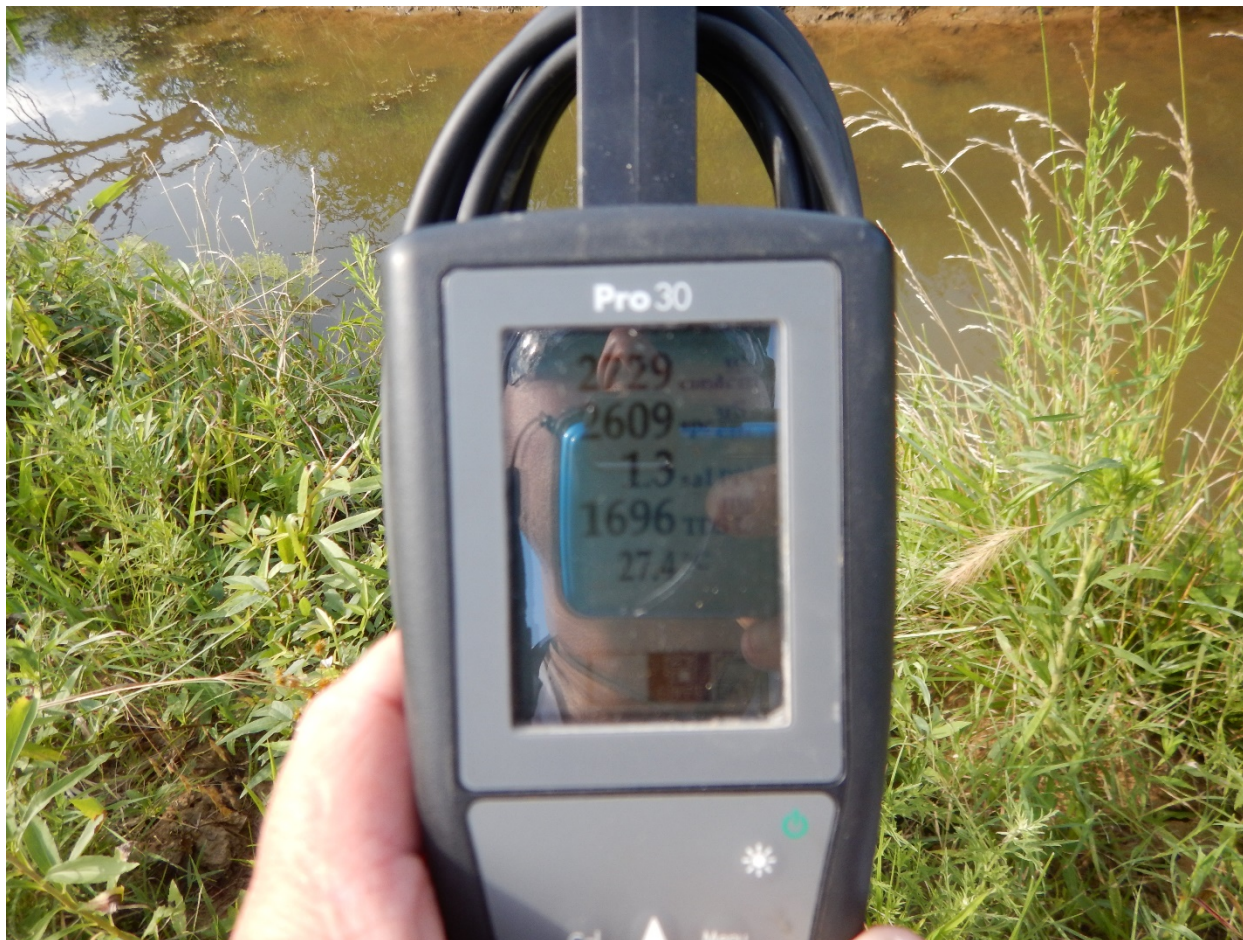
Photo No. 7

Approximately 550 feet downstream (GPS 36.871013, -96.123746) from the POE, I observed an elevated TDS field reading of 1,696 mg/L, which was documented in Photo No. 7. Approximately 1,650 feet downstream (GPS 36.870223, -96.122420) from the POE, I observed an elevated TDS field reading of 1,820 mg/L, which was documented in Photo No. 9. I observed an elevated TDS field reading of 1,002 mg/L approximately 3,000 feet downstream (GPS 36.868564, -96.121399) which was documented in Photo No. 12.

**Description:** This was an elevated TDS field readings of 1,696 mg/L taken in the main channel of the tributary approximately 550 feet downstream from the POE.

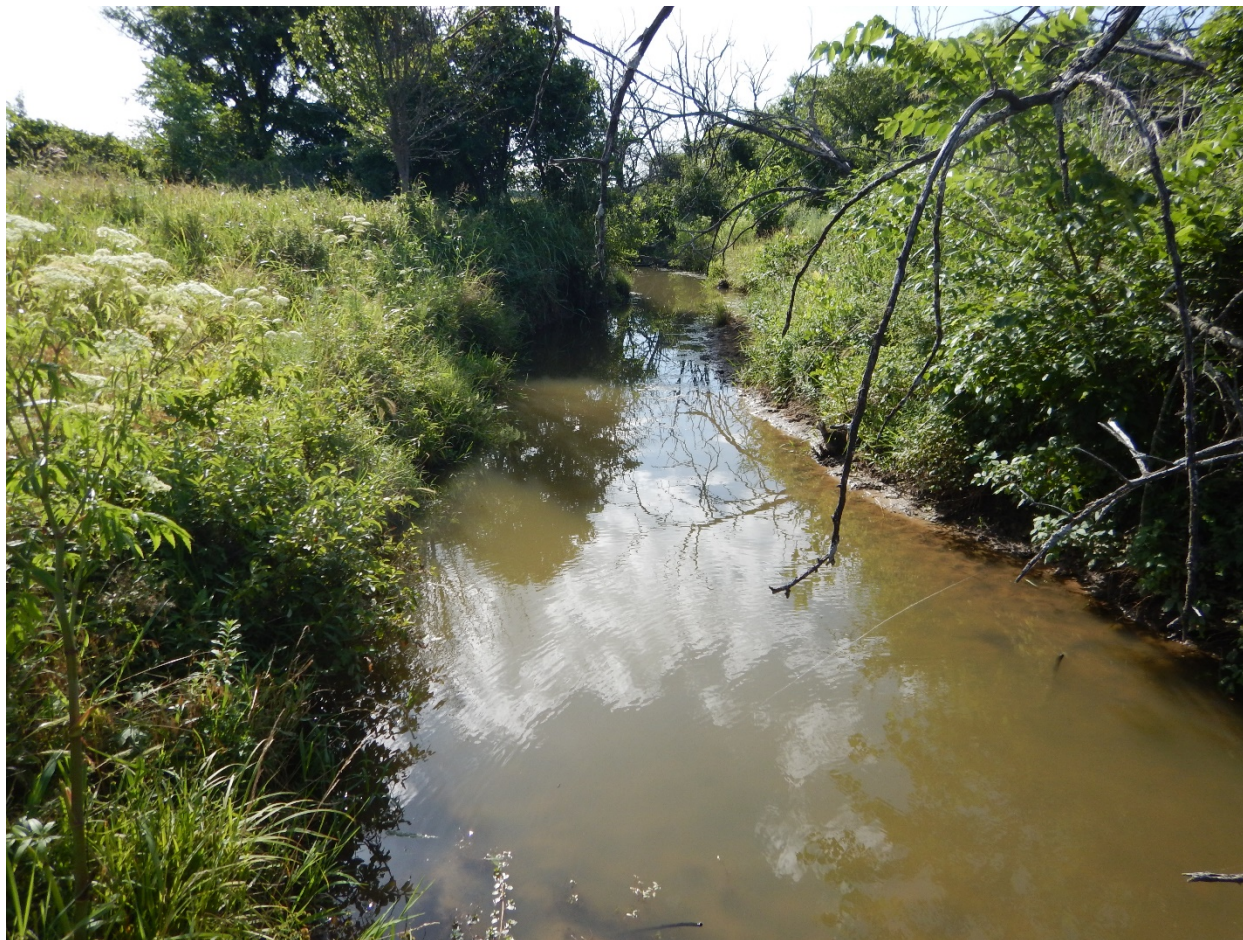
Photo No. 8

**Description:** This was the location where the TDS field reading from Photo No. 7 was taken. This photo provided an accurate representation of the bed and bank features along this section of the impacted tributary.

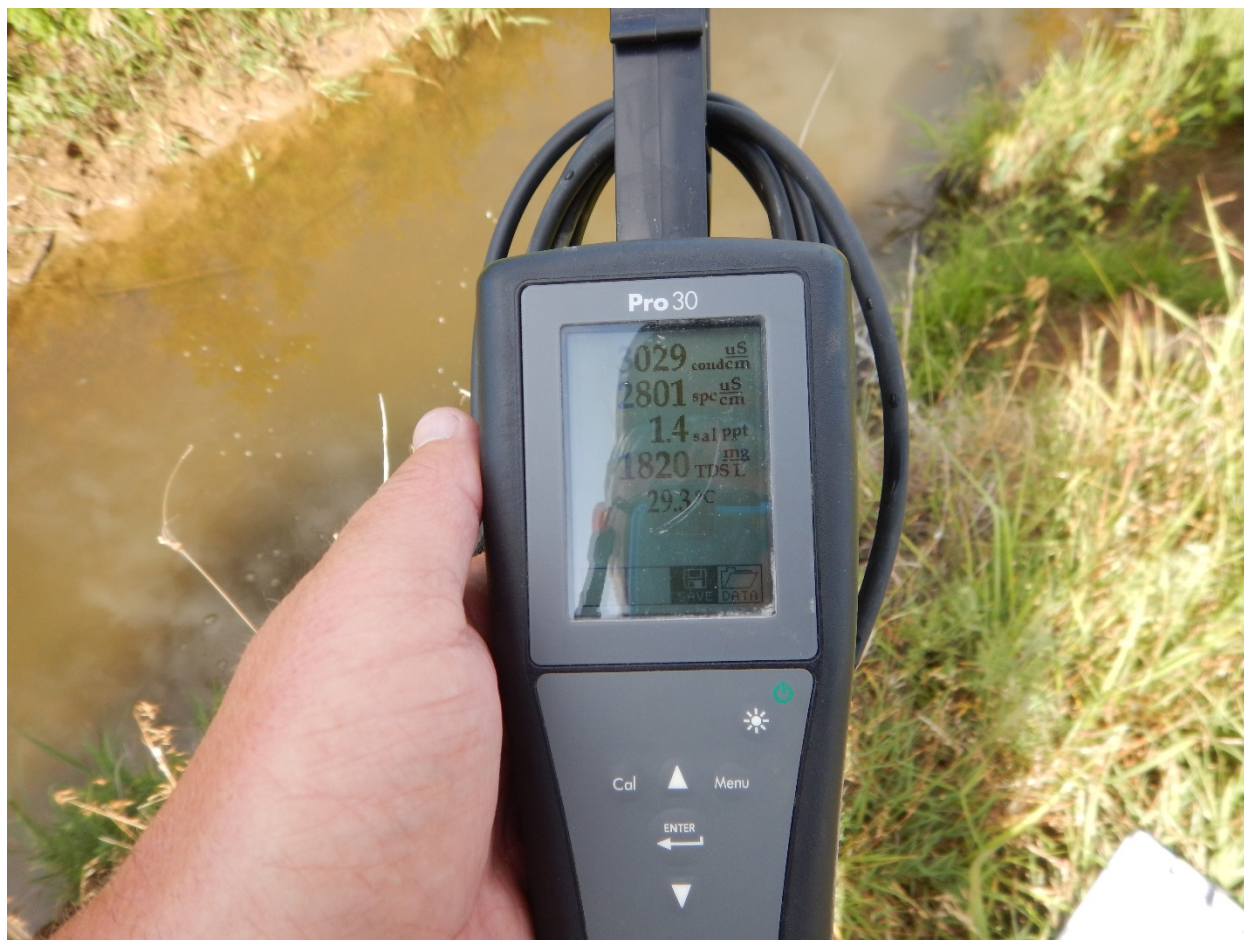
Photo No. 9

**Description:** This was an elevated TDS field reading taken in the main channel of the impacted tributary approximately 1,650 feet downstream from the POE measuring 1,820 mg/L.

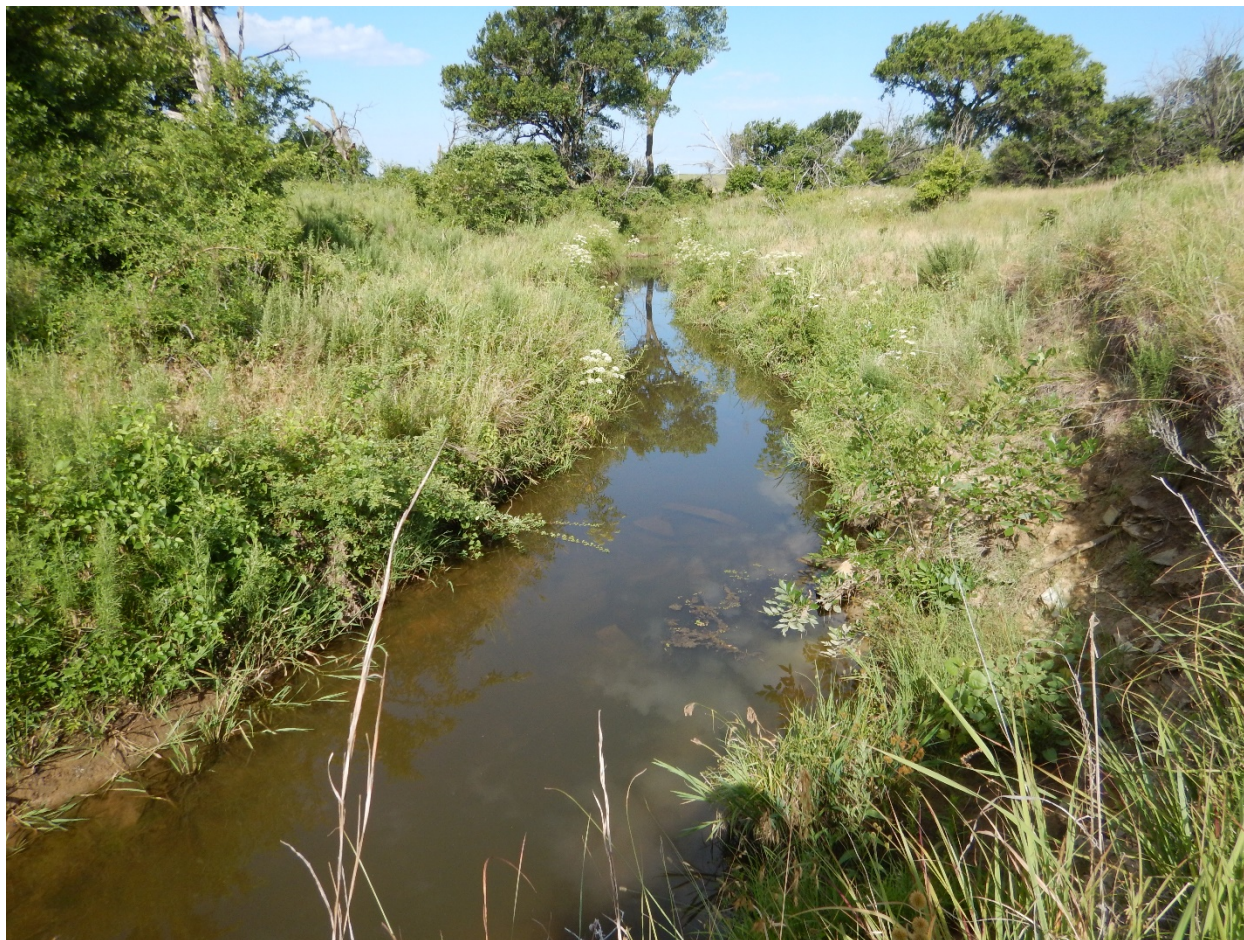
Photo No. 10

**Description:** This was a photo documenting the bed and bank characteristics of the impacted tributary with a view looking NW/upstream from the location. This photo was taken at the same location as Photo No. 9.

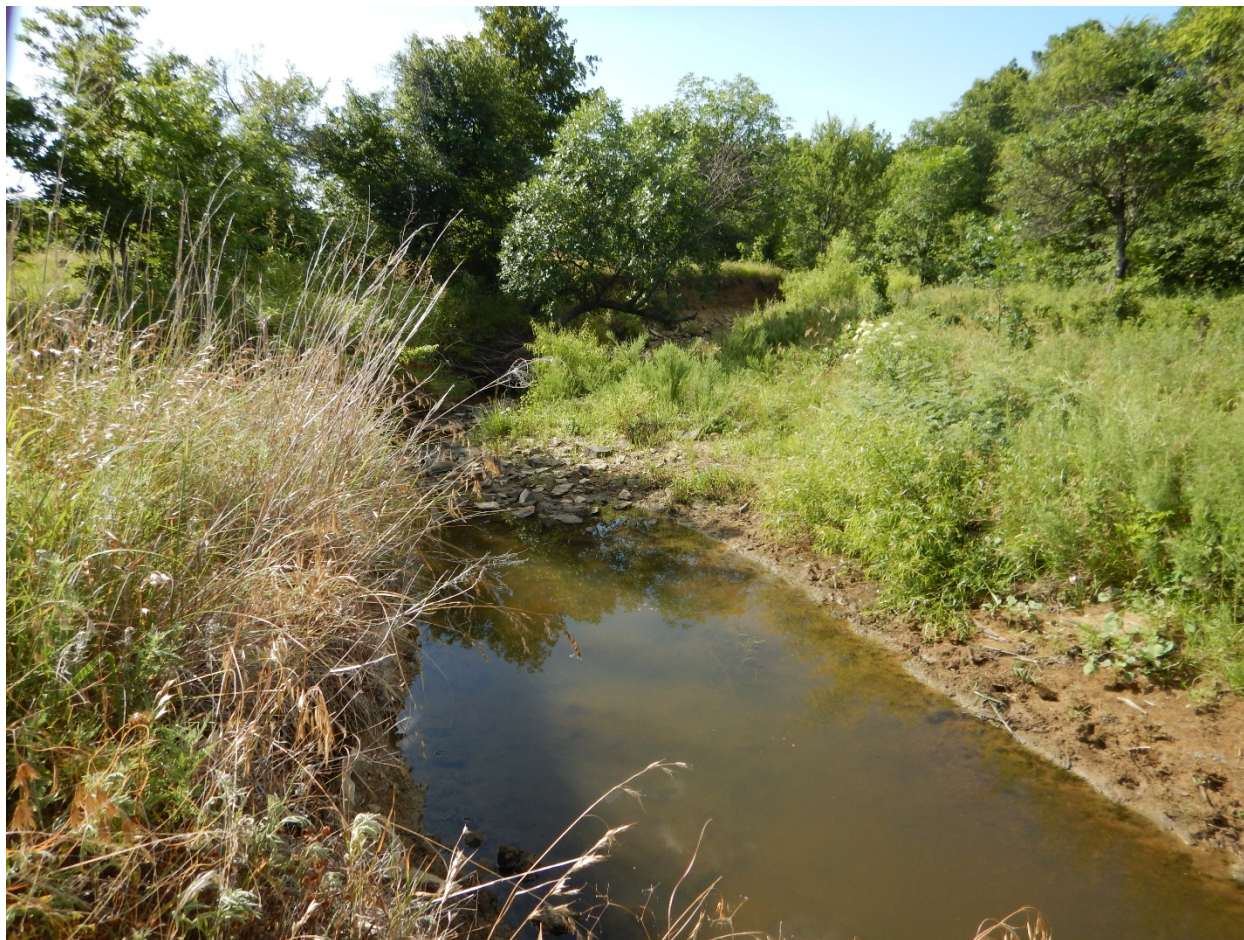
Photo No. 11

**Description:** This was a photo documenting the bed and bank characteristics of the impacted tributary with a view looking SE/downstream from the location. This photo was taken at the same location as Photo No. 9.

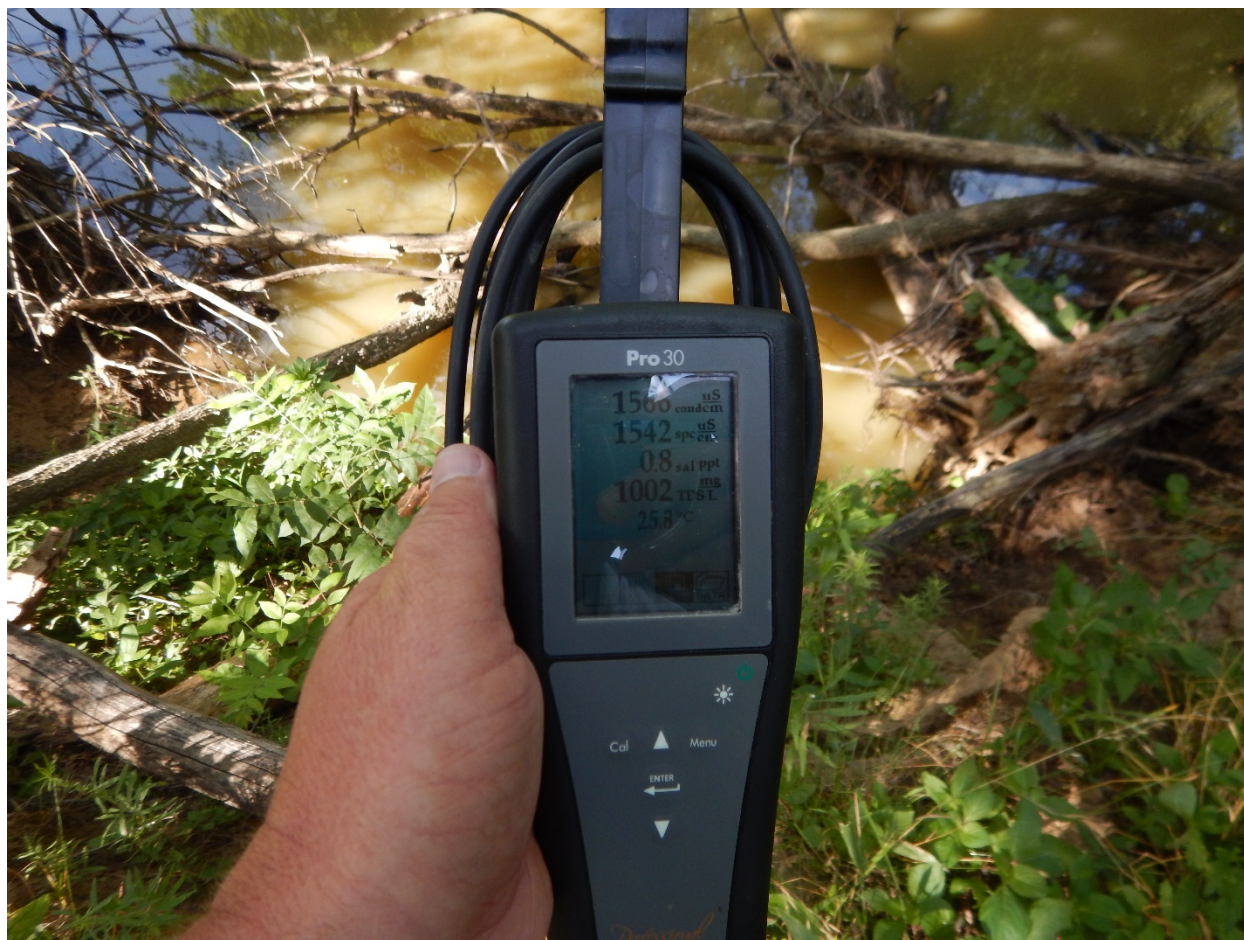
Photo No. 12

**Description:** This was an elevated TDS field reading of 1,002 mg/L, taken in the main channel of the impacted tributary approximately 3,000 feet downstream from the POE.

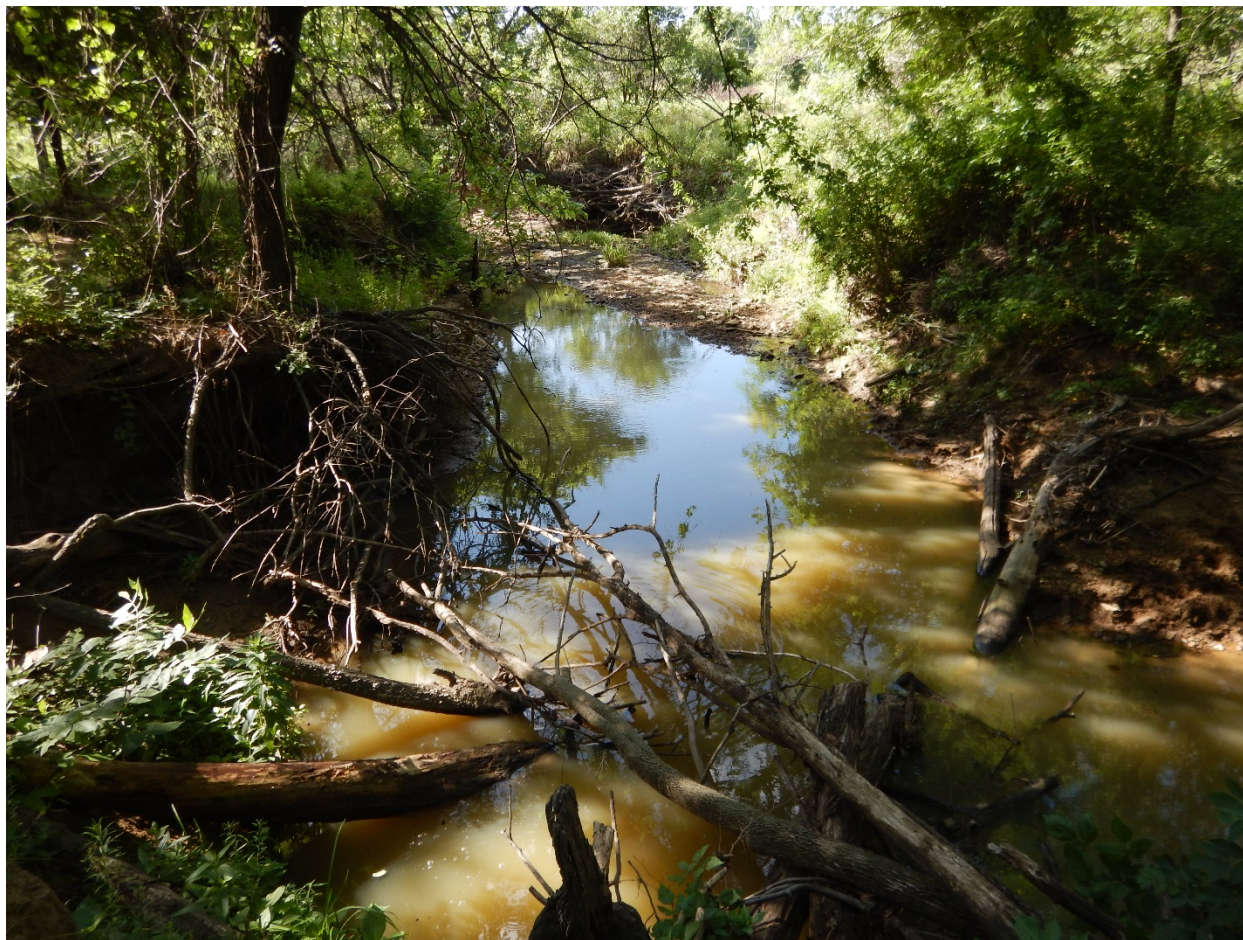
Photo No. 13

**Description:** This was a photo documenting the bed and bank features where the TDS field reading from No. 12 was taken. This photo was taken with a view to the southeast/downstream.

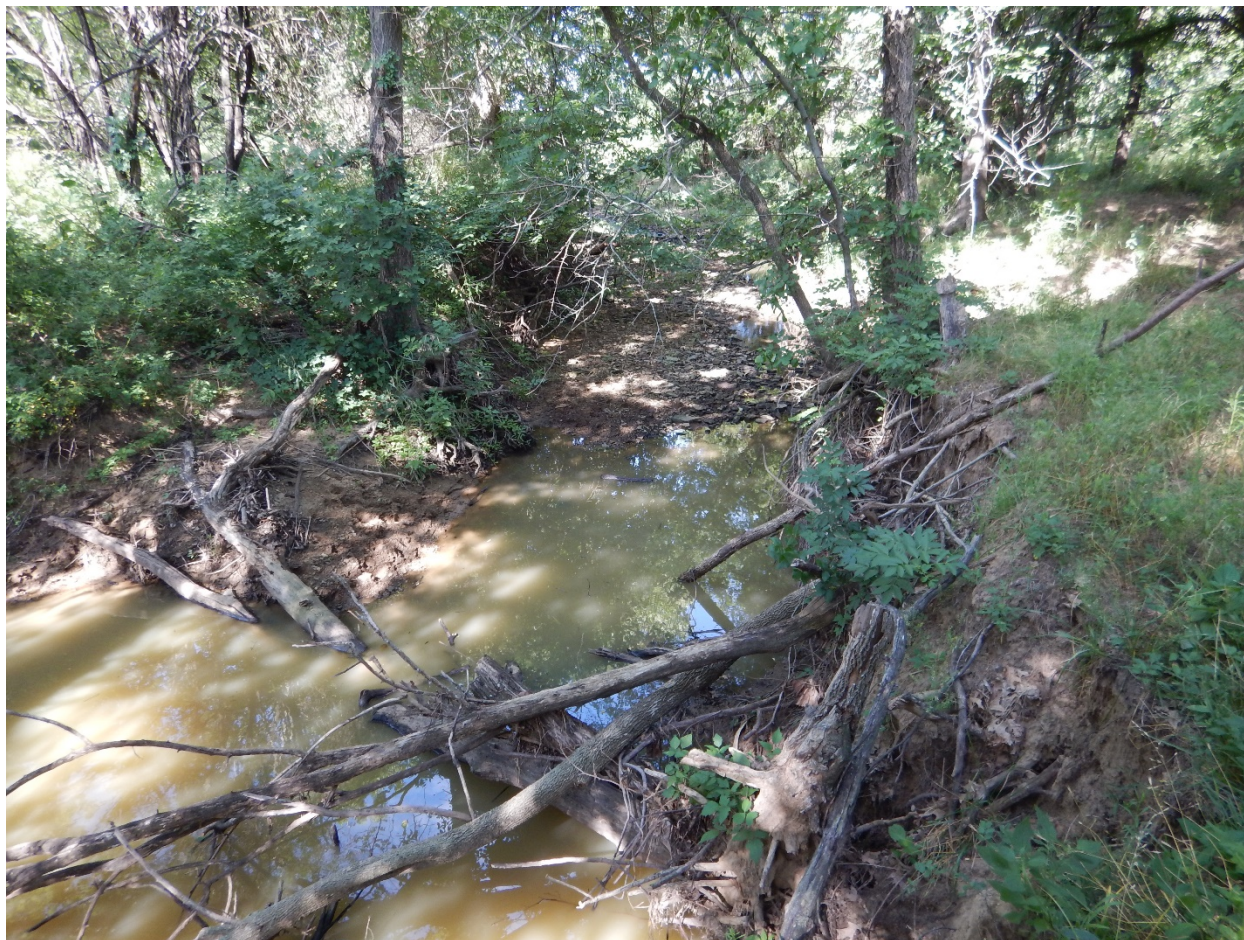
Photo No. 14

**Description:** This was a photo documenting the bed and bank features where the TDS field reading from No. 12 was taken. This photo was taken with a view to the southwest/upstream.

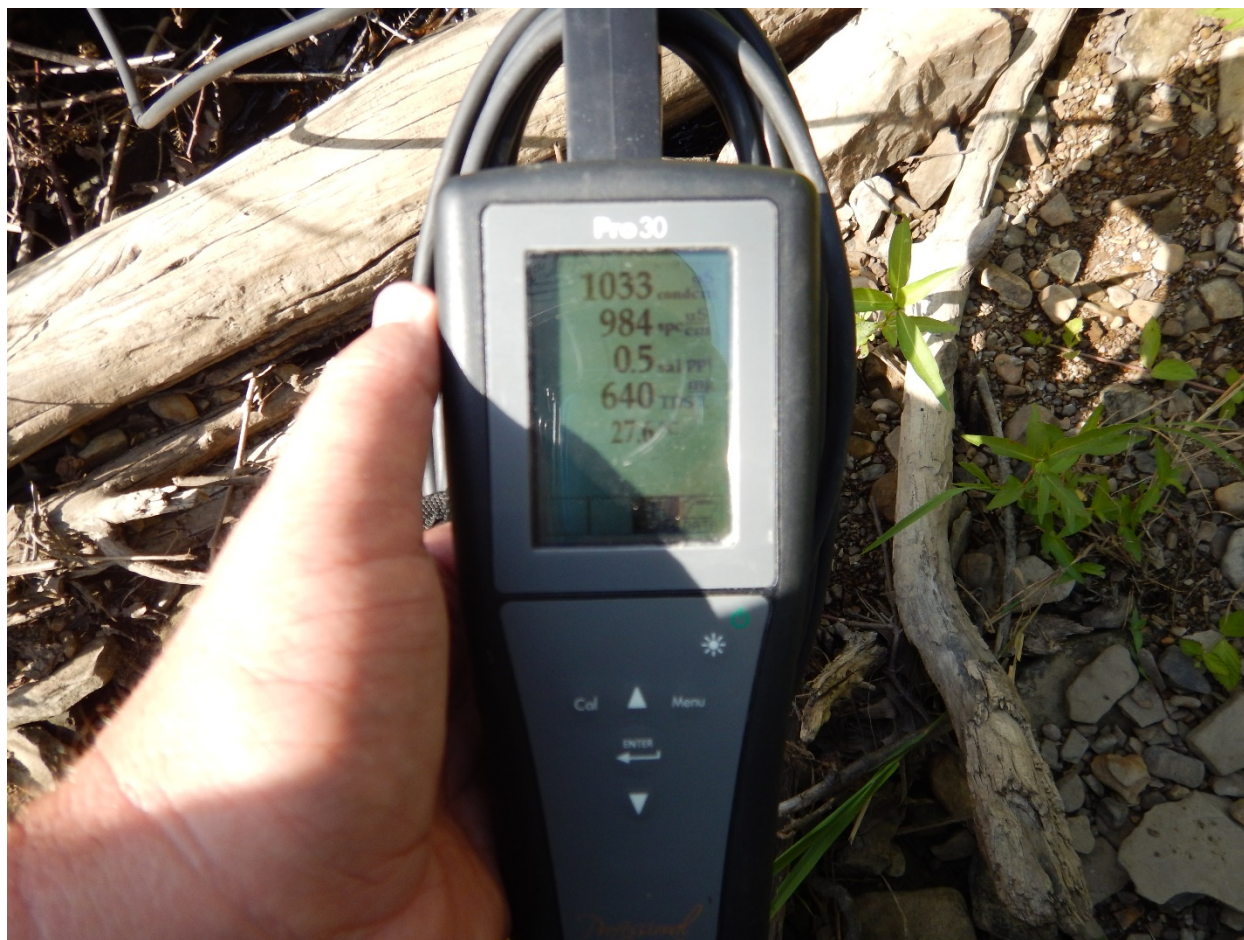
Photo No. 15

I observed an elevated TDS field reading of 640 mg/L approximately 3,950 feet downstream (36.867486, -96.119518) from the POE, which is documented in Photo No. 15. Approximately 4,550 feet downstream (GPS 36.866729, -96.119610) from the POE, I observed an elevated TDS field reading of 543 mg/L, which was documented in Photo No. 17.

**Description:** This was an elevated TDS field reading of 640 mg/L taken approximately 3,950 feet downstream from the POE in the main channel of the impacted tributary.

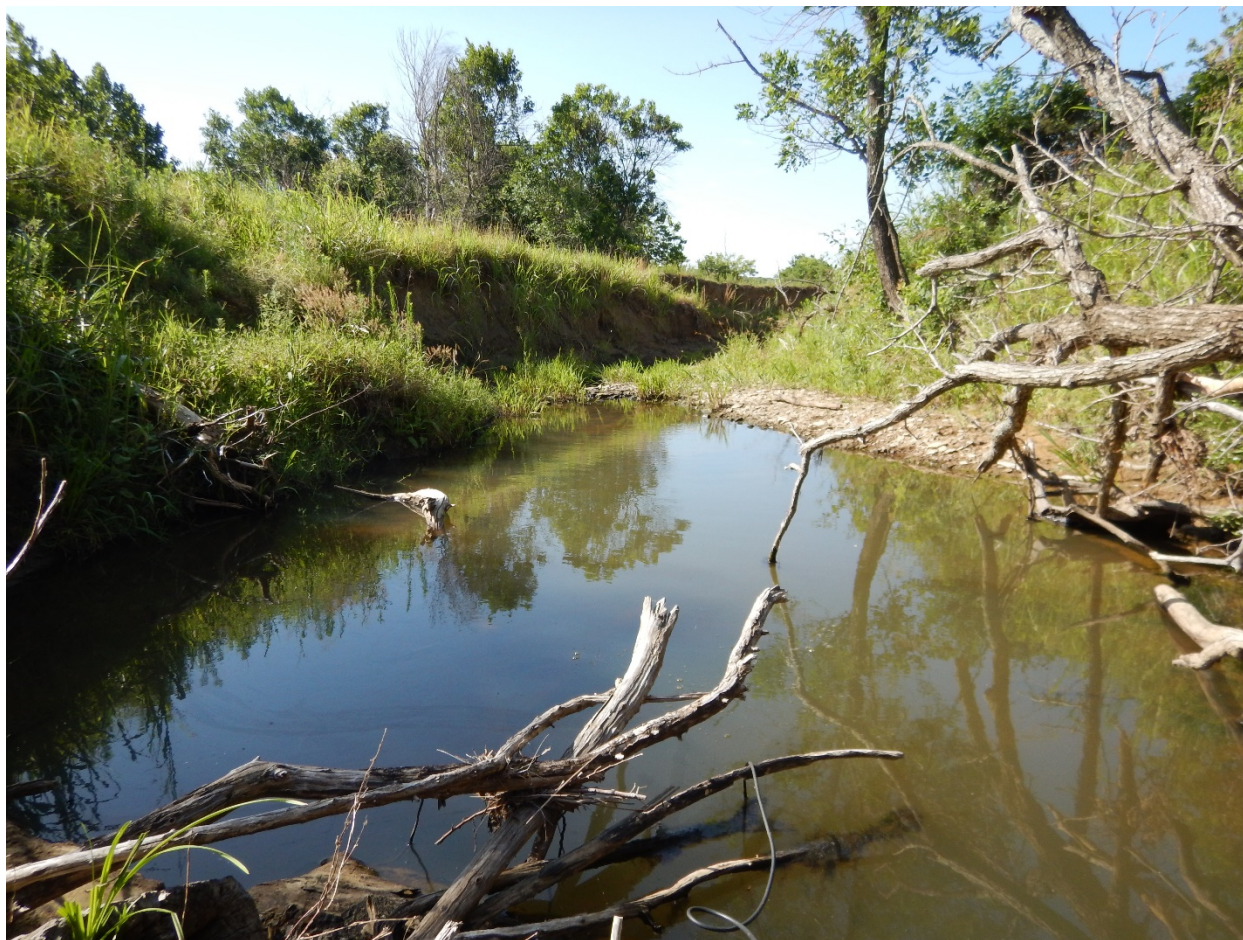
Photo No. 16

**Description:** This was a photo documenting the bed and bank features where the TDS field reading from No. 15 was taken. This photo was taken with a view to the southeast/downstream.

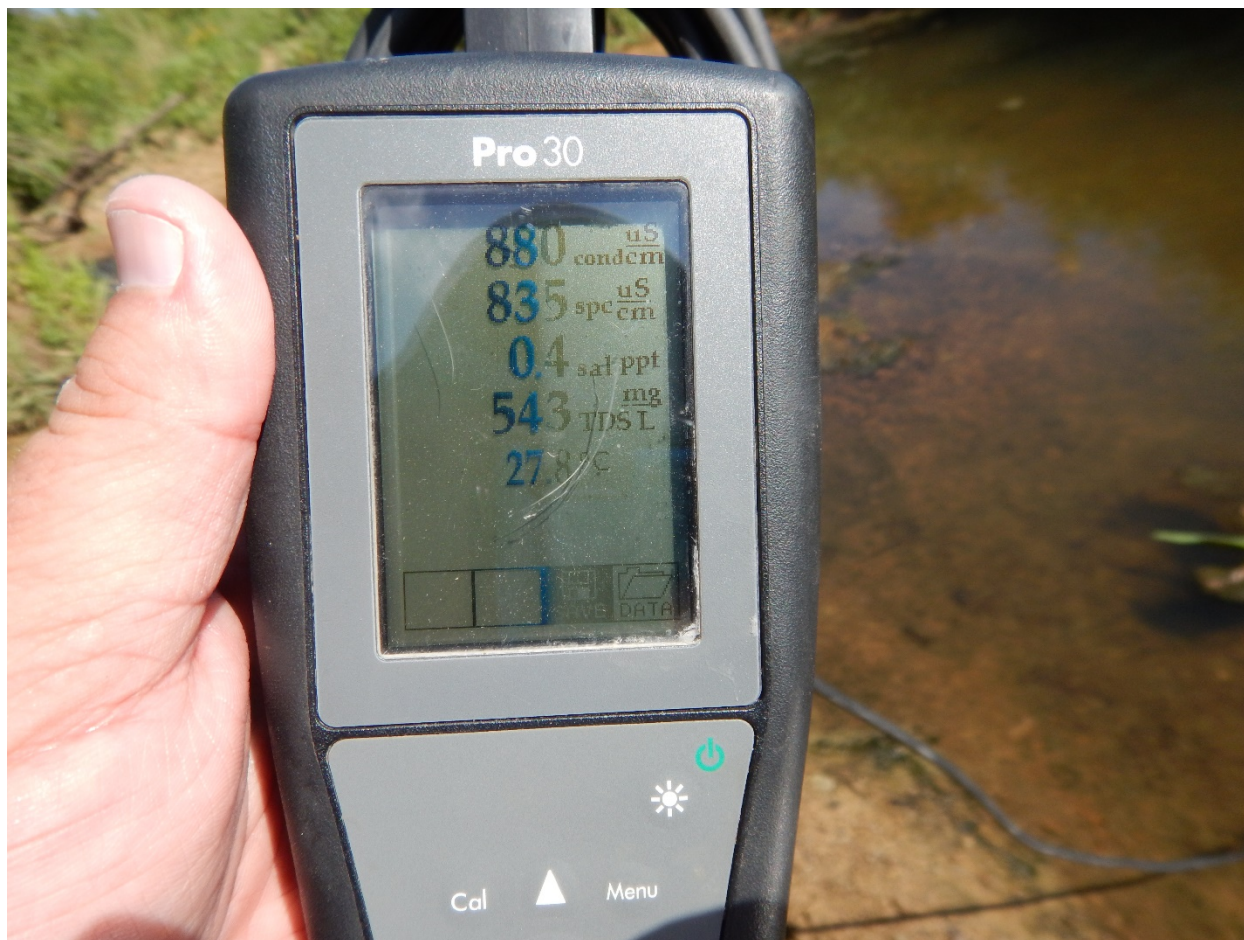
Photo No. 17

**Description:** This was an elevated TDS field reading of 543 mg/L taken approximately 4,550 feet downstream from the POE in the main channel of the impacted tributary.

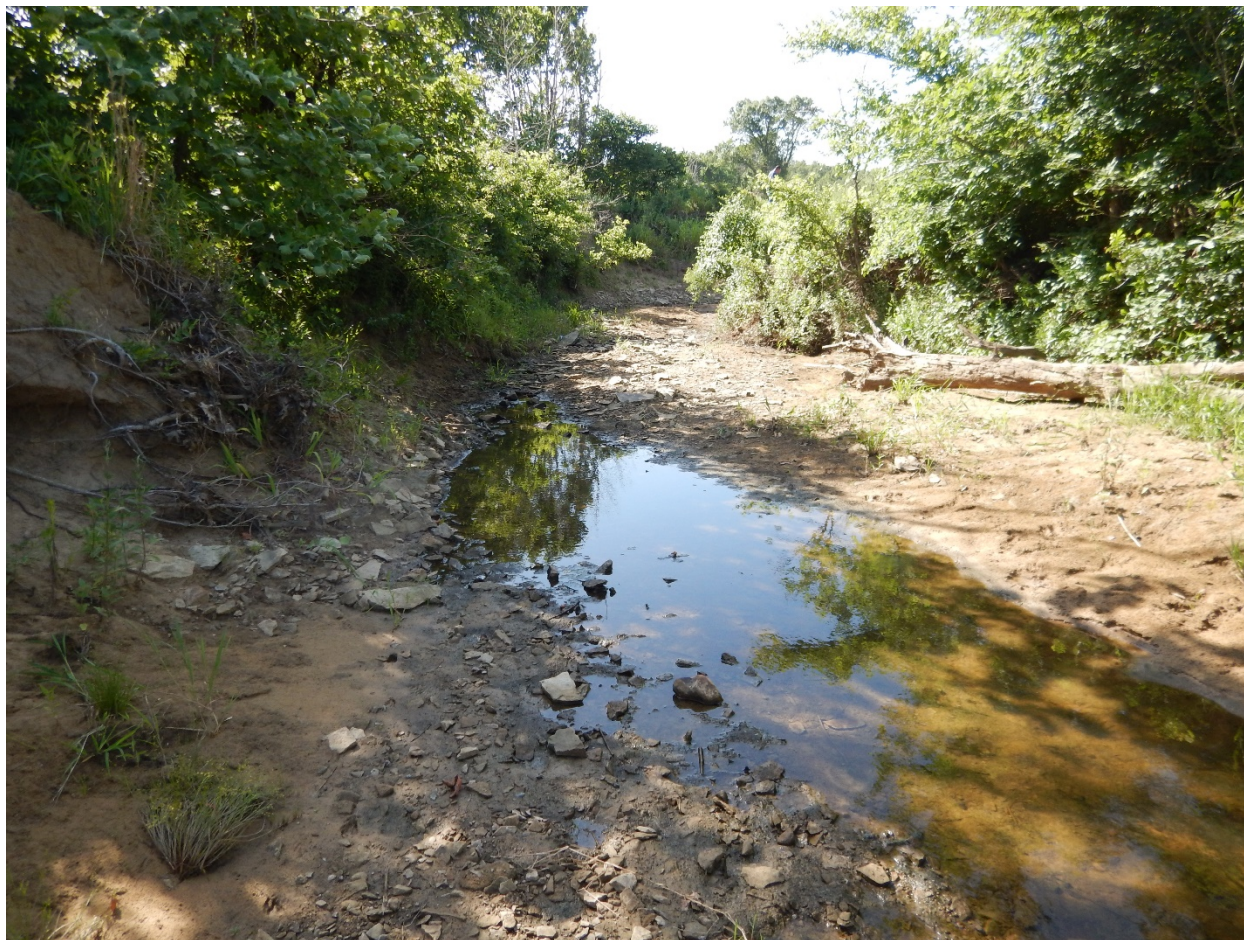
Photo No. 18

**Description:** This was a photo showing the bed and bank features of the impacted tributary, this photo was taken approximately 150 feet upstream along the impacted tributary, prior to the confluence with Mission Creek.
