**Region 6 - Enforcement & Compliance Assurance Division**  
**INSPECTION REPORT**

| Inspection Date(s): | 07/06/2022 | |
| Company Name: | McCann Resources, Inc | |
| Facility Name: | Bowring Lease | |

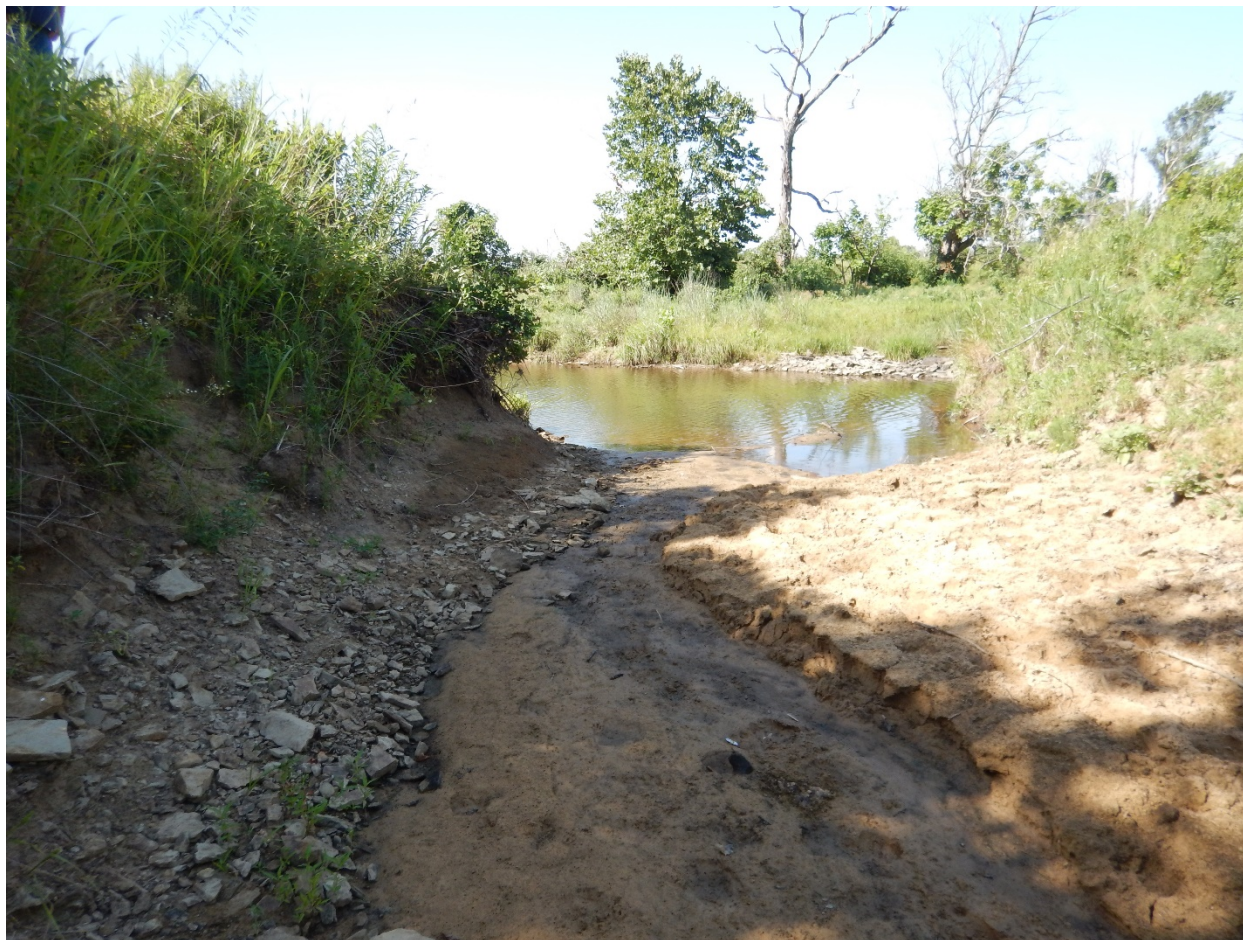
Photo No. 19

**Description:** This was a photo of the main channel of the impacted channel as it connected to Mission Creek. Mission Creek was flowing from right to left or west to east in the photo. At the time of the inspection, there was no surface flow from the impacted tributary into Mission Creek.

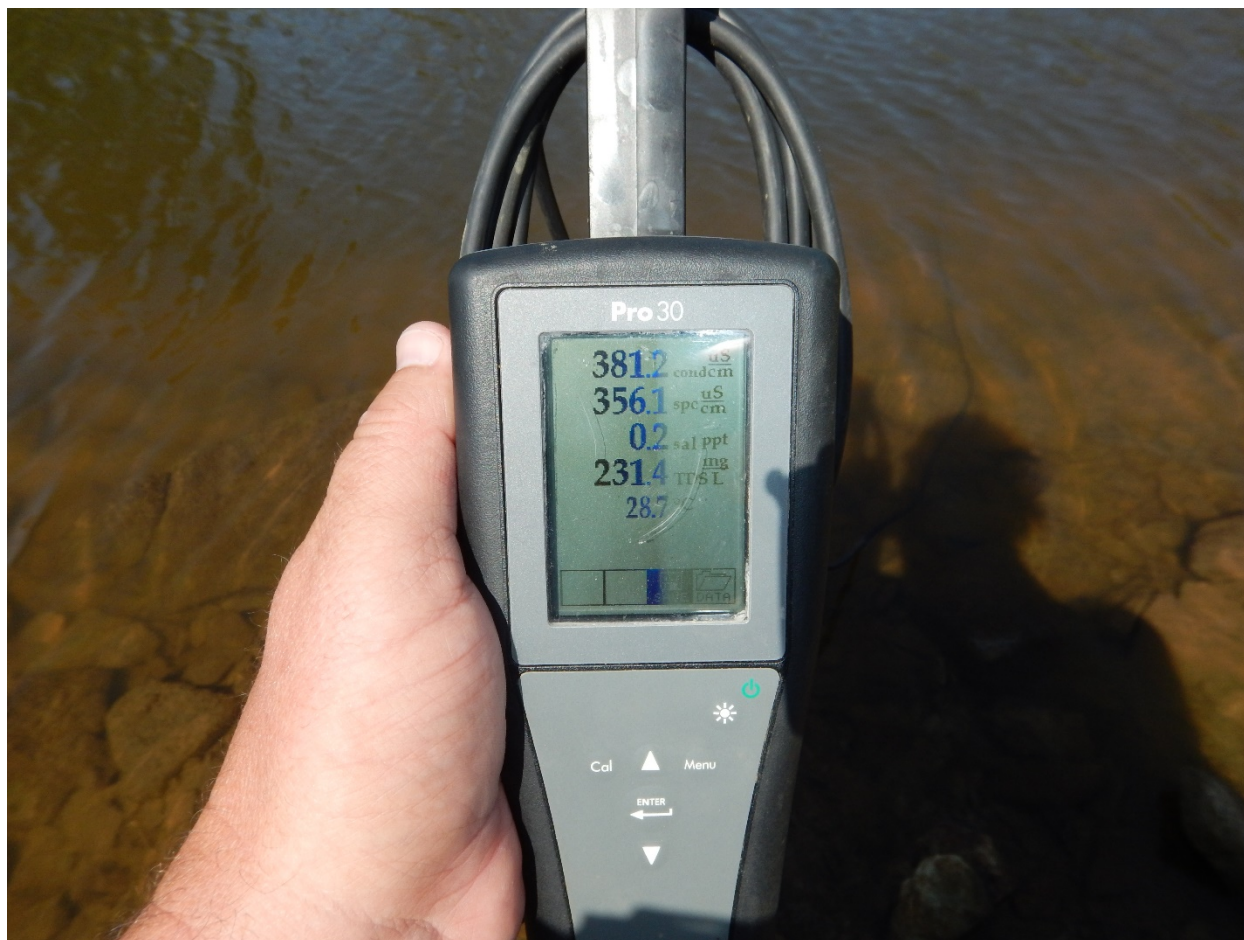
Photo No. 20

I observed a TDS field reading of 231.4 mg/L in Mission Creek at the confluence with the impacted tributary, which is documented in Photo No. 20. I observed the confluence of the impacted tributary and Mission Creek, a detailed description of the confluence was documented in the photo log, Photos No. 19, 21, 22, 23, and 24. I observed a "background" TDS field reading of 216.0 mg/L in Mission Creek approximately 50 feet upstream and prior to the confluence with the impacted tributary, which is documented in Photo No. 25.

**Description:** This was a TDS field reading of 231.4 mg/L taken in Mission Creek at the mouth/confluence of the impacted tributary.

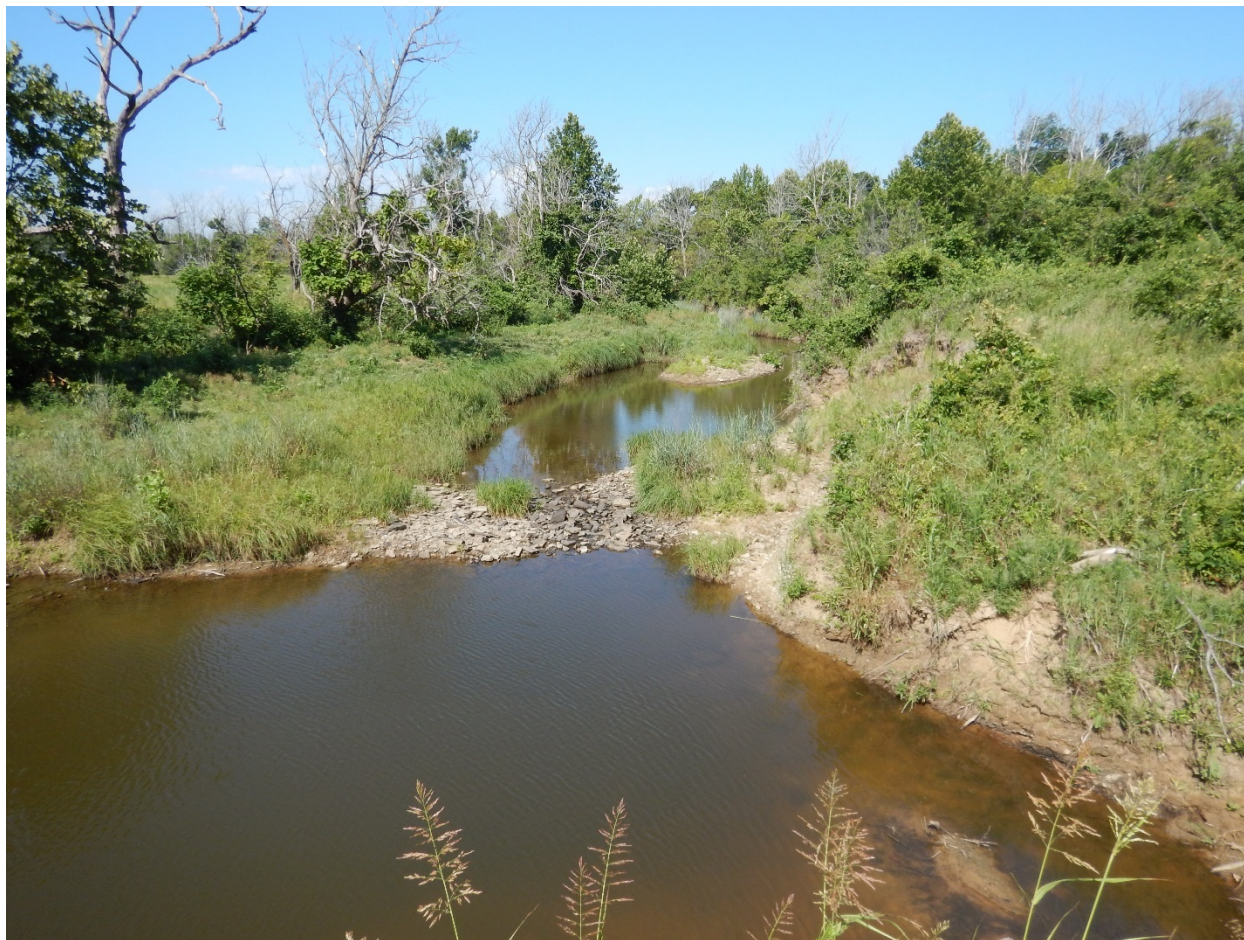
Photo No. 21

**Description:** This is a view to the southwest, which looked upstream along Mission Creek from the confluence of Mission Creek and the impacted tributary. The mouth of the impacted tributary was in the lower right-hand corner of the photo.

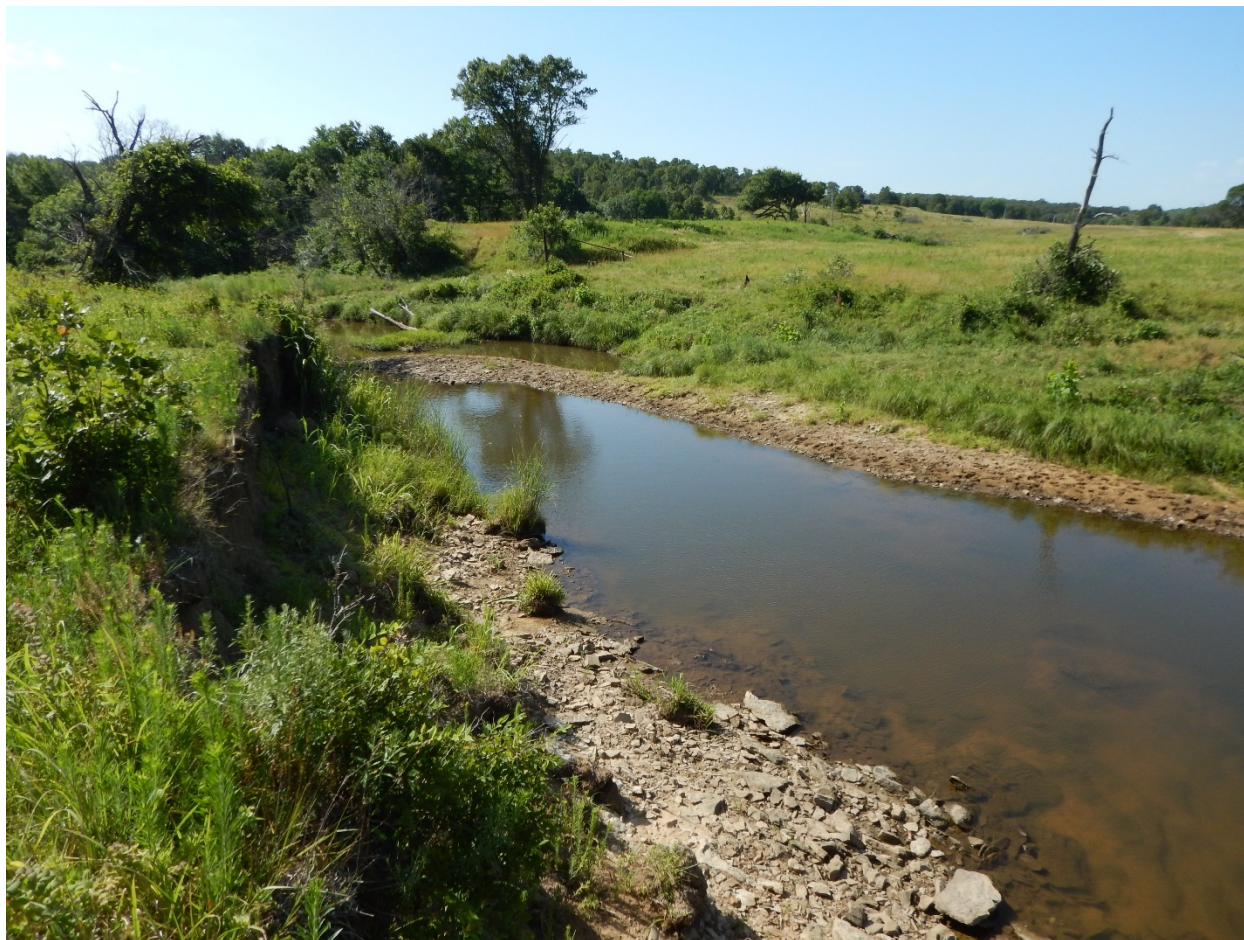
Photo No. 22

**Description:** This is a view to the southeast, which looked downstream along Mission Creek from the confluence of Mission Creek and the impacted tributary. The mouth of the impacted tributary was immediately behind the photographer at the time of the photo. Mission Creek flowed from the lower right corner toward the upper left corner in the photo, or generally toward the east.

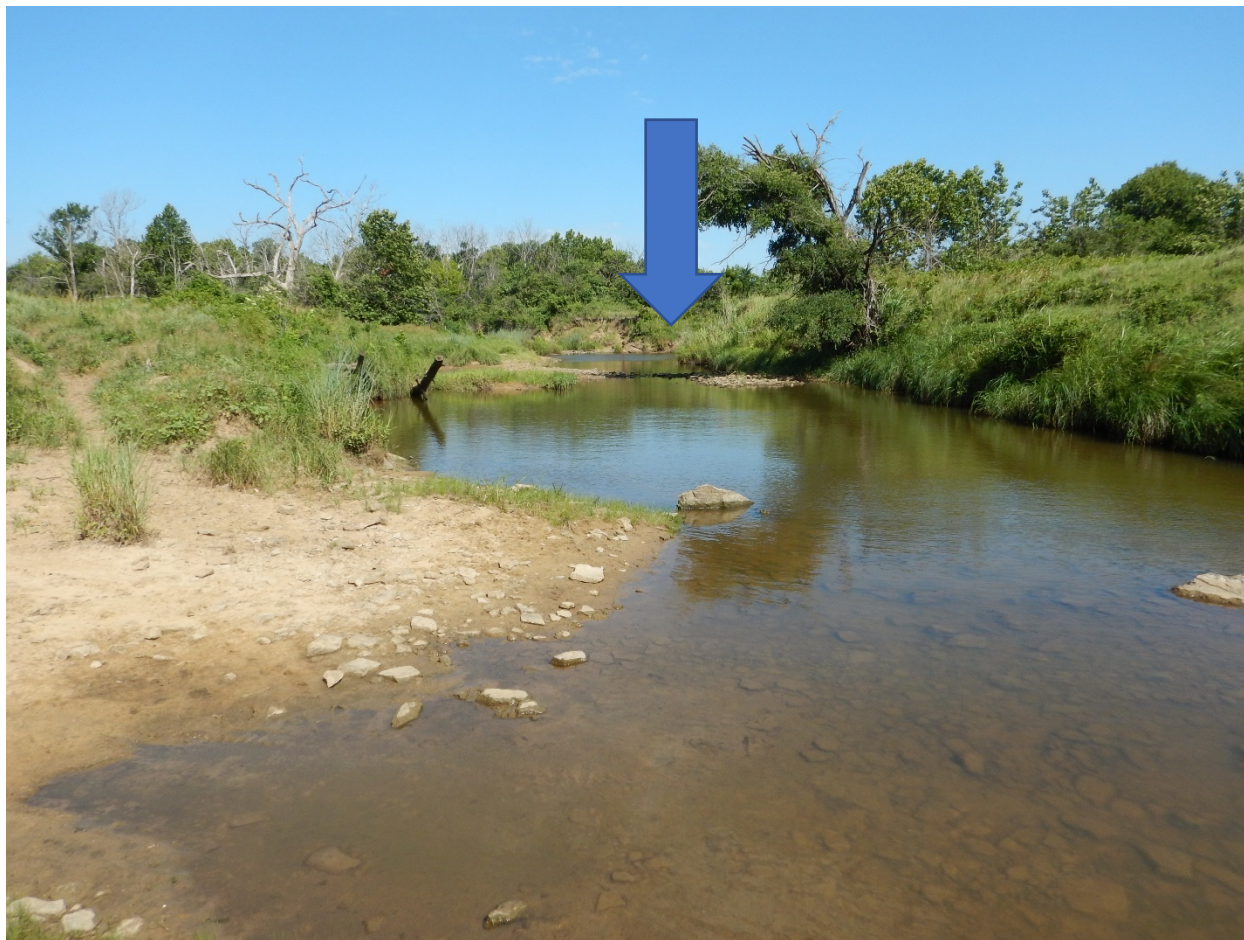
Photo No. 23

**Description:** This was a photo taken approximately 250 feet downstream from the confluence of Mission Creek and the impacted tributary. The photo was taken from the south bank of Mission Creek looking west toward the mouth of the impacted tributary. The mouth of the impacted tributary was located below the arrow in the photo.

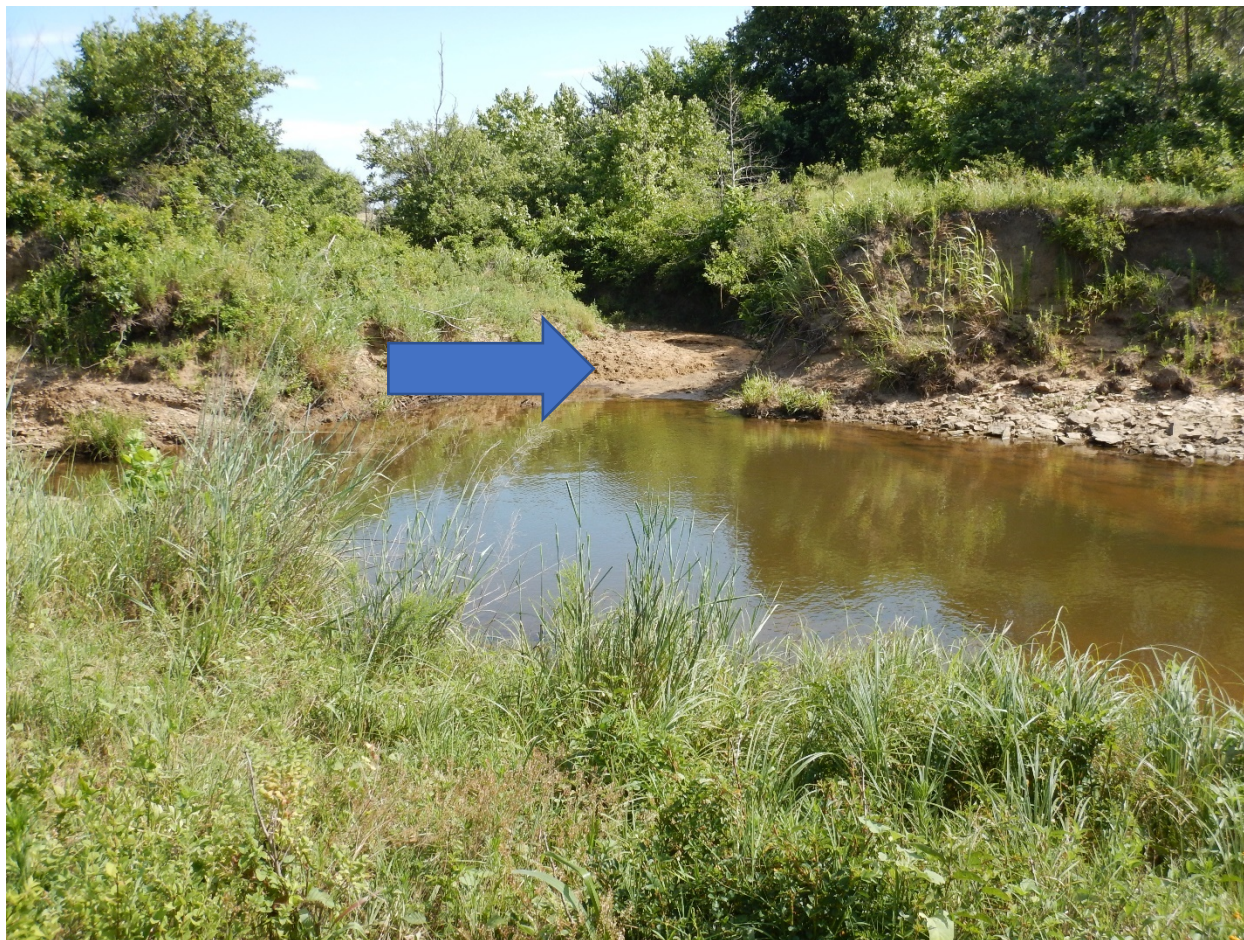
Photo No. 24

**Description:** This was a photo taken from the south bank of Mission Creek with a view looking to the northwest. This was a photo showing the confluence of the impacted tributary and Mission Creek.

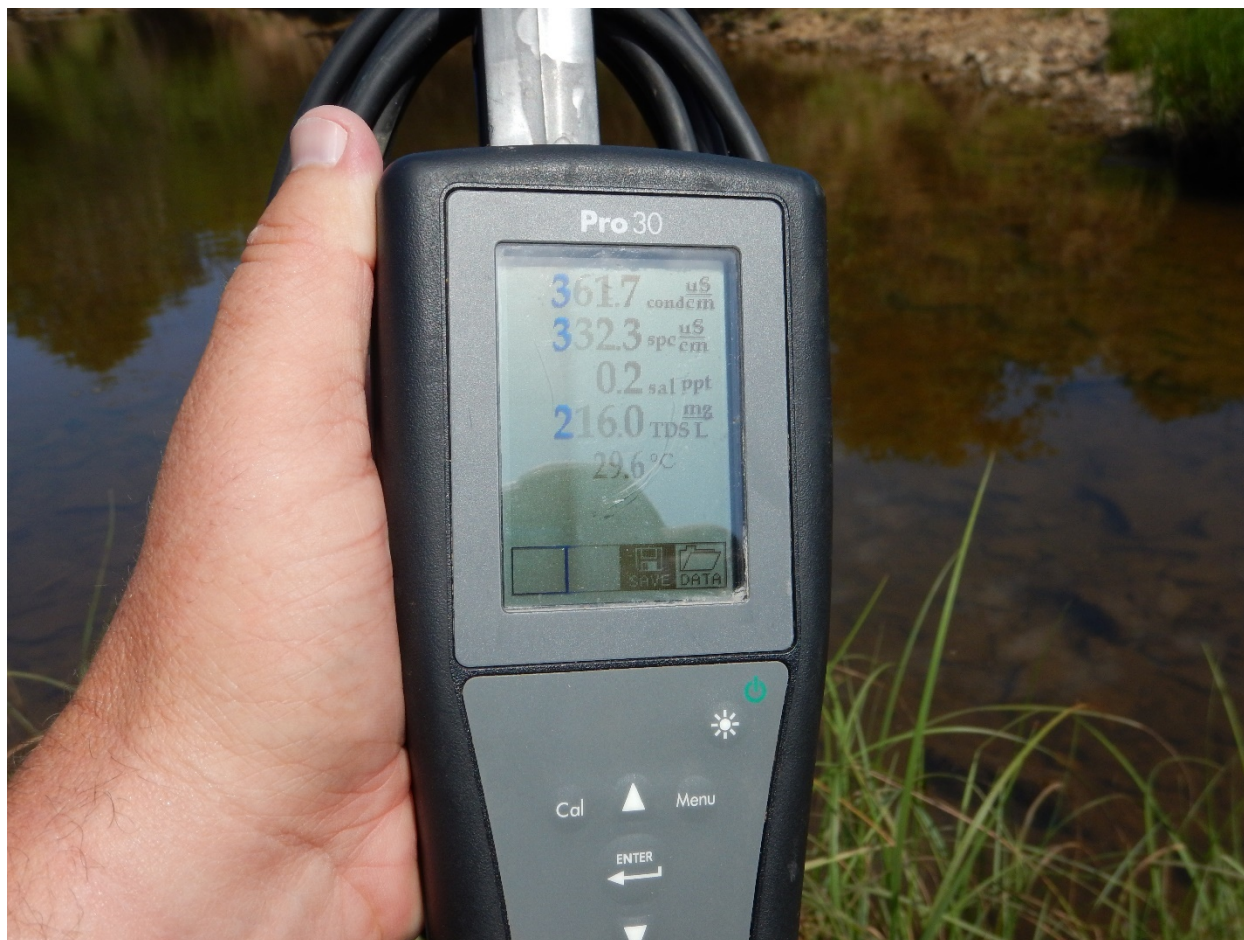
Photo No. 25

**Description:** This was a TDS field reading of 216.0 mg/L taken in the main channel of Mission Creek, approximately 50 feet upstream, prior to the confluence with the impacted tributary.

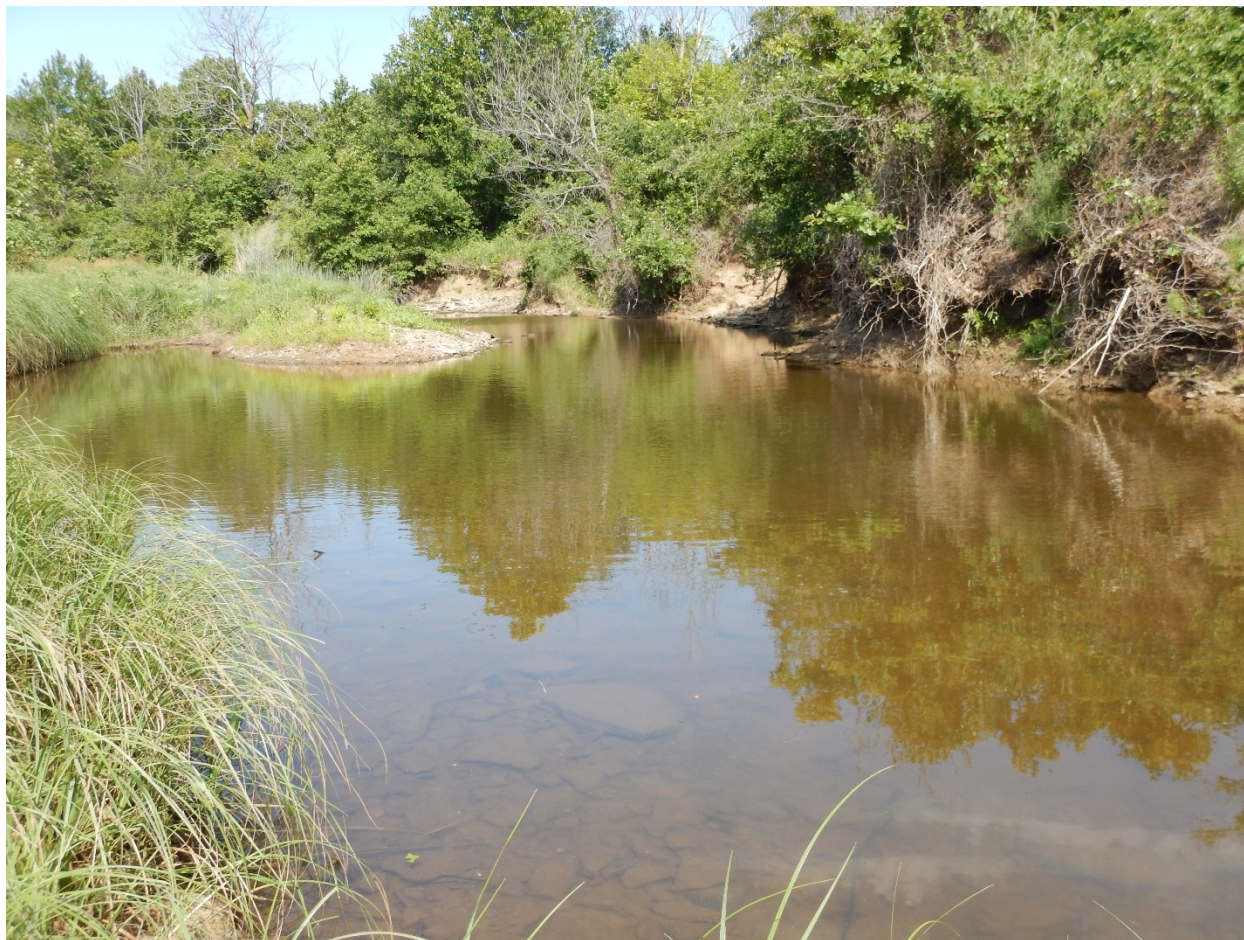
Photo No. 26

**Description:** This was the upstream pool along Mission Creek where Photo No. 25 and a TDS field reading of 216.0 mg/L were taken.

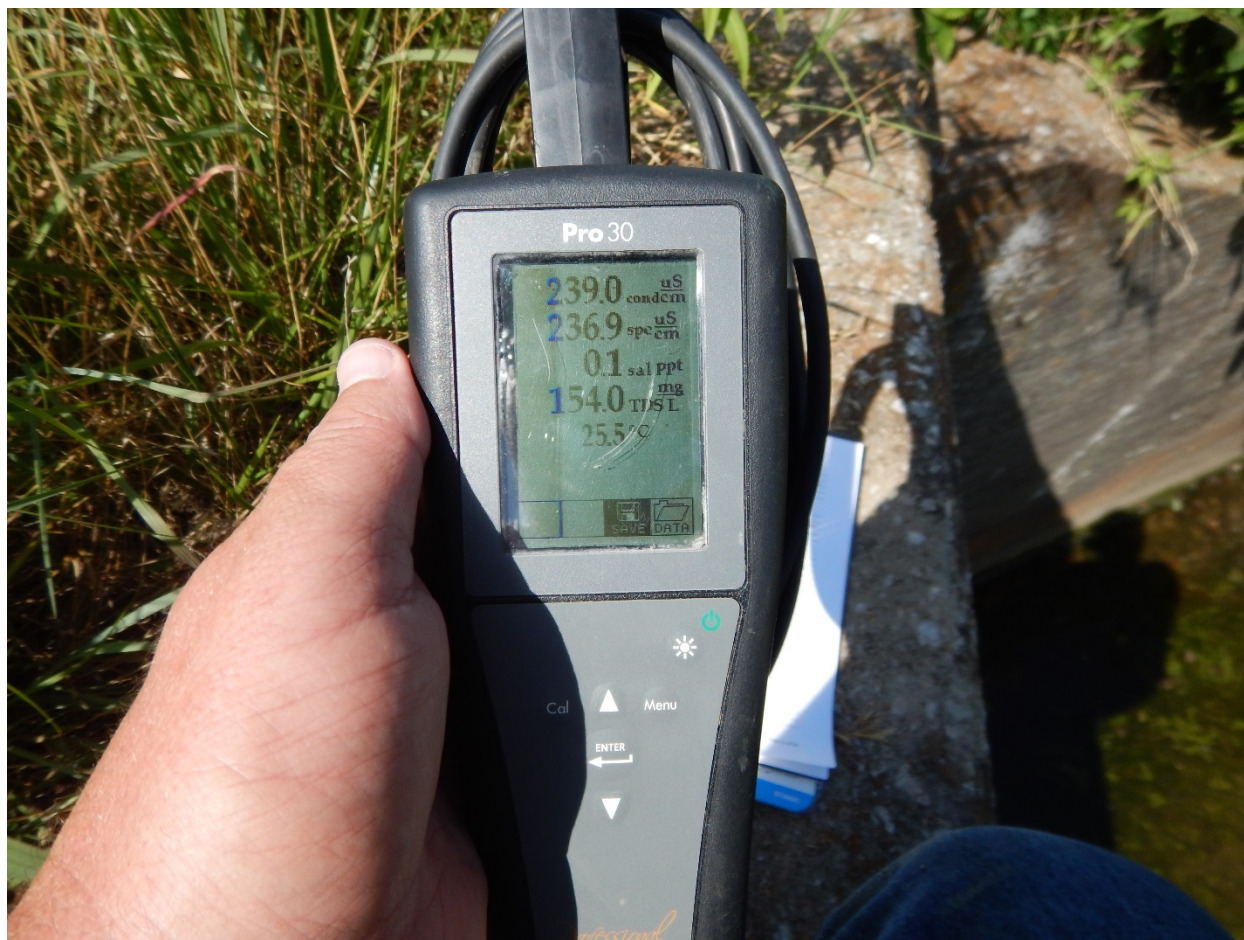
During the inspection, I observed a “background” Total Dissolved Solids (TDS) field reading of 154 mg/L (GPS 36.875613, -96.129601) approximately 2,650 feet upstream from the Point of Entry POE, this field reading was documented in Photo No. 27 of Appendix 1 / photo log which is included in this report. The background TDS field reading, and all other field readings observed and documented during the inspection were taken with a properly calibrated YSI Pro 30 conductivity meter.

**Description:** This was a TDS field reading taken approximately 2,650 feet upstream from the POE along the impacted tributary, where the impacted tributary crossed under Highway 10. This TDS reading should be used to assess "background" TDS levels for the impacted tributary.

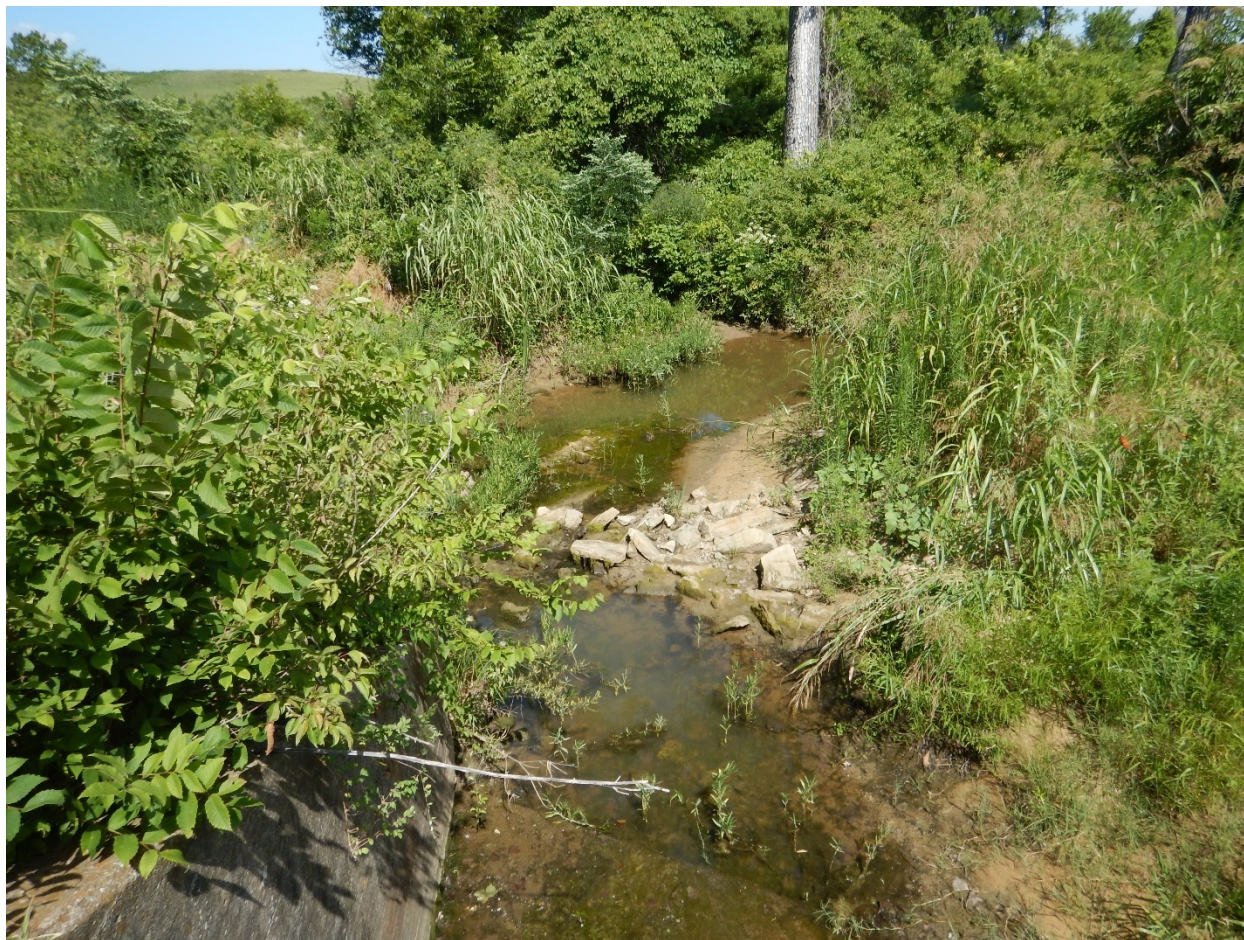
Photo No. 28

**Description:** This was a photo documenting the location of Photo No. 27. This was the location where the impacted tributary crossed through a culver under Highway 10, approximately 2,650 feet upstream from the POE.
