# NPDES Compliance Inspection Report

## Vista Ridge Subdivision Ridgefield, Washington

NPDES Permit Tracking Number  
# WAR309985

Inspection Date: 12/20/2022

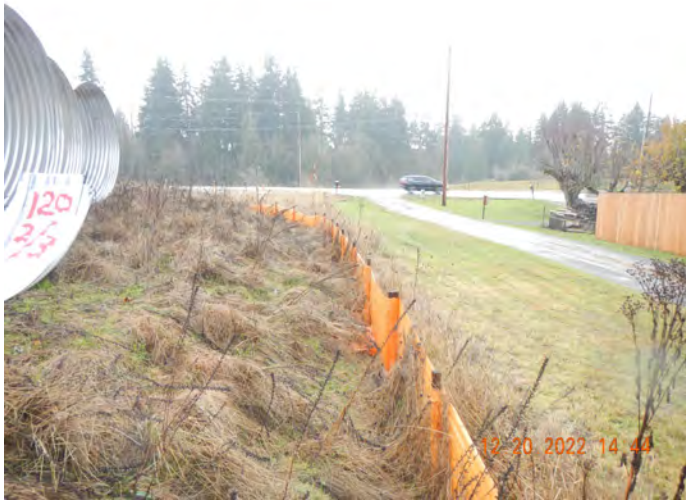
We first observed the west/southwest perimeter near the construction entrance, the area was well vegetated, and sections of large culverts were staged in the general vicinity (**Photo 1 & Photo 2**).

Photo #:01 (DSCN3128)  
Description: Facing south/southwest, photo of southwest perimeter silt fencing.

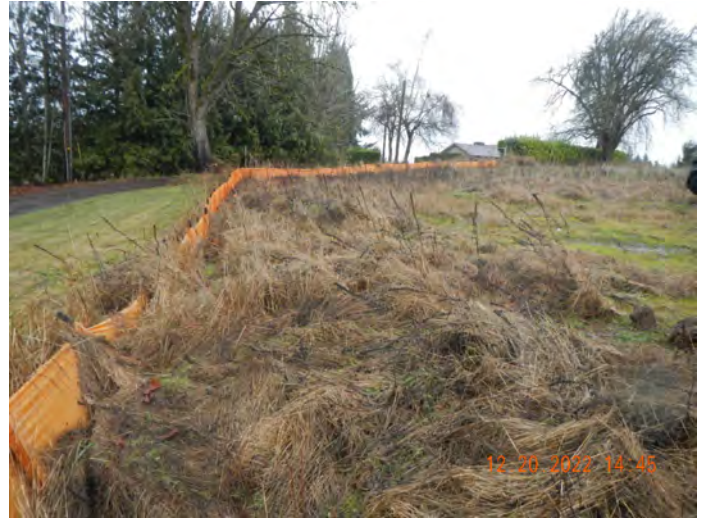
Photo #:02 (DSCN3129)  
Description: Facing north, photo of southwest perimeter silt fencing.

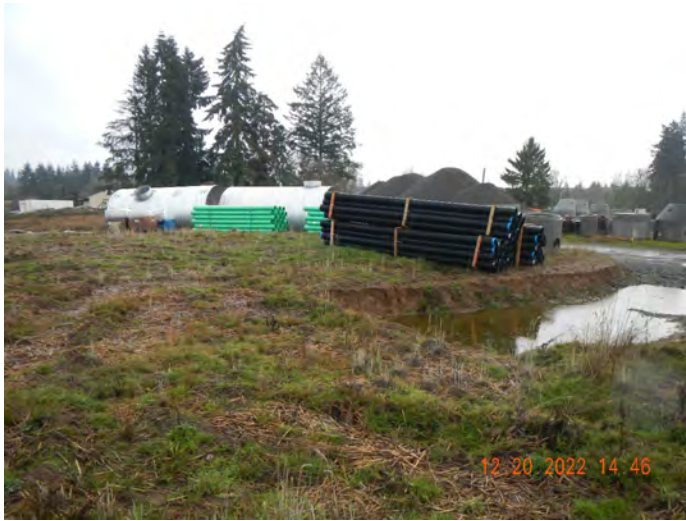
We then traveled slightly east and observed the area where the recently removed soil stockpile was previously located. The area was also well stabilized, I observed straw mulch covering areas less vegetated (**Photo 3**). This general area is also near the established construction entrance and used for staging new construction material, including rock stockpiles, culvert piping and concrete vaults.

Photo #:03 (DSCN3130)  
Description: Facing south, photo of previous soil stockpile location and material staging area.

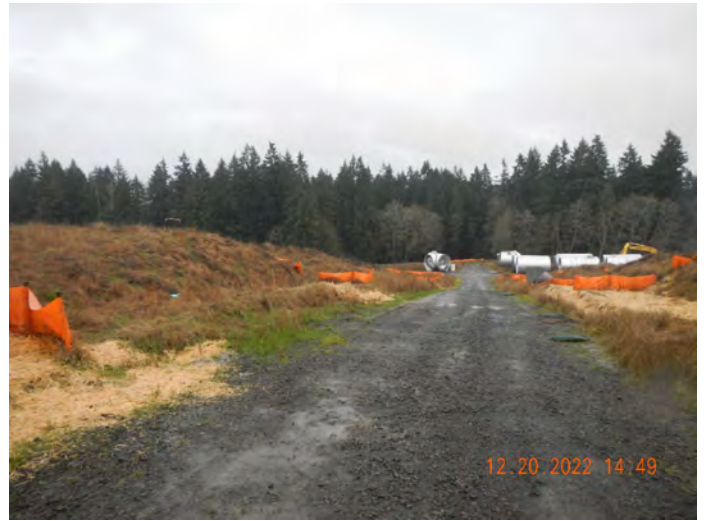
Photo #:04 (DSCN3131)  
Description: Facing east, photo of pond access road and BMPs.

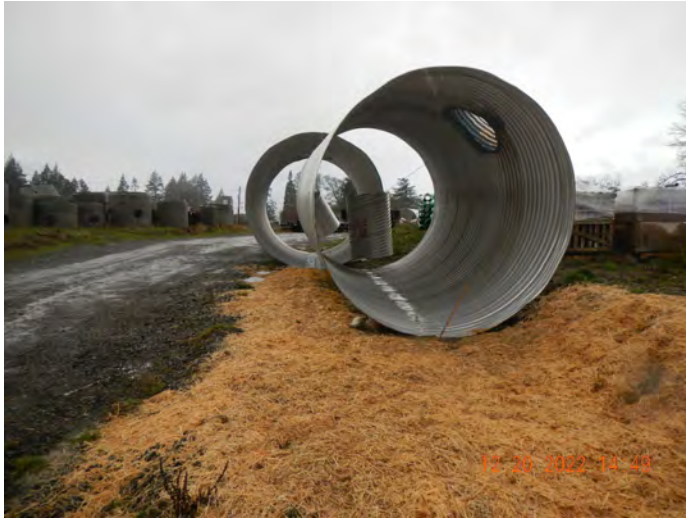
Photo #:05 (DSCN3132)

Description: Facing south, photo of culvert staging along access road, west of the South Pond.

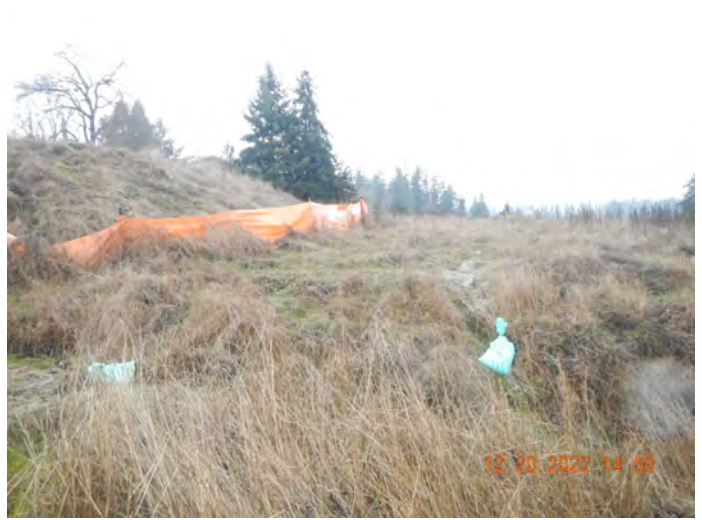
Photo #:06 (DSC3133)

Description: Facing north, photo of vegetation coverage and silt fencing along northwest slopes.

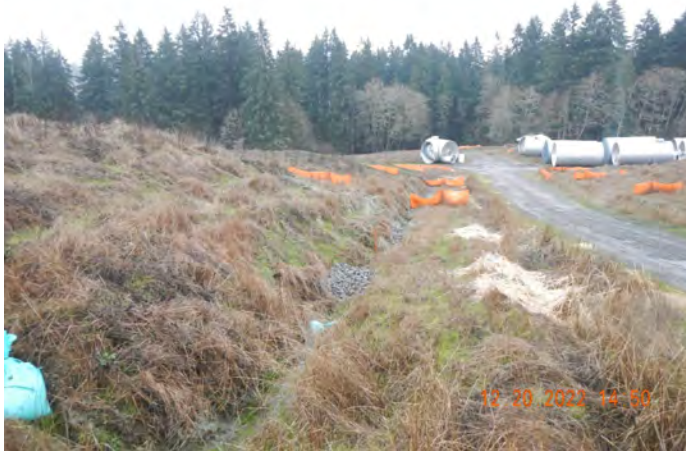
Photo #:07 (DSCN3134)

Description: Facing east, photo of access road BMPs including silt fencing, rock check dams and straw mulch.

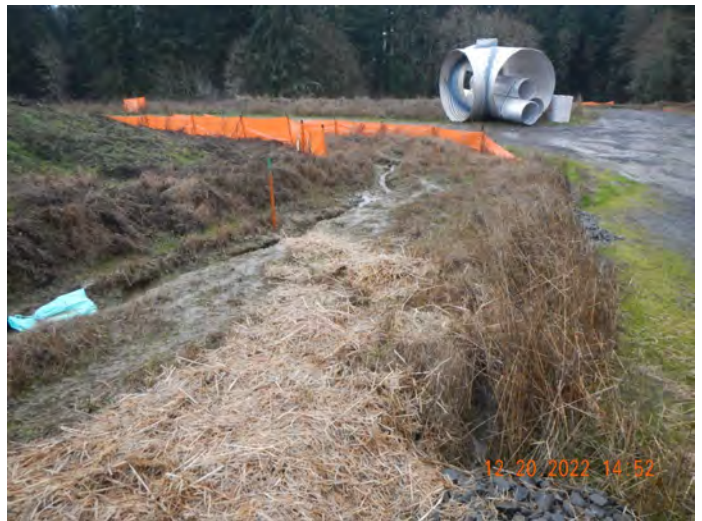
Photo #:08 (DSCN3135)

Description: Facing east, photo of access road BMPs including silt fencing, rock check dams and straw mulch.

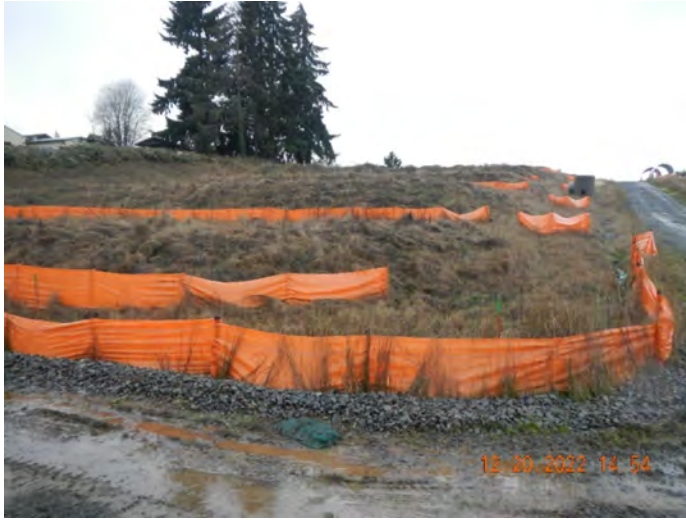
Photo #:09 (DSCN3136)

Description: Facing west, photo of silt fencing along southern slopes.

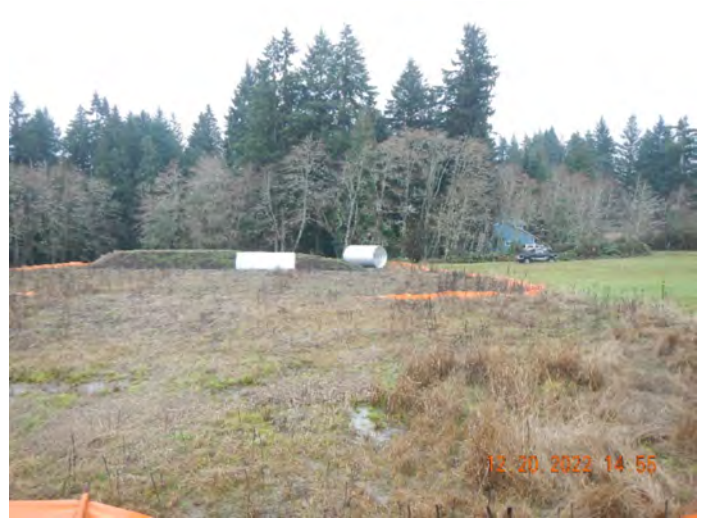
Photo #:10 (DSC3137)

Description: Facing east, photo of vegetation coverage along southeastern slopes, west of South Pond.

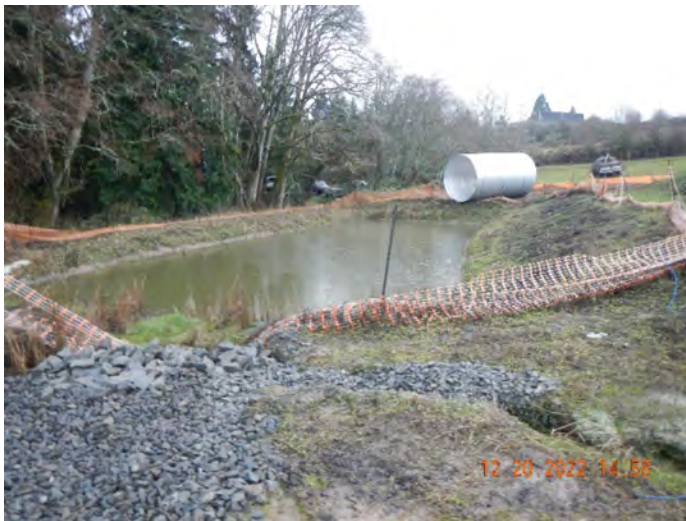
Photo #:11 (DSCN3138)

We then arrived at the South Pond (**Photo 11**). The South Pond was not discharging at the time of inspection. According to Peter Dewitz, he believed the South Pond last discharged on approximately December 8, 2022, and turbidity was measured below the benchmark value (25 NTU) at 8.73 NTUs. The South Pond discharges/overflows via a matted channel along the northeast bank to a vegetated area toward Gee Creek. Silt fencing was installed downslope of the discharge area along the heavily vegetated tree line. In this area I observed a section of silt fencing where sediment was deposited above one-third the height of the section of silt fence (**Photo 12 & Photo 13**). In addition, it was observed that the South Pond's discharge location could benefit from additional maintenance/BMPs to in order to prevent channelized erosion from occurring during high discharge events (**Photo 14**).

Description: Facing south, photo of South Pond inlet.

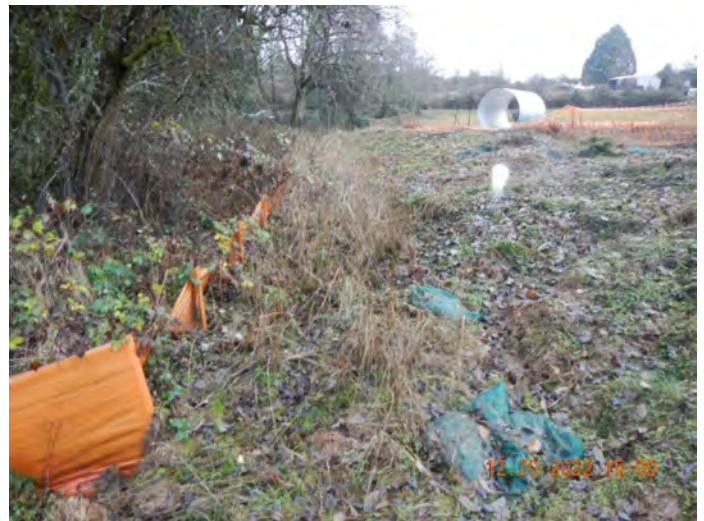
Photo #:12 (DSCN3139)

Description: Facing south, photo of vegetative area east of the South Pond discharge.

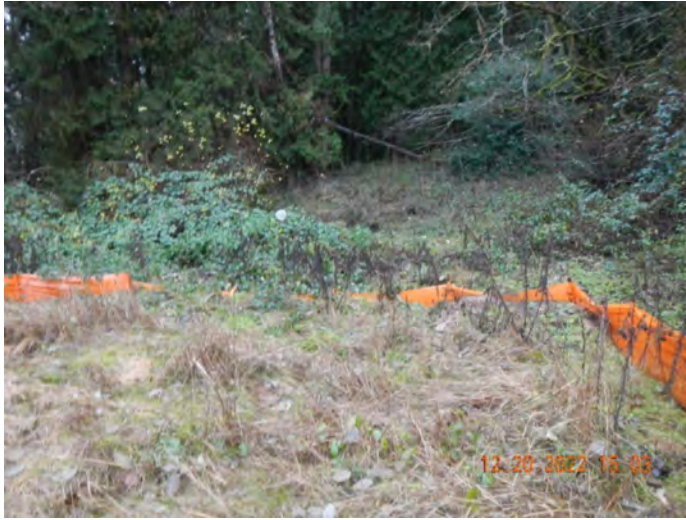
Photo #:13 (DSCN3140)  
Description: Facing east, photo of vegetative area east of the South Pond discharge.

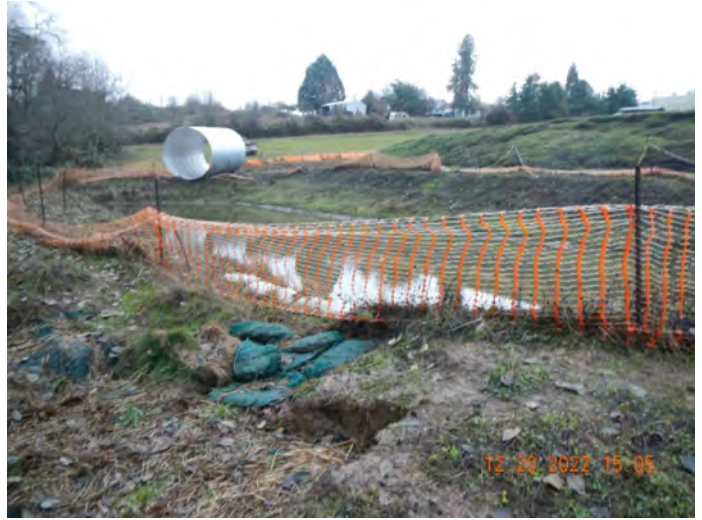
Photo #:14 (DSC3141)  
Description: Facing south, photo of South Pond discharge location.

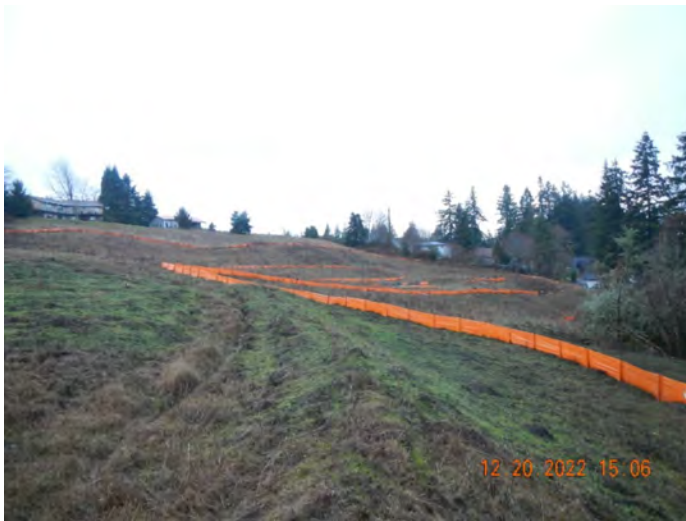
We continued the walk-through north from the South Pond. Silt-fencing was installed throughout the northern and eastern slopes (**Photo 15 & 16**). We arrived at the North Pond, riprap lined the conveyance channel down to the pond (**Photo 17**). Similar to the South Pond, the North Pond discharges/overflows via matted channel along the northeast bank to a vegetated area toward Gee Creek. At the time of inspection, the North Pond was discharging slightly to the vegetated area. The discharge appeared to be clear and was infiltrating within the vegetative area. According to Mr. Dewitz, the North Pond discharge was last sampled on approximately December 8, 2022, and turbidity was measured below the benchmark value (25 NTU) at 14.8 NTU.

Photo #:15 (DSCN3142)  
Description: Facing north, photo of eastern slope and perimeter silt fencing.

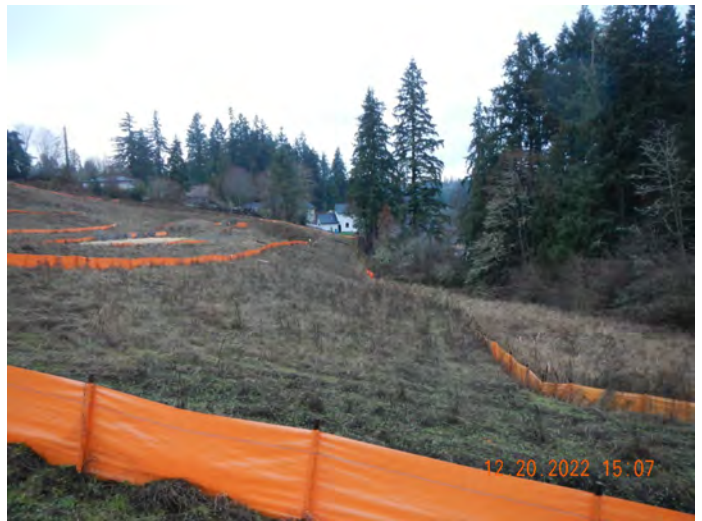
Photo #:16 (DSCN3143)  
Description: Facing north, photo of eastern slope and perimeter silt fencing.

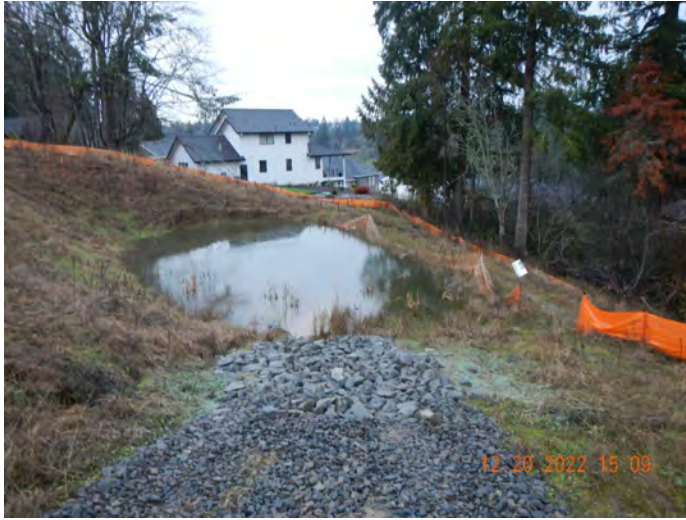
As discussed earlier in this inspection report, at the time of inspection during the walk-through of the North Pond, I observed a gap in the riprapped channel just prior to the entrance to the North Pond. Stormwater was observed to be clear leaving the riprapped channel however, the riprap channel ended just prior to entering the pond which was causing some turbidity and erosion as stormwater was entering the inlet of the North Pond (**Photo 19**). It was discussed that the riprap channel could be improved to prevent the turbidity observed at the North Pond inlet, potentially impacting the quality of the pond’s discharge. Peter Dewitz and John Dewitz stated that the concern would be addressed.

Photo #:17 (DSCN3144)  
Description: Facing north, photo of North Pond and riprap channel.

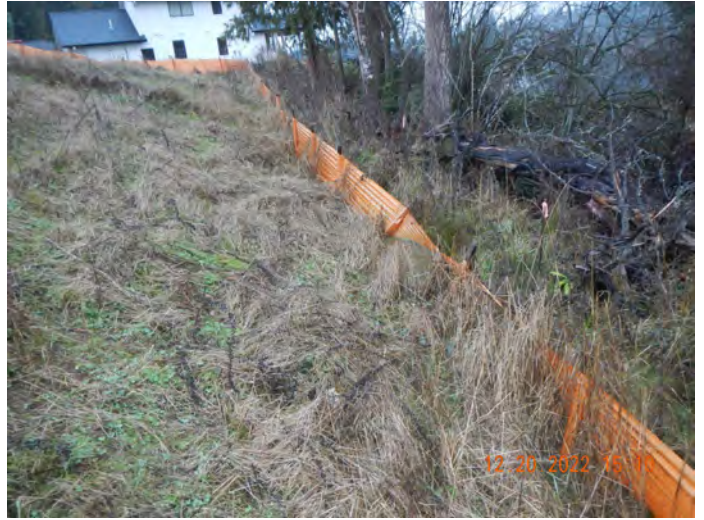
Silt fencing was installed downslope of the discharge area along the heavily vegetated tree line. In this area, I observed a section of silt fencing where sediment was deposited above one-third the height of the section of silt fence (**Photo 18**). I also observed a gap in the riprapped channel just prior to the entrance to the North Pond. The riprap channel ended just prior to the pond which was producing slight erosion as stormwater was entering the North Pond (**Photo 19**) and causing some turbidity. Above the riprap lined conveyance channel at the North Pond, straw wattles were staked along the west side of the access road in addition to rock check dams and silt-fencing (**Photo 20**).

As discussed earlier in this inspection report, at the time of inspection during the walk-through of the North and South Ponds, I observed sections of silt fencing where sediment was deposited above one-third the height of the section of silt fence (**Photo 12, Photo 13, Photo 18**). Sediment was still contained by the silt fence, but the fence was in need of maintenance based upon the written standard.

Photo #:18 (DSC3145)  
Description: Facing north, photo of the vegetative area east of the North Pond discharge and perimeter silt fencing.

We discussed the silt-fence maintenance standard and John Dewitz stated that due to the soft ground and current weather, the likely remediation would be to install a second fence and that the silt fence concern would be addressed.

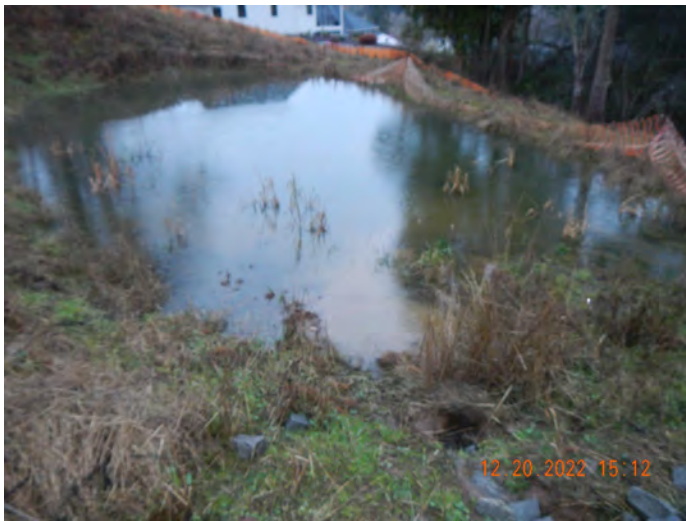
Photo #:19 (DSCN3146)  
Description: Facing north, photo of the inlet to the North Pond after the riprap channel.

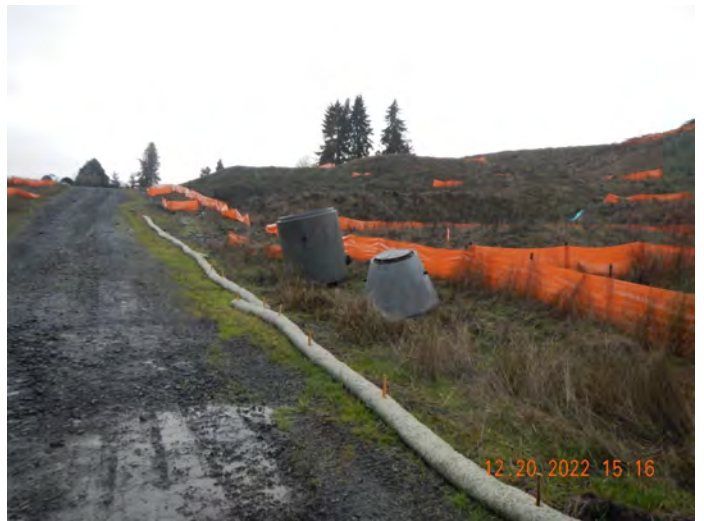
Photo #:20 (DSC3147)  
Description: Facing south/southwest, photo of BMPs along the North Pond access road.
