**UNITED STATES ENVIRONMENTAL PROTECTION AGENCY  
REGION 8  
RESOURCE CONSERVATION AND RECOVERY ACT**

**Facility Name:** 12 Mile Wash COWDF

**Type and Purpose of Inspection:** Compliance Evaluation Inspection and Compliance Schedule Evaluation (CSE)

**Facility Type:** Commercial Oilfield Waste Disposal Facility (COWDF)

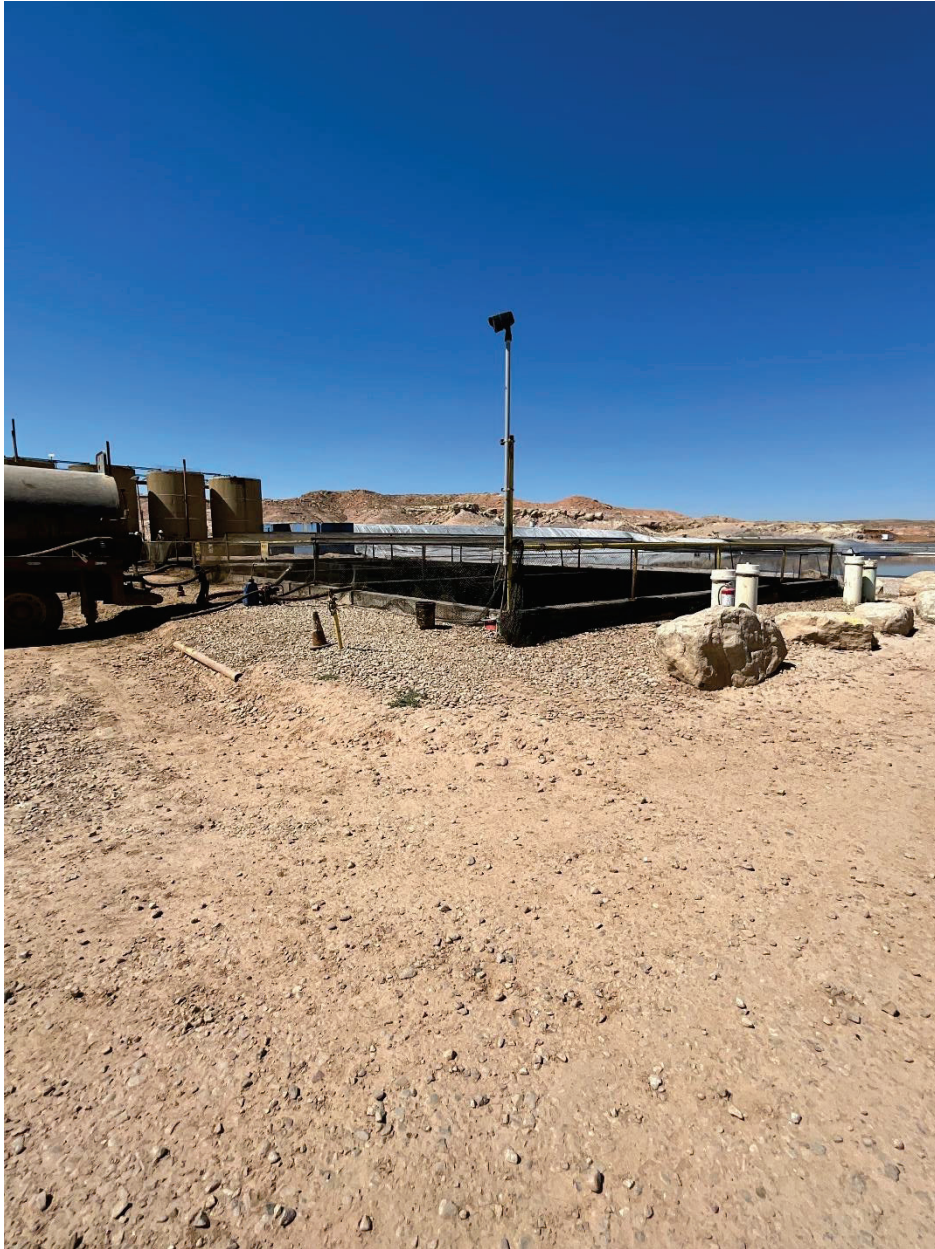
During the site walk-through, at the settling vault (a.k.a. headworks), I observed that the netting was in good condition. See Attachment 2, photo 6.

Photo 6: IMG\_0154.jpg, 7/9/2024 10:58 a.m. – photo of the slop/skim vault.

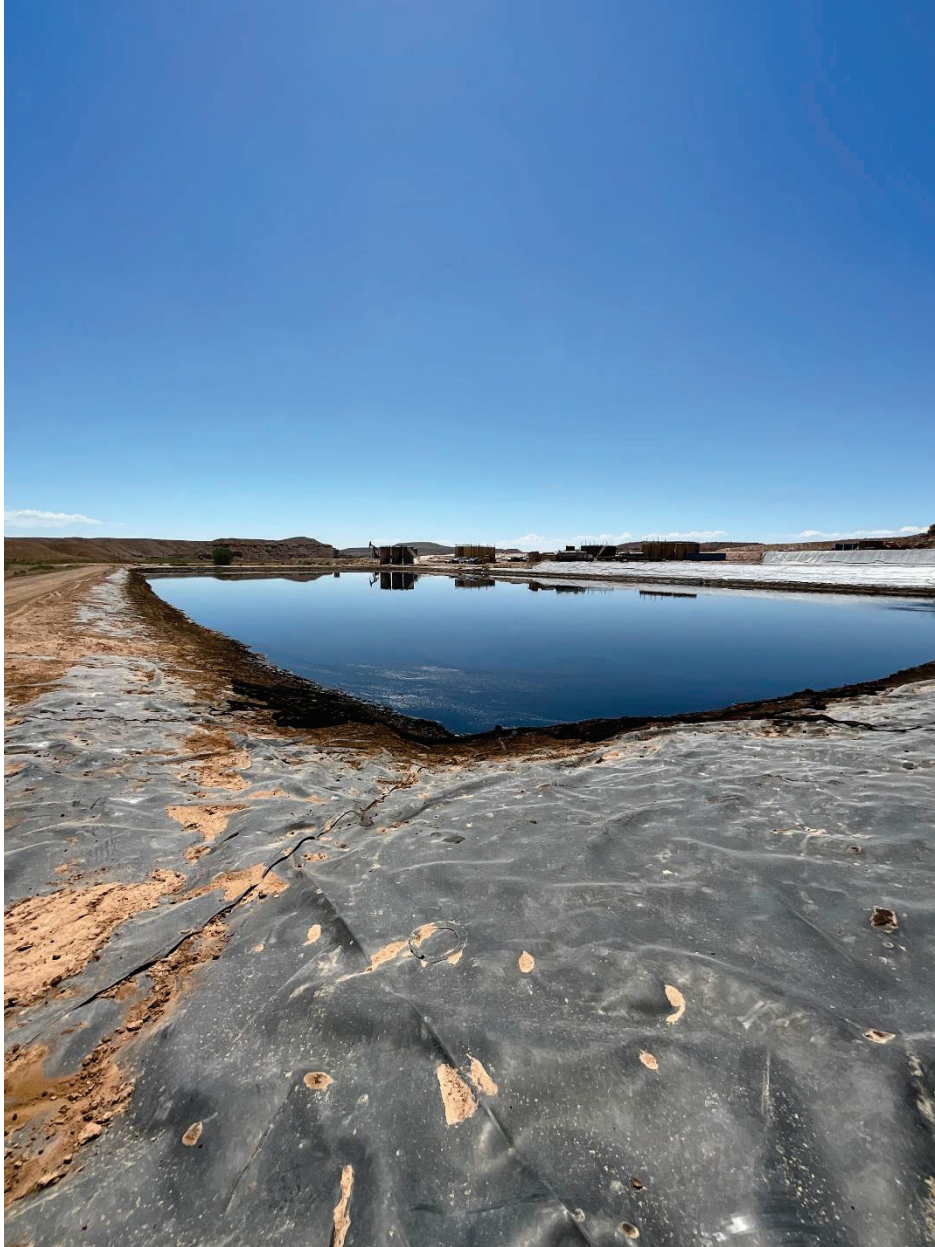
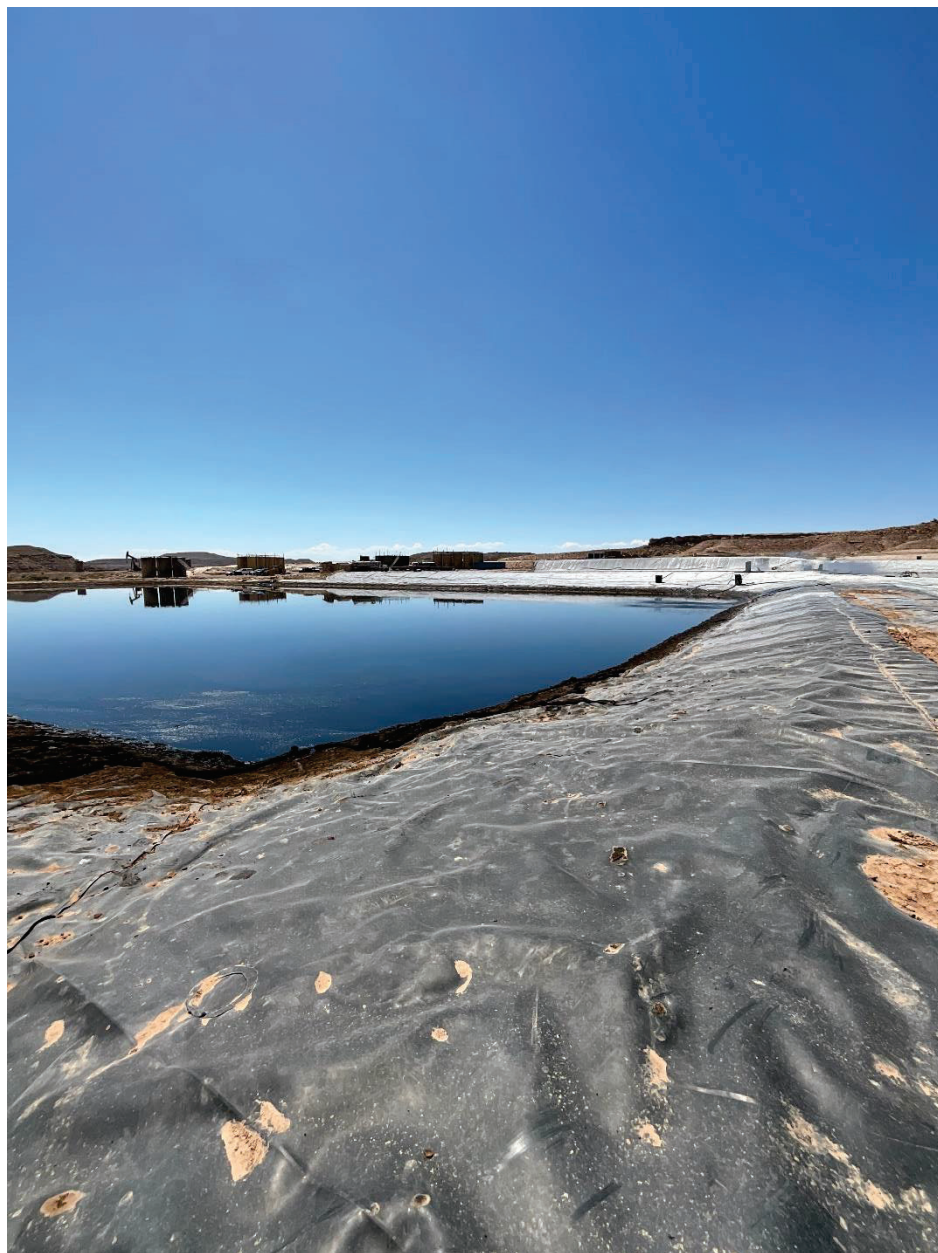
At Pond 1, I observed a small amount of oil floating on the surface at the northwest corner of the pond, Attachment 2, photos 7-9.

Photo 7: IMG\_0155.jpg, 7/9/2024 11:16 a.m. – photo of Pond 1 taken from the northwest corner.

Photo 8: IMG\_0156.jpg, 7/9/2024 11:16 a.m. – photo panned right from photo 7.

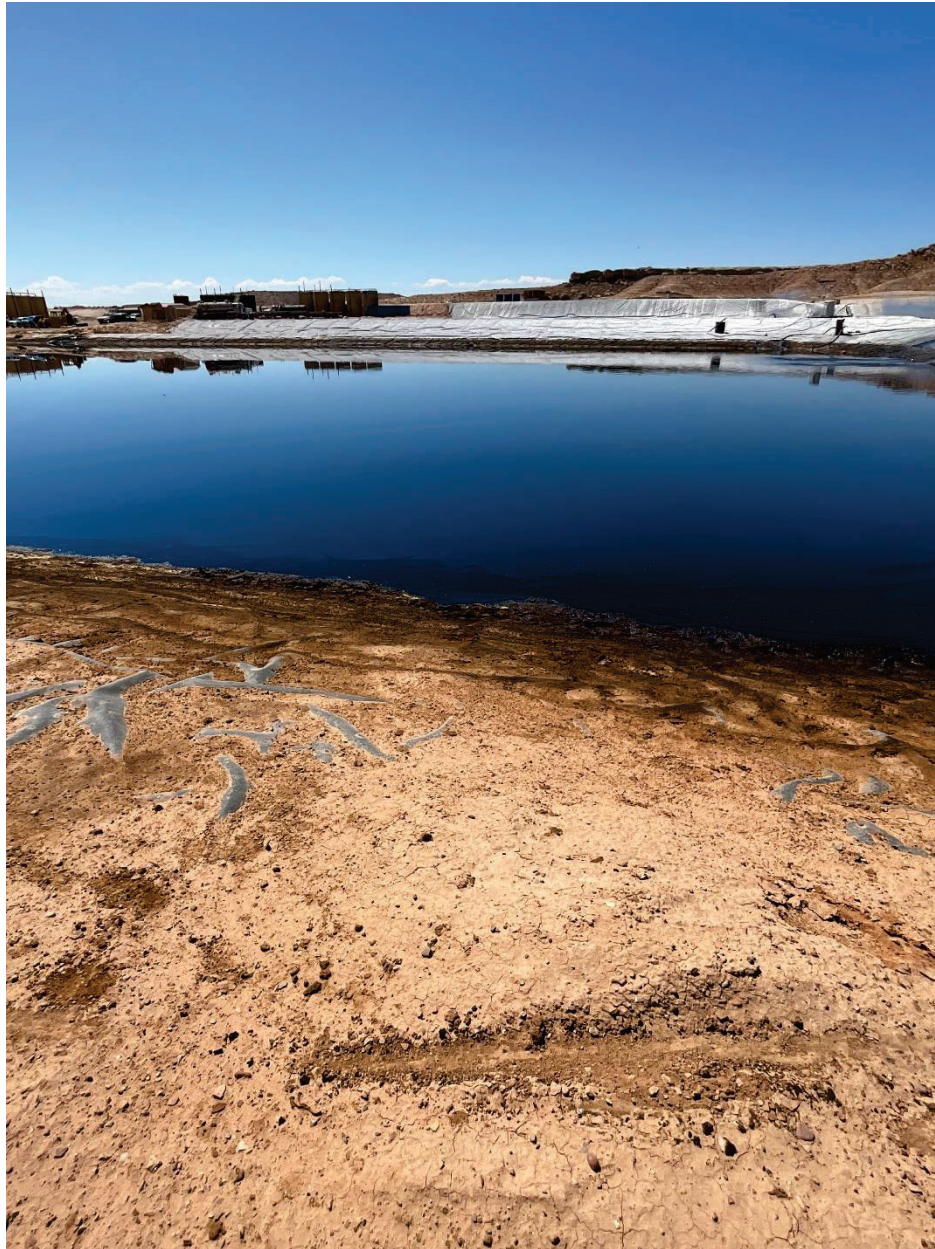
I did not observe spills of oily waste at the facility. Apart from the small amount of oil along the edge of the northwest corner of Pond 1, I did not observe oily waste that was physically unrestricted from access by wildlife. No bird or other wildlife mortalities were observed in any areas of the facility that were inspected.

Photo 9: IMG\_0157.jpg, 7/9/2024 11:17 a.m. – photo of Pond 1, with a discoloration at the edge of the pond that appeared to potentially be a small amount of oil near the northwest corner of the pond.

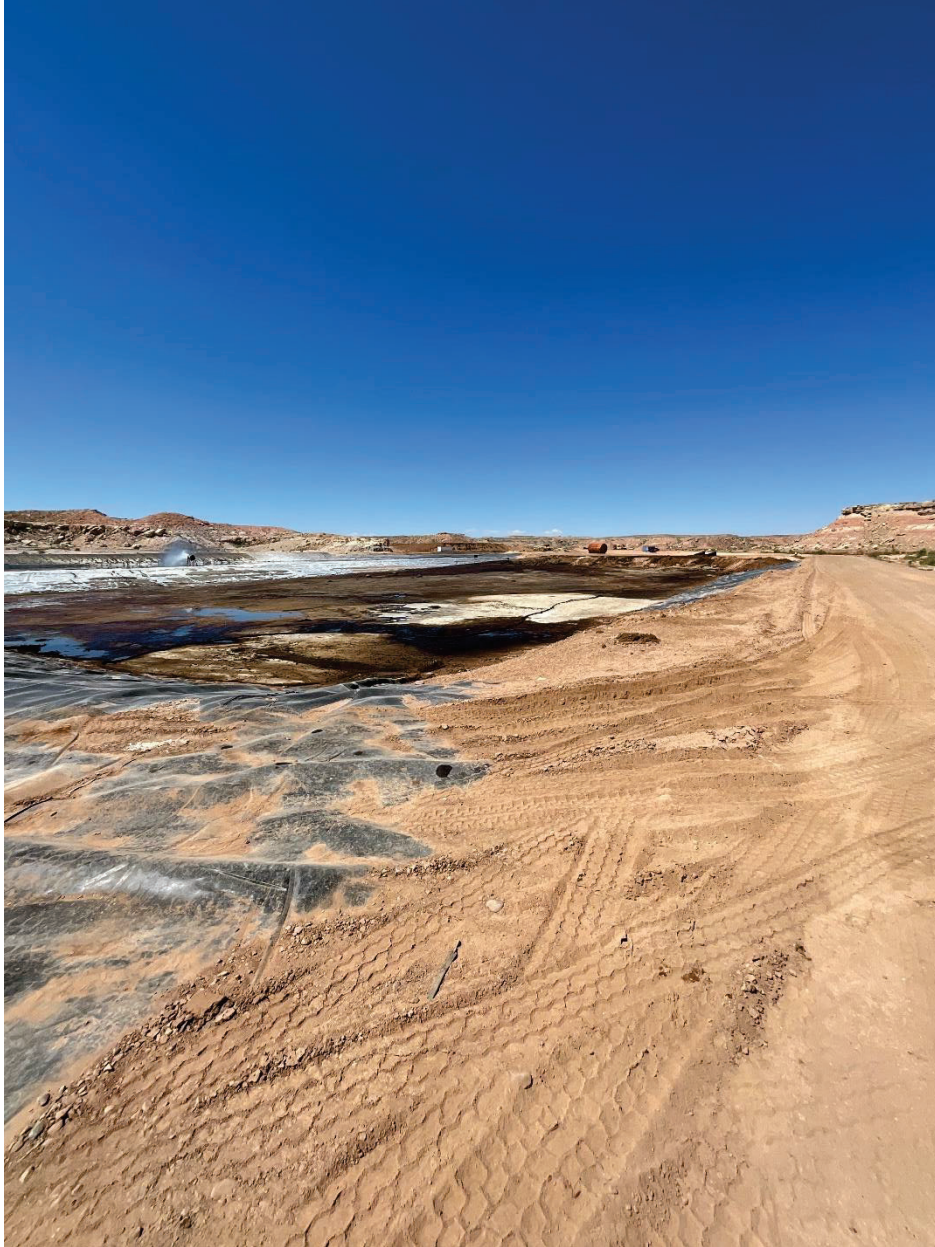
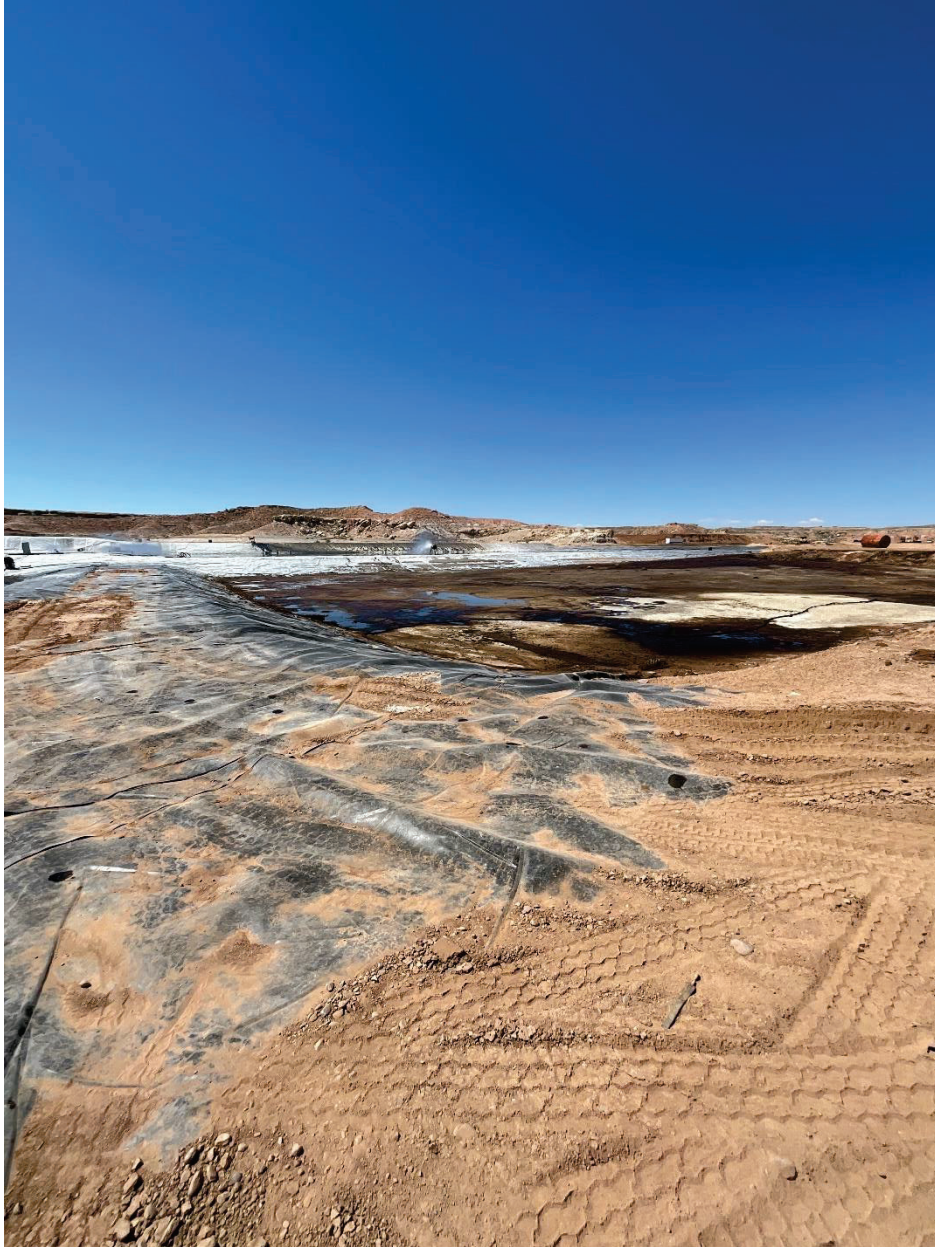
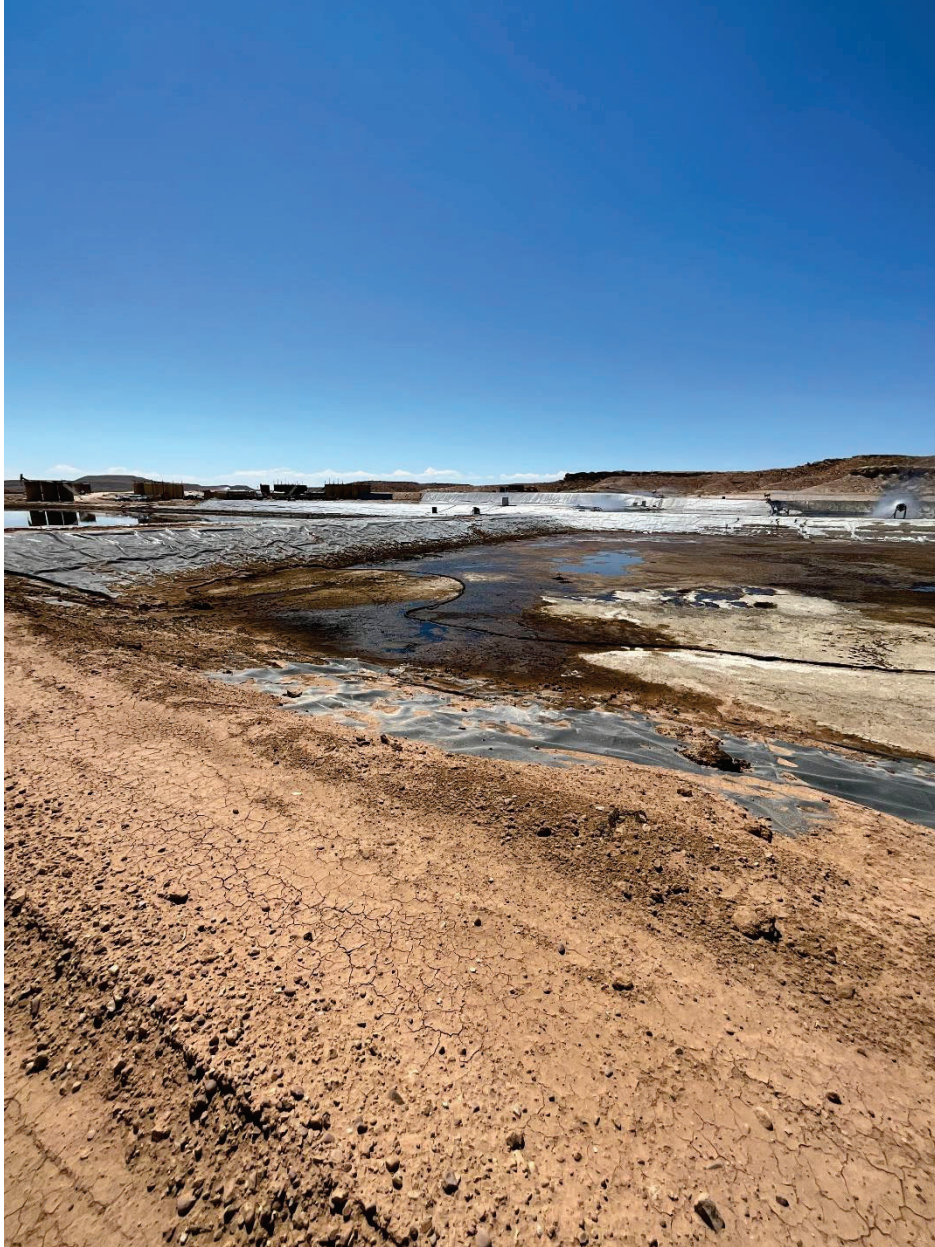
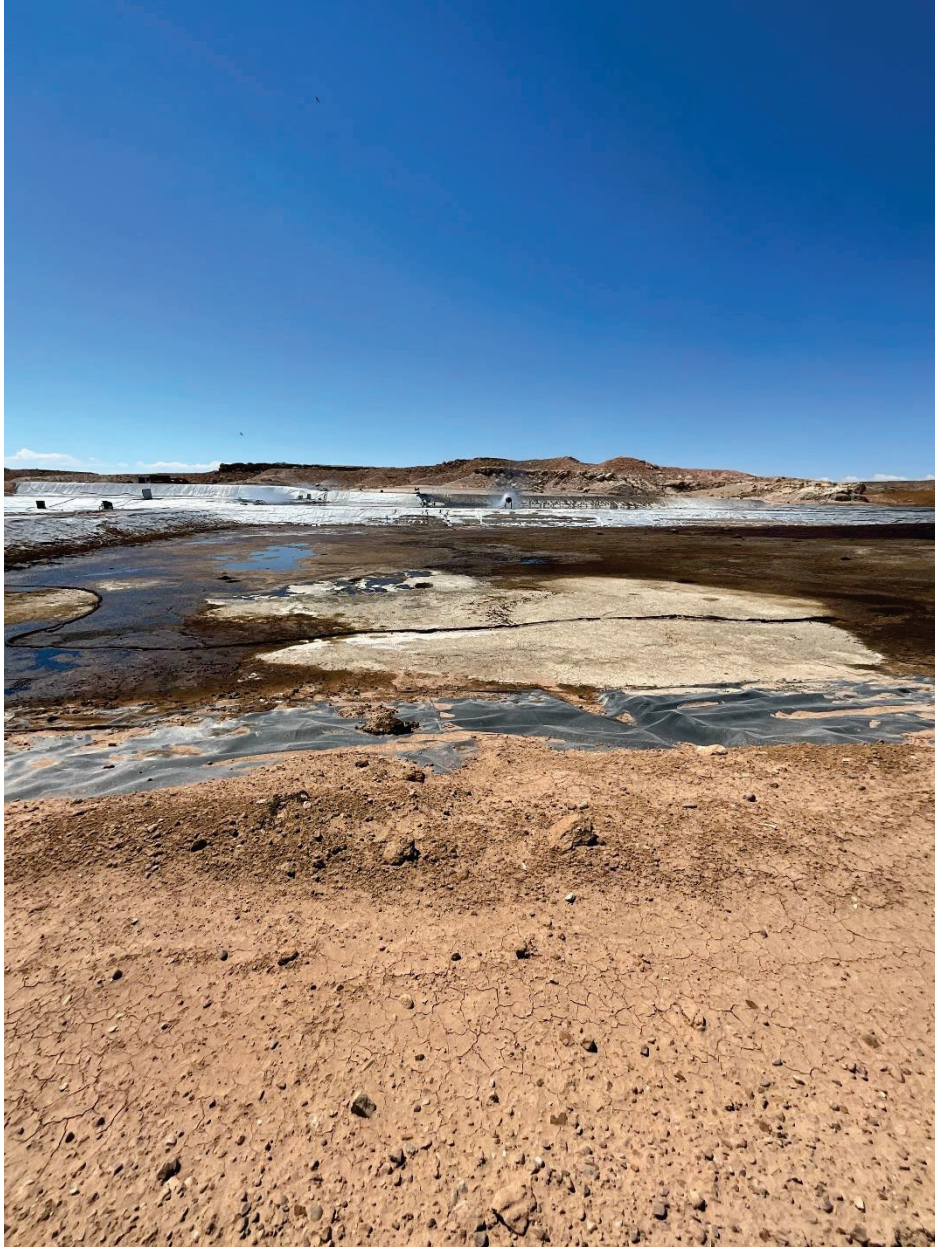
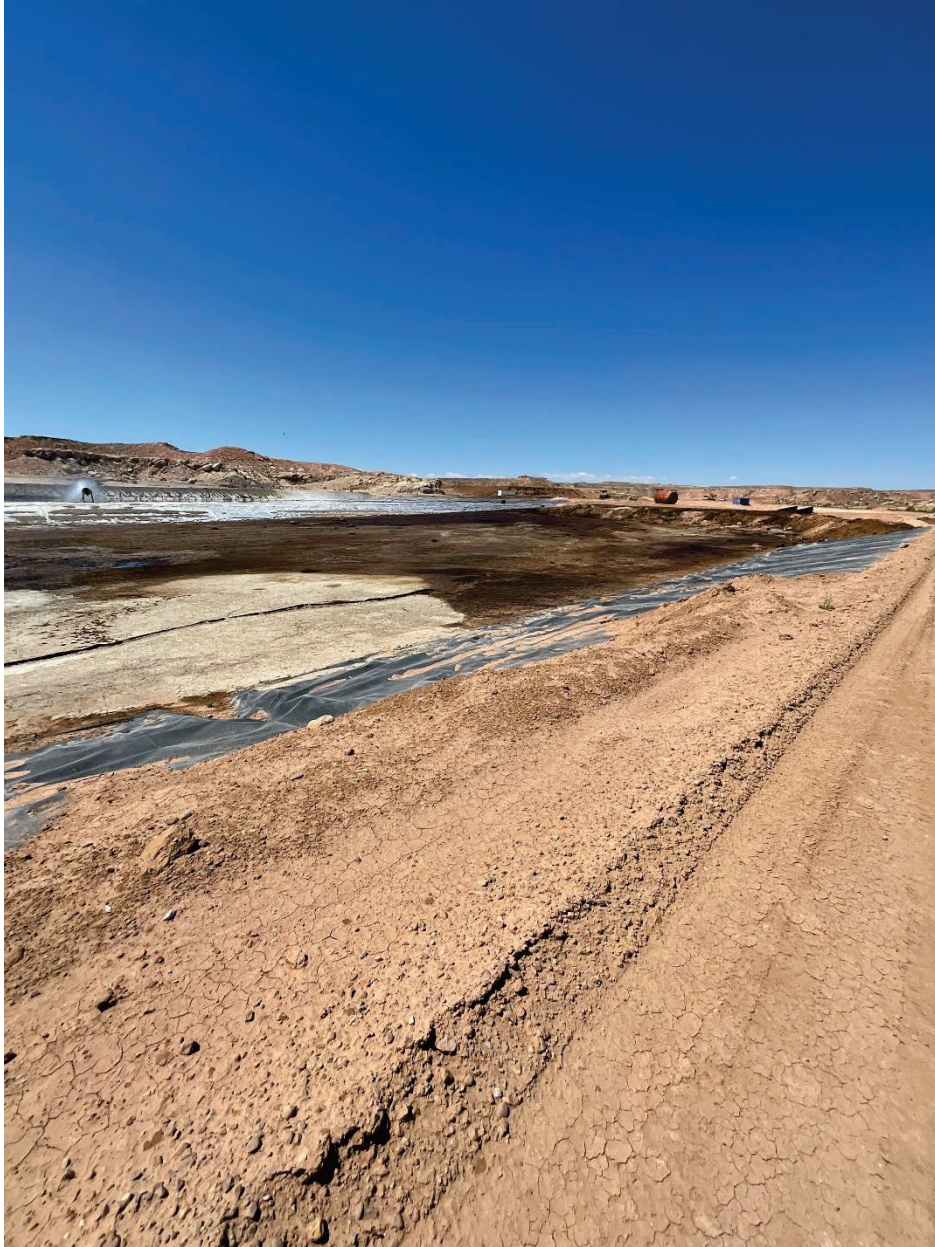
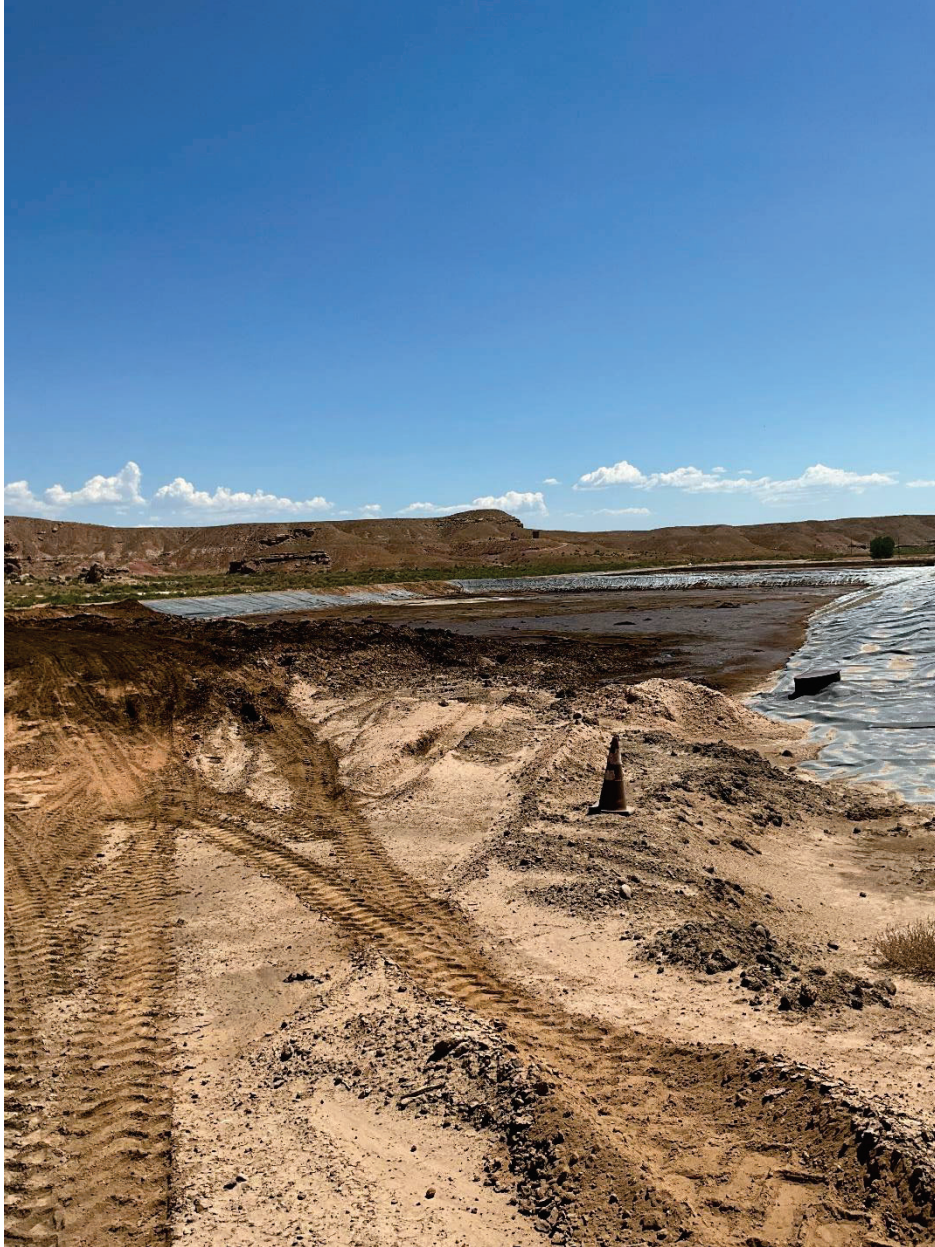
At Landfill 2, I observed that only a small amount of liquid was present on the surface of the landfill. The liquid appeared to potentially be due to previous precipitation and did not appear to be the result of liquid waste disposal. See Attachment 2, photos 10-15.

Photo 10: IMG\_0158.jpg, 7/9/2024 11:19 a.m. – photo of Landfill 2, taken from the northeast corner.

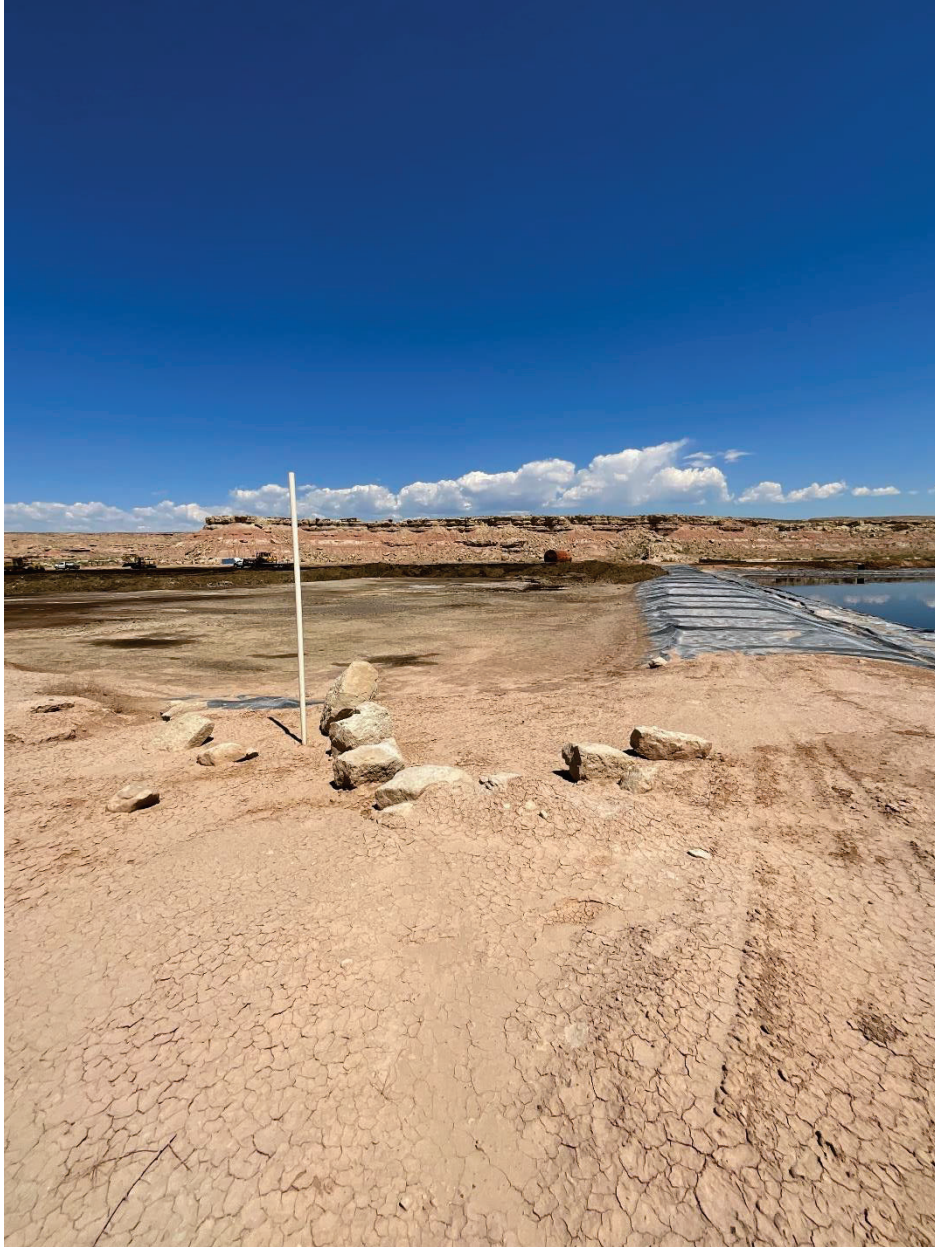
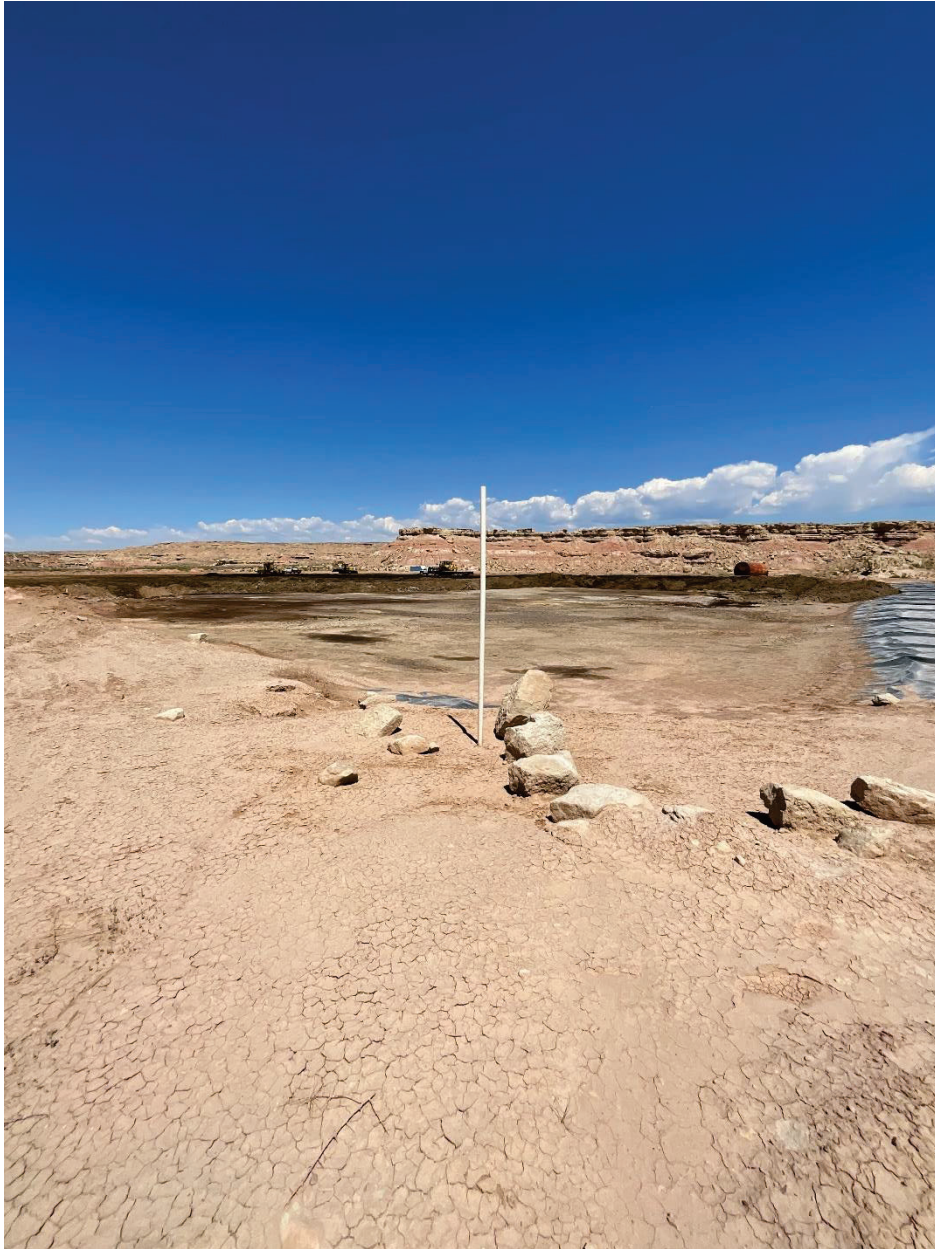
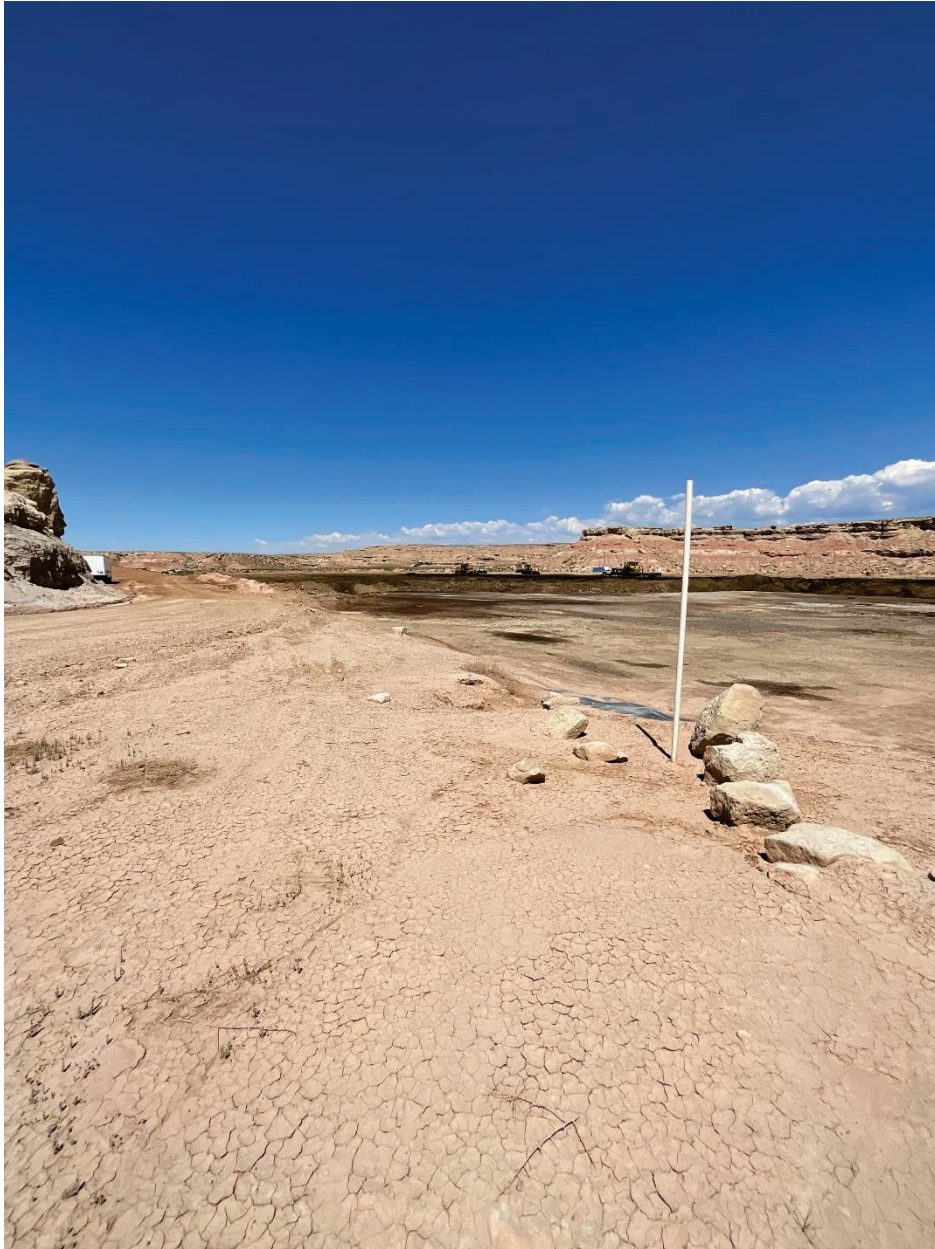
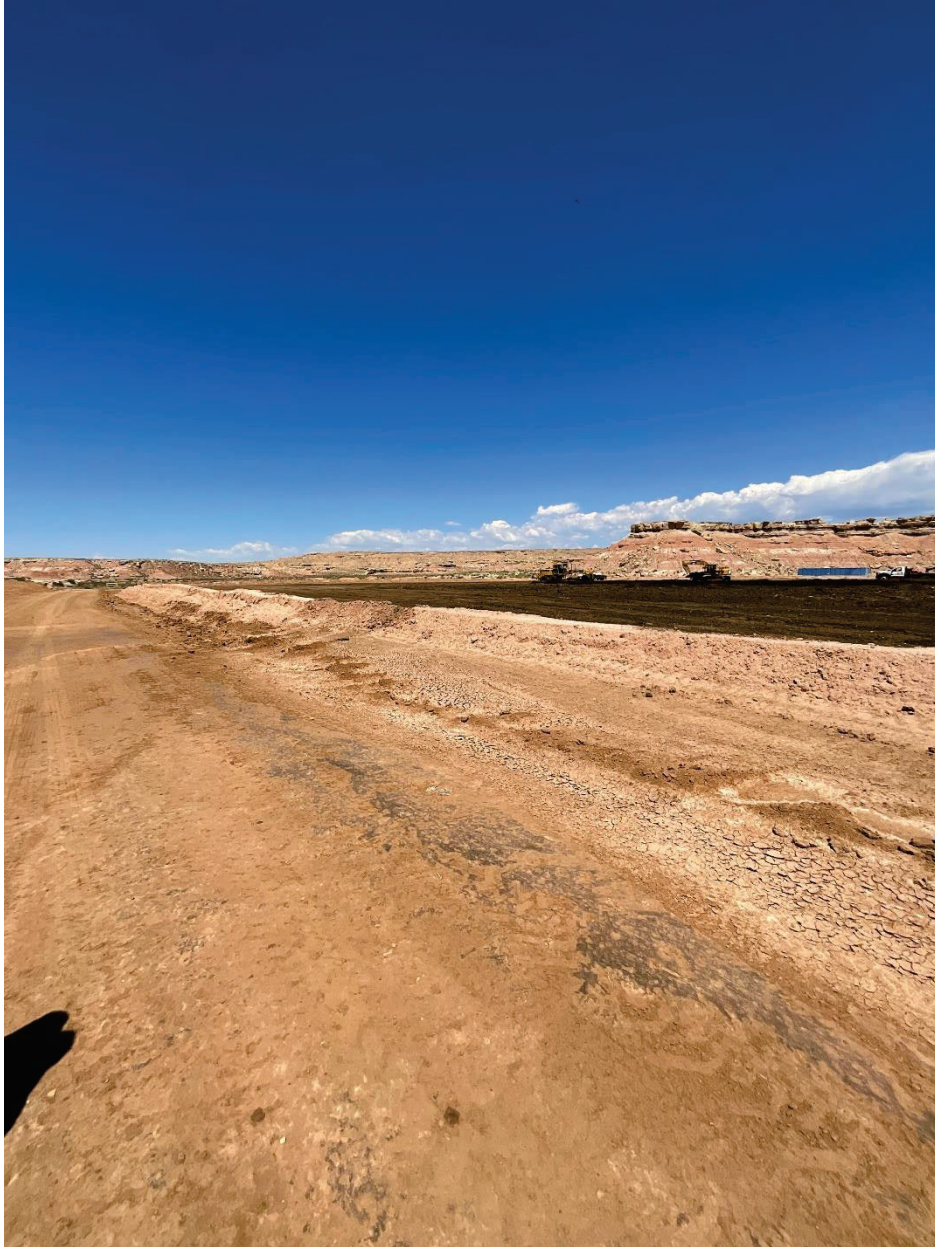
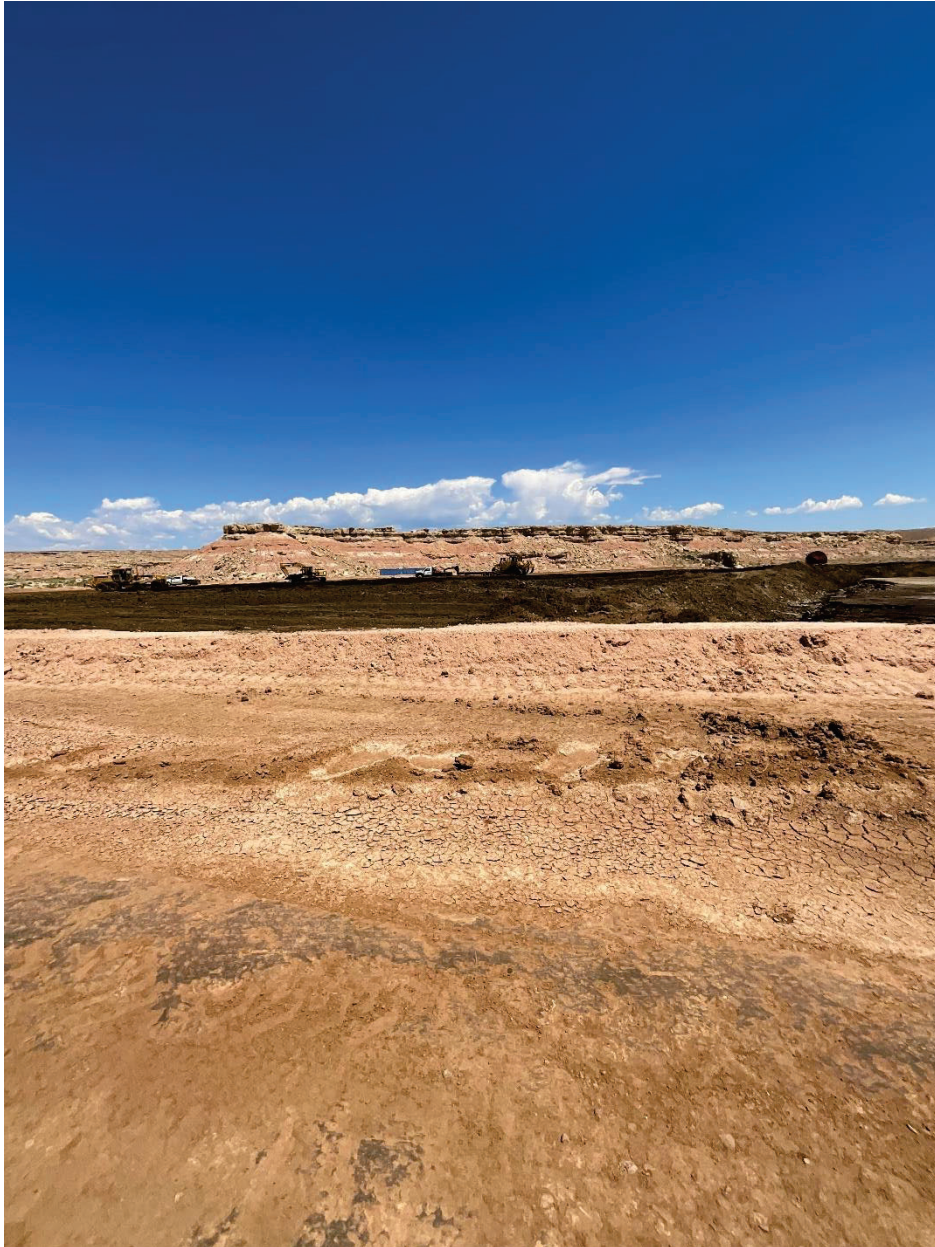
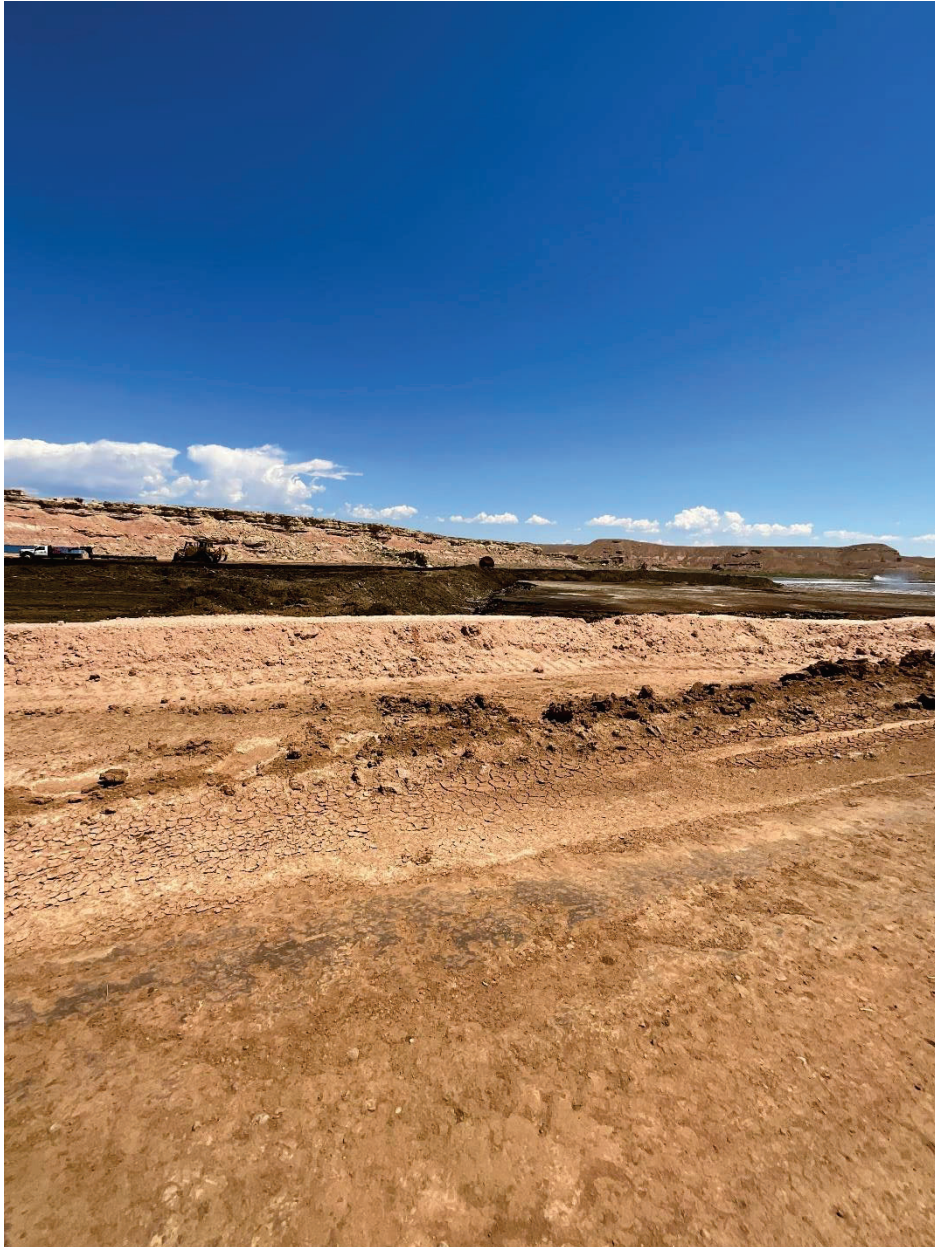
At Landfill 1, I observed no indication of liquid or standing oily waste on the surface of the landfill. See Attachment 2, photos 18-25 and 31-33. I also did not observe any liquid or standing oily waste on the surface of the landfarm, see Attachment 2, photos 26-30.

Photo 18: IMG\_0166.jpg, 7/9/2024 11:48 a.m. – photo of Landfill 1, taken from the southeast corner facing north toward the eastern end of the Landfill 1.
