**UNITED STATES ENVIRONMENTAL PROTECTION AGENCY  
REGION 8  
RESOURCE CONSERVATION AND RECOVERY ACT**

**Facility Name:** 12 Mile Wash COWDF

**Type and Purpose of Inspection:** Compliance Evaluation Inspection and Compliance Schedule Evaluation (CSE)

**Facility Type:** Commercial Oilfield Waste Disposal Facility (COWDF)

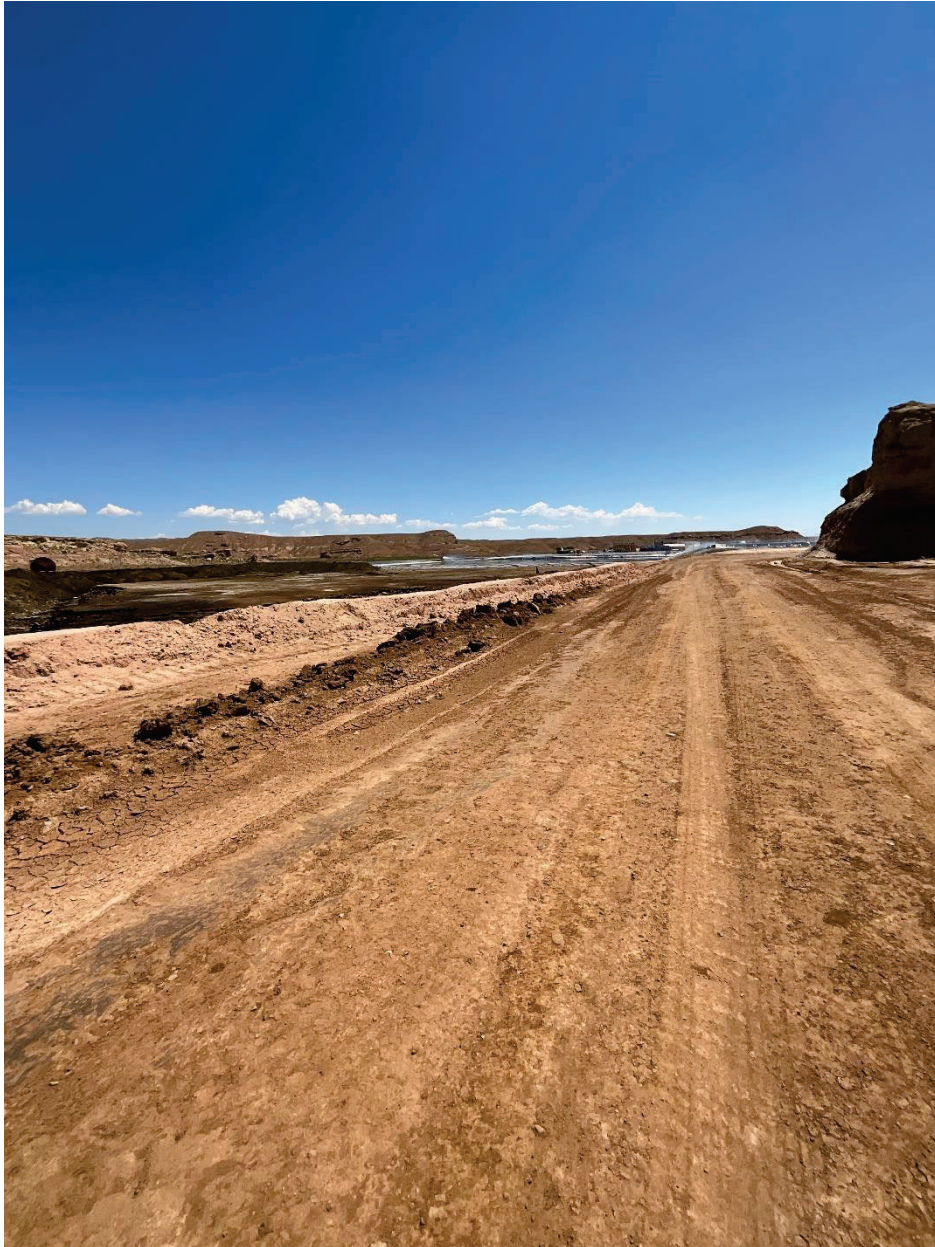
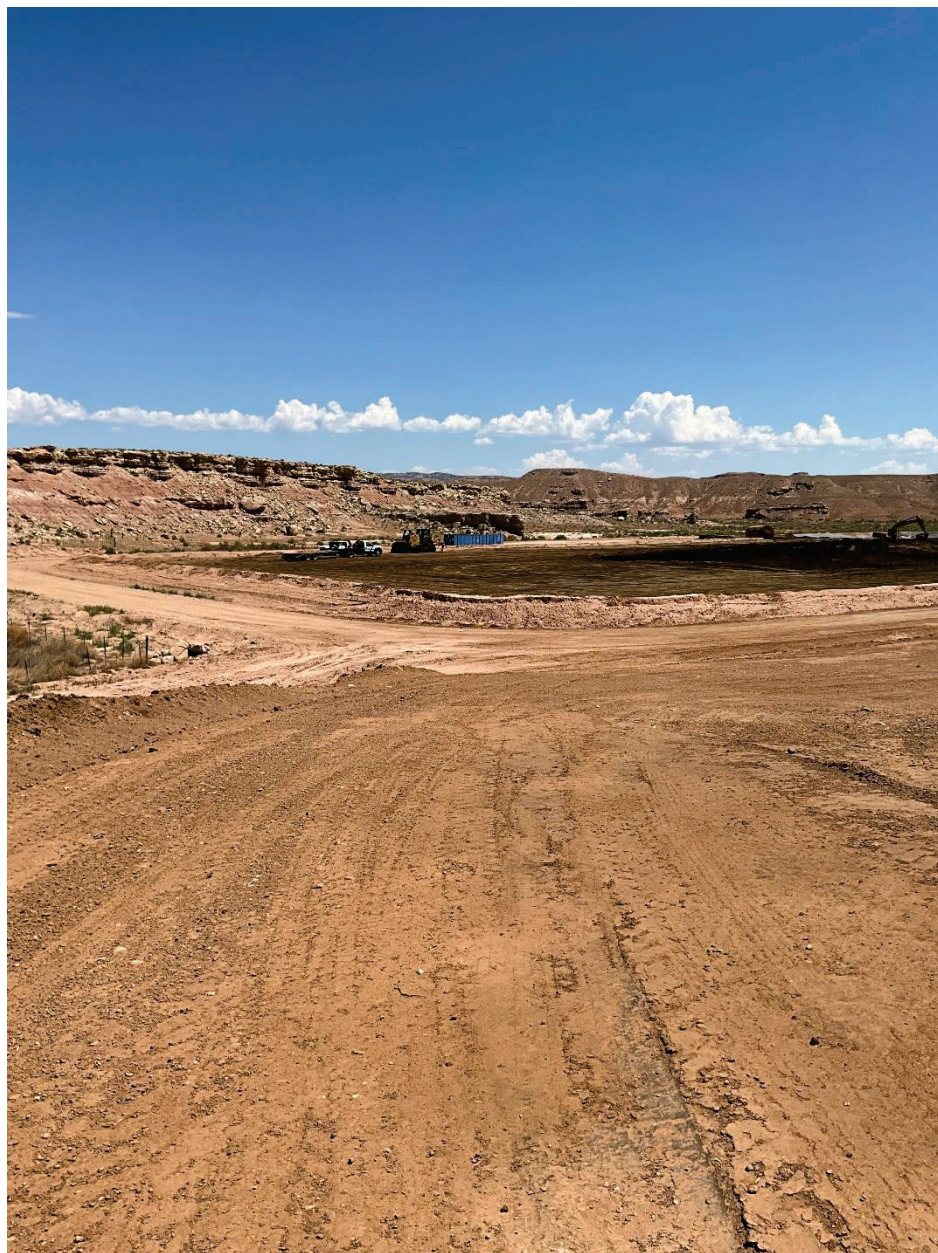
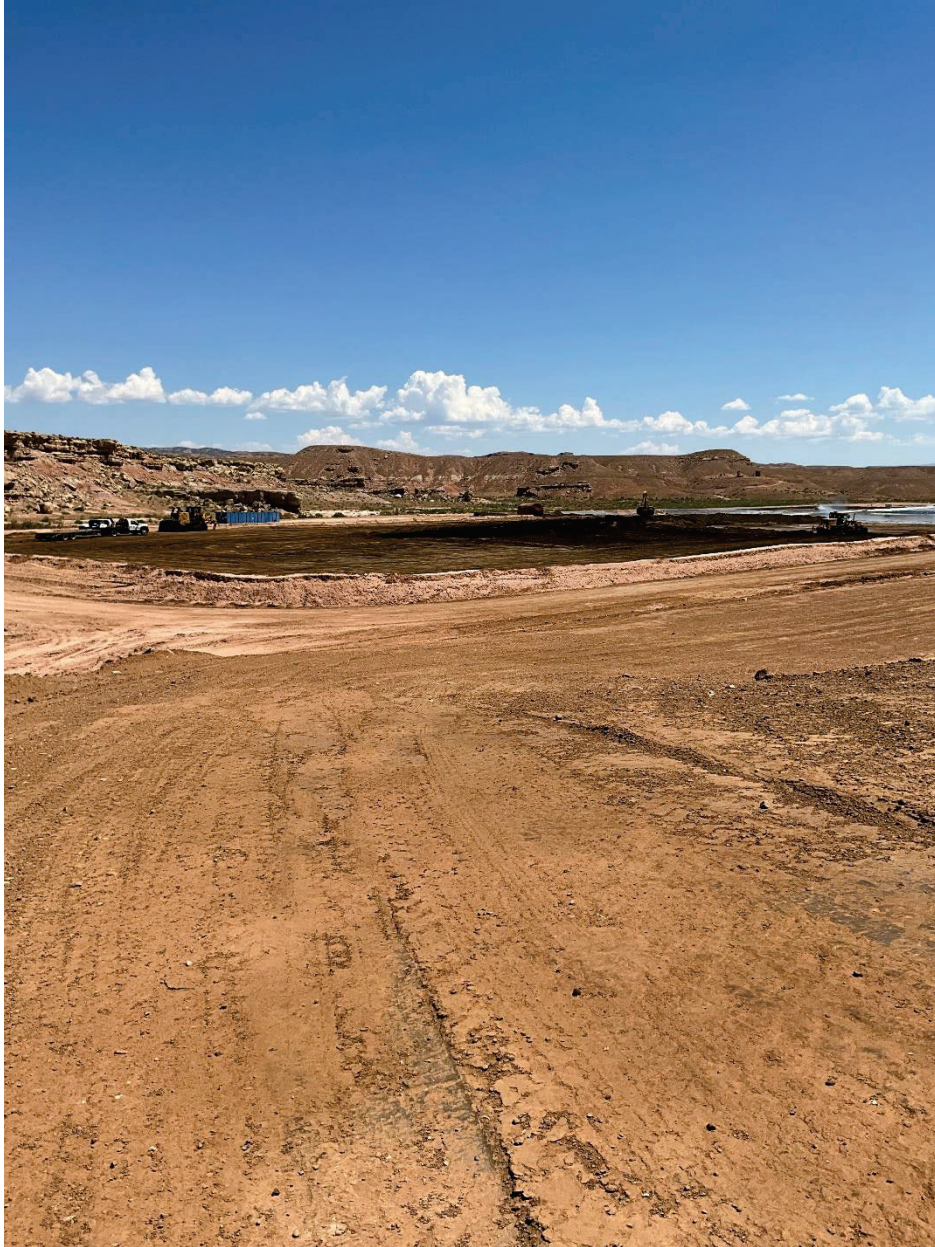
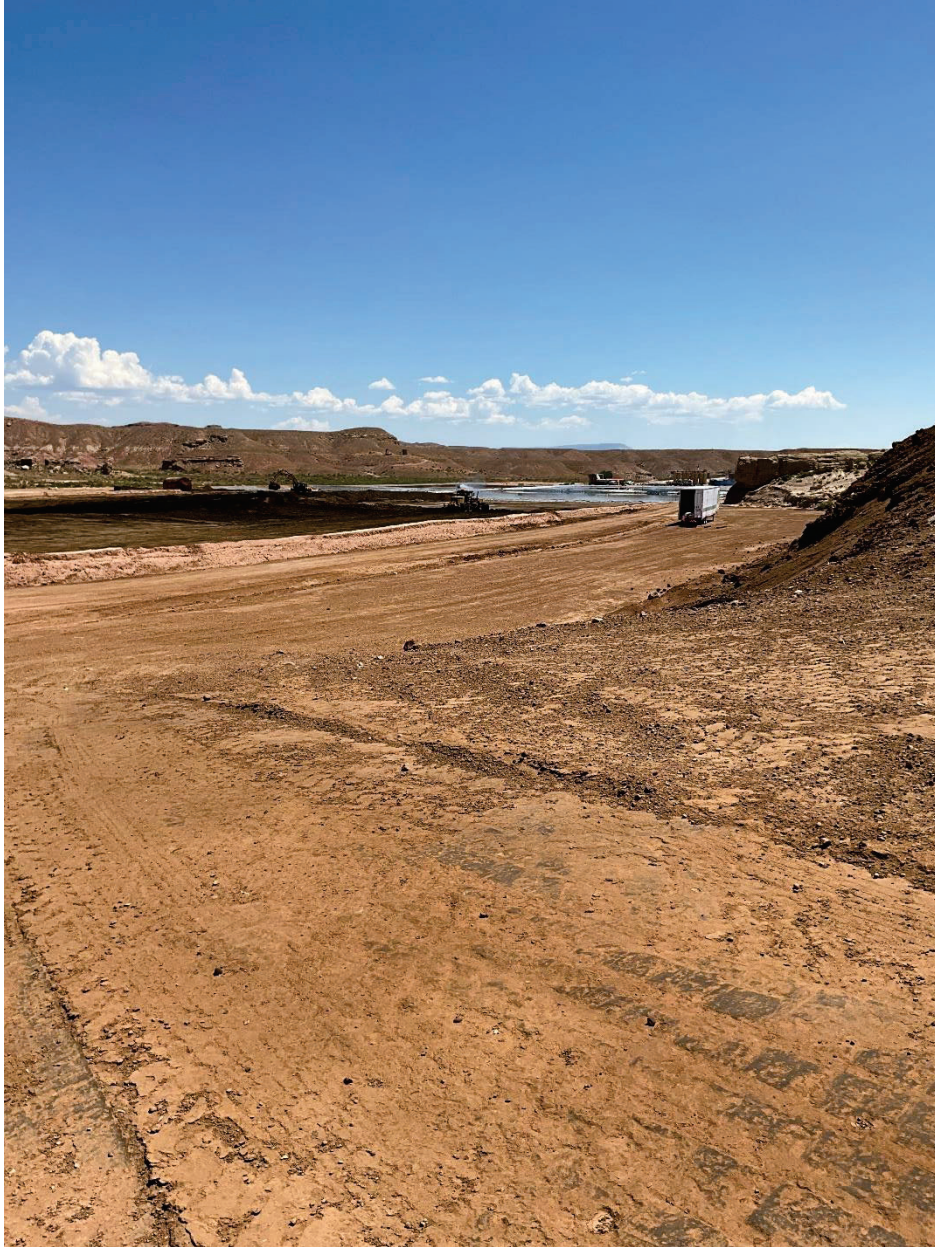
At Landfill 1, I observed no indication of liquid or standing oily waste on the surface of the landfill. See Attachment 2, photos 18-25 and 31-33. I also did not observe any liquid or standing oily waste on the surface of the landfarm, see Attachment 2, photos 26-30.

Photo 25: IMG\_0173.jpg, 7/9/2024 11:53 a.m. – photo of Landfill 1 panned right from photo 24.

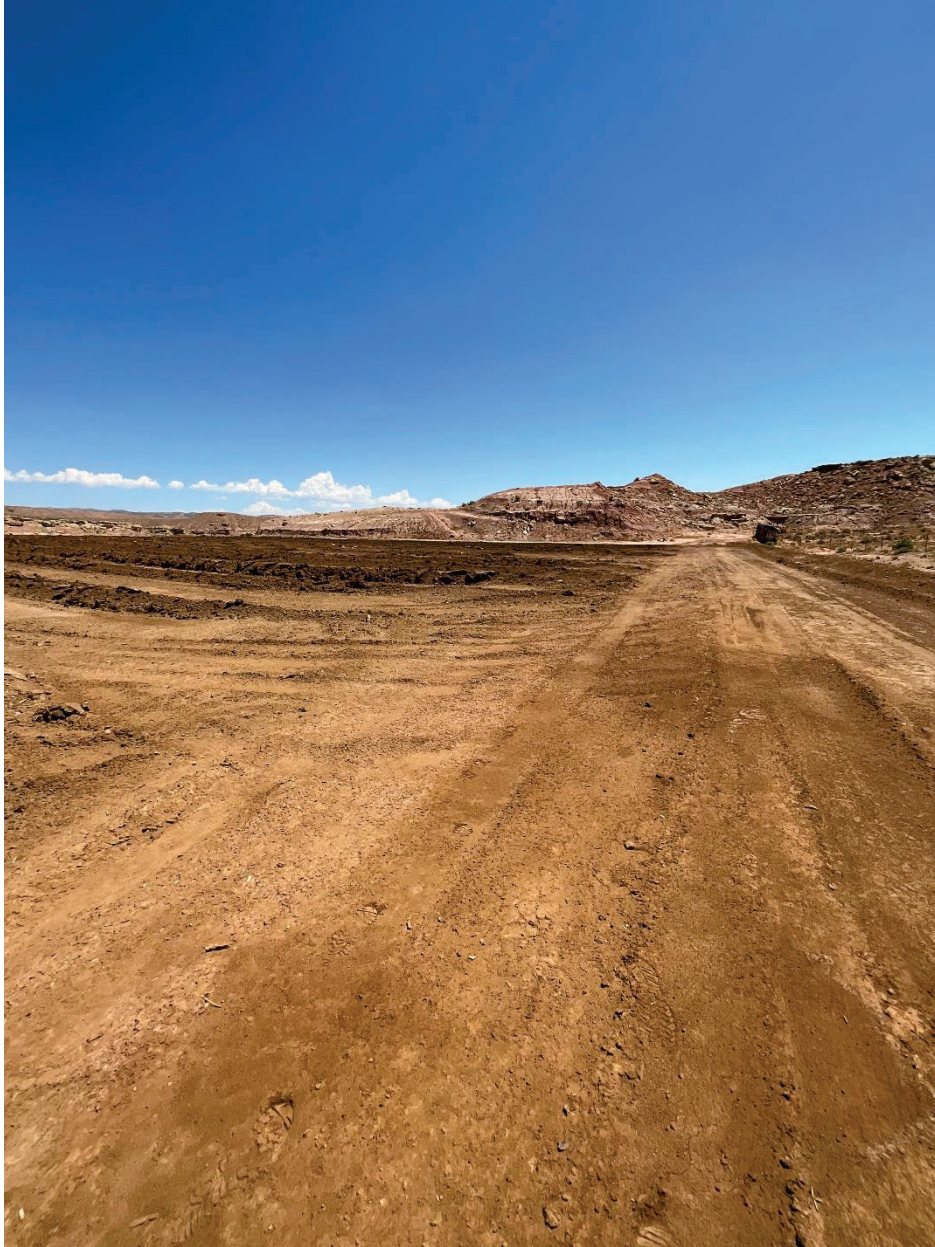
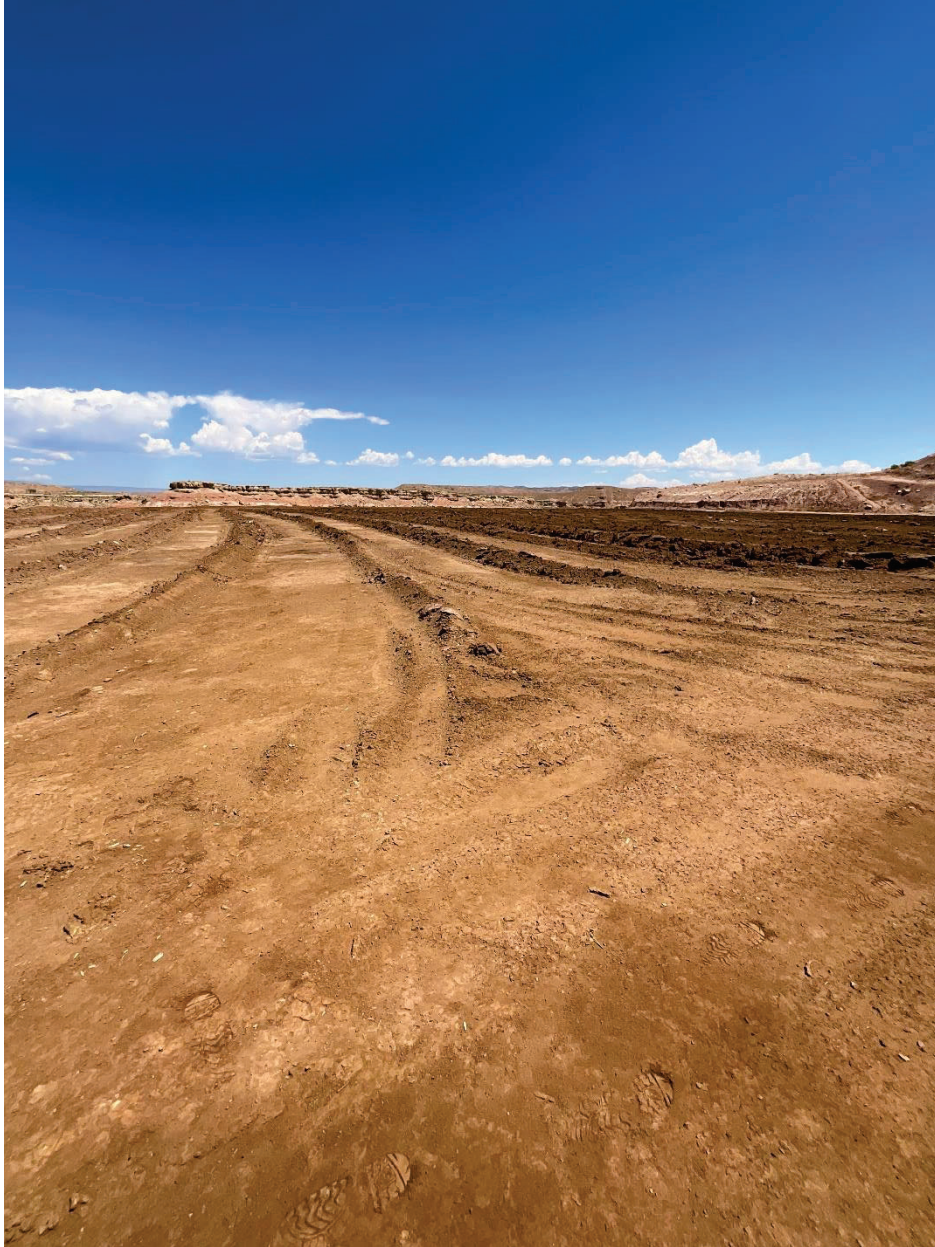
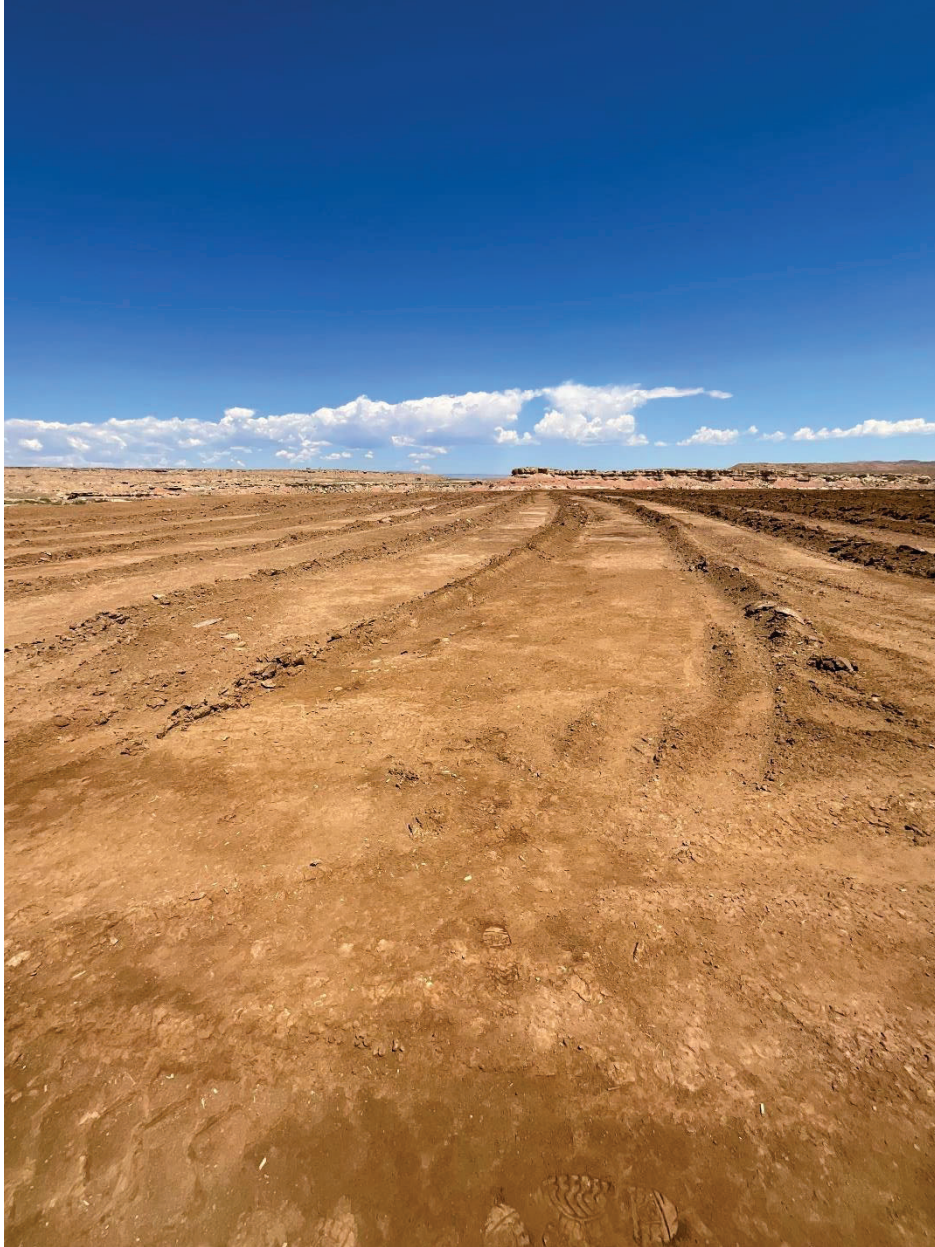
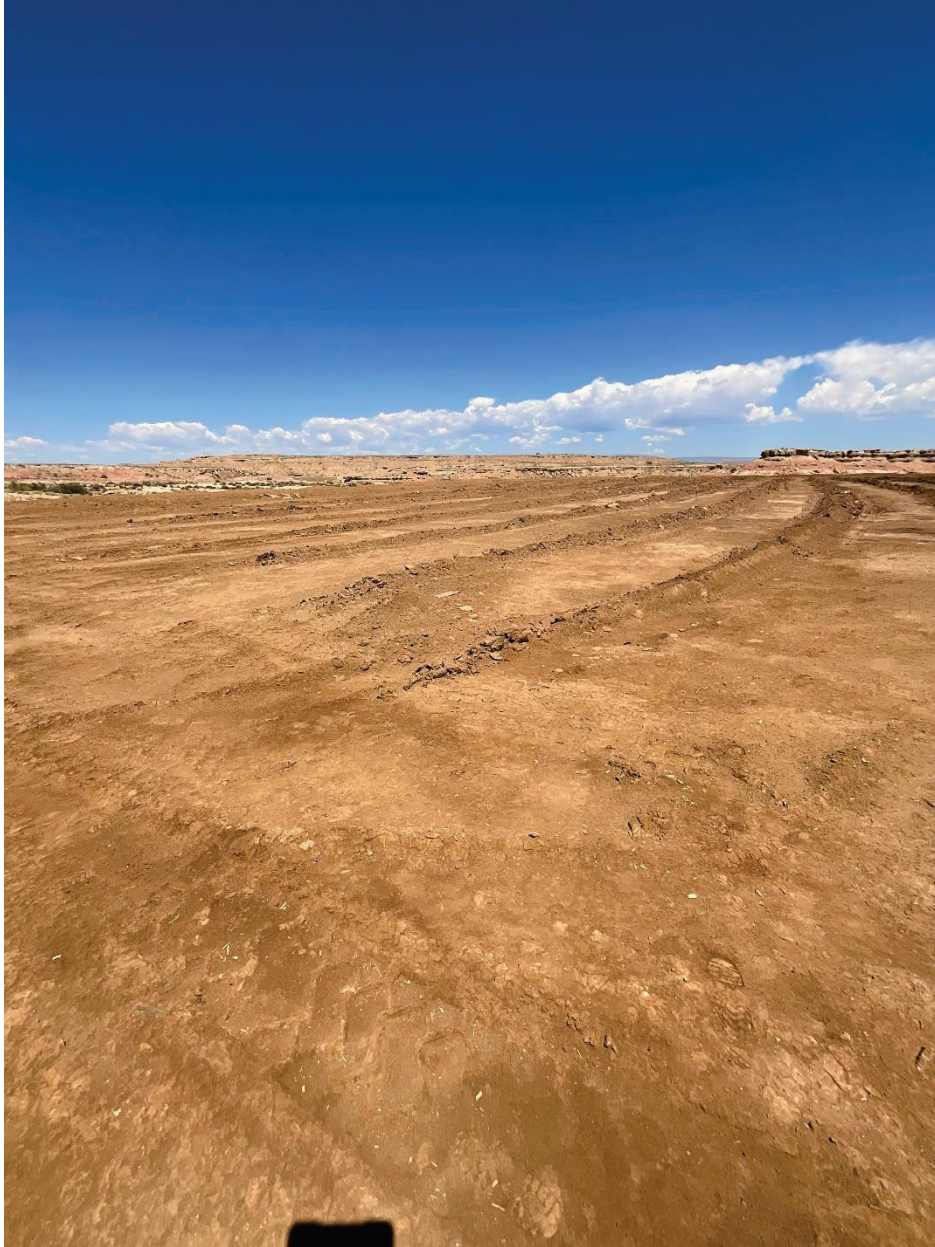
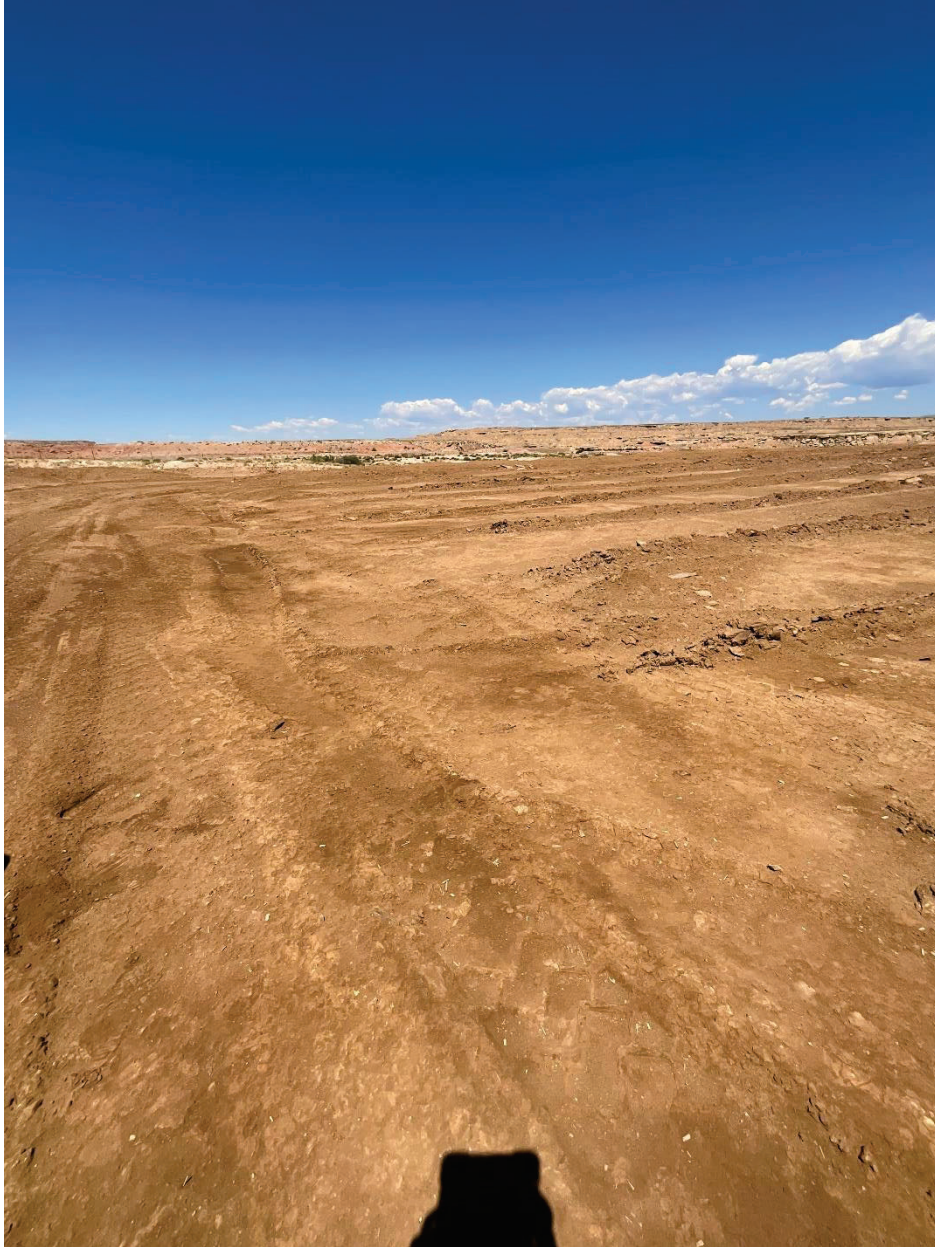
Photo 26: IMG\_0174.jpg, 7/9/2024 12:00 p.m. – photo of the landfarm taken on the south side, near the southwest corner, facing east/northeast.

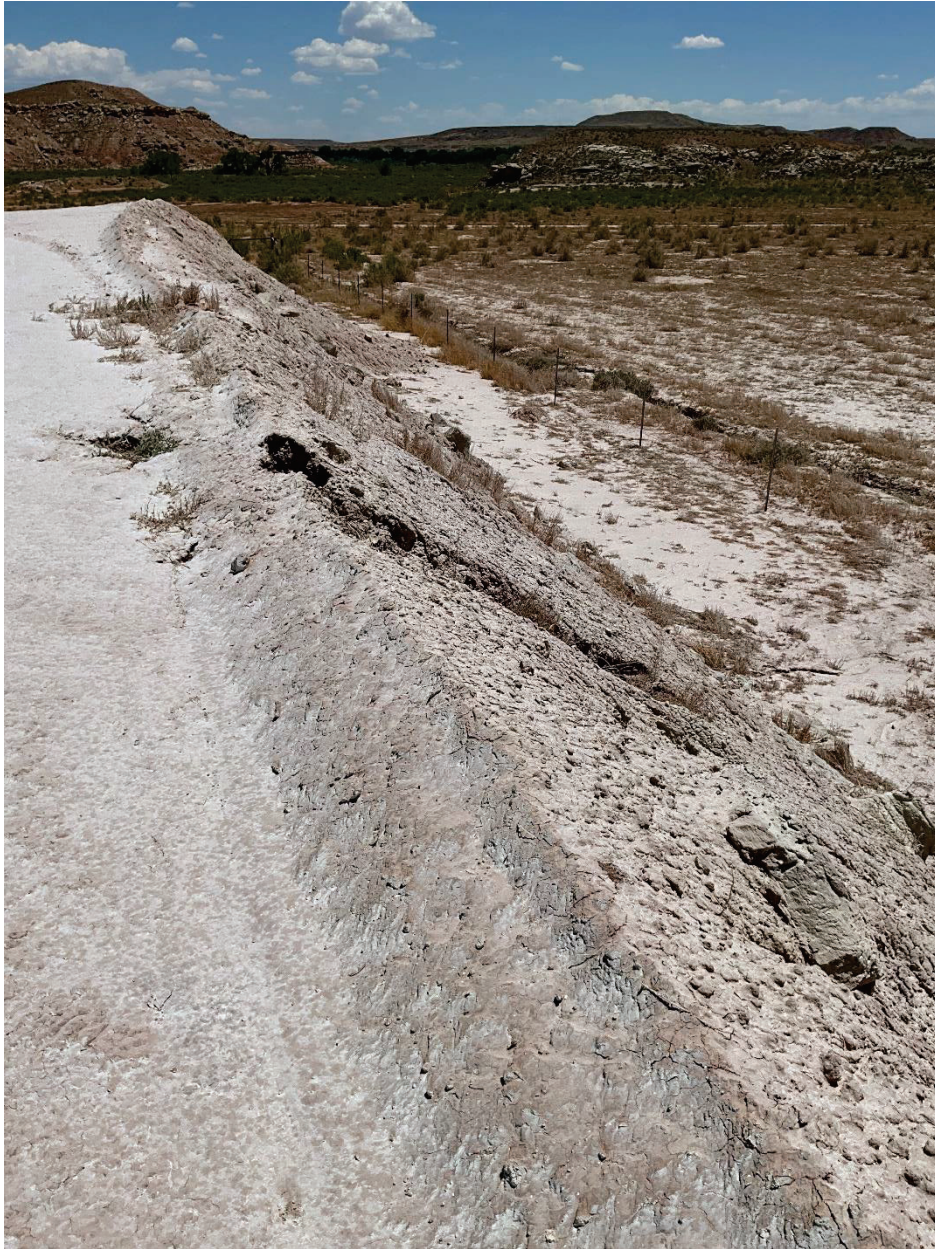
At Pond 9, I observed erosion on the south side of the pond. See Attachment 2, photos 39 and 40. Mr. Nebeker said they would get it repaired promptly.

Photo 39: IMG\_0187.jpg, 7/9/2024 1:11 p.m. – photo of erosion south of Pond 9.

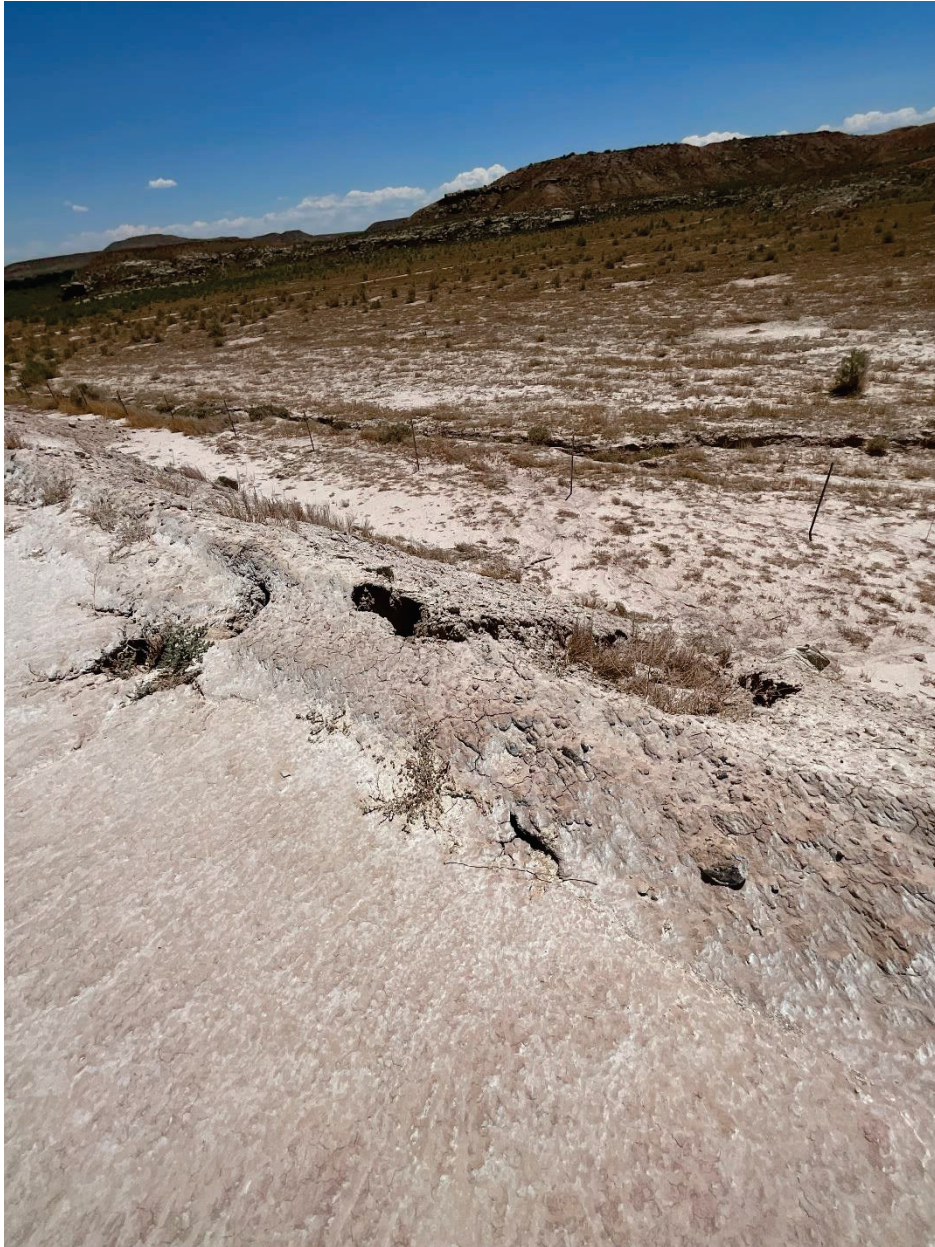
Photo 40: IMG\_0188.jpg, 7/9/2024 1:11 p.m. – photo of the same erosion shown in photo 39.
