**CWA COMPLIANCE EVALUATION INSPECTION REPORT  
U.S. ENVIRONMENTAL PROTECTION AGENCY, REGION 5**

Compliance Sampling Inspection

Conrad Farms LLC  
19900 Indian Hollow Road  
Grafton, Ohio  
Lorain County, Ohio  
41.192011, -82.101401

**Date of Inspection:** 4/18/2022

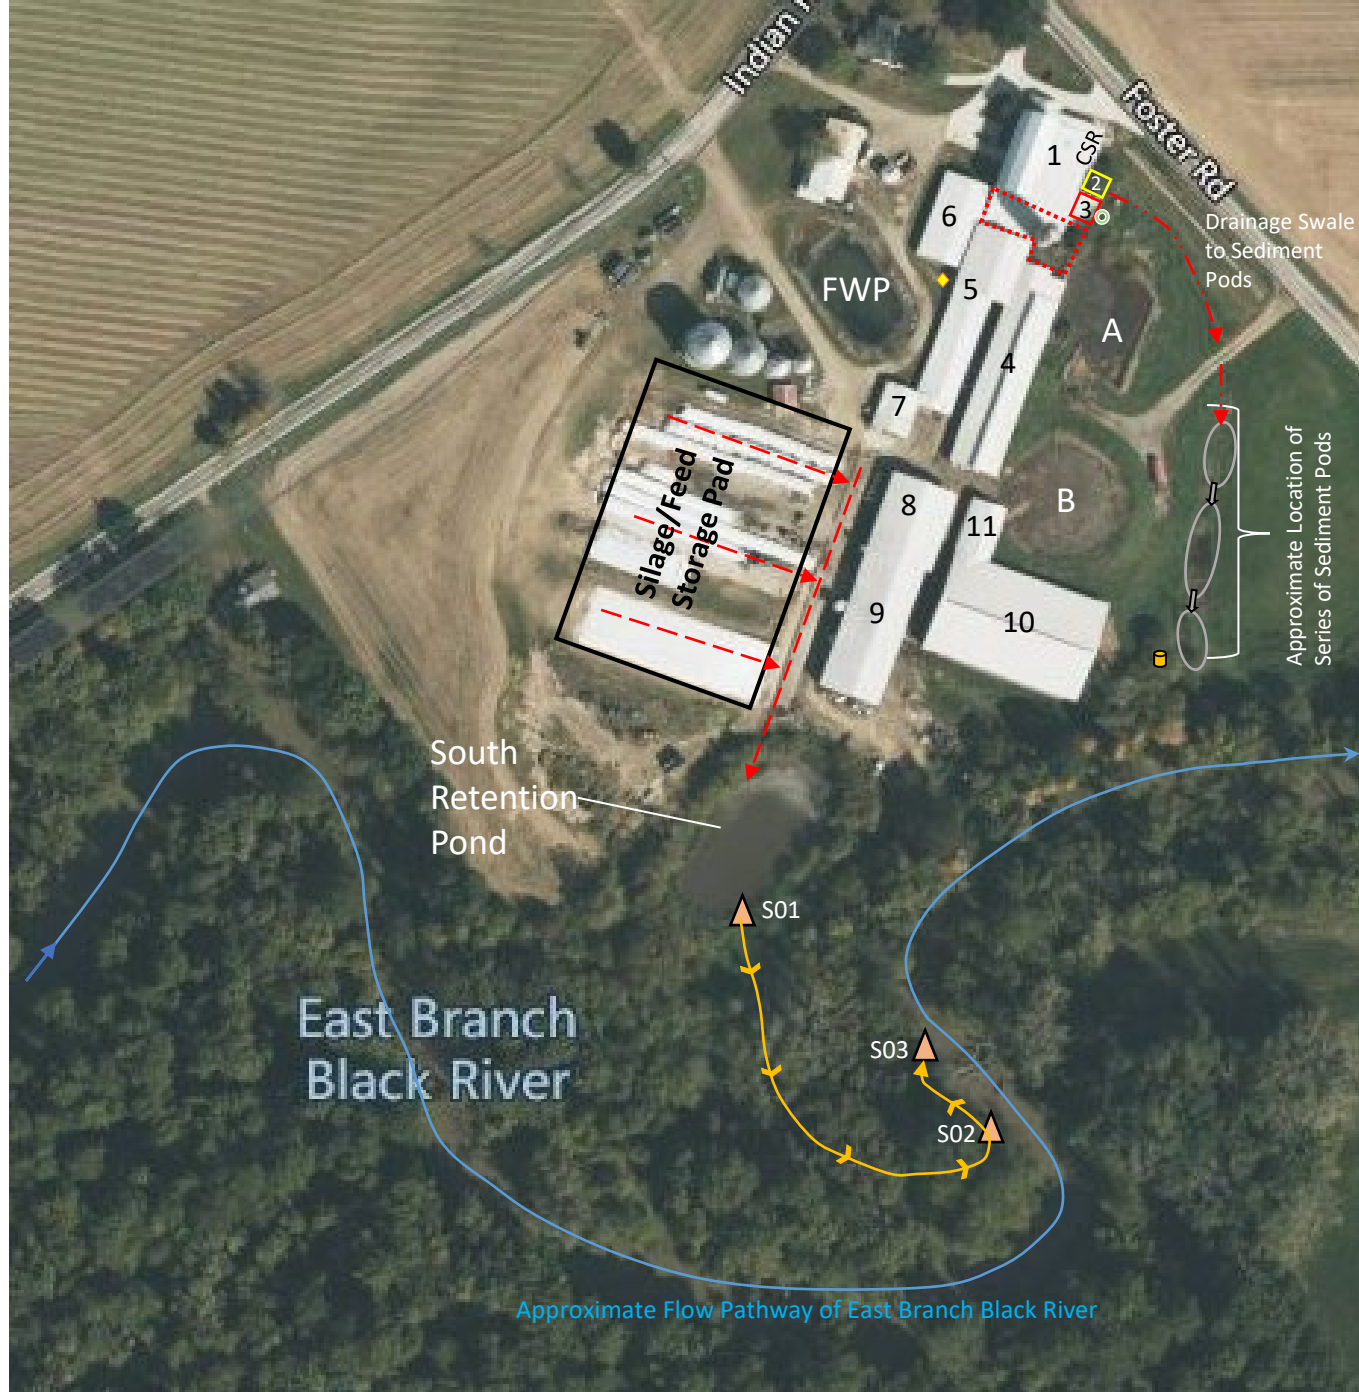
Approximated Flow Pathway of Process Wastewater from South Retention Pond to the Discharge Point into East Branch Black River

Sample Locations (approximate)  
Note: S01 is also the location of the observed overflow from the South Retention Pond.

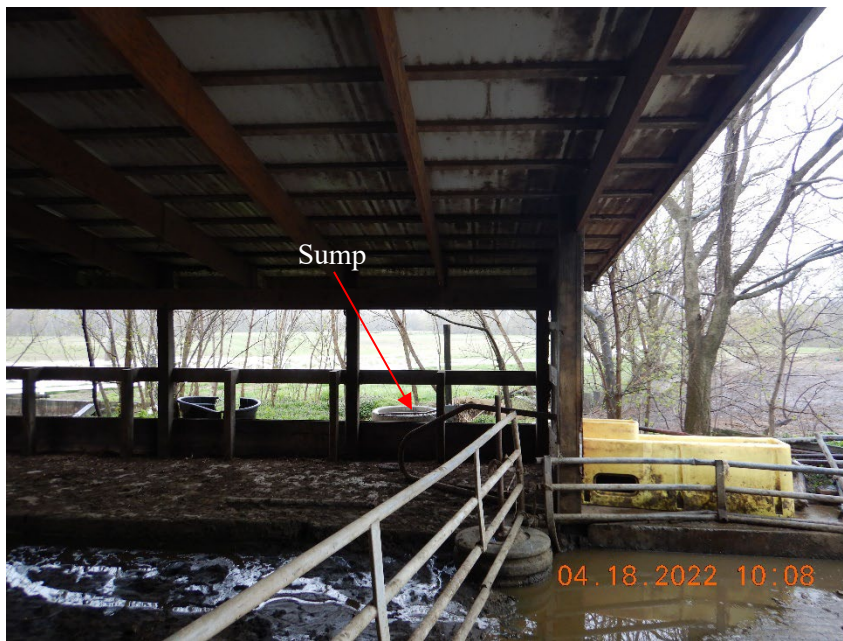
2: DSCN3675

**Description:** Southern end of animal treatment area. View of concrete reception sump (see arrow) that receives milking parlor flush water, and discharges it via a float activated sump pump through a pipe, into the north manure lagoon.

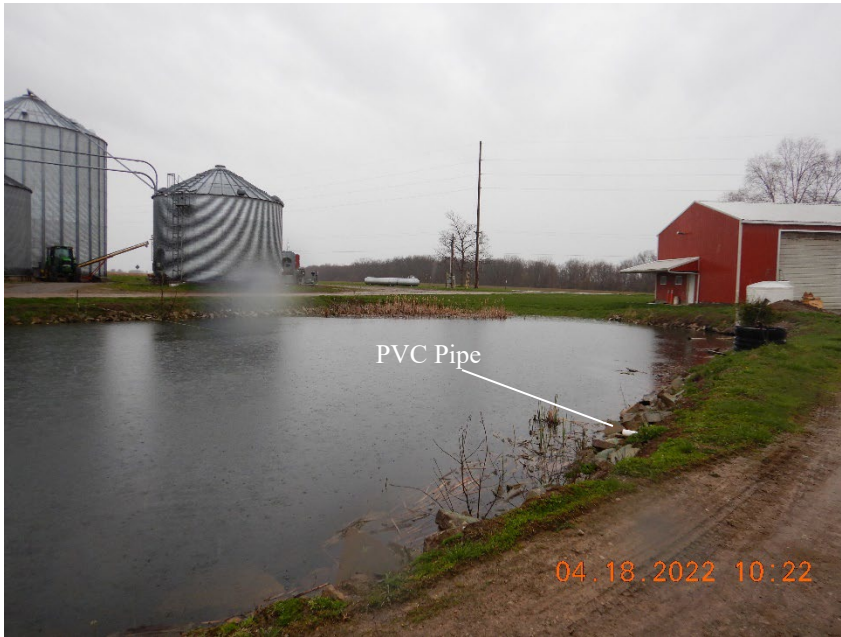
3: DSCN3676

**Description:** Clean water pond

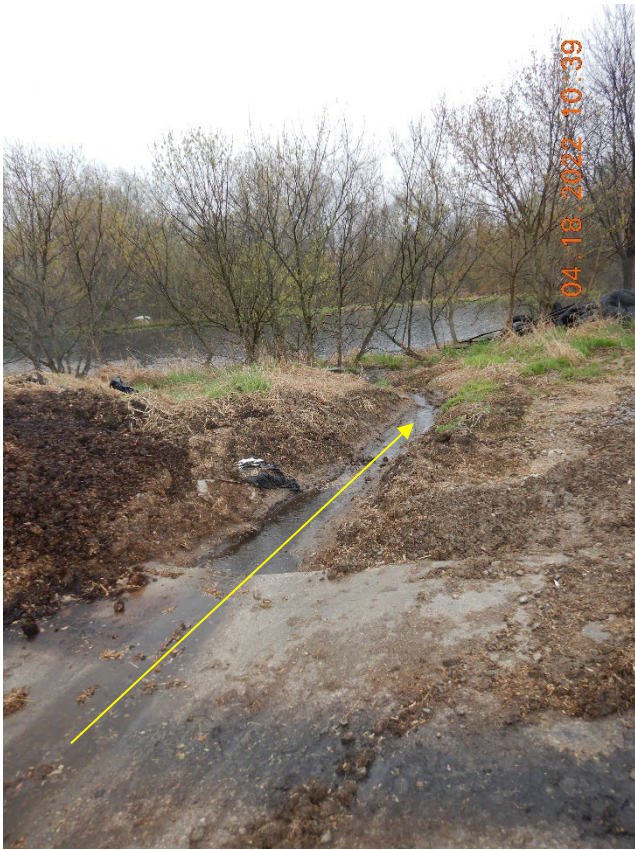
6: DSCN3679

**Description:** Process wastewater run-off from the silage/feed storage pad is designed to flow from the southeast corner of the silage/feed storage pad, south into the south retention pond. Arrow shows general direction of flow.

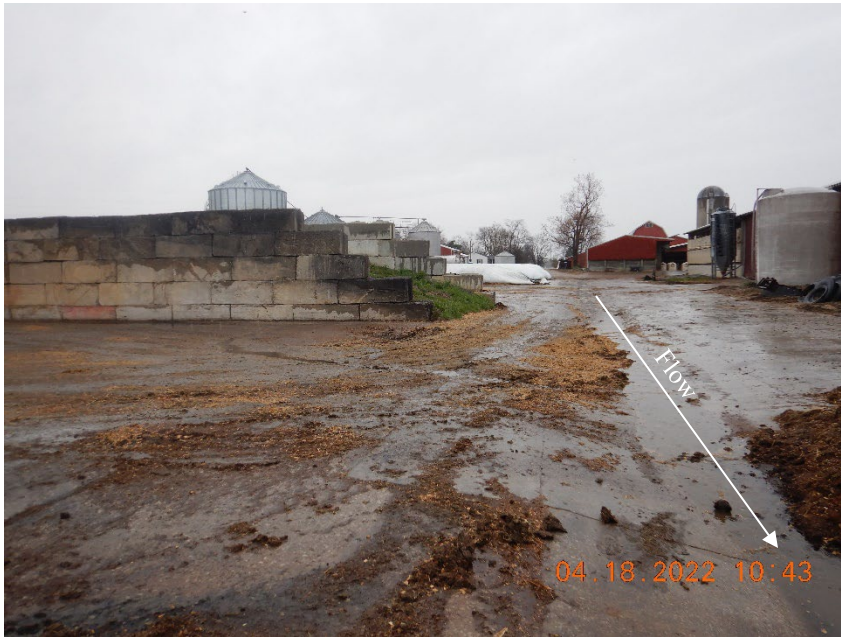
8: DSCN3681

**Description:** View looking north at the concrete drainage pathway for silage/feed storage pad process wastewater run-off along the eastern edge of the pad area.

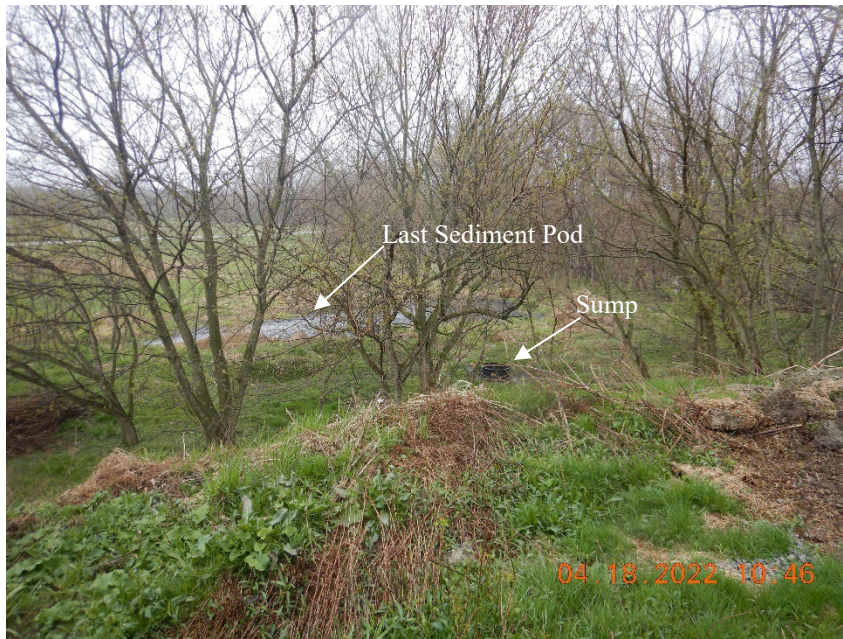
10: DSCN3683

**Description:** The black corrugated plastic reception sump (center-right in the photograph) receives flow from the last sediment pod in the series.

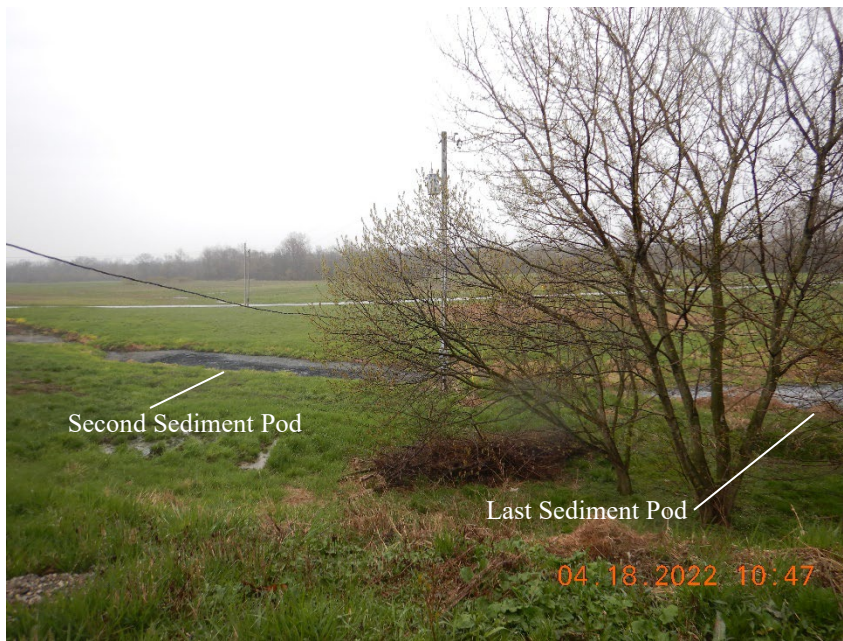
11: DSCN3684

**Description:** View of the second to last sediment pod in the series on the east side of the facility, as seen from the slightly higher elevation off of the east end of the heifer barn. The beginning of the last sediment pod can be seen just off the right edge of the photograph.

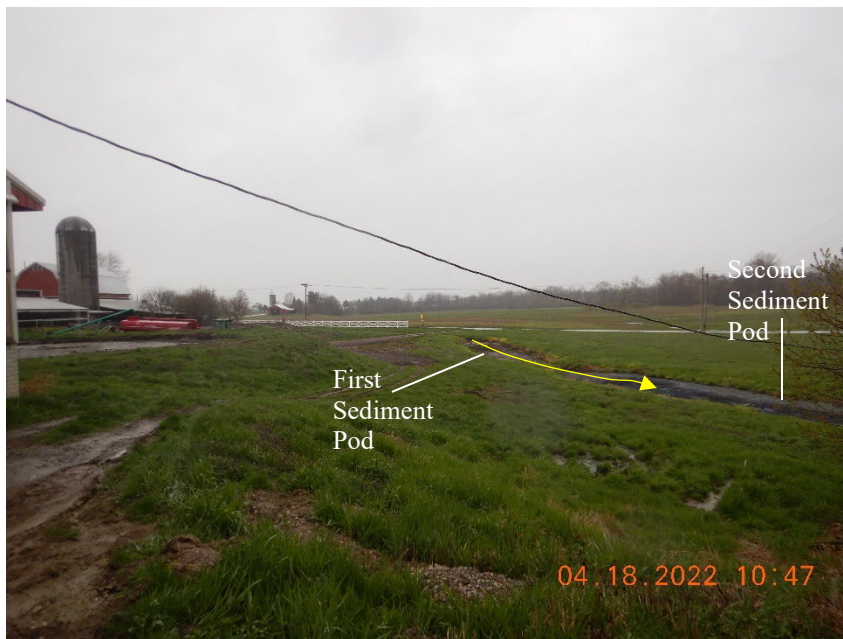
12: DSCN3685

**Description:** View of the beginning of the series of three sediment pods (center right in photograph) on the east side of the facility, as seen from the slightly higher elevation off of the east end of the heifer barn. Arrow shows general direction of flow.

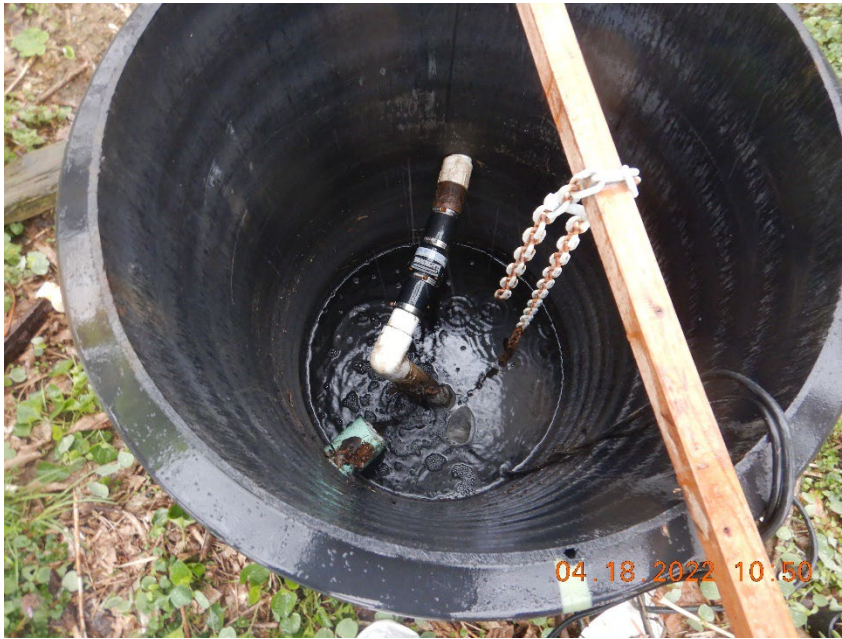
13: DSCN3686

**Description:** There is a submersible pump in the plastic reception sump that receives flow from the last sediment pod in the series. The pump operates on a float and pumps the collected production area storm water and process wastewater run-off from the last sediment pod into the northeast corner of the south retention pod.

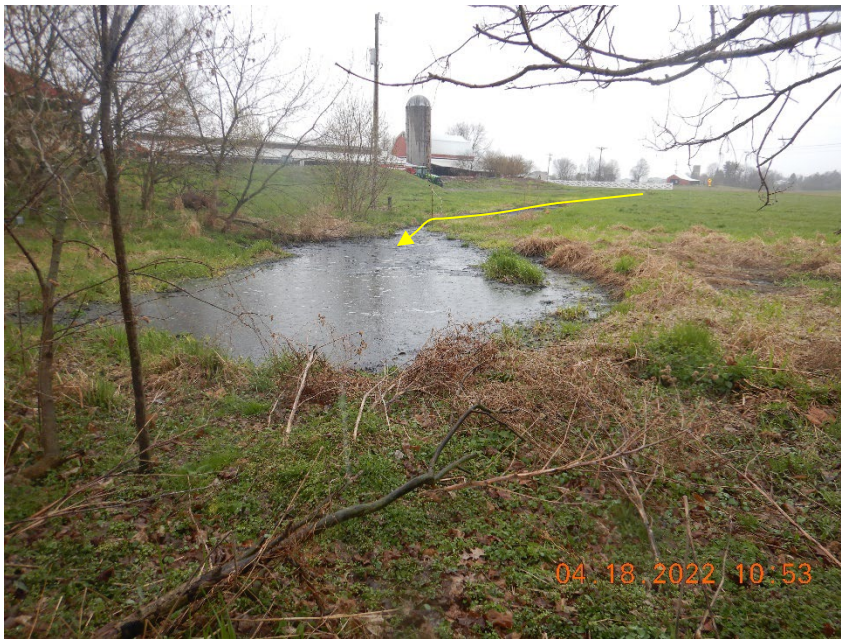
14: DSCN3687

**Description:** Last sediment pod in the series. The pod is surrounded by a raised earthen berm on its east, edge, south and west banks. Arrow shows general direction of flow.

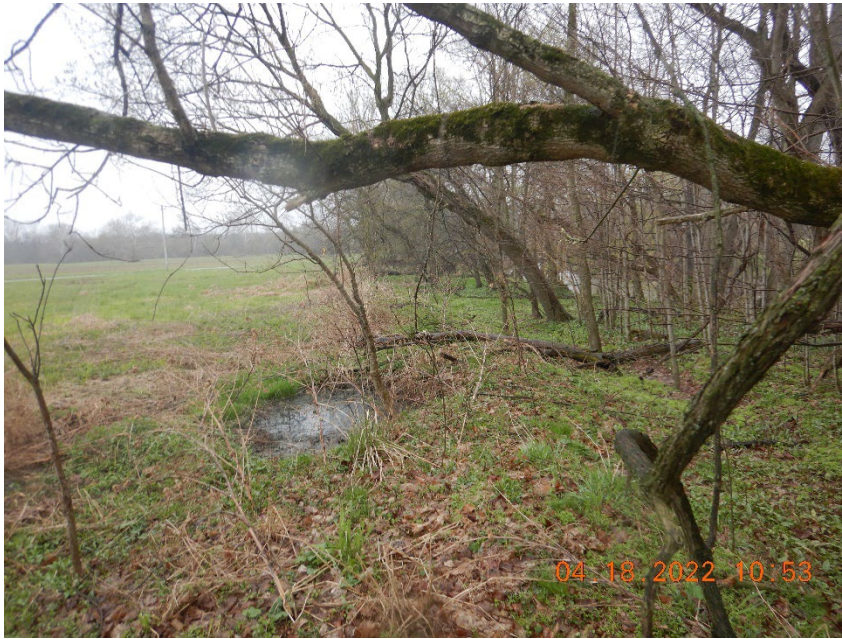
15: DSCN3688

**Description:** Rased vegetated earthen berm constructed to the south of the last sediment pod, between the pod and the woodline along the bank of the East Branch Black River. This earthen berm extends east and west along the woodline. This is the view to the east.

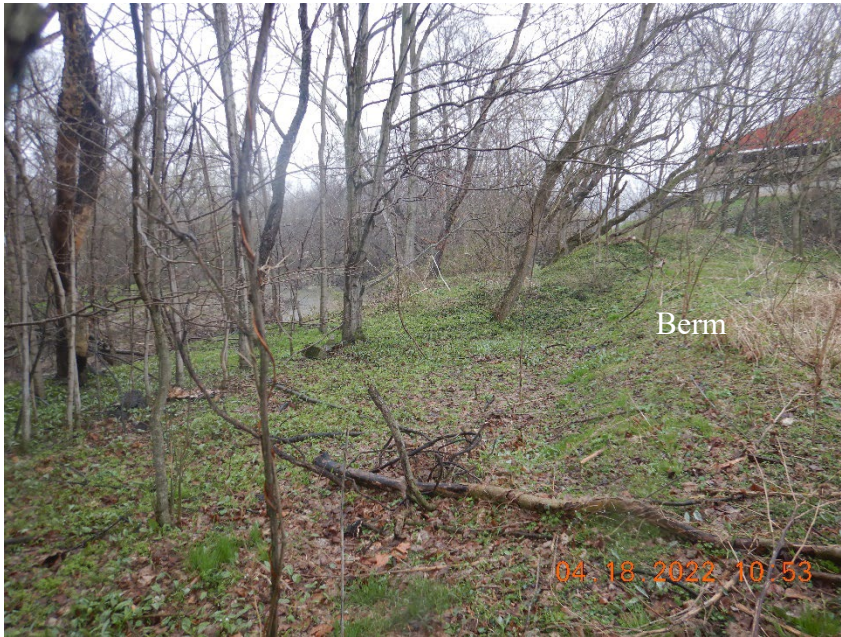
16: DSCN3689

**Description:** Raised vegetated earthen berm constructed to the south of the last sediment pod, between the pod and the wood line along the bank of the East Branch Black River. This view is of the earthen berm extending to the west along the woodline.

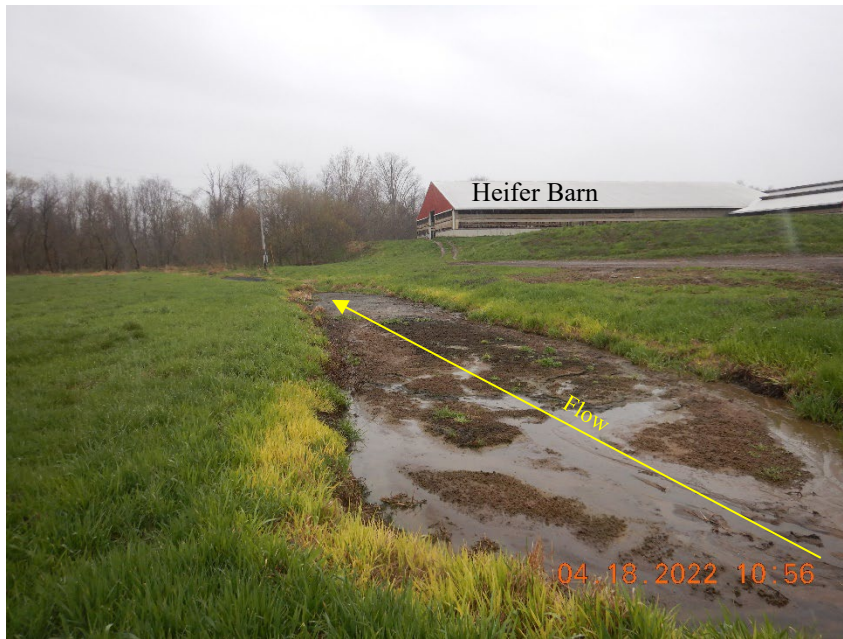
17: DSCN3690

**Description:** First sediment pod in the series of three pods. The series of sediment pods is located at a slightly lower elevation to the rest of the production area. The north side of the heifer barn is visible in the background. The grassed berm in the upper right of the photograph is the berm of the larger south manure lagoon.

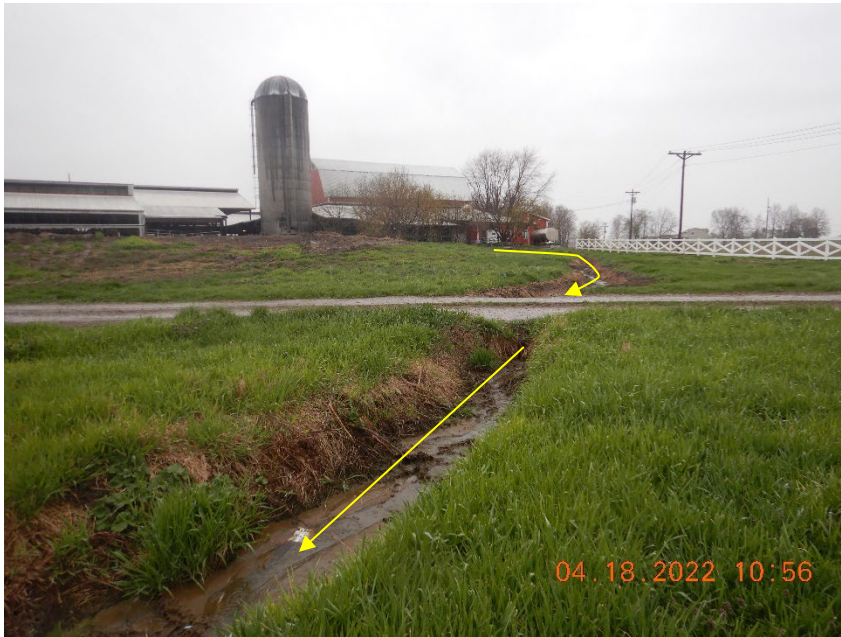
18: DSCN3691

**Description:** View of the drainage swale that directs production area stormwater run-off to the series of sediment pods. This view is looking upstream towards the northeast corner of the milking parlor building and animal treatment area where run-off flow begins. The production area stormwater run-off in this drainage swale is from the northeast side of the facility and includes roof run-off from the milking parlor, roof run-off from the cow treatment area, and process wastewater/stormwater surface run-off from the unroofed portion of the north end of the animal treatment area. Arrows show general direction of flow.

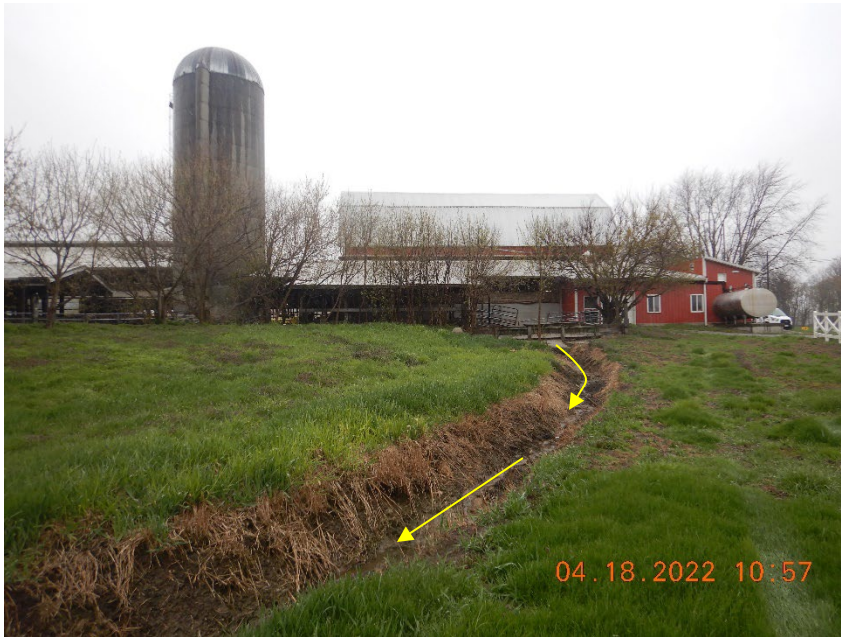
19: DSCN3692

**Description:** View of the drainage swale looking upstream towards the northeast corner of the milking parlor building and animal treatment area where the production area stormwater/process wastewater run-off flow begins. Production area stormwater run-off from the unroofed portion of the cow treatment area (process wastewater), roof run-off from the roofed portion of the cow treatment area, and the milking parlor roof run-off flows into the swale and then into the series of sediment pods. Arrows show general direction of flow.

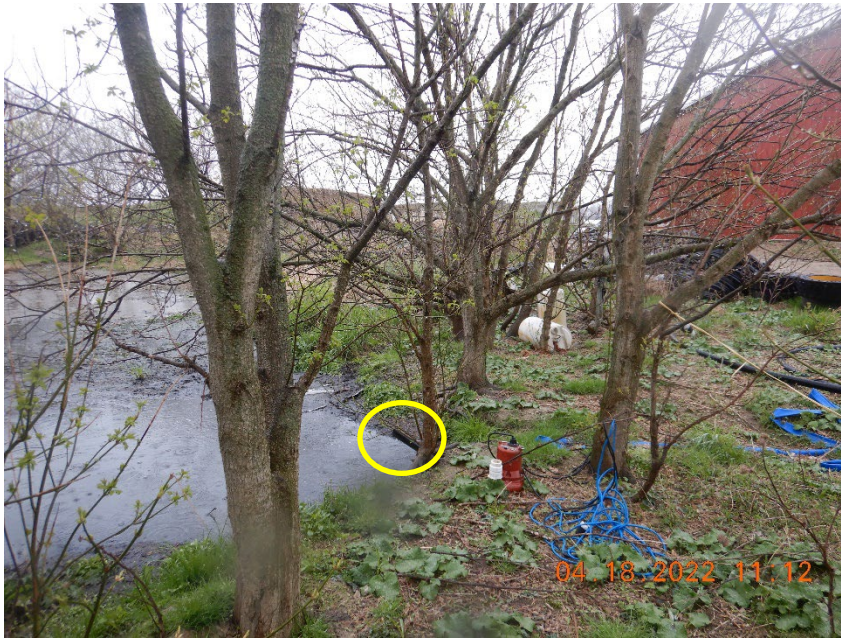
20: DSCN3693

After walking the flow path for the series of sediment pods, EPA, Richard Conrad, and Dave Conrad walked the perimeter of the south retention pond. At the northeast edge of the south retention pond, EPA observed a length of black plastic piping rising out of the bank of the pond. Richard Conrad identified that this pipe discharges the liquid flow from the last sediment pod reception sump into the south retention pond. There was also a submersible pump present that is used to transfer liquids from the pond to the manure storage lagoons as needed. EPA photographed the northeast edge of the pond to document the black pipe, submersible pump, and the adjacent blue lay-flat overland hose (Photographs DSCN3693 and DSCN3694). Evidence of solids deposition within the south retention pond was also visible in Photograph DSCN3694. EPA walked south/southwest from the northeast edge of the south retention pond (Photograph DSCN3695) to the southeast edge of the south retention pond. EPA photographed the grassed and partially bermed area to the east of the south retention pond (Photographs DSCN3696 and DSCN3697). At the northeast edge of the south retention pond, EPA observed that the south retention pond was actively discharging. EPA followed the active discharge flow through the grassed area and into the woods located to the south/southeast of the south retention pond. EPA continued to follow the discharge flow southeast through the woods and then northeast/north along the edge of the woods adjacent to the bank of the East Branch Black River where the flow then discharged into the East Branch Black River.

**Description:** Northeast edge of the south retention pond. EPA observed a length of black plastic piping rising (circled in yellow) out of the bank of the pond. This pipe discharges the liquid flow from the sediment pod reception sump into the south retention pond. The red submersible pump and blue lay-flat overland hose are used to transfer liquids from the south retention pond to the manure storage lagoons.

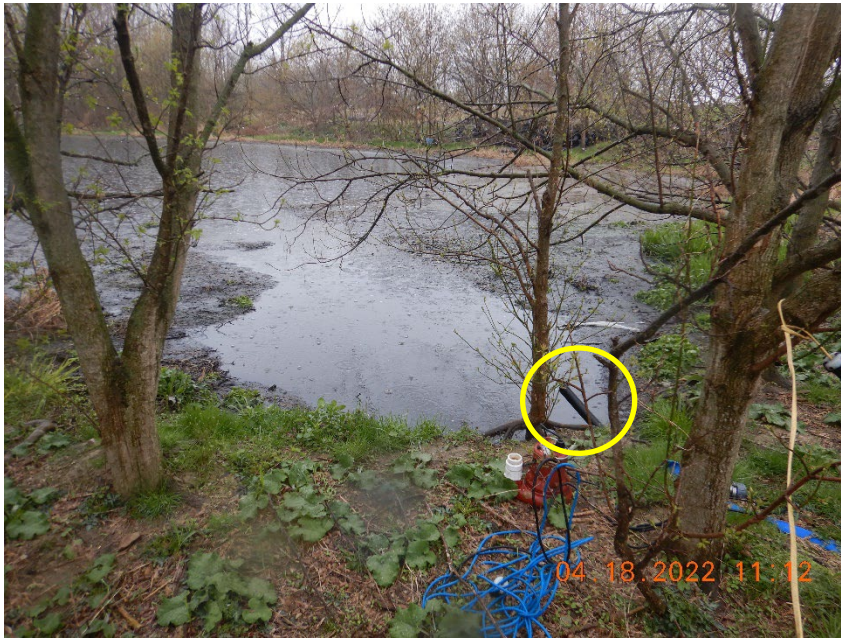
21: DSCN3694

**Description:** Northeast edge of the south retention pond. The black plastic piping (circled in yellow) rising out of the bank of the pond discharges the liquid flow from the sediment pod reception sump into the south retention pond. Evidence of solids deposition within the south retention pond was visible. Silage and feed solids carried in the process wastewater run-off from the silage/feed storage pad would discharge into this south retention pond. The silage/feed storage pad is also used for emergency stacking storage capacity for used penpack bedding; and, at those times, the process wastewater run-off from the silage/feed storage pad may also contain manure solids which would be discharged to this south retention pond as well. Fine sediments may also be contributed by the liquids pumped from the sediment pod series reception sump into the south retention pond.

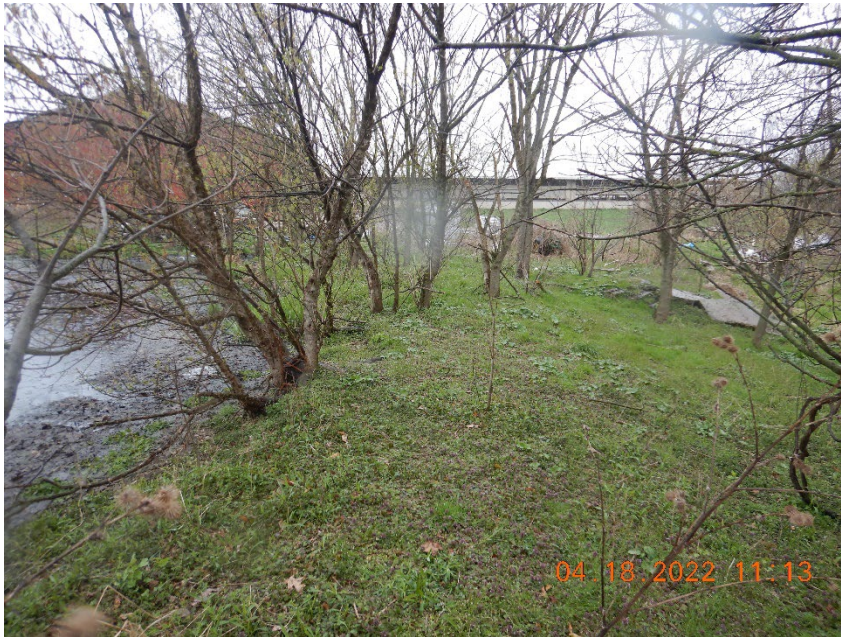
22: DSCN3695

**Description:** View along the east edge of the south retention pond (pond to the left in photograph). Woody vegetation is growing along the edge of the pond.

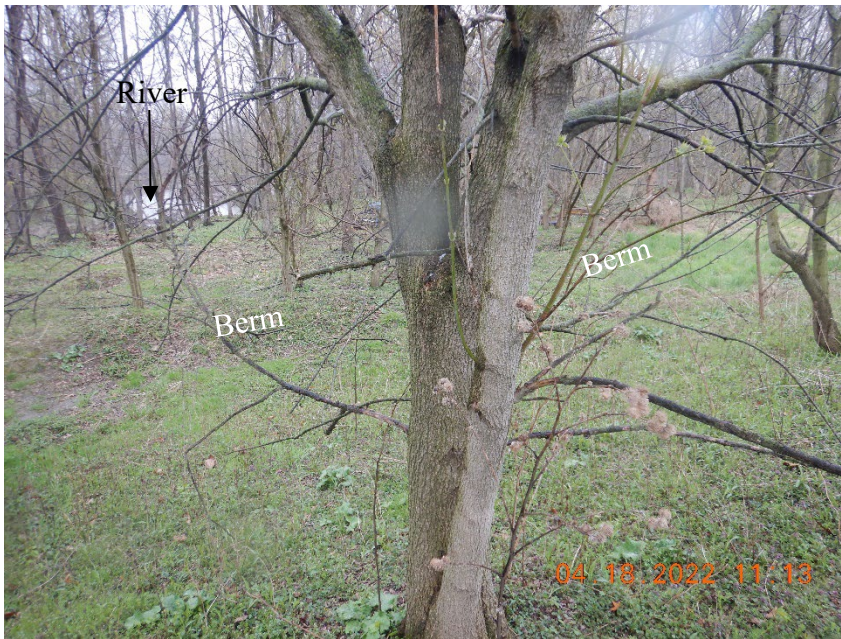
24: DSCN3697

**Description:** View from the east edge of the south retention pond. Note the secondary raised earthen berm southeast of the south retention pond. The East Branch Black River can be seen in the upper left corner of the photograph between the trees.

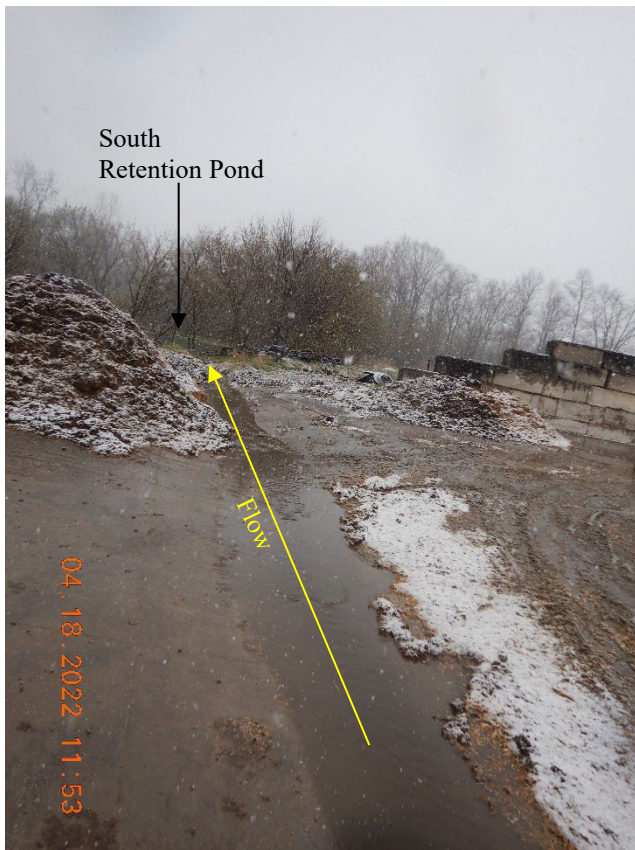
25: DSCN3698

**Description:** Silage/feed storage pad process wastewater run-off is designed to drain east towards the eastern edge of the pad, and then south/southeast into the south retention pond.

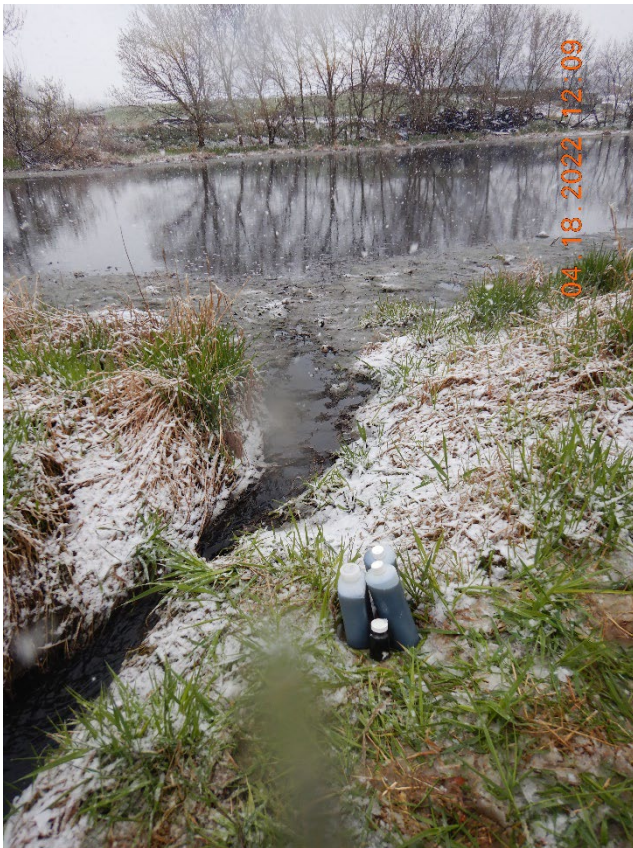
26: DSCN3699

<b>Describe the surface flow pathways:</b>	
At the time of the inspection, EPA observed the southeast edge of the south retention pond to be overflowing and discharging into the tall grass area. EPA followed the flow through the grassed area and into the woods located to the southeast of the south retention pond. EPA observed the flow as it continued southeast/east through the woods and then northeast/north along the edge of the woods adjacent to the bank of the East Branch Black River where the flow then discharged into the East Branch Black River.	
<b>How many months out of the year is there flow in the nearest surface water pathway:</b>	According to Richard Conrad, the East Branch Black River flows 12 months out of the year.
<b>Are there any storm water pathways entering the facility?</b>	No storm water pathways were observed entering the facility.
<b>Are there any clean water ponds on site?</b>	Yes. One clean water pond on the west side of the property.

<b>Were specific Areas of Concern discussed with facility personnel?</b>	Yes.
<b>Who were the Areas of Concern discussed with?</b> Mr. Richard Conrad	
<p><b>Specific Areas of Concern Discussed:</b> EPA explained that the discharge from the south retention pond was observed to be flowing through the thick grass, south/southeast through the adjacent woods and then finally discharging into the East Branch Black River. EPA explained that this was a concern because the south retention pond receives process wastewater run-off and leachate from the silage/feed storage pad, as well as the process wastewater run-off and stormwater run-off that is contained in the series of sediment pods and subsequently pumped into the south retention pond. The discharge from the south retention pond therefore is comprised of production area process wastewater and contaminated stormwater. The discharge is an unpermitted discharge.</p>

**Description:** The south retention pond was observed to be overflowing from its southeast edge. sample S01 was collected from the point of overflow.

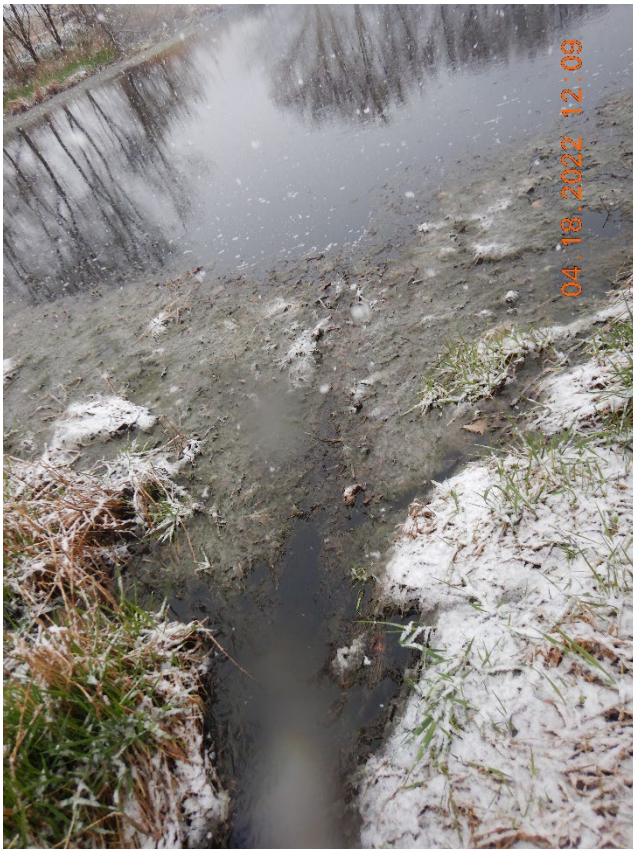
27: DSCN3700

**Description:** Close up view of the overflow point from the south retention pond where sample S01 was collected.

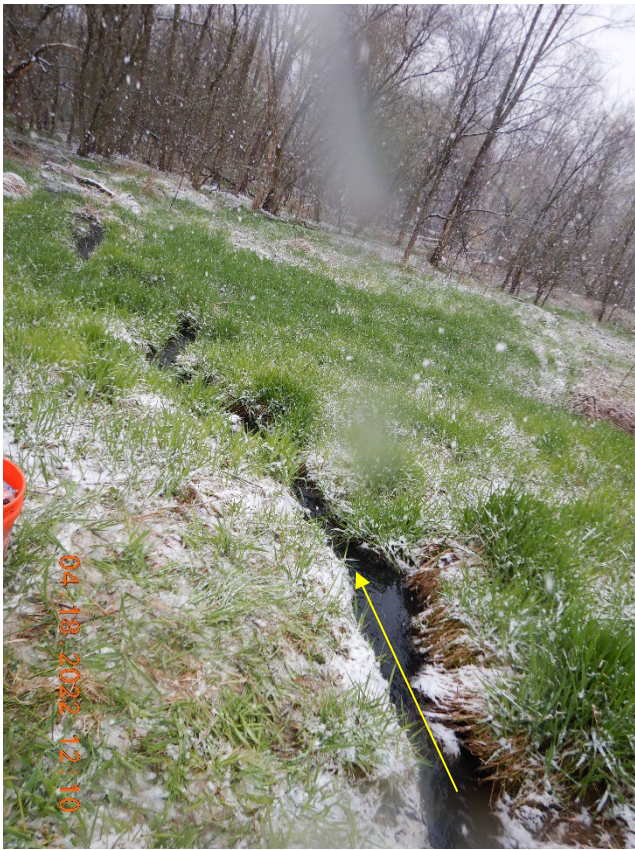
28: DSCN3701

**Description:** View of the flow pathway of the process wastewater discharge from the south retention pond overflow into the adjacent grassed area. Arrow shows direction of flow.

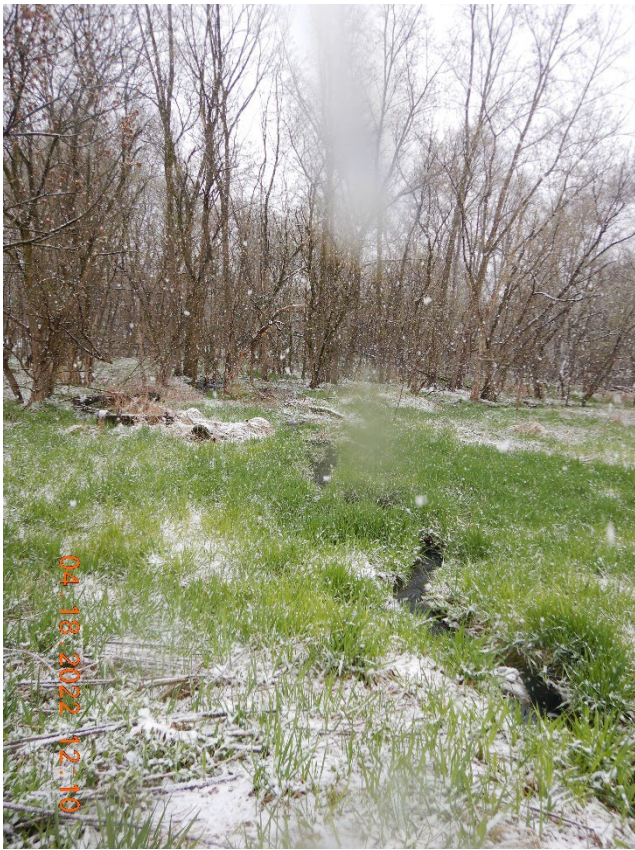
29: DSCN3702

**Description:** View of the flow pathway of the process wastewater discharge from the south retention pond overflow through the adjacent grassed area as it reaches the woodland located to the south/southeast of the pond.

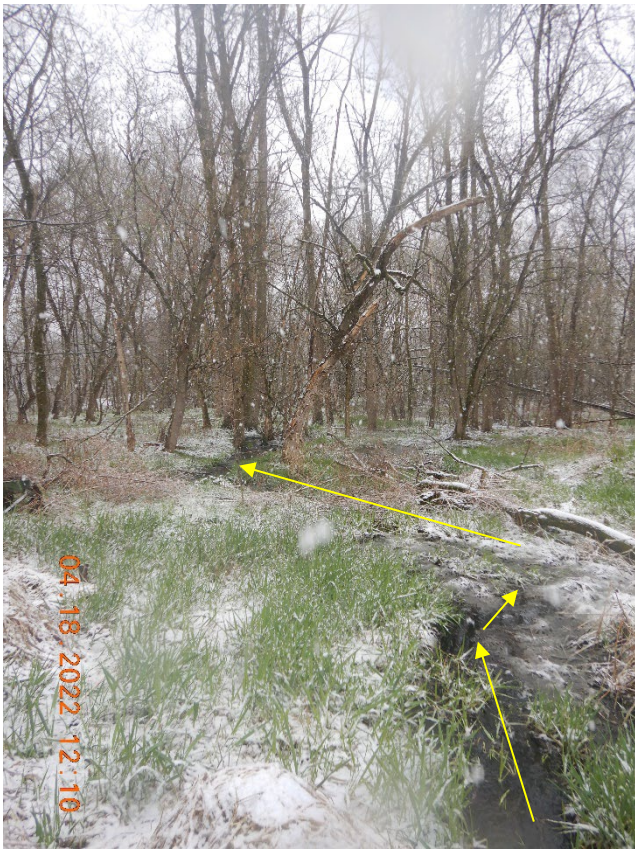
30: DSCN3703

**Description:** View of the flow pathway of the process wastewater through the grassed area as it enters the woodland located to the south/southeast of the pond. The general direction of flow is identified with arrows.

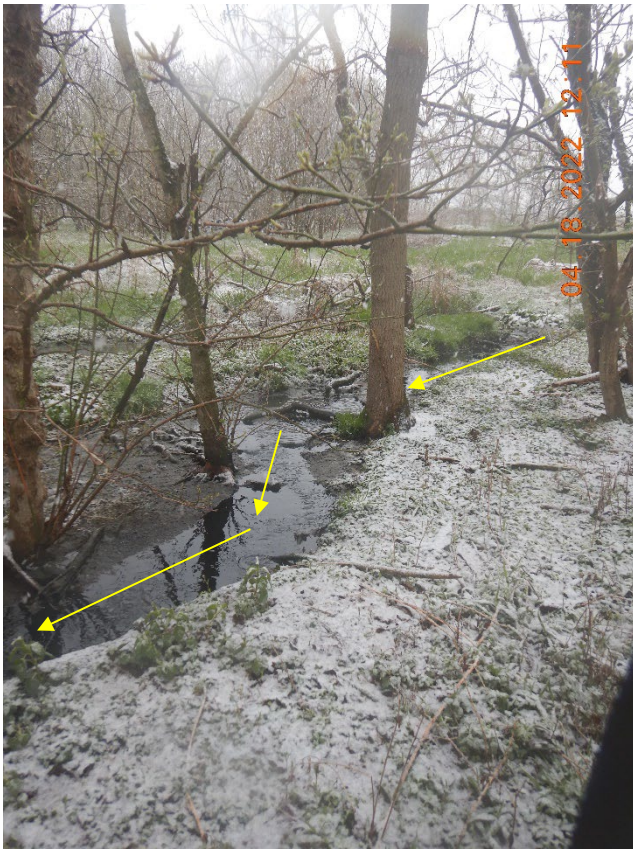
31: DSCN3704

**Description:** View of the flow pathway of the process wastewater discharge as it enters the woods, looking back towards the south retention pond through the grassed area as it enters the woodline located to the south/southeast of the pond. Direction of flow is from the right side towards the left lower corner of the photograph.

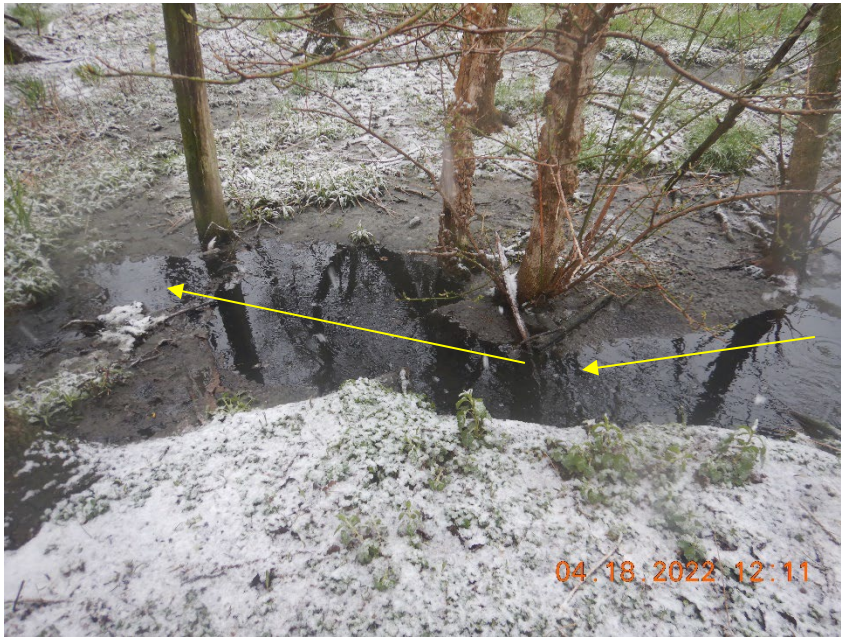
32: DSCN3705

**Description:** Flow pathway of the process wastewater discharge through the woods, next section of flow immediately after Photograph DSCN3704. Arrows show general direction of flow.

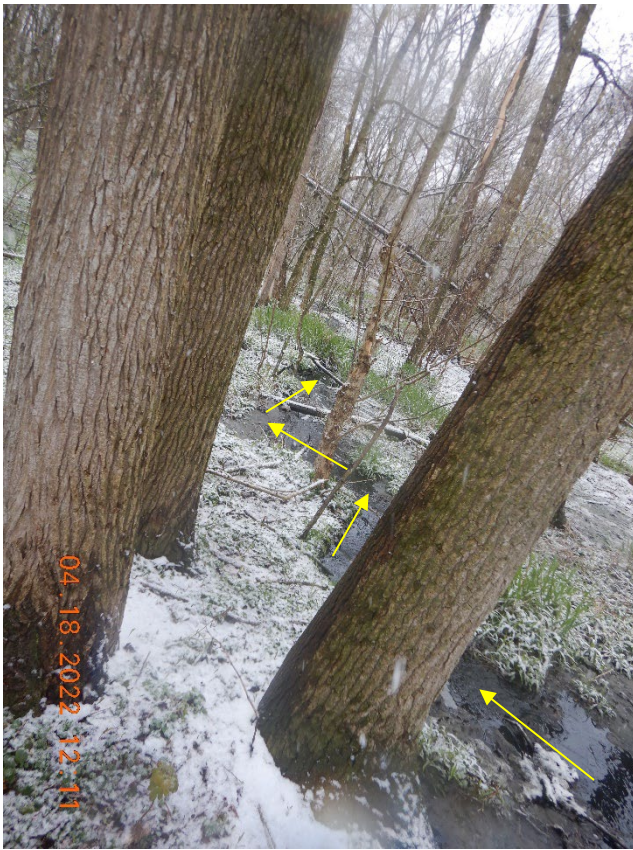
33: DSCN3706

**Description:** Flow pathway of process wastewater discharge through the woods, next section of flow in sequence after Photograph DSCN3705. Arrows show general direction of flow.

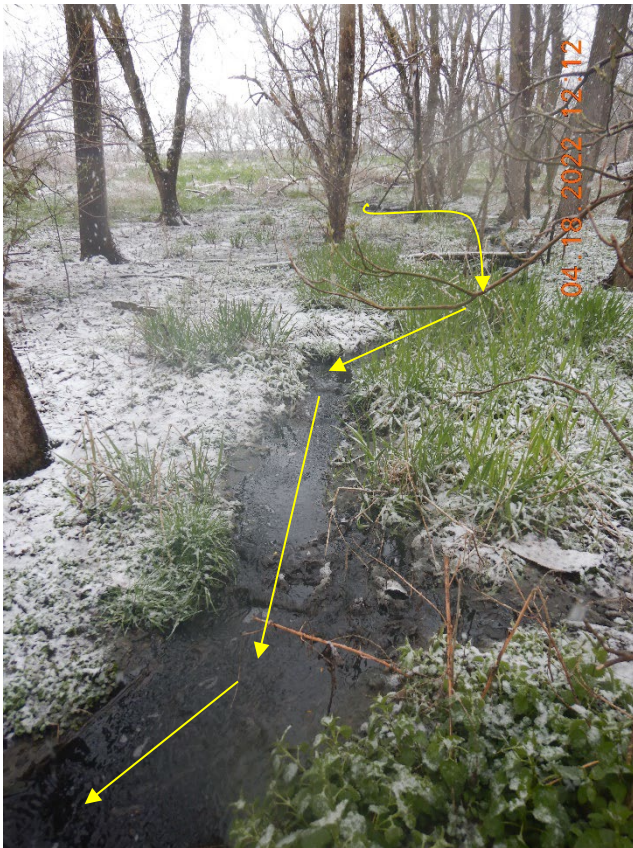
34: DSCN3707

**Description:** Flow pathway of the process wastewater discharge through the woods, looking upstream, towards the south retention pond. Photograph looking back towards area seen in Photograph DSCN3706. Arrows show general direction of flow.

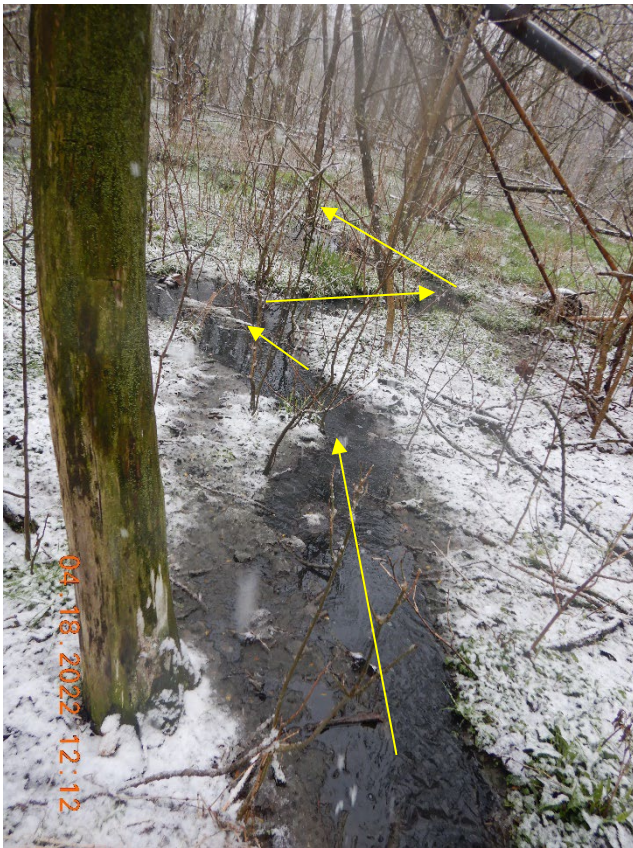
35: DSCN3708

**Description:** Flow pathway of the process wastewater discharge through the woods, next section of flow in sequence after Photograph DSCN3706. Arrows show general direction of flow.

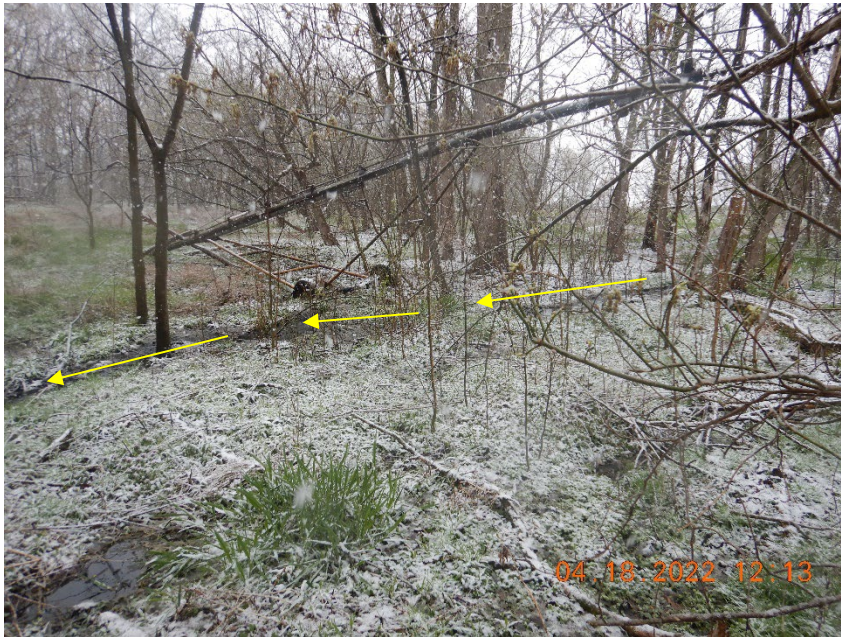
36: DSCN3709

**Description:** Flow pathway of the process wastewater discharge through the woods, next section of flow in sequence after Photograph DSCN3708. Flow direction from right side of photograph to left side of photograph. Arrows show general direction of flow.

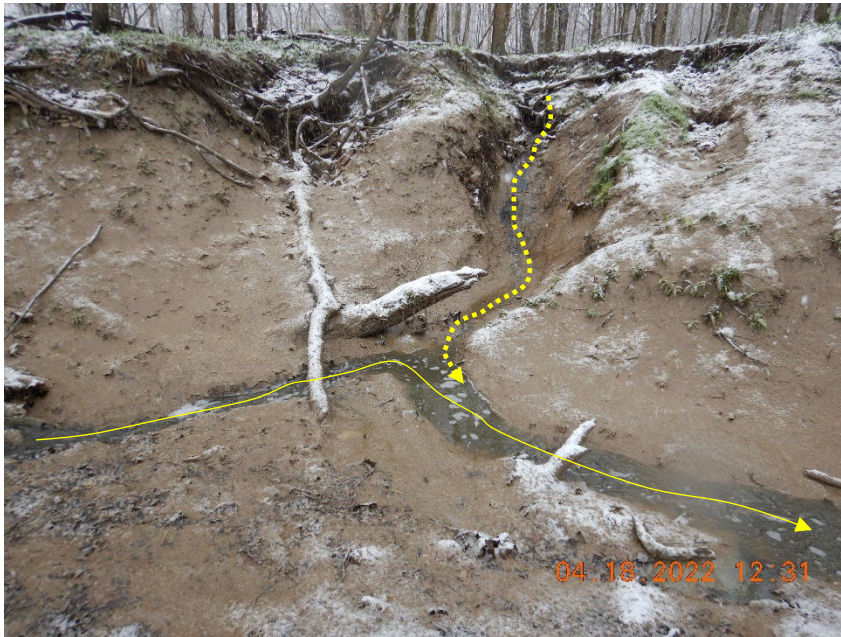
70: DSCN3744

**Description:** Flow pathway of the process wastewater discharge along the east edge of the woods adjacent to the bank of the East Branch Black River, next section of flow in sequence after Photograph DSCN3742. A solid line arrow shows the general direction of flow for the process wastewater discharge pathway. Clear colored run-off from the top edge of the woodline (dotted arrow) was observed to be flowing into the drainage pathway of the process wastewater discharge.

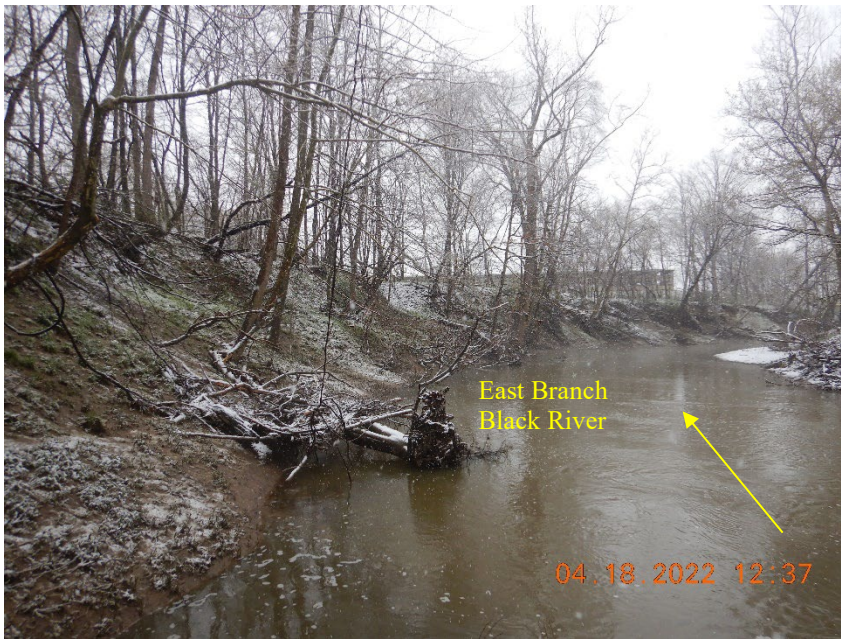
81: DSCN3755

**Description:** East Branch Black River. The Conrad Farms heifer barn is visible to the north. Arrow shows general direction of flow.
