**CWA COMPLIANCE EVALUATION INSPECTION REPORT  
U.S. ENVIRONMENTAL PROTECTION AGENCY, REGION 5**

Compliance Sampling Inspection

Conrad Farms LLC  
19900 Indian Hollow Road  
Grafton, Ohio  
Lorain County, Ohio  
41.192011, -82.101401

**Date of Inspection:** 4/18/2022

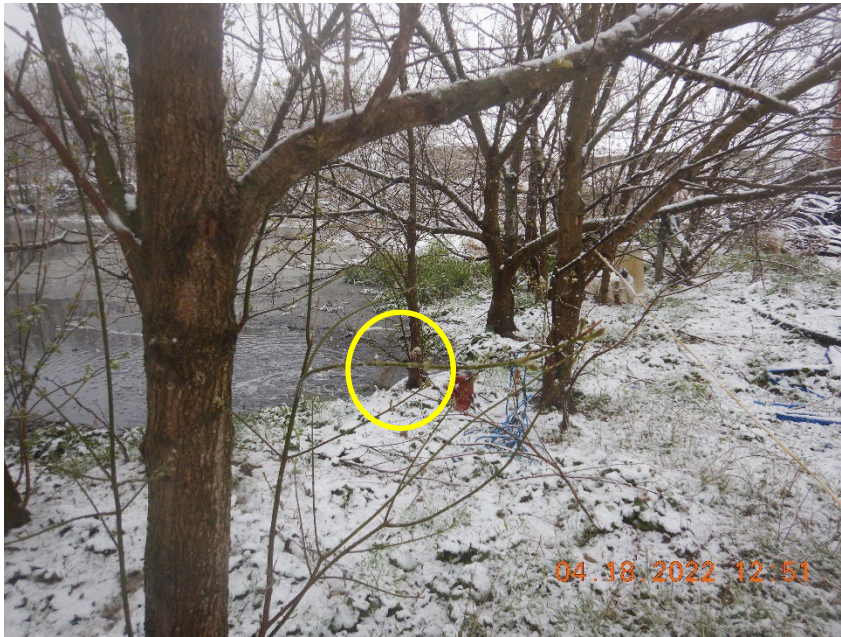
82: DSCN3757

During the walk back to the EPA vehicles, EPA observed the black pipe at the northeast edge of the south retention pond discharging sediment pond liquid into the south retention pond. EPA photographed the flow from the pipe (Photographs DSCN3757 and DSCN3758). EPA also documented the stormwater flow in the drainage swale along the exterior of the west side of the west freestall barn located on the east side of the driveway. The flow in the swale enters into a catch basin located in the grassed area on the west side of the west freestall barn (Photograph DSCN3759) between the commodity barn on the south end and the section of the west freestall barn for recently calved cows. This catch basin receives storm water from downspouts on the west freestall barn as well as runoff from the grass swale (Photographs DSCN3760 and DSCN3761). Richard Conrad stated earlier in the inspection walk-through that this catch basin drains to a surface outlet in the woods on the south end of the farm property and does not outlet to the river.

**Description:** While returning to the EPA vehicles with the collected samples, EPA observed liquid discharging into the south retention pond from the black plastic piping rising out of the bank of the pond. This pipe discharges the liquid flow from the sediment pod sump into the south retention pond. The liquid can be seen entering the pond just to the left of the red submersible pump, in the center of the photograph (circled in yellow).

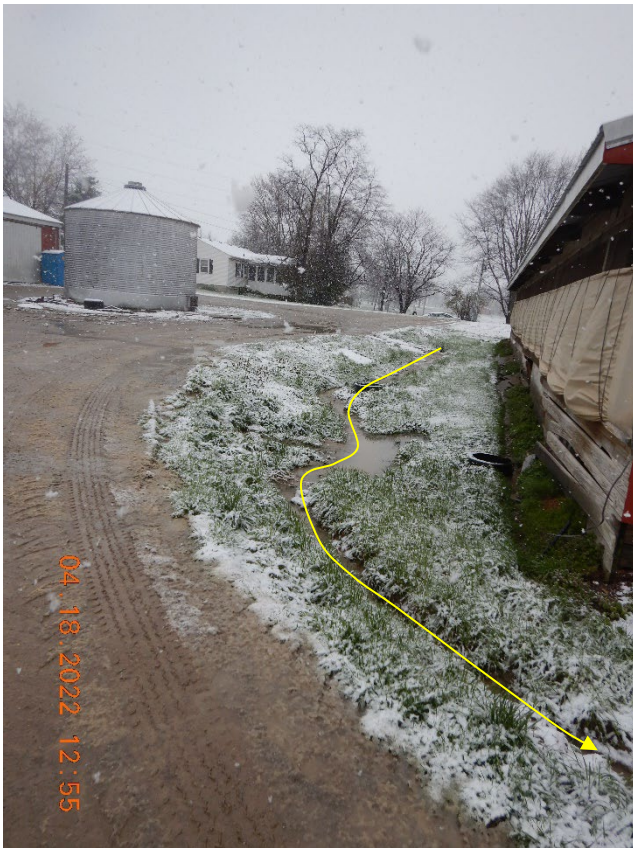
85: DSCN3760

**Description:** EPA observed precipitation run-off in the grassed swale on the west side of the fresh pen area for recently calved cows (part of the west freestall barn). The swale flowed around the fresh pen area of the west freestall barn and into a catch basin as described in Photograph DSCN3759. An arrow shows the general direction of flow in the swale.

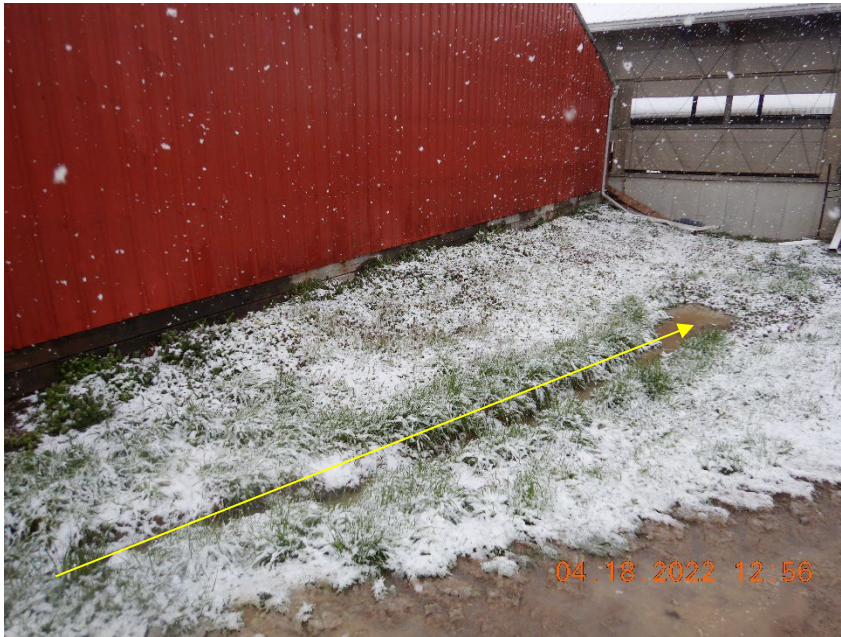
86: DSCN3761

**Description:** EPA observed the precipitation run-off in the grassed swale (Photograph DSCN3760) to be flowing east around the south end of the fresh pen area towards the catch basin. Refer to Photograph DSCN3759 for catch basin description. An arrow shows the general direction of flow in the swale.
